Case Summary

Details				
Case File #:	201509578	Opened Date:	2015-12-02 09:46 AM	
Category:	CO SERVICE	Discovery Date:	2015-11-13	
Type:	WASTE MANAGEMENT	Closed Date:		
Status:	Open	Admin Org Unit:	SOUTH ISLAND ZONE	
Opened By:	PAUWELS, CHARLENE : 64730	Source:	OBSERVE, RECORD AND REPORT PROGRAM	
Lead Investigator:	KISSINGER, MARK	Source Ref #:	15-5485	
Lead Investigator's Phone:		Other Source Agency:		
Major Case:	No	Transferred to Agency:		
Paper File Created:	No	Other Transferred Agency:		
Joint Investigation:	No			
Investigation Review Process:	No	Transferred Agency Contact:		
Investigation Review Date:		Lead Agency:	MINISTRY OF ENVIRONMENT	
Investigation Start Date:	2015-11-13	Joint Agency:	MINISTRY OF ENVIRONMENT	
Joint Agency Contact:		Joint Agency Phone:		
Other Joint Agency:		Joint Agency Case No:		
Case Description:	ERS 15-5485 TOXIC WASTE SITE AND A TAILINGS POND BREACH.			
Members:				
Name	Phone Number	Start Date	End Date

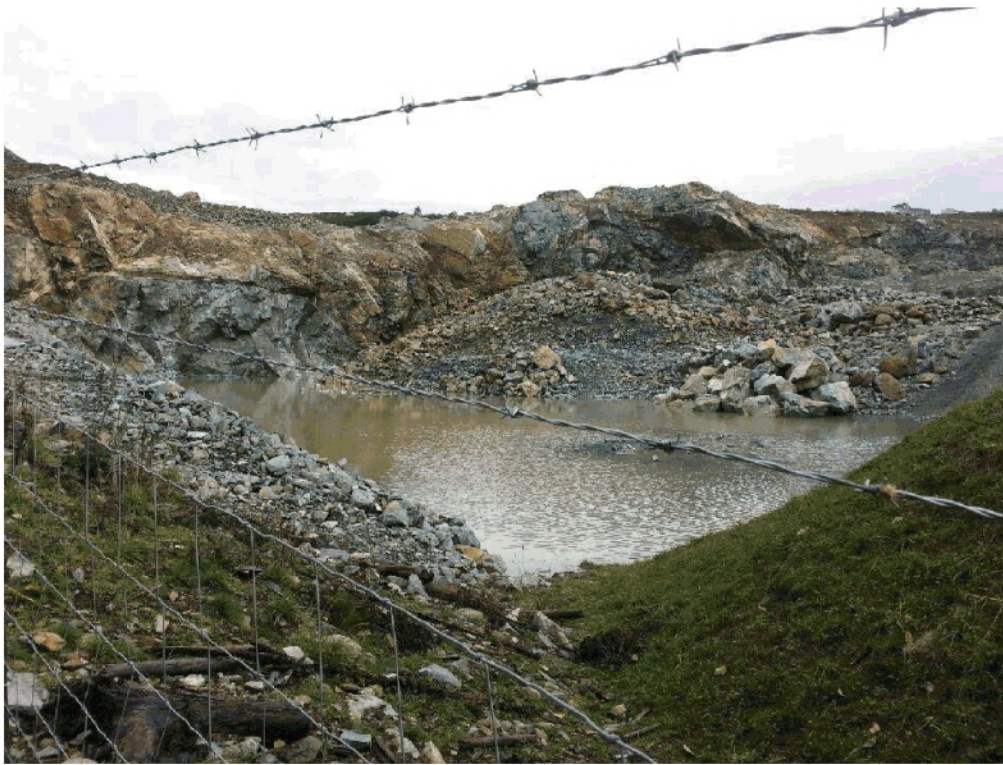
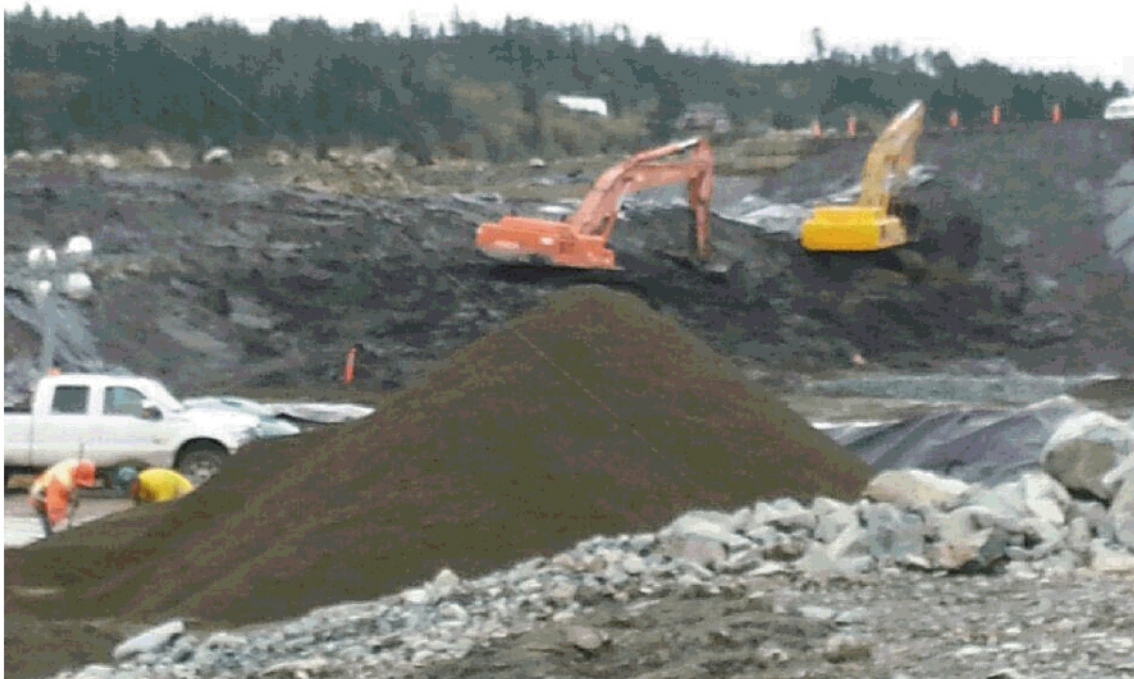
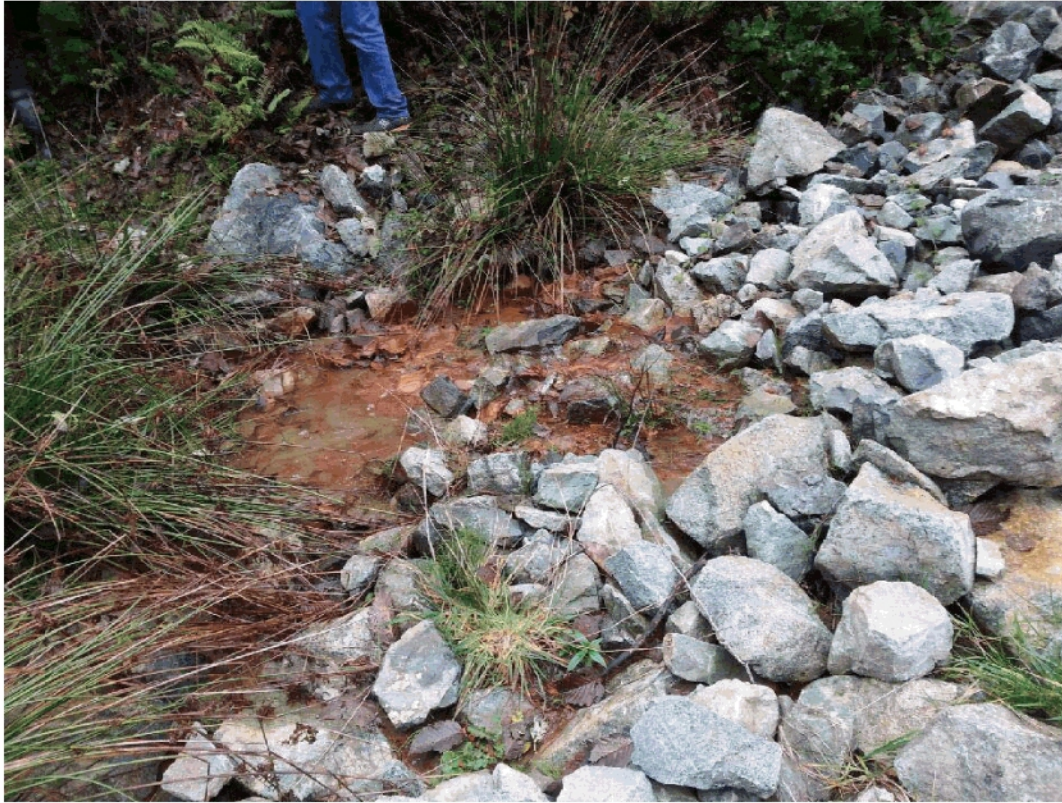
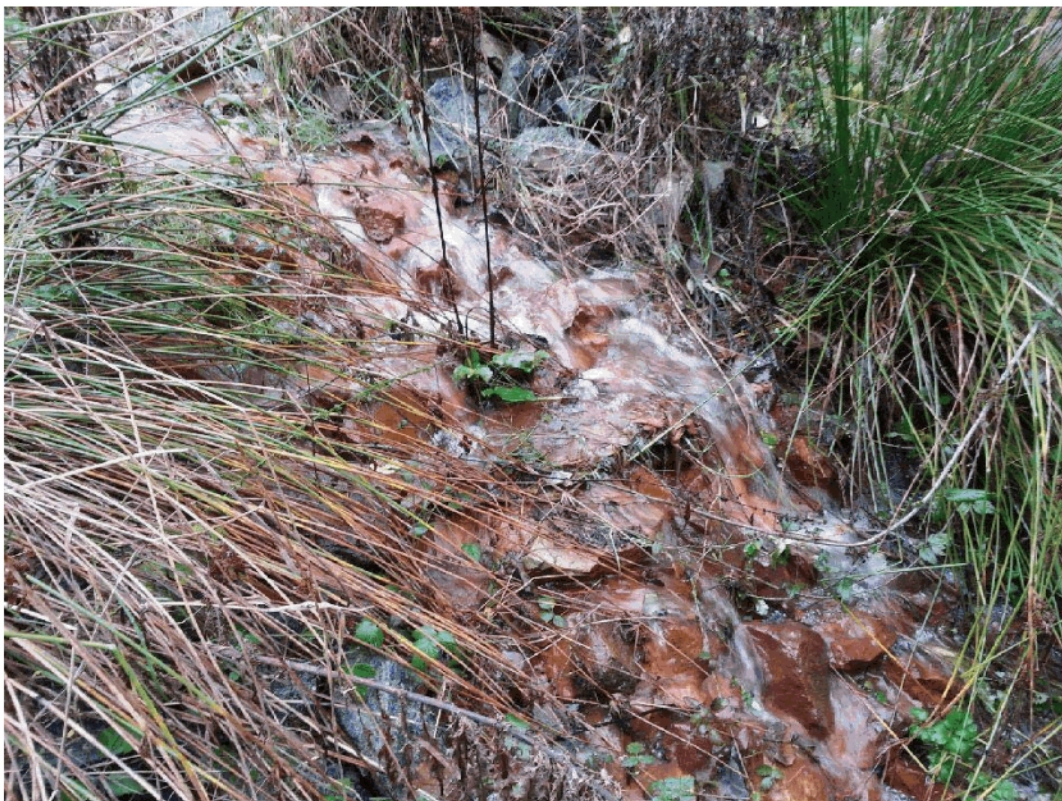
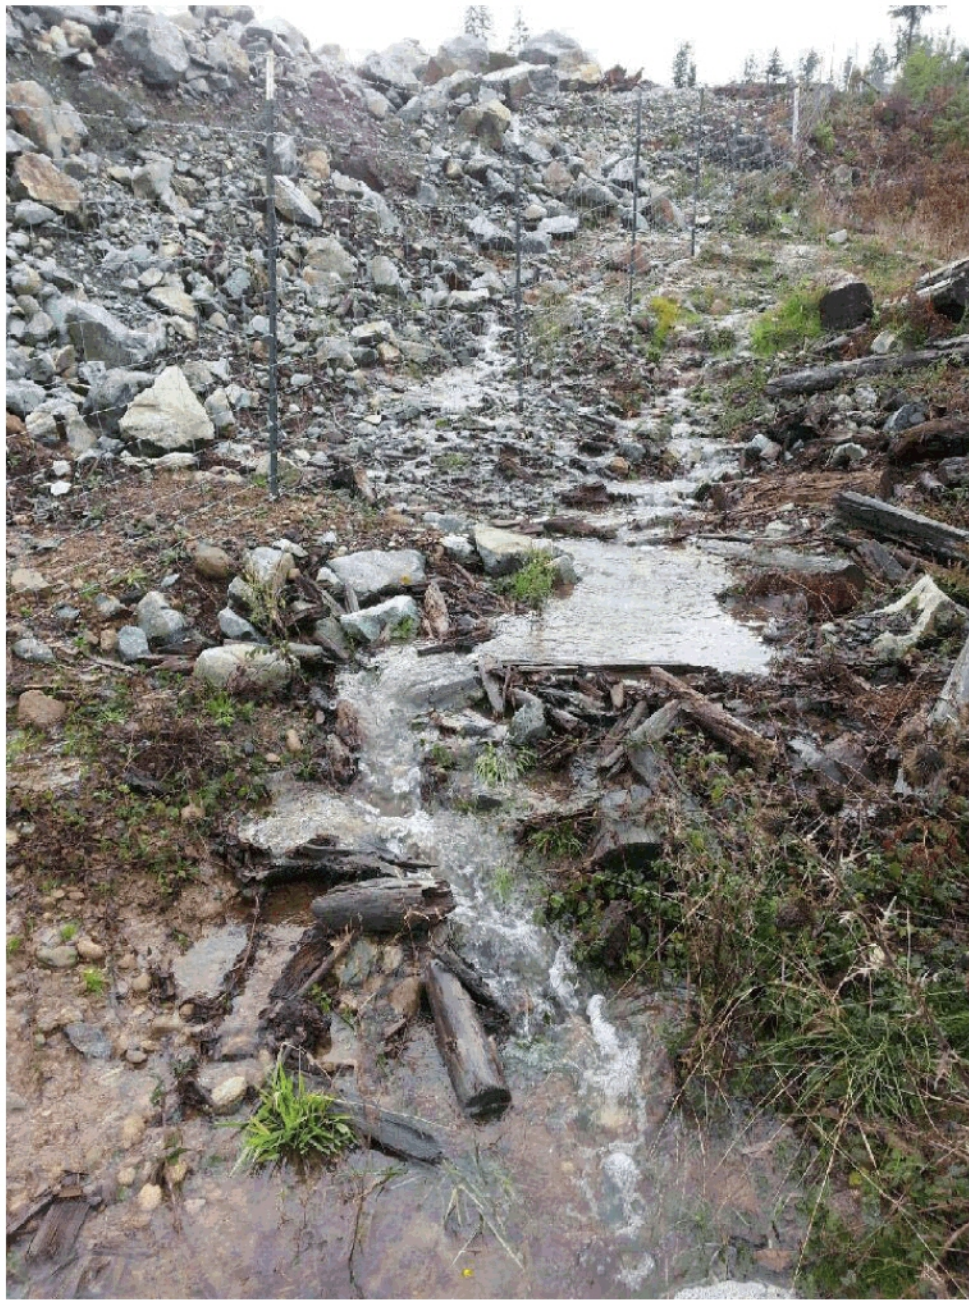
Right at the bottom of lot 21 just above where it meets the creek. They would just be led to walk to the bottom of lot 21 and they will find the pools and streams of red water.

Also - just think about why the "settling pond" is empty when water is rushing off that site.

1. Engineering failure. Water is flowing all over but NOT going to settling pond
 2. Settling pond is not holding the water because it was not designed properly and there is no liner underneath - water is leaching out from underneath and into the creek on cvrd.
- This is not about coming back and saying everything is fine because water samples come back fine. 8 months into this permit, one rain event, and there is a total failure of the so-called engineering at this site. There is no way to say that this is an acceptable situation.

The settling pond does not hold water. Where is the water going, Jennifer? There is no liner, just gravel. Water is pouring out from underground into the stream.
