Ministry of Environment Inspection Record

Inspection Number: 18407		Inspection Status: FINAL	
EP System: <u>AMS</u>		Inspection Date: 2015-02-02	
EP System Number: 11678		EP System Status: <u>Active</u>	
Region: <u>Cariboo</u>		Office: <u>Williams Lake</u>	
Trigger: <u>Incident</u>		Incidents of Non-Compliance Observed: <u>Yes</u>	
Non-Compliance Decision Matrix Level: <u>Level 1</u>		Non-Compliance Decision Matrix Category: <u>Category B</u>	
Inspector Name(s): Jack Green		CPIX: <u>1 to 2 = Medium</u>	
Audit:		Total Non-Compliance(s): 2	
Regulated Party: Mount Polley Mining Corporation			
Regulated Party Contact(s): Colleen Hughes			
Legal Address: PO Box 12 Likely, BC V0L 1N0			
Phone No: (250)790-2215		Fax No:	
Contact Email: <u>chughes@mountpolley.com</u>			
Location Description or Site Address: Mount Polley is an open pit copper/gold mine located near Likely, BC.			
Latitude: 52.54547 N		Longitude: 121.63433 W	
Receiving Environment(s): <u>Surfacewater</u>

PE11678	Mount Polley Mining Corporation
August 19, 2015	Mount Polley Mine

PE11678	Mount Polley Mining Corporation
December 3, 2015	Mount Polley Mine

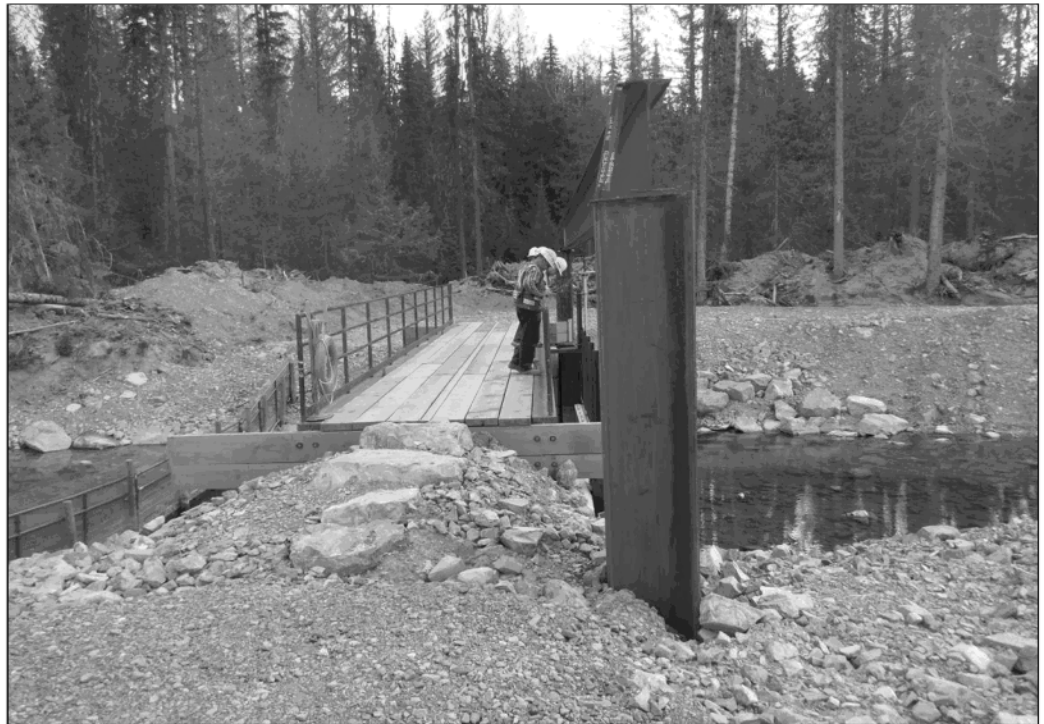
Weir at head of Hazeltine Creek. Note the fish barrier upstream (left) of the weir.

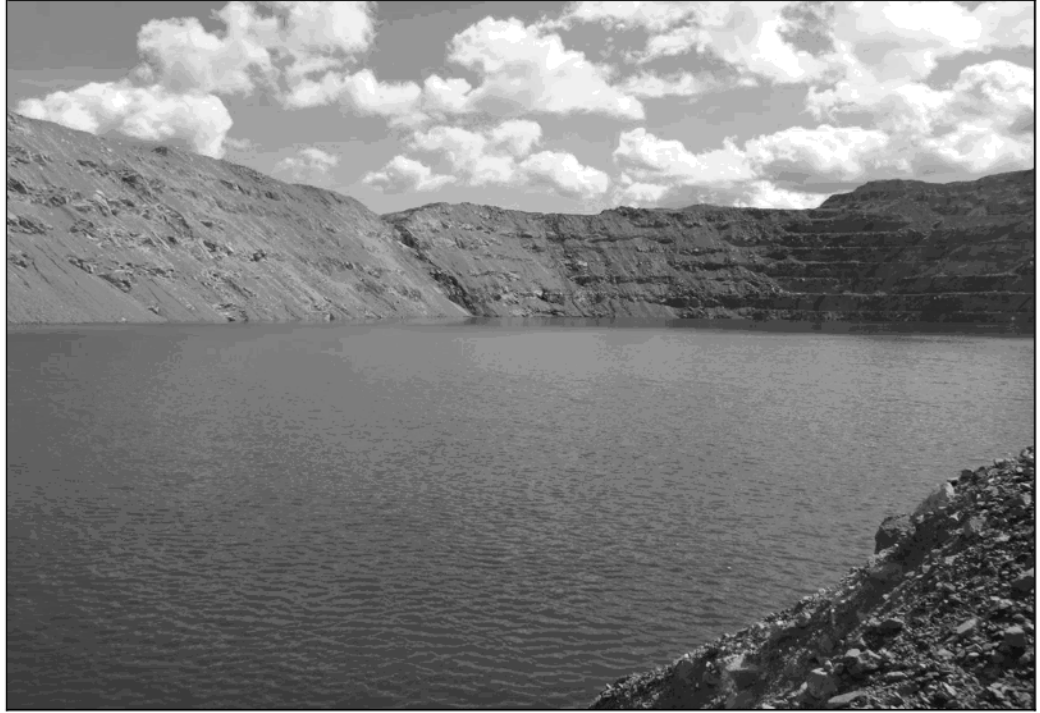
Springer Pit. The discharge from the mill is in the centre of the picture.

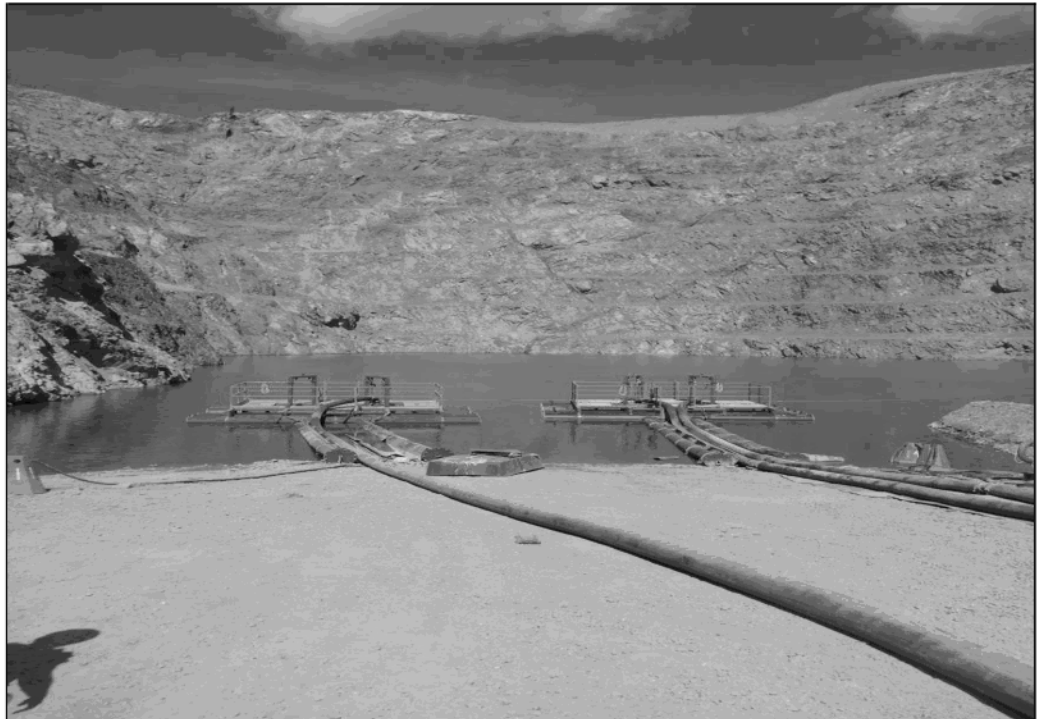
3 pumps in Springer Pit pumping water to the CCS for use as mill process water.

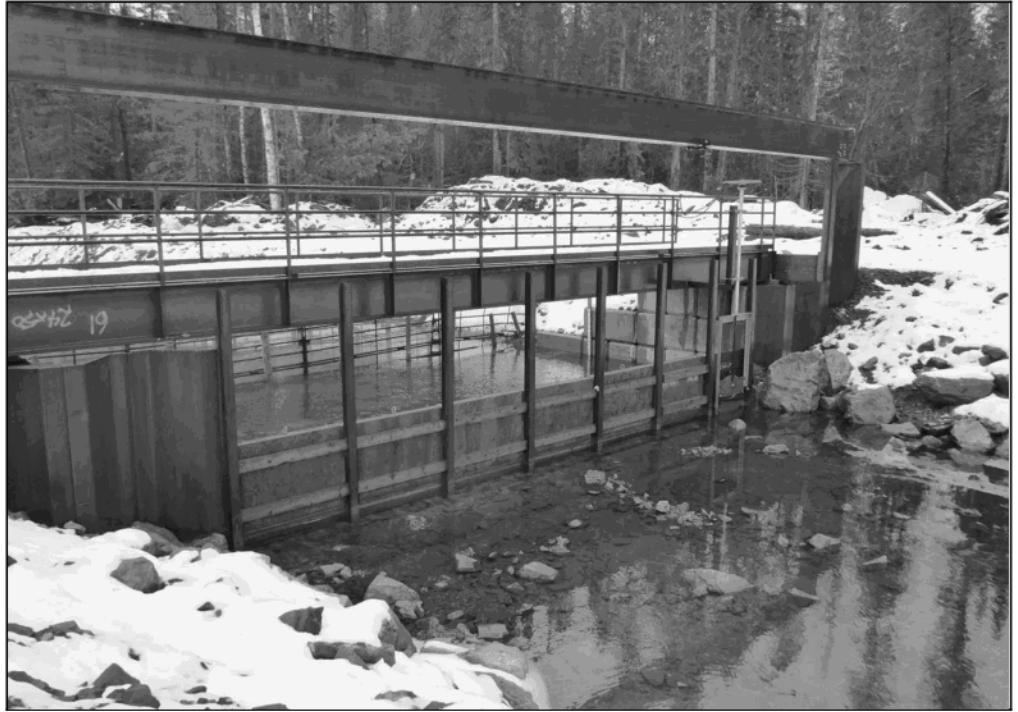
The weir below Polley Lake had been closed on the day of inspection.

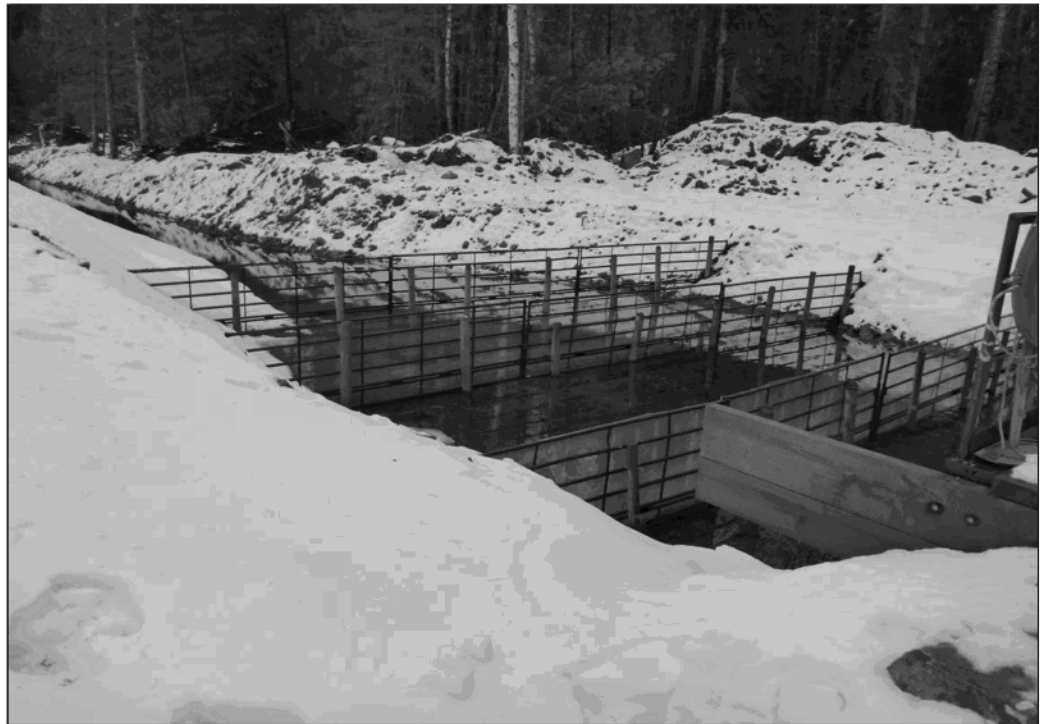
Fish/debris barrier upstream of weir consists of 3 fences of graduated mesh.

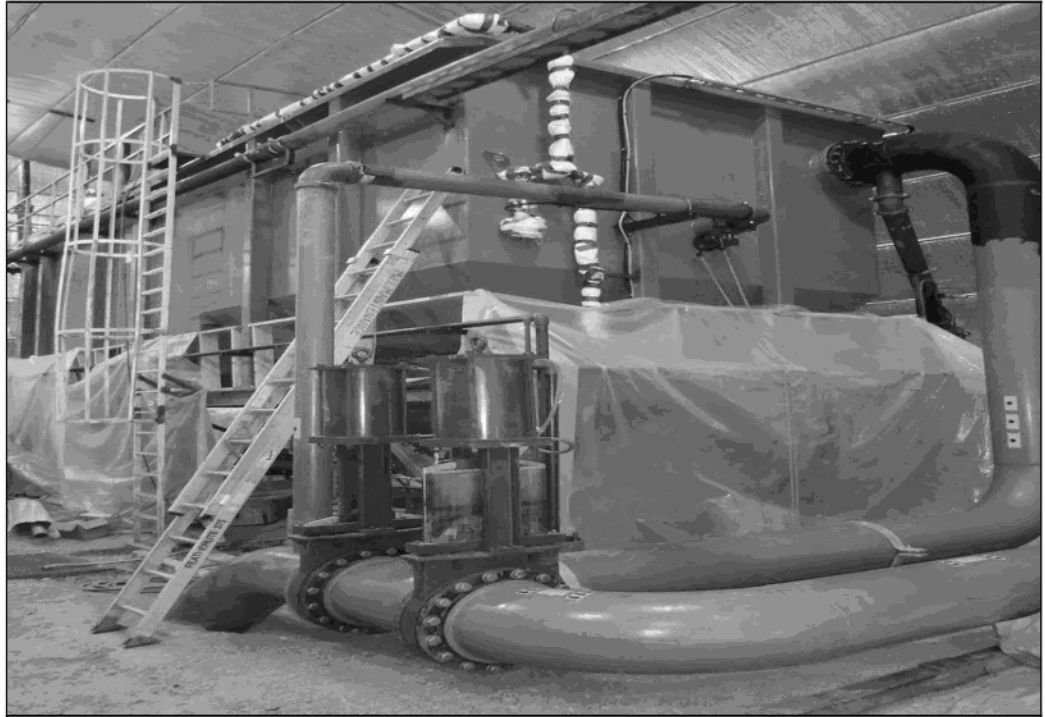
Veolia Water Treatment Plant. The automatic shut off/diversion valves are painted red in the foreground.

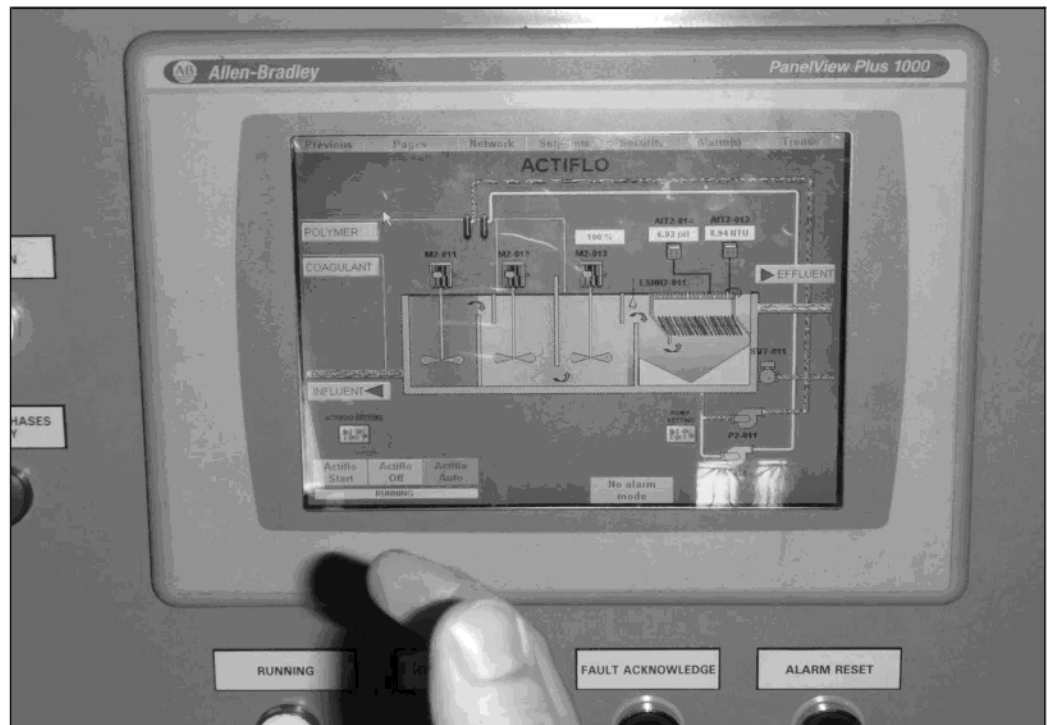
Computer image of stages of treatment process.

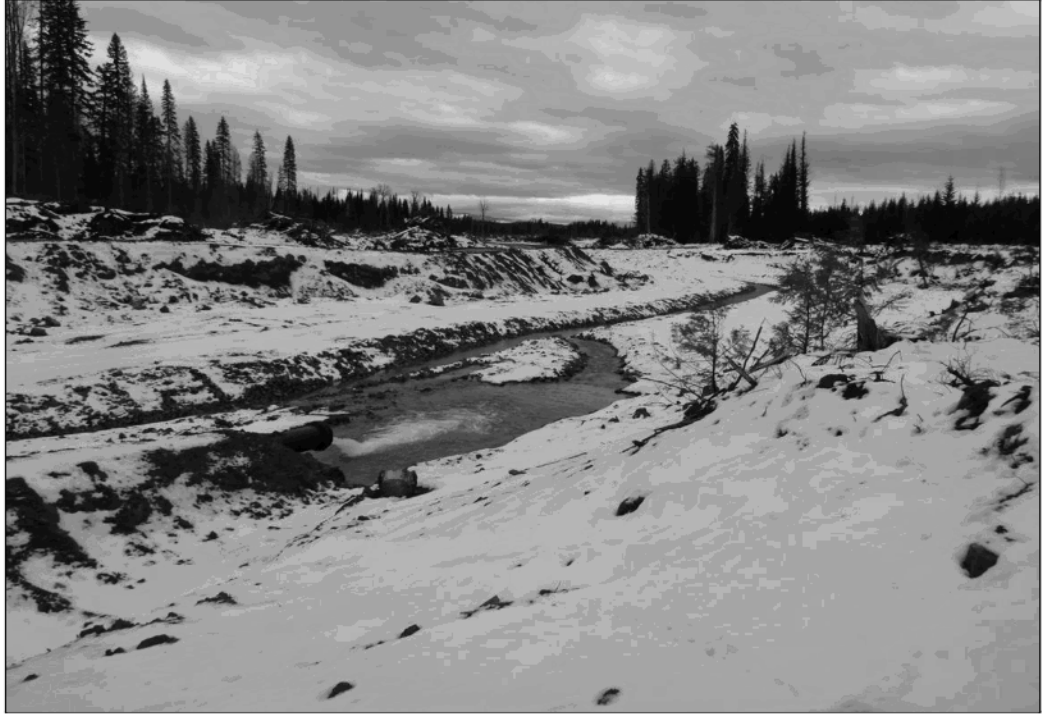
Discharge to Hazeltine Creek.

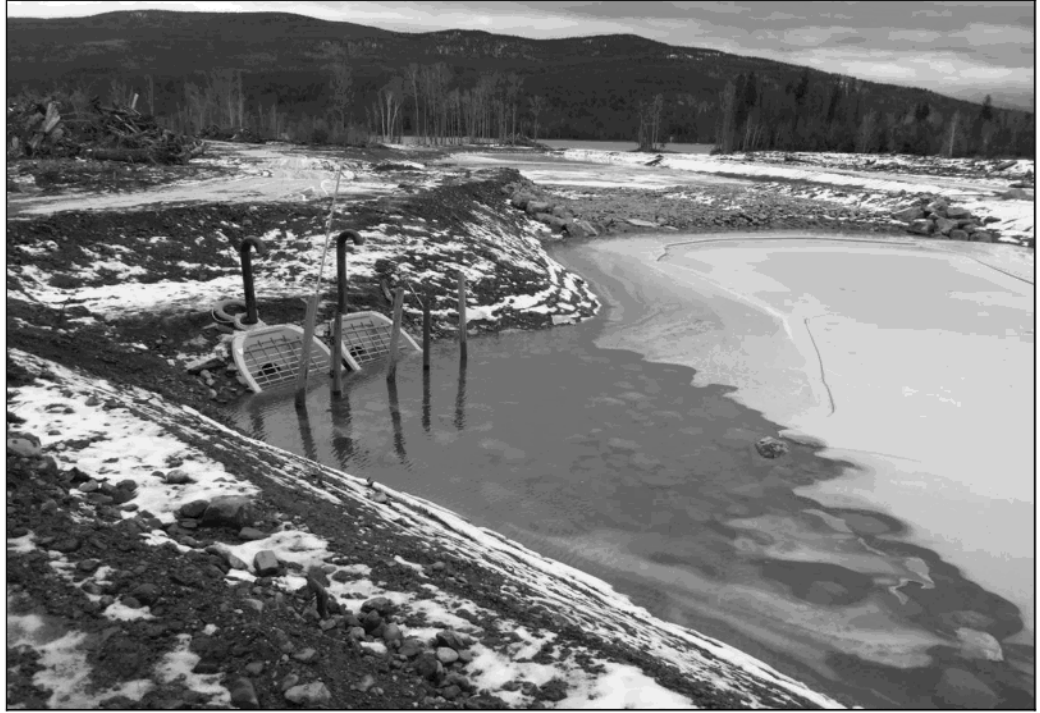
Outfall from Settling Pond 1 to Quesnel Lake. Settling Pond 2 can be seen beyond the rock overflow.
