## INSPECTION REPORT

Inspection Date/Time: May 25, 2011  
Authorization No: PR-11191  
Authorization Holder: Mounce Construction Ltd.  
Location: Salmon Arm  
Site Contact: Wayne Mounce  
Inspector: Frank Rhebergen

PR-11191 Mounce Construction Ltd. May 25, 2011

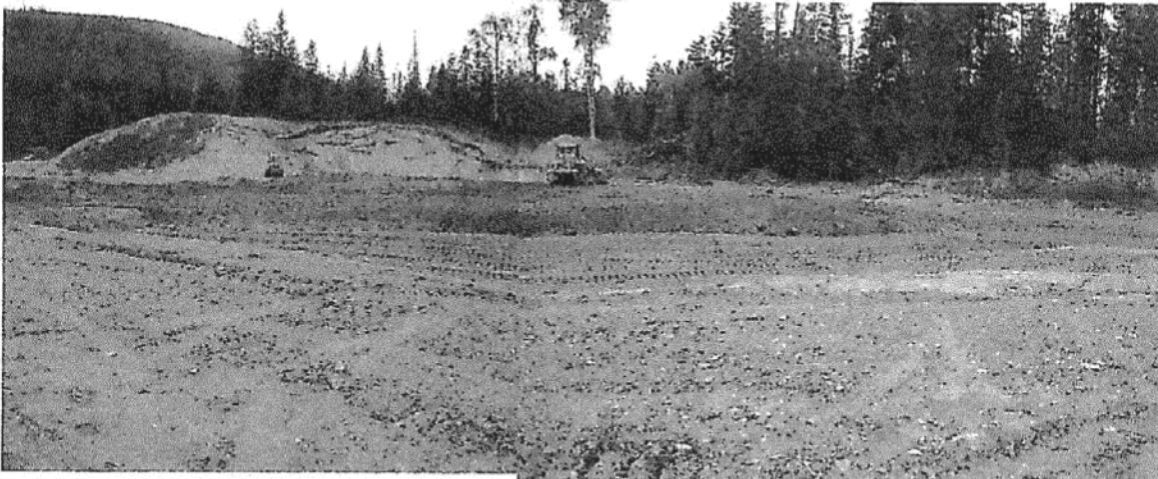
Wayne Mounce compacting the DLC landfill, recontouring/sloping as needed to achieve the required minimum slope for closure, applying final cover soil, etc. From now on, only "clean" earth fill will be deposited at this site; no more DLC waste.

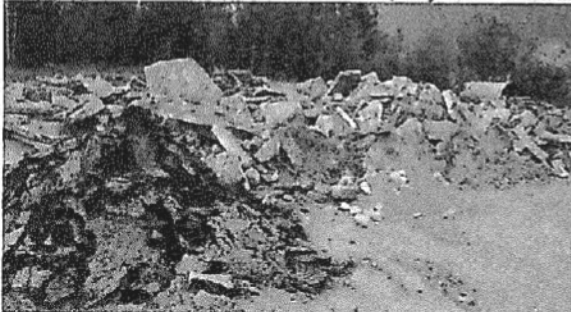
New stockpile of waste asphalt pavement and concrete starting up again as the former stockpile was processed by March 2011

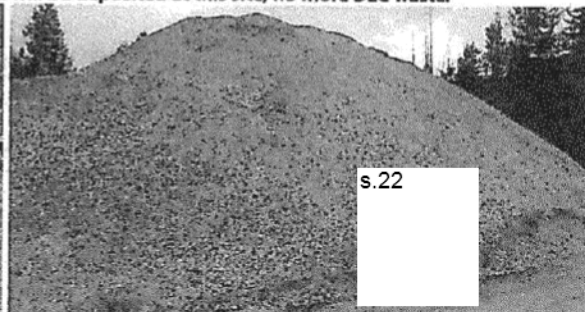
5600 m3 pile of crushed/screened aggregate recovered from several years' worth of stockpiled waste concrete and asphalt

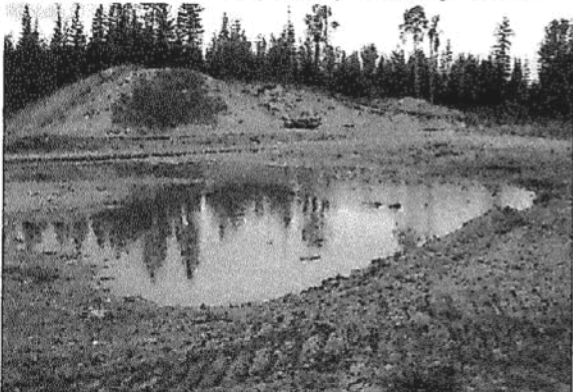
- Western Water Associates Ltd is preparing a quote for post-closure groundwater monitoring pgm
- Landfill is sited in an area of well drained sand to 10s of metres depth but finer grained imported soils have typically been used as landfill cover material. Large area of ponded water observed at inspection time.

Fairly wet spring in 2011... water ponded on top of closed DLC landfill area. Final slopes will have to prevent ponding of water.

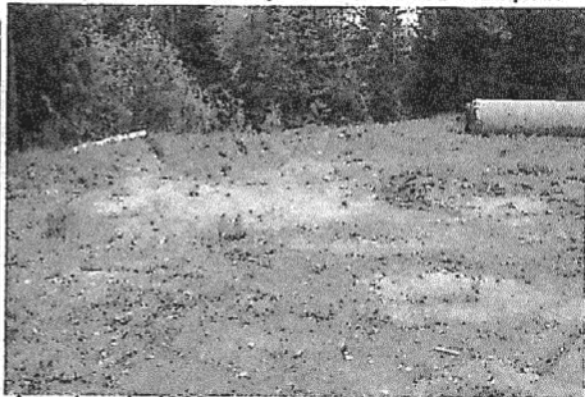
- ABC Destructor has been sold recently and the trench burner area filled in with soil.

Area where the ABC Destructor trench burner was formerly located (under permit PA-14742 which is now cancelled)

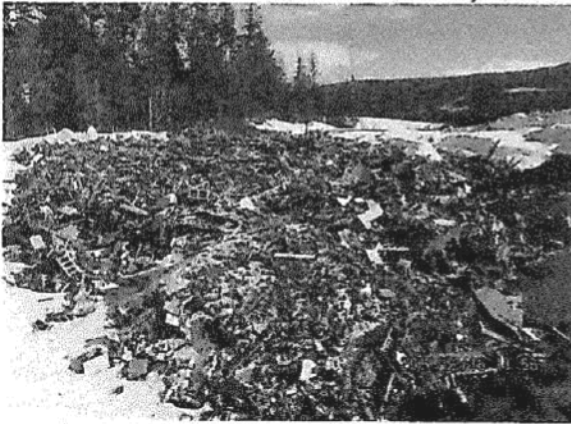
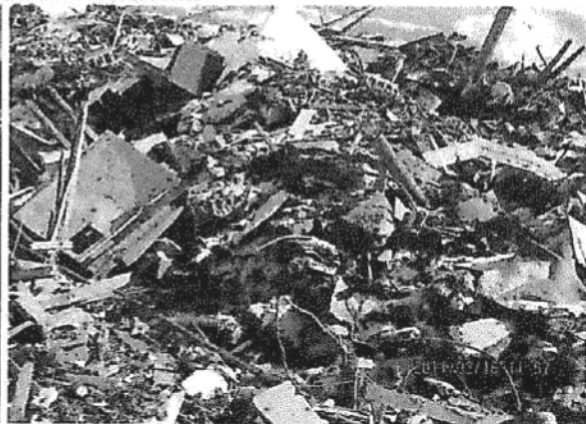
Recently deposited demolition waste from a Mounce Construction demolition project in Salmon Arm

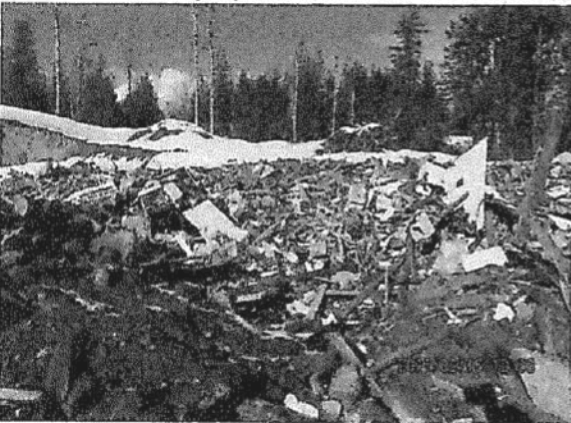
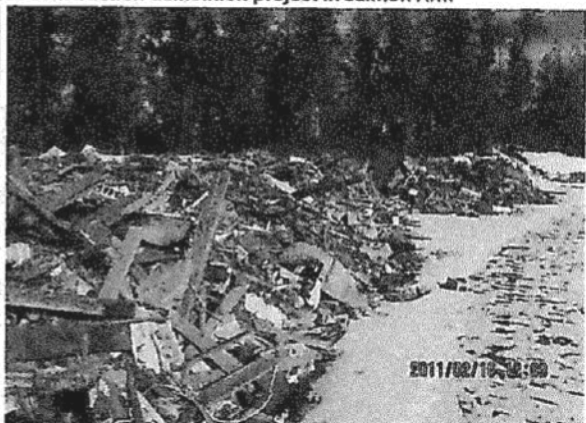
Other views of the same demolition waste

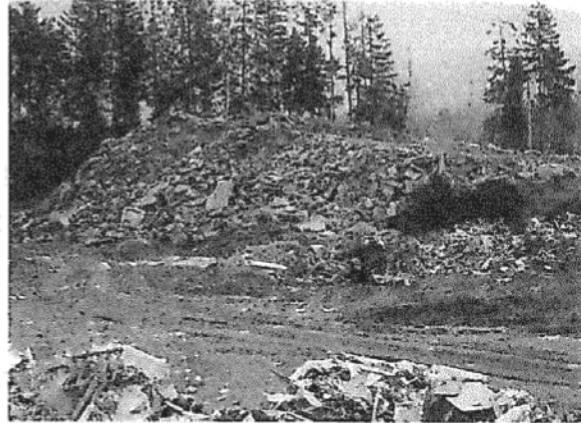
Dec 4, 2008 site inspection. The beginning of a large waste concrete stockpile, added to over next 2 years and processed in early 2011 as shown in bottom photo.

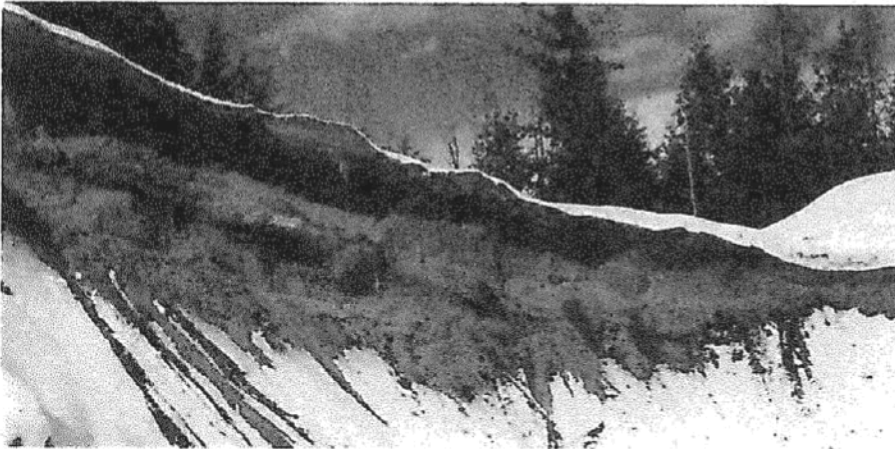
Cut bank on left shows profile of the sand that underlies the entire site, according to Wayne Mounce. Very well drained site with minimal surface runoff (if any). Excavation of cover soil material on adjacent CSRD Landfill site shows same sandy material over entire site to many metres depth. Based on hydrogeo work on the CSRD site, water table is expected to be at least 60 ft below the base of the Mounce landfill.

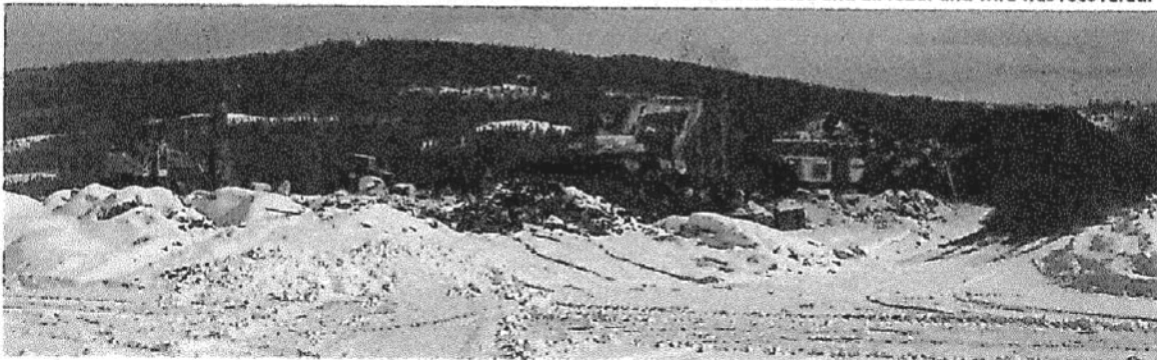
Photo below shows waste concrete reprocessing operation on March 3, 2011. This job provided full time work for 3 employees for one month during the winter "slow" season. Waste concrete was crushed and screened and all rebar and wire was recovered.

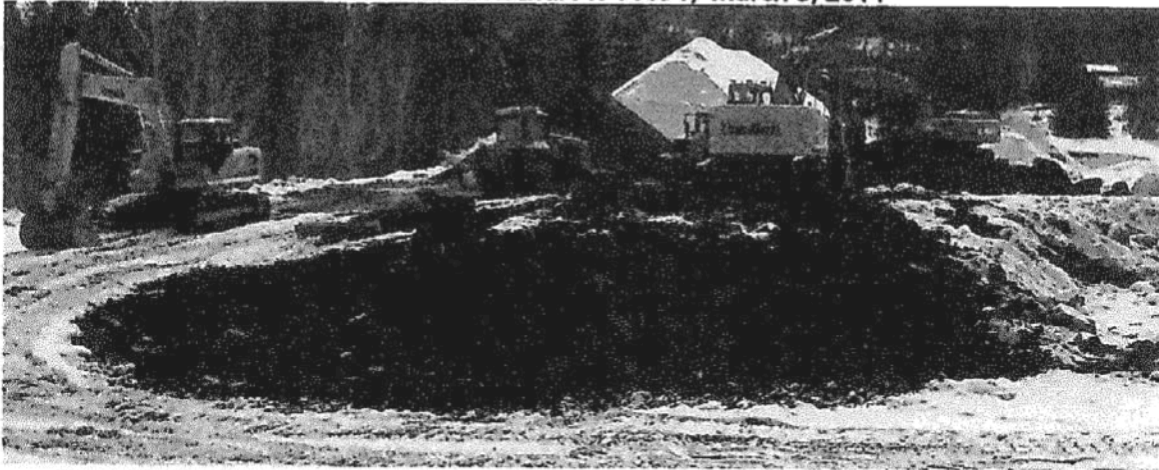
Nearing the end of the waste concrete reprocessing; 5600 m3 stockpile of aggregate (under snow) in the background.

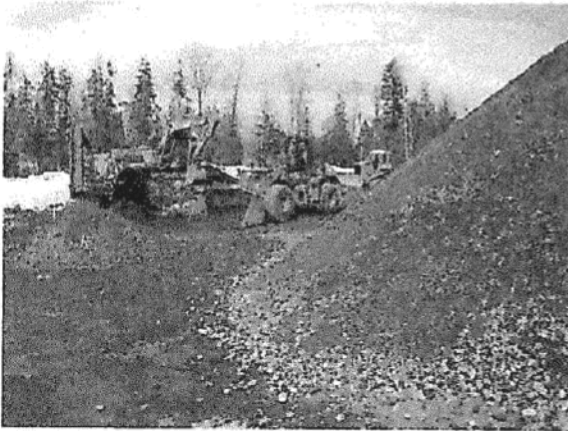
Crushed aggregate stockpile from waste concrete.

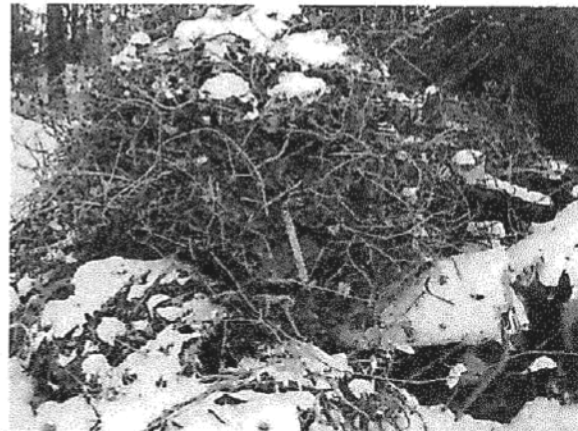
Steel recovered from waste concrete (above) and other scrap metals for recycling (below).

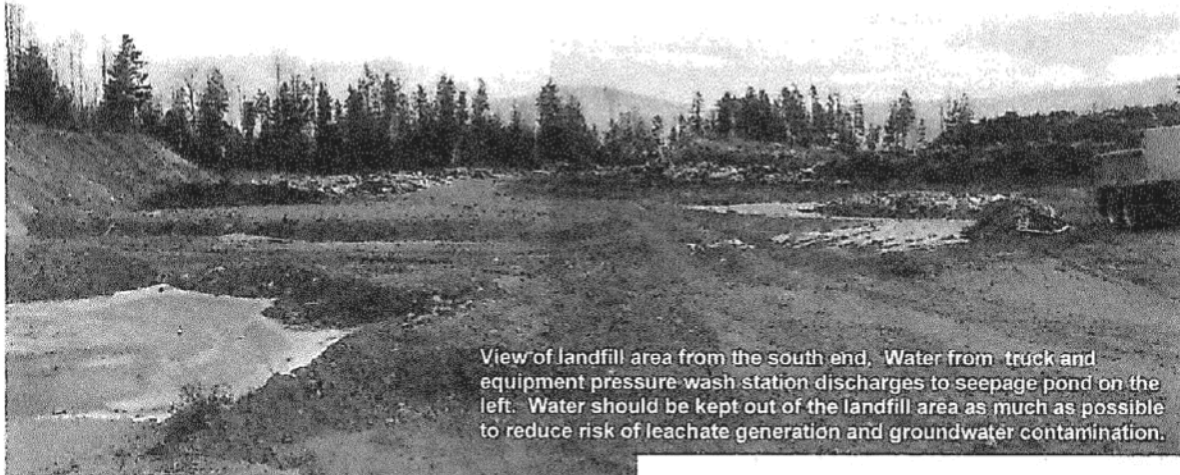
- Waste water from a truck wash facility is discharged to an infiltration area along the south end of the landfill
- As outlined in the attached email, this landfill operation does not meet current Ministry standards; it needs to be substantially upgraded and the permit amended or the permit needs to be abandoned and the landfill operation closed.

View of landfill area from the south end. Water from truck and equipment pressure wash station discharges to seepage pond on the left. Water should be kept out of the landfill area as much as possible to reduce risk of leachate generation and groundwater contamination.

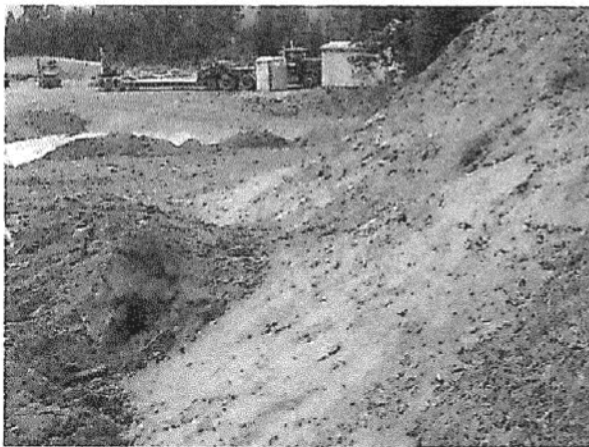
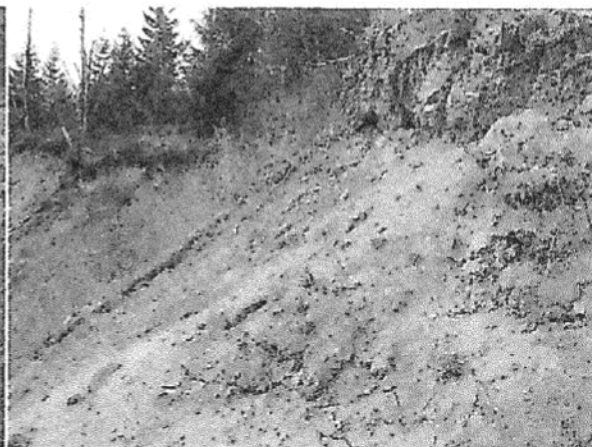
Cutbank along west side of landfill area shows the sandy soil profile, typically overlain with about 2 feet of silty topsoil. Profile appears very similar to that of the adjacent well drained Salmon Arm MSW landfill east of Mounce property.

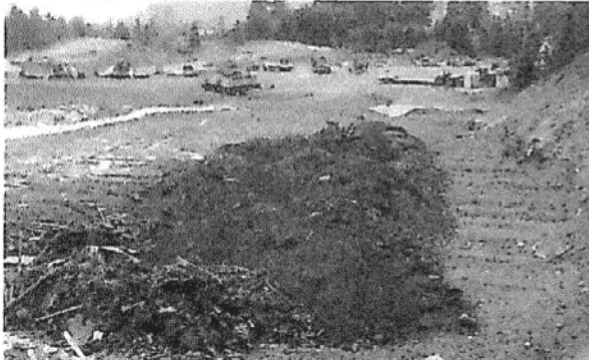
Burn residue recently removed from trench burner to prepare for final burn.

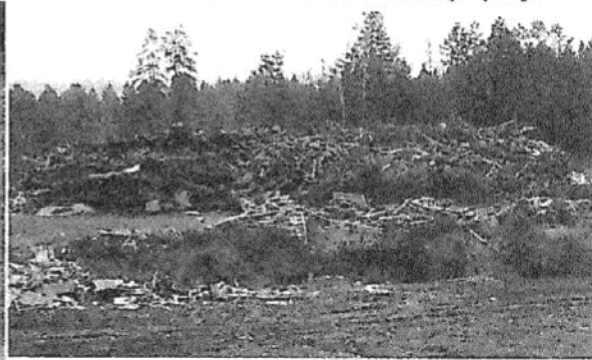
Burnpile consists only of "clean" wood waste this year.

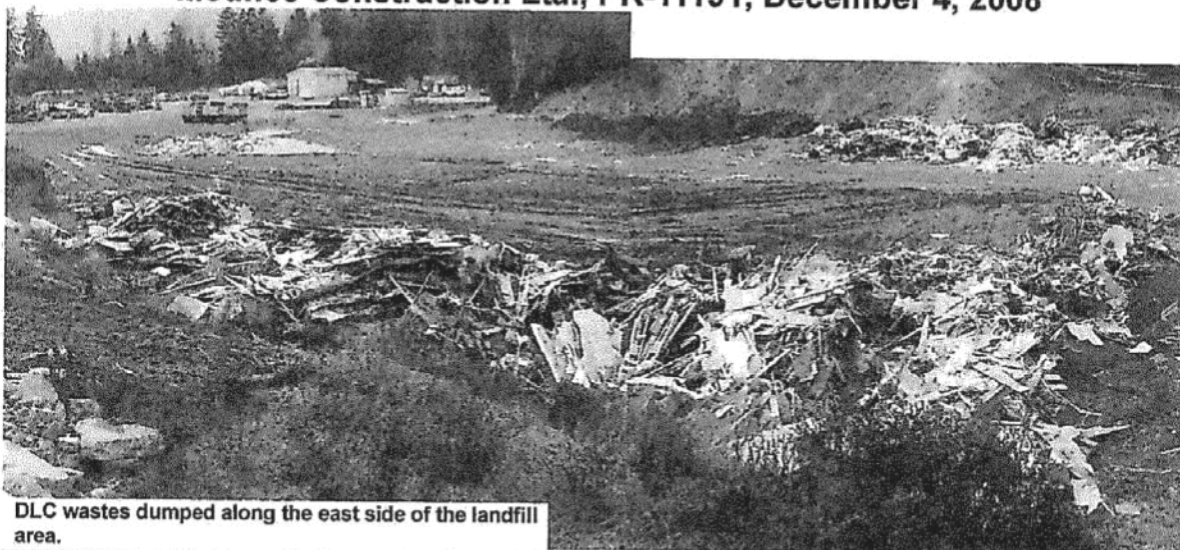
**DLC wastes dumped along the east side of the landfill area.**

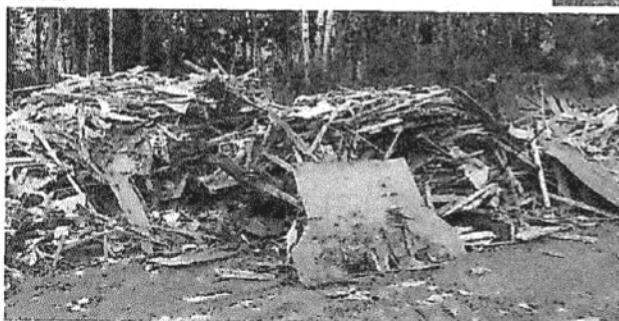
**Lots of waste wood from demolition sources**

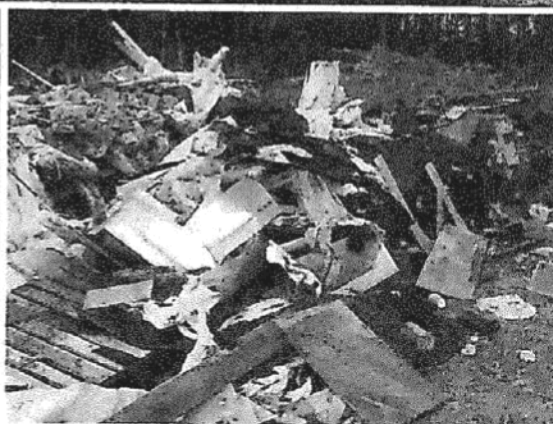
**Waste roofing materials**

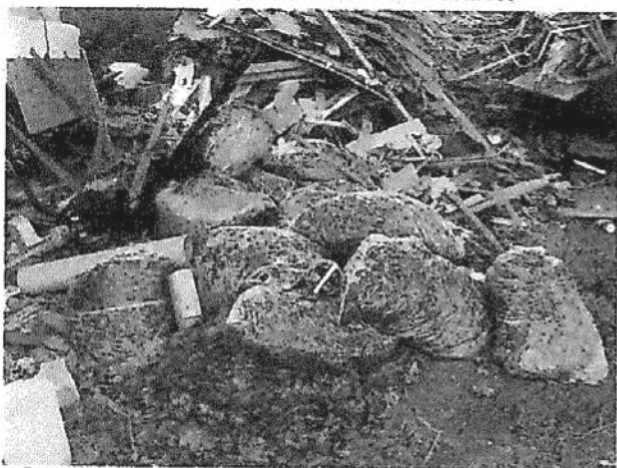
**Occasionally a bit of domestic municipal solid waste found mixed in with the 99% DLC wastes.**

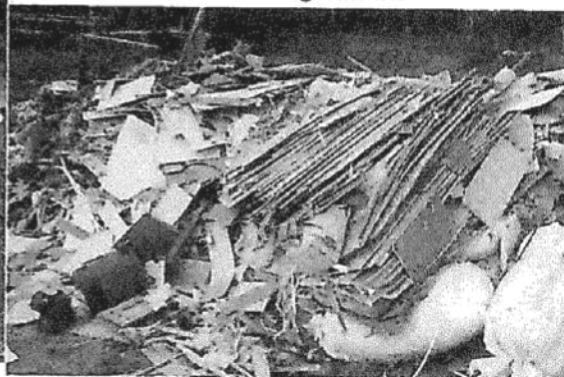
**Waste gypsum wallboard**

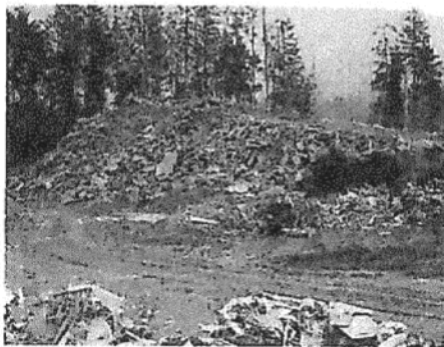
**Waste concrete pile. Depending on economics, may be recycled in future: crushed, and steel removed.**

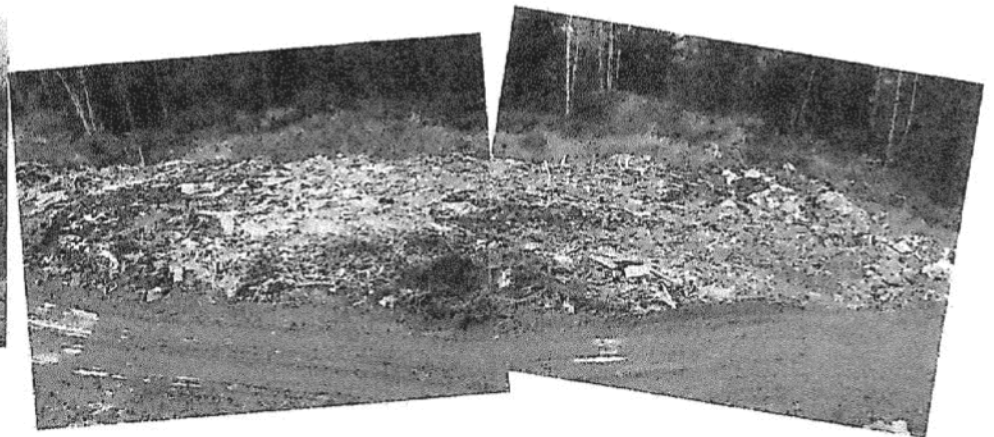
**Compacted DLC waste in NW corner of landfill area. Soil cover to follow.**

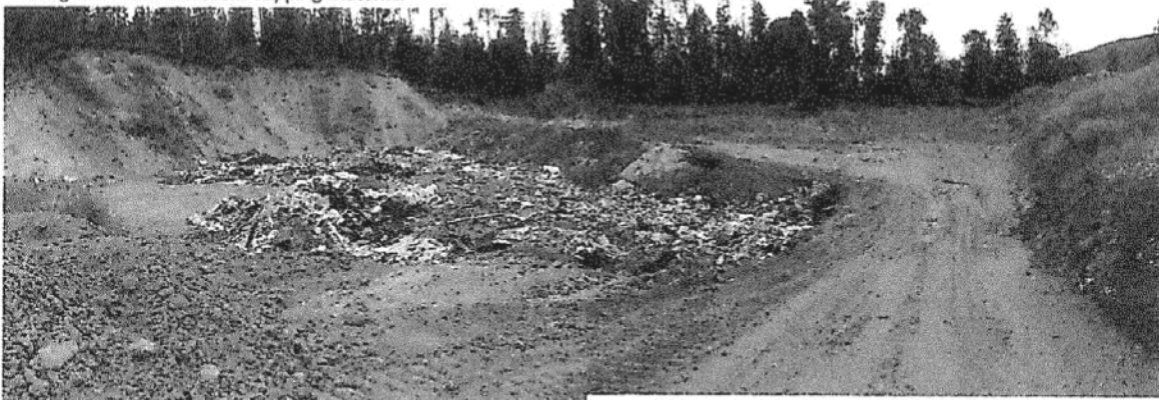
DLC waste gets compacted in 1 metre lifts and then a good layer of inorganic earth fill is applied as cover material.

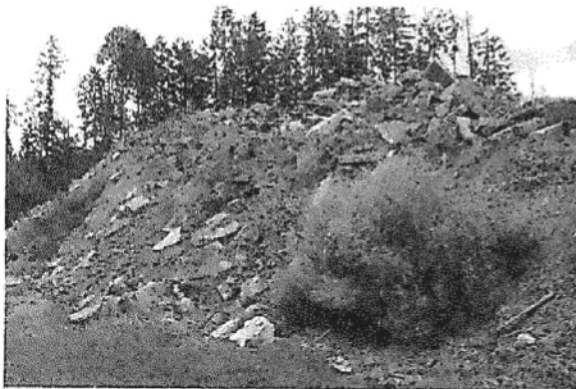
Pile of waste concrete and imported earth fill

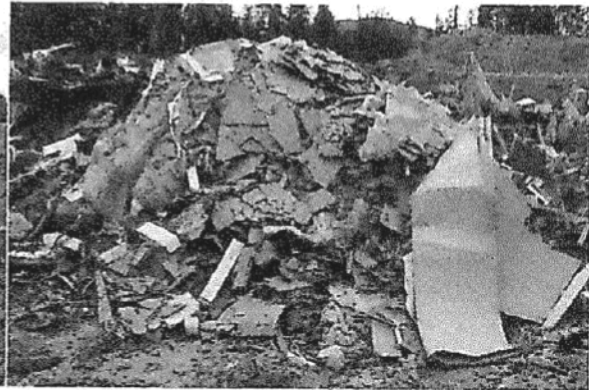
Good-sized load of old stucco

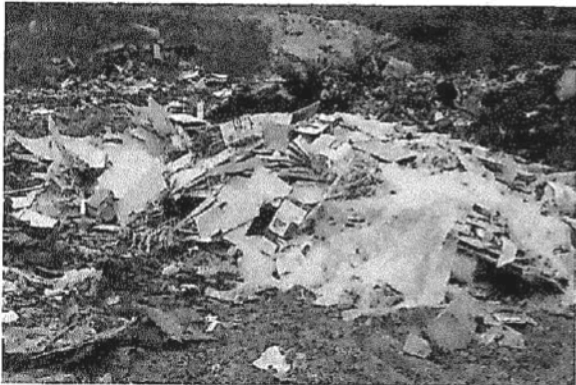
Waste gypsum wallboard materials

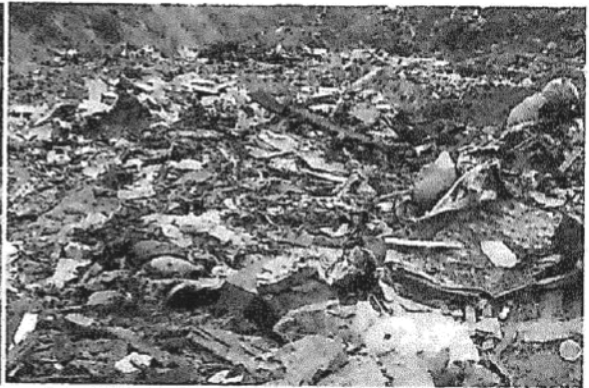
Wide variety of non-putrescible DLC type waste

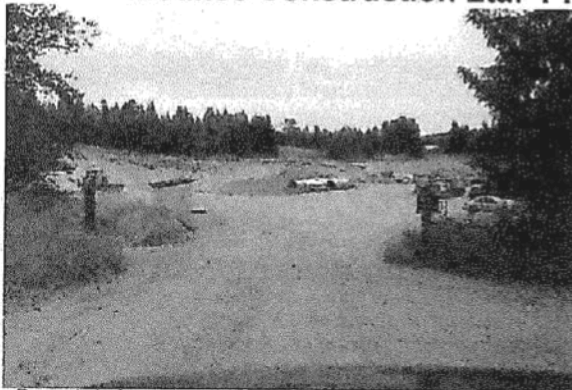
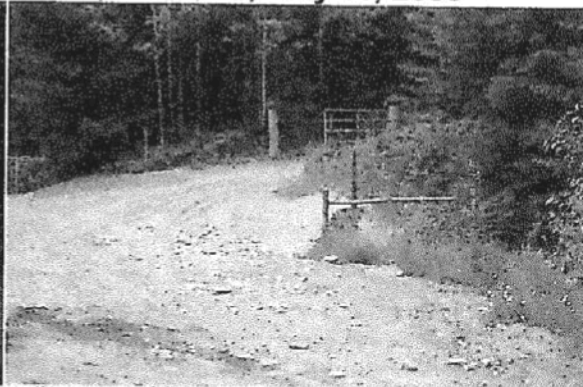
Property is fenced and gated. Company employee also resides on the property full-time. Signage does not comply with Section 2.4 of Permit PR11191, however, explanation is acceptable. Only limited number of known individuals/companies are accessing the site for their DLC disposal needs and Permittee does not wish to expand this part of the business.

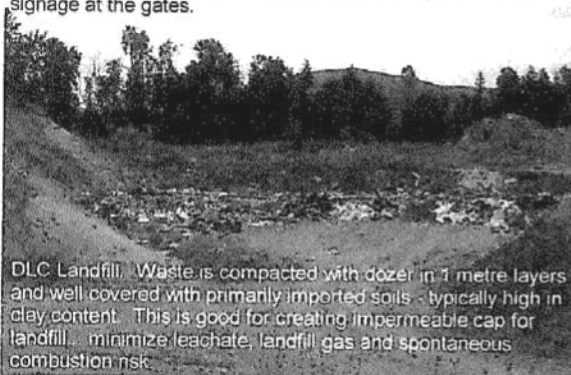
DLC Landfill. Waste is compacted with dozer in 1 metre layers and well covered with primarily imported soils - typically high in clay content. This is good for creating impermeable cap for landfill. minimize leachate, landfill gas and spontaneous combustion risk.
