# **Rails to Trails** **Routine Condition Bridge Inspection Form**

Crossing <b>OTTER CREEK</b>	Structure # <b>KV-060</b>	Site # <b>KV-060</b>	Length <b>103</b>	UTM Zone and E <b>10 662211</b>	UTM N <b>5491037</b>
Trail Name <b>KVRT</b>	Km <b>139.3</b>		Deck Type <b>TIMB</b>	Girder Type <b>TIMBER</b>	Abutment Type <b>TIMBER</b>
Inspection Co. Name <b>SNT Engineering Ltd.</b>	Inspector's Name /Signature <b>J Cox, E Miller</b>			Inspection Date: <b>3-Oct-12</b>	Next Inspection: <b>1-Jul-13</b>

## BRIDGE INFORMATION:

<b>Bridge No./Name</b>	KV-060: Kettle Valley Railway		
<b>Inspection Date</b>	October 9, 2020		
<b>Inspected By</b>	Mike Hanson, P.Eng. Josh Stadnyk, EIT.		
<b>Temperature (°C)</b>	15		
<b>Access Method</b>	Ground level assessment		
<b>Year Built</b>	Unknown		
<b>Camp/Town</b>	River Right		
<b>Number of Spans</b>	23	<b>Span Lengths (m)</b>	4.3 to 4.8 m
<b>Superstructure</b>	Six creosote treated sawn stringers, spaced 150 mm in pairs and 650 mm clear distance between pairs. Stringers are 245 x 500 mm and generally continuous over two spans, aside from the stringers in the first and last spans, which are simply supported.		
<b>Deck</b>	Untreated ties, 185 x 185 mm spaced

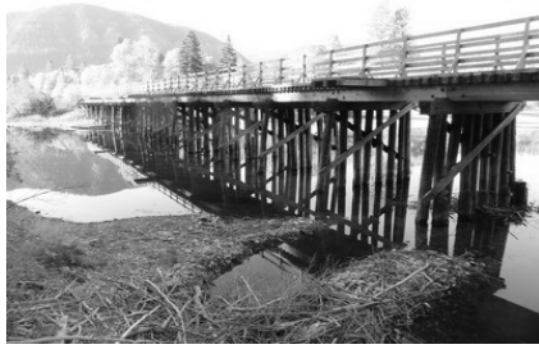
**VIEW FROM DOWNSTREAM**

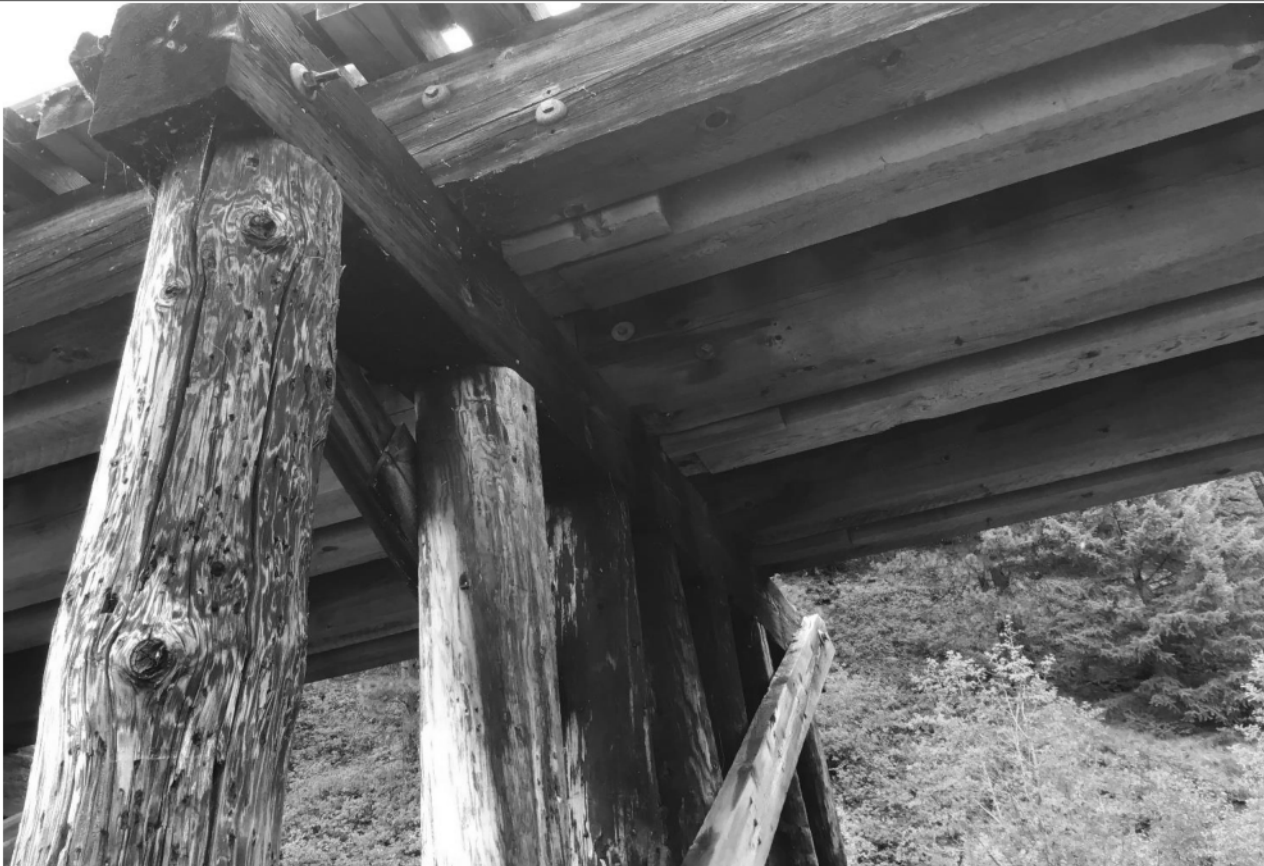
Piers

Cap or Sills	Bearings
Condition	Fair	Good
Comment	Signs of rot and deterioration on most caps.	Timber bearing pads in overall good condition.

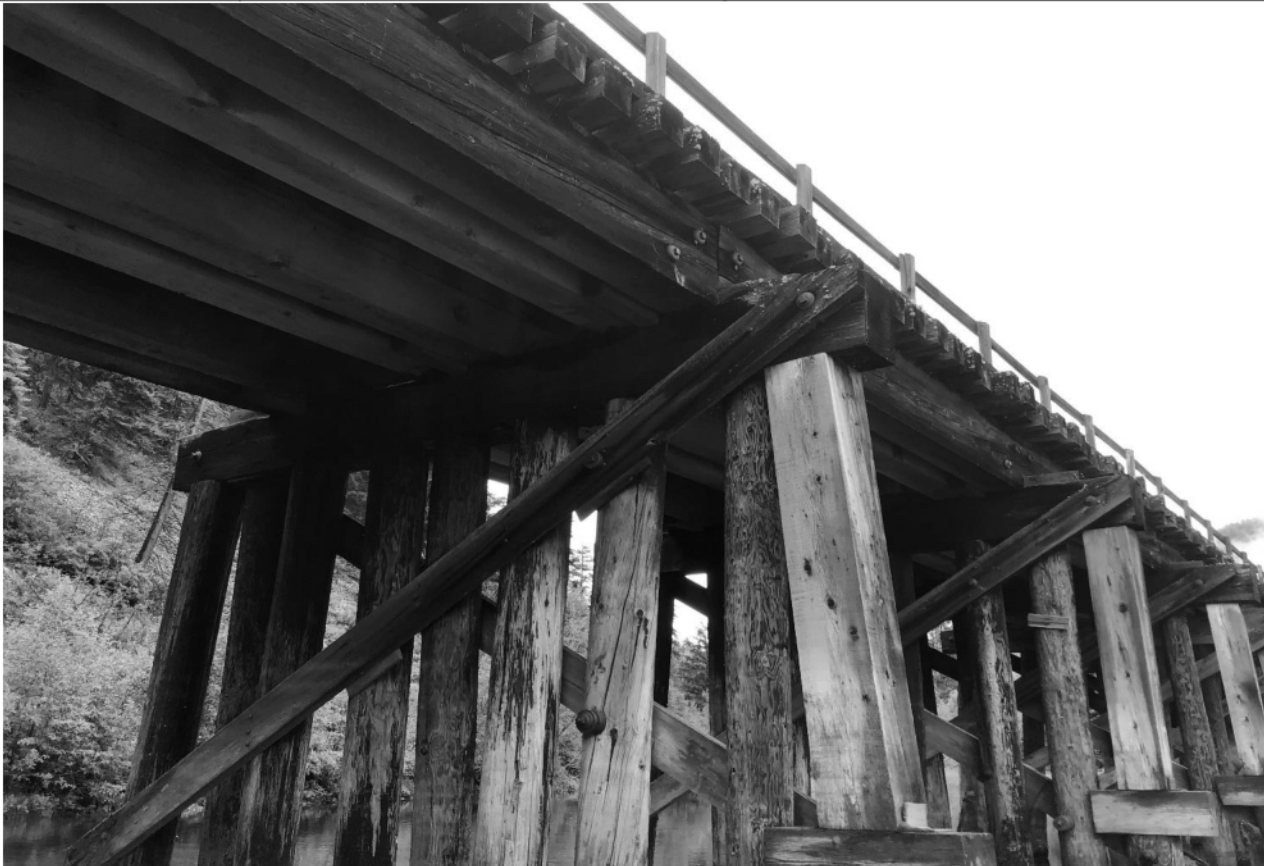
Piers

Cap or Sills	Bearings
Condition	Fair	Good
Comment	Signs of rot and deterioration on most caps.	Timber bearing pads in overall good condition.

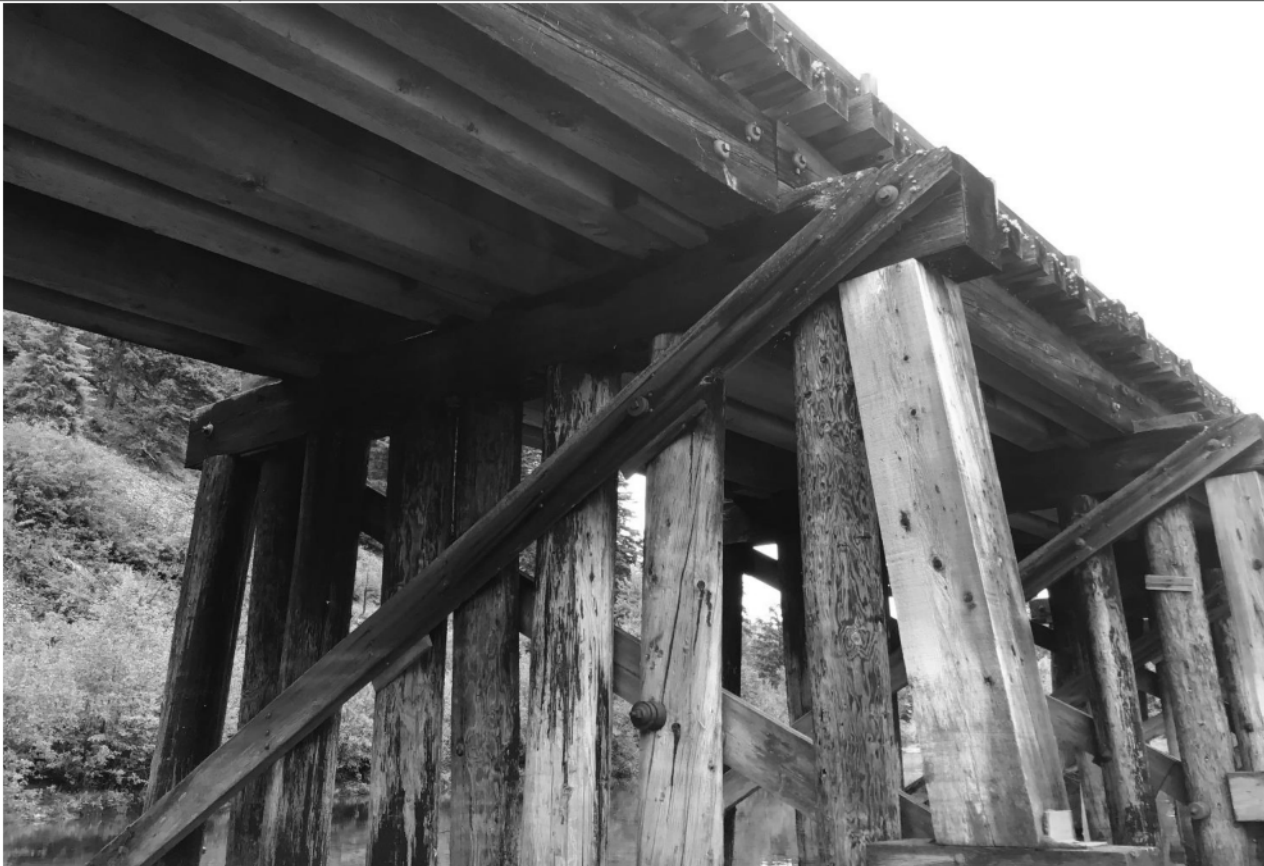
Piles

Cap or Sills	Bearings
Condition	Fair	Good
Comment	Some piles show large cracks and deterioration.	Timber bearing in overall good condition.

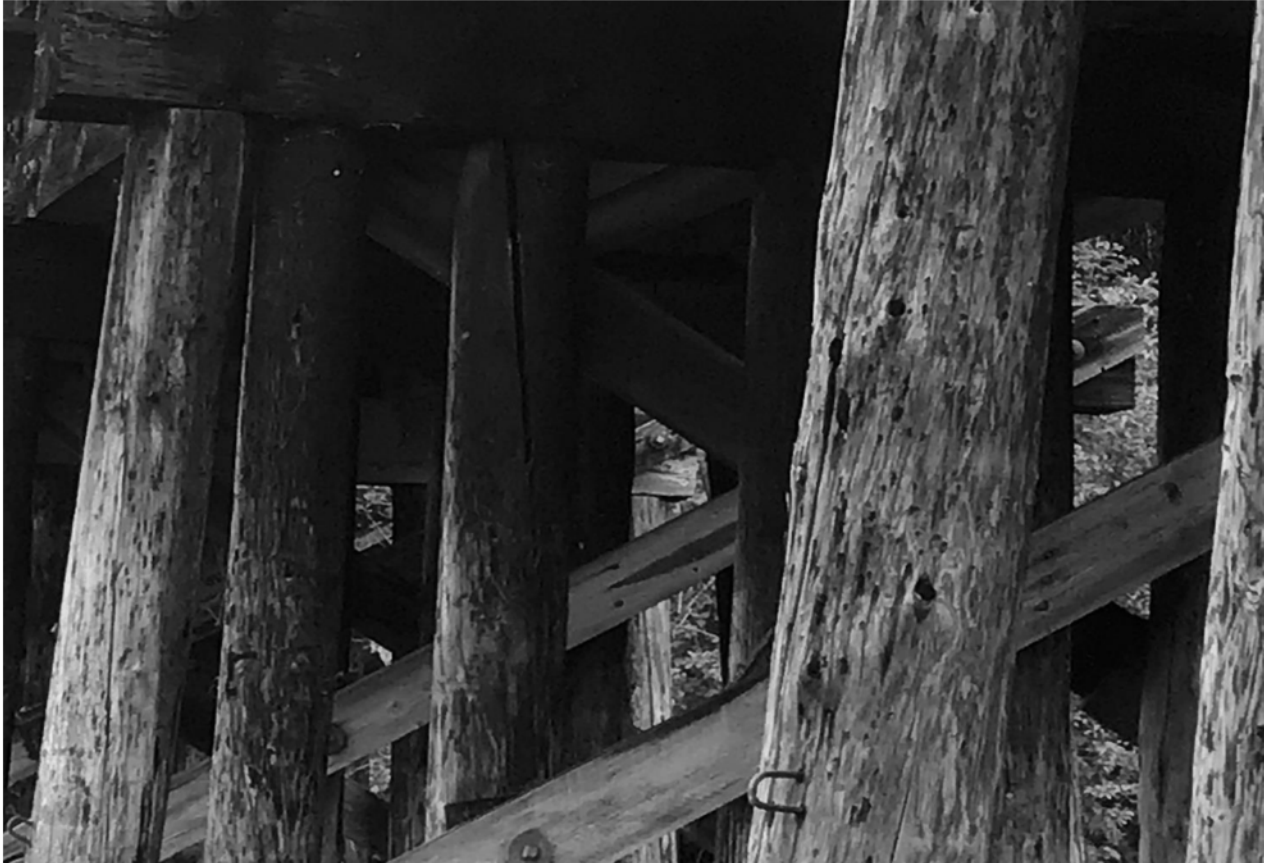
Piles

Cap or Sills	Bearings
Condition	Fair	Good
Comment	Some piles show large cracks and deterioration.	Timber bearing in overall good condition.

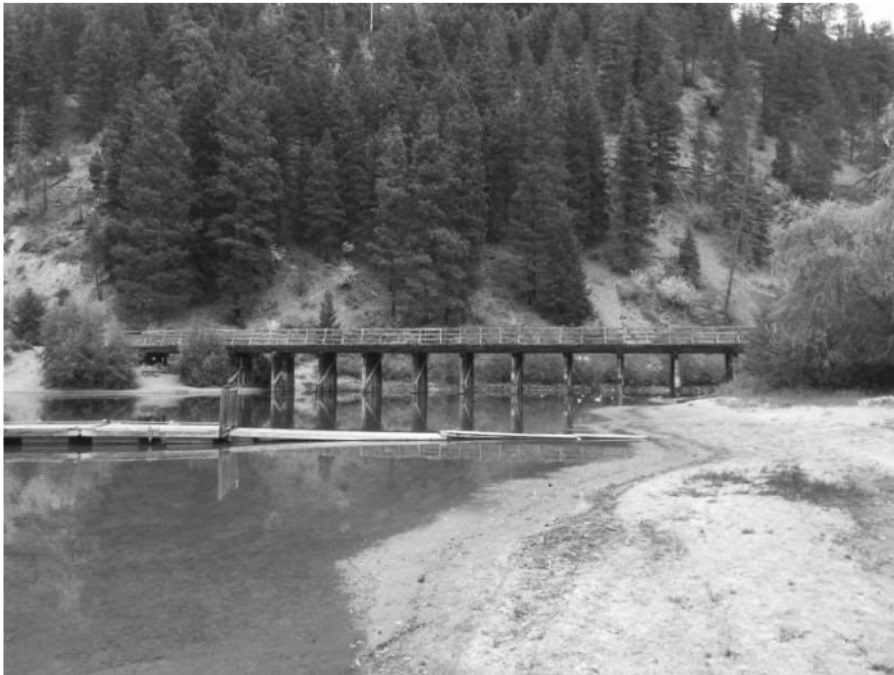
**Photo 1**  
Bridge elevation from upstream (Lake)

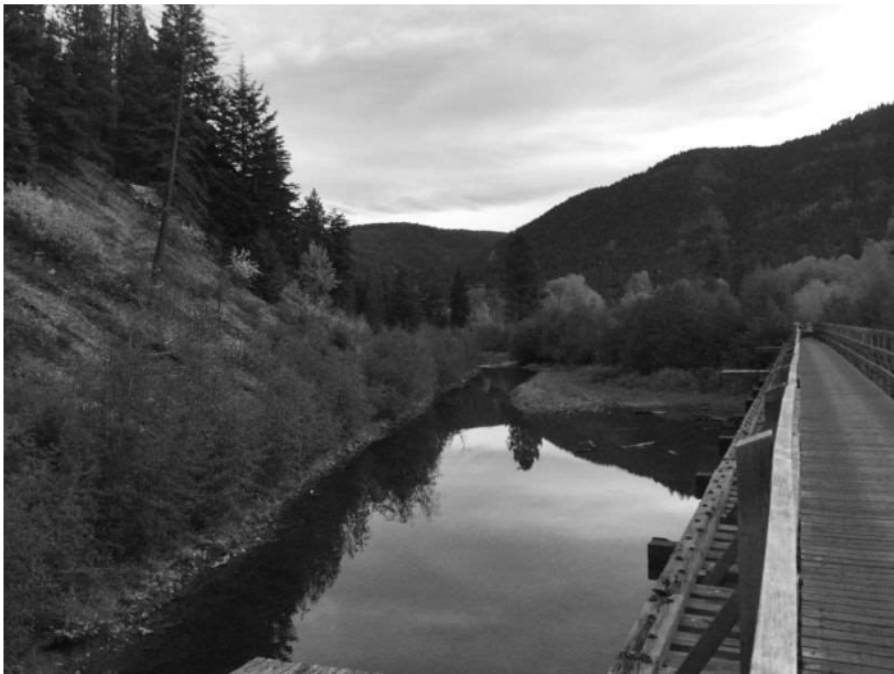
**Photo 2**  
Looking downstream

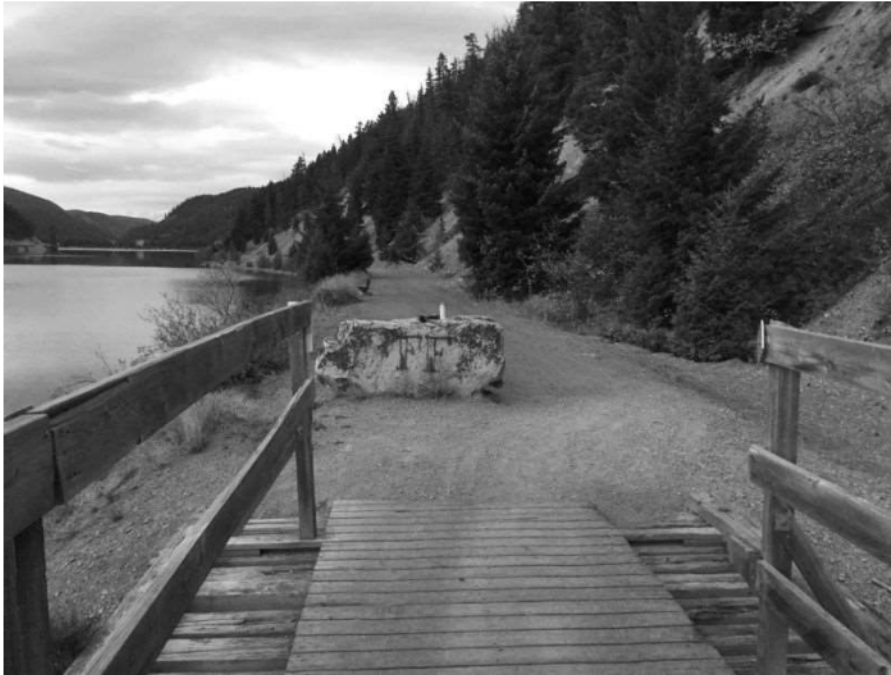
**Photo 3**  
Left approach, looking away from bridge

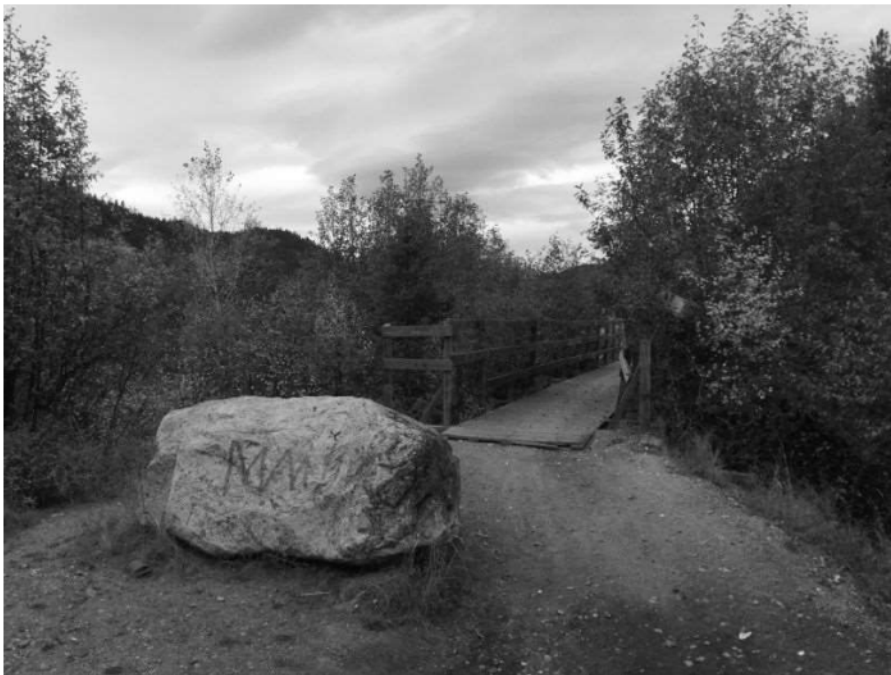
**Photo 4**  
Right approach, looking towards bridge

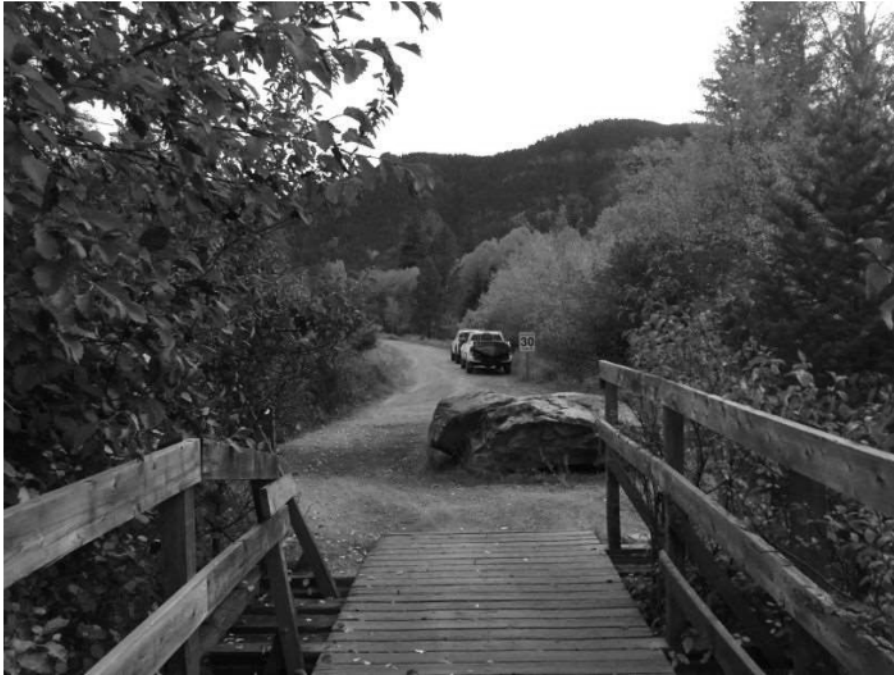
**Photo 5**  
Right approach, looking away from bridge

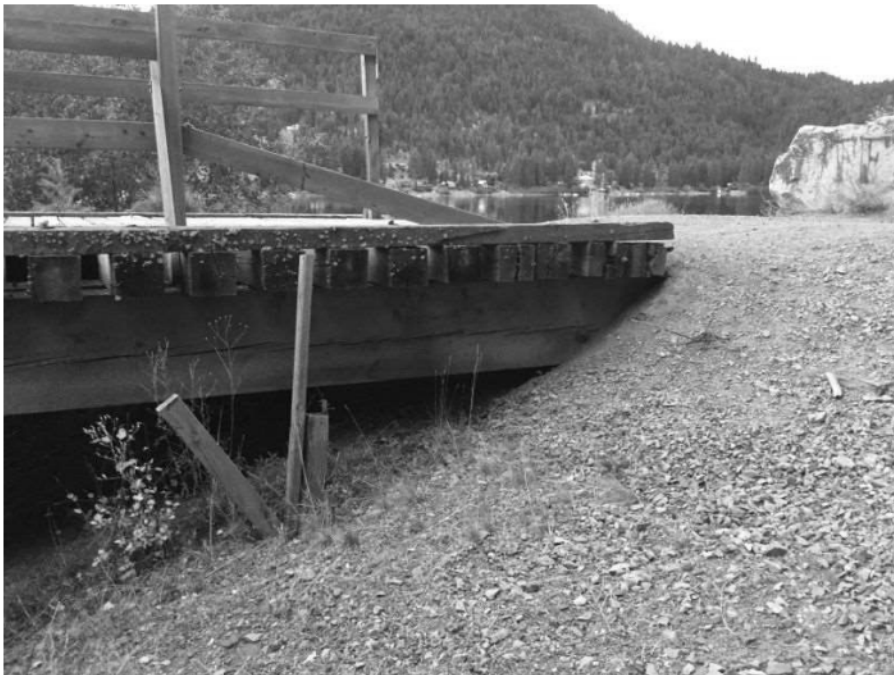
**Photo 6**  
Railing at left abutment

Item No.	Description	Priority
1	Replace broken handrails	High
2	Install additional vehicle barriers	High
3	Plan for full bridge replacement	High

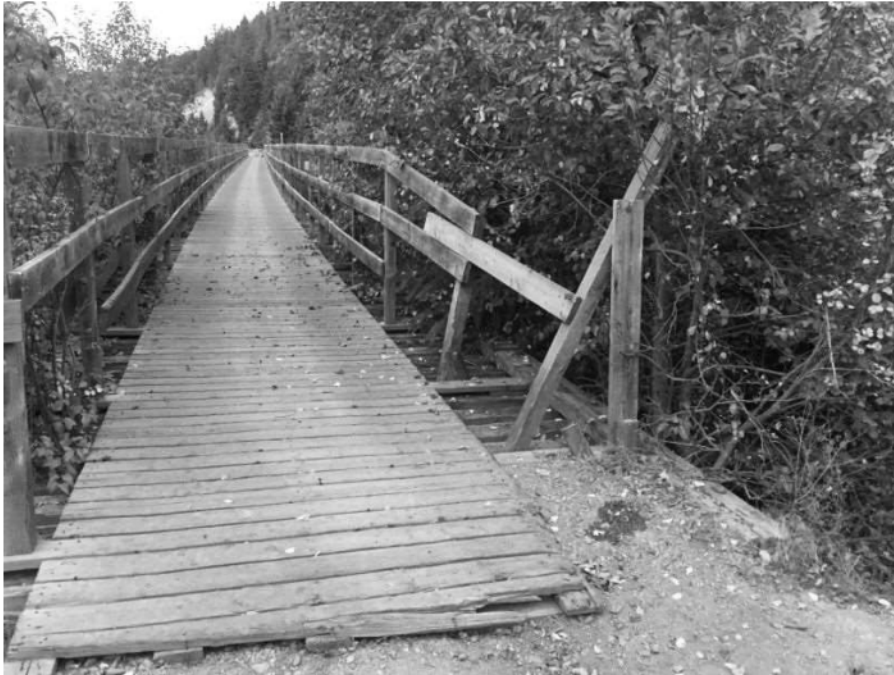
**Photo 9**  
Railing at right abutment

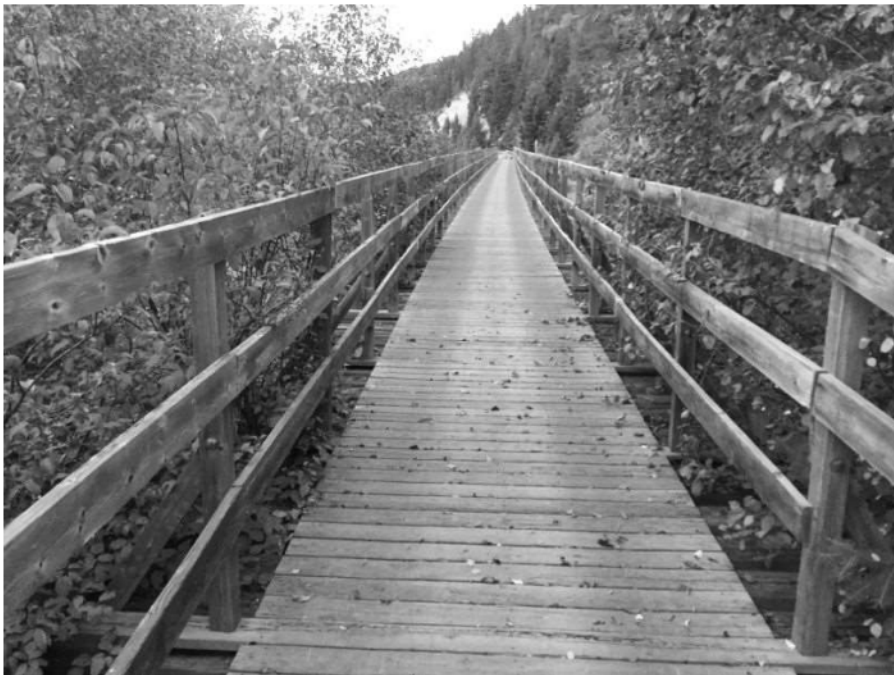
**Photo 10**  
General deck condition

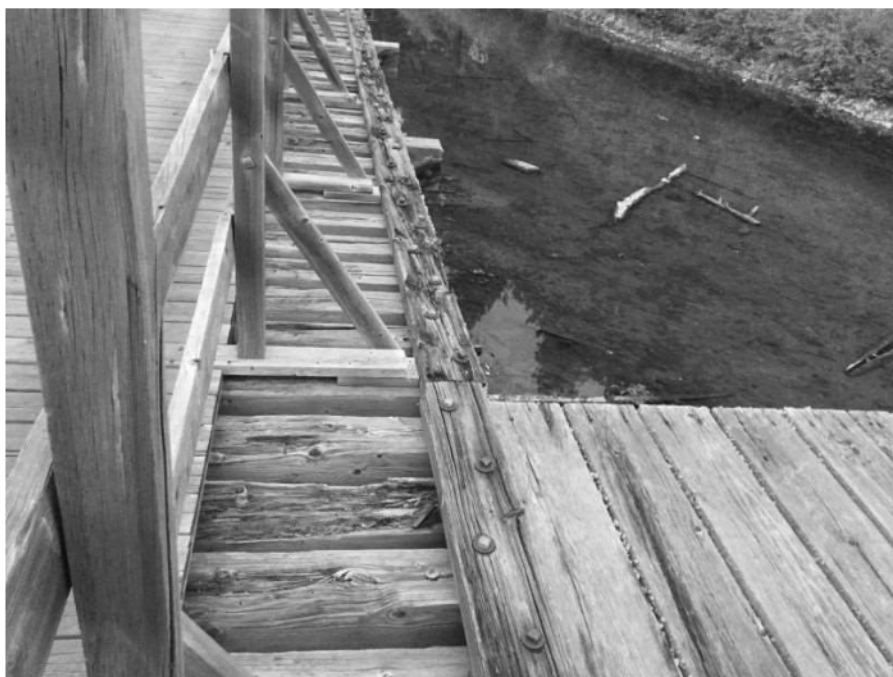
- The deck is generally in poor condition.
- The ties have widespread decay with at least 75 mm of severe decay noted on the top face of most of the ties. At least 75% of ties are in poor condition.
- The nailing planks and deck planks are in fair condition with minor decay in isolated areas.
- Limited access to inspect deck from under bridge.
- The handrails are generally in fair condition with several isolated sections with damaged handrail posts and planks.
- The handrails at both ends of the bridge are damaged and appear to have either been purposely removed or damaged for additional vehicle clearance.

**Photo 11**  
Typical deck tie condition

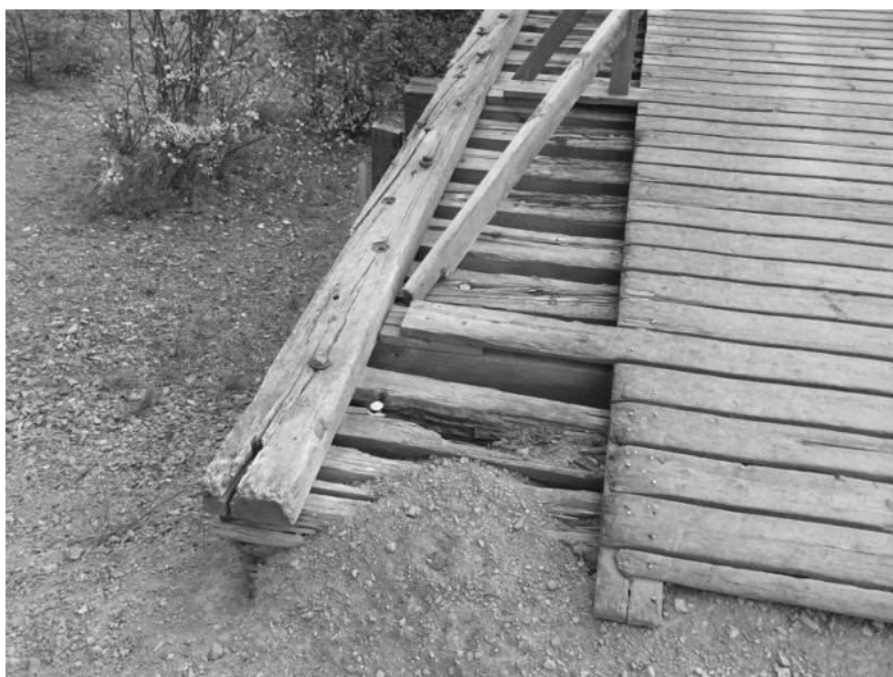
**Photo 12**  
Typical deck tie condition

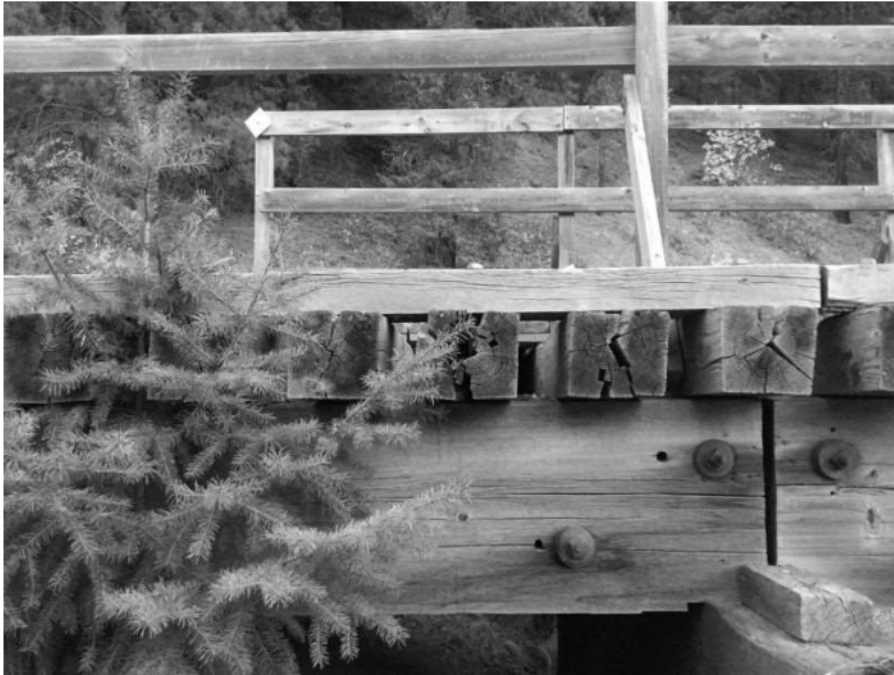
**Photo 13**  
Typical deck tie condition

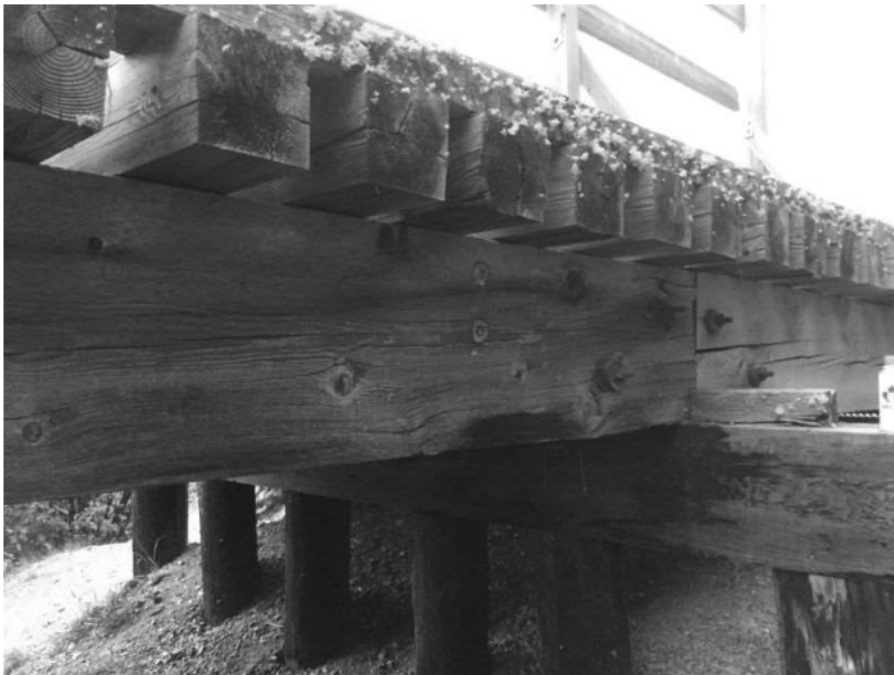
- Limited access from ground level to inspect stringers.
- Stringer 6 on spans 1 and 2 cored, 25 mm shell remaining on upper 150 mm of both stringers.
- Interior stringers at spans 1 and 2 sounded, no rot noted.
- Ends of stringers at spans 1 and 23 are buried; end of span 23 stringers are heavily decayed.
- Based on visual observations all of the exterior stringers appear to be in similar condition and therefore are likely to all have high levels of decay.

**Photo 14**  
Span 2 stringer 6 condition

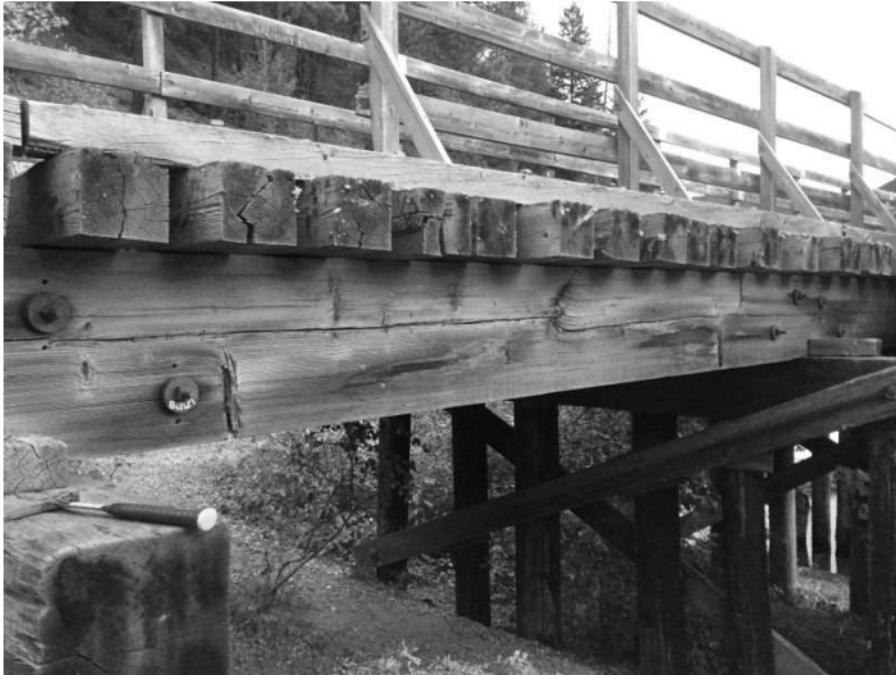
**Photo 15**  
Span 2 stringer 1 condition

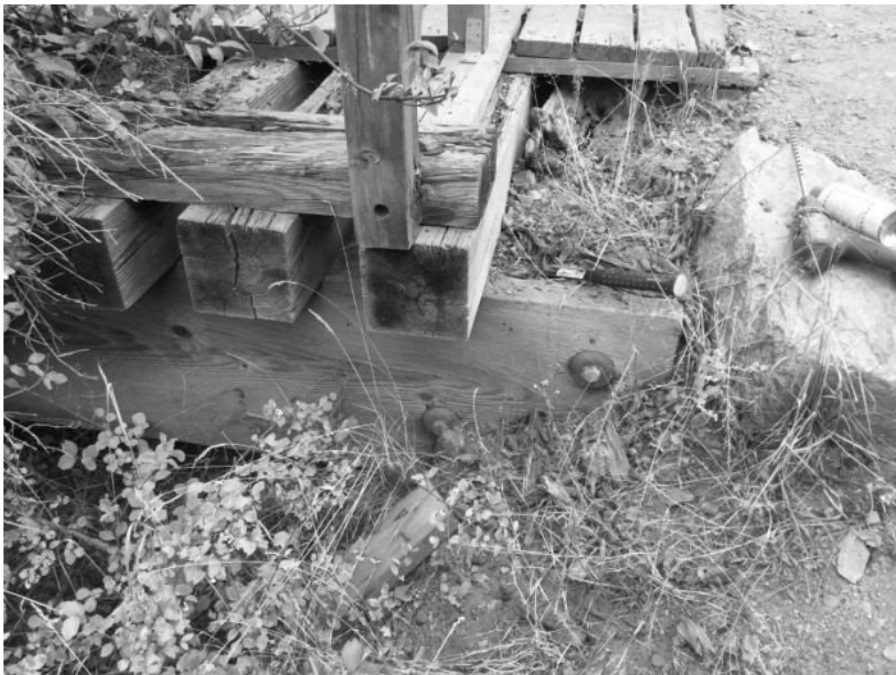
**Photo 16**  
Span 23 stringer 1 condition

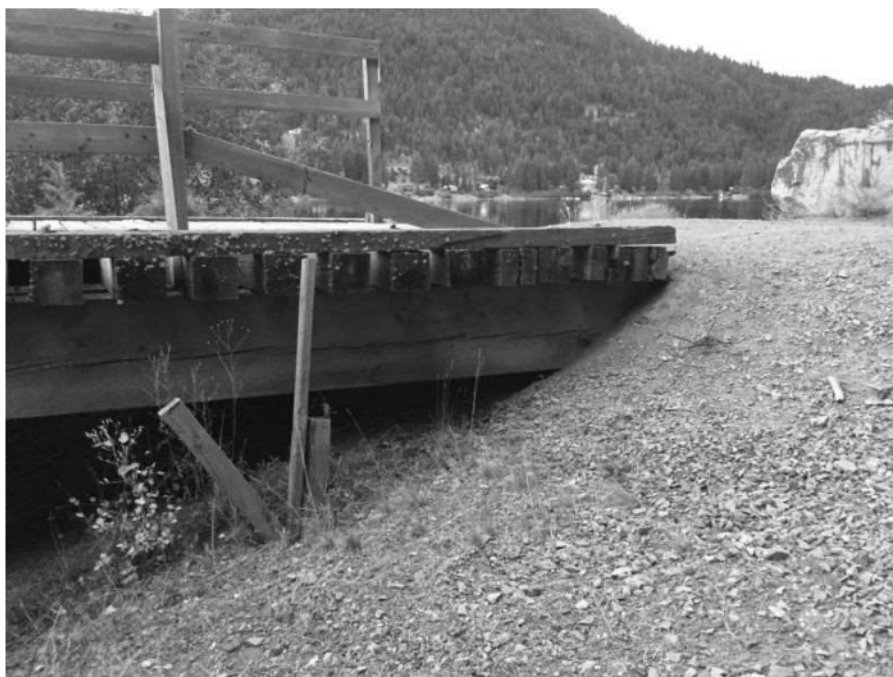
- Both abutments are buried in fill with no access for inspecting the caps/ sills and piles.

**Photo 17**  
Left abutment

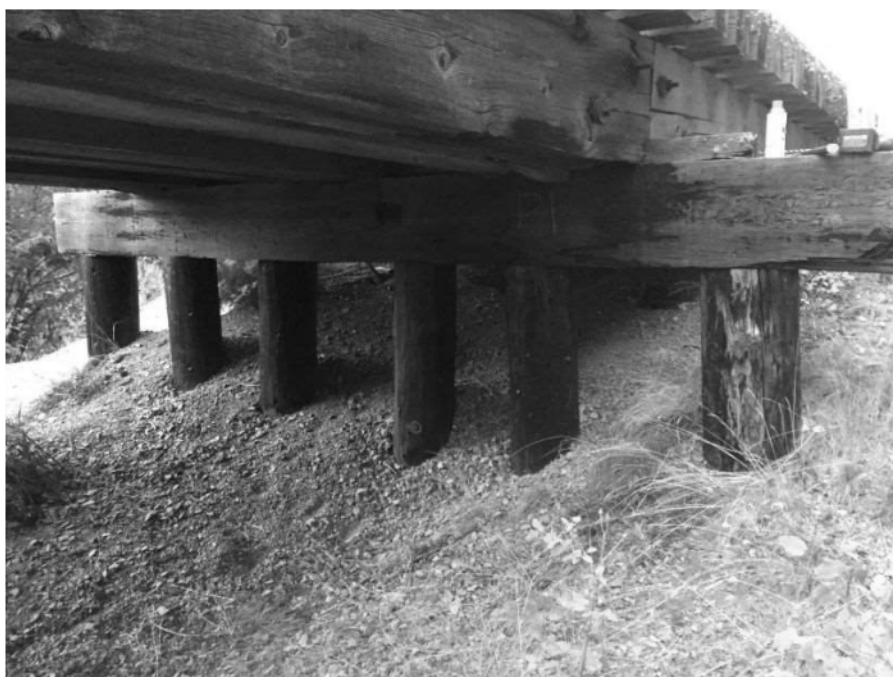
**Photo 18**  
Pier 1

Pier	Pile									Bracing		Comments
	1	2	3	4	5	6	7	8	9	Left	Right	
1												Pile 4 cored, sound
2												
3												Pile 3 sound at ground level
4					P							Pile 1 cored, soft but no rot
5												
6												Pile 8 cored, sound
7												Pile 7 rot at 1.0m above PWL
8												
9	P											Pile 7 cored, sound
10	P											
11	P											Pile 6 cored, sound
12	P											
13	P					P						
14												Pile 3 cored, sound
15												
16						P

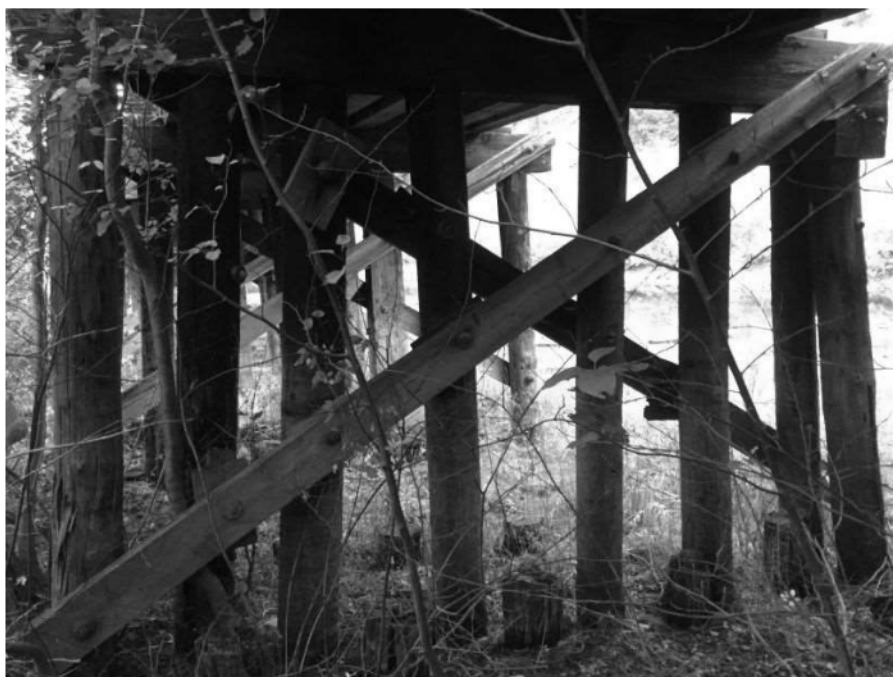
**Photo 39**  
Pier 20

Pier	Pile									Bracing		Comments
	1	2	3	4	5	6	7	8	9	Left	Right	
17								P				
18												
19						P						Pile 3 cored, sound
20												Pair of piles at 7, right is rotten
21	P		P									Pile 6 has wide split, no rot
22				P								Rot in pile 4 is in the sill/ blocking, no crushing noted
