Rails to Trails

Routine Condition Culvert Inspection Form

Crossing	Structure #	Site #	Length(m)	UTM Zone and E	UTM N
Sutherland Creek	CW-042	CW-042	60.0	11 / 412432	5434957
Trail Name	Km		Dimension(mm)	Culvert Material	Flumes (Y or N)
CWRT	83.5		3000 x 2500	rock tunnel	N
Inspection Co. Name	Inspector's Name /Signature			Inspection Date:	November 12 2011
SNT Engineering Ltd.	R.L.Johnson			Next Inspection:	November 12 2014

Structure # : CW-042

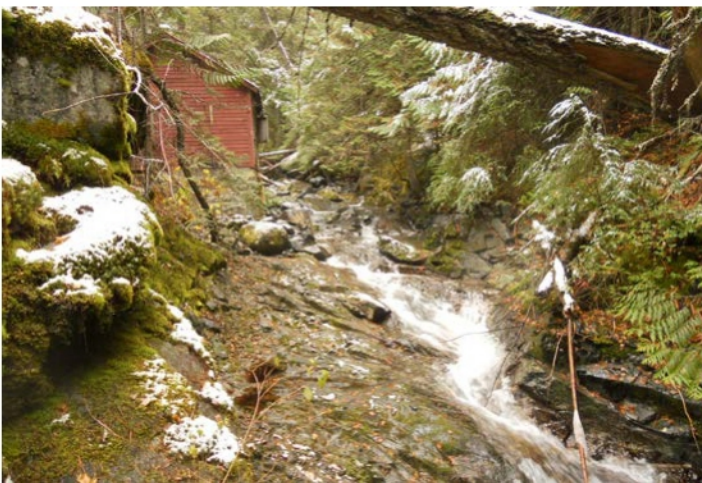
There is a well-kept shed upstream; this may be part of Christina Lake water system. Note that a ladder is required to access the stream bed.

Upstream and water district shed

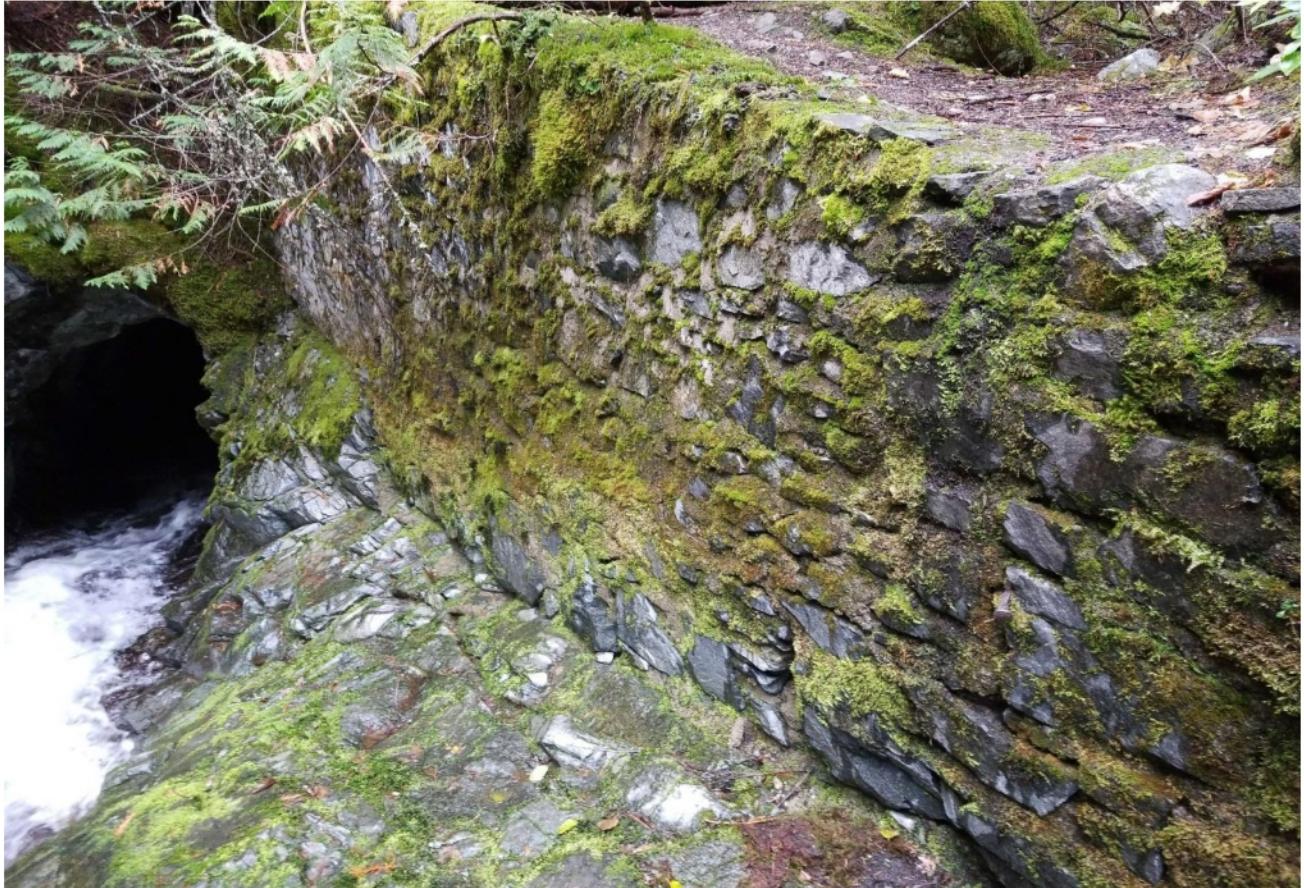
2.5m rock and mortar headwall at inlet

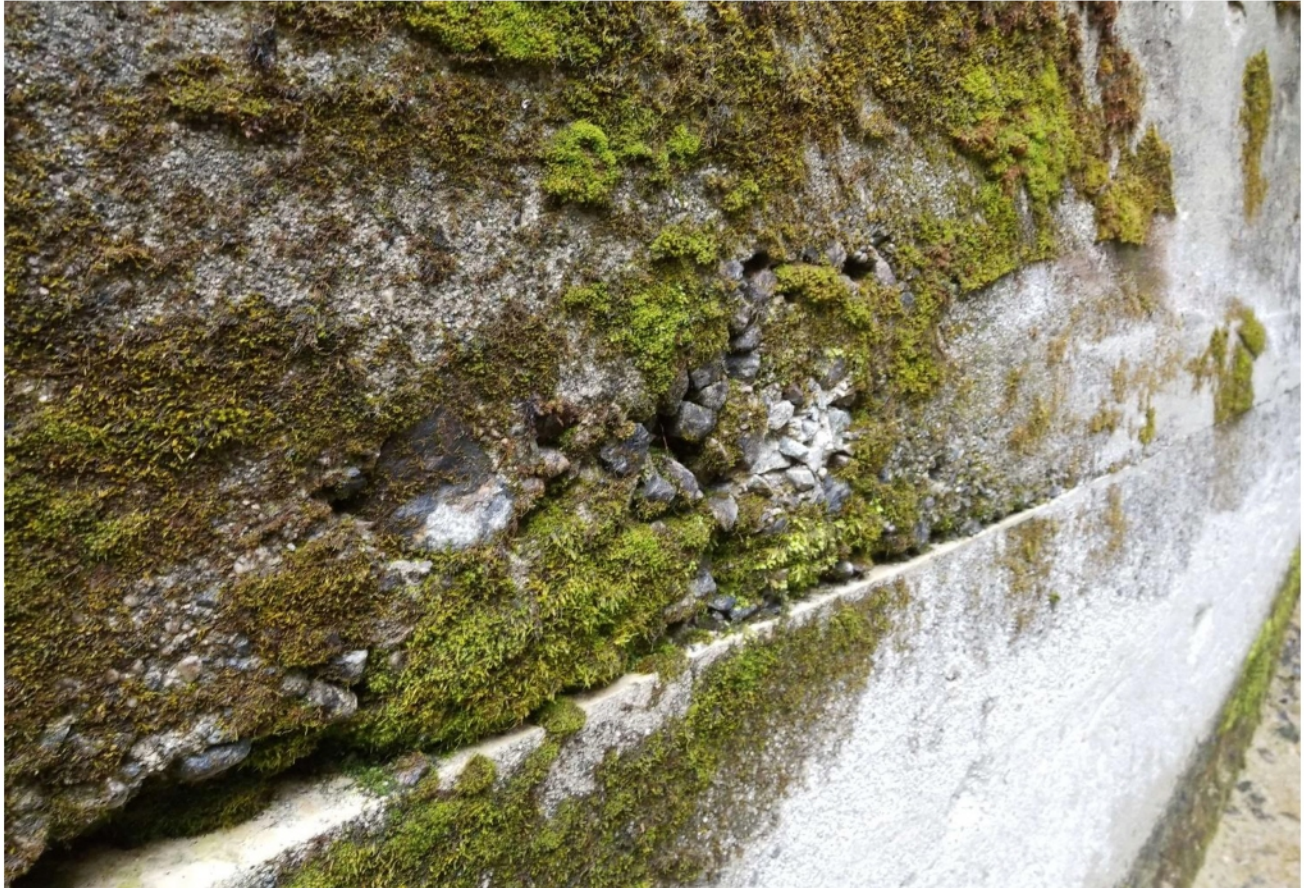
Item	Present Condition	Comments
Headwalls	Good	Rock and mortar at inlet. Stable no signs of movement. 2m tall. CIP concrete wall at outlet. 3.0m tall. Minor spalling at terminal end. Cold joints appear stable. No observed movement
Wing Walls	NA	
Inlet	Good	1.4m wall at inlet where access is. Ladder required.
Outlet	Good	
Riprap	NA	
Trash Rack	NA	
Aprons or Other Inlet/Outlet Items	Poor	Concrete apron at outlet completely scoured away
Overall Condition	Good

#	Description					
1						
2						
3						
4						
5						
General Comments						
Rock tunnel. Ladder needed at inlet. Good condition. Minor localized spalling in CIP headwall at outlet

Localized spalling on outlet headwall

#	Priority	Description			Estimate (\$)	
1	Low	Grout patch localized CIP wall spalling at outlet			1000	
2						
3						
4						
5						
ITEMS TO MONITOR
