FIRE REPORT - **STRUCTURE**

INCIDENT NUMBER: **NMH 2017 04 05 05 01**

**Fire Investigation**  
**BKB Cedar Manufacturing**  
**2940 Museum Road, Mc Bride, B.C.**  
**April 05, 2017**

# FIRE INVESTIGATION REPORT

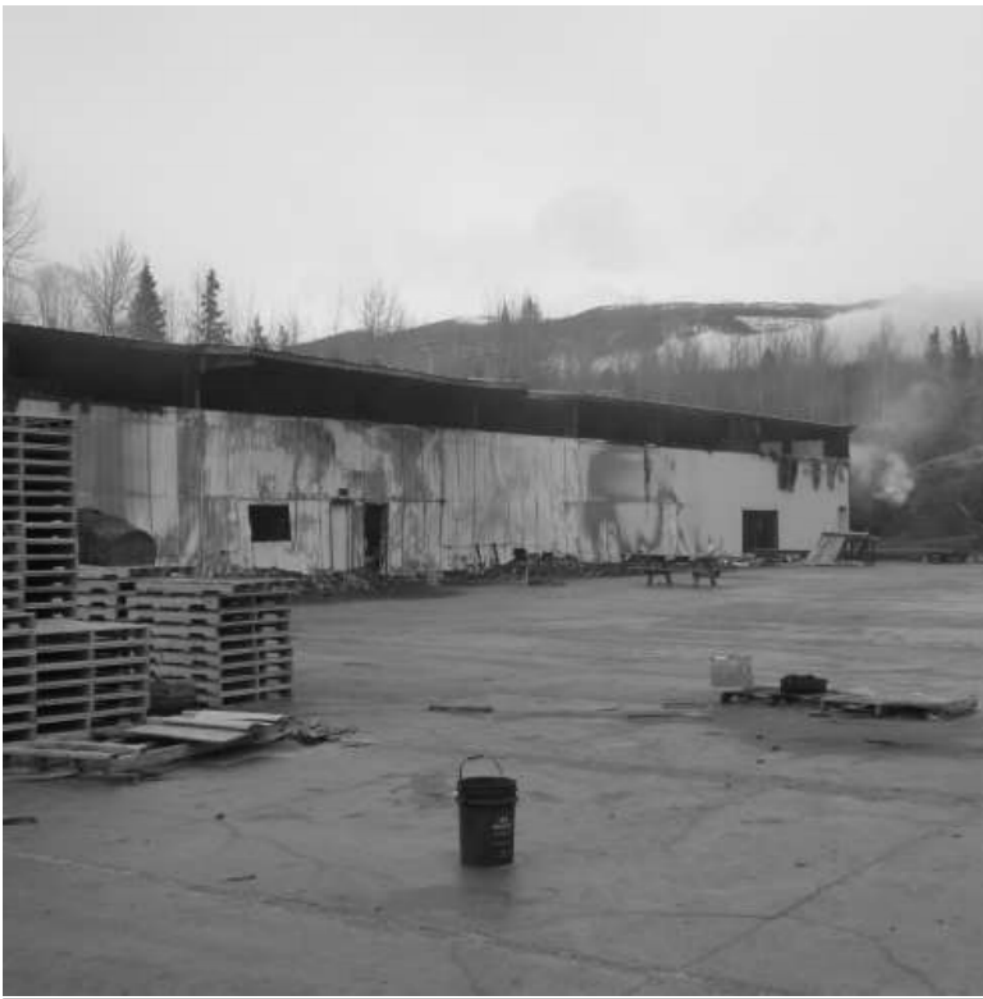
**Photo # 1** “A” Side of building - Chip pile to the right is an exposure fire and started after the mill was already burning.

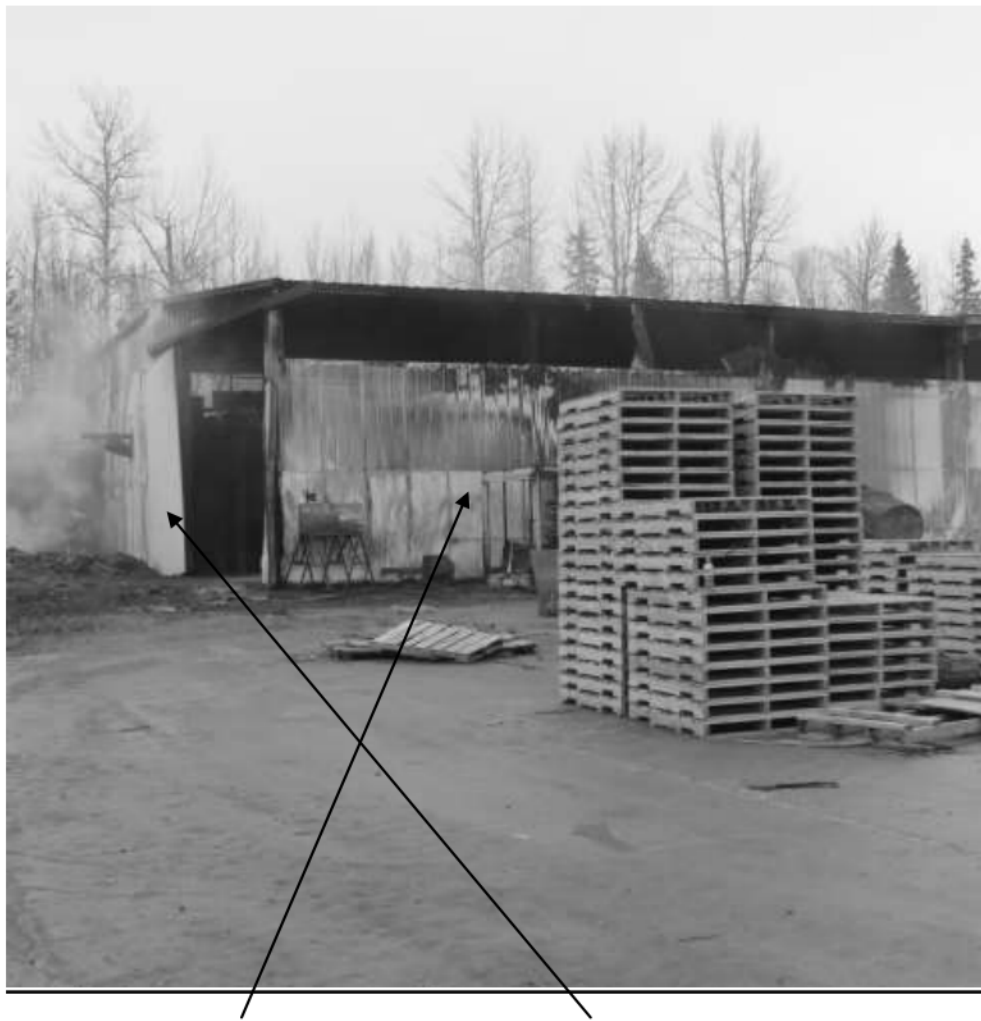
**Photo #2** “A” Side of building closer to “B” side

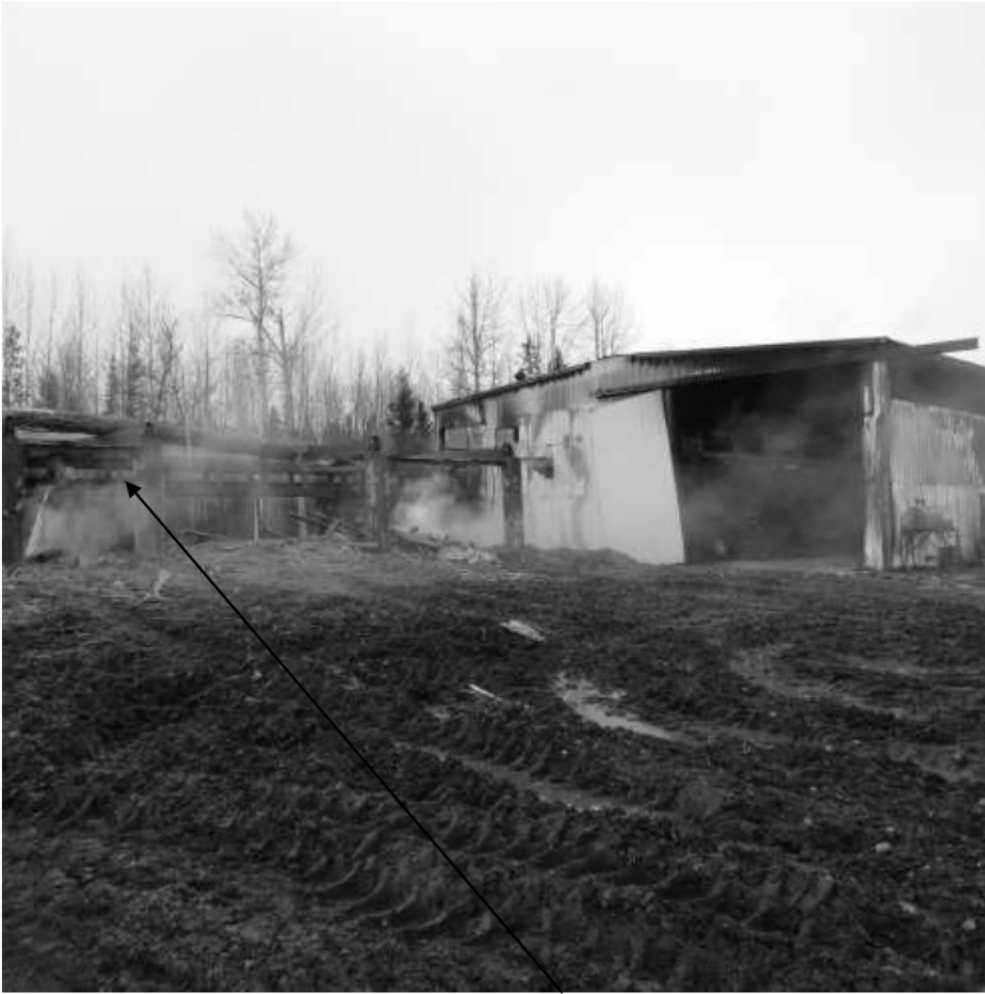
**Photo #3** “B” Side of the mill - Main infeed where logs are feed into the mill.

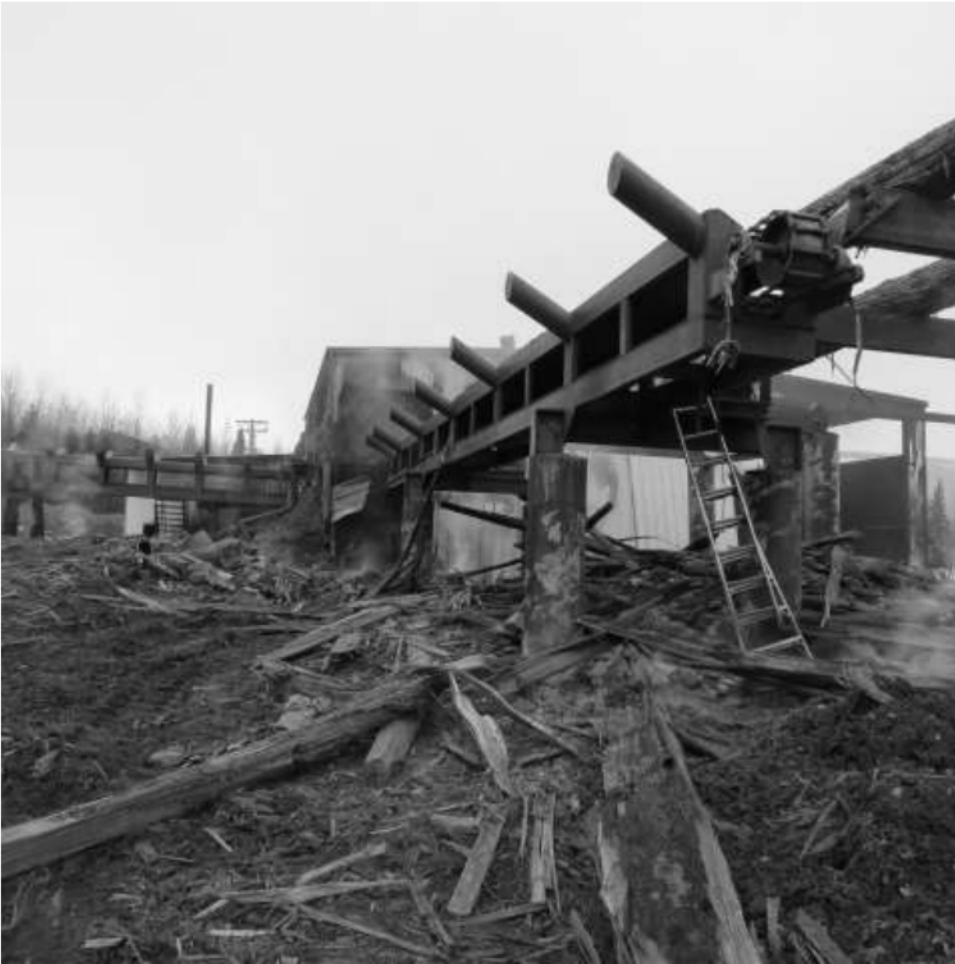
**Photo #4 “B”** Side- Main log deck/ infeed where logs are feed into the mill.

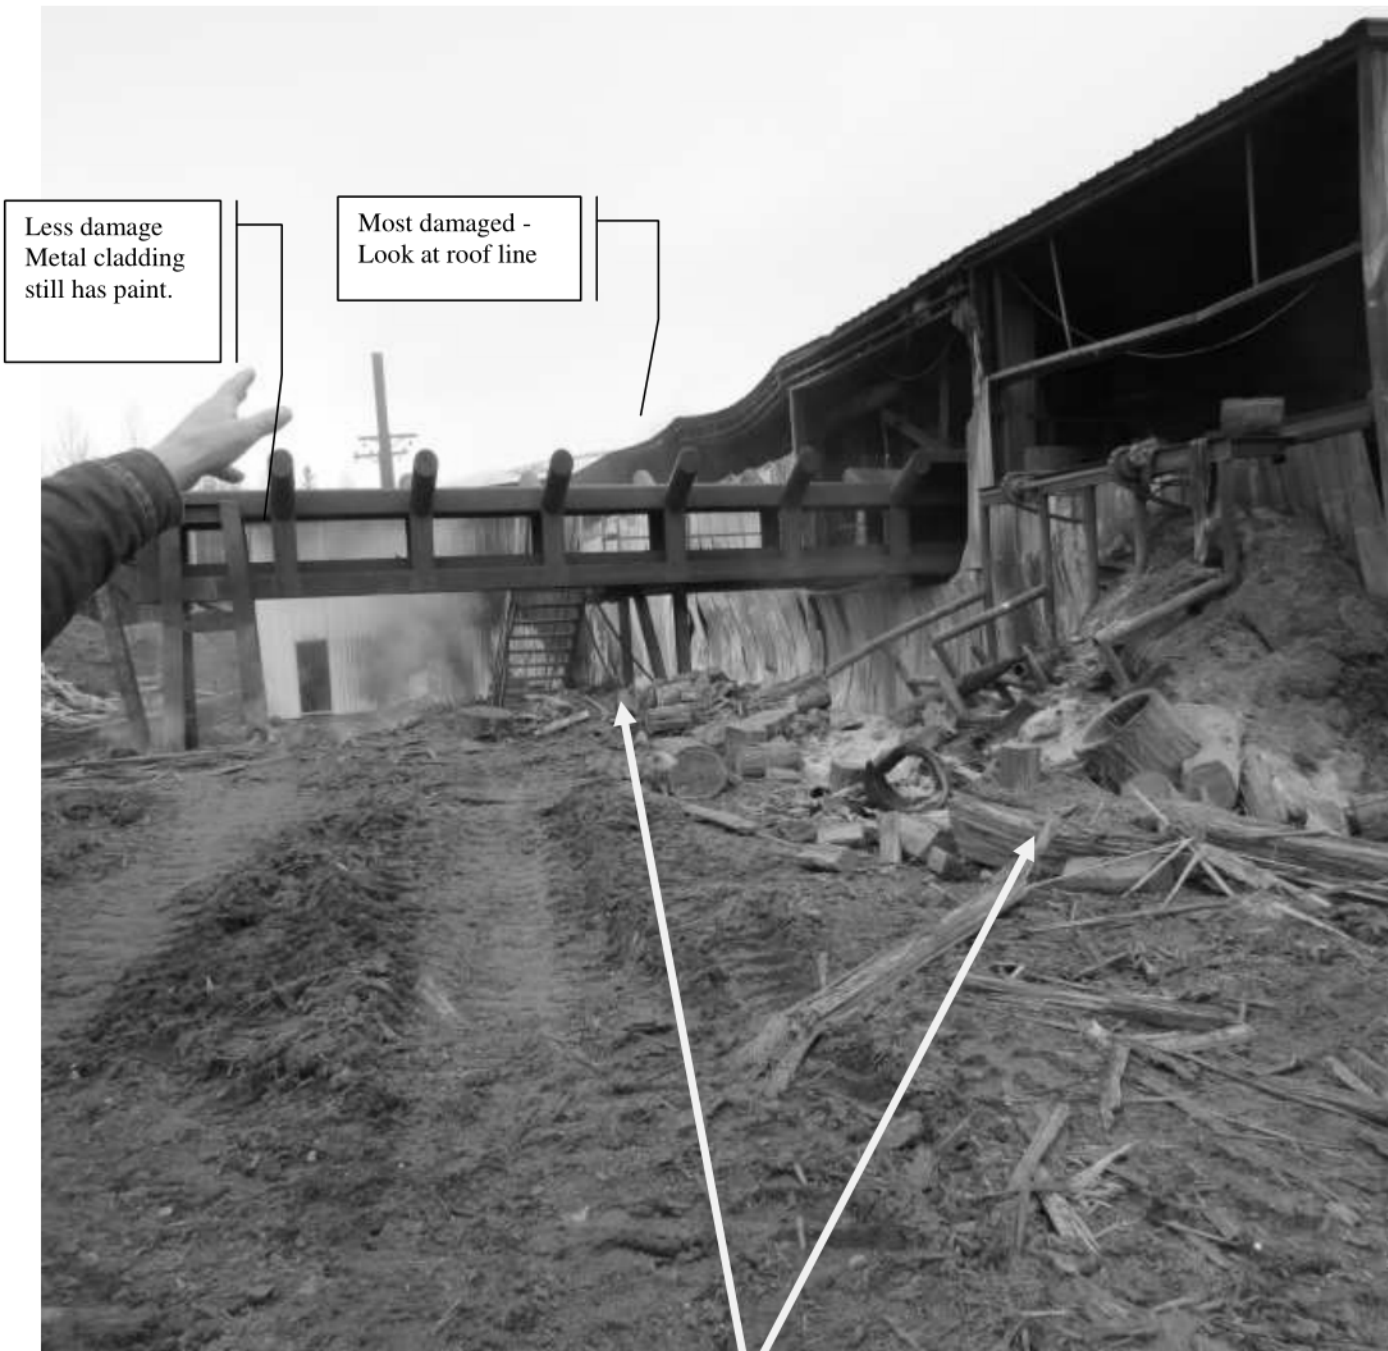
**Photo #5** “C” Side of the building (Back) Additional wood on outside of building added to fire load.

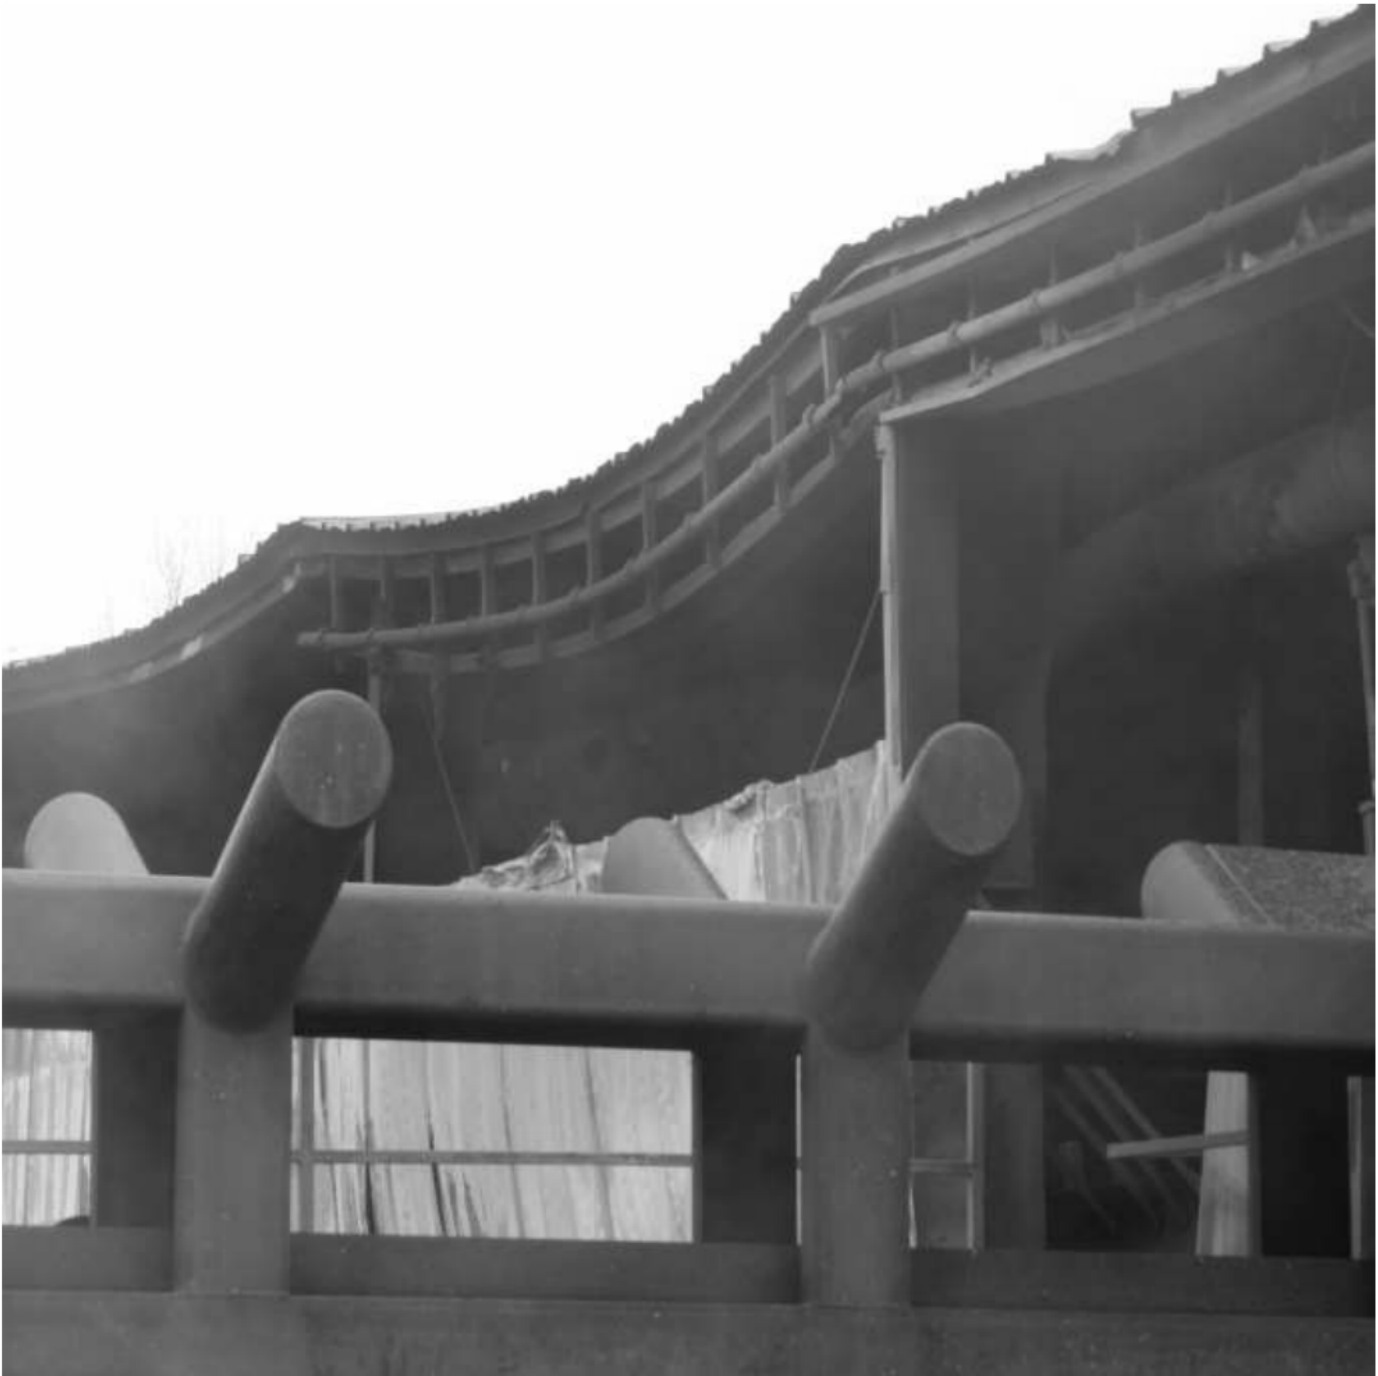
**Photo #6** Roof line damage above area of origin which was on grade level - this is above 2<sup>nd</sup> story - main mill operations floor.

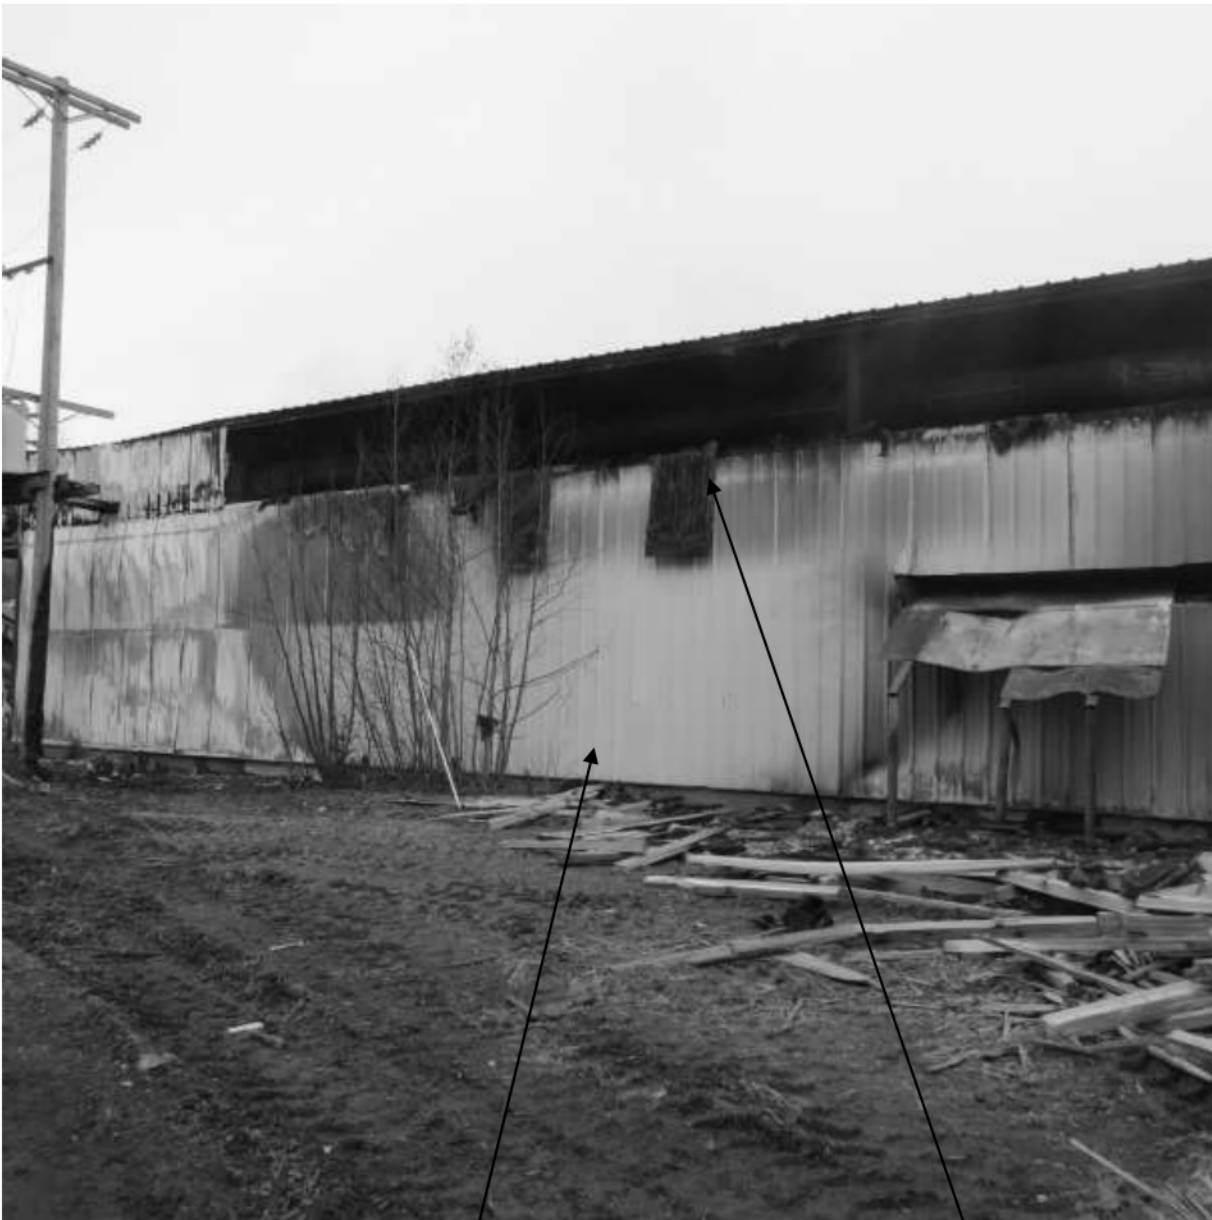
**Photo #7 "C"** Side of building - Metal cladding. Top row was clear fibreglass to let in natural lighting and in most cases has melted away.

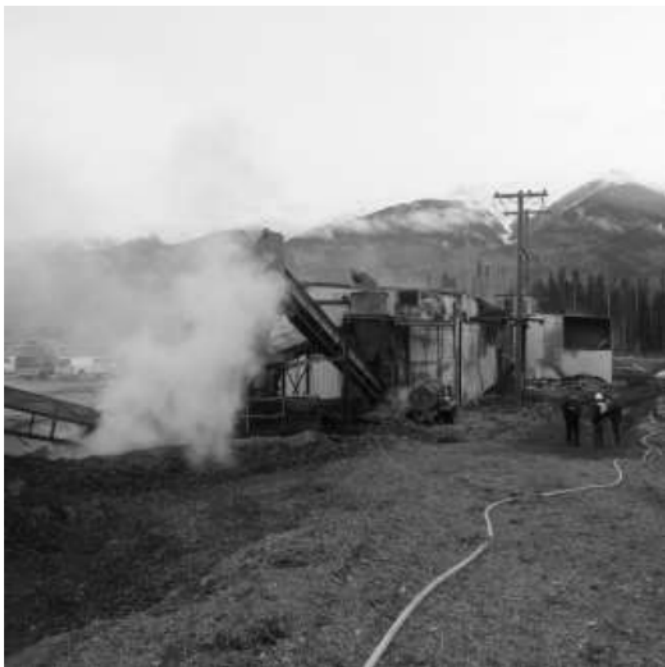
**Photo #7** “D” side of building -  
Conveyor to chip pile

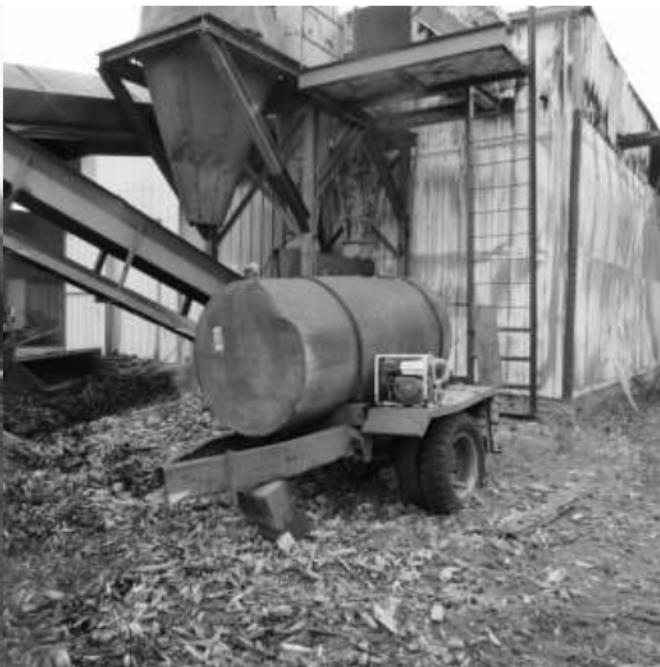
**Photo #8** Water tank empty over the winter.  
Mill not sprinklered - No FD water supply.

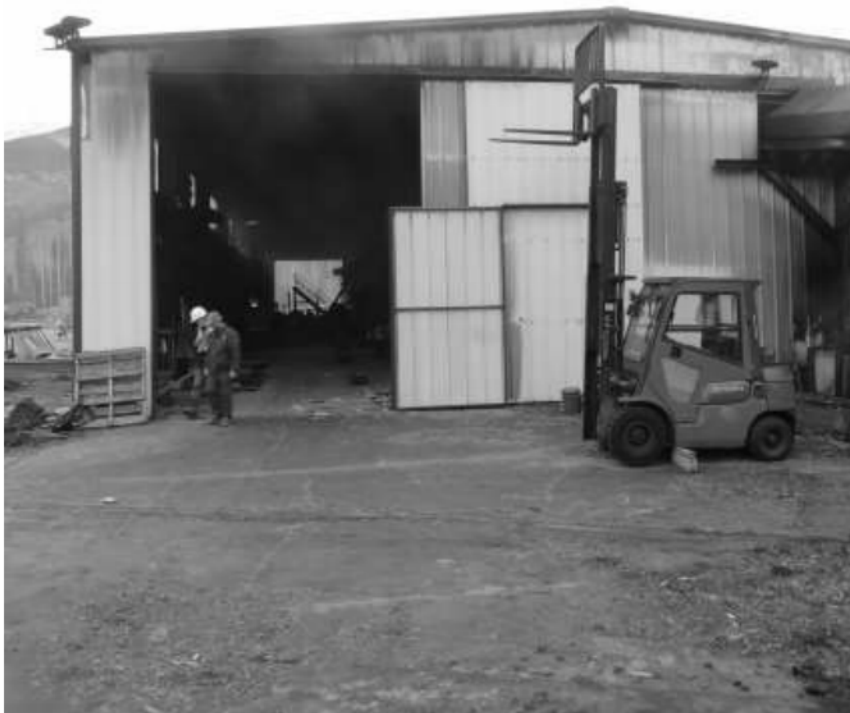
**Photo #9** “D” Side looking towards “B” side

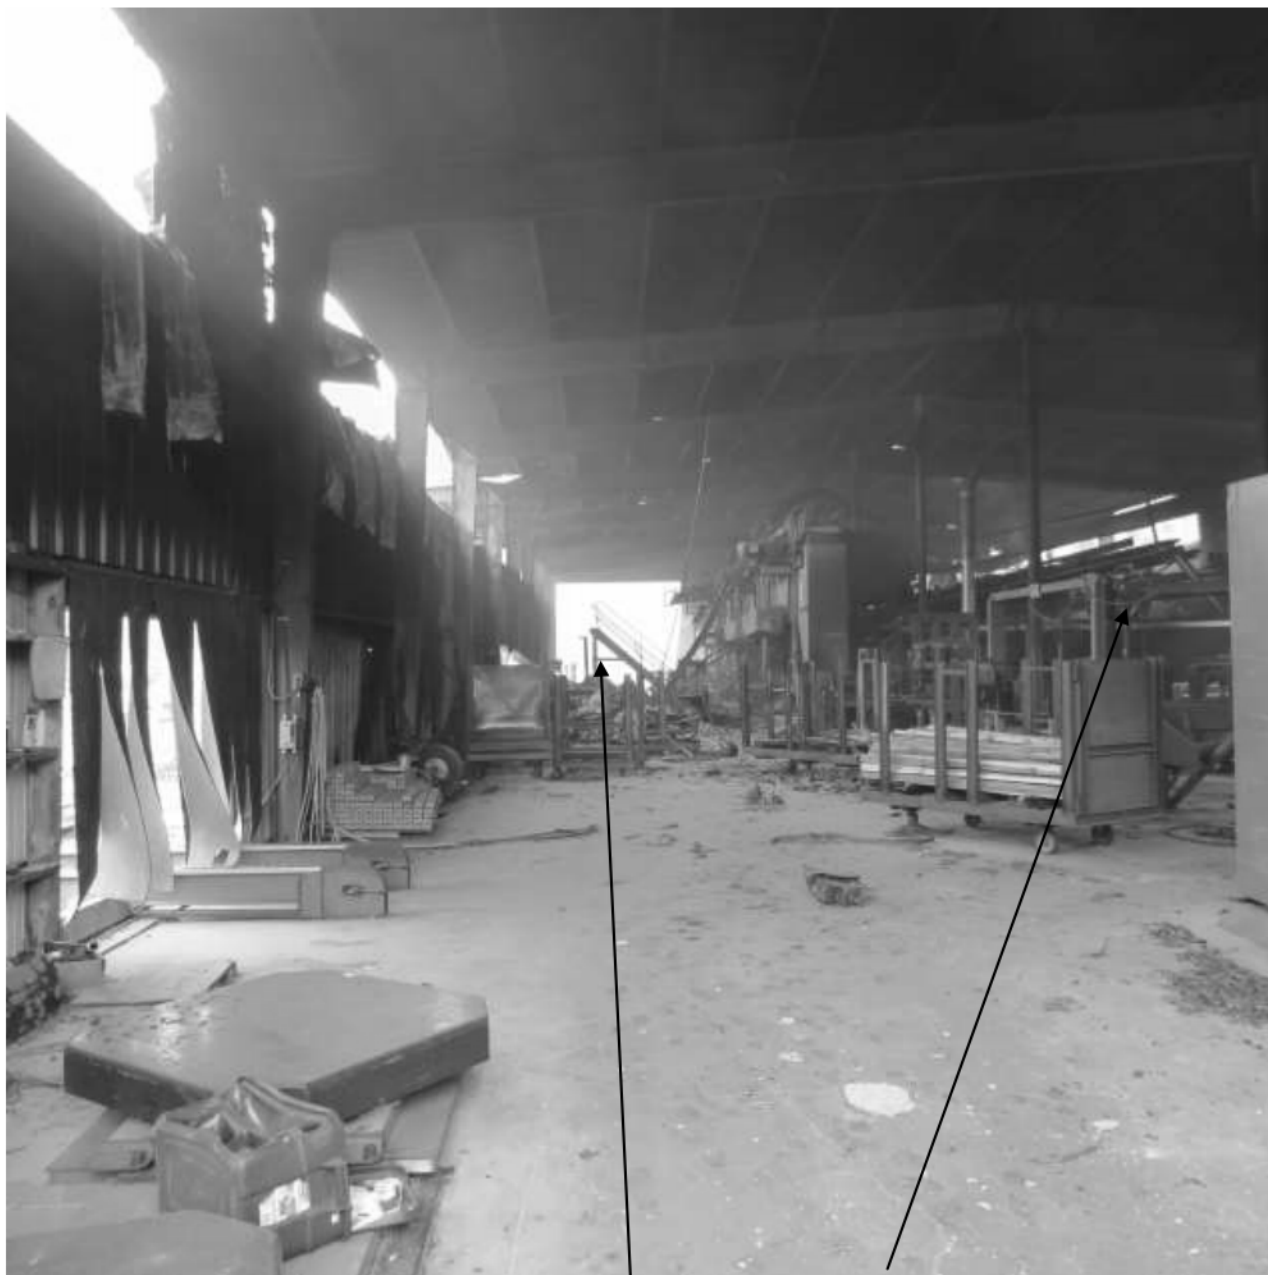
**Photo #10** “D” Side looking towards “B” side - Stairs at office area - 2<sup>nd</sup>/main working floor

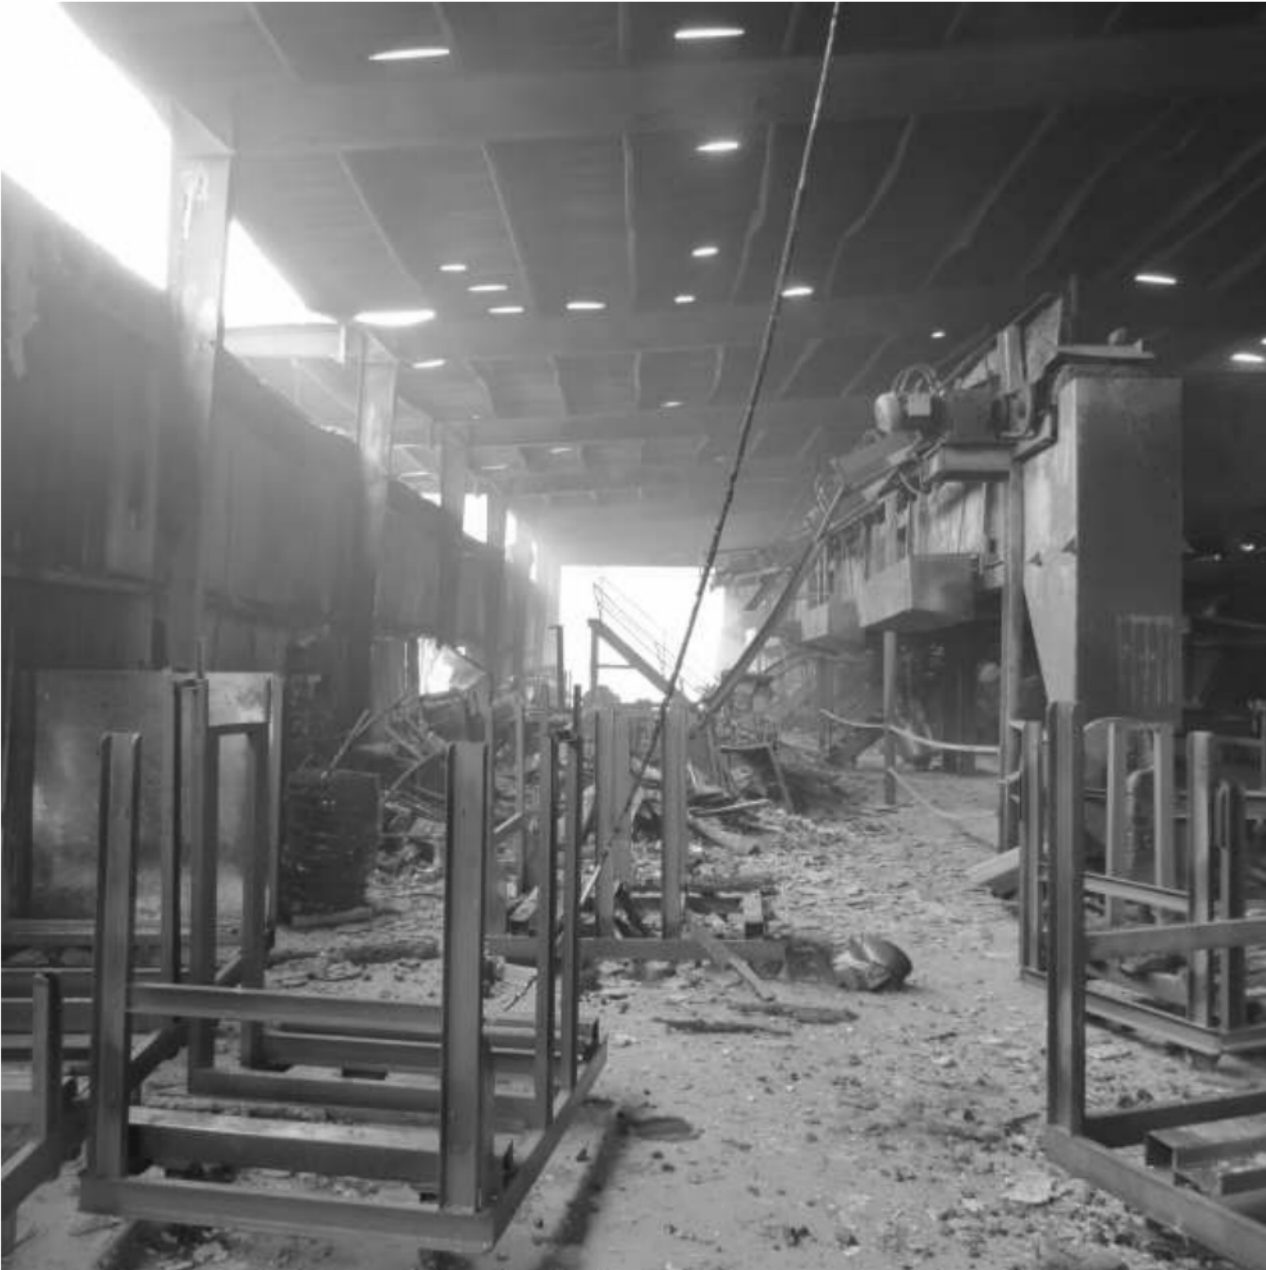
**Photo 11** “D” Side looking towards “B” side part way in the building

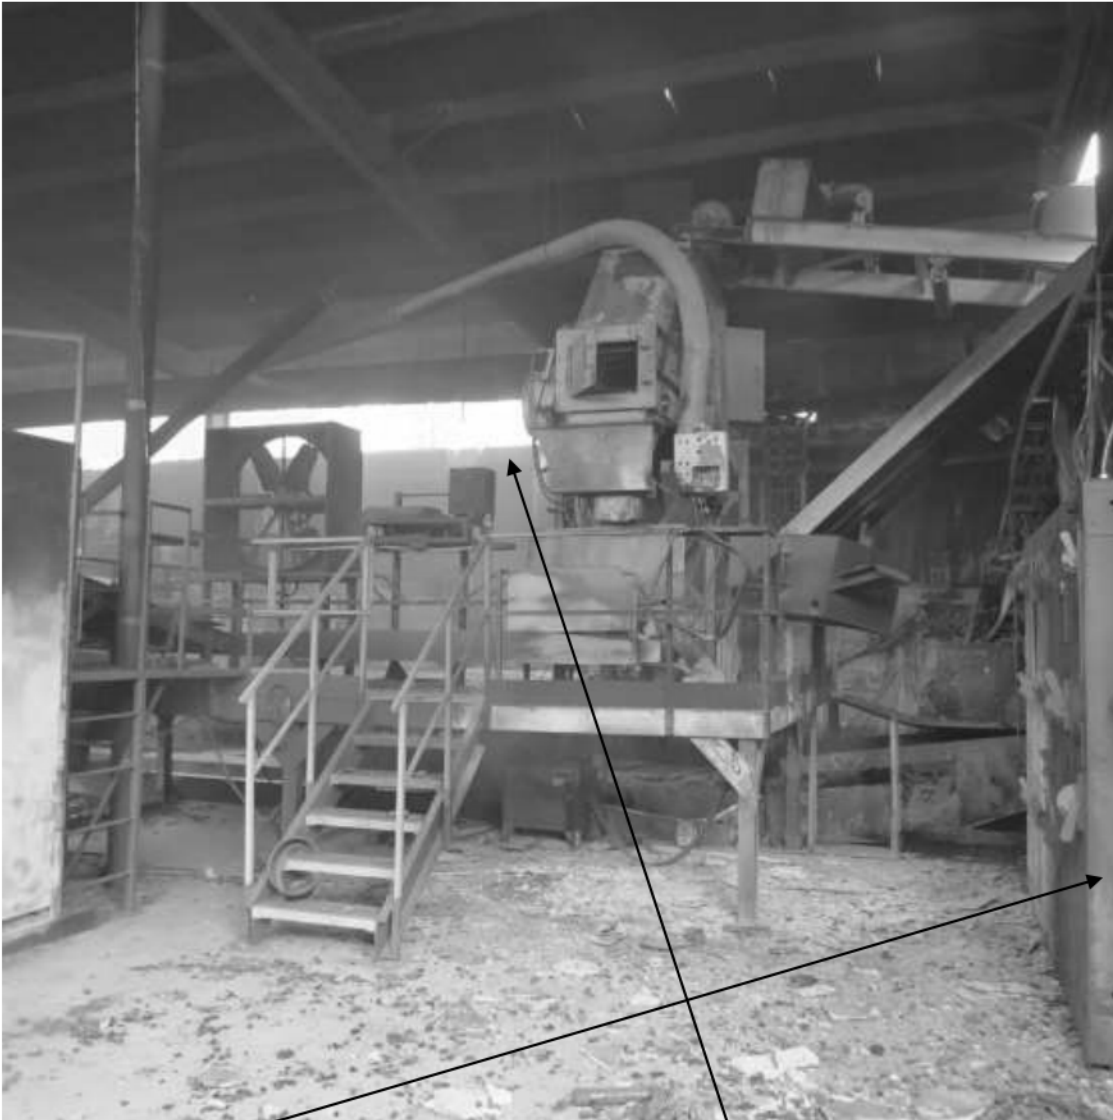
**Photo 12** “D” End looking towards the Side looking towards “C” side part way in the building

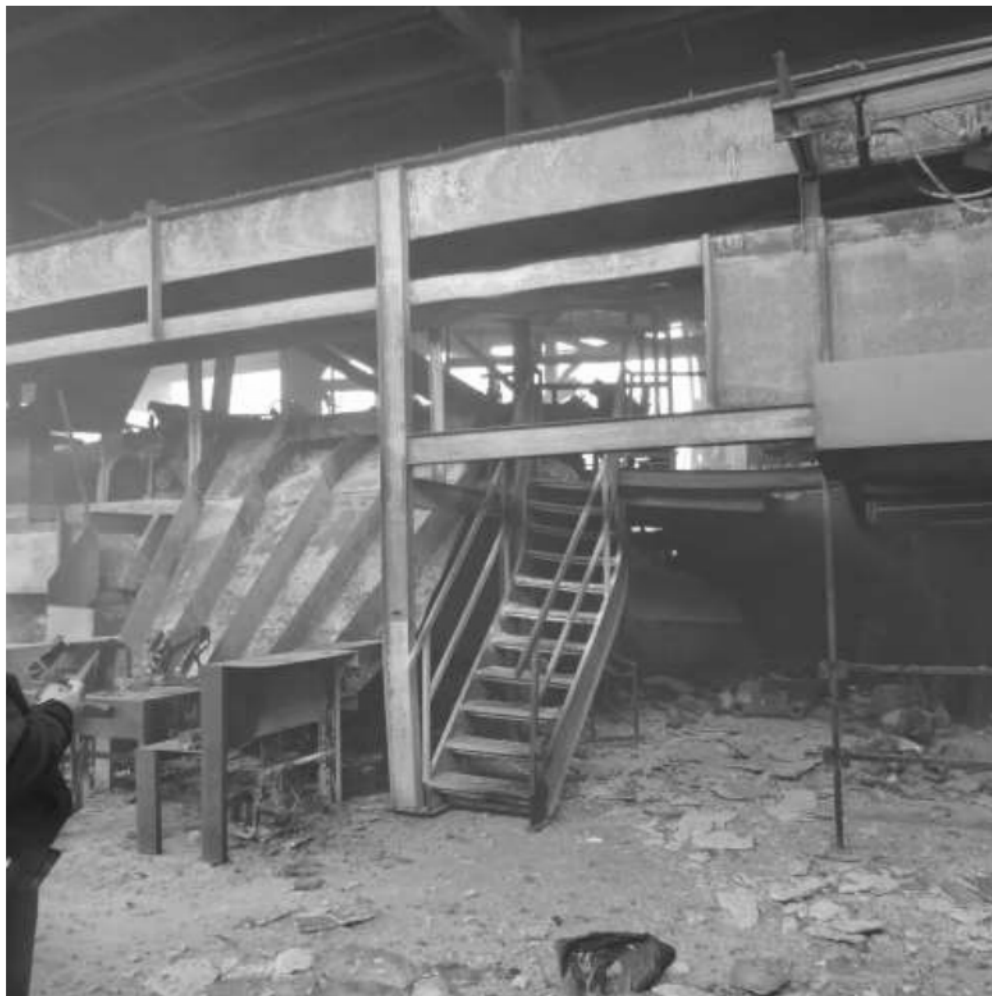
**Photo #13** two-thirds the way down looking from D side - Looking towards "C" (back wall) 4 separate stairs going up to main deck - one on each end and two spaced in between the two end stairs.

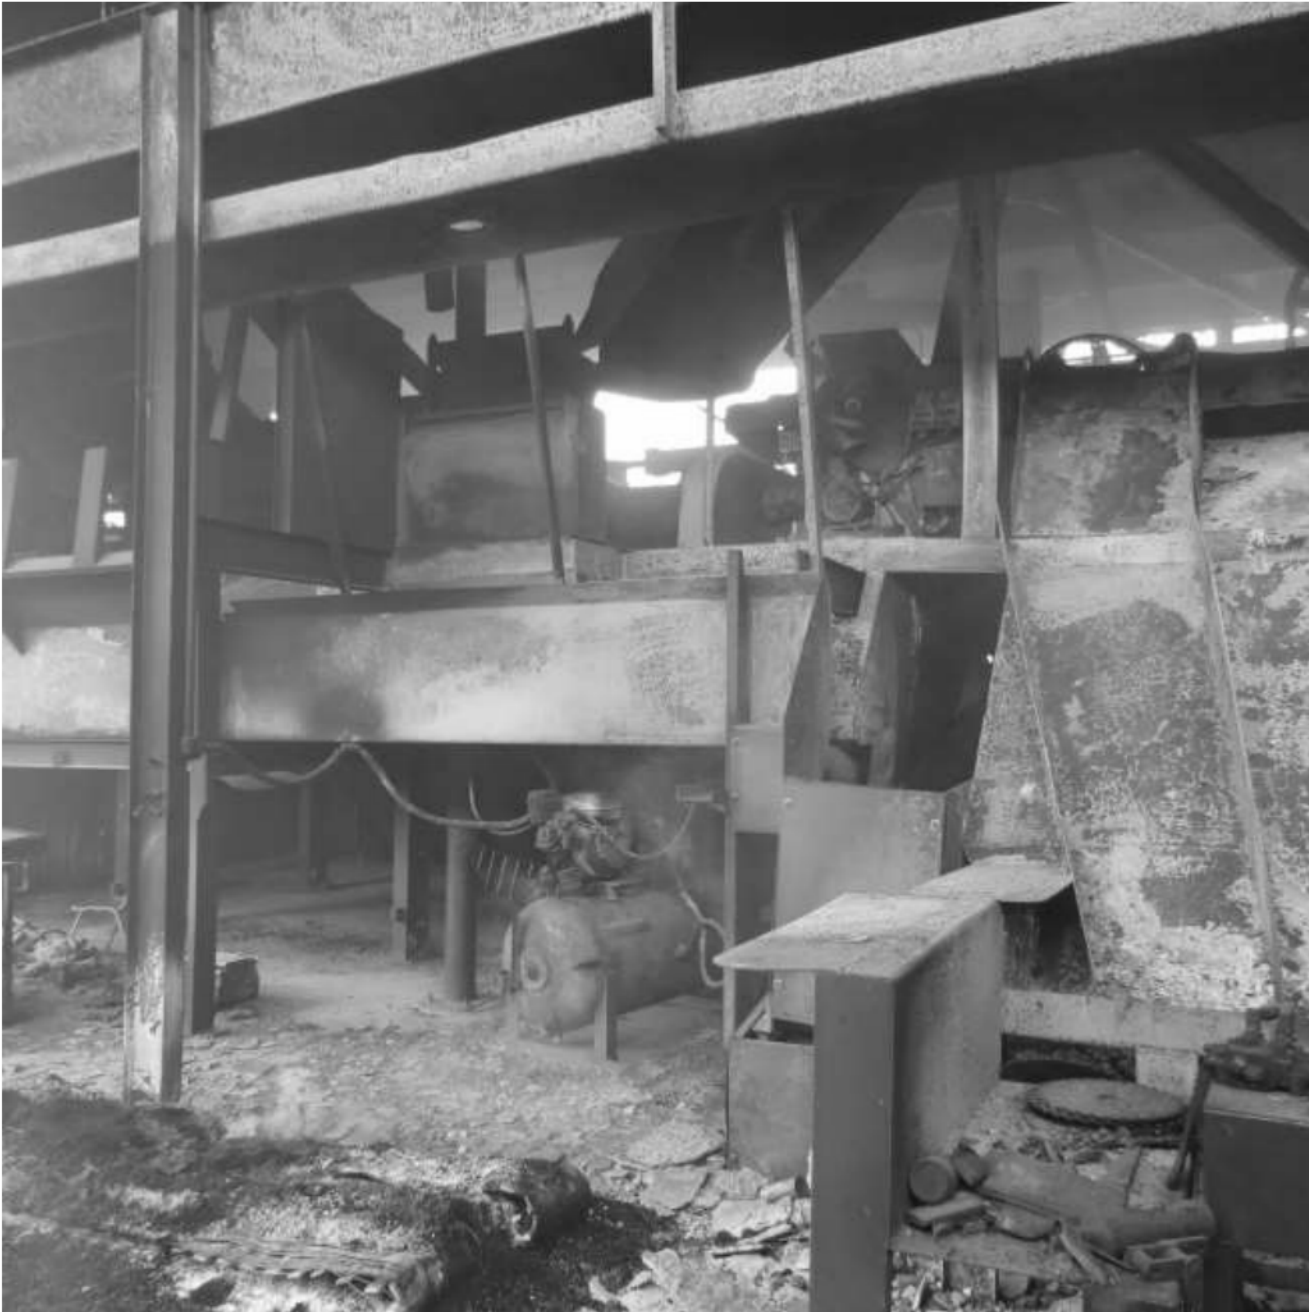
**Photo #14** Another example of heat damage to both lower and upper decks & equipment.

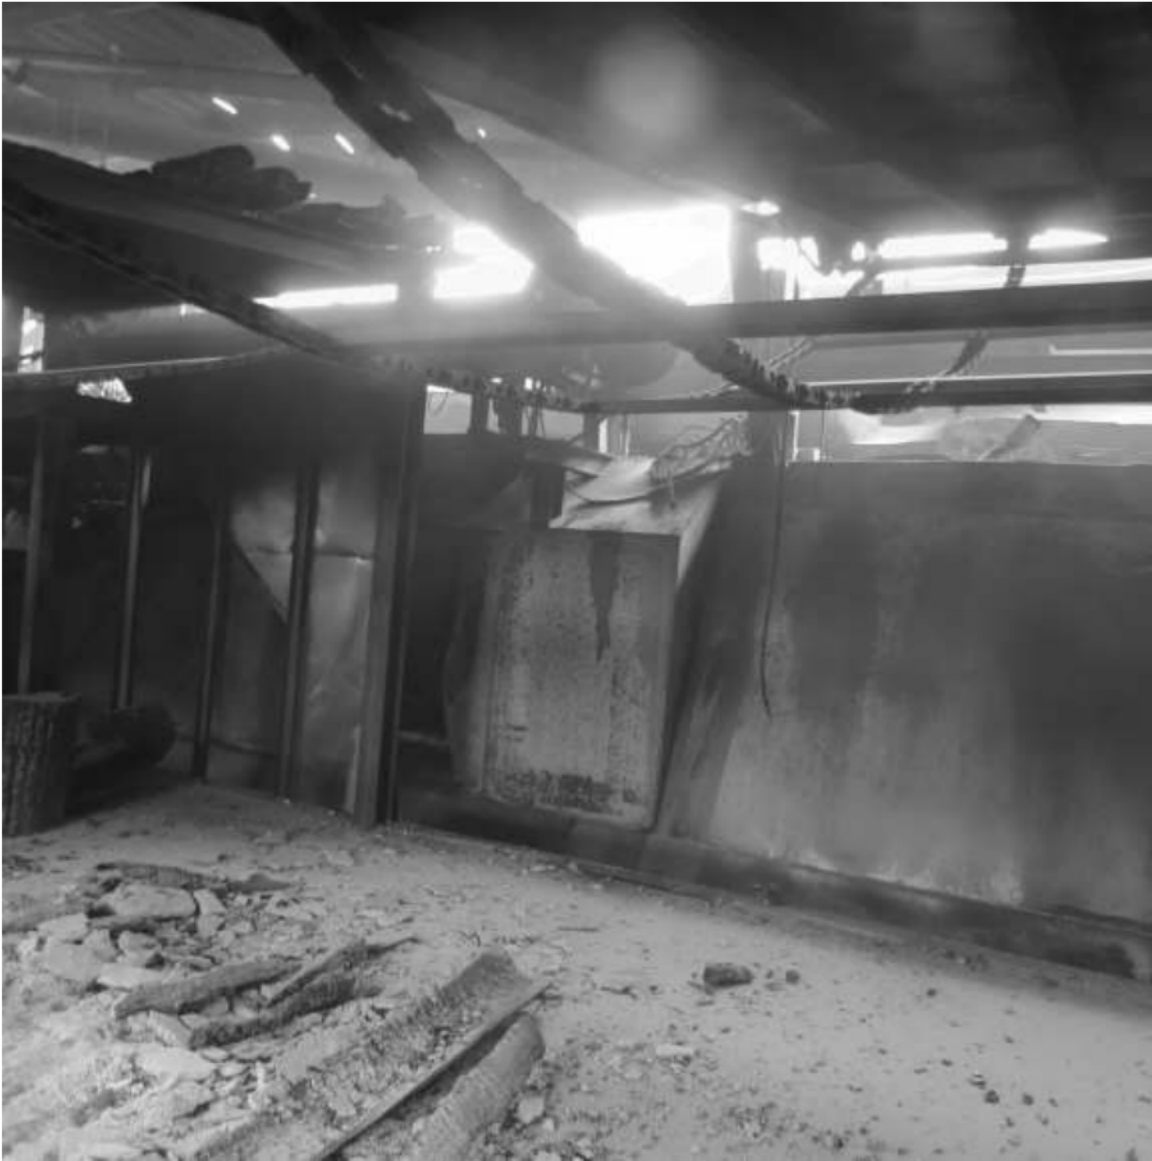
**Photo #15** Looking towards “C” side or back wall - Access point for hydraulic tank and motors.

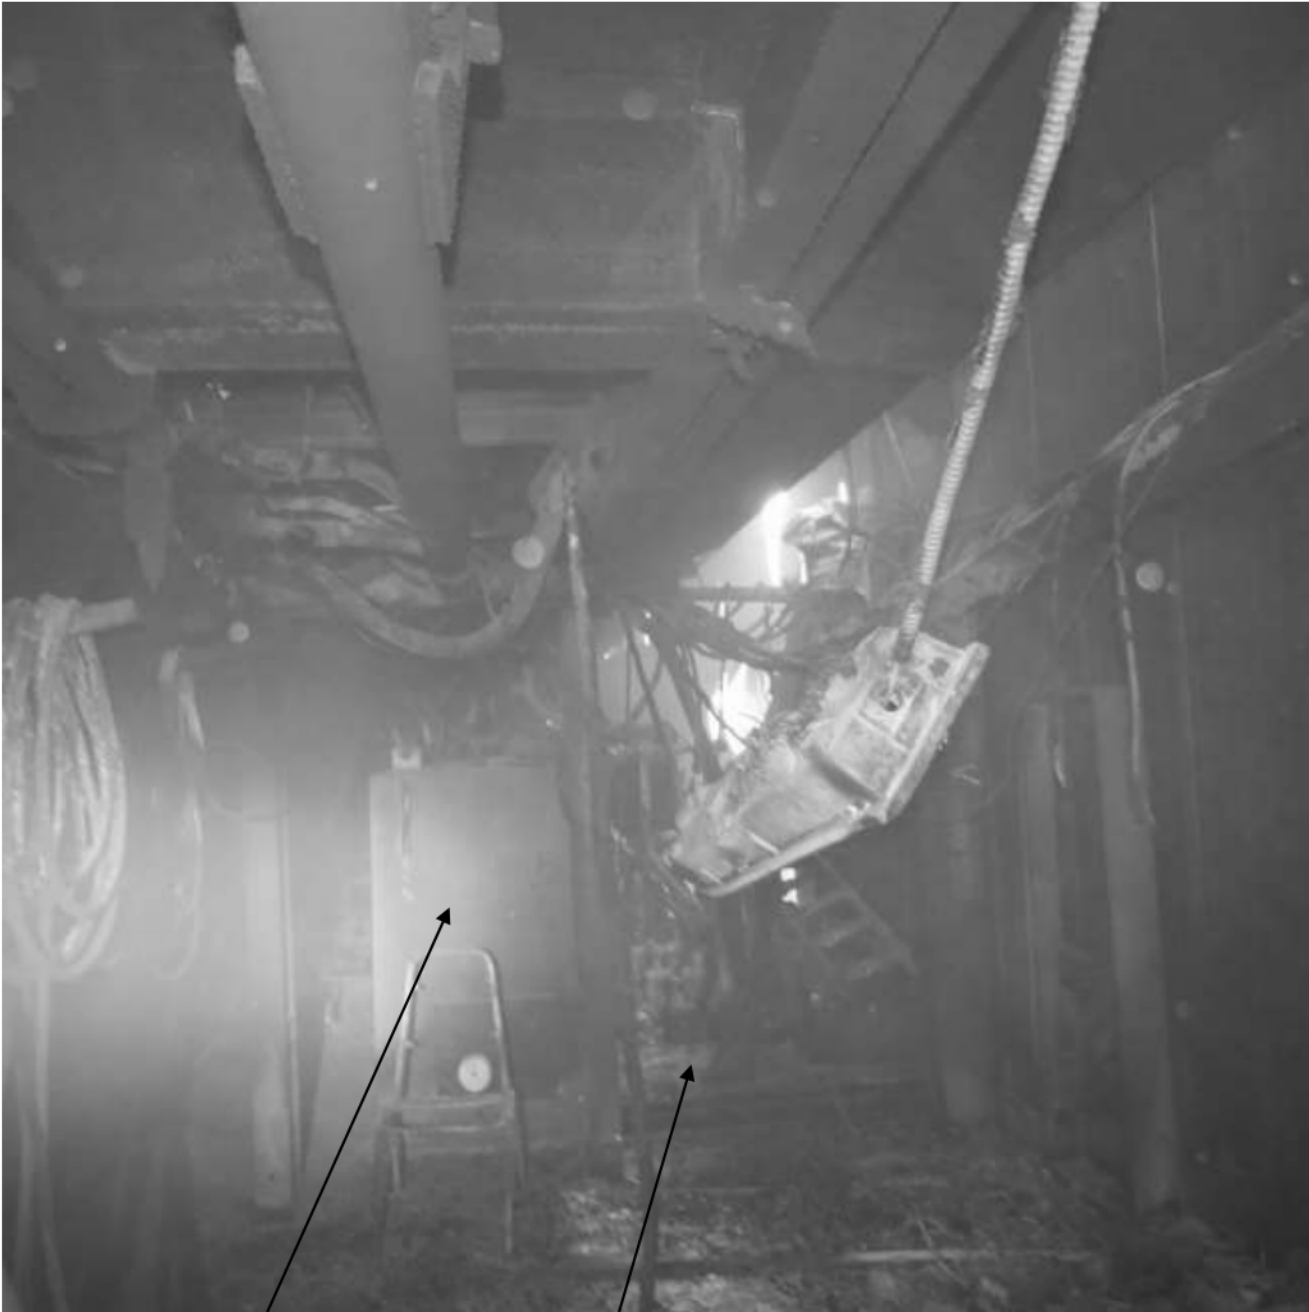
**C. Source of Heat** Overheated industrial electric motor driving a hydraulic pump.

**D. Material First Ignited** It would appear the motor overheated and ignited combustible/flammable materials including hydraulic oil from the burned hoses and oil storage tank feeding the mill log splitters and machinery.

With the information available at the time of the investigation it appears the most probable cause of this fire was the overheated electrical motor. (Mechanical failure)

**Photo #16** Hydraulic oil tank - electric motors and pumps - area of origin

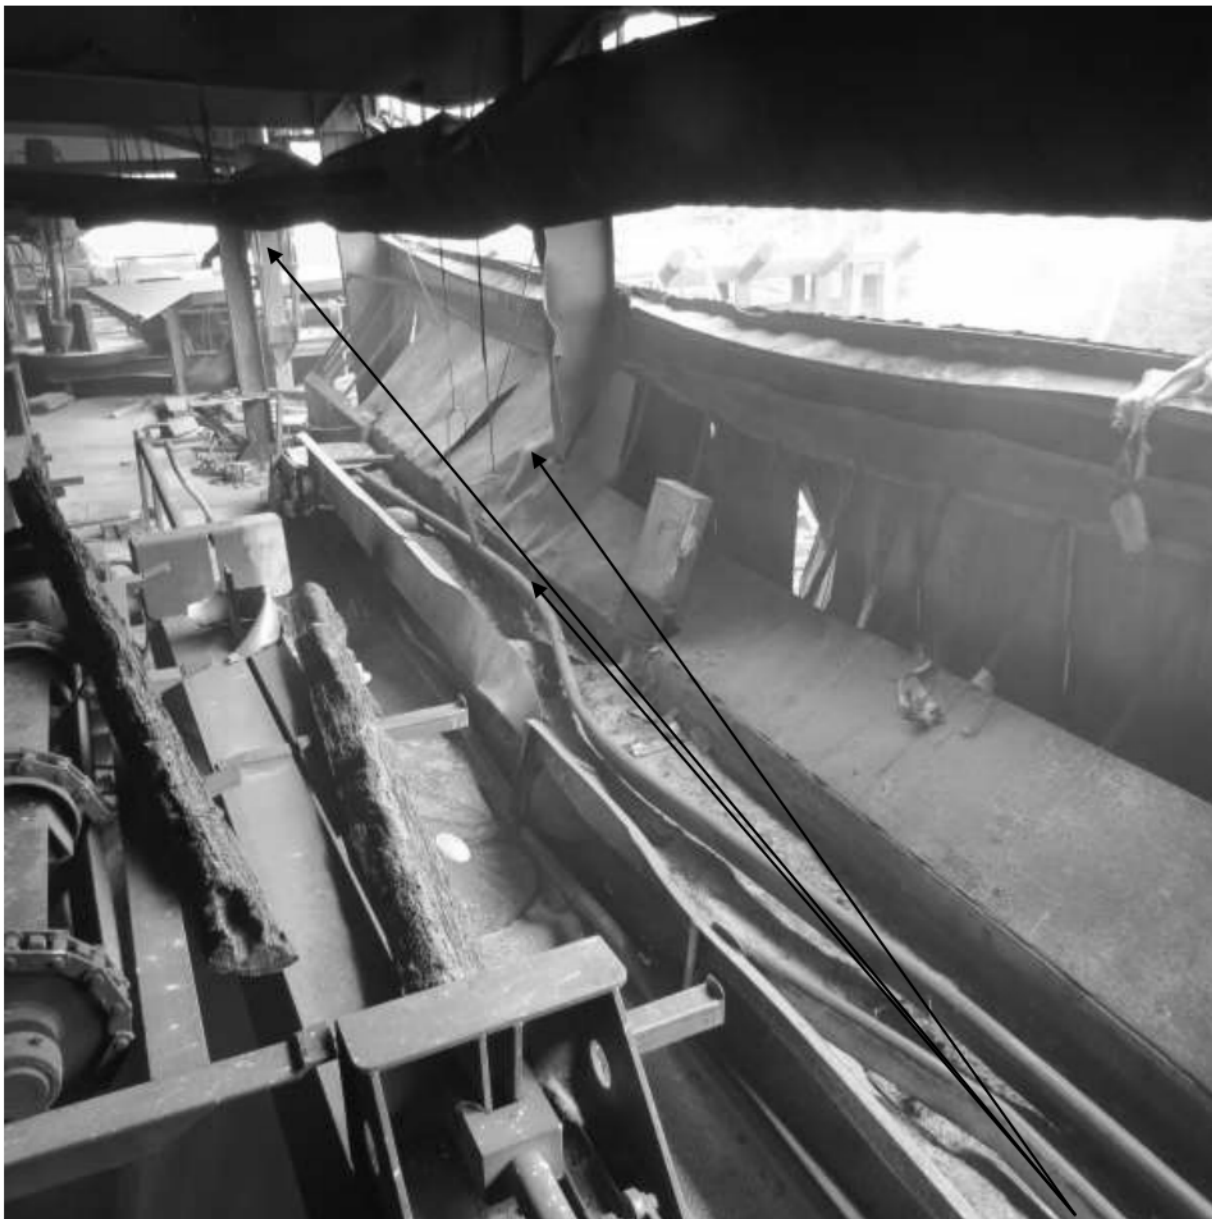
**Photo #17** Area above Hydraulic oil tank/electric motors/pumps. High heat- metal buckling
