BGC ENGINEERING INC.

Project No. 0378-002-01

January 3, 2008

Re: Cohoe Creek Landslide and Landslide Induced Wave (Seiche) at Chehalis Lake

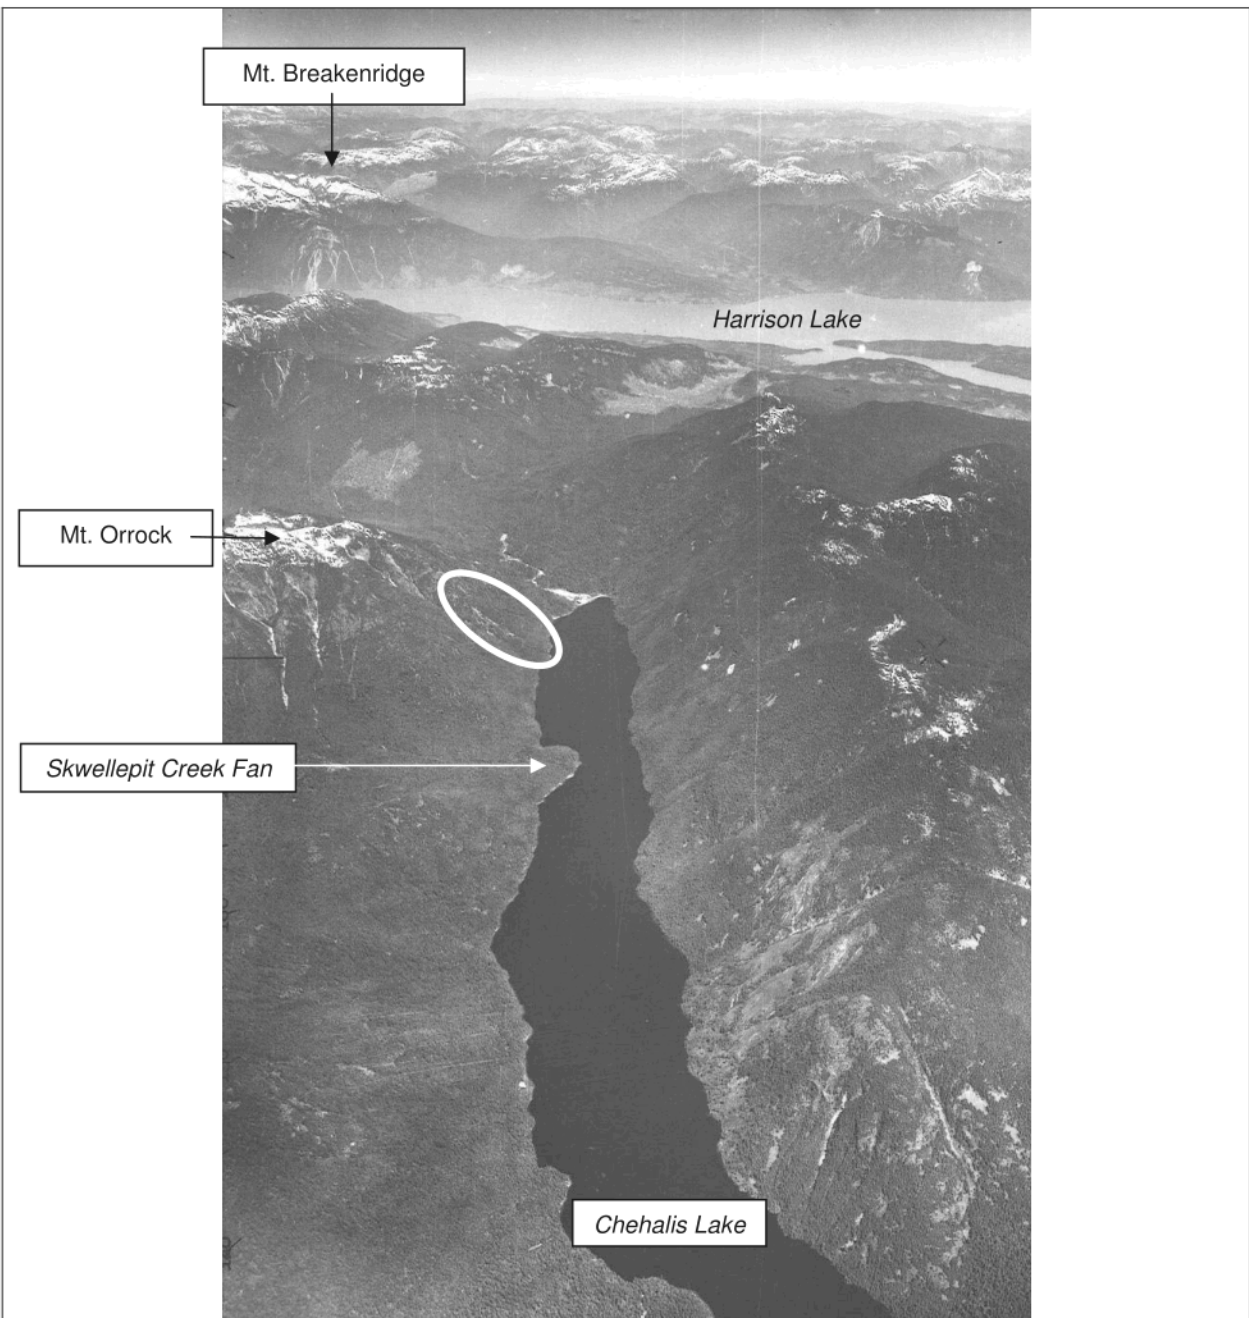
The landslide developed on the left side of Cohoe Creek as shown in Photo 1. The highest headscarp elevation is approximately 843 m, which is 648 m vertically above Chehalis Lake (elev. ~235 m) as shown in Figure 1. The source area extends from the headscarp down to approximately elevation 444 m (Photos 2 and 3), an on-slope distance of ~675 m. The total on-slope distance affected between the headscarp and the lake is ~1,130 m and the line-of-sight angle over this distance is between 31° and 32°. The total extent of debris runout into Chehalis Lake is unknown.

Photo 1: View north-northeast along Chehalis Lake with Harrison Lake and Mt. Breakenridge in the background. The location of the Cohoe Creek landslide is indicated by the ellipse. (B.C. Government oblique air photo BC499-99, taken June 20, 1948)

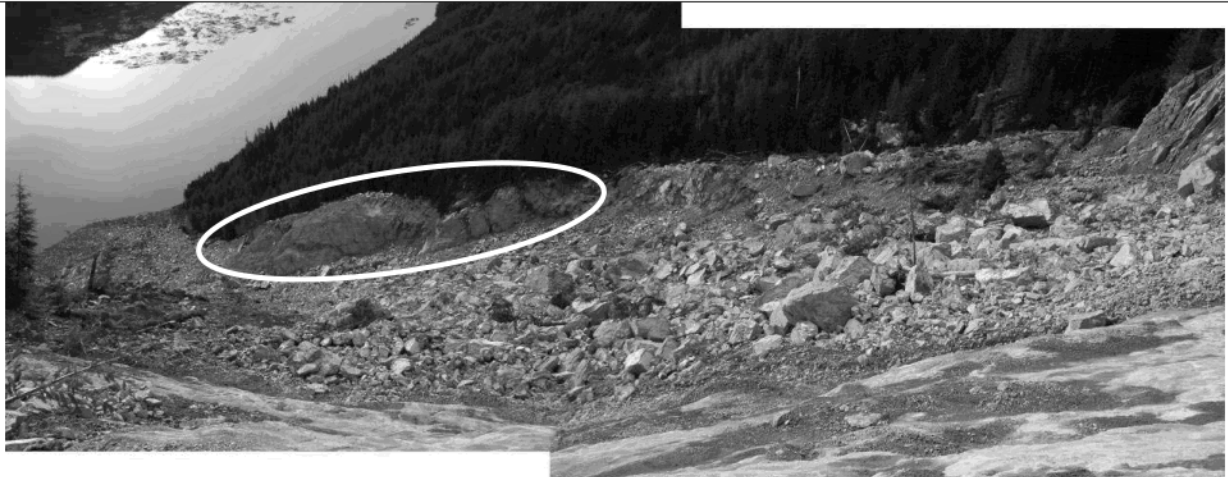
Photo 10: View south from the upper left lateral margin of the Cohoe Creek landslide. The slide surface is visible in the foreground but debris covers it over most of the affected area. The thalweg of Cohoe Creek is present a short distance inside the debris relative to the disturbance limit in the forest across the top of the photo. The morphology of the upper right lateral margin along Cohoe Creek suggests the slide margin developed through some combination of shearing and up thrusting thereby accentuating relief by as much as 10 m along the pre-existing steep right lateral slope of the creek, a portion of which is indicated by the cliff face in the ellipse. Photo taken by K.W. Savigny on December 11, 2007.

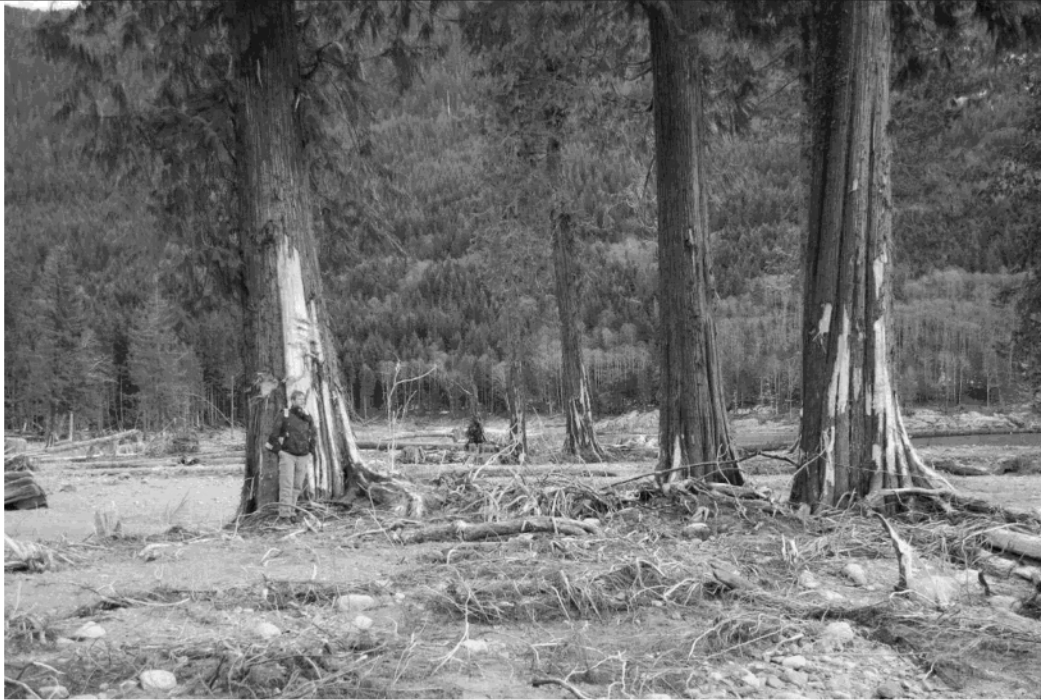
Photo 11: 5 m high impact scars on trees located at the campground at the north end of Chehalis Lake.

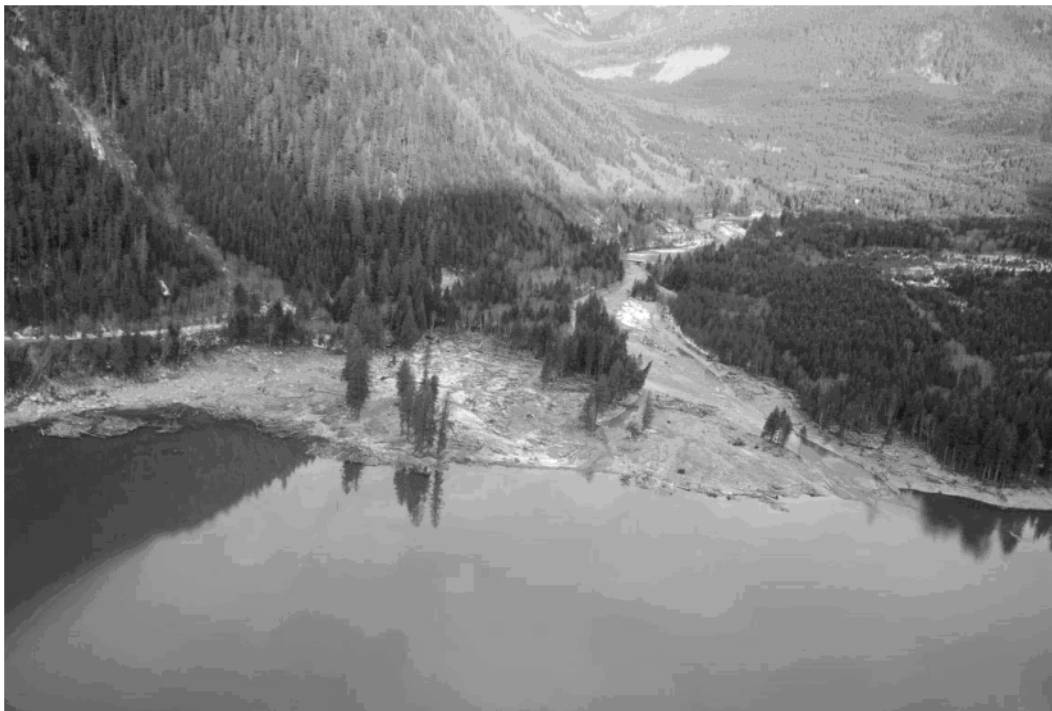
The large volume of rock entering the lake and its extremely rapid velocity generated a large wave. Landslide-generated waves have been well-documented in the scientific literature and their hazard potential has been identified in numerous studies. The wave impacted both the east and west shorelines north of and including the Skwellepit Creek fan. A wave run-up of 22 to 23 m¹ was measured on the west shoreline at the north end of the lake, while a 5 m high wave impacted the adjacent campground (Photos 11 and 12). This north campground was completely destroyed by the wave. Opposite the landslide, the wave run-up was about 30 m, while on the fan of Skwellepit Creek the run-up was approximately 7 to 9 m.

Photo 12: Aerial view of damage caused to the campground at the north end of Chehalis Lake. The wave run-up measured on the shoreline at the far left of the above photo was 23 m.

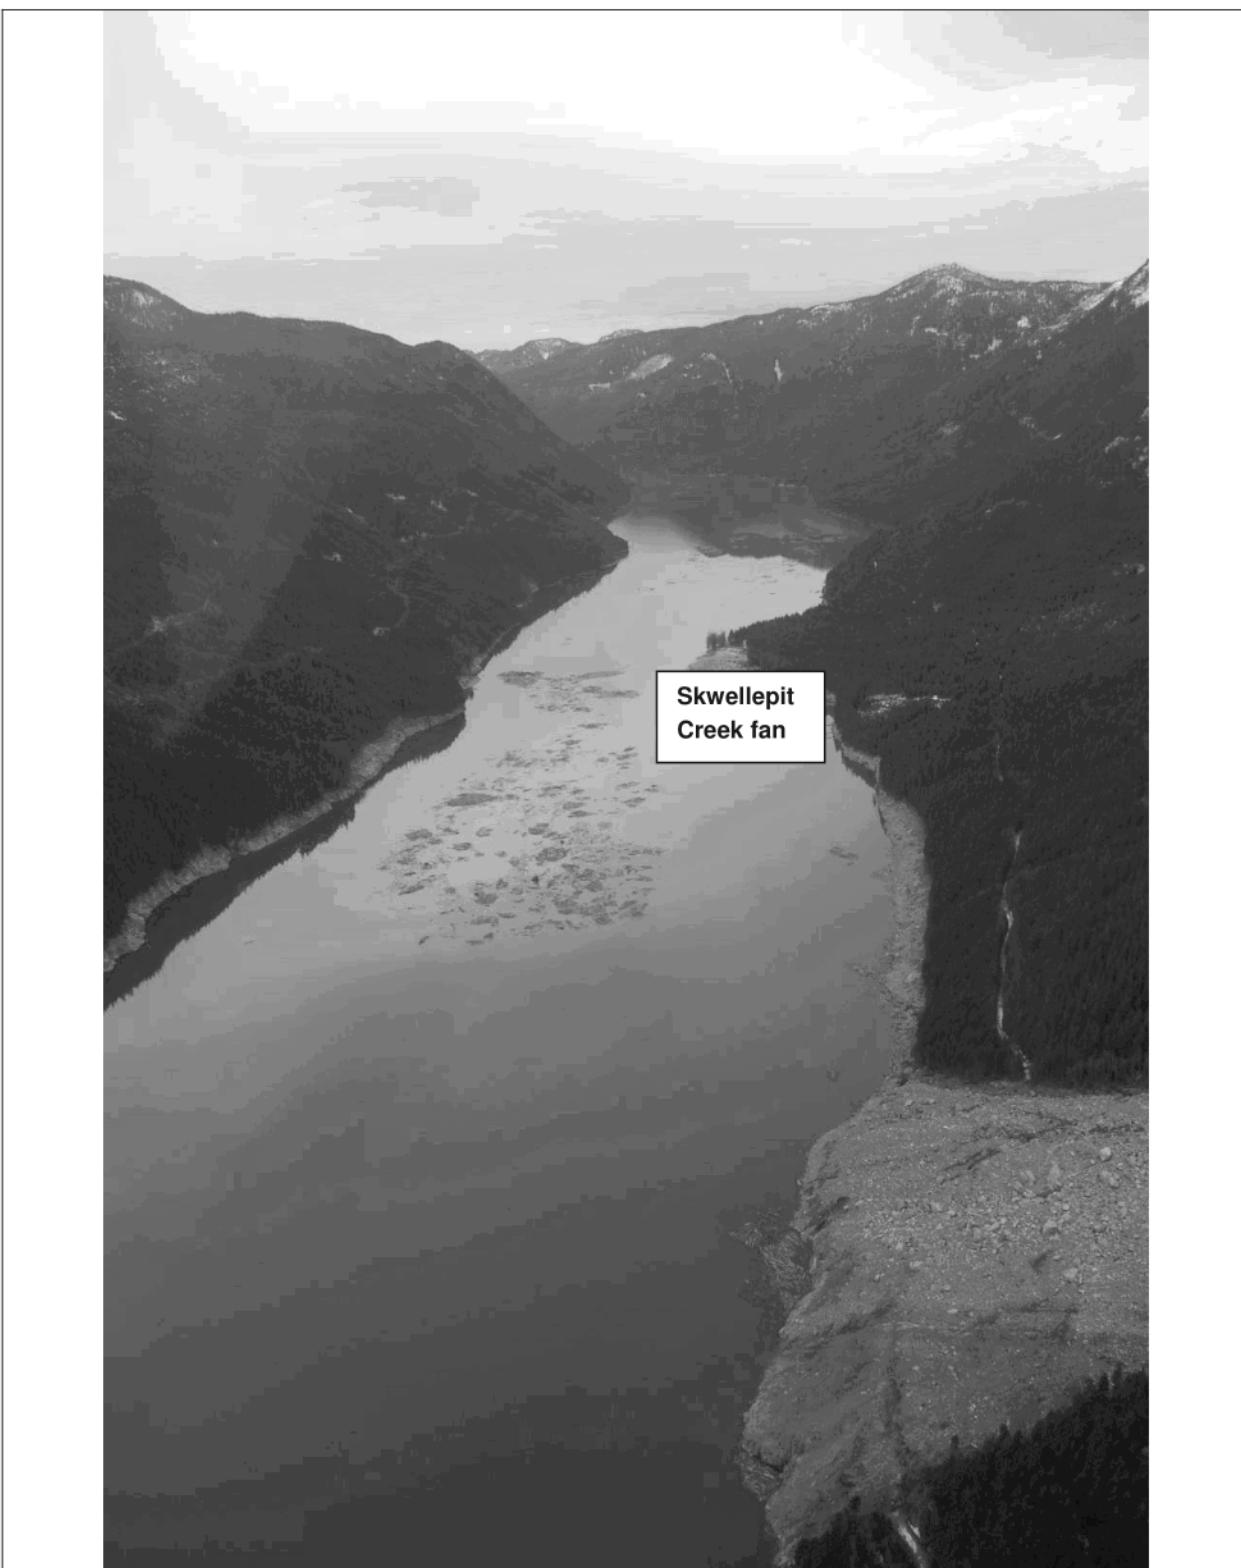
South of Skwellepit Creek the wave run-up on the west and east shores was significantly less, as indicated by a general lack of disturbance to the shoreline vegetation (Photo 13). However, a significant wave did propagate down the lake. A wave run-up of 5 to 6 m was measured at the campground at the south end of the lake. The campground is located in the southeast corner of the lake, to the immediate east of the lake outlet. Damage at this campground was generally restricted to the deposition of woody debris and existing infrastructure, such as picnic tables and outhouses, being moved.

Photo 13: Aerial view of damage looking down (south-southwest along) the lake. Note the general lack of shoreline damage to the south of Skwellepit Creek fan.

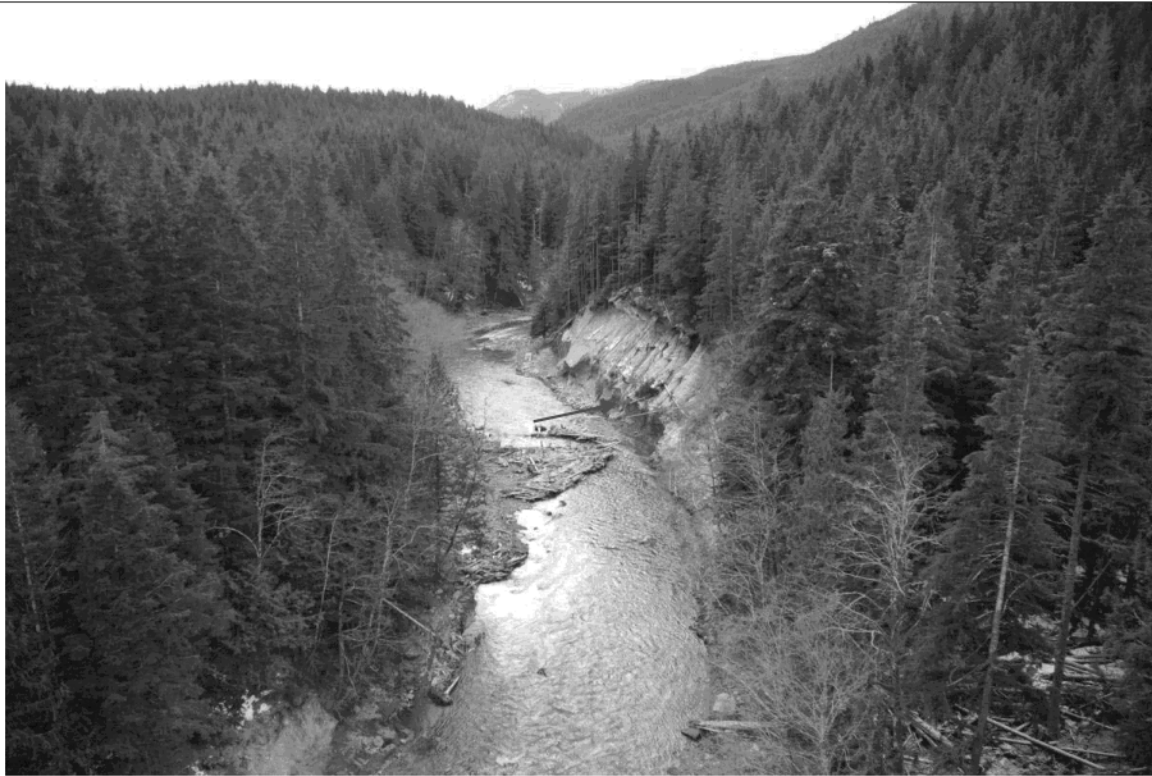
The present concern is that the LWD mat at the lake outlet could be transported into the canyon and cause problems downstream. It is very unlikely that the entire debris mat would be transported downstream during a single rainstorm or spring runoff, as the tendency is for the LWD to cluster rather than disperse thus reducing its mobility. However, over a number of years, the debris mat will progressively break-up and send waves of LWD downstream. High winds from the north would increase the mobility of the LWD. While it is not known how much lake levels fluctuate, water depths will be sufficient deep to transport logs during rainstorms and spring runoff (as evidenced by an older log jam located immediately below the lake outlet, Photo 14). There are two concerns associated with the LWD.

Photo 14: Downstream view of Chehalis River from the outlet of Chehalis Lake. Note the scour on the right bank adjacent to the log jam.

Given these two concerns, it is recommended that the floating LWD in the lake be removed. It is important to note that there is limited equipment or vehicle access to the river between the lake outlet and the fan apex. It would be very difficult to extract logs from a major log jam in the canyon once it establishes.

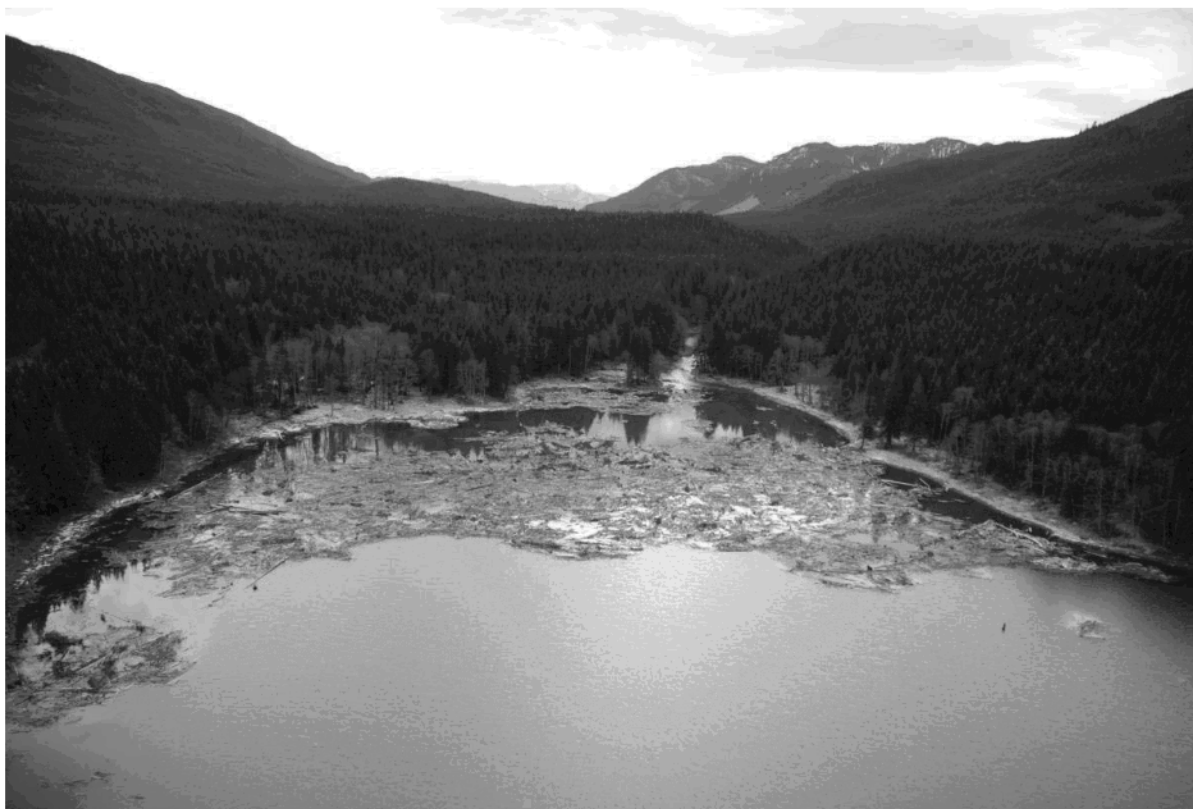
The landslide and shore damage from wave run-up generated a significant amount of large woody debris (LWD) that is presently floating in the lake, including a large debris mat at the lake outlet. The debris mat there is about 200 m wide and 100 m long (Photo 15). A similar area of debris is distributed in a number of mats that are located in the middle of the lake between the landslide and Skwellepit Creek (Photo 13). The LWD at the lake outlet appears to have grounded in relatively shallow water. During the site visit, water depths at the lake outlet were less than 1 m (Photo 16). While water depths increase rapidly away from the outlet, water depths at the lake outlet are the ultimate control for downstream transport of LWD. During spring runoff or a large rainstorm, water depths would likely be sufficiently deep to transport the logs into the canyon section.

Photo 15: Debris mat at south end of Chehalis Lake.

As an interim measure, it was suggested that a log boom be set-up immediately upstream of the lake outlet. This initial log boom would prevent any LWD from being transported downstream into the canyon in the short-term. However, at this location, water levels are too shallow for a boom boat to operate and remove the woody debris. A second log boom will be

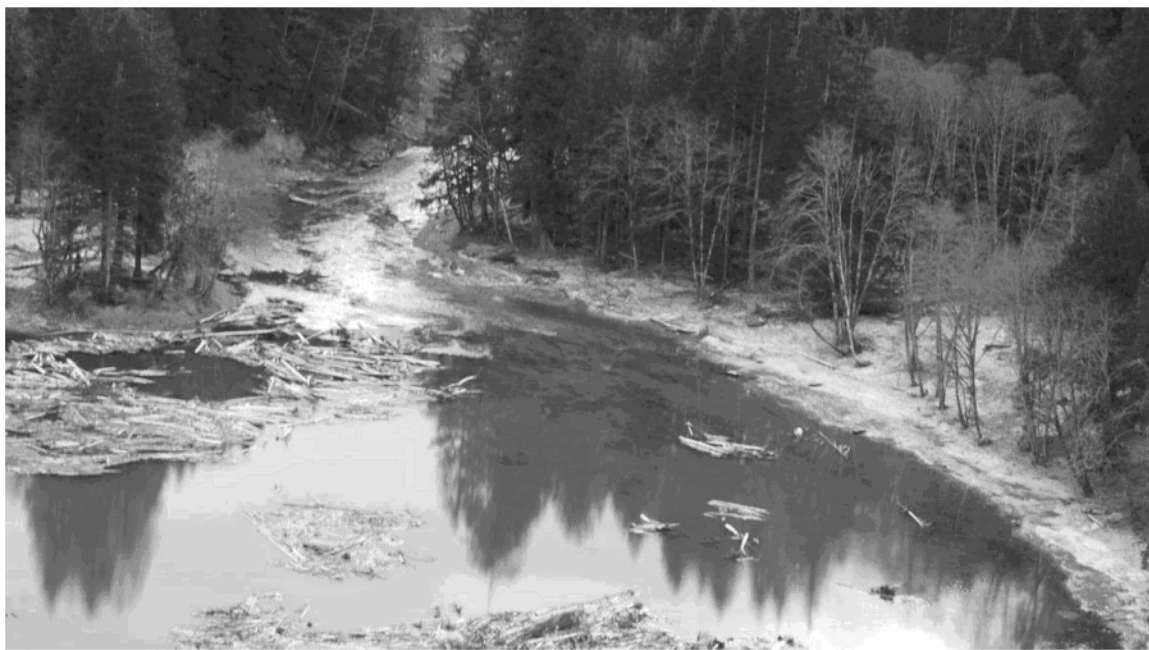
Photo 16: Lake outlet of Chehalis Lake. Note the shallow water at the outlet.

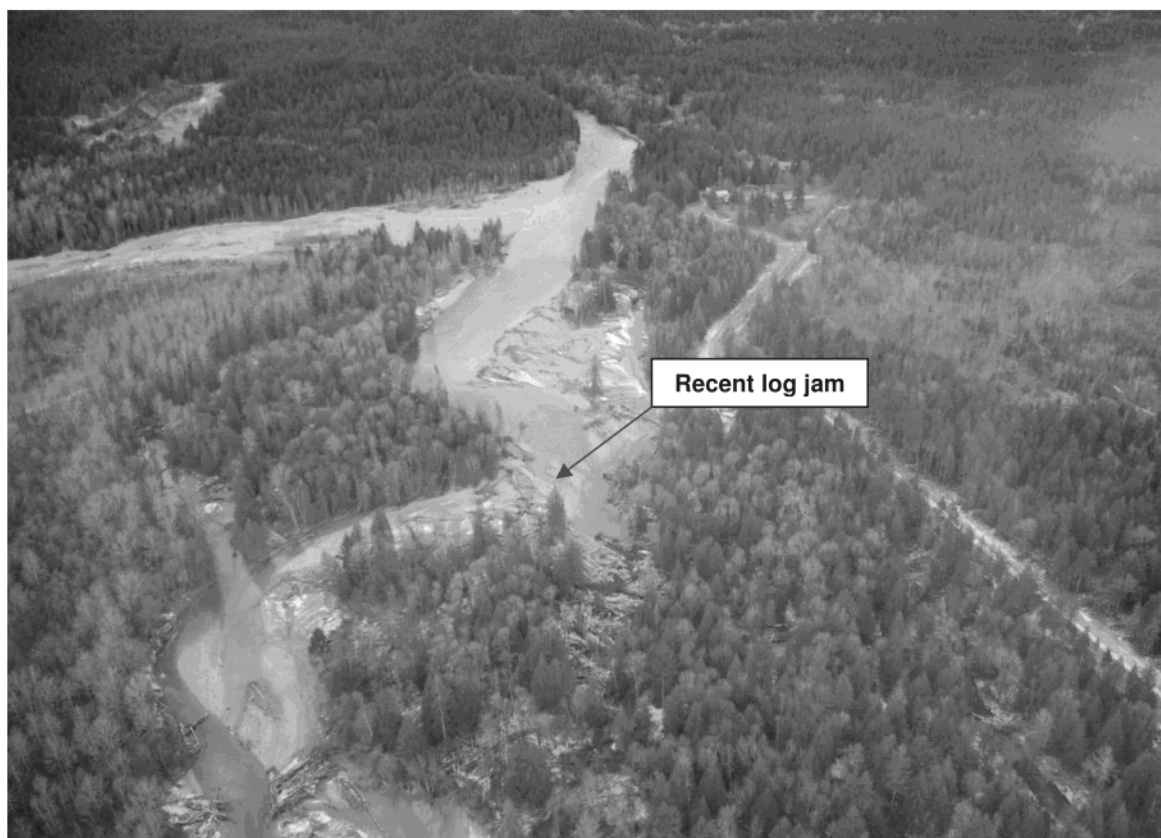
A minimal amount of LWD appears to have been transported down Chehalis River as a result of the waves generated by the landslide. No fresh log jams were observed between the lake outlet and the fan apex. On the fan of Chehalis River, one fresh log jam was observed about half way down the main channel (Photo 17). Compared to older log jams on the fan, the fresh deposit represents a small percentage. A lack of downstream transport of LWD during the rock slide is not surprising, as the initial wave that moved down the lake would not have been carrying a surge of wood.

Photo 17: Upstream view of Chehalis River on the alluvial fan. The recently constructed dyke is visible on the right side and an arrow points to a log jam that is likely associated with the rock slide and/or recent storm.

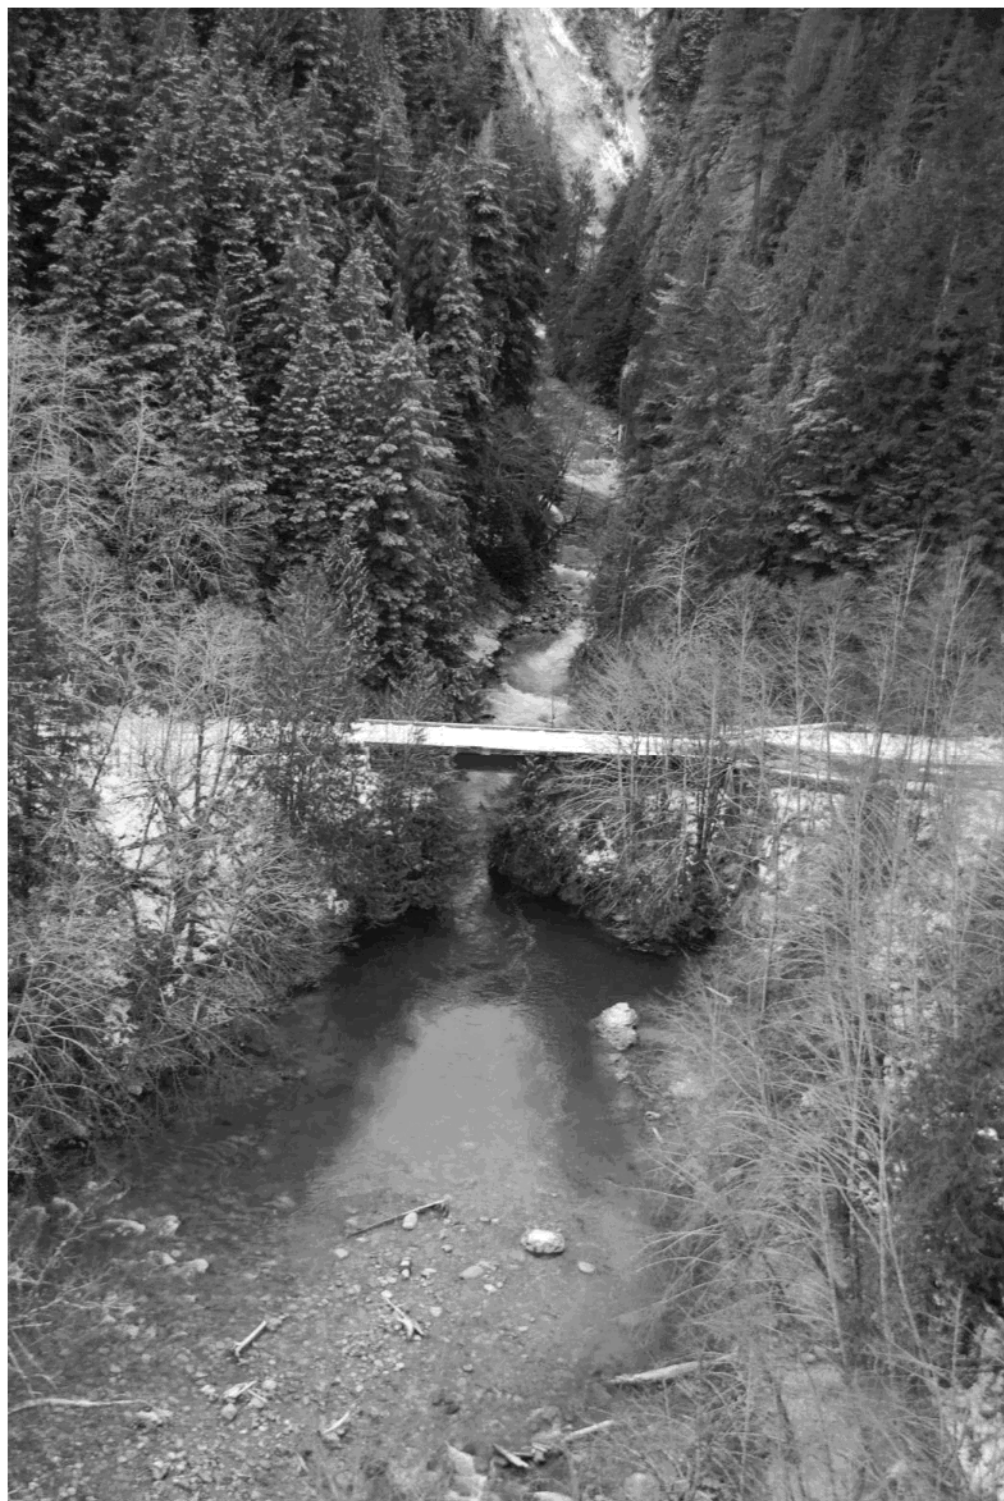
First there is significant potential for large log jams to form downstream of the lake outlet, particularly where bedrock exposures constrict the channel. For example, the channel width is constricted to less than 10 m in two locations in the initial kilometer downstream of the lake

(Photos 18 and 19). Log jams several metres in height or higher could easily form at these constrictions and provide a barrier to fish migration. Coho and an introduced run of summer steelhead move through the canyon reach to use tributary streams, Chehalis Lake, and the upper section of the river above the lake. Resident rainbow trout, cutthroat trout, as well as anadromous Dolly Varden char are also known to use the watershed. Log jam barriers could have significant negative impacts to these fish.

Photo 18: Bedrock constriction of Chehalis River about 1.5 km downstream of the lake outlet. This crossing leads to the south campground on Chehalis Lake.

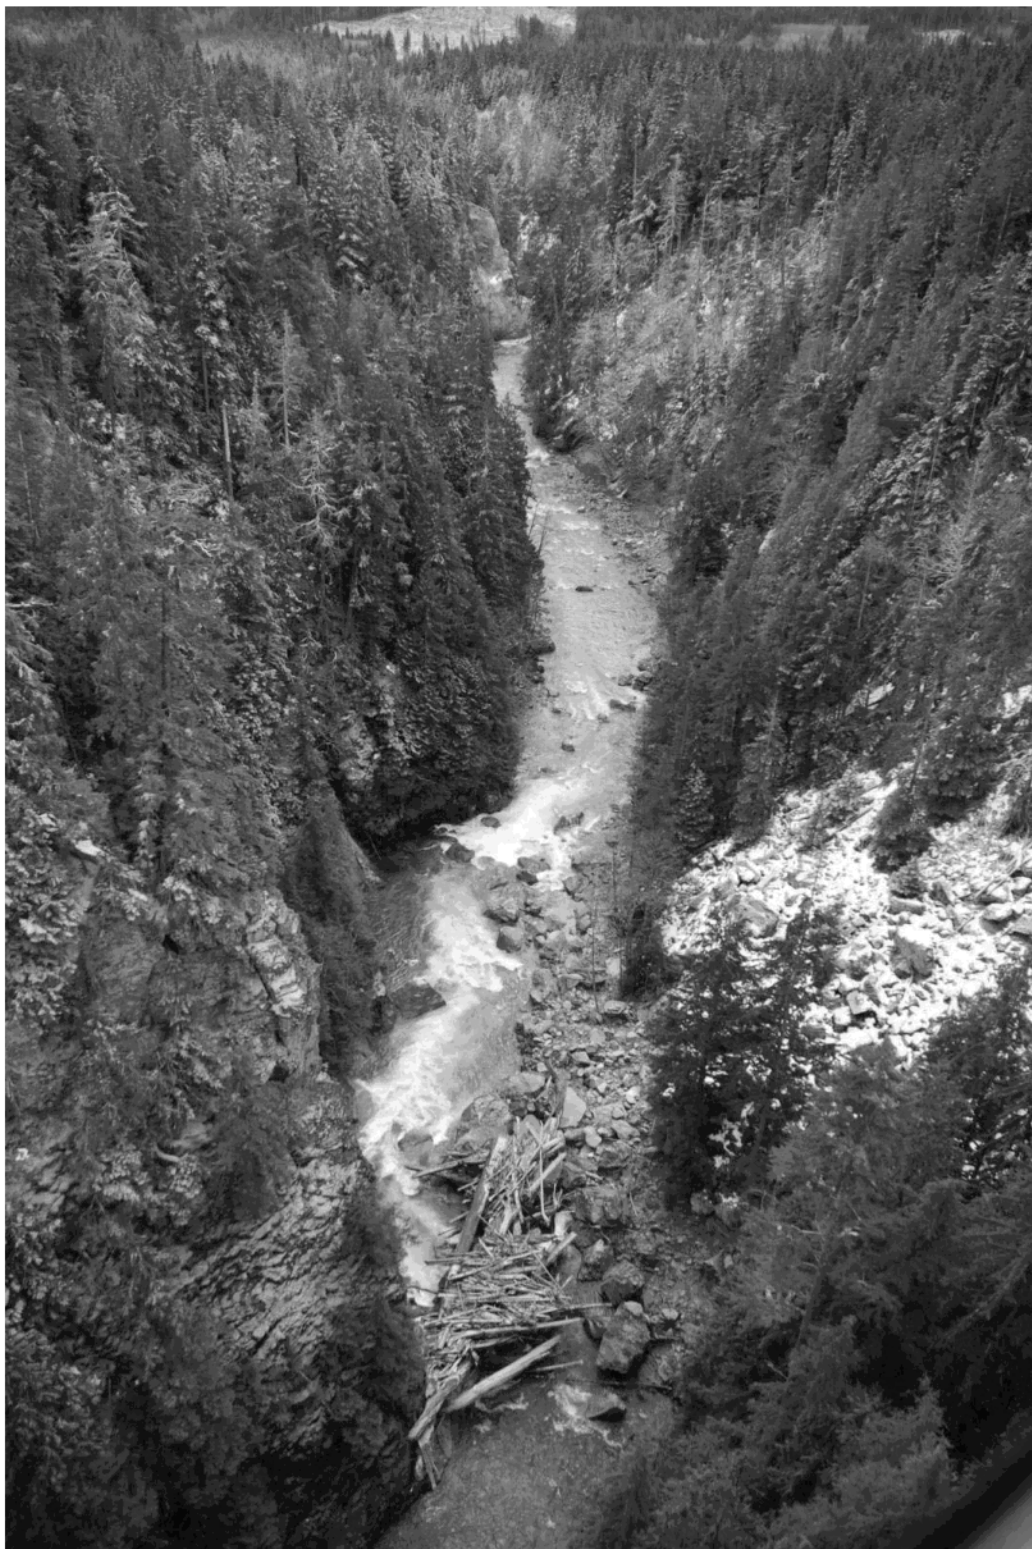
Photo 19: Existing log jam (that predates the rock slide) located about half way between Chehalis Lake and the alluvial fan.

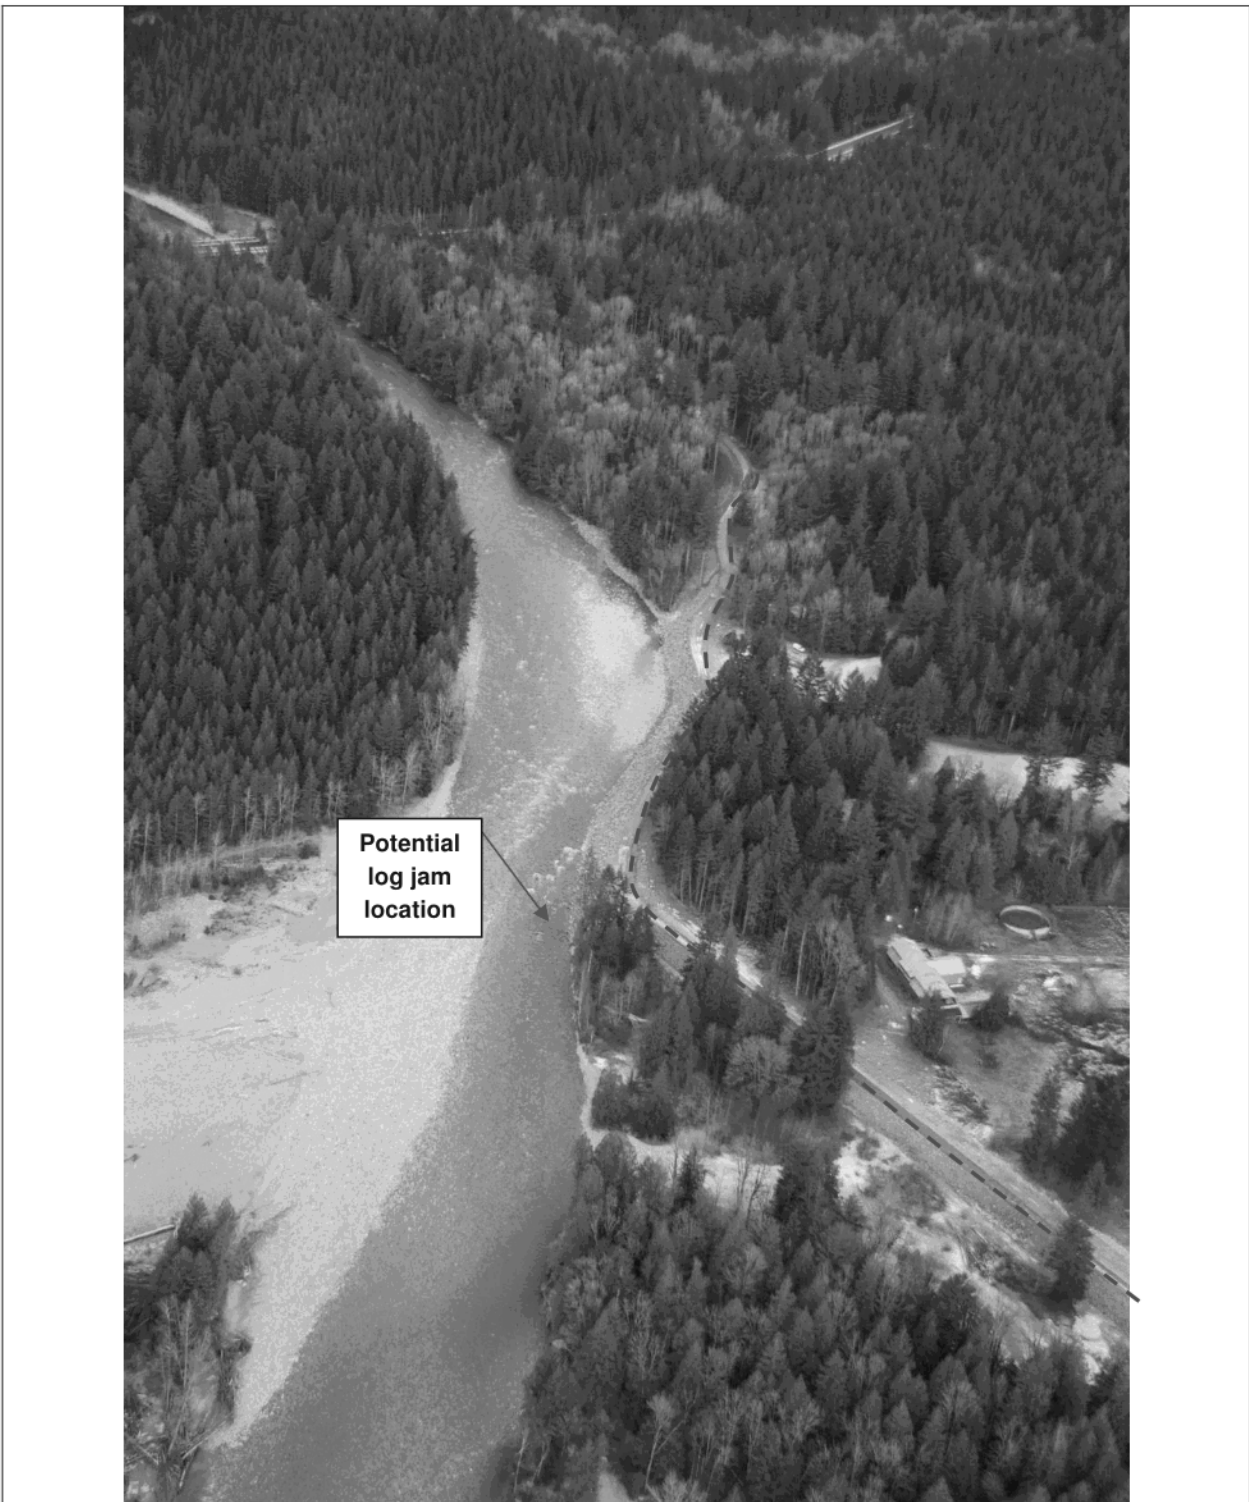
The second potential impact is immediately downstream of the fan apex, where the Chehalis Indian Band has recently constructed a \$3M dyke on the left bank. The dyke is offset from the main channel except at its upstream end, where the formation of a large log jam could divert flows directly against the dyke. While log jams naturally form downstream of this location where the river is less confined and wider, a log jam could form on the right bank at the location indicated on Photo 20. Flows would then be diverted against the left bank and recently constructed dyke. Log jams further downstream could also encourage increased lateral instability on the left bank despite the dyke offset. While the alluvial fan of the Chehalis River is characterized by naturally high lateral instability, the potential volume of LWD that could be introduced to the fan (albeit episodically and over a period of many years if not decades) would likely increase bank erosion rates considerably.

Photo 20: Upstream view of Chehalis River at upper end of alluvial fan. A log jam could potentially form at the location indicated and direct flows against the recently constructed dyke (dashed red line).

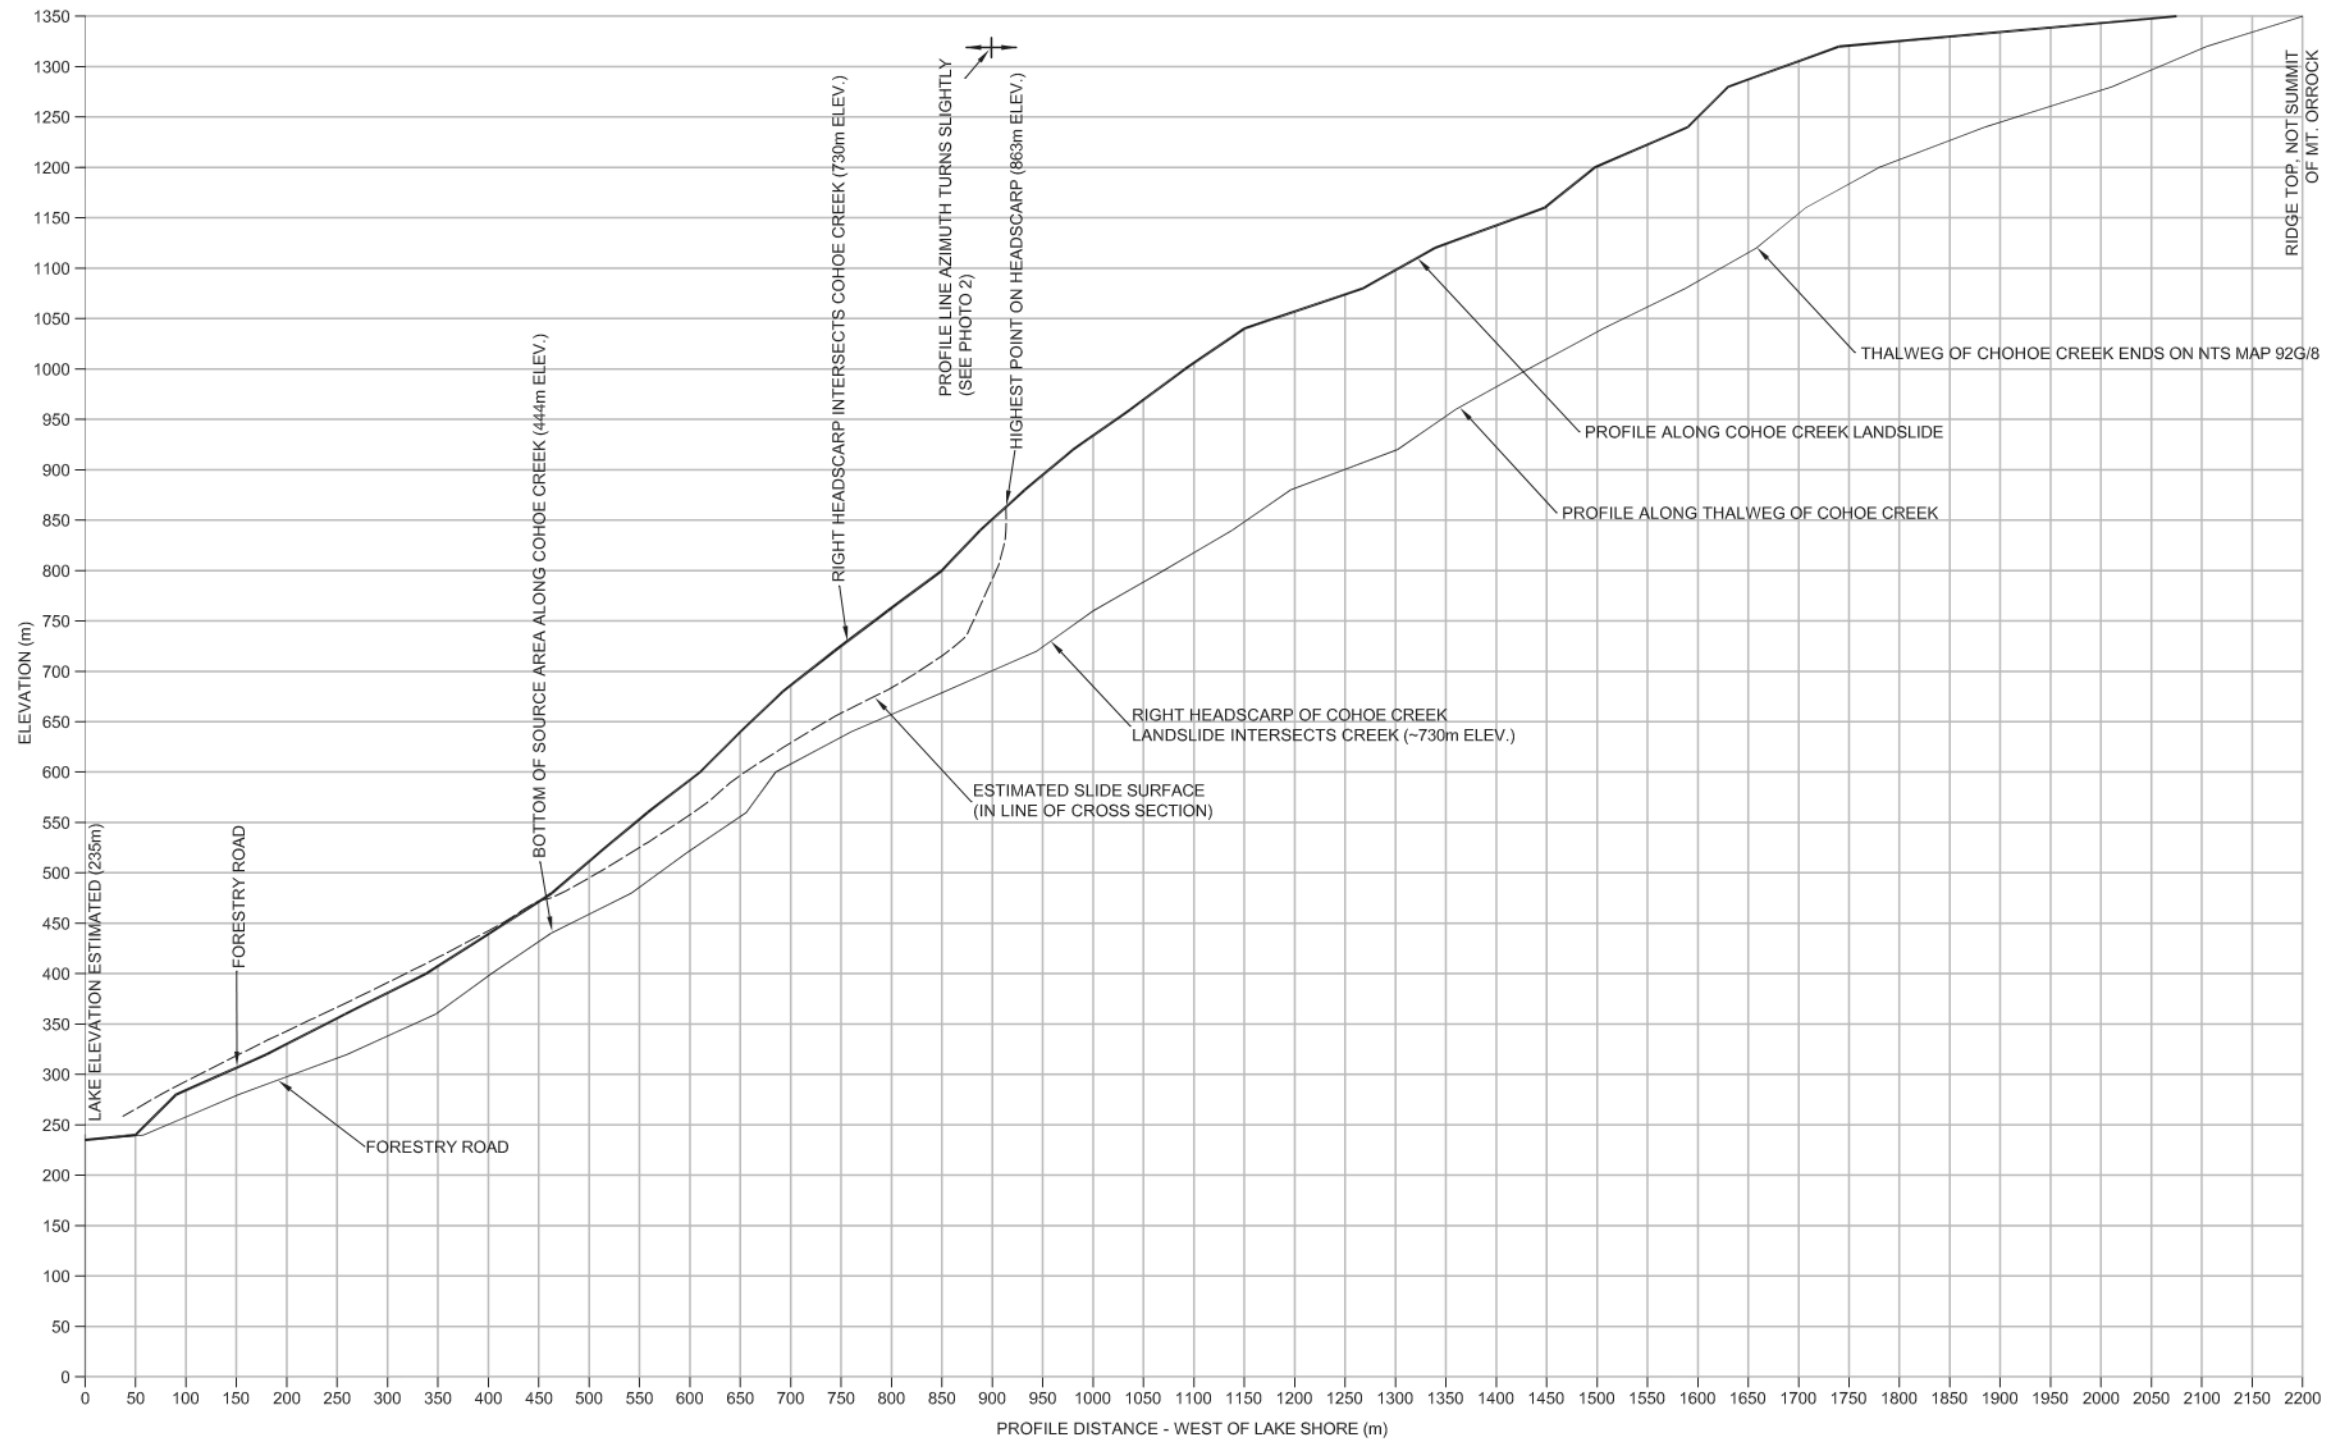
PROJECT: COHOE CREEK LANDSLIDE AND LANDSLIDE INDUCED WAVE (SEICHE) AT CHEHALIS LAKE		
TITLE: COHOE CREEK THALWEG AND LANDSLIDE PROFILES		
PROJECT No.: 0378-002	FIGURE No.: 1	REV.: 0

The right lateral margin of the landslide headscarp developed approximately parallel to and coincident with the thalweg of Cohoe Creek. An extensive tract between elevations ~600 m and ~740 m, and possibly more, is controlled by subvertical northwest-trending joints. Some combination of shearing and up thrusting occurred along the joints to facilitate slide movement, thus capturing/deepening the thalweg of Cohoe Creek by as much as 10 m over the same elevation range (Photos 3 and 10). The thalweg of Cohoe Creek below approximately 740 m elevation is somewhat deeper and marked by a precipitous right slope into the creek. The precipitous relief increases below approximately 600 m elevation and continues as low as approximately 444 m elevation, which may indicate that the previous instability reported above had similar characteristics.

As indicated in the previous paragraph, the thalweg elevation of Cohoe Creek appears to have been deepened by the landslide. However, the authors emphasize that the actual path of Cohoe Creek was not visible across the landslide scar on December 11, 2007. Rather, the creek flow disappeared into the debris at approximately 740 m elevation and no single breakout location was visible. On a December 21, 2007, return visit courtesy of B.C. Hydro, the creek flow appeared to break out over a wide area at approximately 400 m elevation along the right (south) half of the slide scar. Here it caused shallow instability that extended all the way down to the lake shore.

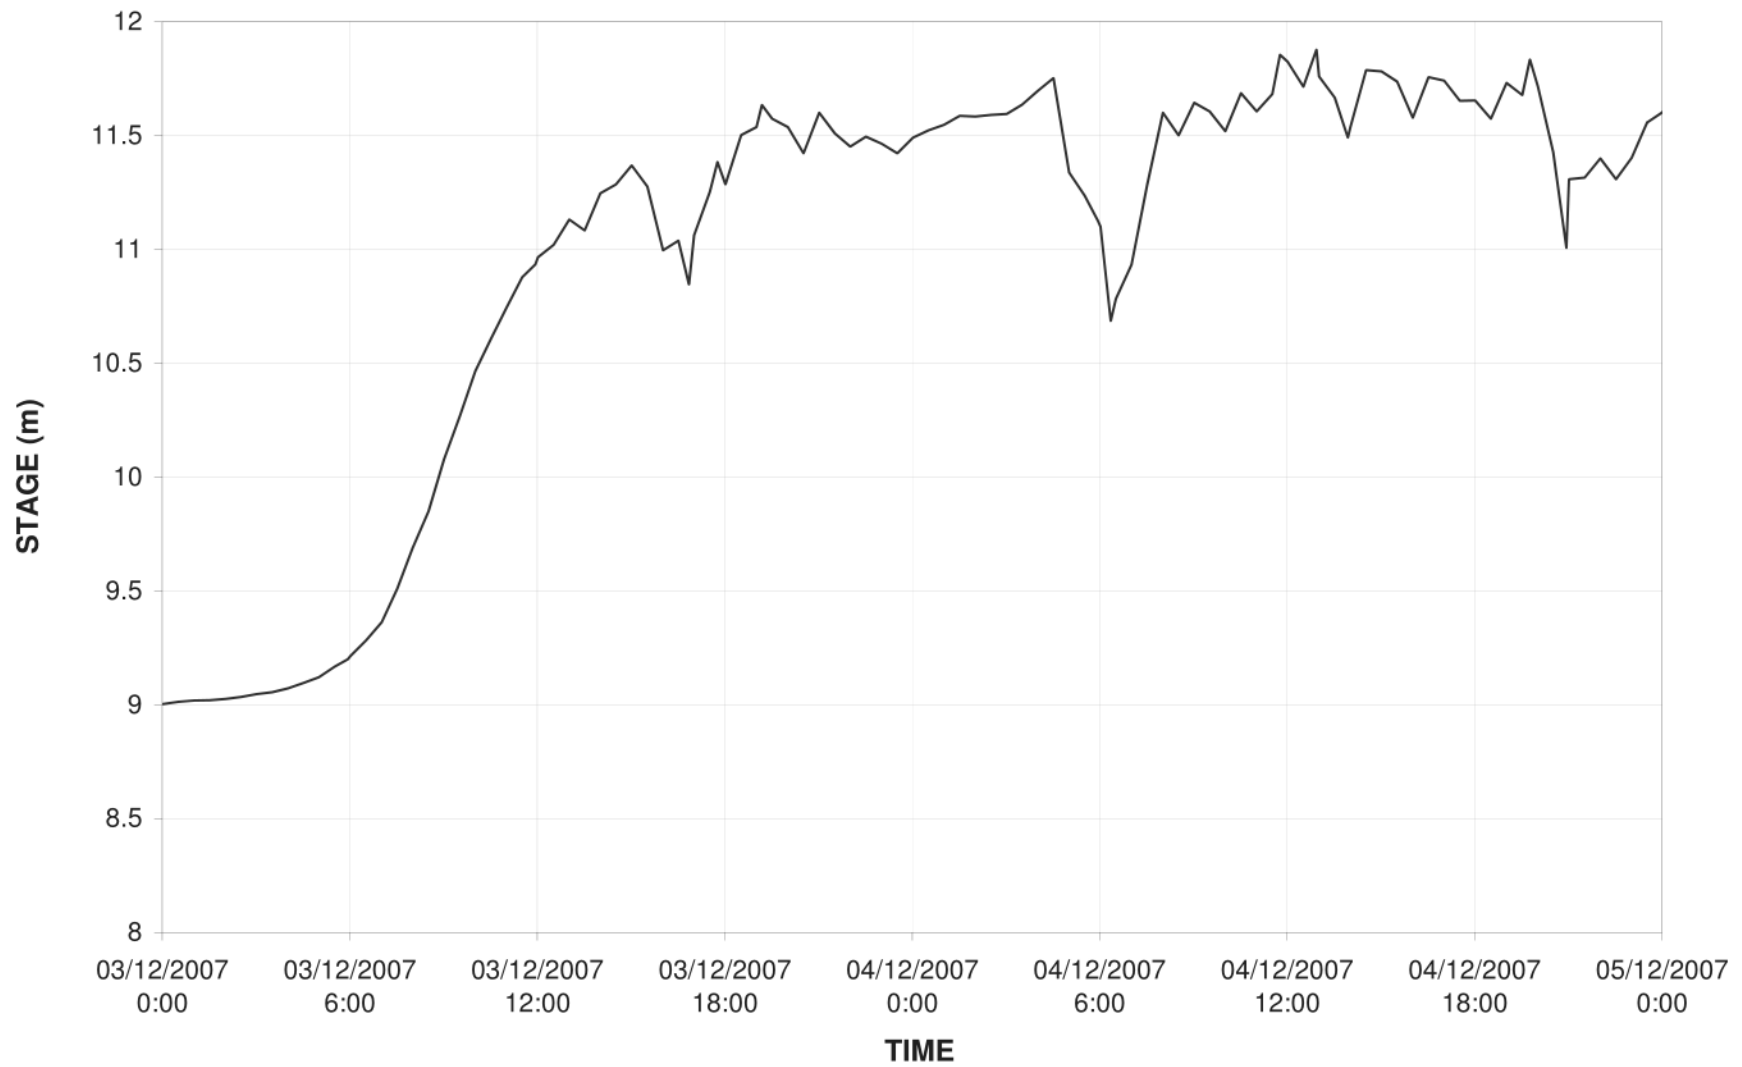
Figure 2

Lower Chehalis River is gauged by the Water Survey of Canada (WSC) (#08MG001) at the fan apex. Here the upstream drainage area is 383 km². Gauge stage records were obtained by BGC from the WSC for the period December 3 to 6, 2007. The resulting data do not show an obvious flood wave that could be attributed to the landslide (Figure 2). However, data are
