Alders Road Culvert Layout

**RE: SAFE ENTRY REQUIREMENTS
CULVERT REPLACEMENT ON SLOPE BELOW ALDERS ROAD
SALT SPRING ISLAND**

An existing corrugated steel pipe (CSP) failed on the slope below the houses at 121 and 123 Alders Road sometime in early 2013. The failure likely occurred during or shortly after a heavy rain event. The site appears to encompass a marginally stable slope under normal conditions.

ALDERS CULVERT REPLACEMENT

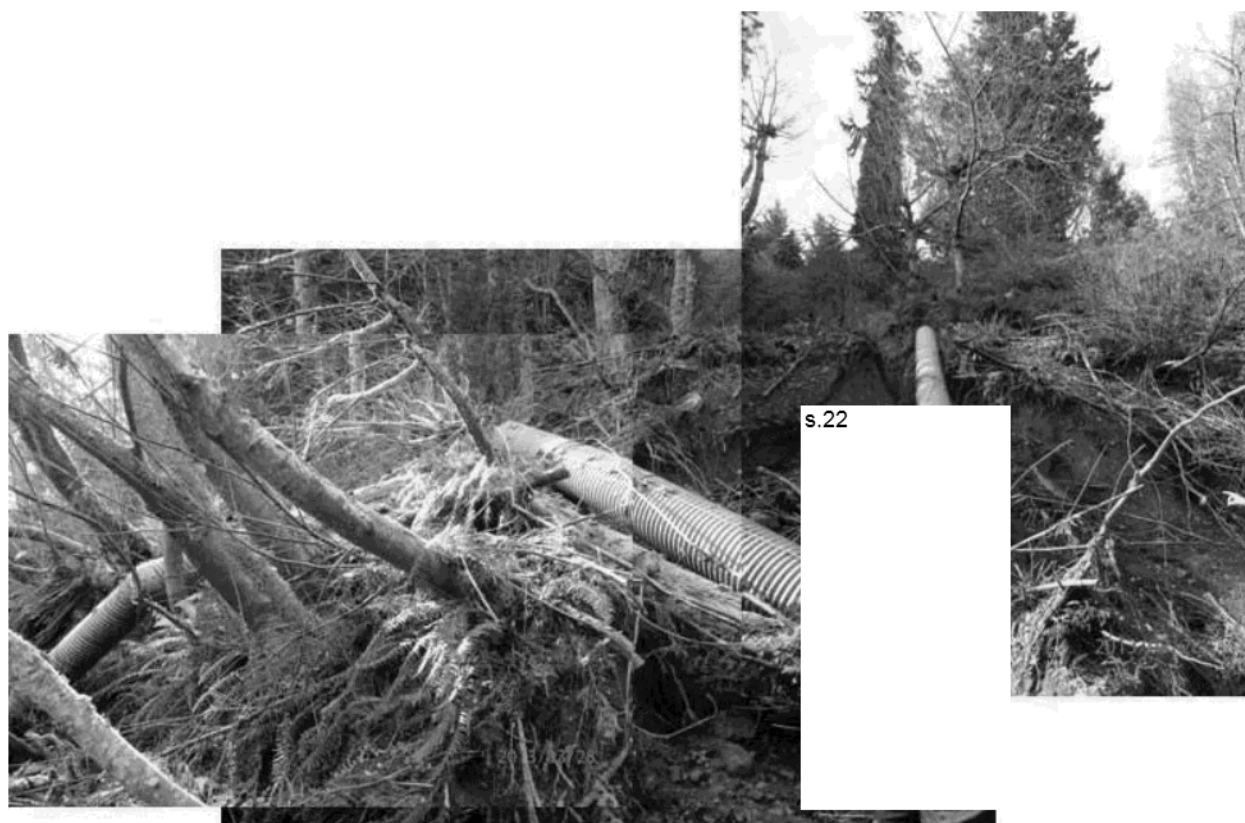
Photo showing soil slope Phase 2 work area from near the bottom, looking up at failed culvert section.

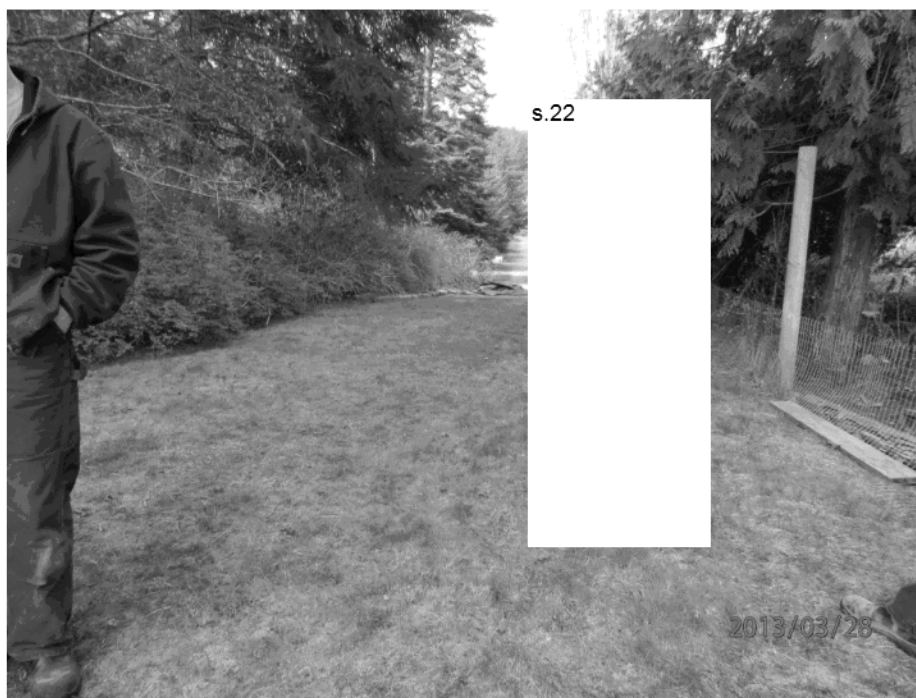
Photo showing bench area above slope, work area for Phase 1.

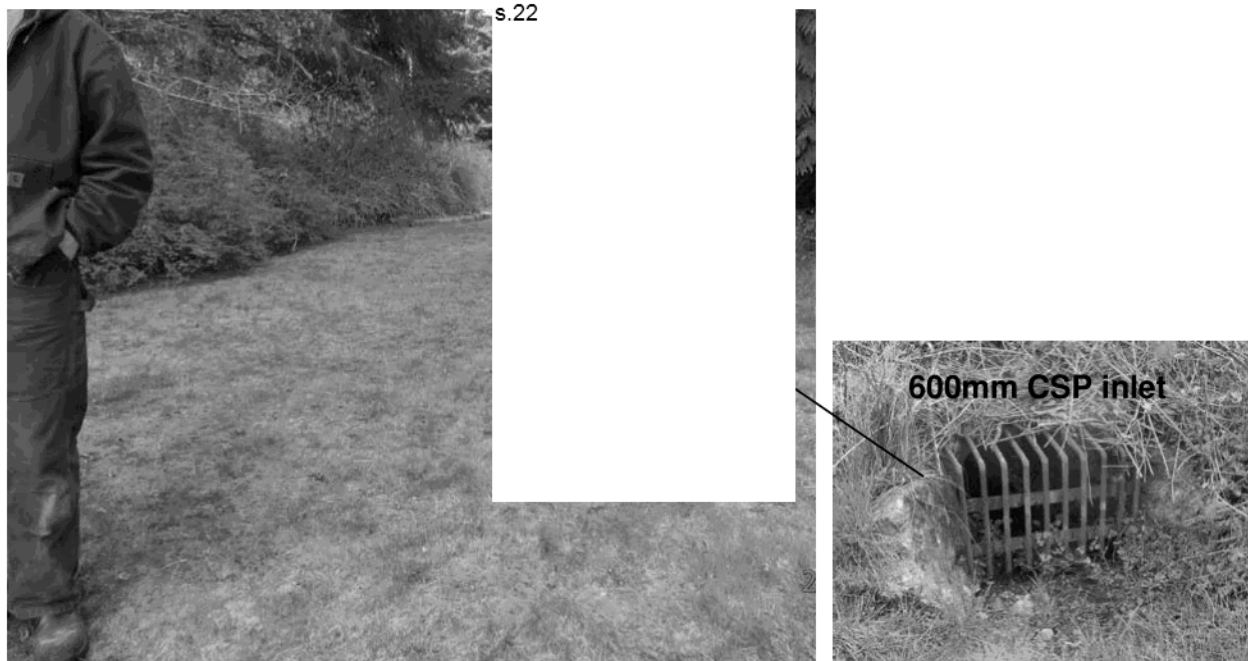
A MoT open ditch runs down the south side of Alders Road carrying surface drainage. The ditch continues down to a relatively level grassy area between the properties at 121 and 123 Alders Road. This 12m wide area appears to be Ministry RoW. The grade of the ditch at this spot is perhaps 1 or 2% and just enough to keep the water moving but when there is heavy rain the neighbours report the ditch filling up and the water ponding. The homeowner at 123 Alders has a sump pump in the basement that kicks in suggesting the entire groundwater table responds quickly to high precipitation events.

Photo 1: View of flat area at top of slope, looking west towards Alders Road

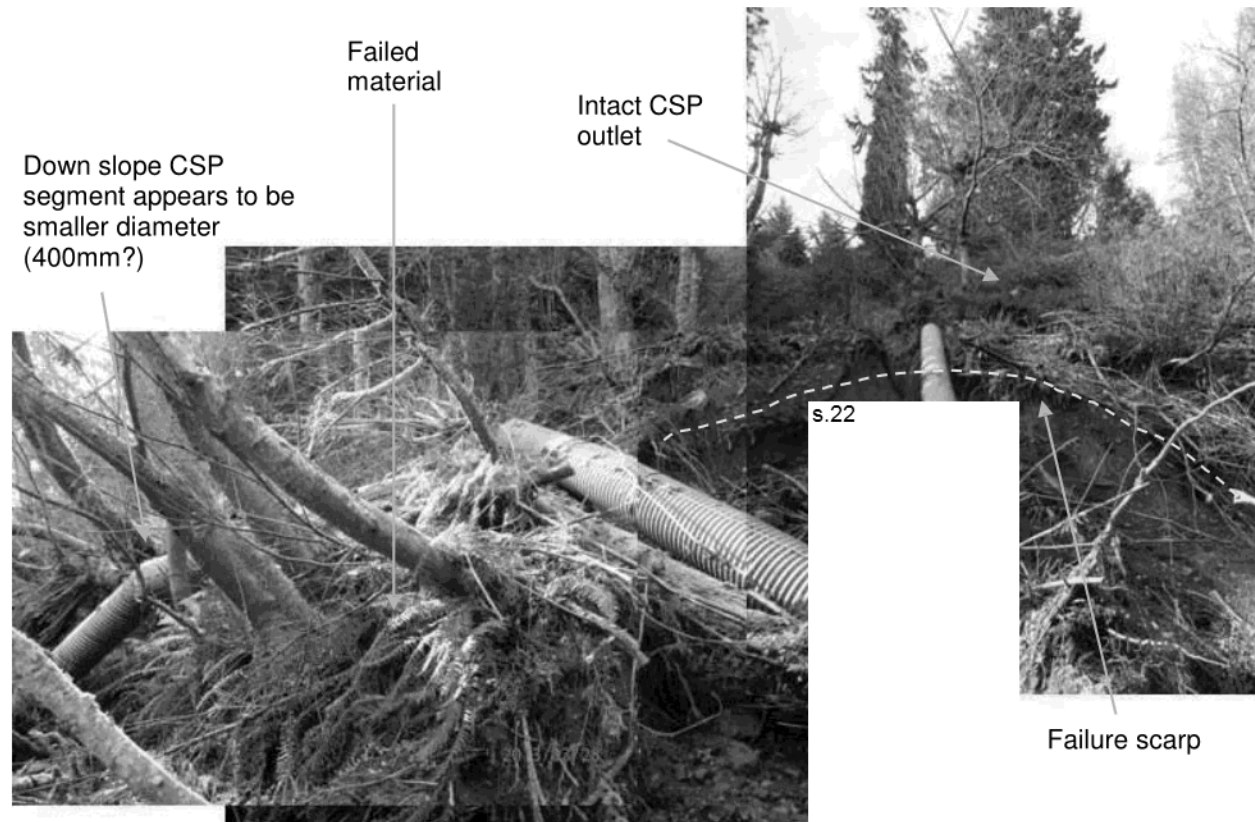
The top 15m of the slope is 45° and shallows out to ~24° down the remainder of the slope. At the beach, there is a vertical step of about 1.5m down to the beach and it appears to be due to ongoing erosion at high tide.

Photo 2: View of slope looking upwards to the west. Failed CSP segments in the foreground

The entire slope appears to be marginally stable with over steepened areas lacking vegetation and discrete offsets in the slope. The slope was covered in vegetation ranging from trees to various shrubs and ferns. Many of the trees, both young and old, had inclined trunks at the base but vertical orientation above suggesting slow ongoing creep. The trees shown in Photo 2 on the left side which are inclined throughout their length are the result of the recent slough.

A small zone of failed material was located about halfway down the slope and the failure scarp measured approximately 2m deep, 8m down the slope by 10m across the slope suggesting a failure volume of approximately 160m³. Much of the failed material had slumped down slope approximately 10m. Perhaps up to a third of the material has been transported further down slope by the surface drainage over time. At the time of the site visit the exposed slide scarps appeared dry and stable. There were no seepage zones identified although it is expected that they do exist especially after heavy rain.

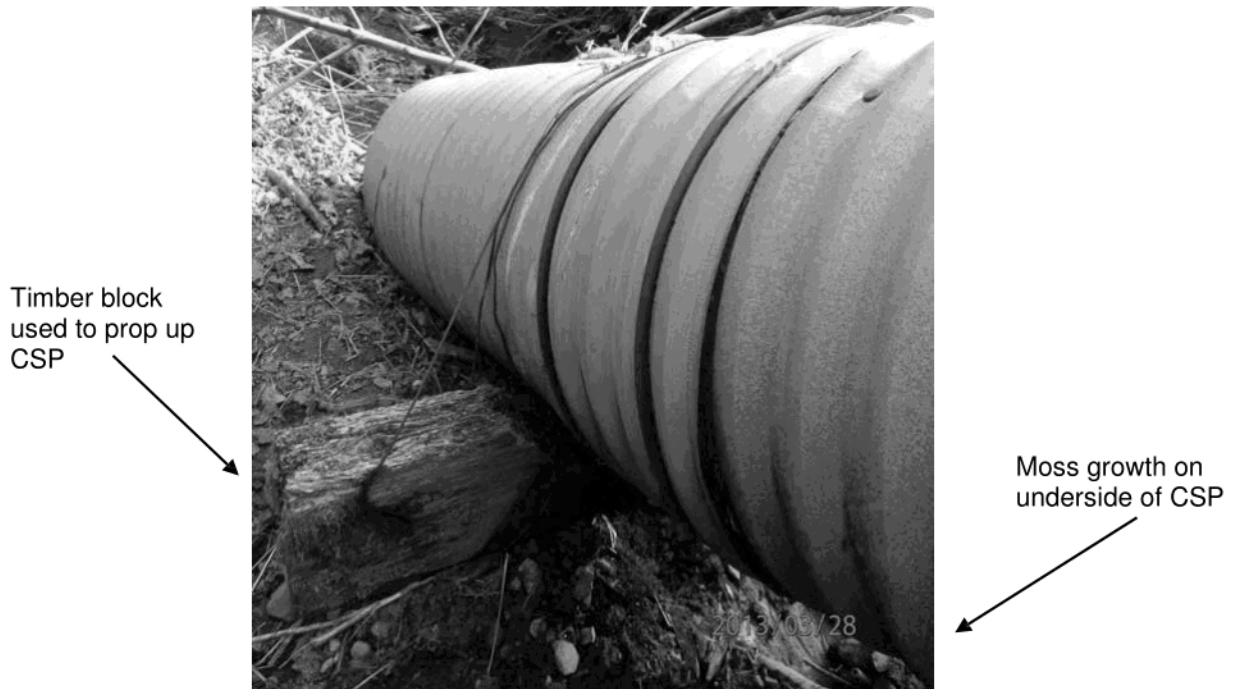
The failed segments of CSP appeared to be in reasonably good condition. There was no indication of corrosion, just some moss on the outside bottom. Large blocks of timber (cedar? fir?) had been used to prop up the CSP in spots. These pieces were soft and spongy but still intact. The ends appeared to be crumpled from the failure. Cables had been used to secure

the culvert. Those pieces of cable that were viewed appeared to be in reasonably good condition as well.

Photo 3: View of CSP

An HDPE pipe is recommended to replace the failed portion of CSP. The existing inlet and top segment is to be replaced. The BOSS 1000 by Armtec, or equivalent, is a single wall corrugated pipe and is suitable for the site due to its flexibility and ability to conform to steep slopes. A 600mm diameter pipe is available but the Victoria office bridge branch has offered to complete a drainage assessment to ensure a proper sized pipe is reconstructed. Survey information is required to complete the assessment. Please contact Mike Feduk, Senior Hydrotechnical Engineer, to determine the required information. The pipe needs to extend all the way to the ocean. It is understood that the district wants to install a surplus catch basin at the pipe inlet to separate out any debris or sludge.
