Ministry of Transportation and Infrastructure

Commercial Vehicle Inspection Report

**Subject:** Cariboo Hwy #97 Bus Crash update

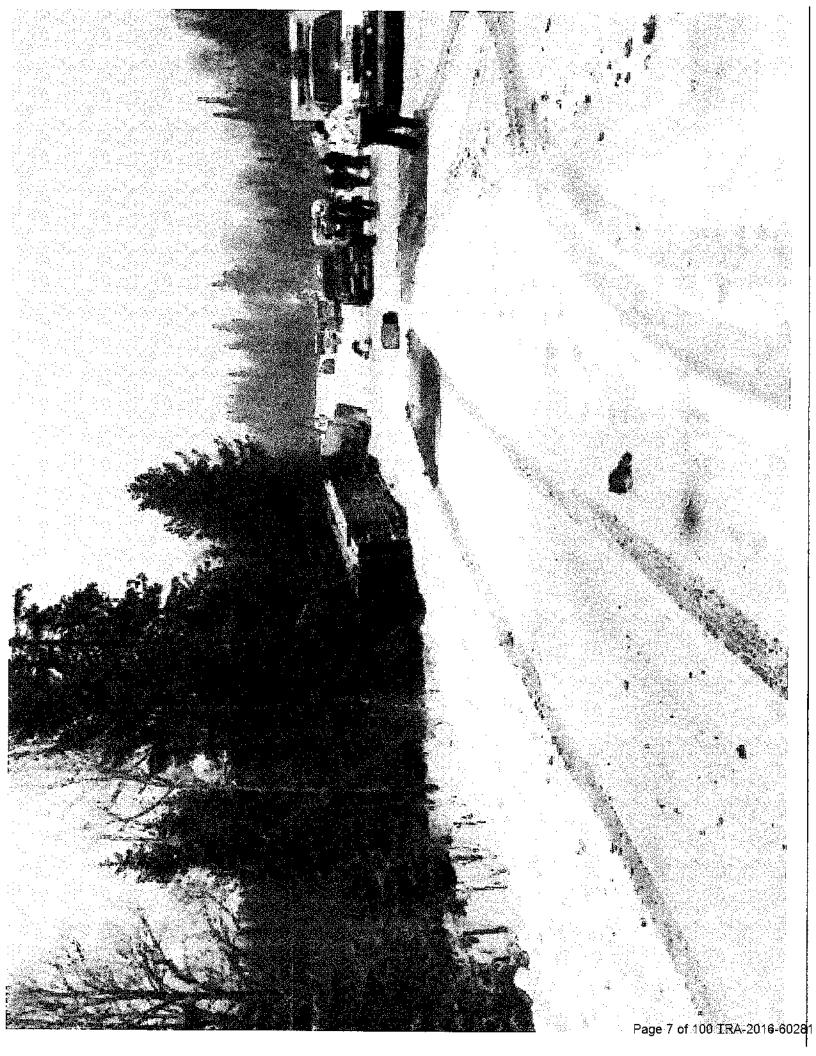
Emcon provided us with their best photo of the roadsurface taken at the time that they arrived (just after the crash occured), (quality is not the best), however there is clear evidence of abrasive and the wheel paths also slushing up.

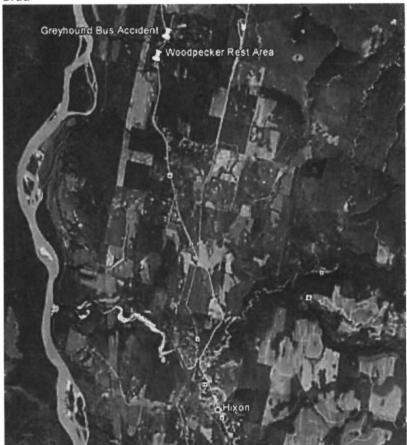
Hi, attached are the Greyhound bus accident. The bus was South Bound.
