WILSON MOUNTAIN FIRE- OLIVER BC

AUGUST 14TH 2015

INVESTIGATION REPORT

DARRELL GREEN

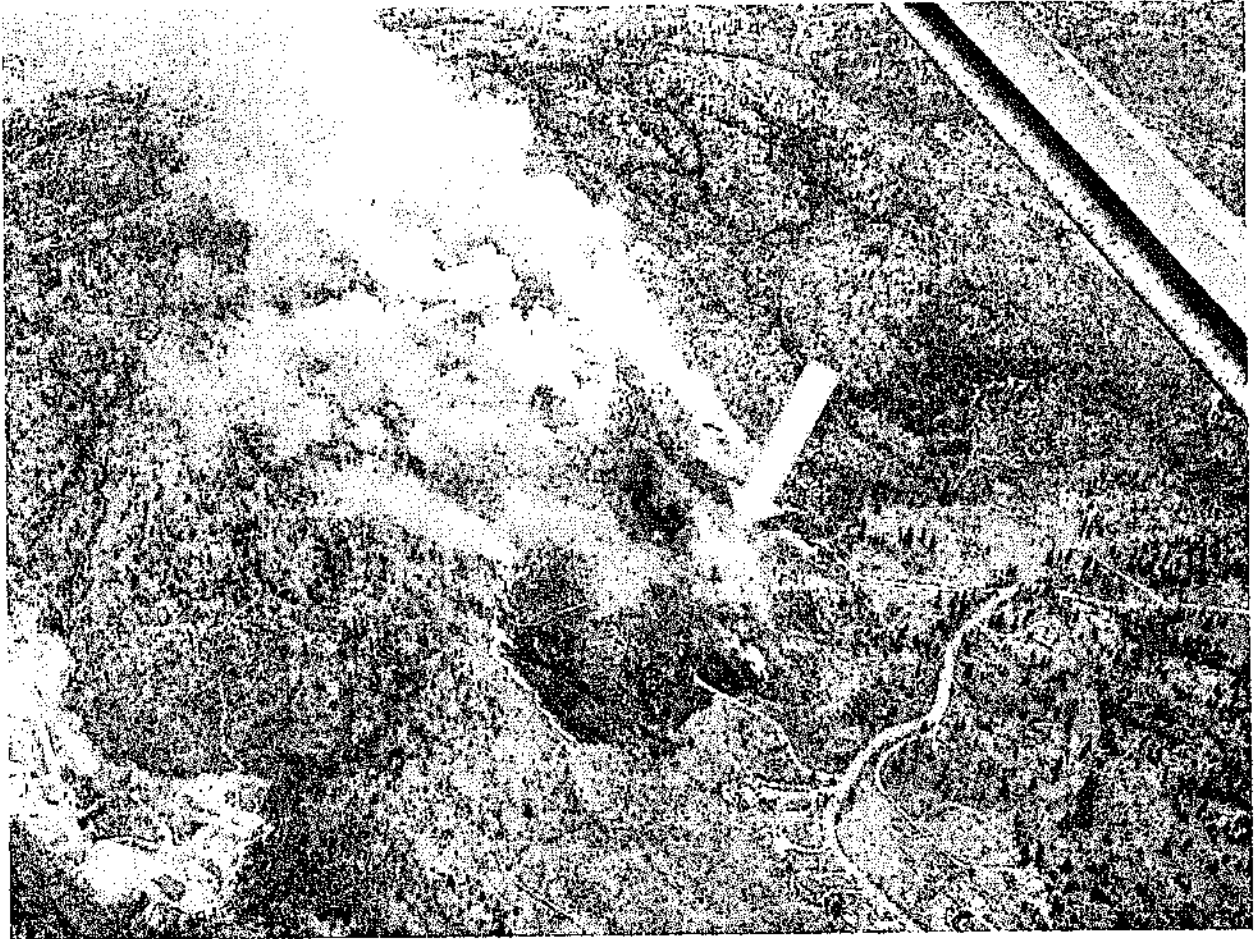
AERIAL VIEW OF FIRE AT APPROXIMATELY 18.30PM ON AUGUST 14TH 2015. THE ARROW SHOWS THE APPROXIMATE LOCATION OF THE ENTRANCE s.22

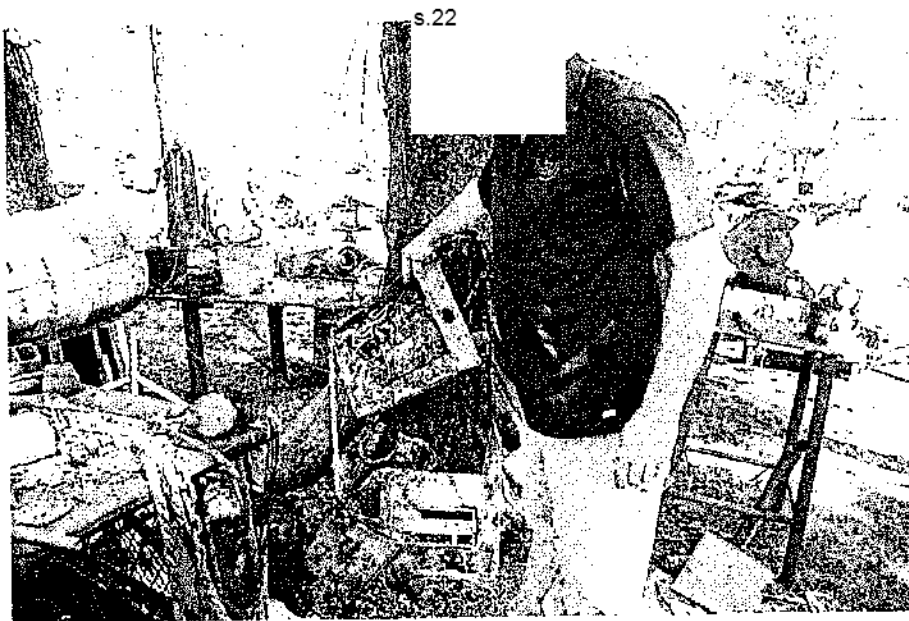
Picture of Large Combination panel attached to tree. Panel cover was on at the time of the fire. Note complete devastation to interior of panel

MR FRICKS EXAMINATION OF THE COMBINATION PANEL FOUND THAT THE INTERIOR CONTENTS OF THE PANEL WERE INCINERATED. HE CONCLUDED THAT THE NEAR COMPLETE DESTRUCTION OF THE CONTENTS OF THE PANEL INDICATES A VERY HIGH TEMPERATURE FOR AN EXTENDED PERIOD OF TIME. MR FRICK ALSO NOTED IN HIS REPORT THAT IMMEDIATELY ADJACENT TO THE PANEL IN THE TREE HE FOUND VARIOUS OTHER PIECES OF ELECTRICAL EQUIPMENT OF SIMILAR TYPES OF MATERIAL IN PARTICULAR A RECEPTACLE. (Picture of receptacle in report). HE NOTED THAT THE PLASTICS OF THE RECEPTACLE WERE HEAVILY DAMAGED BUT STILL INTACT AND THAT THESE PLASTICS ARE OF SIMILAR TYPES THAT BREAKERS ARE CONSTRUCTED OF.

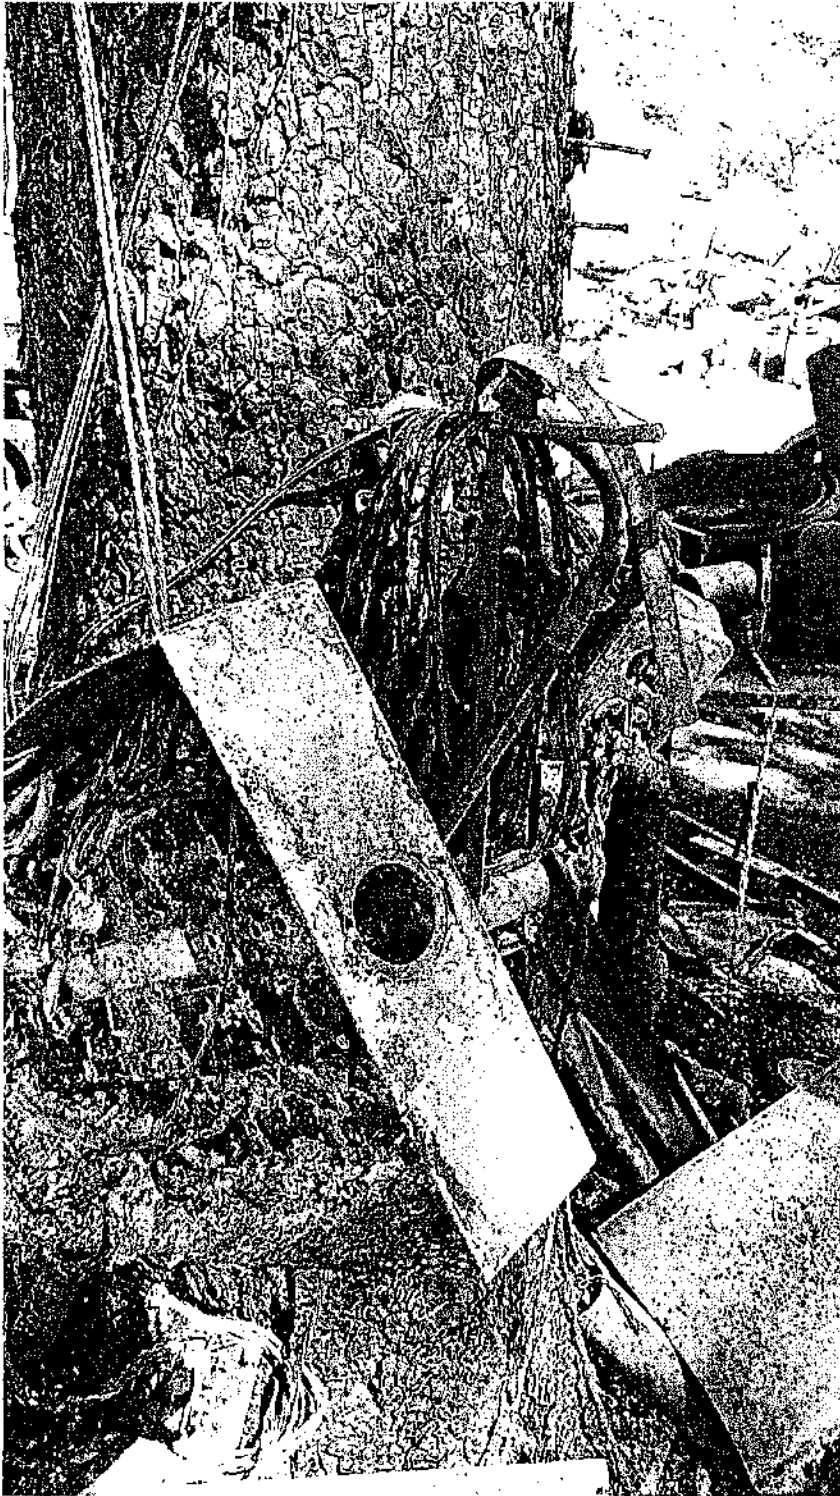
Picture of combination panel located at the tree. Panel cover removed which revealed complete devastation inside the panel.

Note the receptacle to the right that is still partially intact.

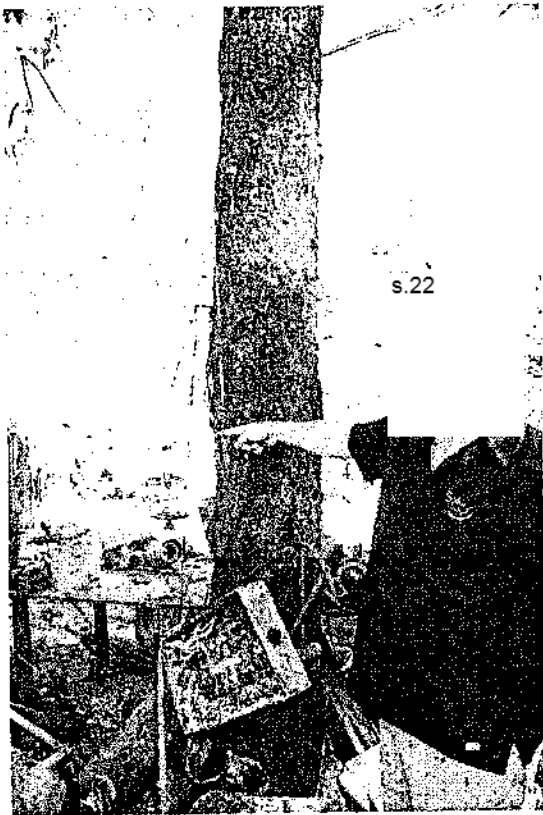
Picture of wires exiting the subpanel and traveling up the tree

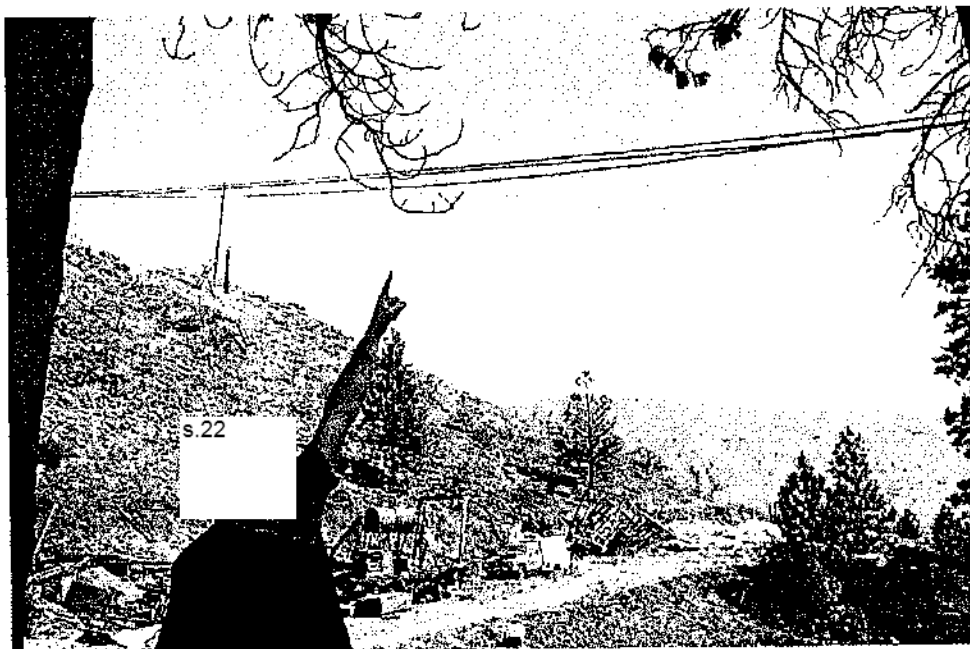
Picture of wires strung between the trees.

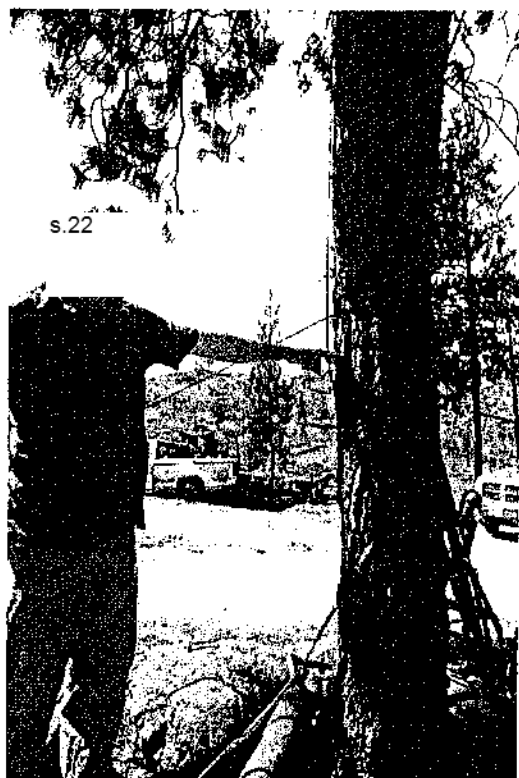
Picture of wires traveling down the tree opposite to tree with the panel

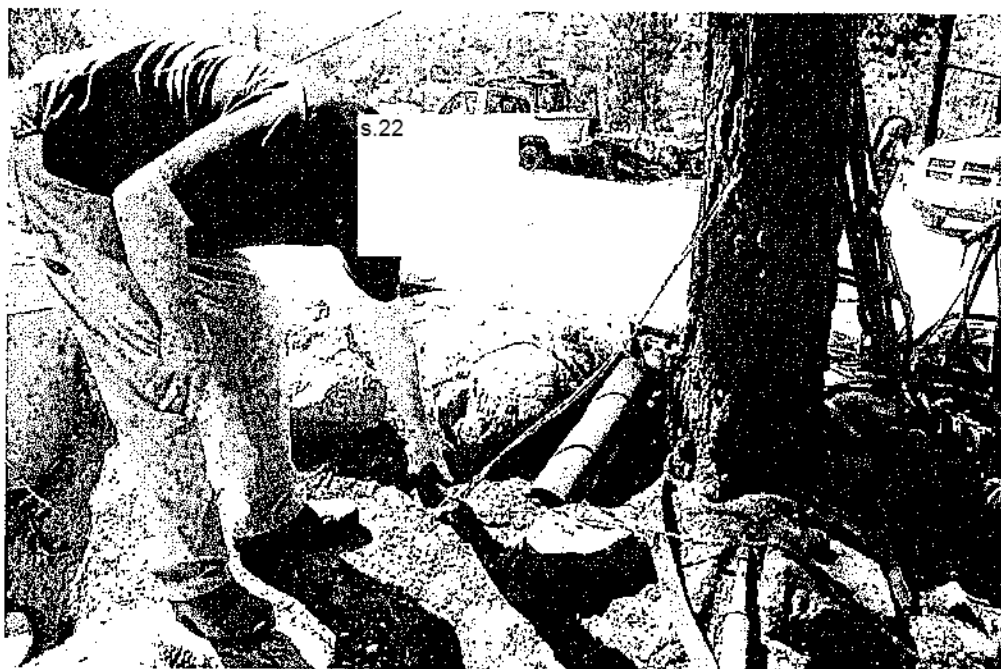
Picture of wires entering the ground.

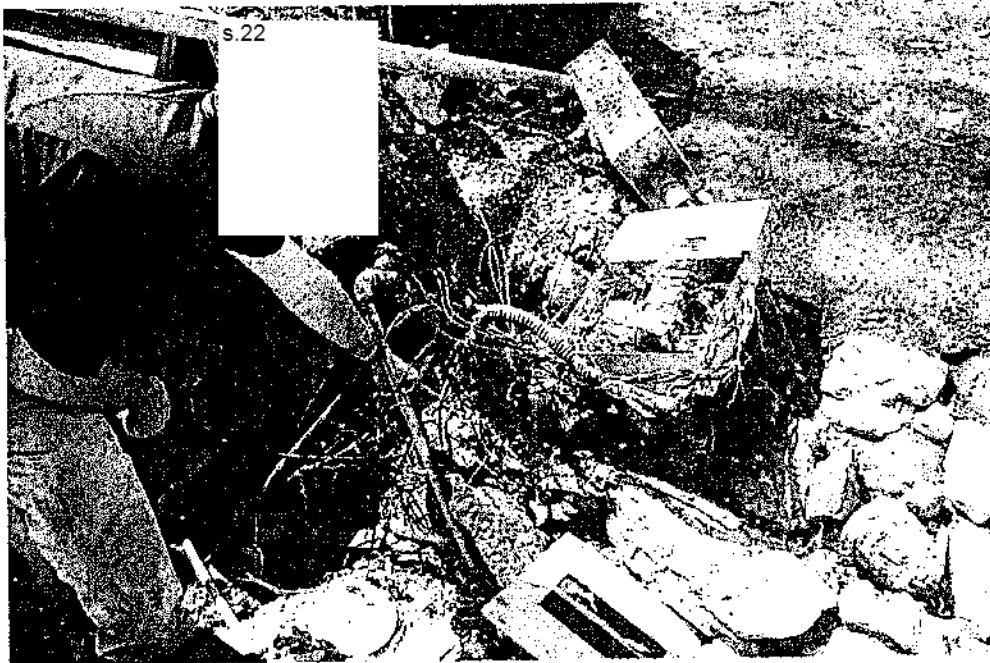
Picture of wires exiting the ground and going to the main service panel

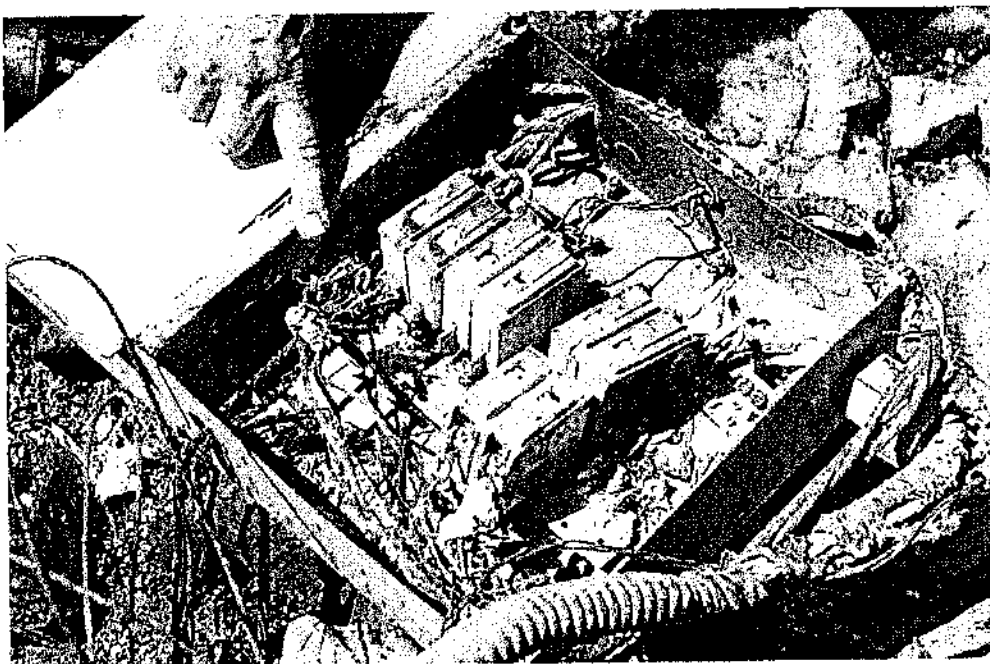
Picture of main service panel showing the location of the breaker that had wires attached to it that is believed to have fed the sub-panel located at the tree. **Note that breaker had completely disintegrated compared to the other breakers in the panel**

TO CONCLUDE HIS REPORT MR FRICK INDICATED THAT THE CONDUCTORS FEEDING THE PANEL WOULD HAVE BEEN SUSCEPTIBLE TO MECHANICAL DAMAGE DUE TO THE MOVEMENT OF THE TREES FROM THE WIND AND MECHANICAL DAMAGE FROM THE TENSION ON THE CONDUCTORS WOULD HAVE EXTENDED INTO THE PANEL COMPARTMENT FROM THE CONDUCTORS BEING PULLED IN THE TREES. THE PANEL ATTACHED TO THE TREE SHOWED SIGNS OF HIGH HEAT ON THE INSIDE. THE SERVICE PANEL WERE THE CONDUCTOR FROM THE PANEL IN THE TREES APPEARED TO CONNECT TO, THAT BREAKER WAS INCINERATED WHILE THE OTHER 4 BREAKERS IN THAT PANEL REMAINED INTACT.

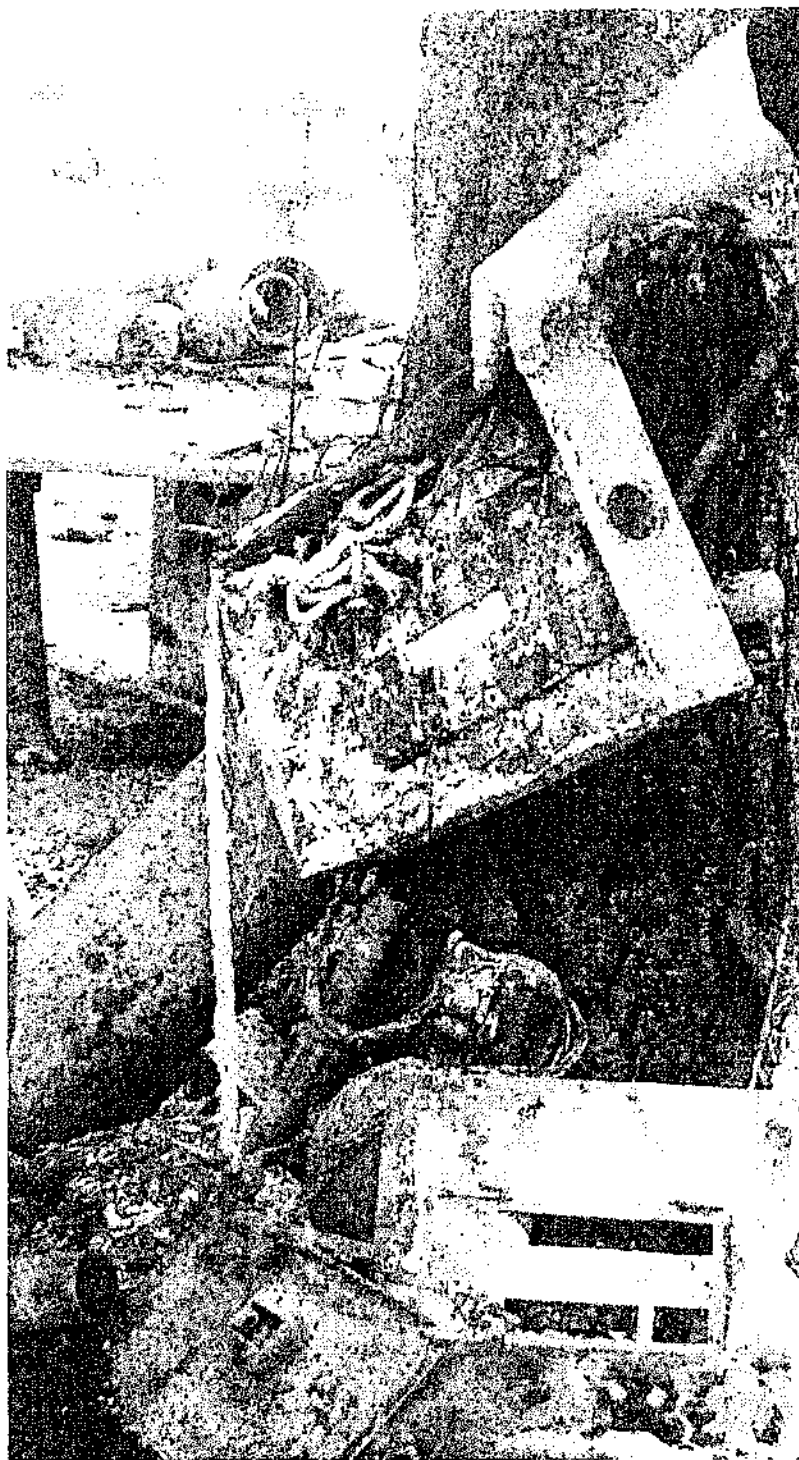
I removed the panel cover and found the contents of this panel were incinerated. The only materials left were ashes, molten metals, remnants of the bus bars and copper conductors. The near complete destruction of the contents of the panel indicate a very high temperature for an extended period of time. Immediately adjacent to this panel hanging in the tree, various other pieces of electrical equipment of similar types of materials were found. A receptacle in a junction box was located attached to a conductor and hanging from the same tree within 10 centimetres of the panel. The plastics of the receptacle were heavily damaged but still intact. These plastics are of a similar type that breakers are constructed of.

The presence of plastics associated with electrical equipment adjacent to the panel lead me to conclude that the panel had sustained damage by heat that was internal in the enclosure.

This would occur with a failure to disrupt the energy being fed into the panel.

Combination panel found in open workshop area. Shows signs of high heat, high energy.

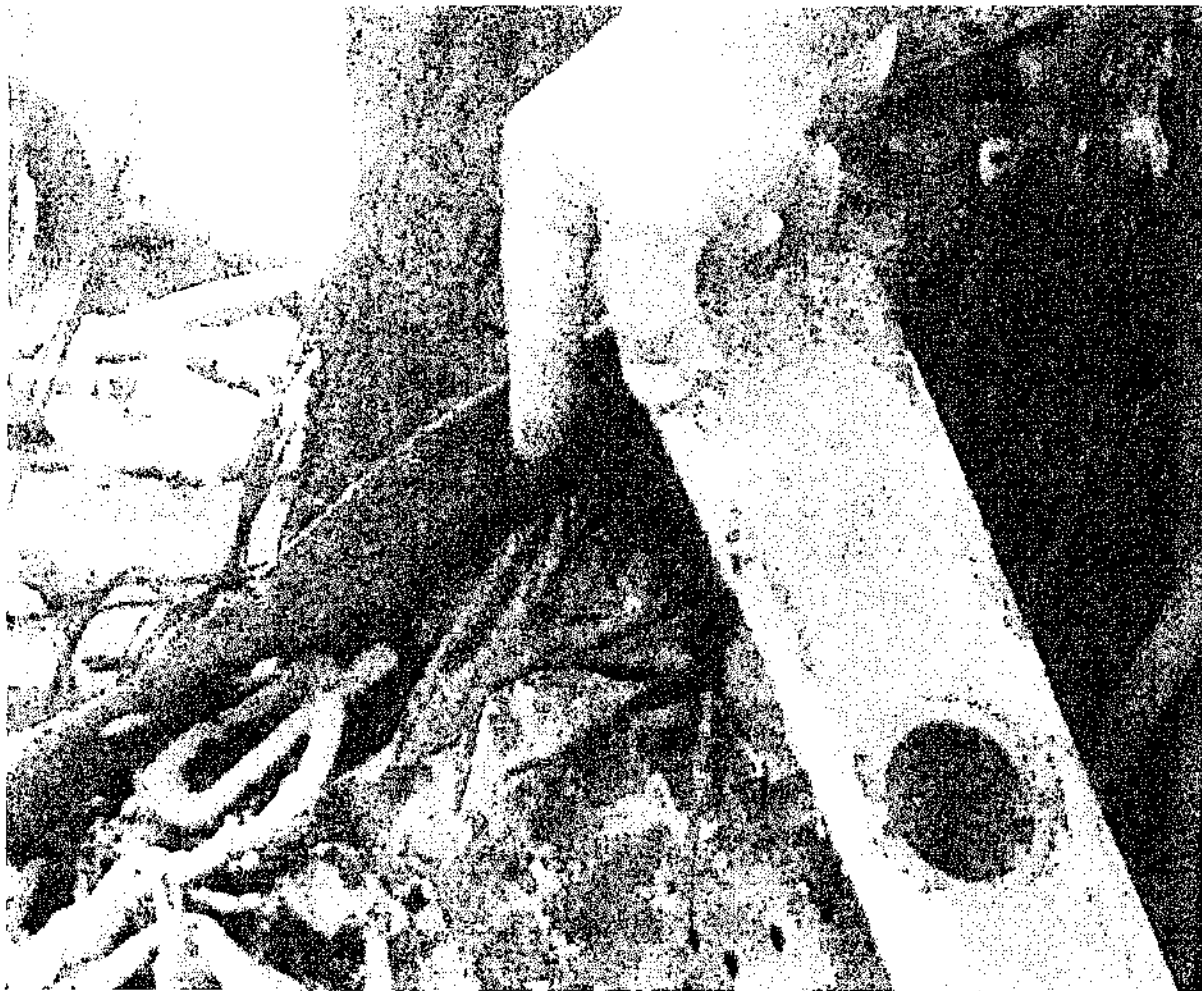
I examined the feeder conductors going into the main compartment of the panel. These conductors were single stranded conductors, insulated, but not part of a cable assembly or suitable for free air hanging. These conductors were subsequently found going up the tree the panel was found hanging off, twisted around the tree and strung from that tree to another tree overhead about 8 feet off the ground then wound around again and then attached to the face of the second tree with common fencing staples, ran down the tree with these staples and into the ground adjacent to the tree.

No mechanical protection was found for these conductors, no supporting means was found for these conductors.

Finger is pointing to the stranded conductors found strung through the trees terminated in the service compartment of the combination panel. These conductors are tied in a knot at the knock out. Single stranded conductors are not suitable for use in a connector into a panel. Connector was not located, possibly melted away or missing?

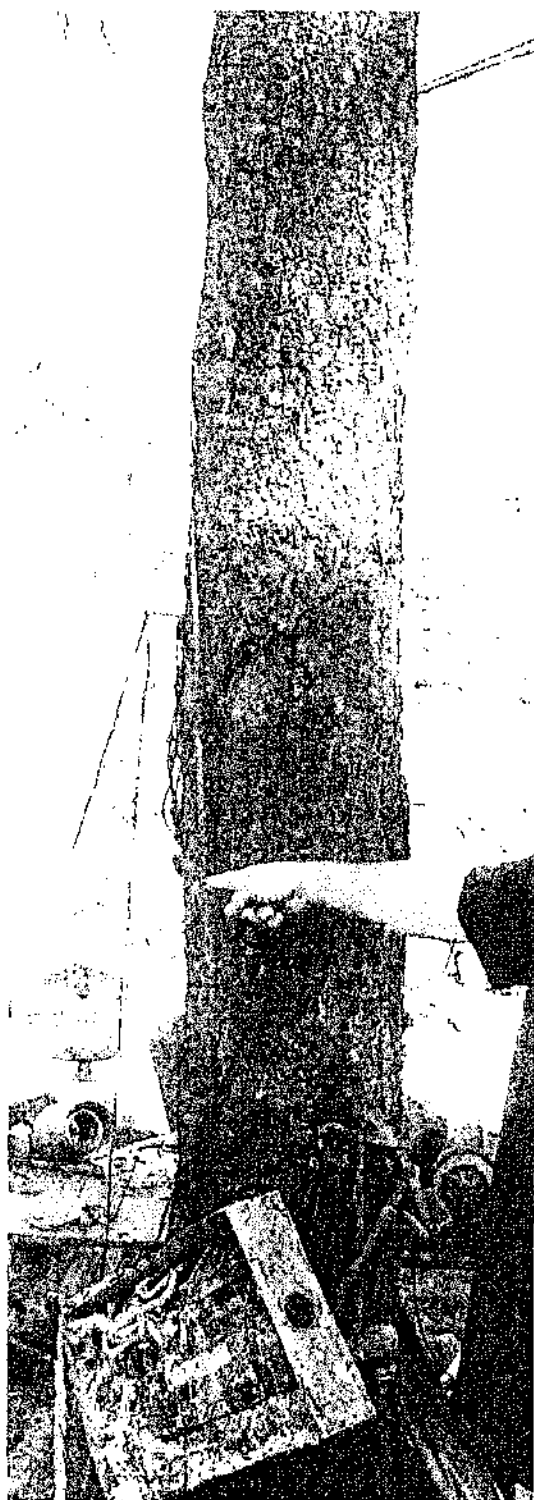
Conductors strung up the tree.

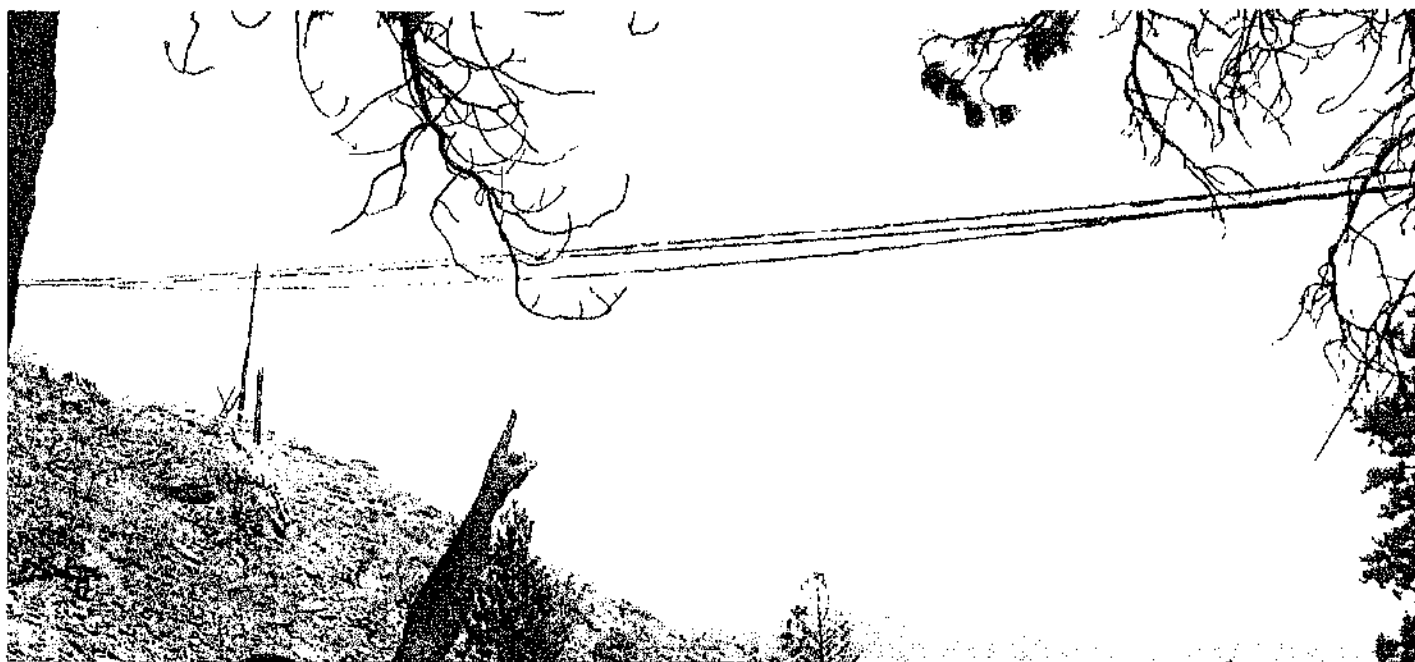
Conductor from panel found strung overhead

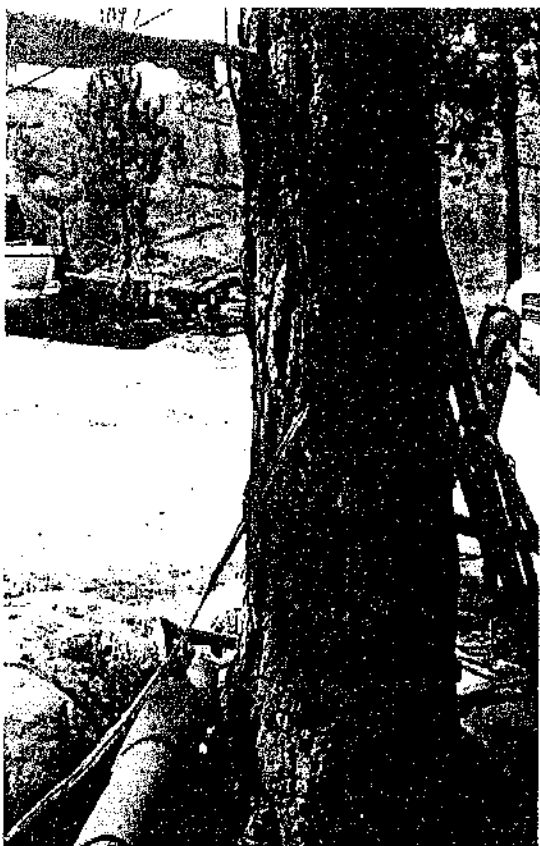
Conductor run down the tree into the ground

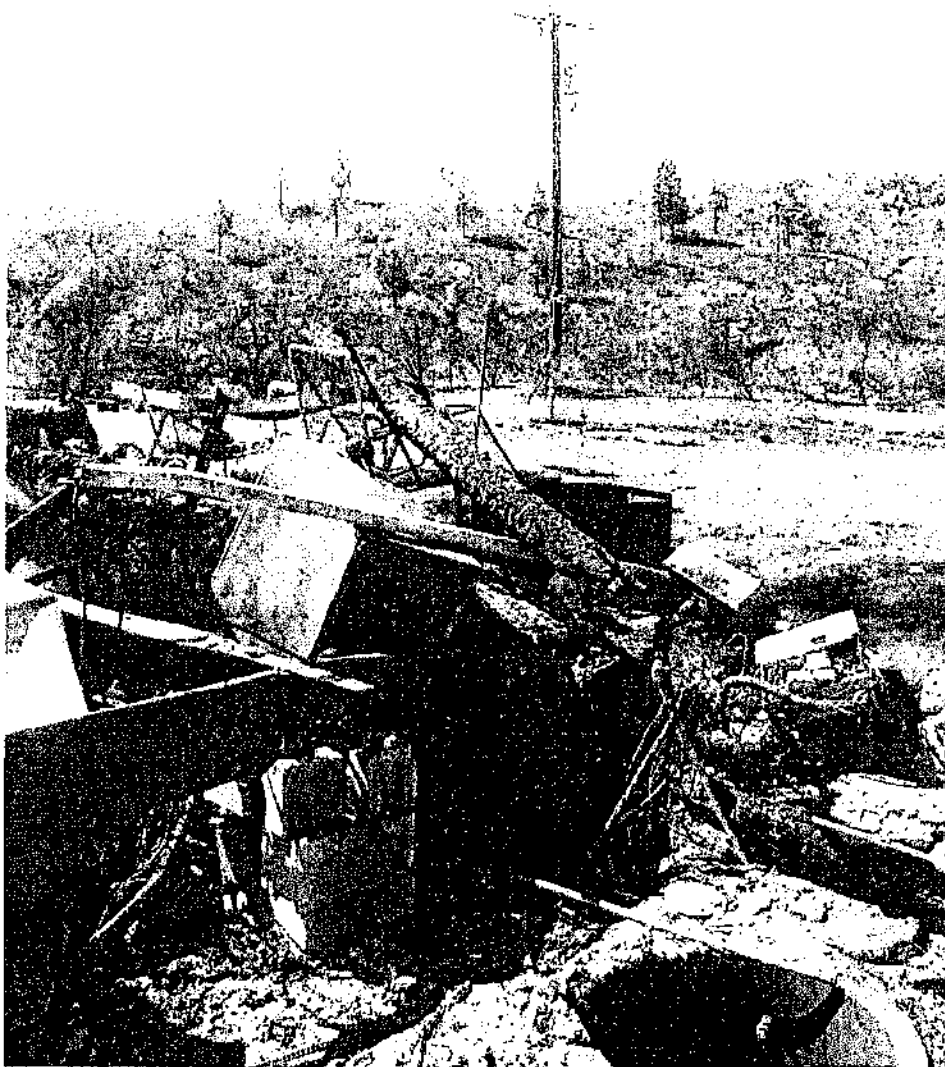
Wide shot of the consumer's service with the utility supply and pole mounted transformer.

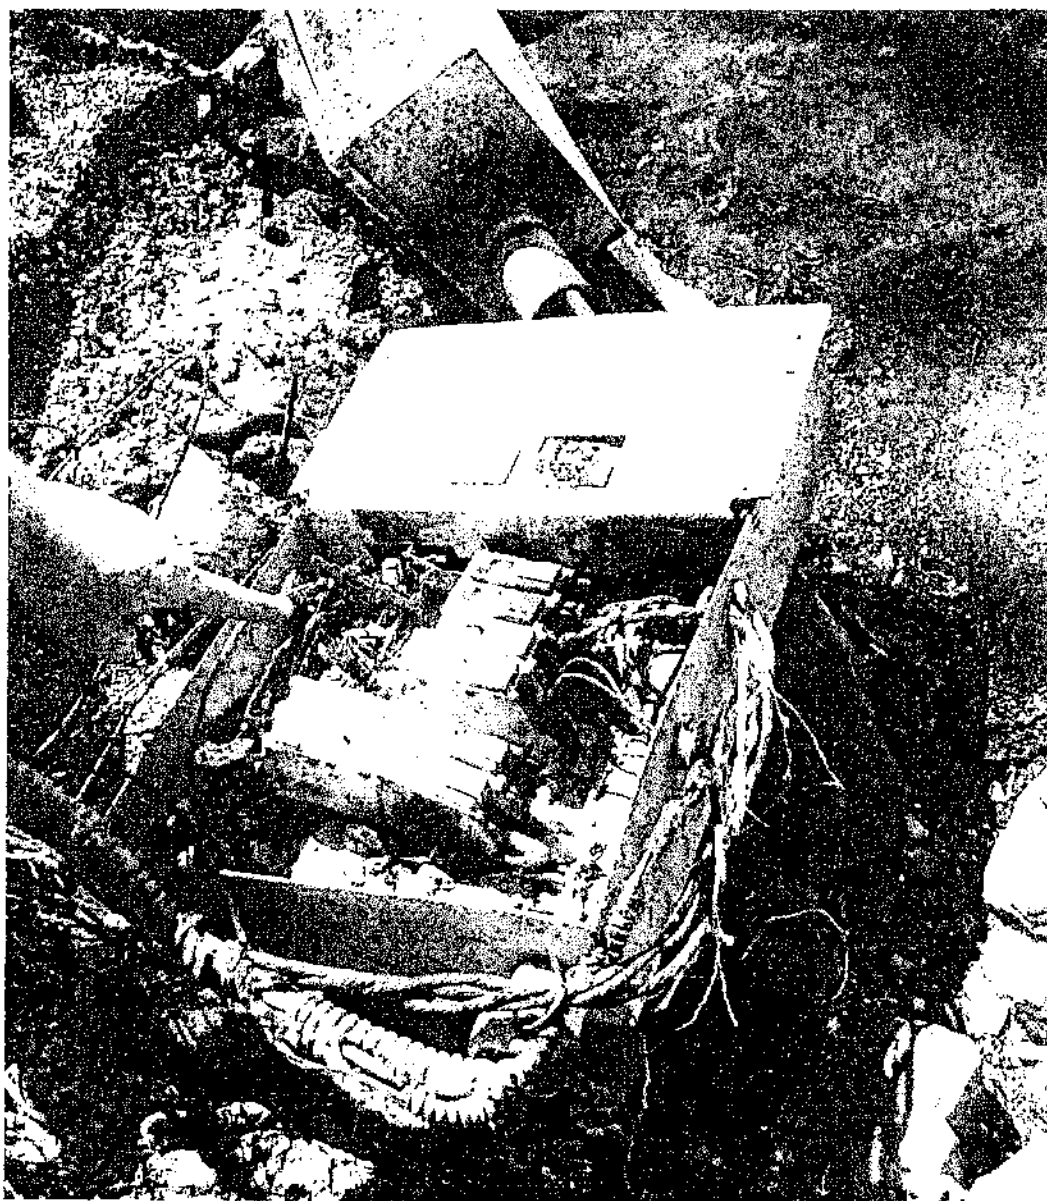
Consumers service branch circuit area

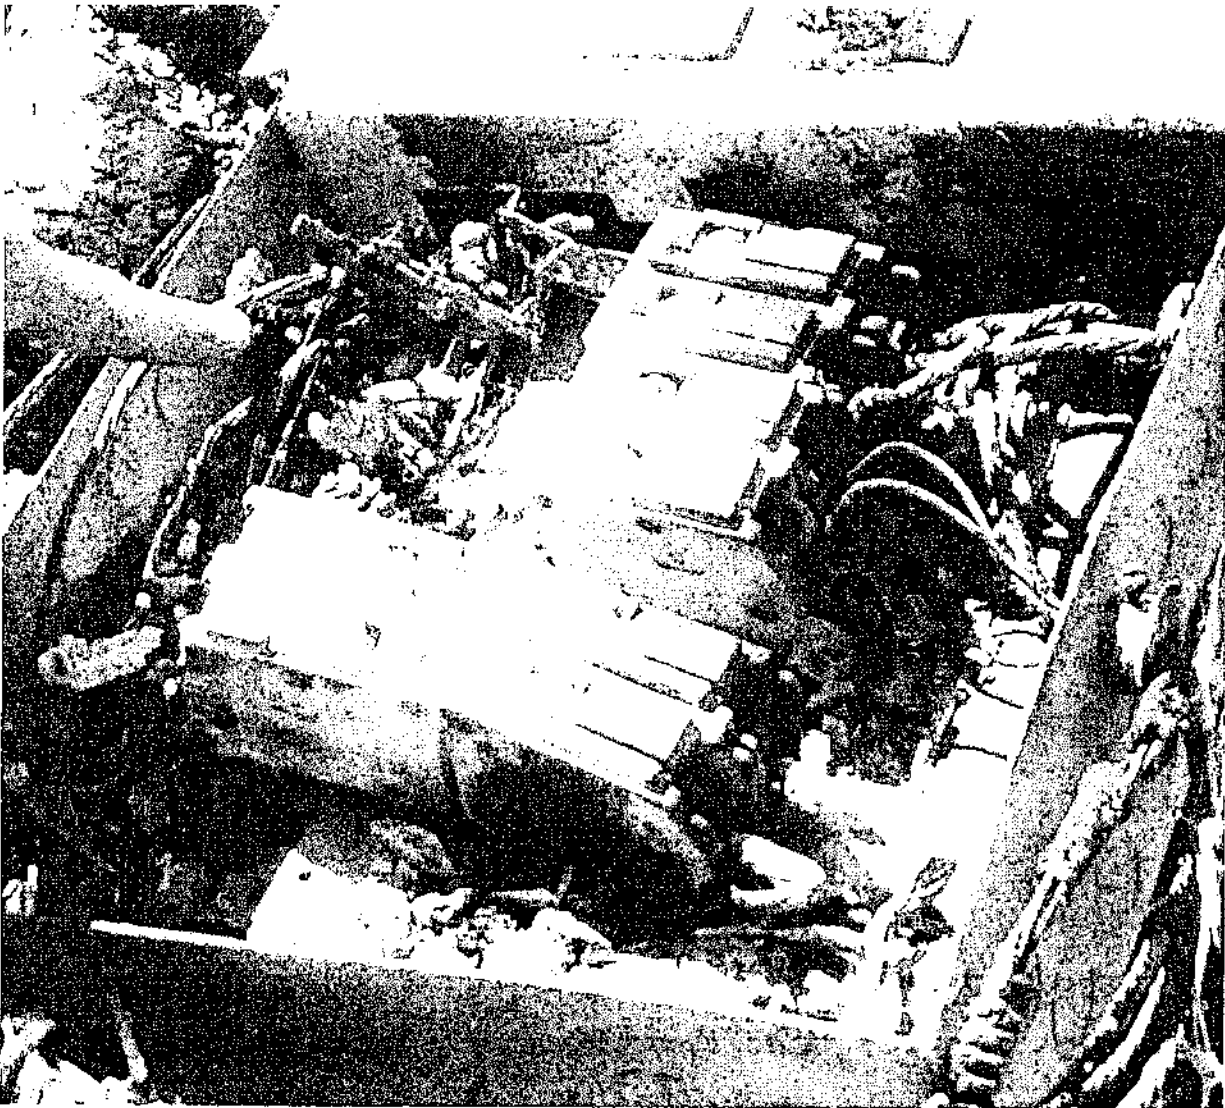
I continued to survey the site to find the source of the feeder into that panel. I began examining the main consumer service panel. The panel showed evidence that one breaker position was more heavily damaged than the others. I removed the cover to expose the contents. I found four 2 pole breakers intact with remains of 1 conductor each on them and the remains of a 2 pole breaker nearly completely incinerated that had 2 conductors on each terminal. One conductor was consistent with the size and stranding of the panel found in the tree, the other was a larger size conductor.

Closer view of the branch circuit area of the consumer service panel. Four 2 pole breakers are mostly intact. Finger points to the remnants of a 2 pole breaker. The incinerated breaker indicates a much higher temperature for a longer period of time at this location.

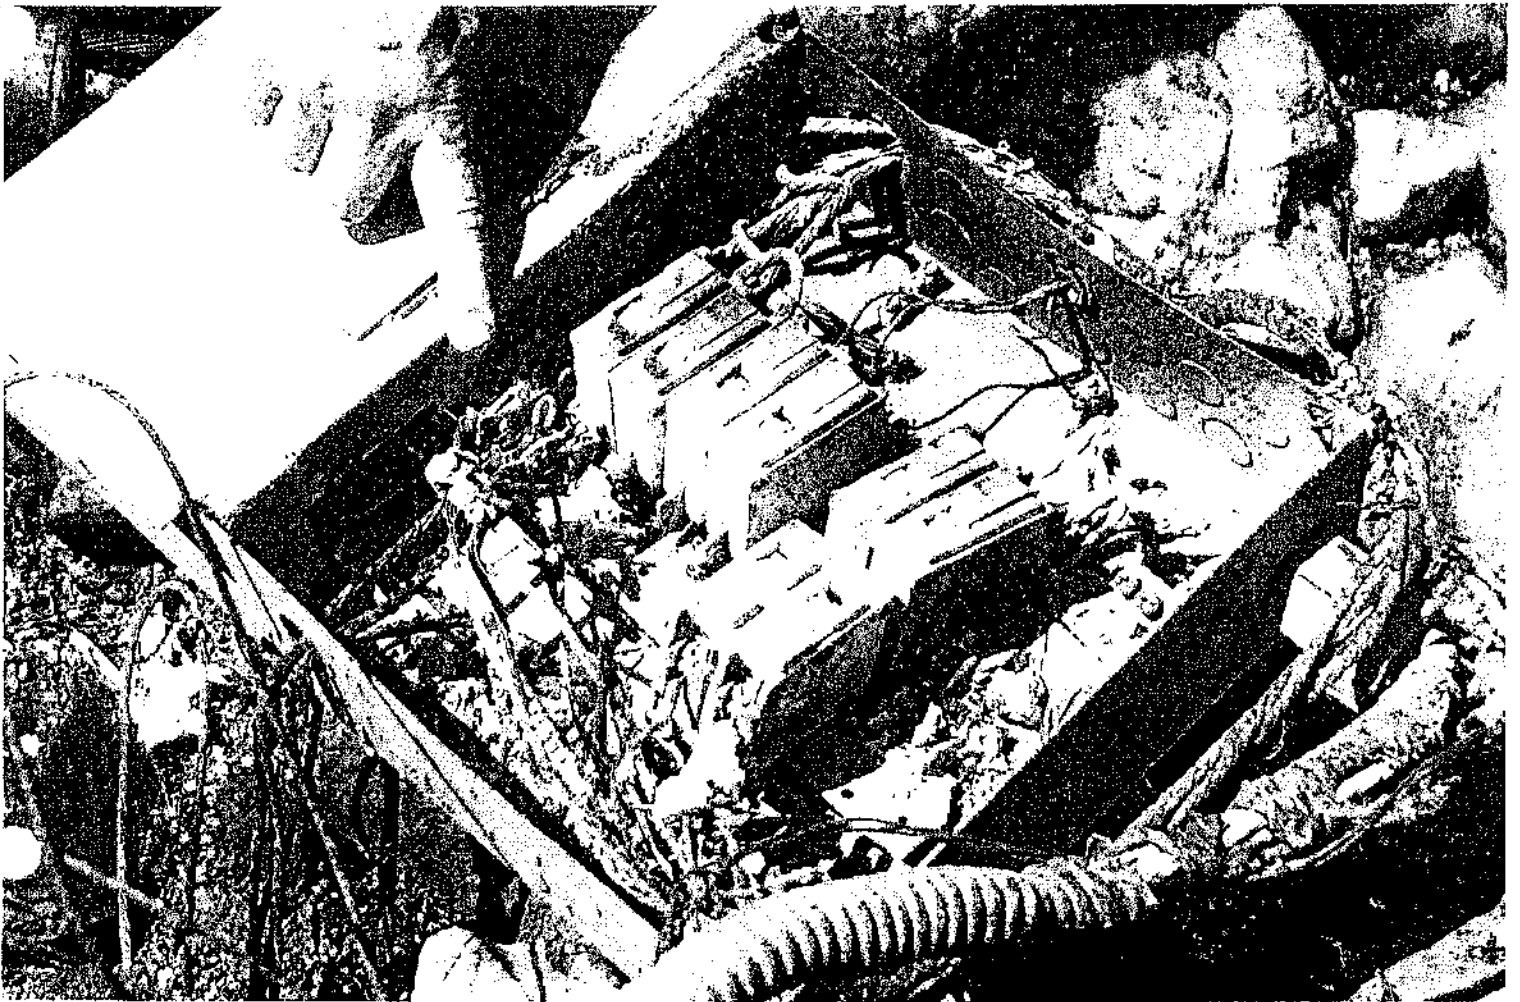
View from another angle. Note that all intact breakers have only one conductor terminated on the breaker terminals. The most damaged breaker has two conductors terminated on the terminals.

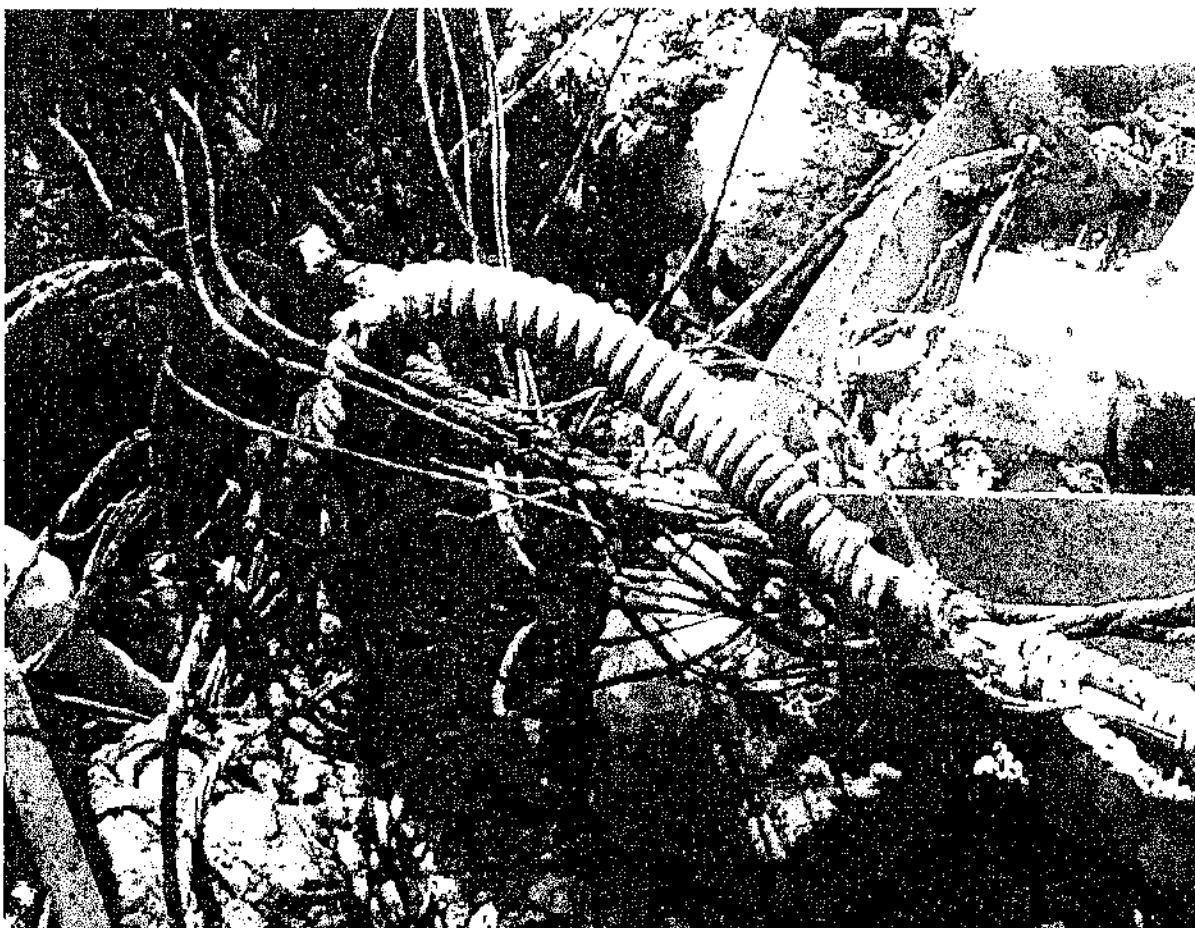
The panel appears to have been fed from the main service at the structure via underground, the conductors are not a suitable type for direct earth burial and lack mechanical protection.

Tracing the conductors of the same size and type as the open workshop area conductors, they go into the earth adjacent to the consumer service location.

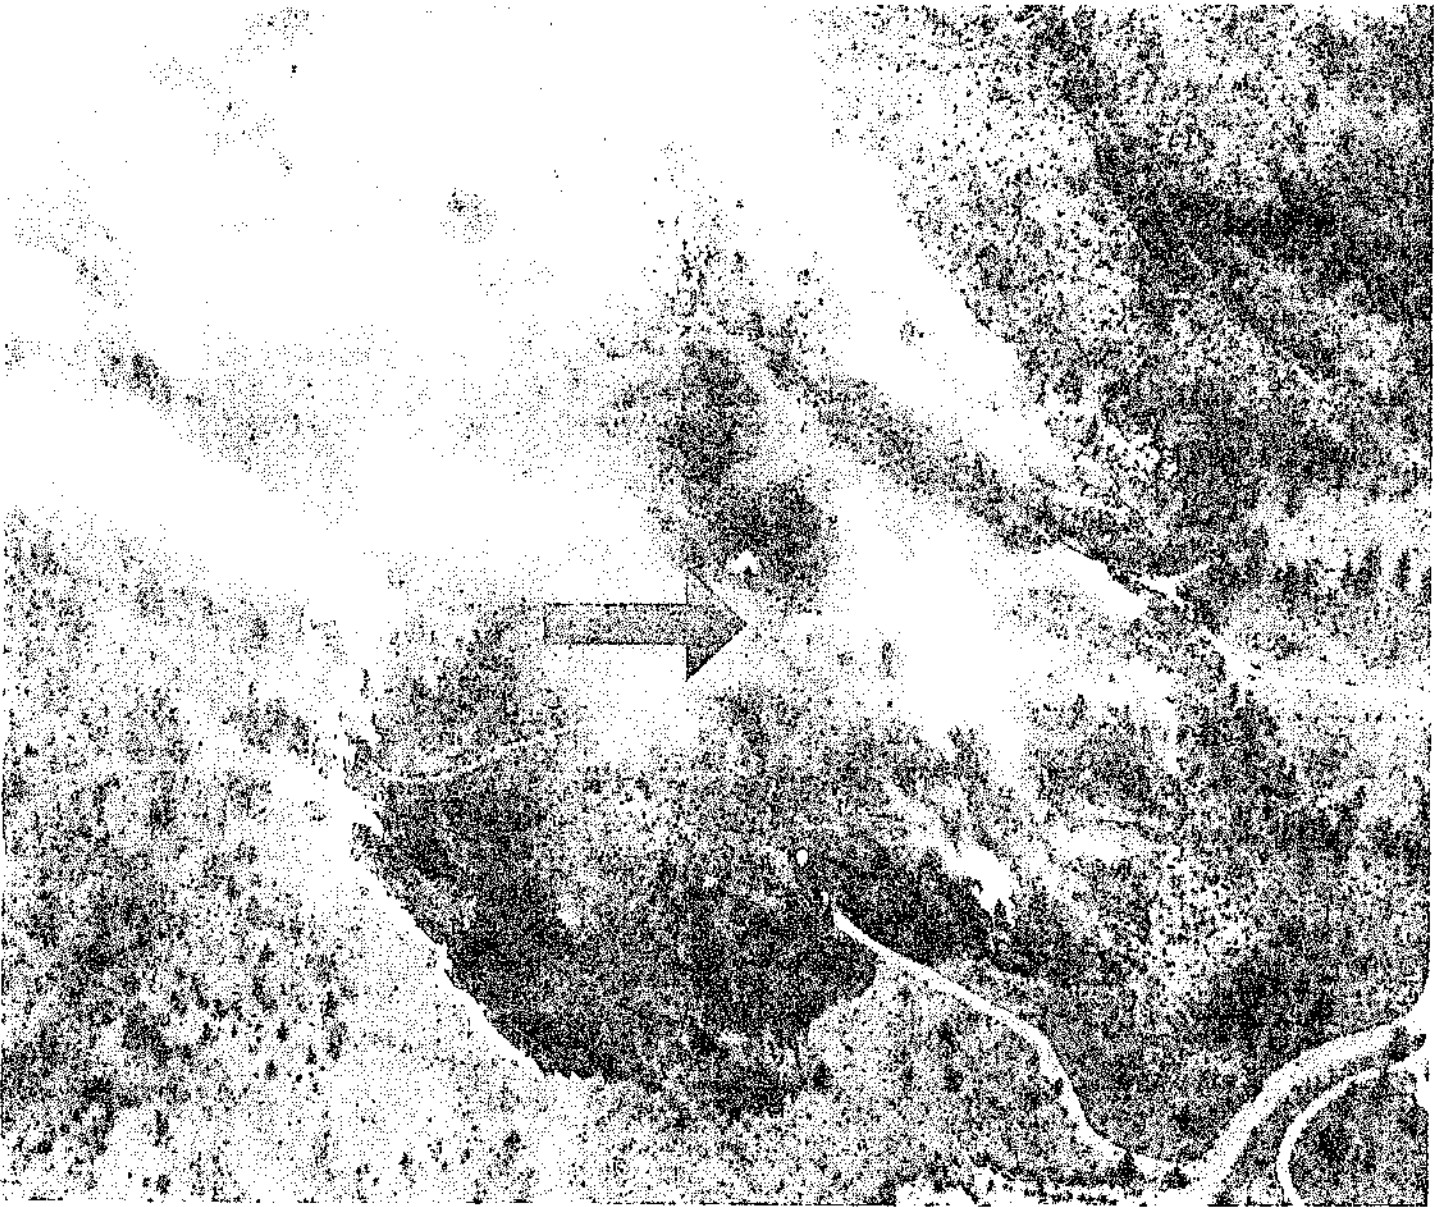
Red arrow indicates the location of the panel found in the open workshop area. Photo supplied by the BC Wildfire service

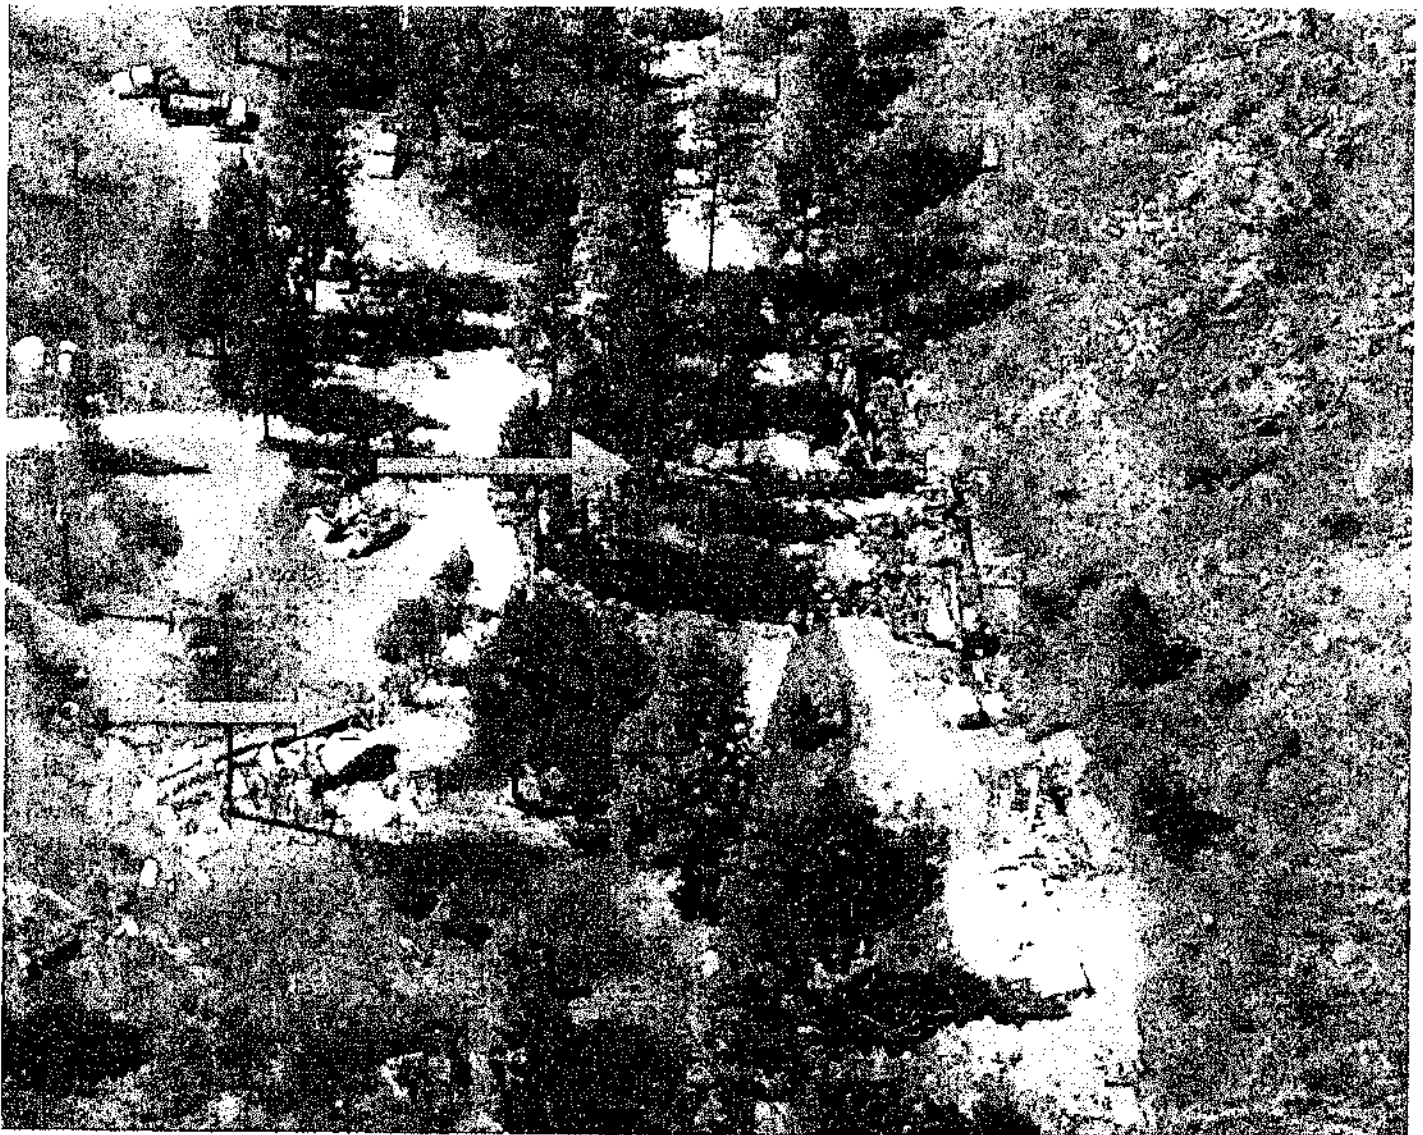
Red arrow indicates the location of the open workshop area panel, green arrow indicates the location of the consumer's service.
