Ministry of Transportation and Infrastructure Geotechnical, Materials and Pavement Engineering Section

MEMORANDUM

February 19, 2013

Re: Walkers Hook Road Instability (#770)

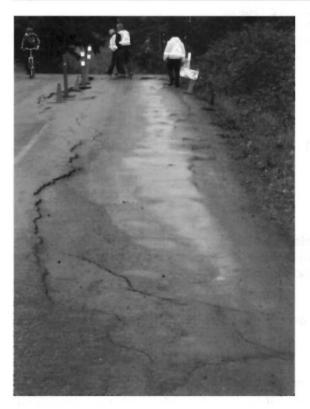
Photo 1: Initial Crack

The crack in the asphalt extended approximately 0.5m over centreline and was 36m long (photo 1). Where movement was the greatest, the asphalt was offset by about 60mm vertically (photo 2). According to the maintenance contractor this site has been repaved 20 times in the past 15 years. The asphalt thickness seemed to be about 1.5m on the down slope shoulder edge.

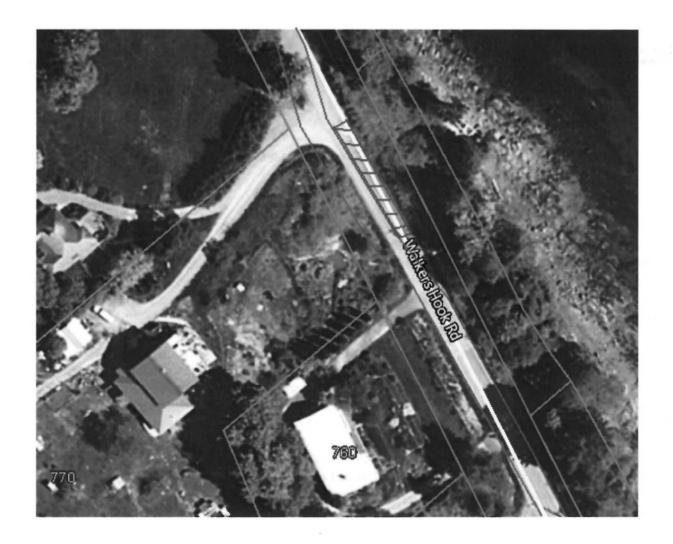
This is another issue that has been ongoing for many years. There are several segments on both Walker's Hook Road and North Beach Road that are in need of base repair. The location in question is on Walker's Hook Road about 270m south of Hedger Road. I've attached a photo of the site which I took back in August for an audit. In recent weeks the displacement of the northbound lane has increased by about another inch, and the cracks in the pavement surface have become more pronounced. To ensure safety, Mainroad has coned off the section where the road is slumping so that there is currently single lane traffic only.

Peter Bullock assessed the site a few years ago and I am told that he gave a rough estimate of about \$100,000 for repairs. Over the years Mainroad has continued to maintain the road surface as best they can by patching distortions in the road with hot mix. Sarah Gaib, Geotech Engineer from HQ had a look yesterday, and I am awaiting a formalized assessment and/or recommendation on how best to proceed. It appears that simply patching the road surface is no longer the best option as the sheer weight of the asphalt may be contributing to the slumping.
