**Fire Cause / Determination  
10003 Llanberis Way  
Popkum British Columbia**

**Date of Incident:** May 7, 2015

**Location of Fire:** 10003 LLANBERIS WAY  
Popkum, British Columbia

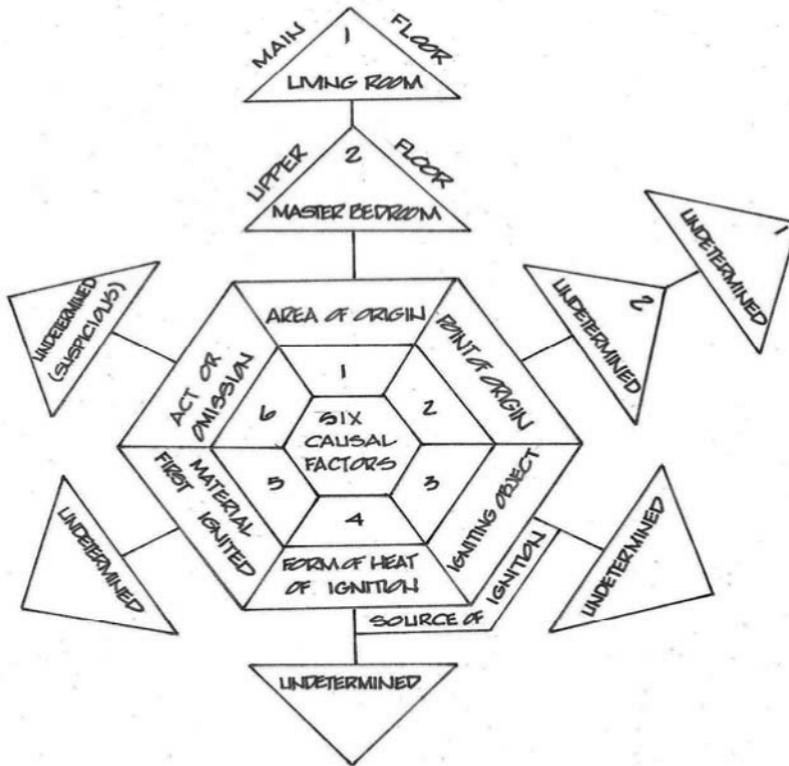
SIX CAUSAL FACTORS  
RESIDENTIAL STRUCTURE FIRE-10003 LLANBERIS WAY, POPKUM, B.C.

FIVE OF THE SIX CAUSAL FACTORS CAN NOT BE DETERMINED
