BRIDGE MANAGEMENT INFORMATION SYSTEM

Condition Inspection Report

Structure No: 01550 - HUNTINGDON O/P

Inspection Type: Routine Condition

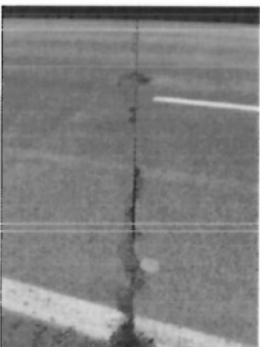
Filename: 01550 068 WB_pier 1
 deck joint looking south
 20140617.JPG

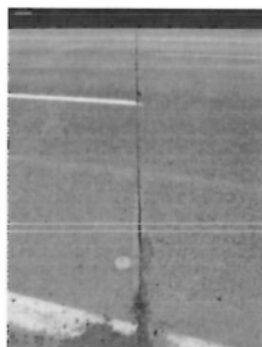
Filename: 01550 076 WB_pier 2
 deck joint looking south
 20140617.JPG

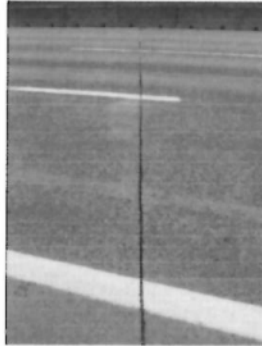
Filename: 01550 028 EB_pier 2
deck joint looking north
20140617.JPG

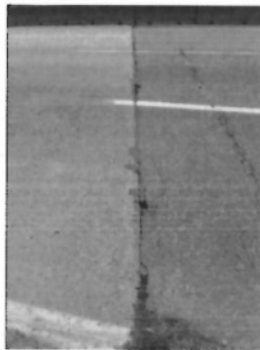
Filename: 01550 080 WB_west
approach-deck interface looking
south 20140617.JPG

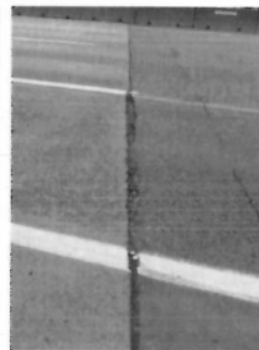
Filename: 01550 020 EB_east
approach-deck interface looking
north 20140617.JPG
