RE: 310 Isabella Point Road Bank Replacement

**Re: Salt Spring Island Isabella Point Road Proposed Rip Rap Source Metal Leaching and Acid Rock Drainage Assessment**

**Re: Isabella Point Road – Site Inspection and Recommended Remedial Measures****Introduction**

Attachments:  
Figure 1 - Proposed Buttress Design  
Photographs 1-10

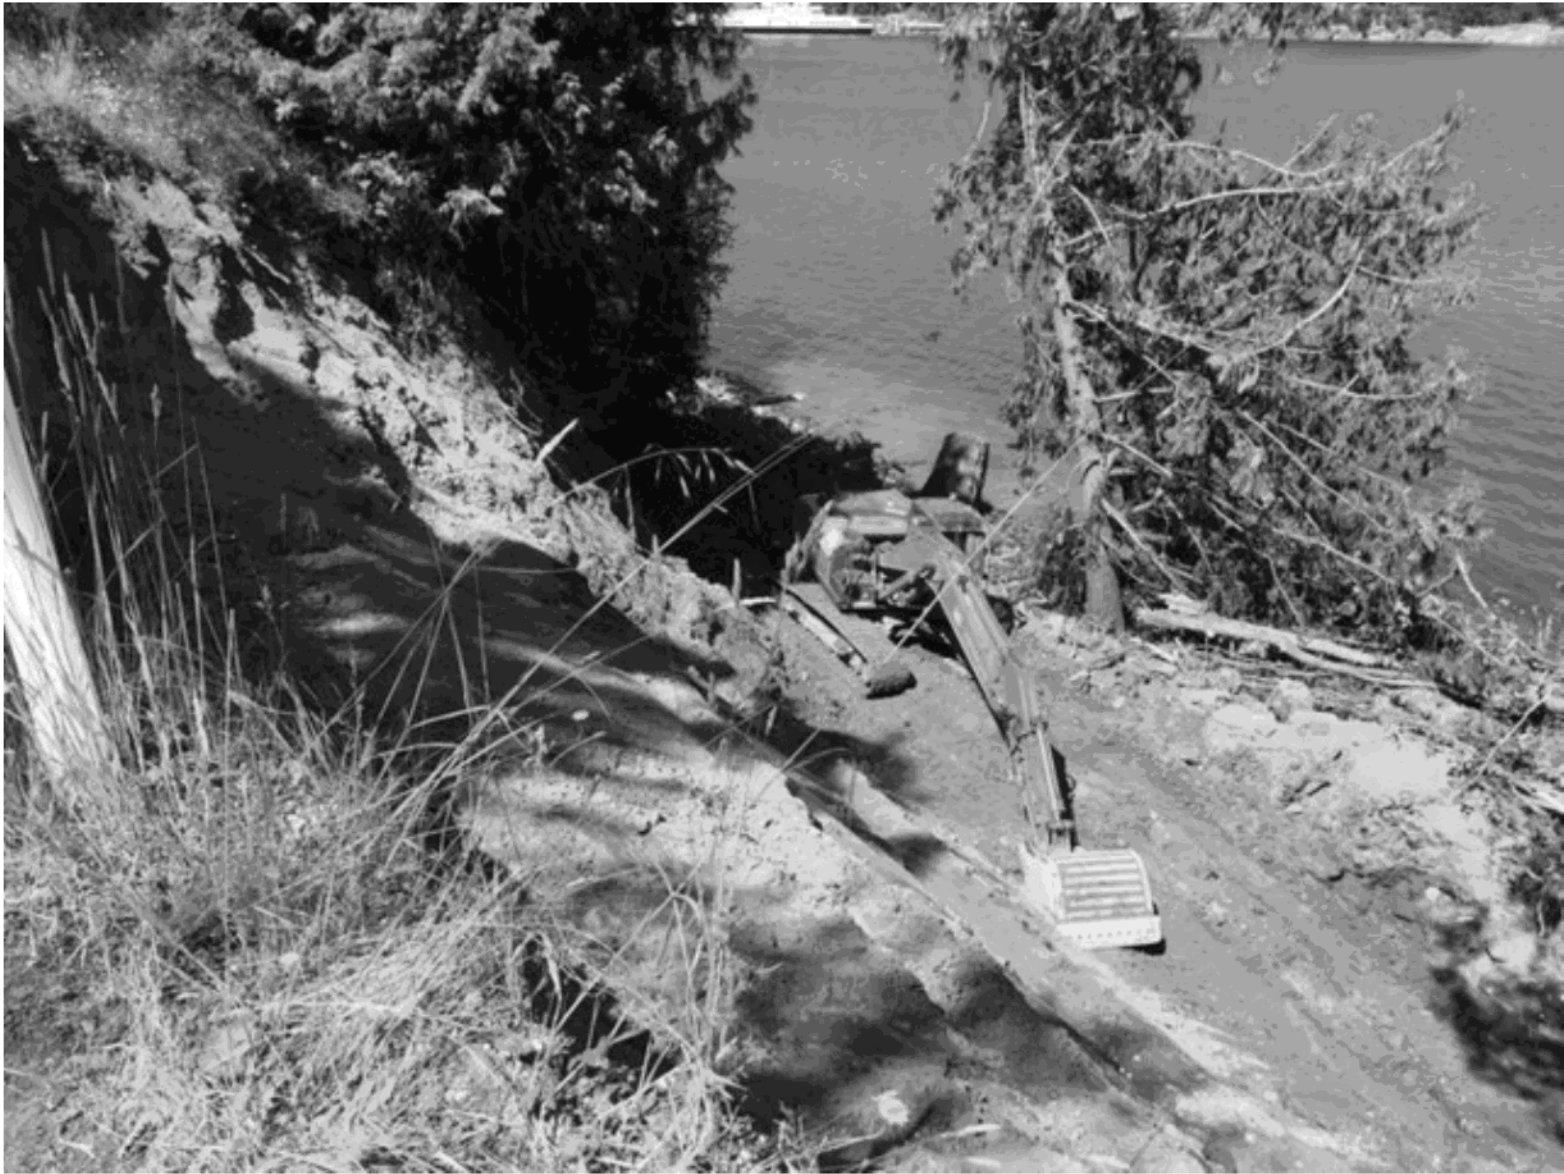
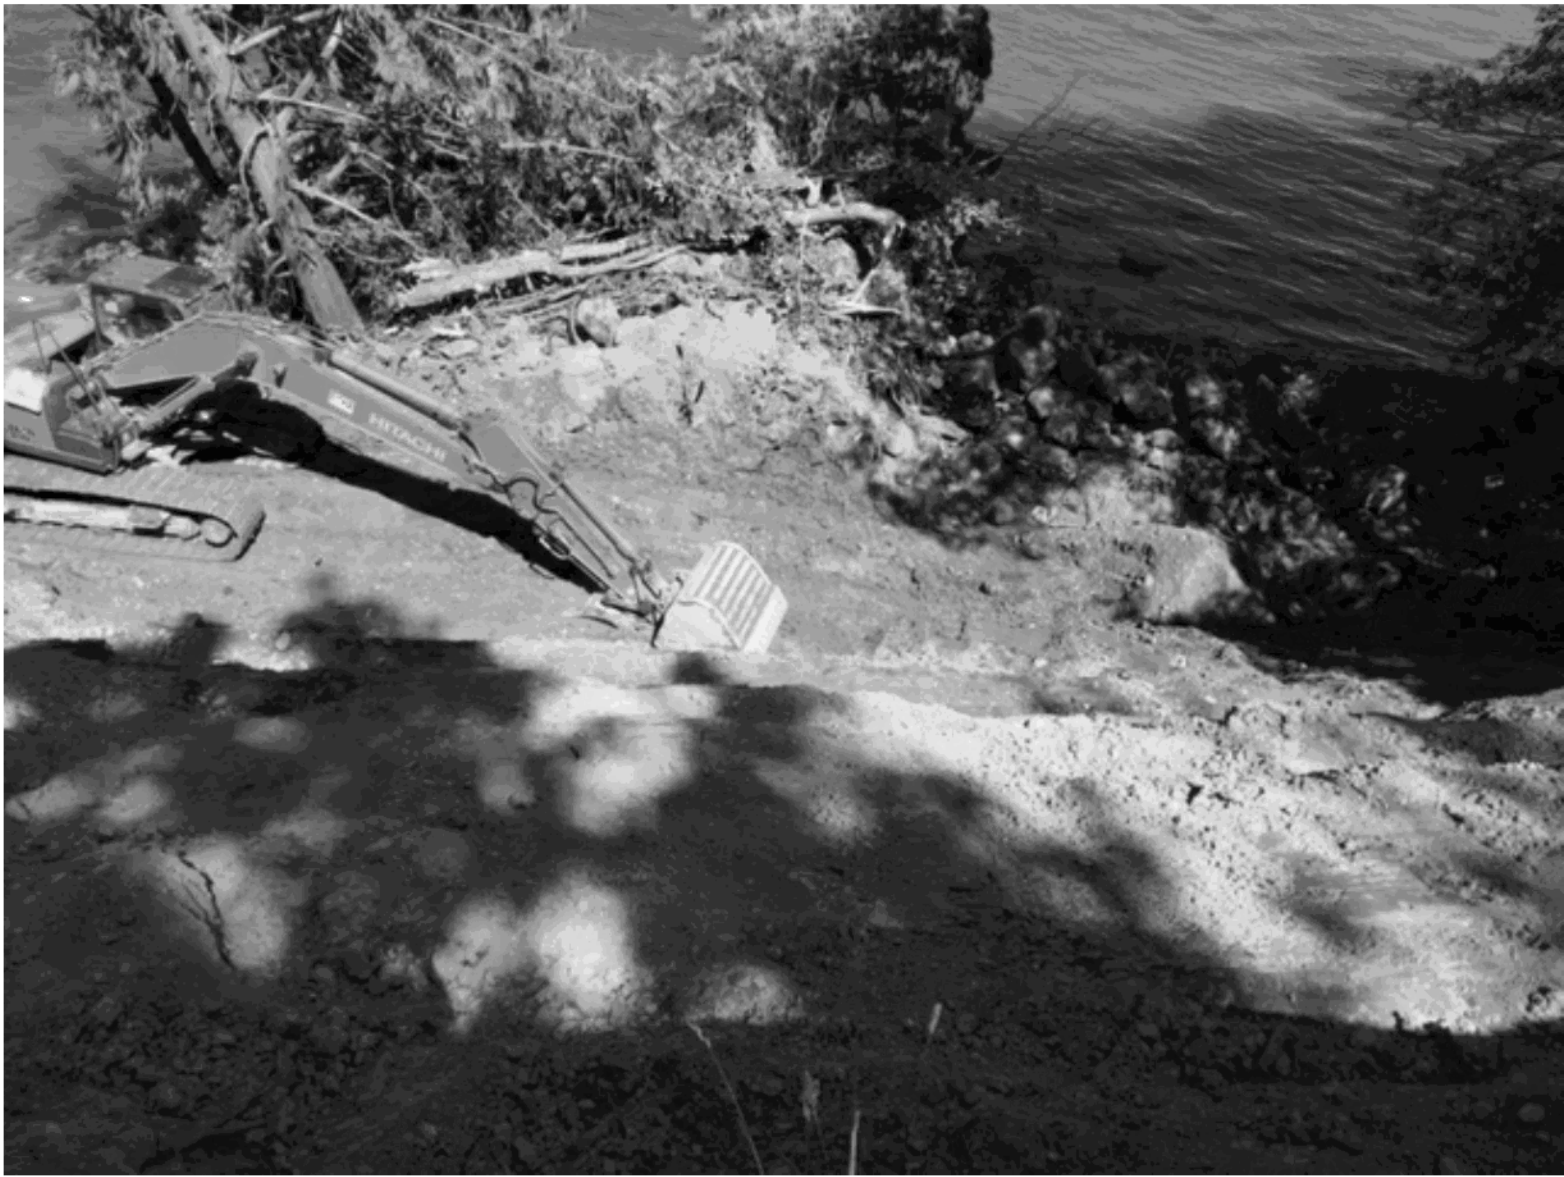
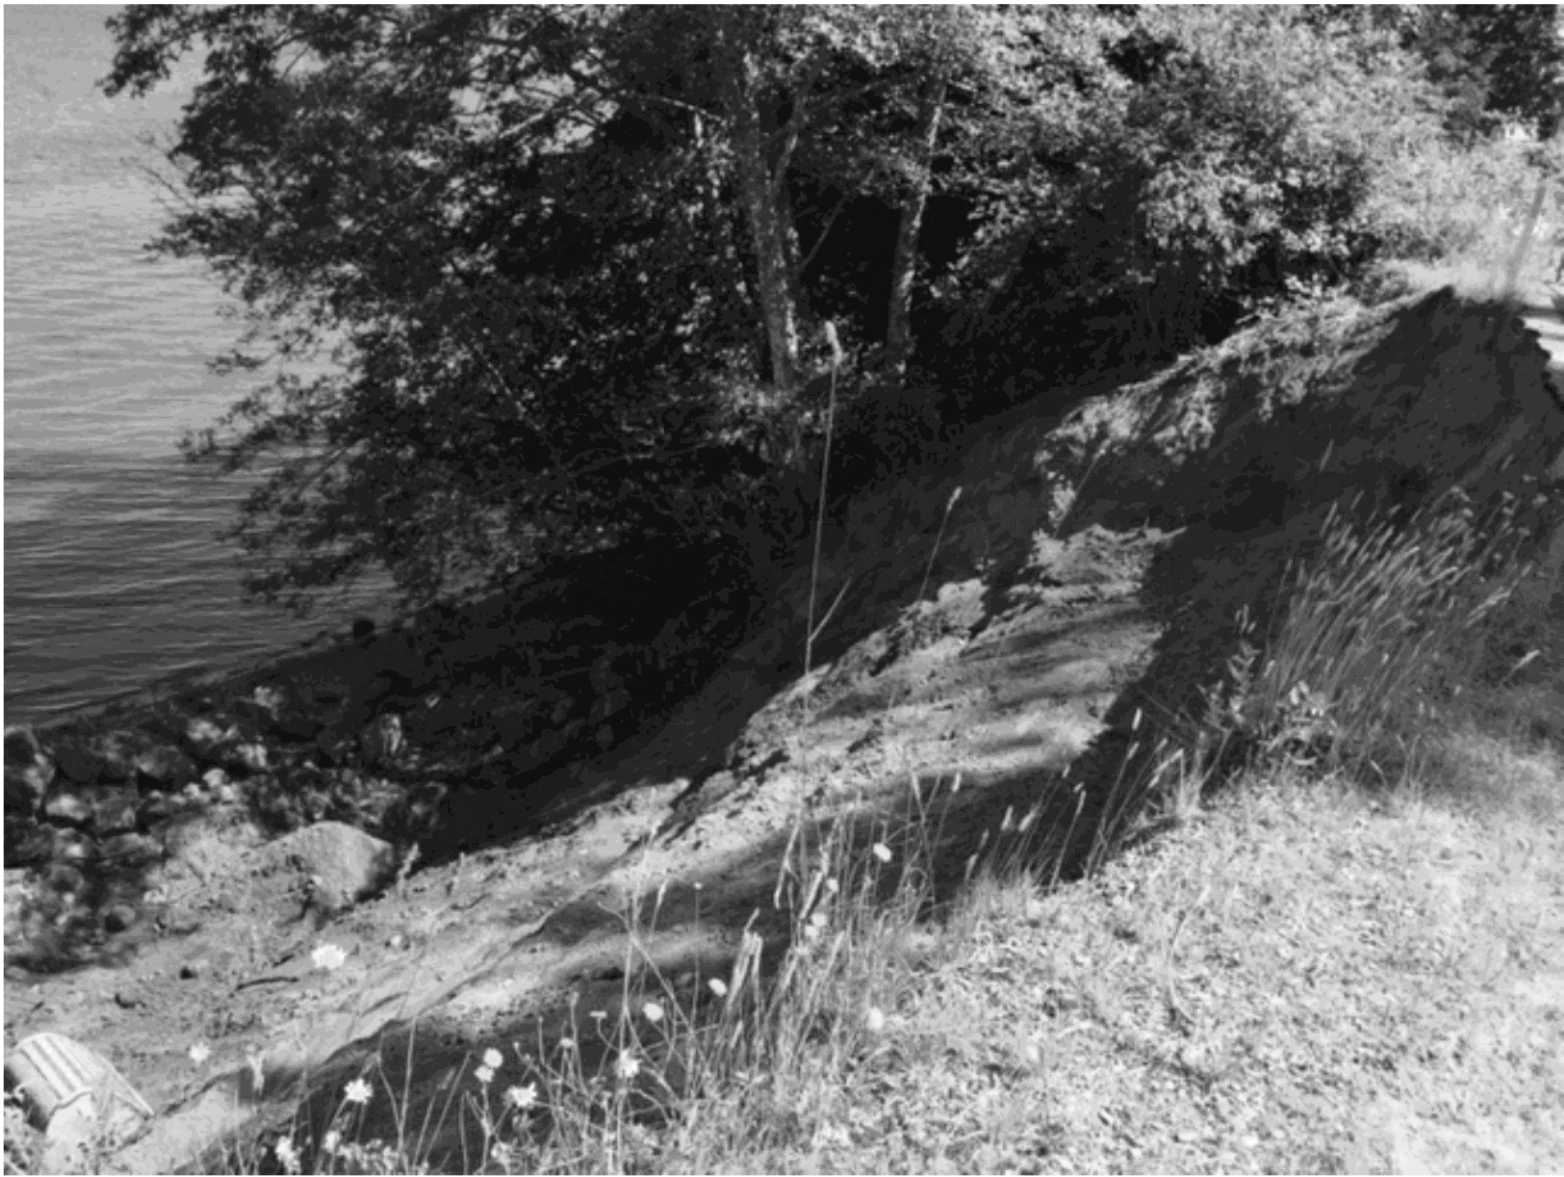
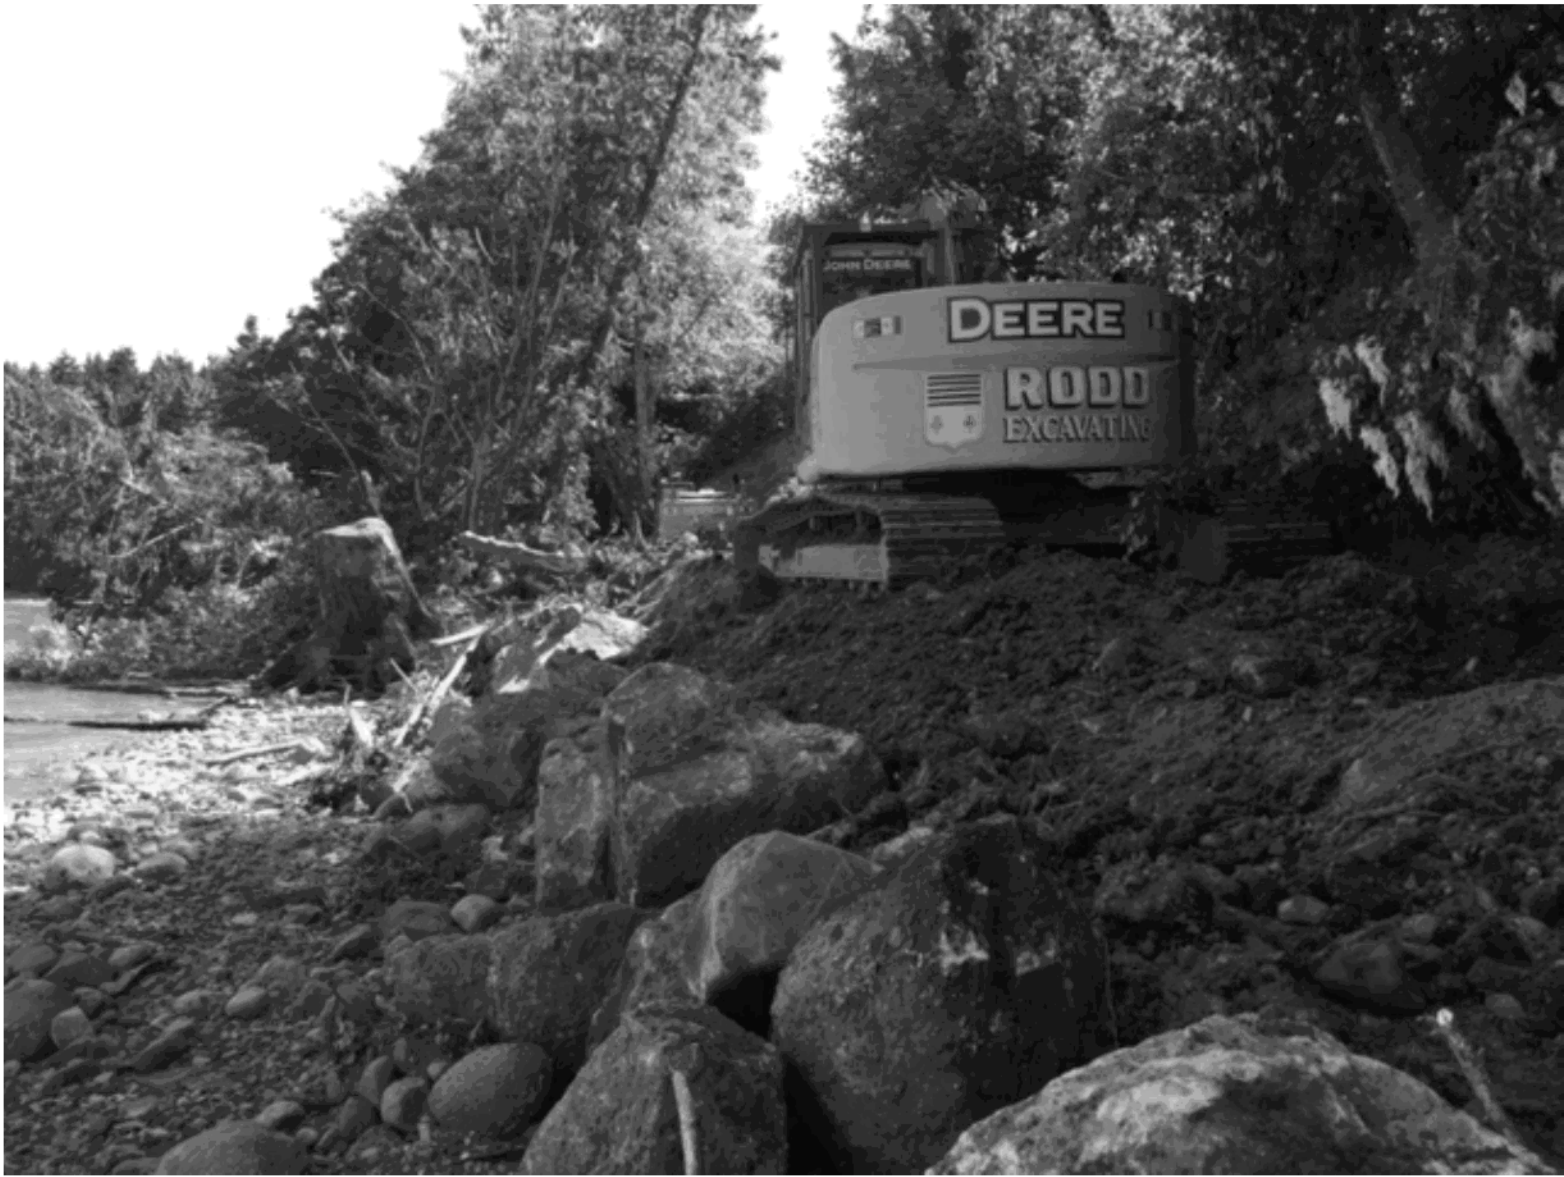
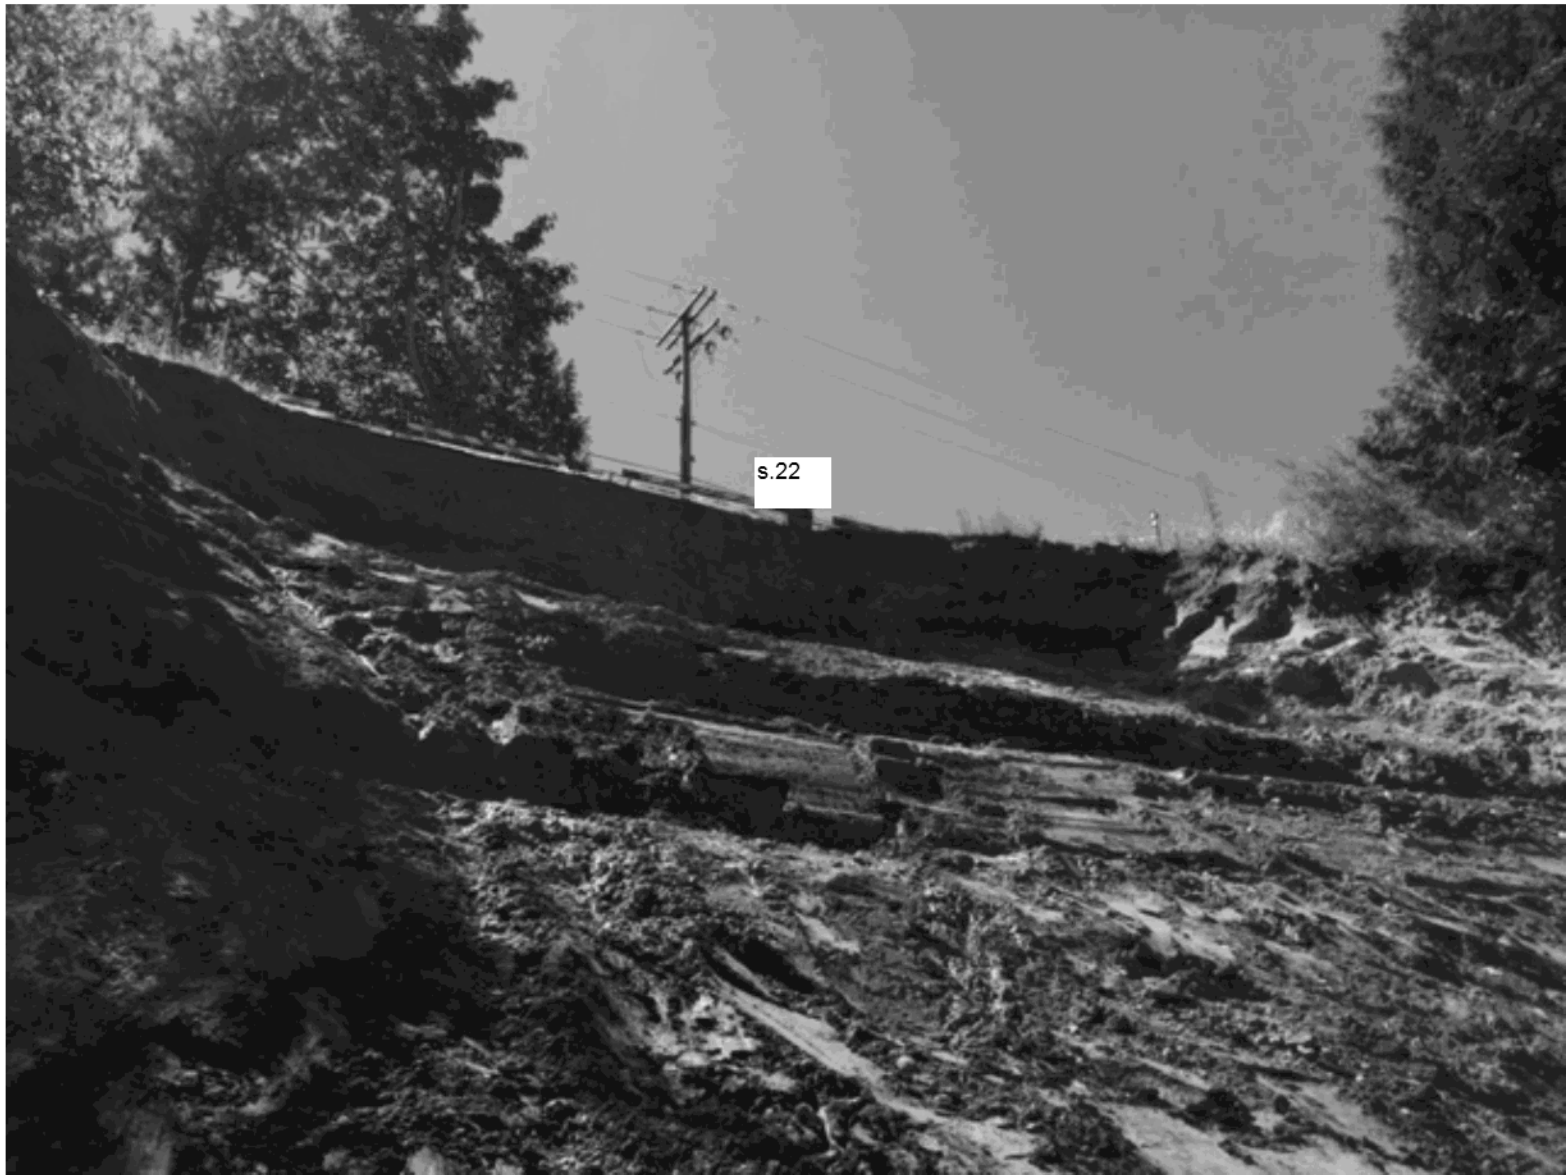
Here we are at beach level just beginning the buttress. Ryan was here today and we are all working well together. We should be bringing some rock in tomorrow.

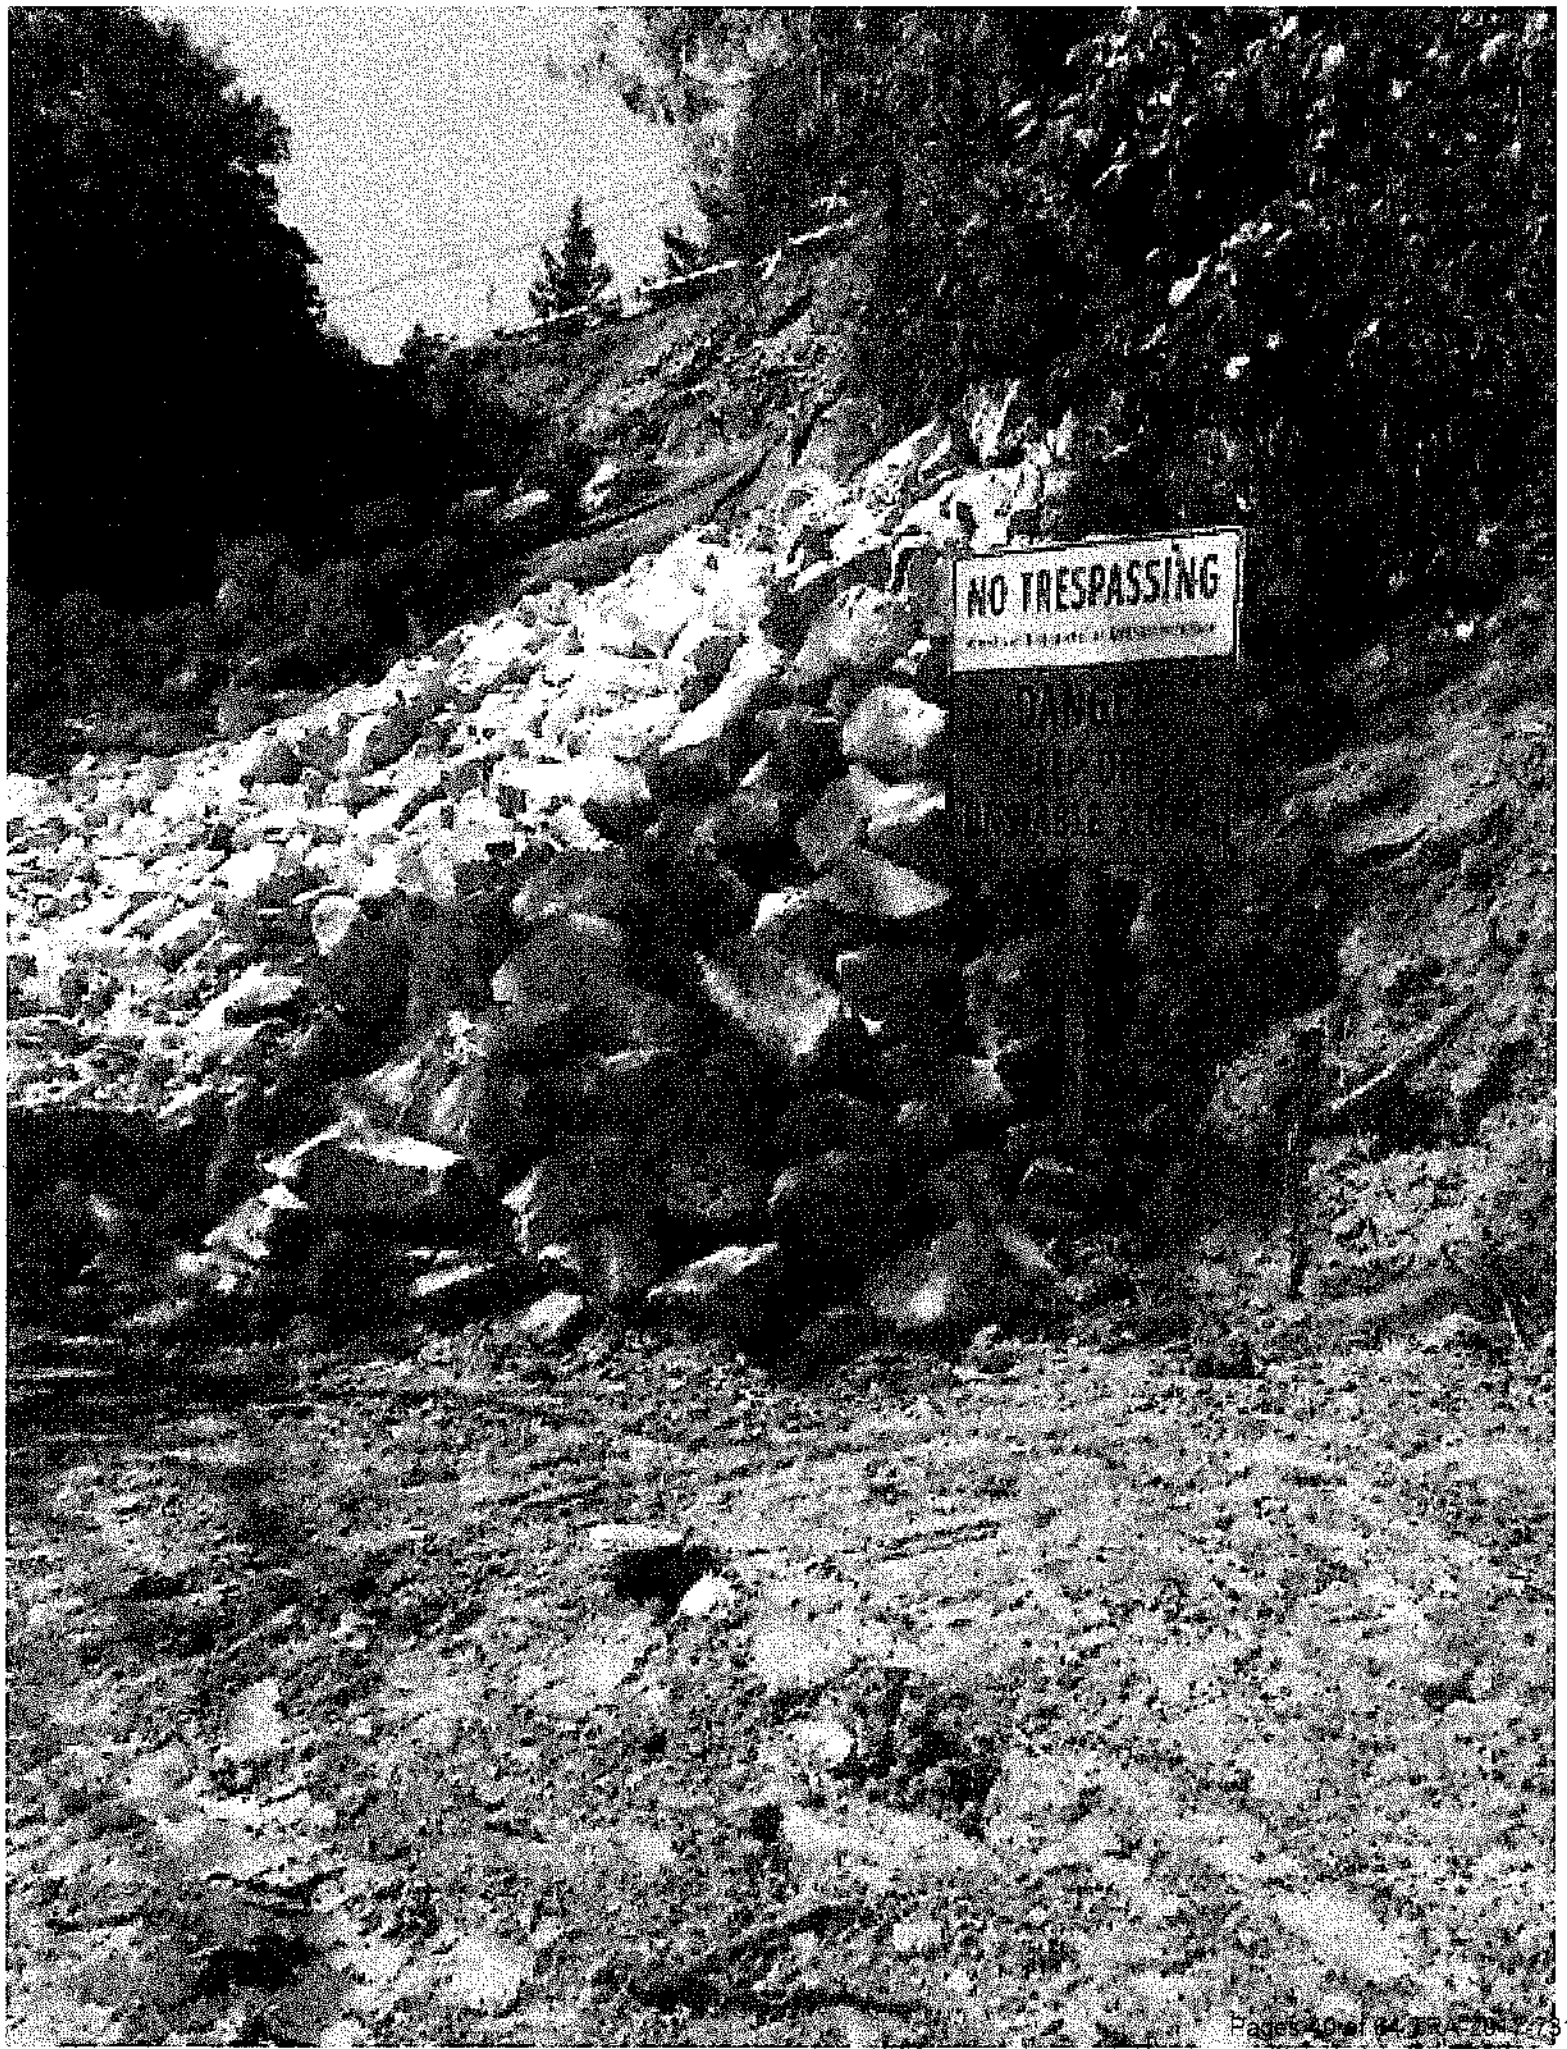
Here are the 2 on the beach

- 5) Appropriate signage for pedestrians and traffic must be placed at the crest of the slope and at the beach level warning of slope hazards and stating no entry. I will leave this to Mainroad and the District to determine the specific signage requirements;

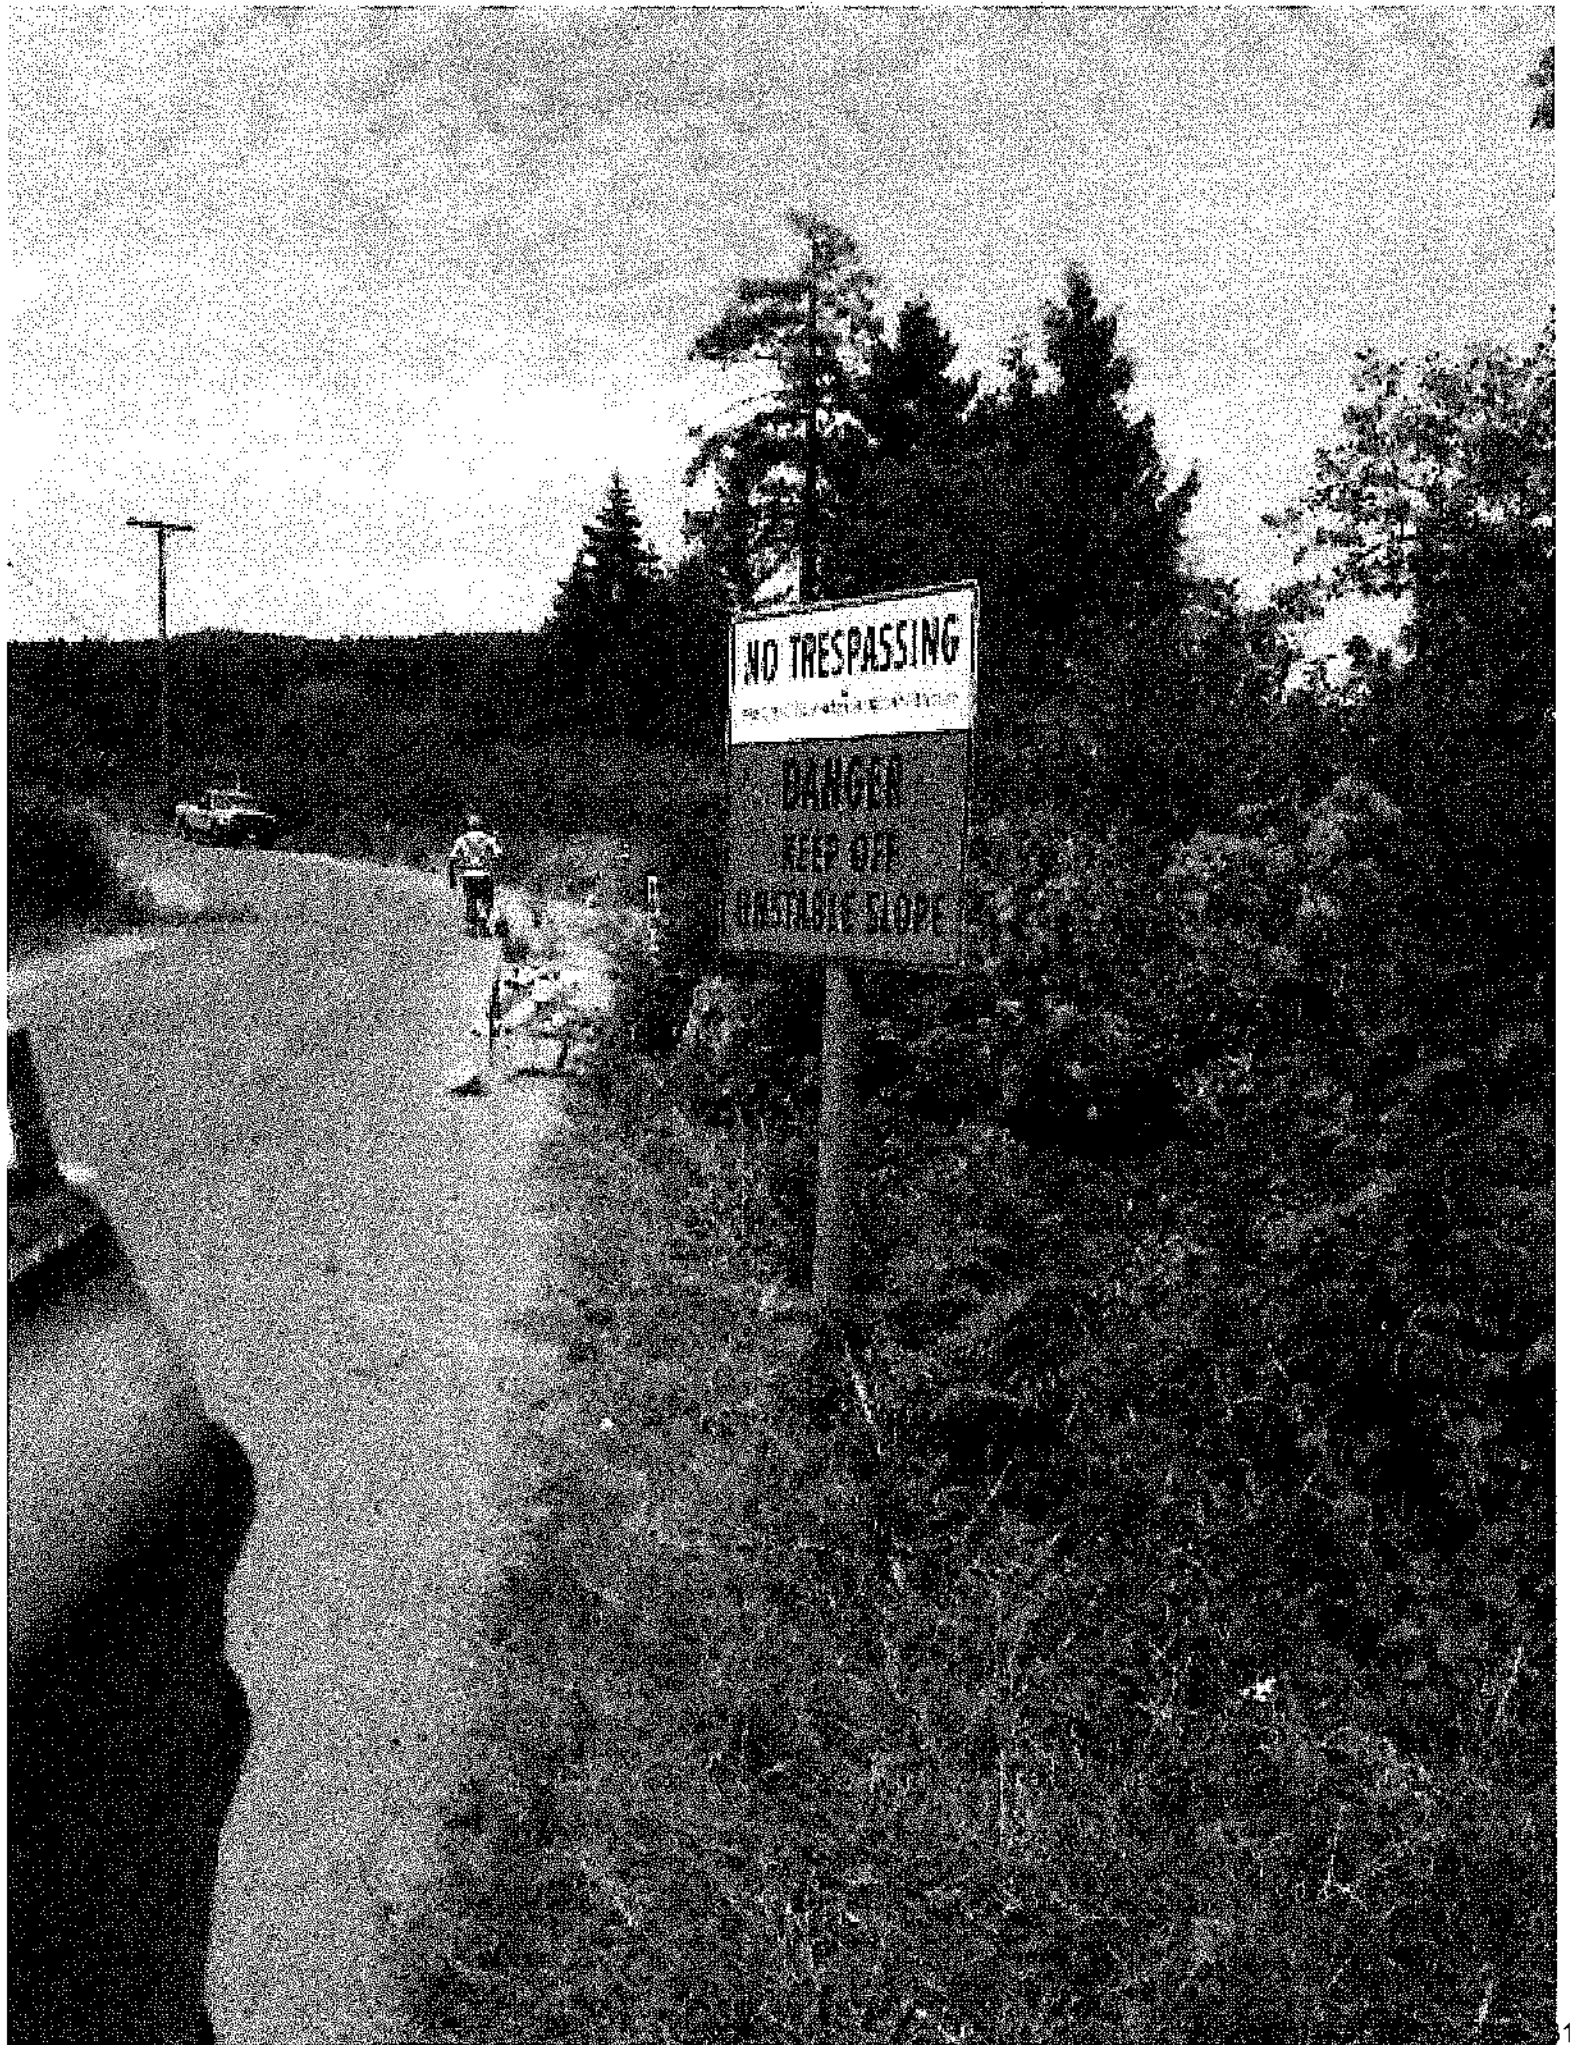
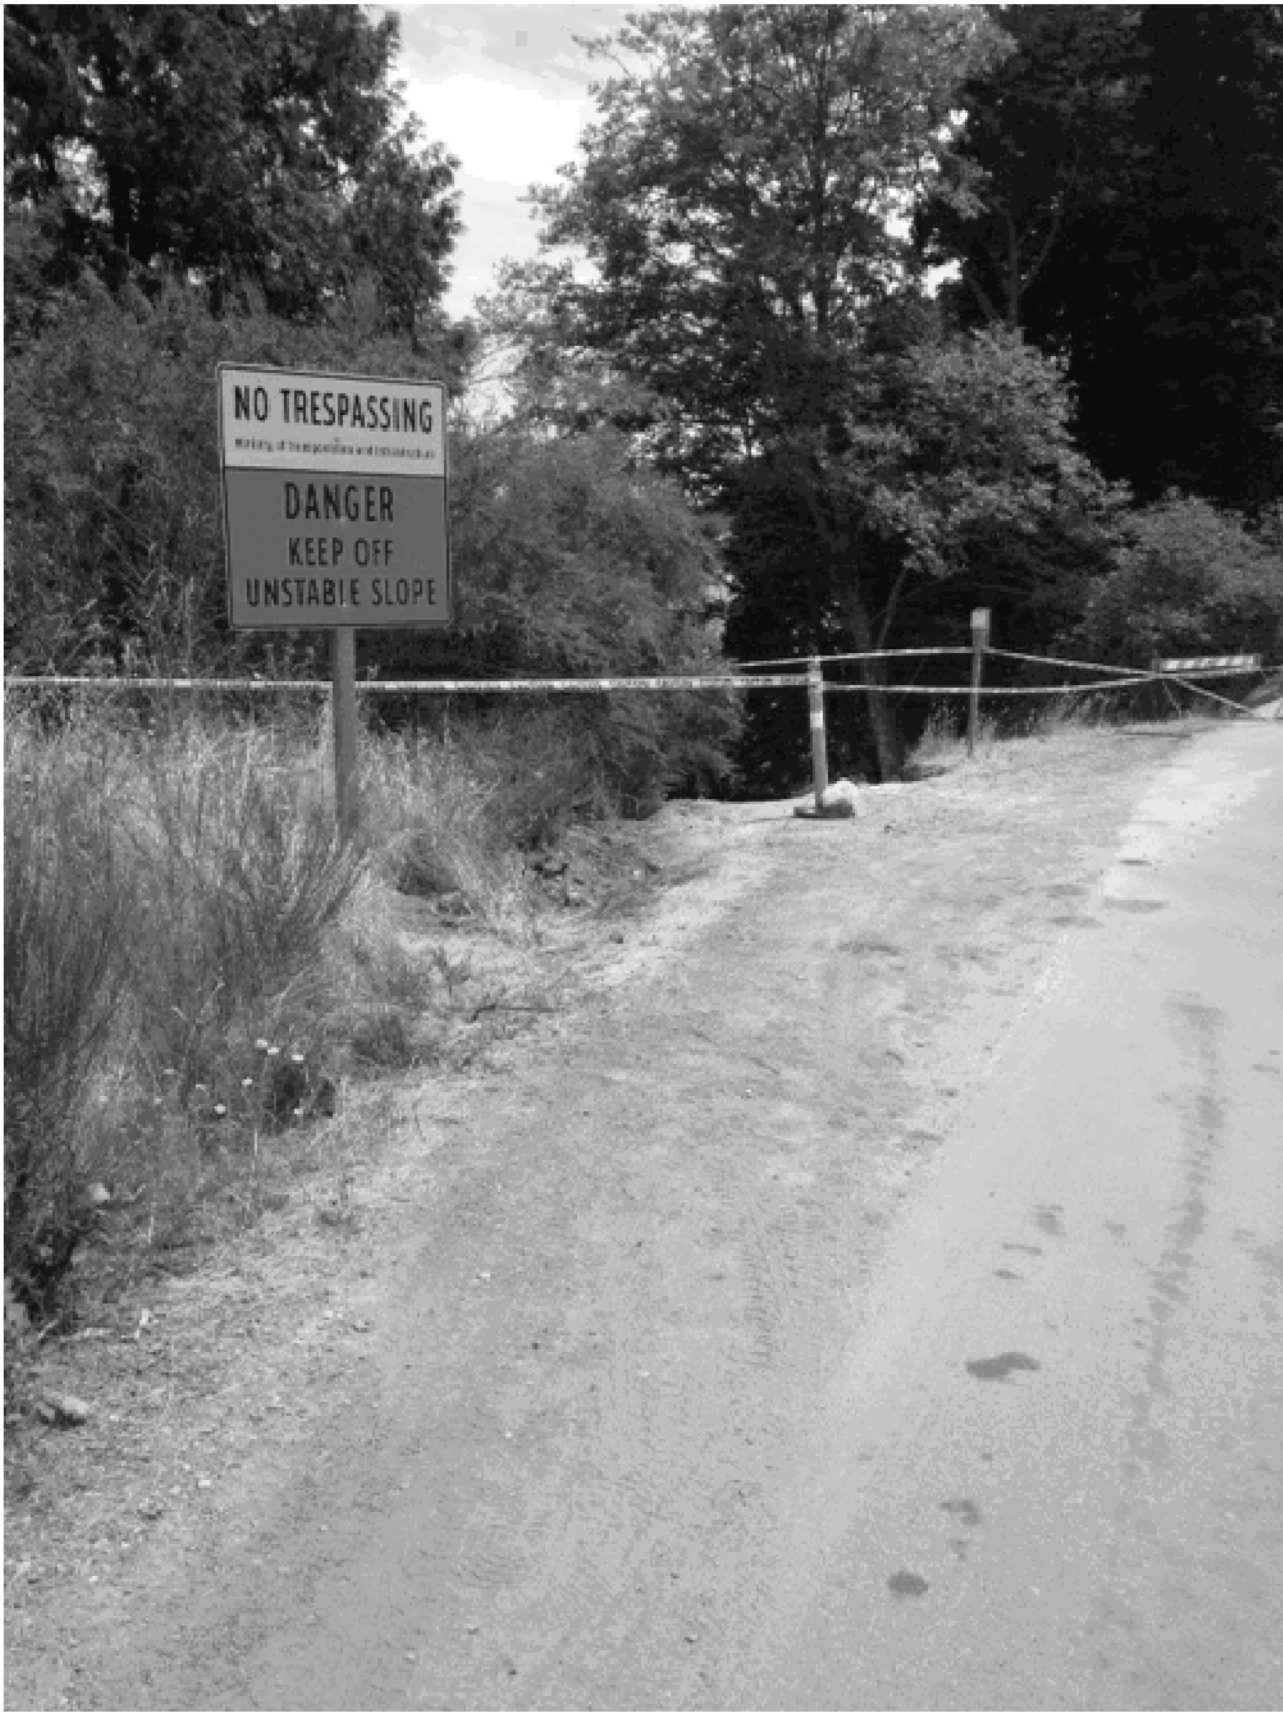
Signage from road

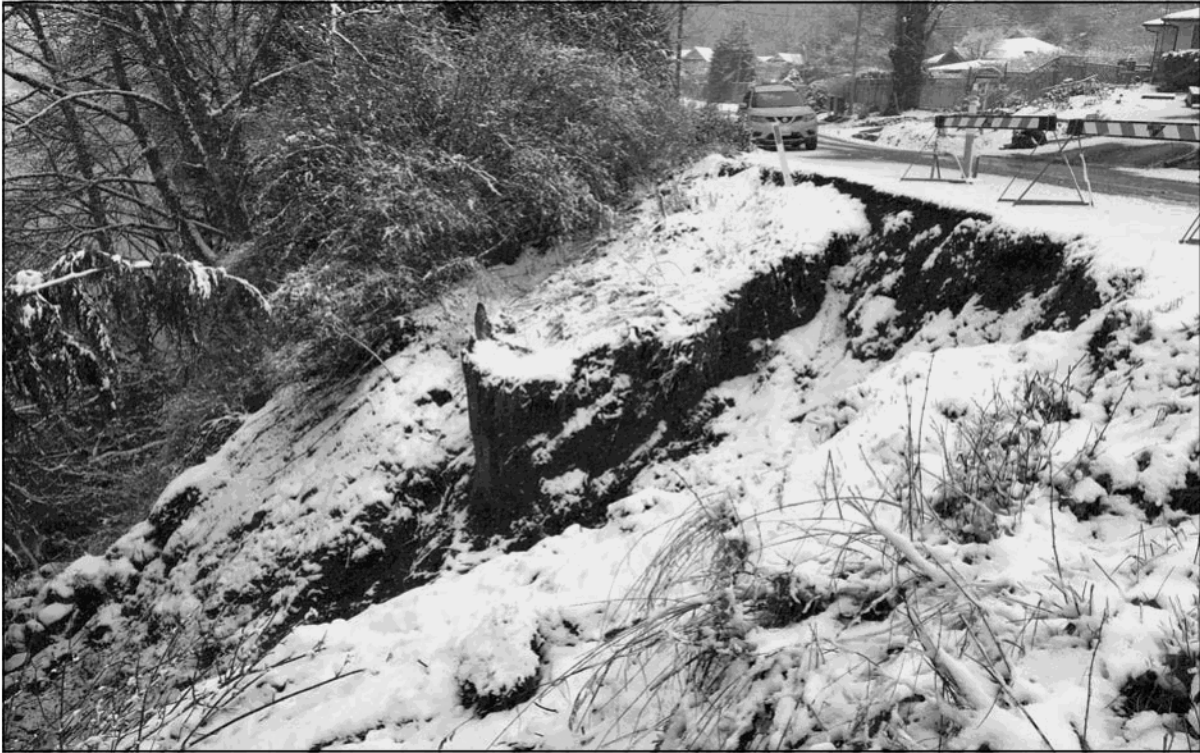
- No pavement distress was noted above the failure area;
- The failed mass is approximately 18 m wide at the toe and 14 m wide at the crest. The slope height is approximately 12 to 13 m, and the base of the failure slopes at approximately 70% (1.4H:1V);

**PHOTO 1:** View of failure looking south.

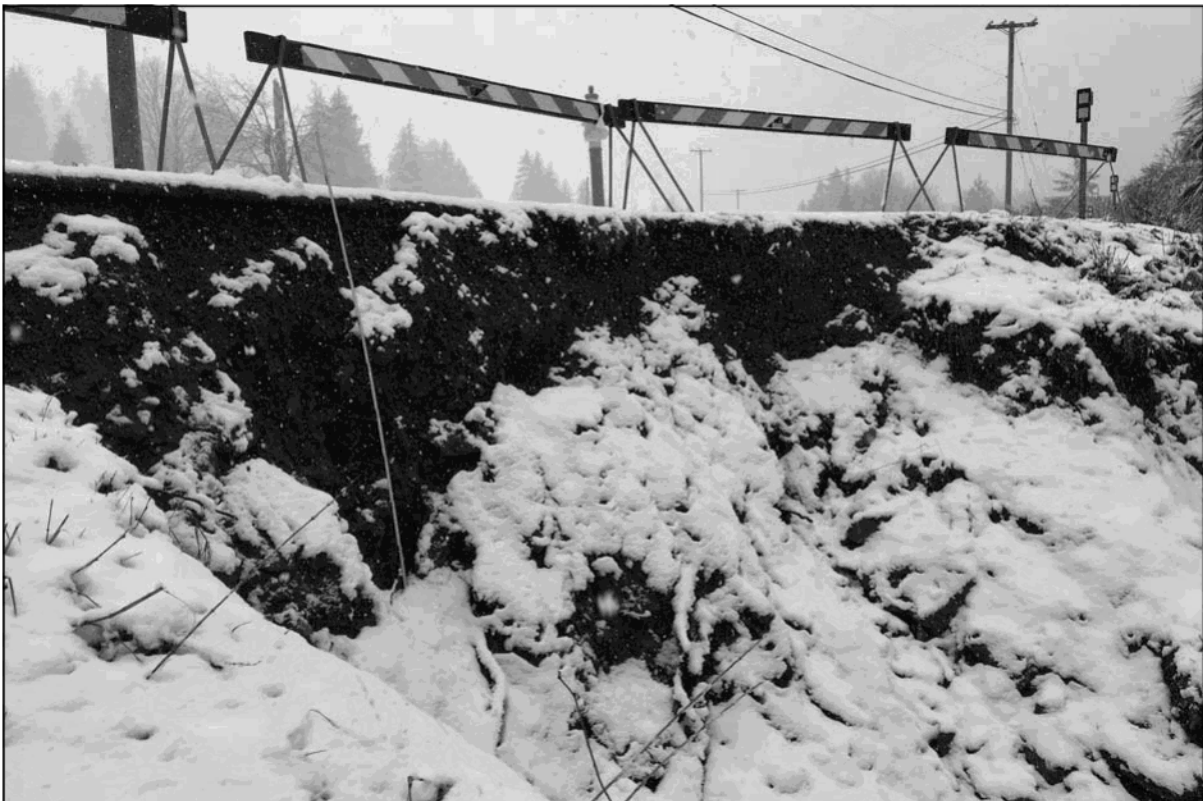
**PHOTO 2:** View of headscarp of failure. Note ruler is 2.0 m in length.

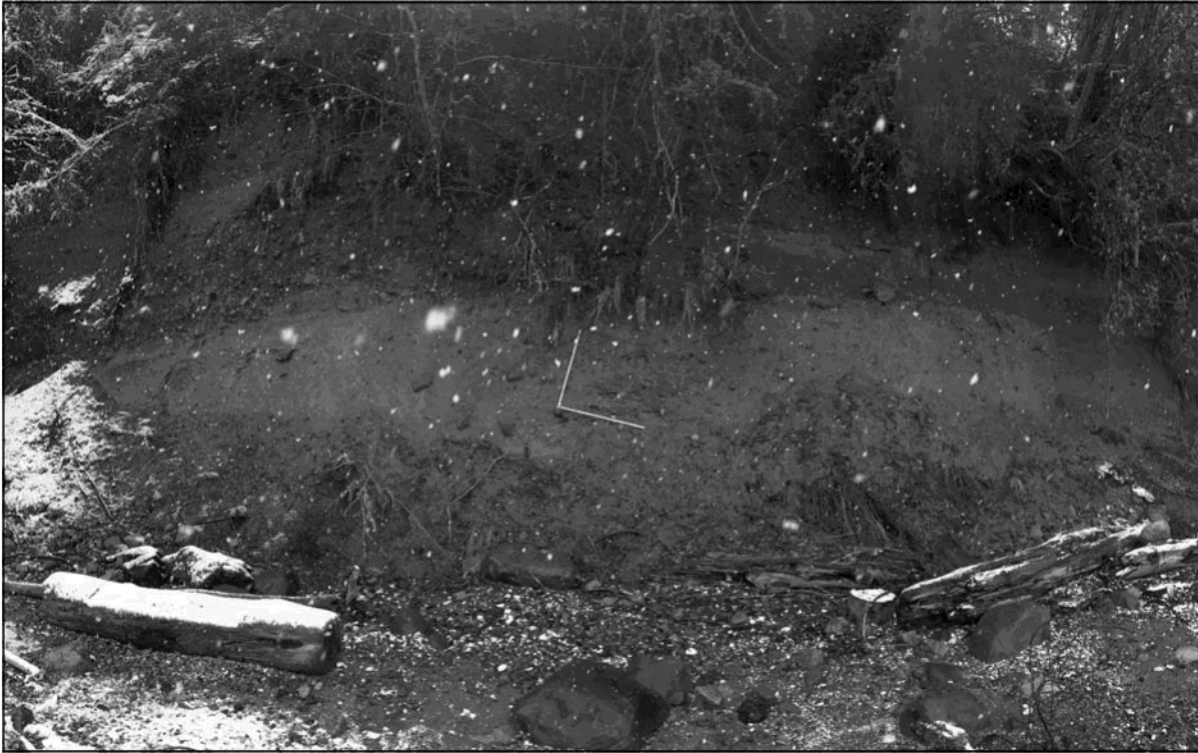
An approximate 8 m high soil exposure, sloping at approximately 80°, was observed approximately 30 m north of the site, extending upwards from the shoreline. The exposure was logged visually, with 0 m corresponding to the base of the slope and roughly equivalent to sea level. The following stratigraphy was exposed:

- 0 m to 3.5 m: SAND, silty, gravelly, some clay, trace cobbles, poorly graded, dense (in the unweathered portion 0.1 m below the slope surface), low plasticity to non-plastic, grey, moist, till-like; overlain by:
- 3.5 m to 3.6 m: SAND, silty, occasional fine gravel, poorly graded, dense to very dense, moist, brown; overlain by:
- 3.6 m to 4.4 m: SAND and GRAVEL, trace to some silt, well graded, dense, moist, brown, overlain by:
- 4.4 to 4.7 m: SILT and SAND, poorly graded, non plastic, hard/very dense, moist, brown; overlain by:
- 4.7 to 7.7 m: SAND, silty, gravelly, some clay, trace cobbles, poorly graded, dense (in the unweathered portion 0.1 m below the slope surface), low plasticity to non-plastic, grey, moist, till-like.

**PHOTO 3:** View of glacial soil exposure described in memo. Note 2.0 m ruler is folded at 1.0 m mark.

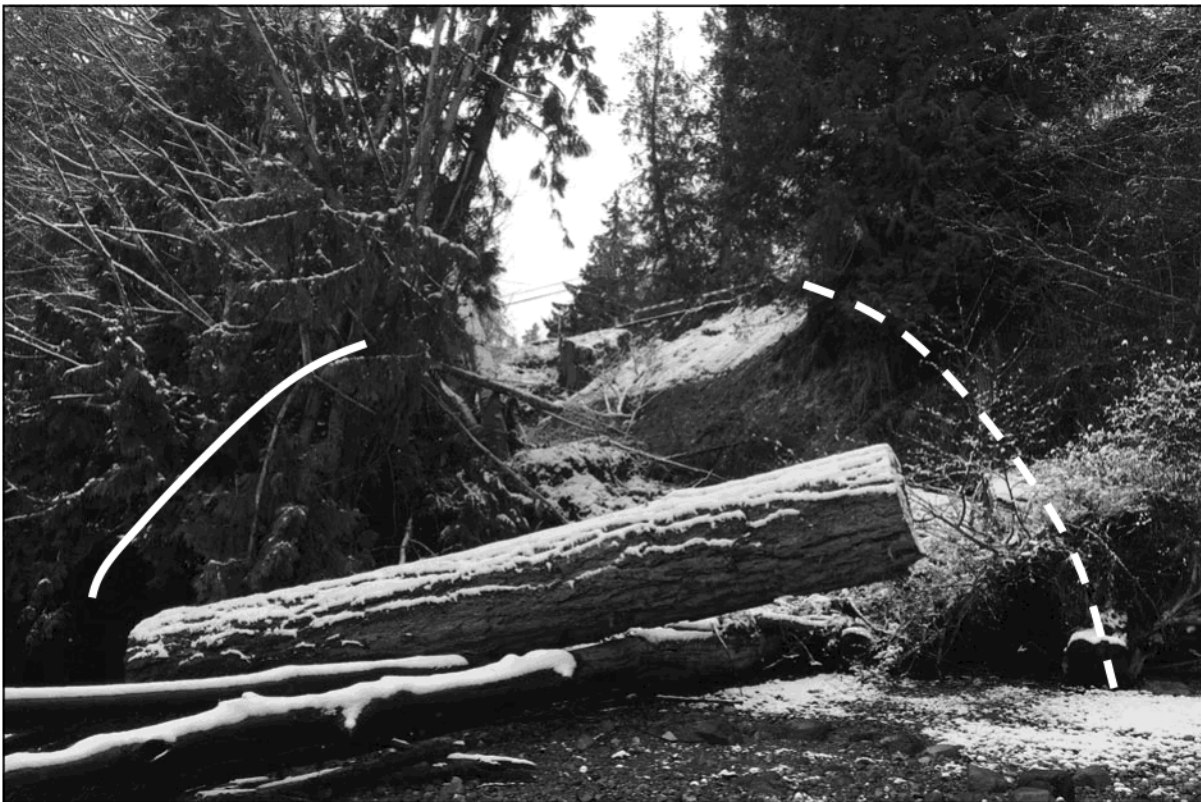
**PHOTO 4:** View of slide debris from base of slope. The proposed remedial measures involve leaving the large logs and tree in the foreground in place, and constructing the buttress behind this material. The dashed line forms the approximate northern end of the "Full Treatment" and "Minimal Treatment" areas. The solid line forms the approximate southern end of the "Minimal Treatment" area, while the southern end of the "Full Treatment" area is out of frame photo 4 left.

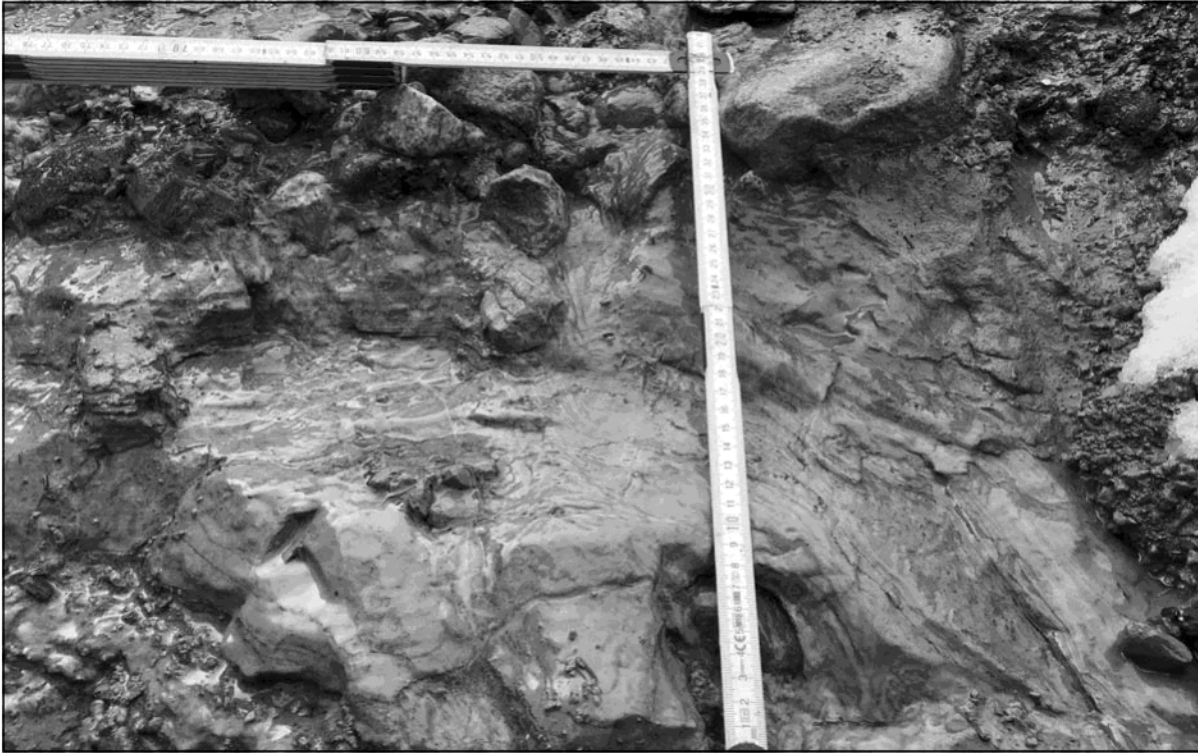
- Soils in the landslide track can be described as SAND and GRAVEL till, as described in greater detail below. The till material is overlain by a 0.2 m organic mat, except within the road prism where fill materials are present as described as above. A SILT layer, corresponding to that described as (4.4 to 4.7m) below was exposed mid track. A short, near vertical step was present below the silt layer. No seepage was observed above or at the silt layer.

**PHOTO 5:** View of silt layer exposed in landslide track.
