RE: 310 Isabella Point Road Bank Replacement

**Re: Salt Spring Island Isabella Point Road Proposed Rip Rap Source Metal Leaching and Acid Rock Drainage Assessment**

**Re: Isabella Point Road – Site Inspection and Recommended Remedial Measures****Introduction**

Attachments:  
Figure 1 - Proposed Buttress Design  
Photographs 1-10

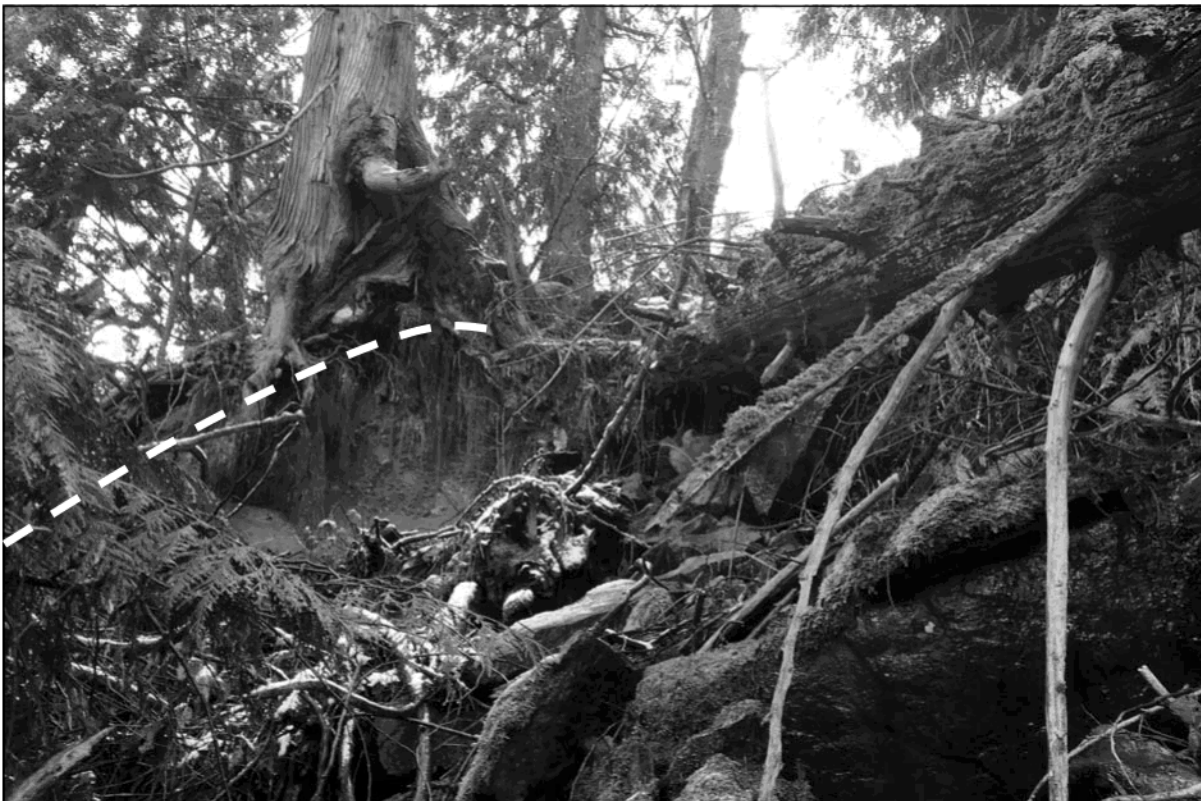
- Below the CMP culvert extending under Isabella Point Road, approximately 25 m south of the site, where the culvert outfall appears to be slumping in a similar manner, but remains in place and is setback from the road sufficiently that a failure would likely not impact the road prism.

**PHOTO 6:** Unstable area identified below CMP culvert outfall, located about 25 m south of site. The white dashed line forms the southern end of the "Full Treatment" area.

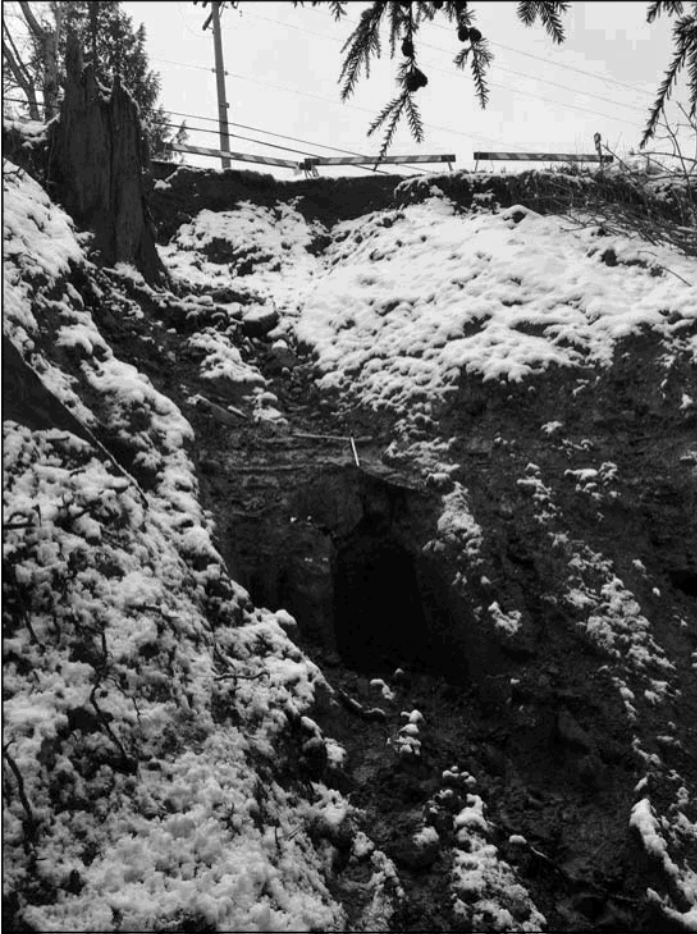
**PHOTO 7:** View of failure surface from below.  
**(LEFT)** Ruler placed on silt layer in track.

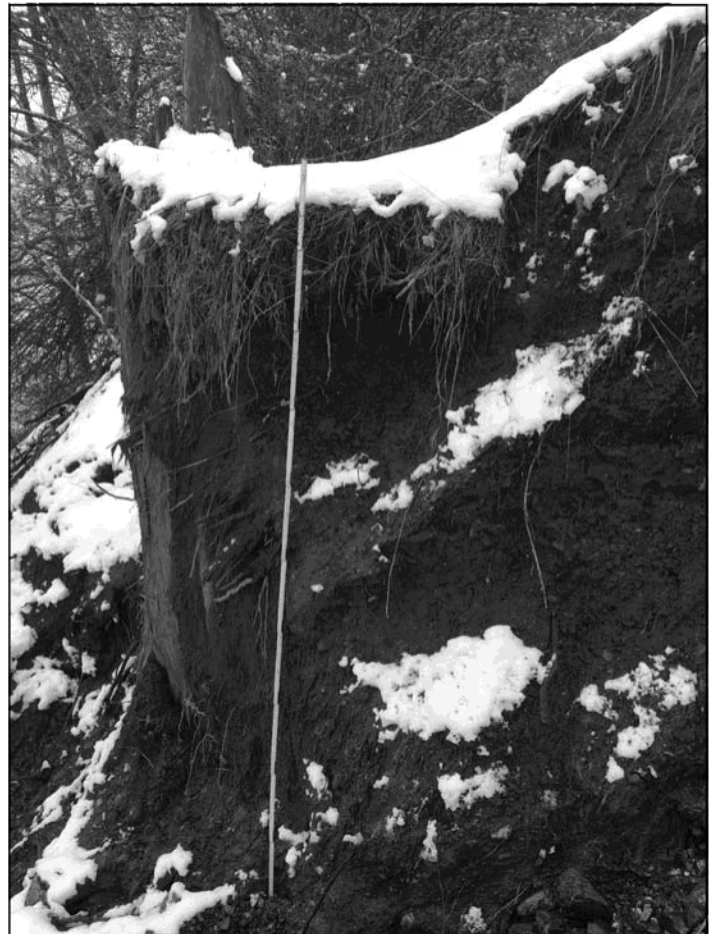
**PHOTO 8:** View of buried stump at the right  
**(RIGHT)** flank of the slide (looking  
downslope).

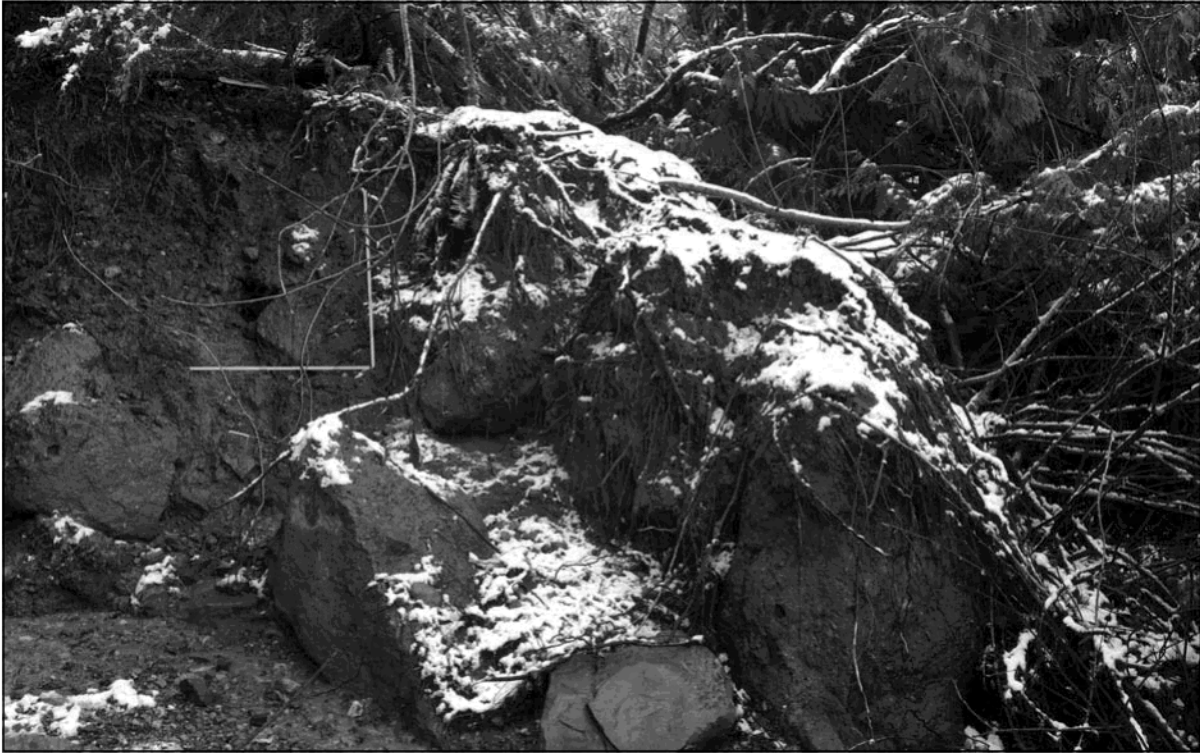
**PHOTO 9:** View of slide debris. Note rip rap material that was incorporated into the slide from the adjacent area.

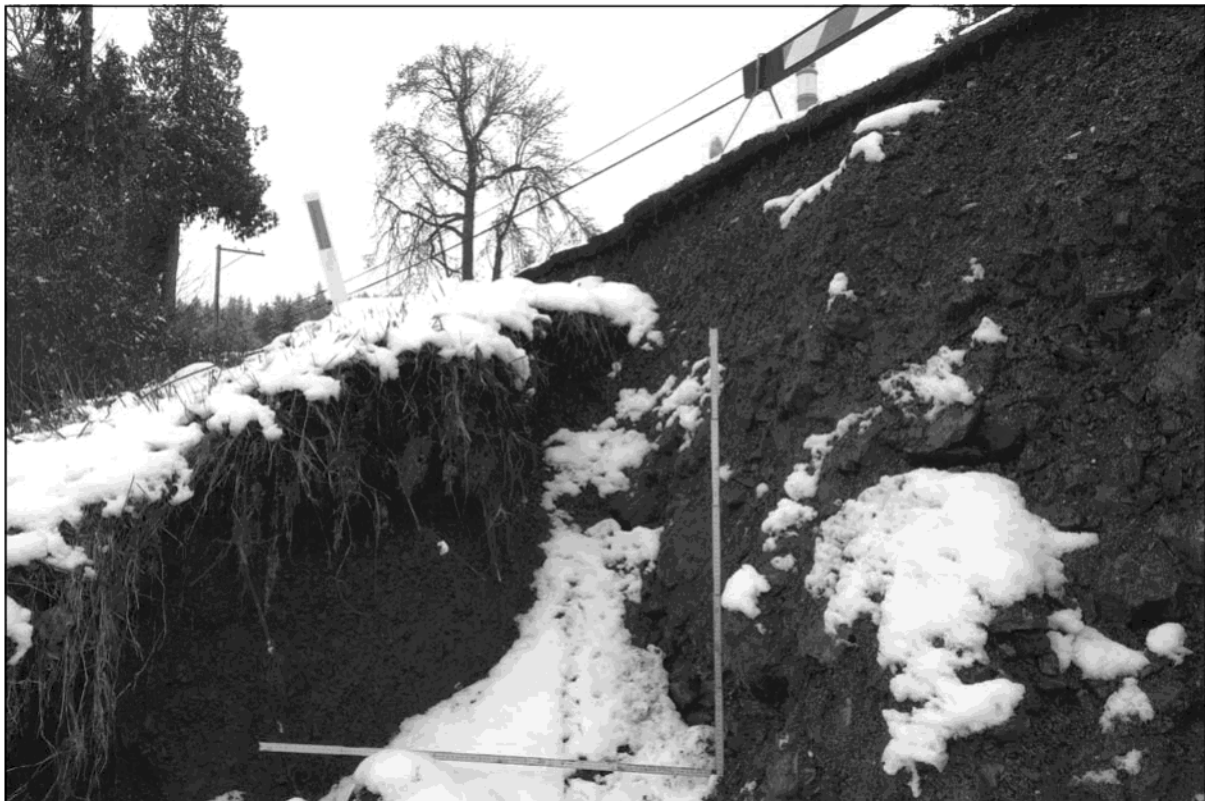
**PHOTO 10** View of slump material remaining in place in the failure area.
