**Golder Associates Ltd.**

07-1430-0130

**RE: CULVERT ASSESSMENT, JIM AND LAJOIE CREEK  
CARPENTER LAKE, BC**

Golder Associates Ltd. (Golder) was retained by the Ministry of Transportation (MOT) to conduct a culvert inspection and site assessment at Lajoie Creek and Jim Creek, near Carpenter Lake. An assessment at both locations was requested by MOT to determine the condition of the culverts, assess the habitat upstream and downstream of the culvert, identify fish passage issues, and recommend potential replacement options for the stream crossing.

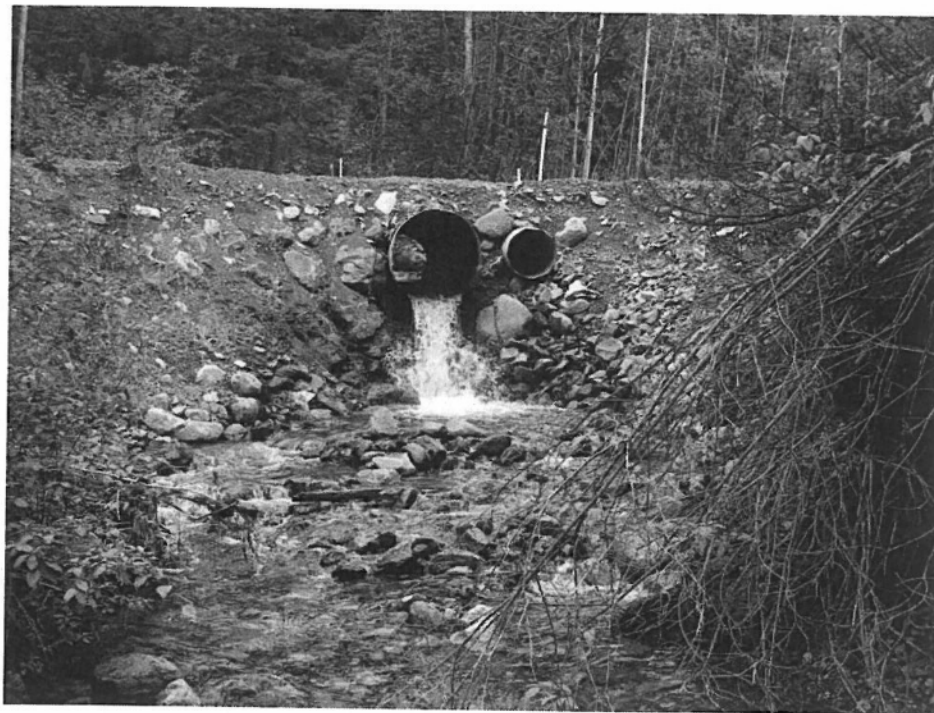
There are two culverts at the Jim Creek crossing; the larger culvert has a diameter of 1070 mm while the smaller culvert is 620 mm in diameter (Photo 1). Jim Creek has an average channel width between approximately 3 and 4 m upstream of the culvert and between 5 and 6 m downstream of the culvert. Bank material was predominantly sand and gravel with some small cobble (Photo 2). Both banks are highly susceptible to erosion (Photo 3). Bed material at the crossing was predominantly cobble with gravel substrate as subdominant. Riparian vegetation consisted of mixed forest with shrub understorey. There is some spawning and rearing habitat available within the vicinity of

**Photo 1:** View of culvert crossing on Jim Creek looking upstream, 20 August 2007.

The existing stream crossing constricts the stream channel, which has resulted in down cutting of the stream bed downstream of the crossing. Either a bridge or a large diameter (>3m) bottomless culvert is recommended for the Jim Creek crossing. A bridge would be favourable for maintaining channel characteristics, enabling and maintaining fish passage, and avoiding future washouts.

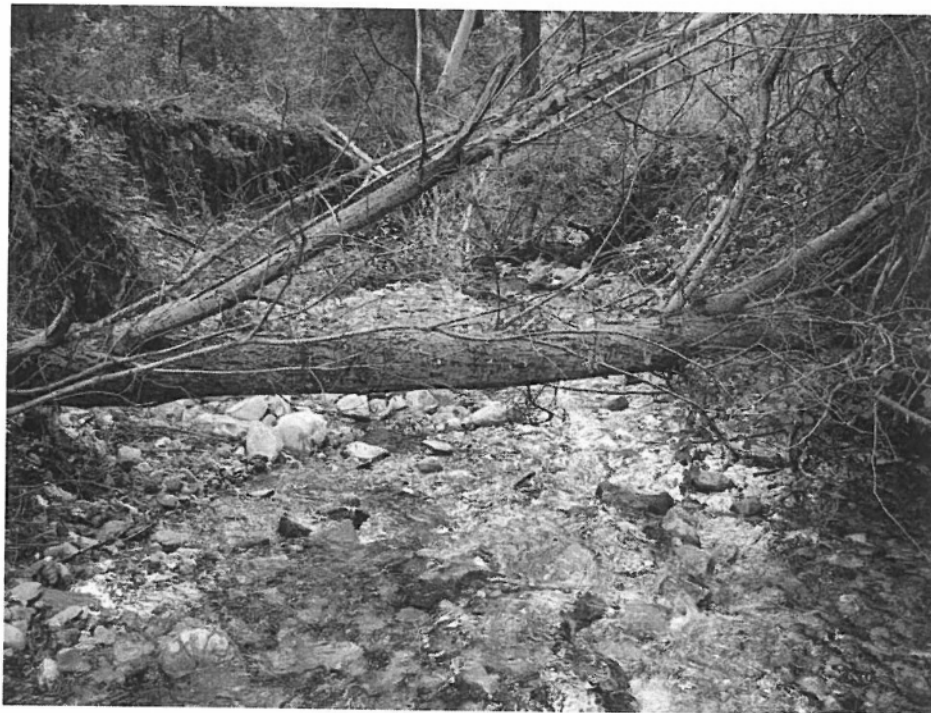
**Photo 2:** View of channel and habitat characteristics of Jim Creek downstream of the culvert crossing, 20 August 2007.

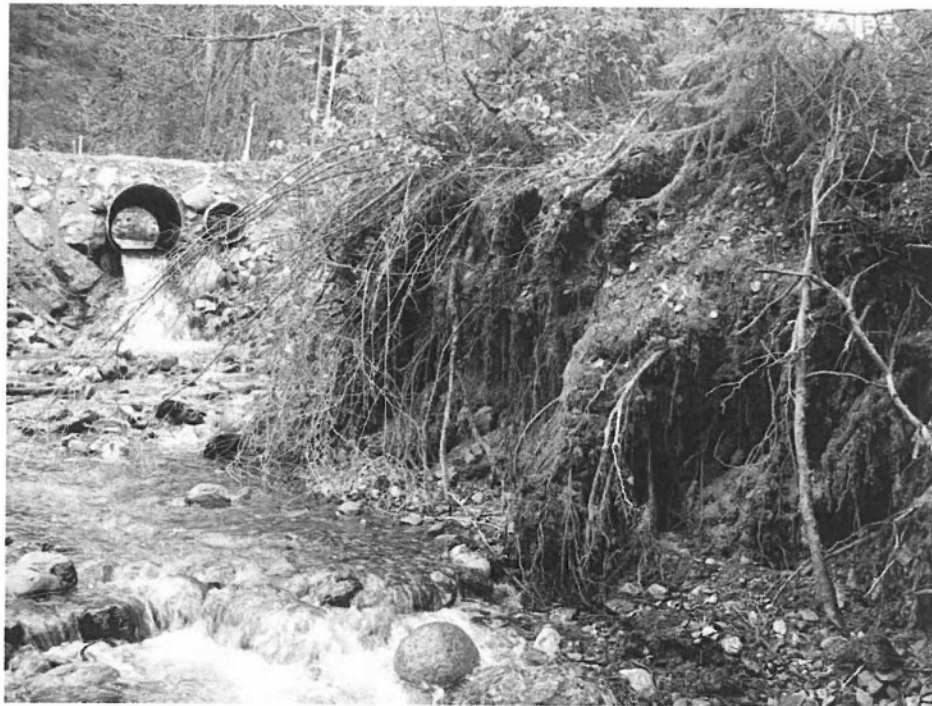
Considerable down cutting of the stream bed has occurred below the road crossing. Therefore, there will need to be instream work at the crossing to adjust the stream bed to a stable gradient and reduce the potential for head cutting after the constriction to the stream channel has been removed.

**Photo 3:** View of eroding left downstream bank downstream of the culvert crossing on Jim Creek, 20 August 2007.

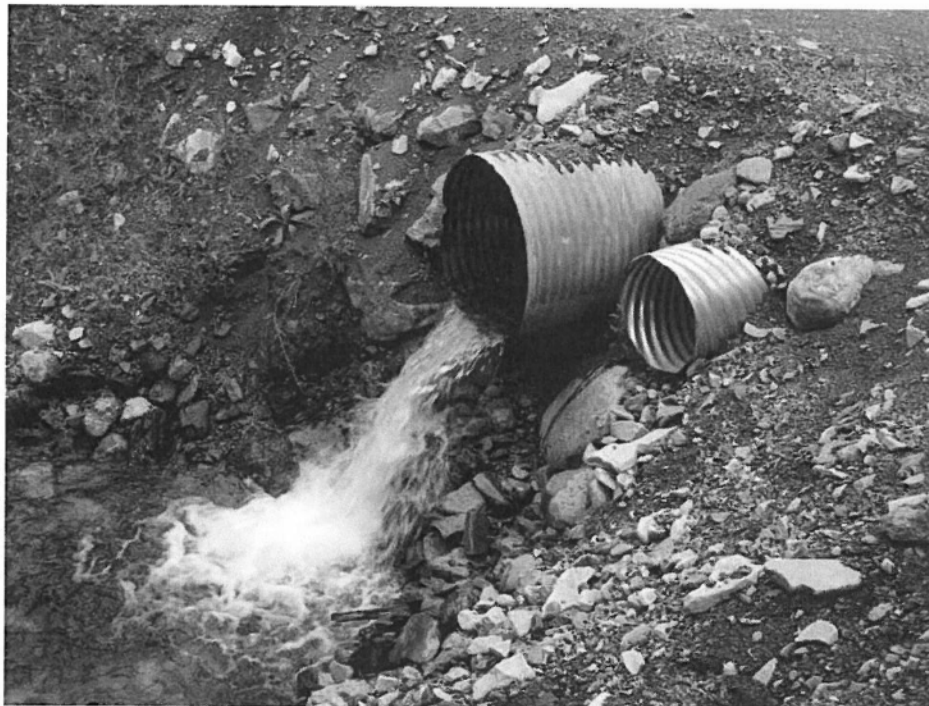
There is evidence of recent road washout mitigation such as fresh gravel and sand placed to repair the road (Photo 5). The culvert outlet is presently hanging 1.6 m above the surface of the water downstream of the crossing (Photos 4 and 6). There are private driveways adjacent to both sides of Jim Creek downstream of Marshall Road.

**Photo 4:** View of hanging culvert at Jim Creek crossing, 20 August 2007.

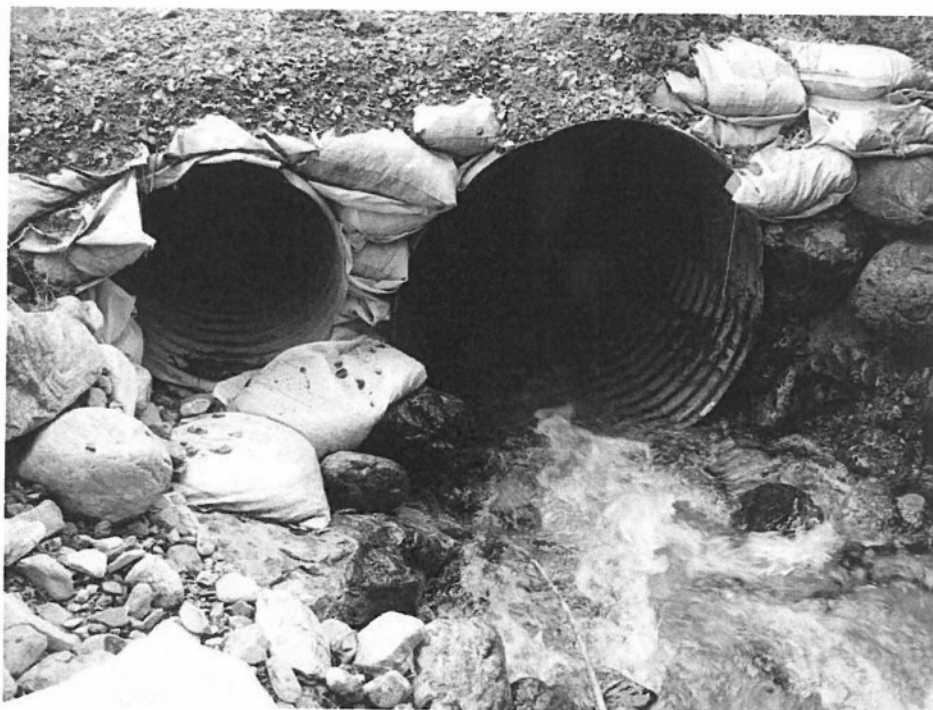
**Photo 5:** View of culverts upstream of road crossing on Jim Creek, 20 August 2007.

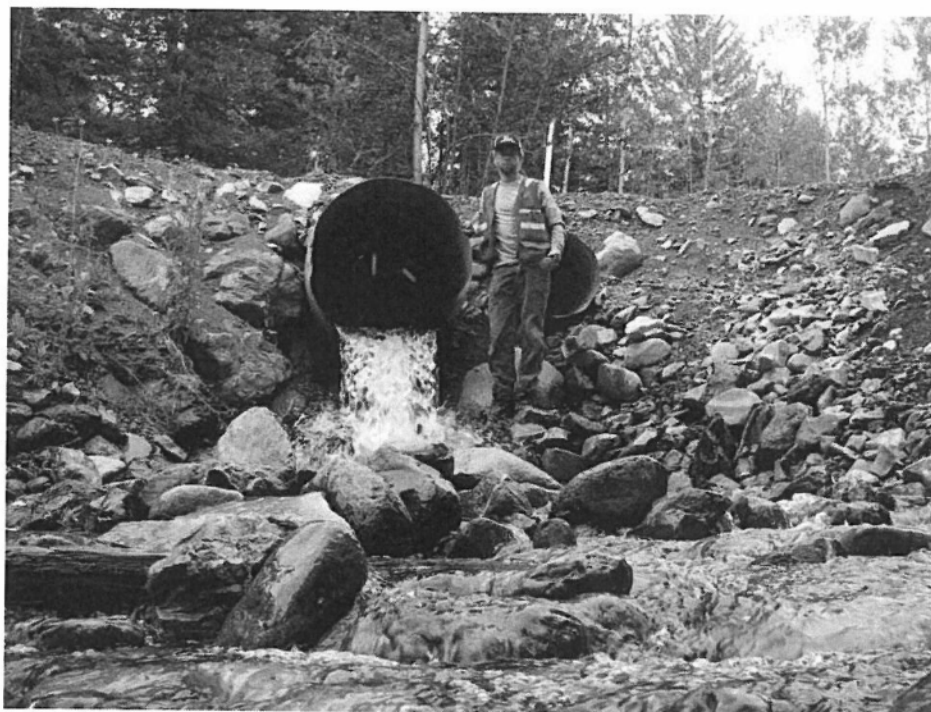
**Photo 6:** View of hanging culvert at Jim Creek crossing, 20 August 2007.

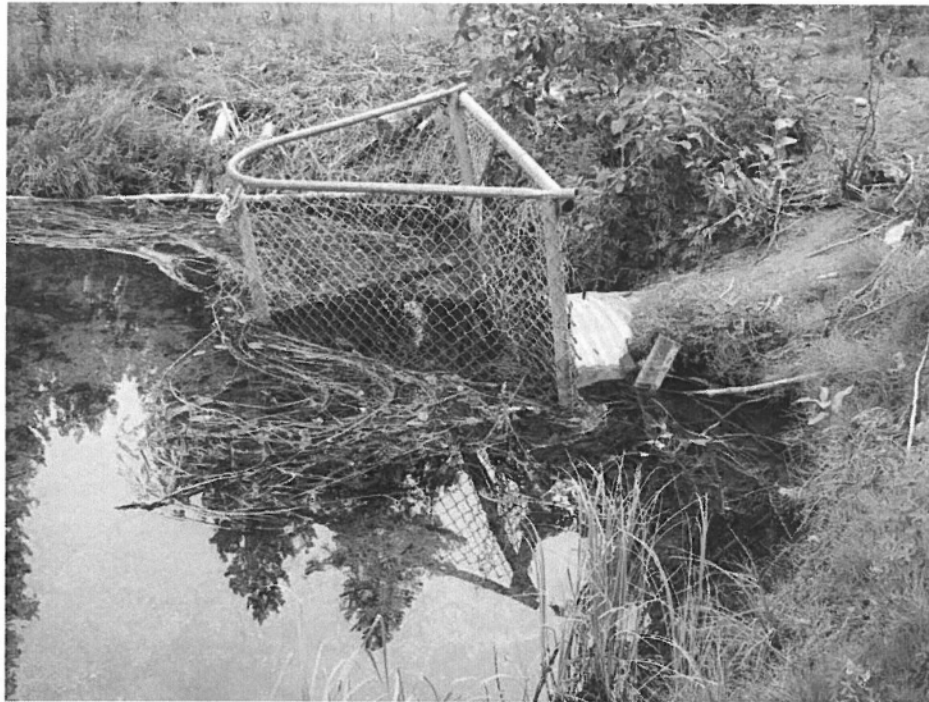
The current culvert is approximately 30 m long and has a diameter of 850 mm (Photo 7 and 9). The culvert is located at the outlet of Lajoie Lake; thus the habitat upstream was primarily littoral (Photo 8 and 10). Bank material was predominantly gravels and sand with some fines. Downstream of the culvert the bed material was predominantly gravel and sand. The morphology downstream of the culvert was described as riffle pool with abundant functional large woody debris (Photos 11 and 12). Riparian vegetation consisted of primarily mixed forest with shrub understorey. Spawning and rearing habitat was observed downstream of the crossing. In addition, numerous salmonid fry were observed rearing upstream of the partially blocked culvert in Lajoie Lake. Overall, habitat within the vicinity of the culvert crossing was important. At present, salmonid passage is inhibited by the blockage of the metal gate installed upstream of the culvert (Photo 7).

**Photo 7:** View of culvert with wire grate at the outlet to Lajoie Lake, 20 August 2007.

Replacing the existing undersized culvert with an appropriately sized open bottom culvert or bridge (i.e., a structure that is wide enough that the stream channel is not constricted) would provide fish passage and maintain channel characteristics downstream and reduce the probability of blockage by beaver activity. Pipe-arch culverts may be less prone than round culverts to being plugged by beavers, most likely because they maintain the natural stream width and are generally large culverts (Jensen et al. 1999). The study conducted by Jensen et al. (1999) concluded that 81% of the culvert sites measured, culvert size (area of inlet opening) was the major determinant of whether the pipe would be plugged by beavers (see attached). Use of a box or pipe-arch culvert with a minimum inlet opening area of 1.67 m<sup>2</sup> would have a 47% probability of being blocked, whereas an opening area of 3.53 m<sup>2</sup> would have a 25% probability of being plugged (Jensen et al. 1999). Similarly, installation of an oversized open bottom culvert may not be feasible because of the current width of the right-of-way including the boat launch.

The width of the road crossing, including the boat launch, is approximately 30 m; therefore, installation of a bridge or open bottom culvert may not be feasible. Maintaining the existing culvert and installing an improved beaver management structure is an alternate option. Attempts to address the problem of beavers obstructing the existing culvert, which can prevent fish migration and cause localized flooding of adjacent property, by trapping the beavers and more recently installation of a metal screen upstream of the culvert, have been largely unsuccessful as the current metal screen is repeatedly blocked by small woody debris.

The Beaver Stop structure is manufactured by FSI Culvert Inc. (FSI Culvert) in Prince George, BC. FSI Culvert recommends a 900 mm Beaver Stop (approximately \$1,410.00) for the diameter of the culvert at Lajoie Creek. Installation is straight forward and would require two people and possibly a loader/backhoe and operator for no more than a days worth of work ([www.fsiculvert.com](http://www.fsiculvert.com)).

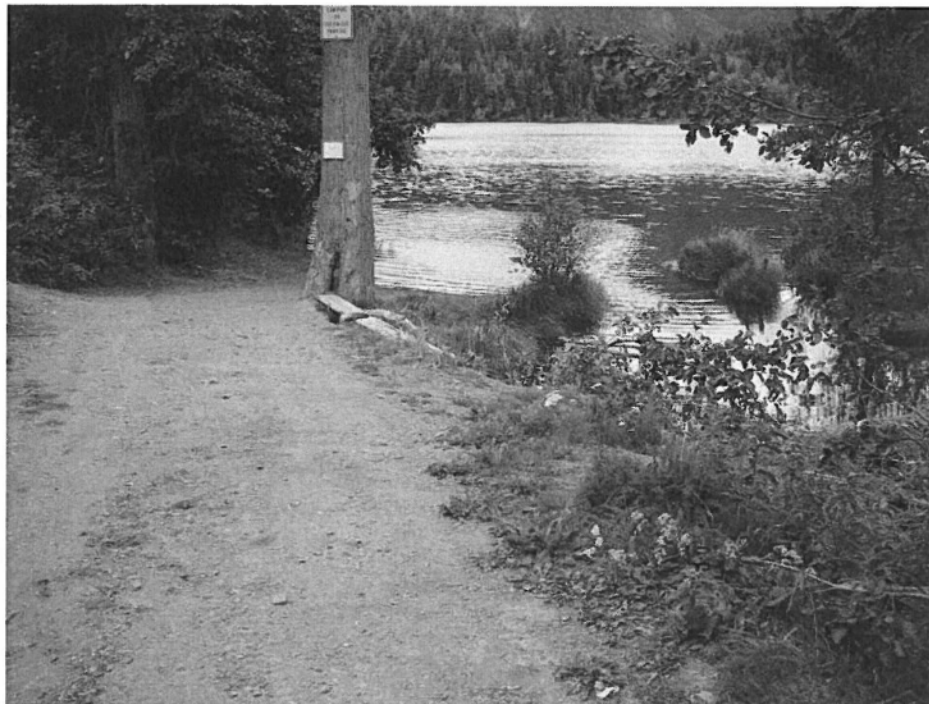
The main access road to Gun Lake crosses Lajoie Creek immediately downstream of the outlet of Lajoie Lake. Adjacent to the road on the upstream side is a boat launch providing access to Lajoie Lake (Photo 8).

**Photo 8:** View of boat launch adjacent to upstream end of culvert and road crossing, 20 August 2007.

Installation of a clear-span bridge would be the preferred option to allow for a wider channel, which would reduce stream velocities aiding in fish passage and reduce the impact of beaver on local flooding. However, this may not be feasible because the width of the current right-of-way. The proposed structure would have to accommodate the road and adjacent boat launch which are approximately 30 m in width. The existing location of the boat launch would have to be incorporated into the design of the bridge. To reduce the width of the structure the feasibility of moving the boat launch to the left downstream bank should be investigated.

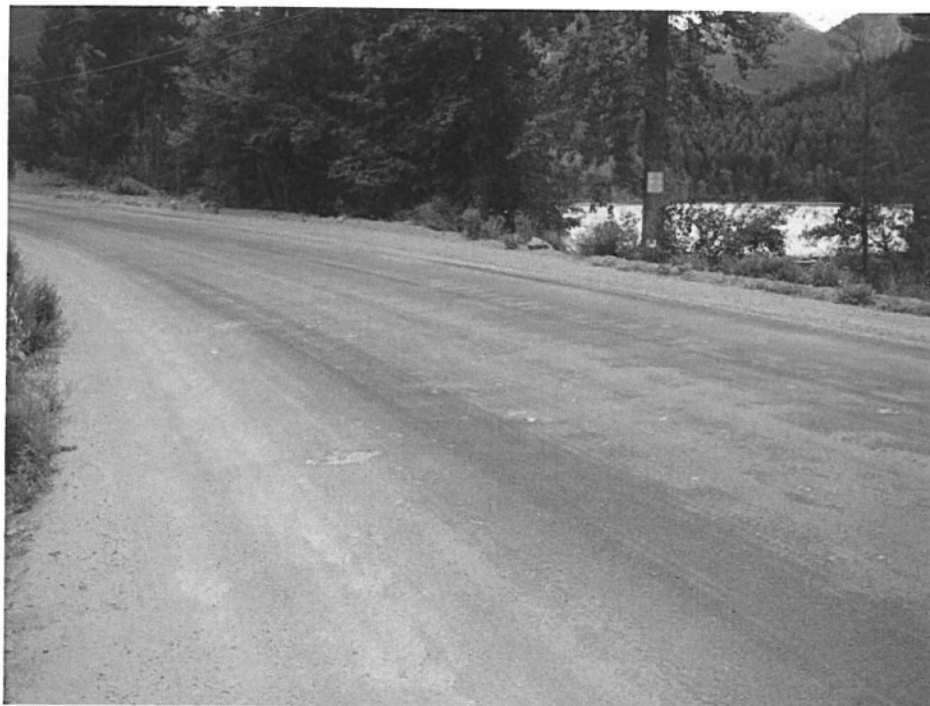
**Photo 9:** View of road crossing with Lajoie Lake and boat launch in background, 20 August 2007.

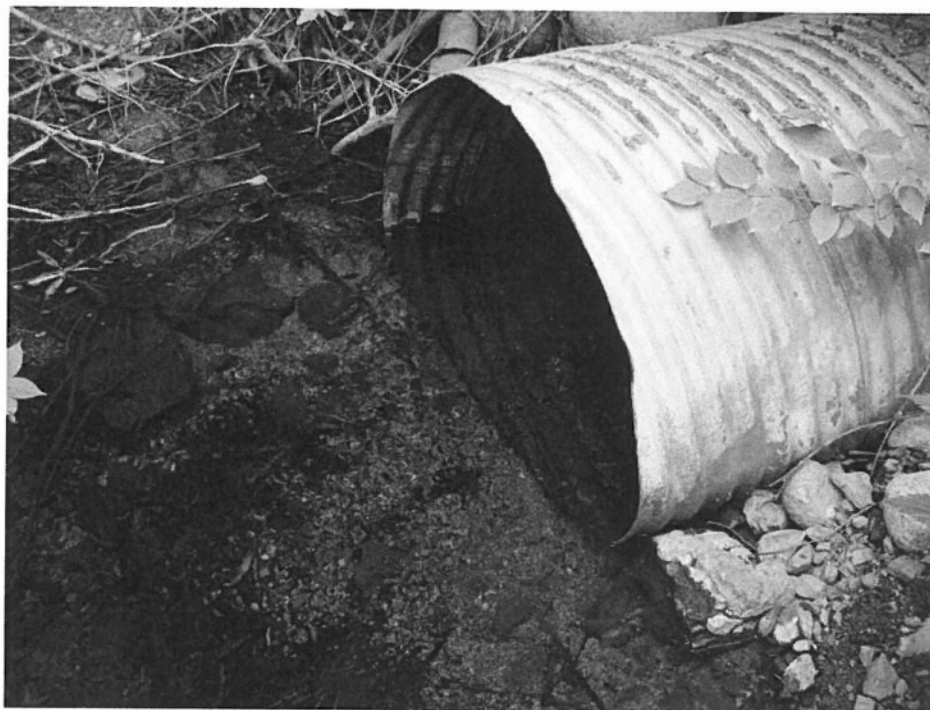
**Photo 10:** View of culvert downstream of road crossing, 20 August 2007.

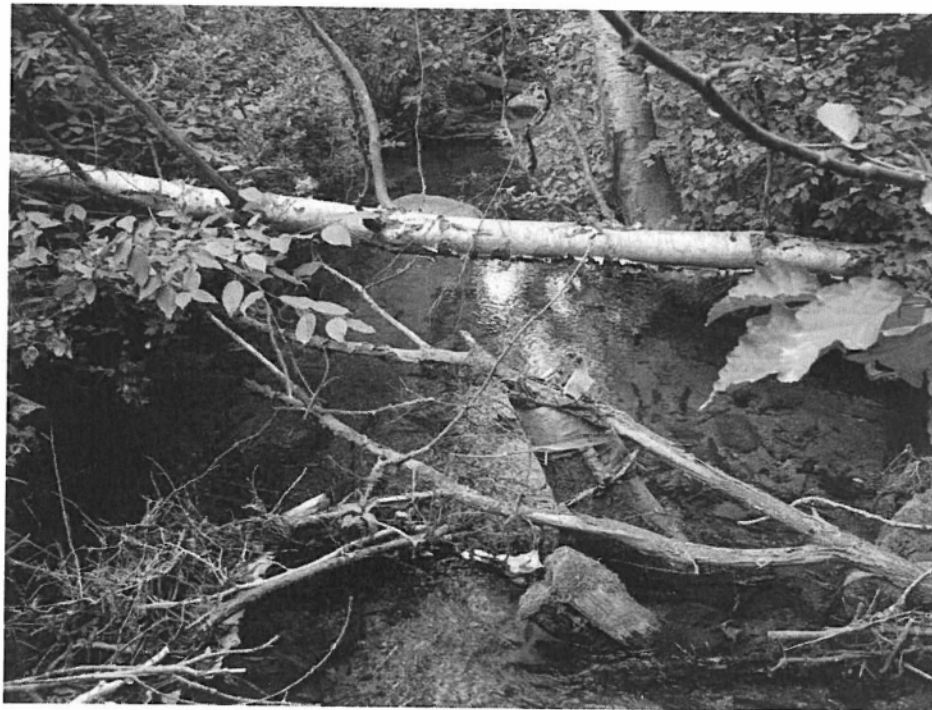
**Photo 11:** View of habitat characteristics of Lajoie Creek downstream of culvert crossing, 20 August 2007.

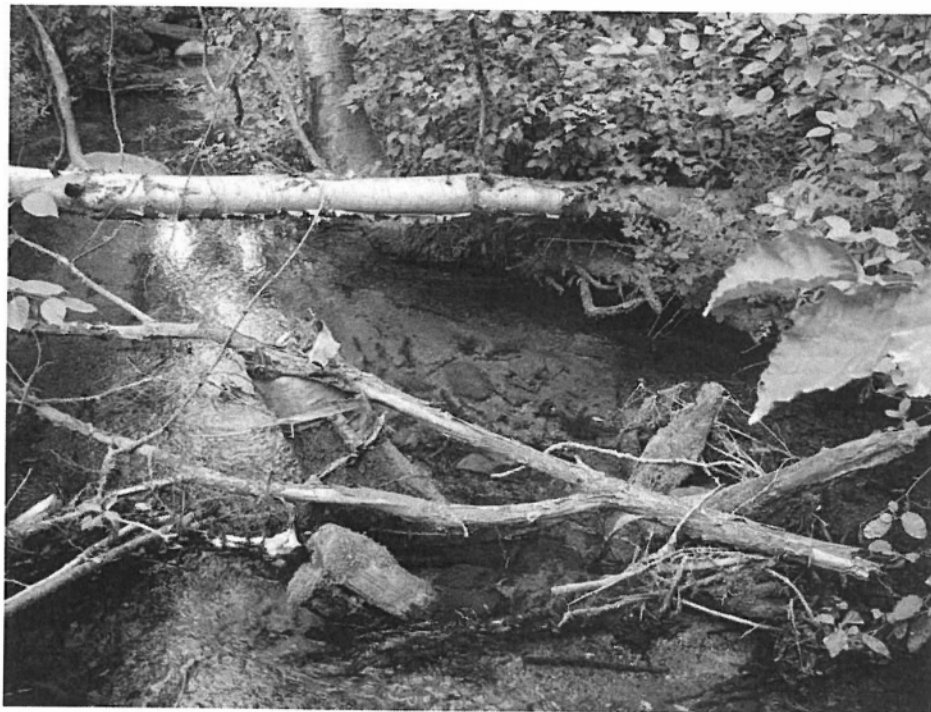
**Photo 12:** View of habitat characteristics of Lajoie Creek downstream of culvert crossing, 20 August 2007.
