June 22, 2018

ISSUED FOR USE
FILE: 704-ENG.VGEO03227-03
Via Email: Ryan.Gustafson@gov.bc.ca

Subject: Rumming Road Erosion Event – Summary of Remediation

RUMMING ROAD FAILURE REMEDIATION
LANTZVILLE, BC

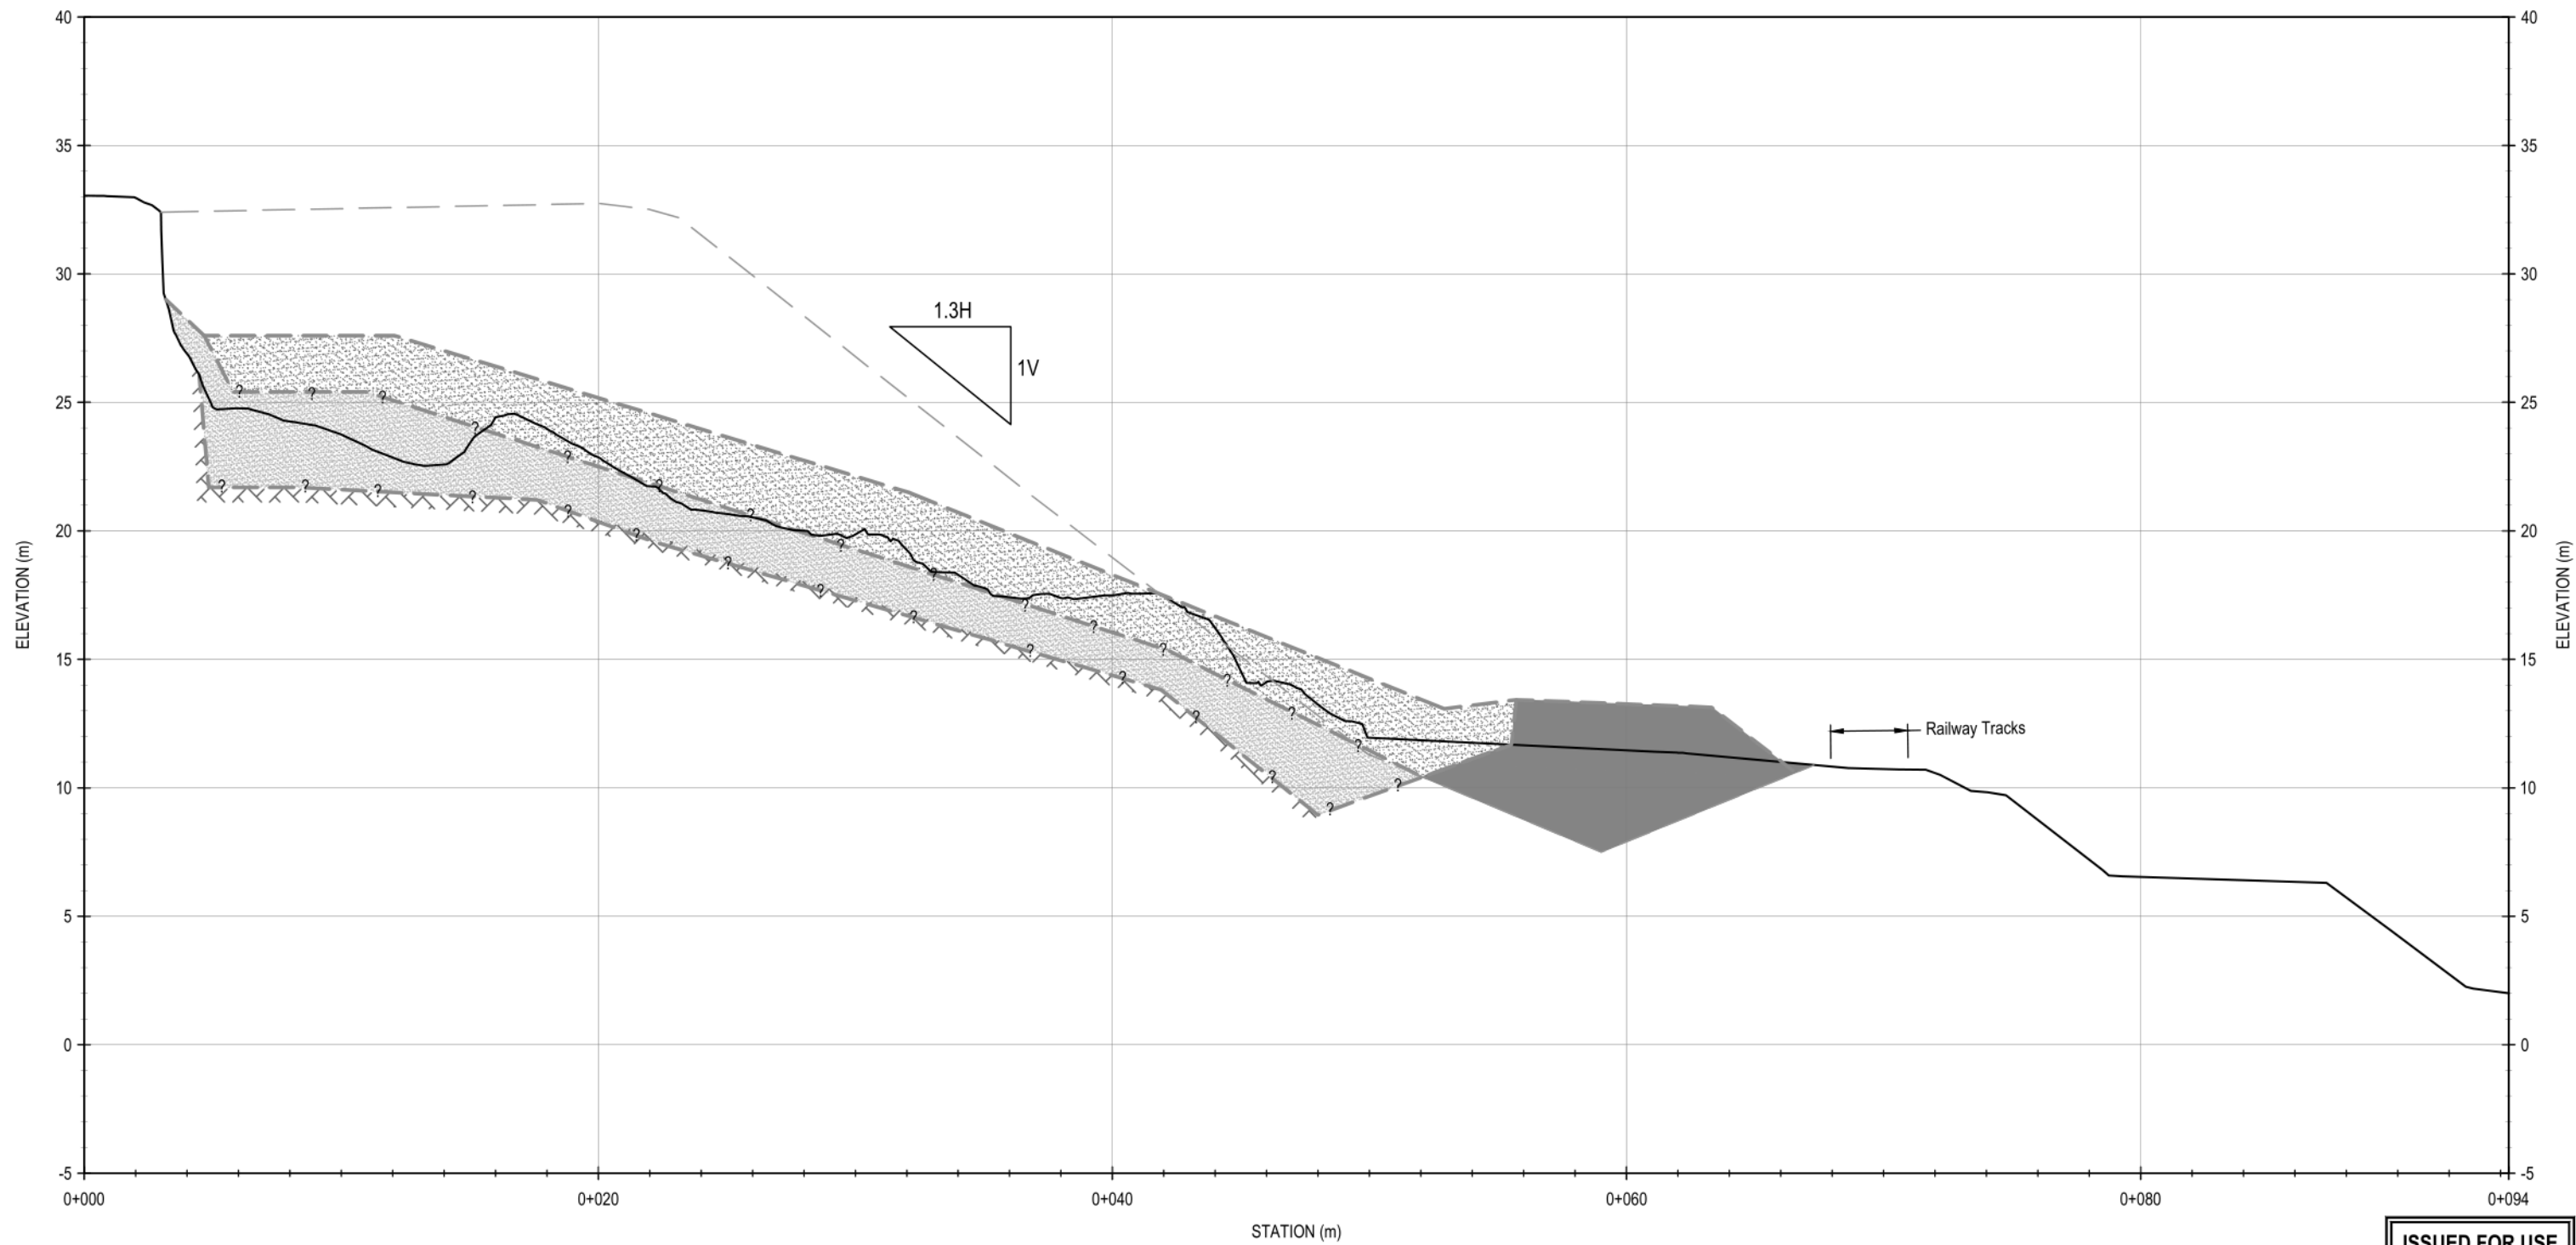
Profile Through Failure Centerline

The filter was placed down the cleaned-out failure and was graded as such to allow the Contractor's articulated rock truck to traverse up and down the failure - as indicated in Figure 4. This was staged in order to haul out the sand debris material at the toe of the slope.

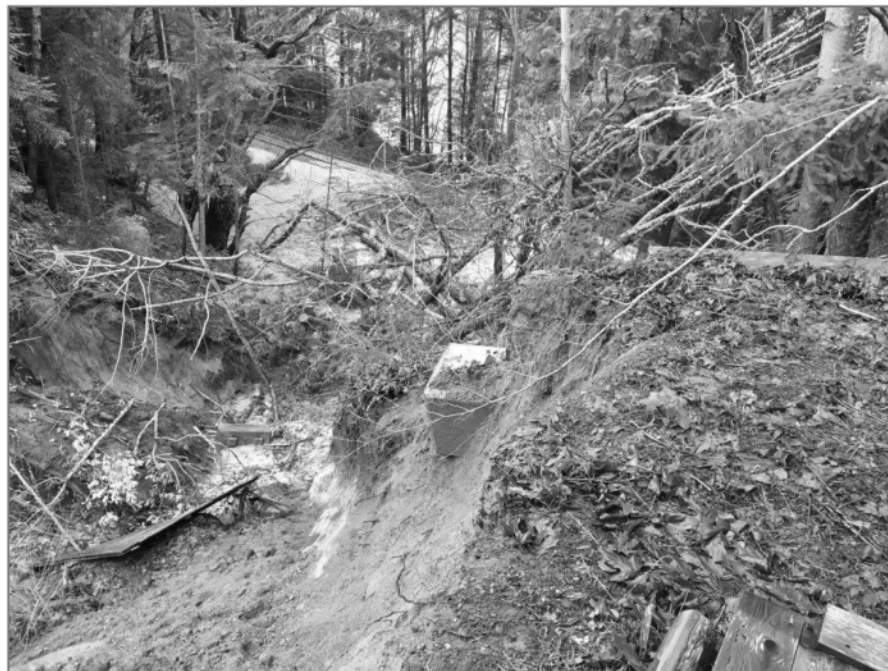
Photo 4: Several lock blocks had dislodged over the weekend and fallen into the failure. Several blocks remain and have distorted from original place. Tension crack visible behind the blocks.

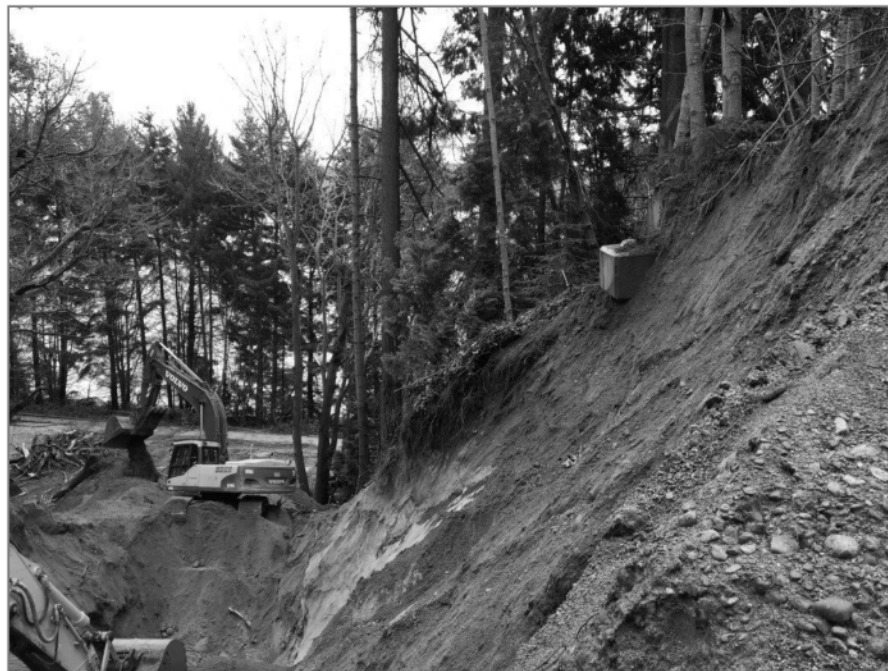
Photo 3: Lock blocks on east flank to be monitored and reviewed as part of the spotter's checks as the excavators work within the failure.

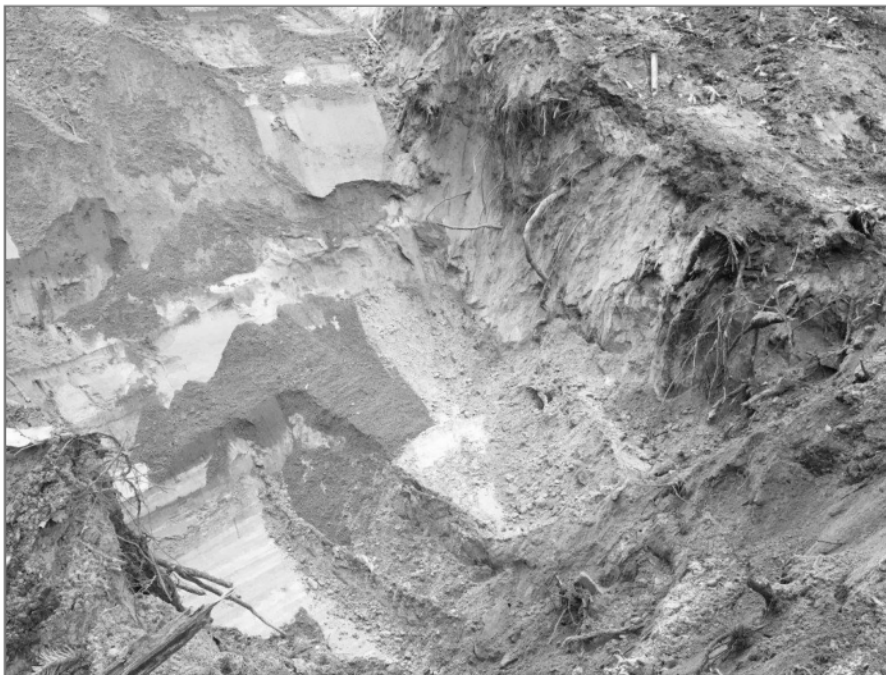
Photo 3: Excavations at the toe steepening due to depth of excavations to find undisturbed ground

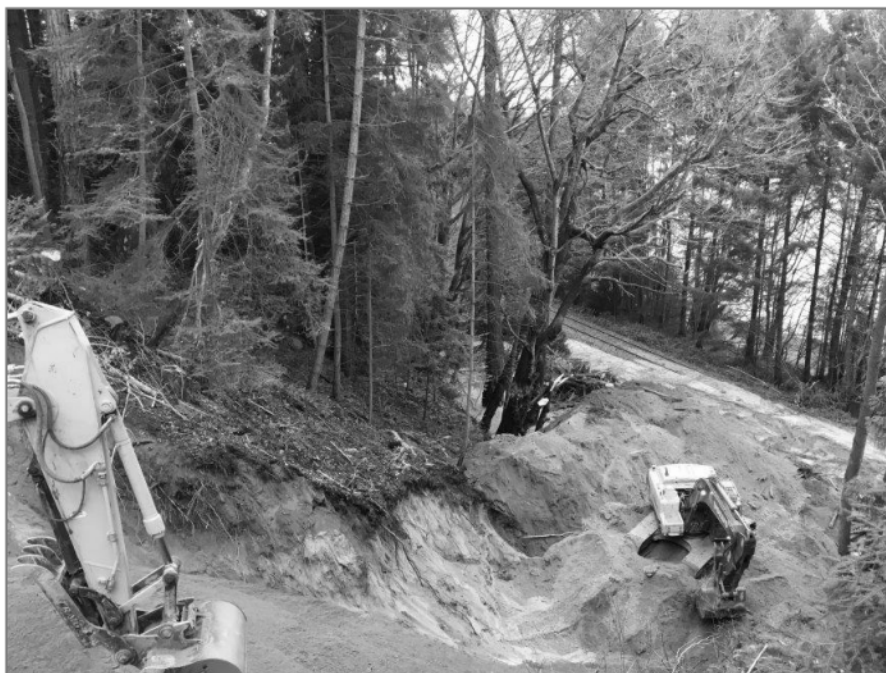
Photo 4: Looking down at the toe cleanup after sloughing of the western flank had occurred

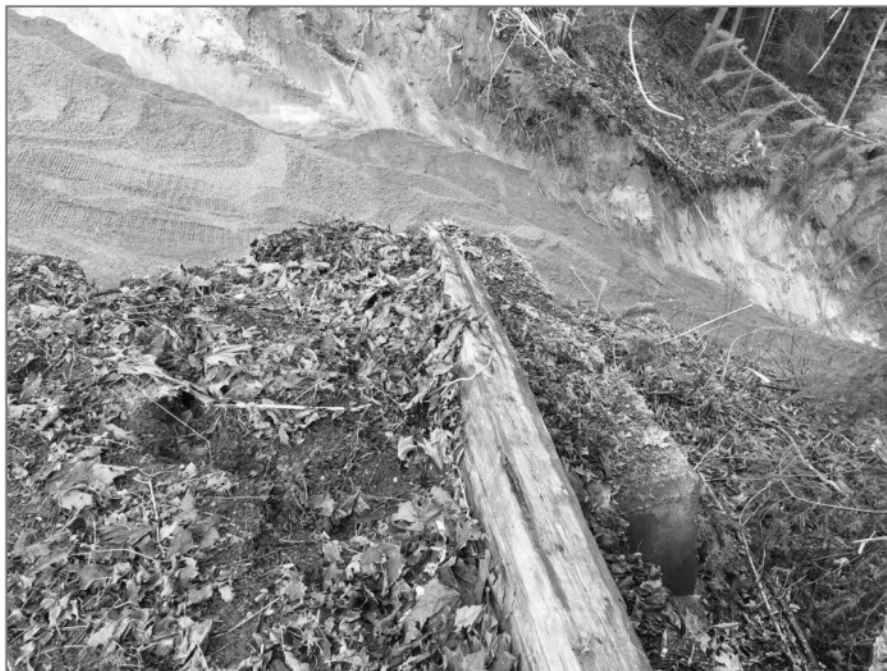
Photo 2: Tension crack behind lock block retaining wall on the east property.

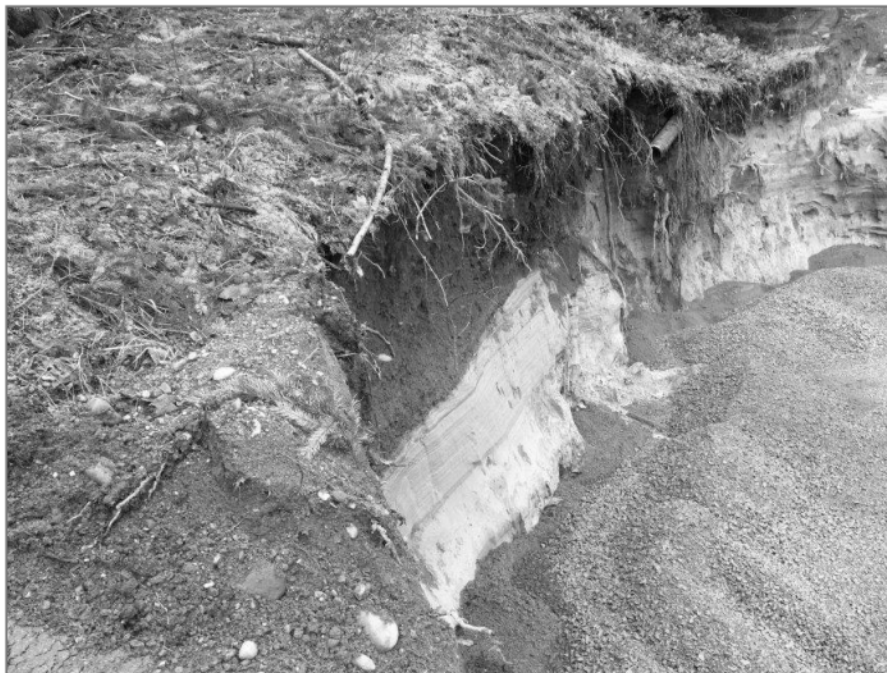
Photo 4: Sand filter material placed against southern (upstream) face of the failure. Generally greater than 0.6 m thick under the excess crush.

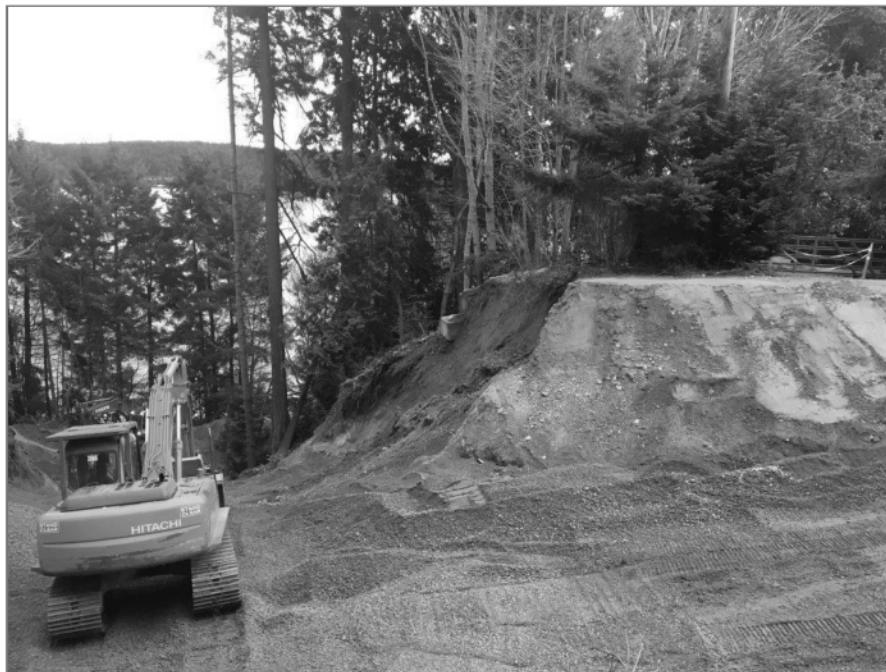
Photo 1: Sloughing on eastern shoulder of the failure sloughed into the work area. Approximately 1 m of horizontal ground was lost.

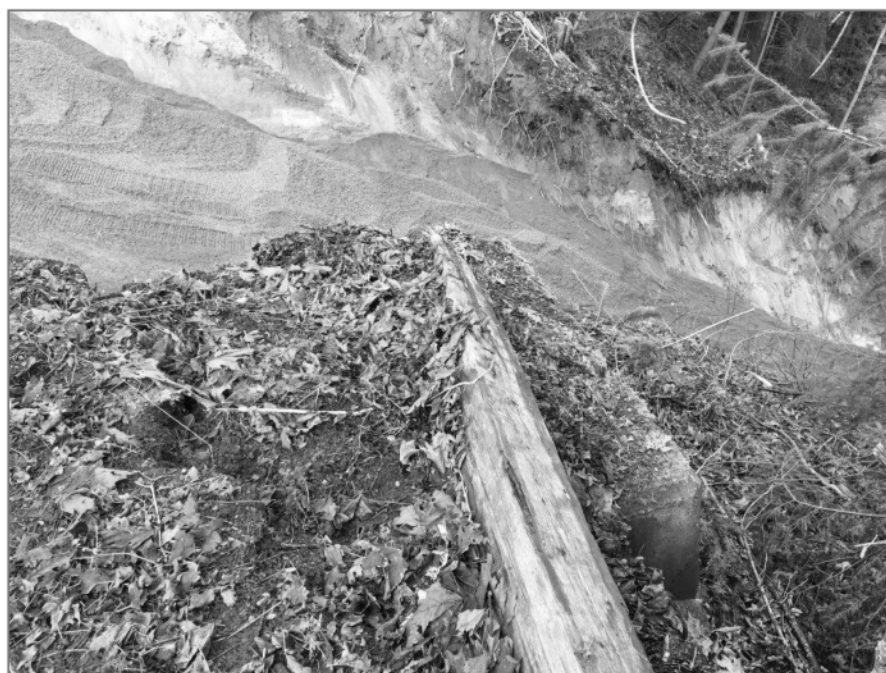
Photo 2: Tension crack behind lock block retaining wall on the east property.

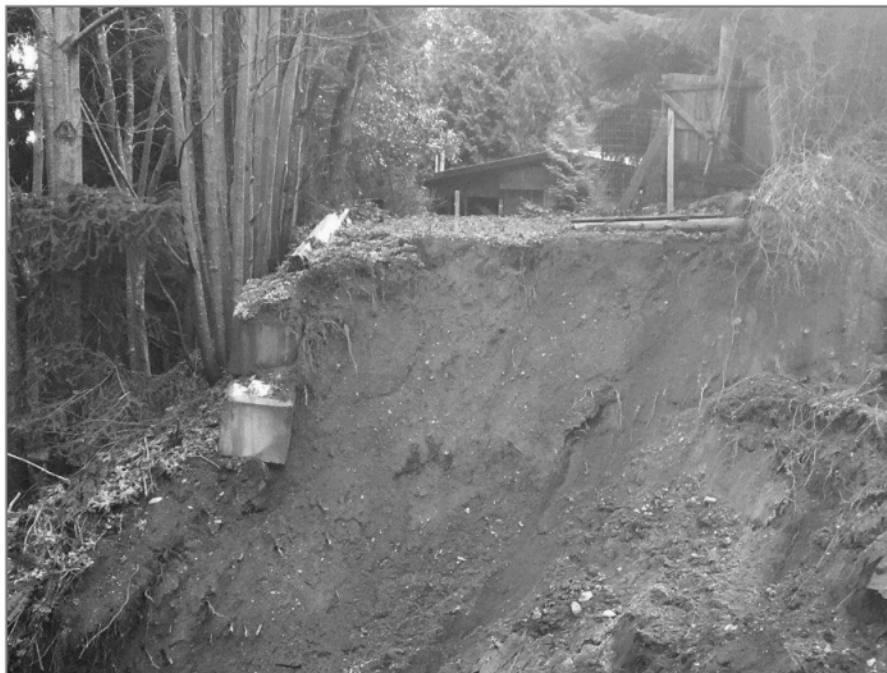
Photo 4: Fill material behind retaining wall obvious in section. Sloughing that occurred shown in right of image.

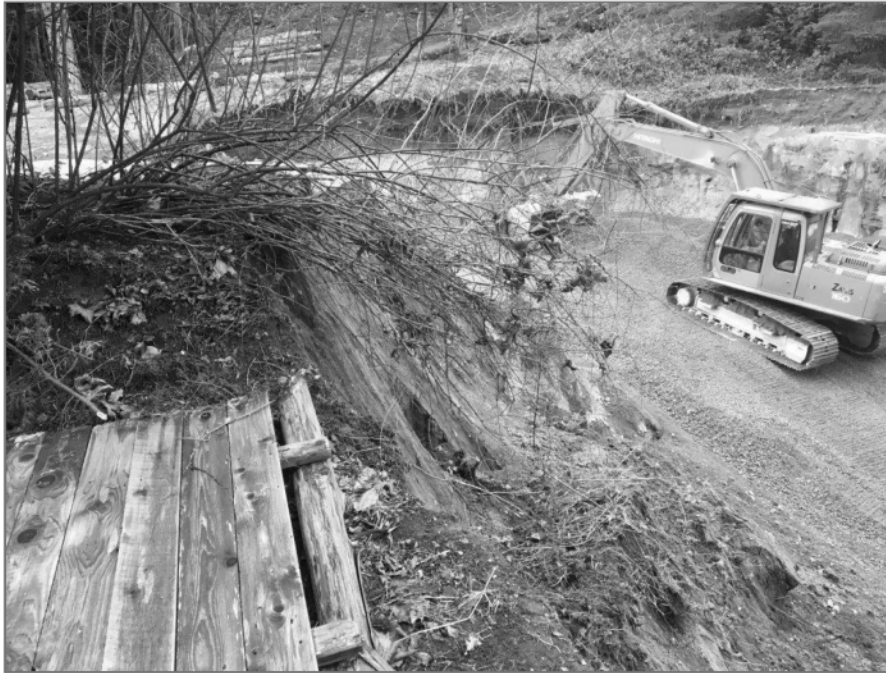
Photo 5: Sloughing that occurred in the morning. ~ 1 m lost on the western side of the hydro pole.

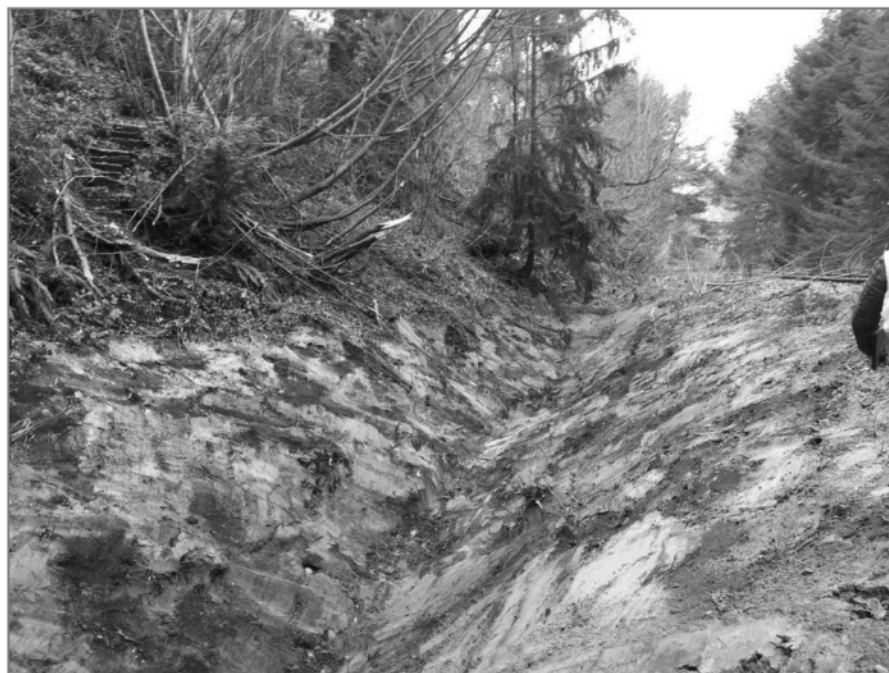
Photo 2: Cleaned out ditch towards the west from the bottom of the failure. Bottom of ditch appears ~3.5 m deep from top of railway.

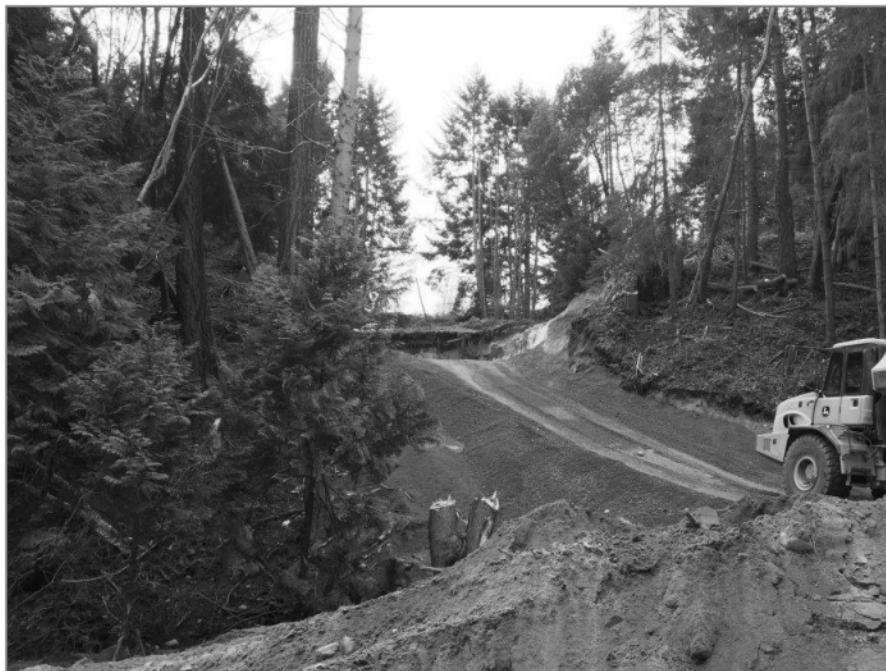
Photo 4: View looking up the failure. Some additional work to clean out the eastern toe will be required to help buttress the slope.

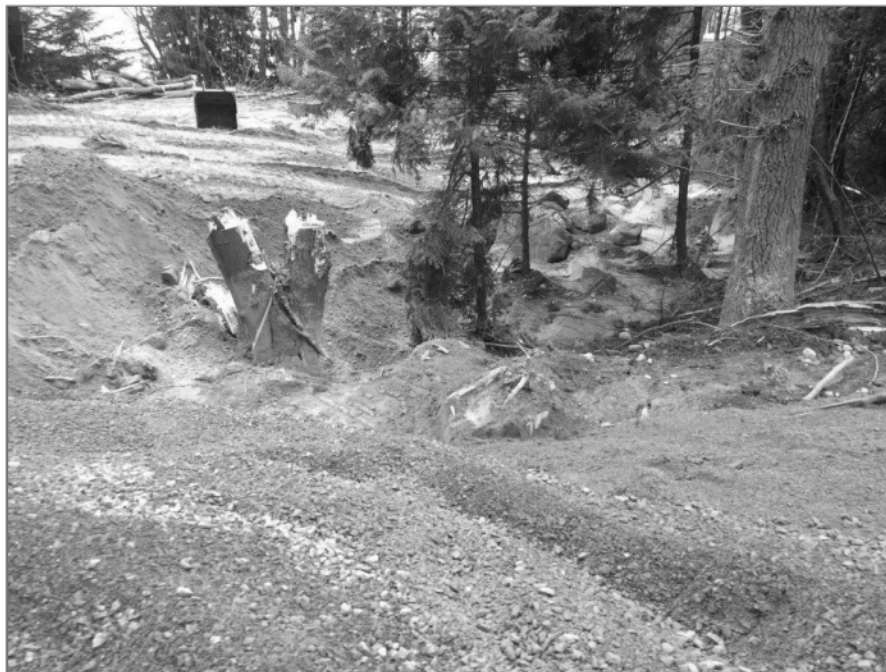
Photo 1: Looking down slope of the area that will require additional excavation to shore up upper areas of the slope. Stump to be removed and tree shown on right will likely be removed.

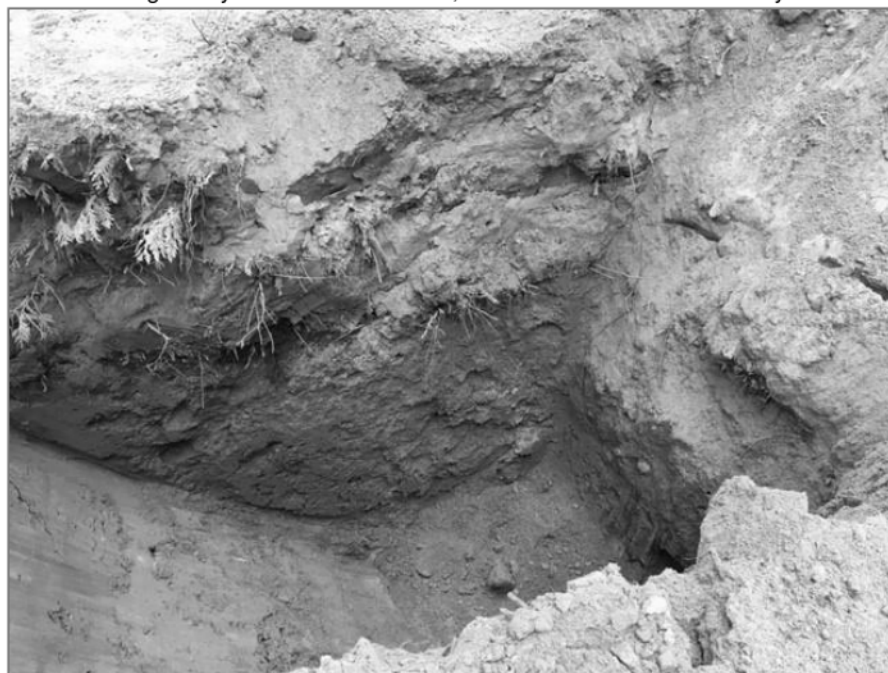
Photo 2: Testpit conducted at the toe of slope. Intermediate topsoil horizons indicating historic layering of colluvial deposits. Loose sand encountered through to end of testpit at a termination depth of 3.5 m.

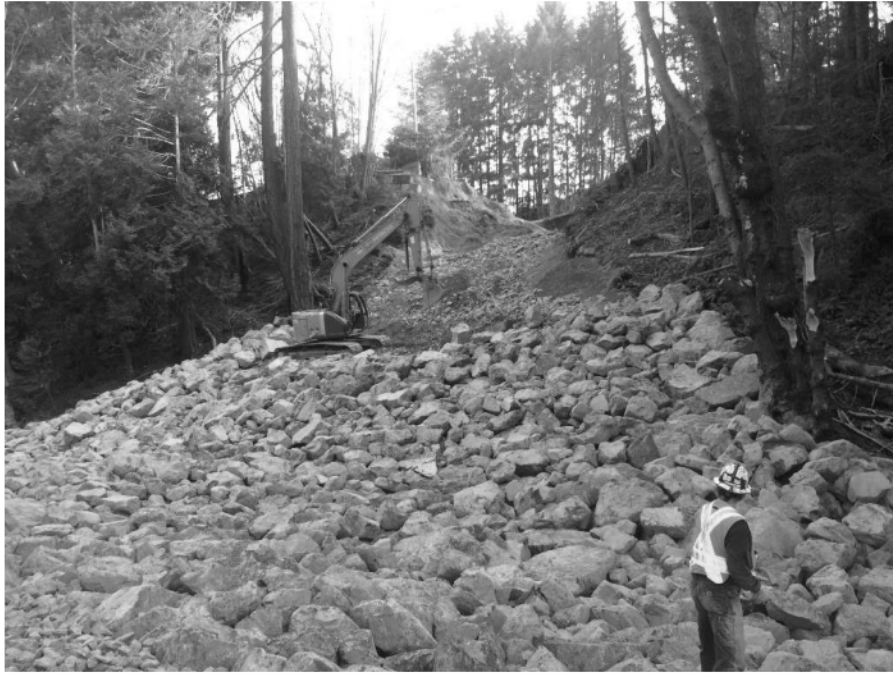
Photo 3: March 21, 2018. View looking upslope at the progress. Slope appears slightly overbuilt from designed slope. Field fit adjustments and ease of track packing contributing to overbuilt.

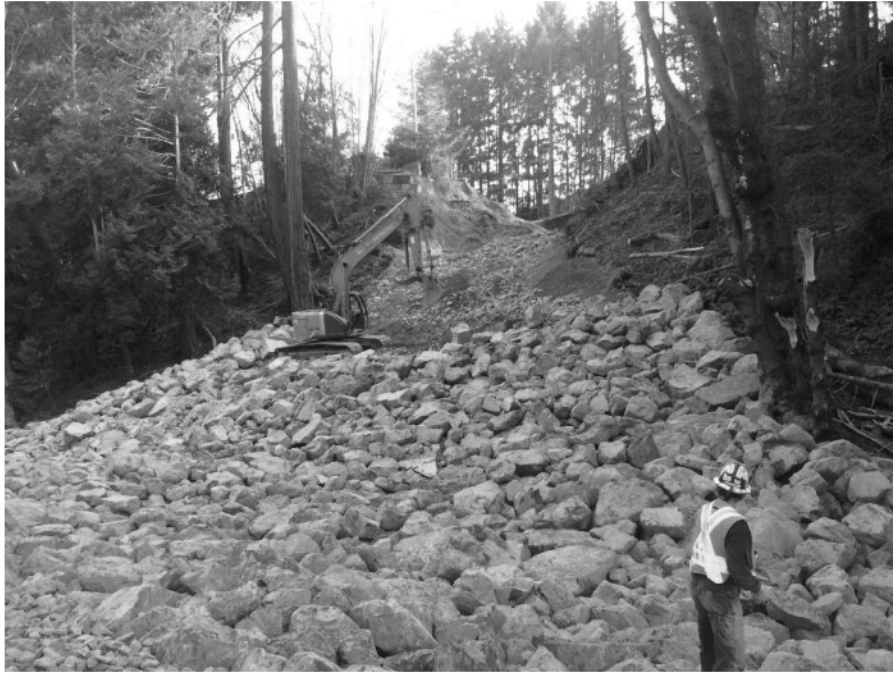
Photo 3: March 21, 2018. View looking upslope at the progress. Slope appears slightly overbuilt from designed slope. Field fit adjustments and ease of track packing contributing to overbuilt.

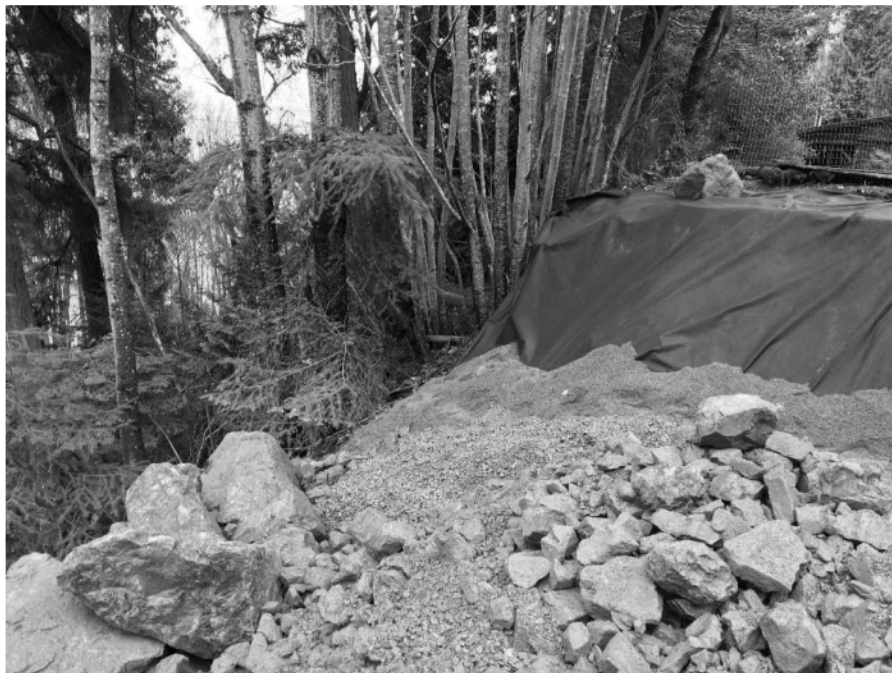
Photo 5: April 6, 2018. Area near the wooden retaining wall that requires some back sloping to provide base for tabular rocks to build up area.
