KC GEOTECHNICAL CONSULTANTS LTD.

April 16, 1999

**Final Report on Geotechnical Stability Investigation
Clarke-Bromley Landslides, Princeton, BC**

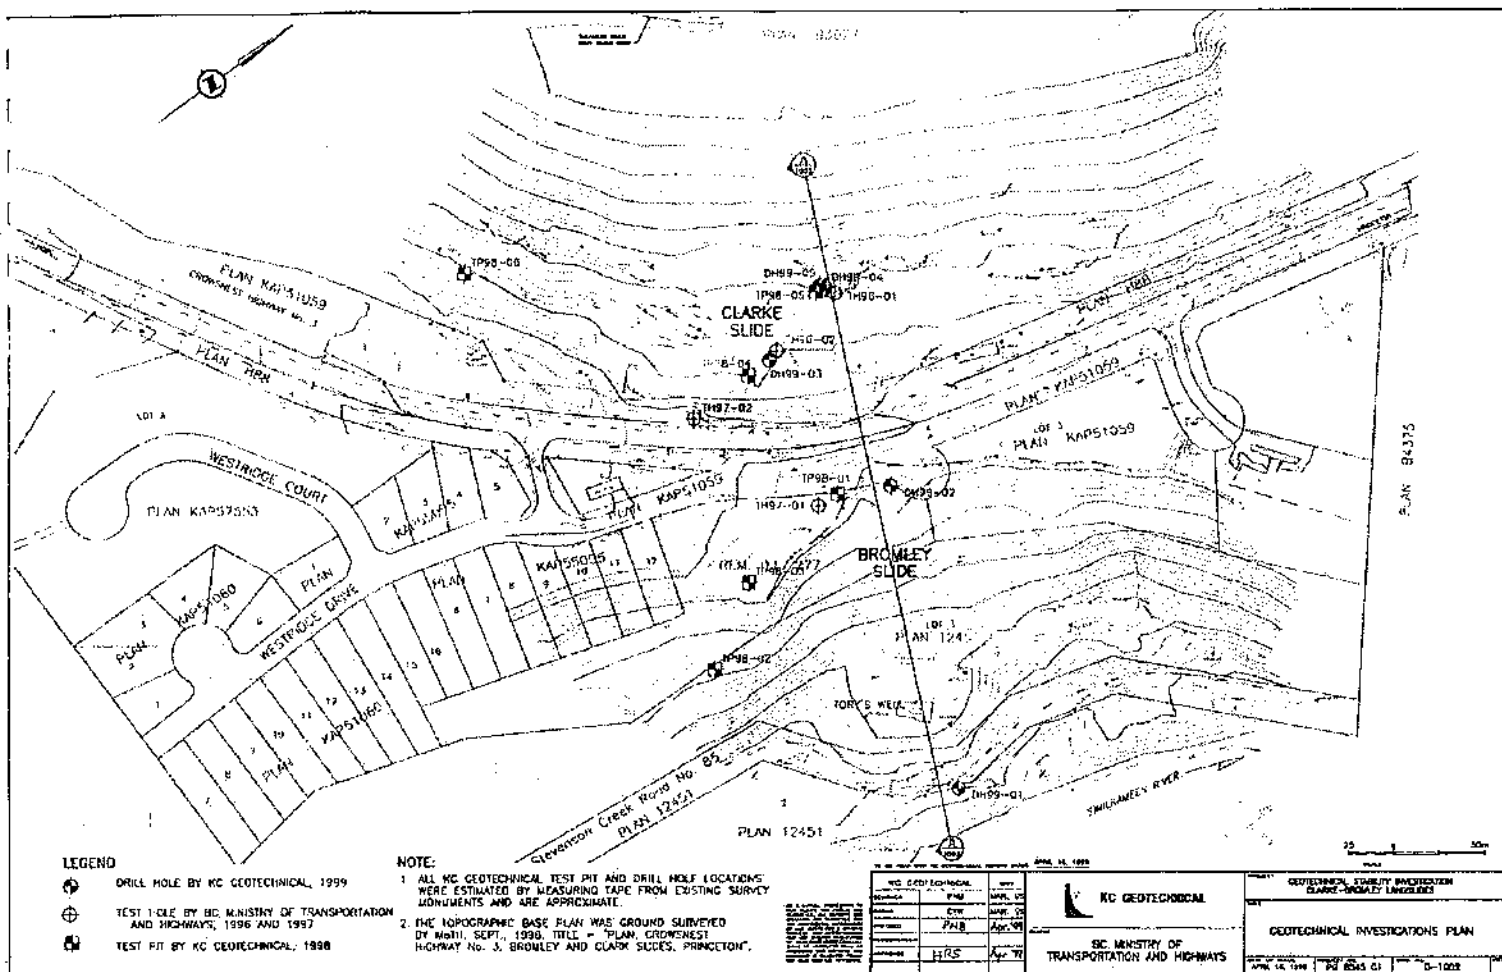
The stability analyses show that failure surfaces B-B through D-D have FOS values near or below one, which is consistent with field evidence that the slope is failing. Scarps and tension cracks mapped in MoTH's plan, and included on Drawing D-1004, appear to confirm failure surface C-C as having the lowest factor of safety.

Failure surface A-A is shallow seated because it is seated mainly in granular materials, and it is unstable at $FOS = 0.99$. Oversteep fill slopes northeast of the stability sections in the carport and house area have also proven to be unstable and have failed as a shallow earth flow.

Potential failure surface E-E, shown on Drawing B-1005, indicates that Highway 3, without its third lane, has a FOS of 1.19, which, although currently stable, is below our recommended minimum FOS of 1.25. Failure of fill placed at the highway edge, Drawing D-1001, may have been caused by removal of toe support when downslope movement of the slide mass occurred along failure surface D-D (Appendix V, Photo 1).

POTENTIAL FAILURE SURFACE	STATIC FACTOR OF SAFETY (NORMINTEGRATED-PRICE METHOD)	SHEAR STRENGTH CONDITIONS
AA	1.01	RESIDUAL FRICTION ANGLES FOR ② AND ③ PEAK FRICTION ANGLE FOR ①
BB	0.89	RESIDUAL FRICTION ANGLES FOR ② AND ③
CC	0.95	RESIDUAL FRICTION ANGLES FOR ② AND ③
DD	1.00	RESIDUAL FRICTION ANGLES FOR ② AND ③
EE	1.19	RESIDUAL FRICTION ANGLES FOR ② AND ③

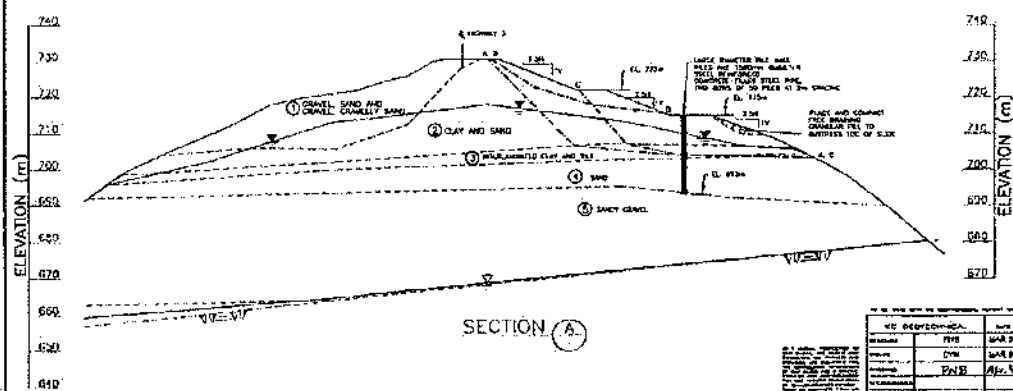
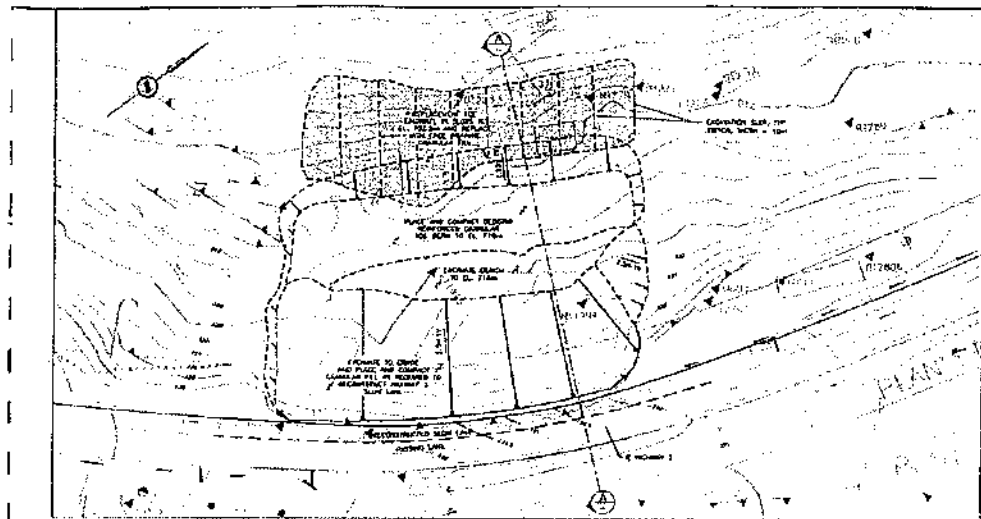
KC GEOTECHNICAL		BC MINISTRY OF TRANSPORTATION AND HIGHWAYS	
PROJECT	CLARK SLIDE REMEDIAL ALTERNATIVE 1 CONCRETE PILES	DATE	PC 0043 01
CLIENT	BC MINISTRY OF TRANSPORTATION AND HIGHWAYS	DATE	B-1006

POTENTIAL FAILURE SURFACE	STATIC FACTOR OF SAFETY (BURNSIDE-SEARBY METHOD)	SHEAR STRENGTH CONDITIONS
AA	1.21	RESIDUAL FRICTION ANGLES FOR ② AND ③
BB	1.79	RESIDUAL FRICTION ANGLES FOR ② AND ③
CC	1.45	RESIDUAL FRICTION ANGLES FOR ② AND ③

Large diameter drilled shafts, or piles, can stabilize landslides. The piles are drilled through the failure surface to form a wall which arrests the sliding movement. A conceptual design for the piles, Drawing D-1006, was developed based on recent experience in similar ground near Fort St. John, BC (Heavy Construction News, 1999). The conceptual pile design consists of a steel pipe, 9.5 mm thick, 1,500 mm diameter,

The shear strength of the pile wall is estimated based on the strength of the concrete. The shear strength is estimated as 706 kPa, or 1.25 MN force per pile (Canadian Portland Cement Association, 1985). SLOPE/W analysis shows that if shear through one pile is assumed, the minimum FOS is 1.31 on potential failure surface A-A, Drawing D-1006. A similar result is obtained by comparing the total driving force to the total resisting force provided by the soil and concrete piles. The shear strengths of the steel casing and reinforcement are ignored in this analysis. The conceptual design meets the minimum design criterion of FOS greater than 1.25 against shear. The design does not quantitatively address bending moments which will be addressed in later design stages. However, we have included typical steel reinforcement to provide bending resistance based on our previous construction experience with reinforced piles (Klohn Leonoff, 1995). This alternative also includes reconstruction of the third lane and resloping to lower the driving forces and load the toe, as shown on Drawing D-1006.

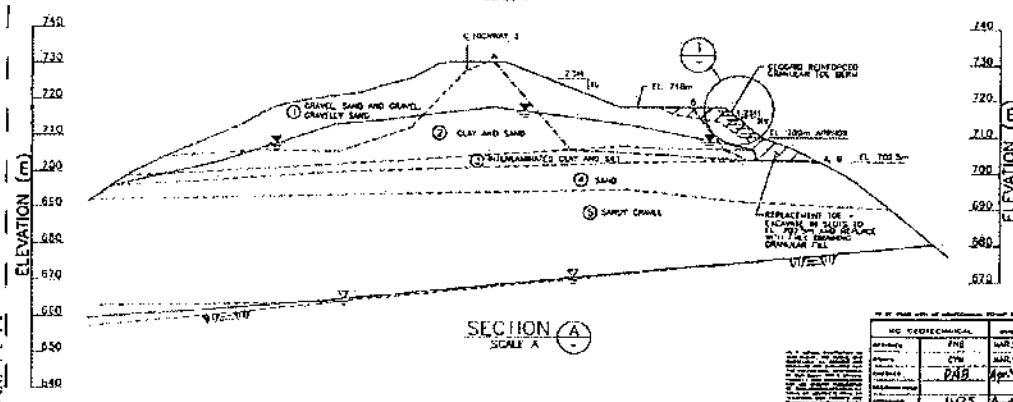
POTENTIAL FAILURE SURFACE	STATIC FACTOR OF SAFETY (UNDERSATURATED, SATURATED, VARIOUS)	SHEAR STRENGTH CONDITIONS
PH	1.01	PLANE SECTION ANGLES FOR ② AND ③
DS	0.81	RESIDUAL FRICTION ANGLES FOR ② AND ③
HN	0.92	RESIDUAL FRICTION ANGLES FOR ② AND ③
AT	0.93	RESIDUAL FRICTION ANGLES FOR ② AND ③
PK	1.07	PLANE SECTION ANGLE FOR ③ BELOW HIGHWAY RESIDUAL FRICTION ANGLE FOR ③ BELOW HIGHWAY RESIDUAL FRICTION ANGLES FOR ② AND ③ IN EXISTING SCARP AREA

The second remedial alternative is a replacement toe berm (Drawing D-1007). The first stage of this concept is to excavate clay and silt down to at least El. 702.5 m at the toe of the translational slide mass, and replace it with free draining granular fill. The replacement fill will provide greater frictional resistance to sliding, and will serve to drain the toe area. The toe must be excavated in slots to reduce the likelihood of slide movement during the work (Drawing D-1007). Each slot should be a maximum of 10 m

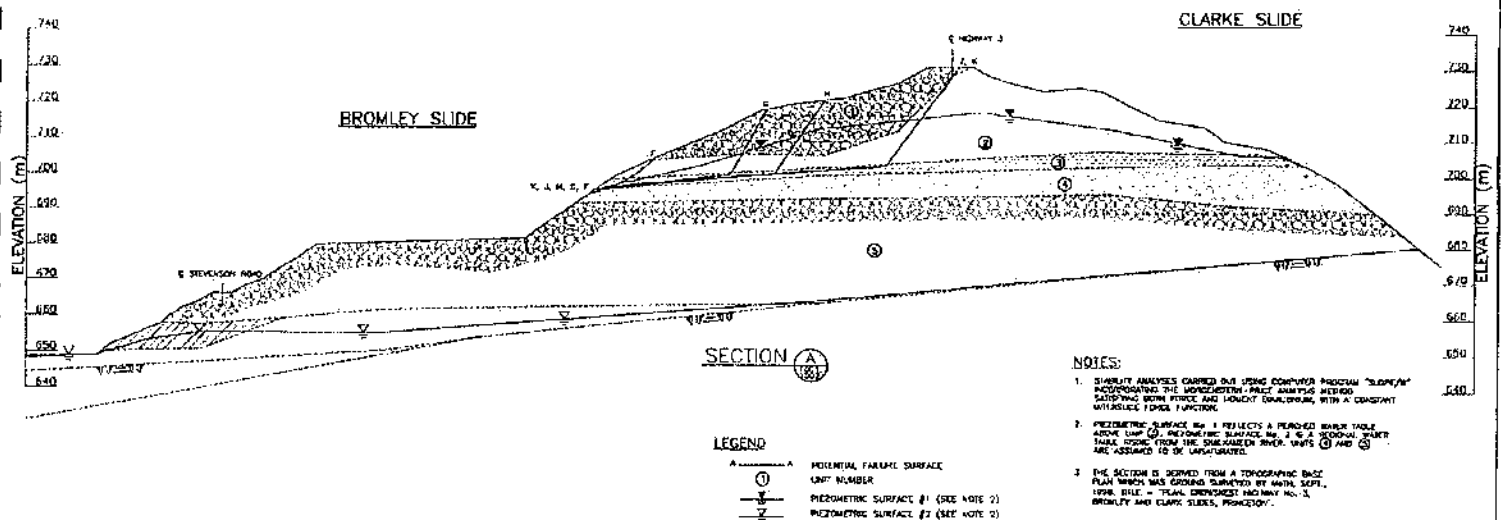
BC GEOTECHNICAL BC MINISTRY OF TRANSPORTATION AND HIGHWAYS		GEOTECHNICAL STABILITY INVESTIGATION CLAY-BROMLEY LANDSLIDES UPPER BROMLEY SLIDE STABILITY ANALYSIS	
PROJECT NO. DRAWING NO. DATE	DESIGNED BY CHECKED BY APPROVED BY	ANALYST DATE	SCALE SHEET NO.

MATERIAL PROPERTIES						
UNIT NO.	MATERIAL	UNIT WEIGHT γ (kN/m³)	EFFECTIVE SHEAR STRENGTH			PIEZOMETRIC SURFACE NO.
			C' (kPa)	φ (DEGREES)	REDUCED φ (DEGREES)	
①	GRAVEL SAND AND GRAVEL, GRAVELLY SAND	20	0	37	—	1
②	CLAY AND SAND	22	0	31.5	20.5	1
③	INTERLAMINATED CLAY AND SILT	16.5	0	25.5	13.5	1
④	SAND	17	0	35	—	—
⑤	SANDY GRAVEL	22	0	38	—	—
⑥	DISTURBED COAL AND SHALE	19	0	18	18	2
⑦	SILT SAND	22	0	38	—	2
⑧	POWER PLANT SHALE	19	0	21	—	2
⑨	SUMMITTS CREEK SANDSTONE	23	0	35	—	2
⑩ AND ⑪	CLAY SEAMS - SHEAR STRENGTH TESTS	18/23	0	21	18	2
⑫ AND ⑬	CLAY SEAMS - BACK ANALYSIS	18/23	0	—	11	2

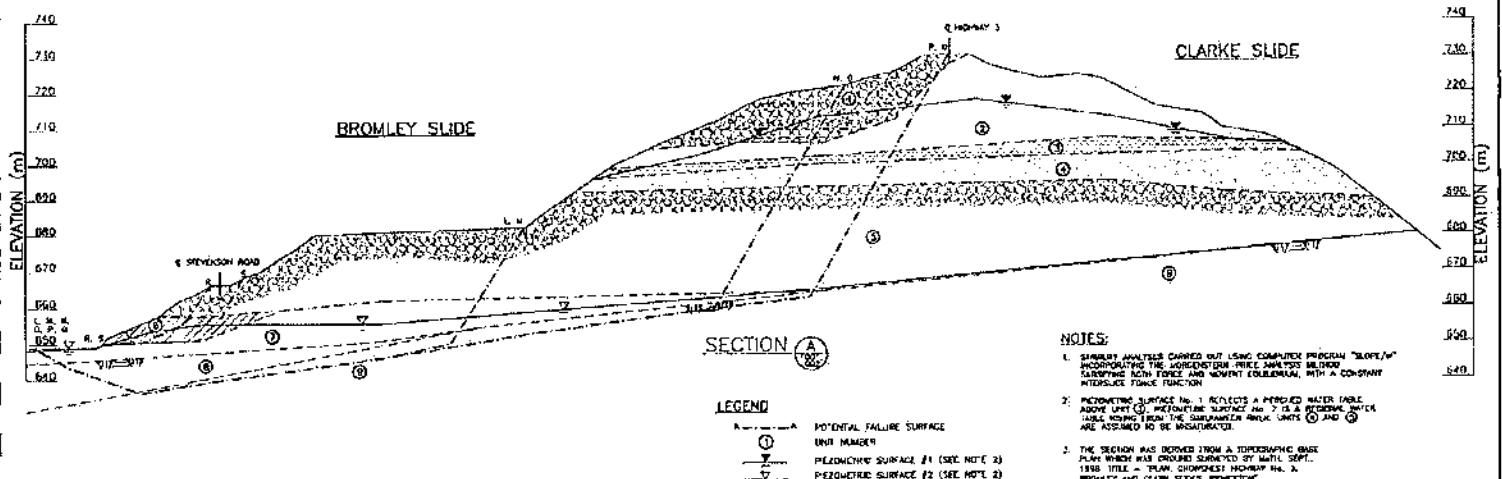
IGC GEOTECHNICAL PROJECT NO. 100 DATE 10/91 BY HPS		IGC GEOTECHNICAL BC MINISTRY OF TRANSPORTATION AND HIGHWAYS	
GEOTECHNICAL STABILITY INVESTIGATION CLARKE-BROMLEY LANDSLIDES LOWER BROMLEY AND STEVENSON ROAD SLIDES STABILITY ANALYSIS		DATE 10/91 BY HPS

POTENTIAL FAILURE SURFACE	STATIC FACTOR OF SAFETY (MORGENTHAU-PRICE METHOD)	SHEAR STRENGTH CONDITIONS
RR	0.80	⑩ CLAY AND SHALE HAVE BEEN DISTURBED BY COLLAPSE OR SLURRY PROCESSES. RESIDUAL FRICTION ANGLE USED.
SS	0.98
