# Post-Crash Vehicle Inspection Report

2017-28337

12-2017-09-05-927

Date: September 07, 2017

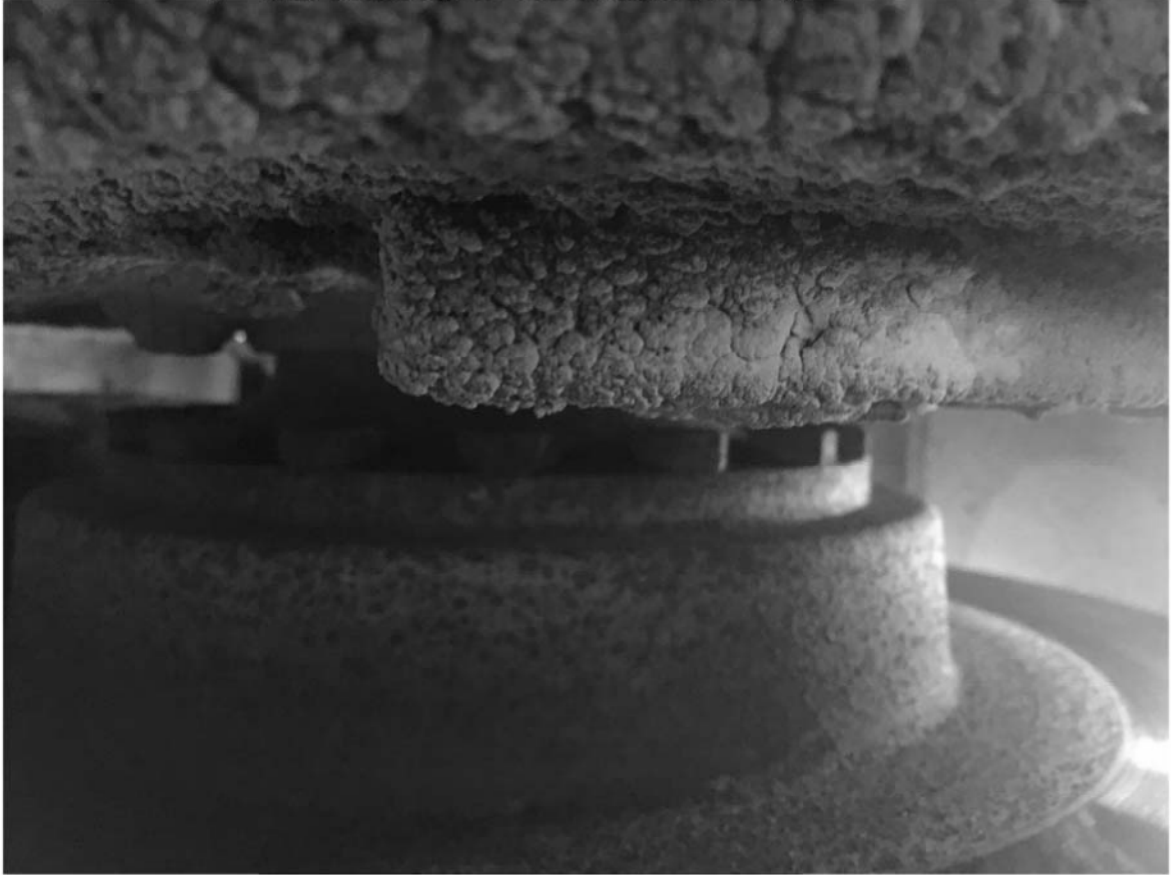
Disk park brake

This Volvo truck is equipped with a driveline air disc brake pad park system. The pads and rotor on the park brake were functional and met the manufactures guidelines for service brake performance. The park brake and braking system were tested at the collision scene and in Coquitlam's towing yard in Port Coquitlam. The brake system operated according to the manufactures specifications.

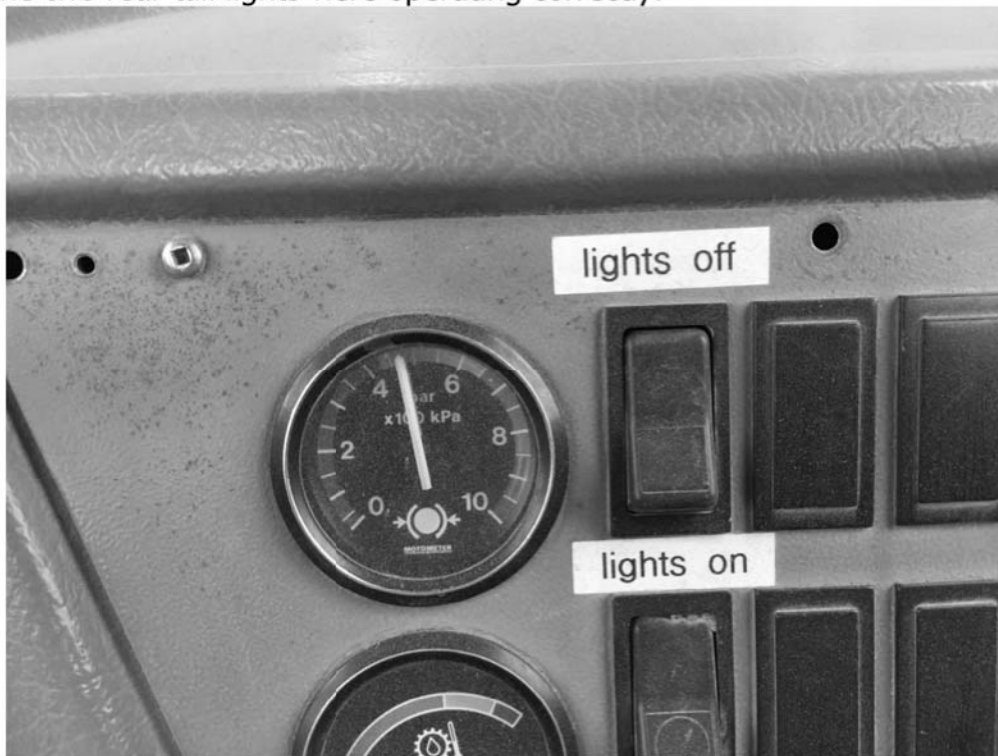
H/ Switch

The headlight switch was in the off position. When placed in the on position the front headlights were no working. The two rear tail lights were operating correctly.

Although this vehicle is design for off road use only it still complied with many of the sections set out in the Motor Vehicle Act & Regulations. The headlights were not operating but this may have been caused by the collision.

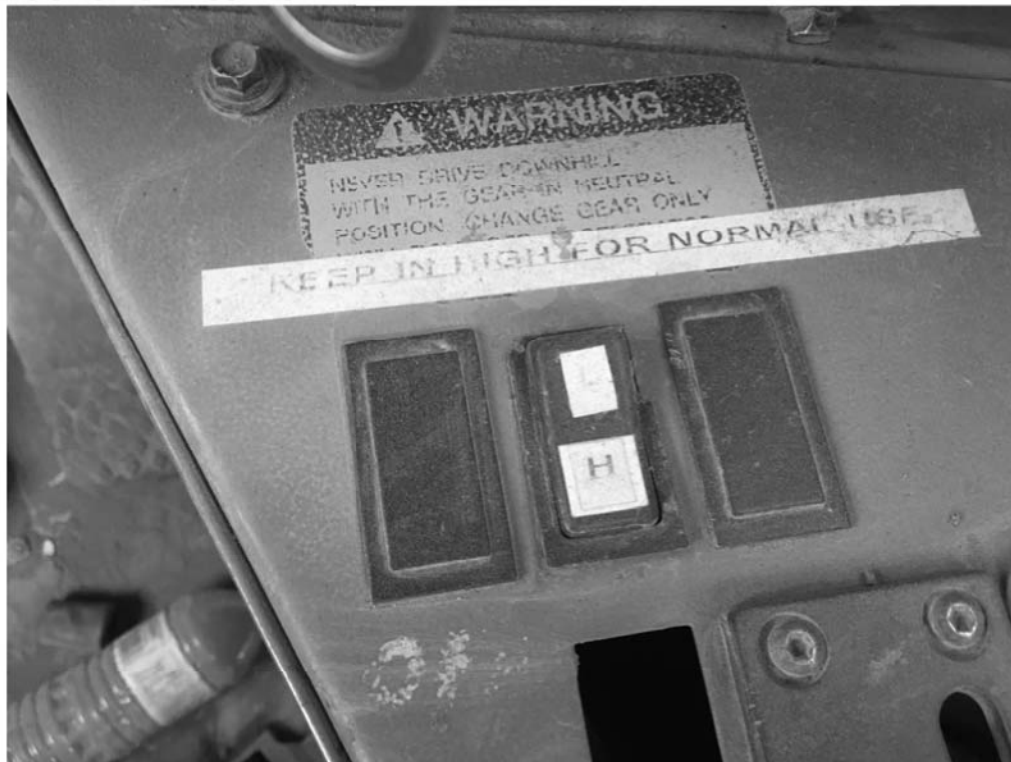
L/switch  
Page 5

## Wheel Locker Switch OFF

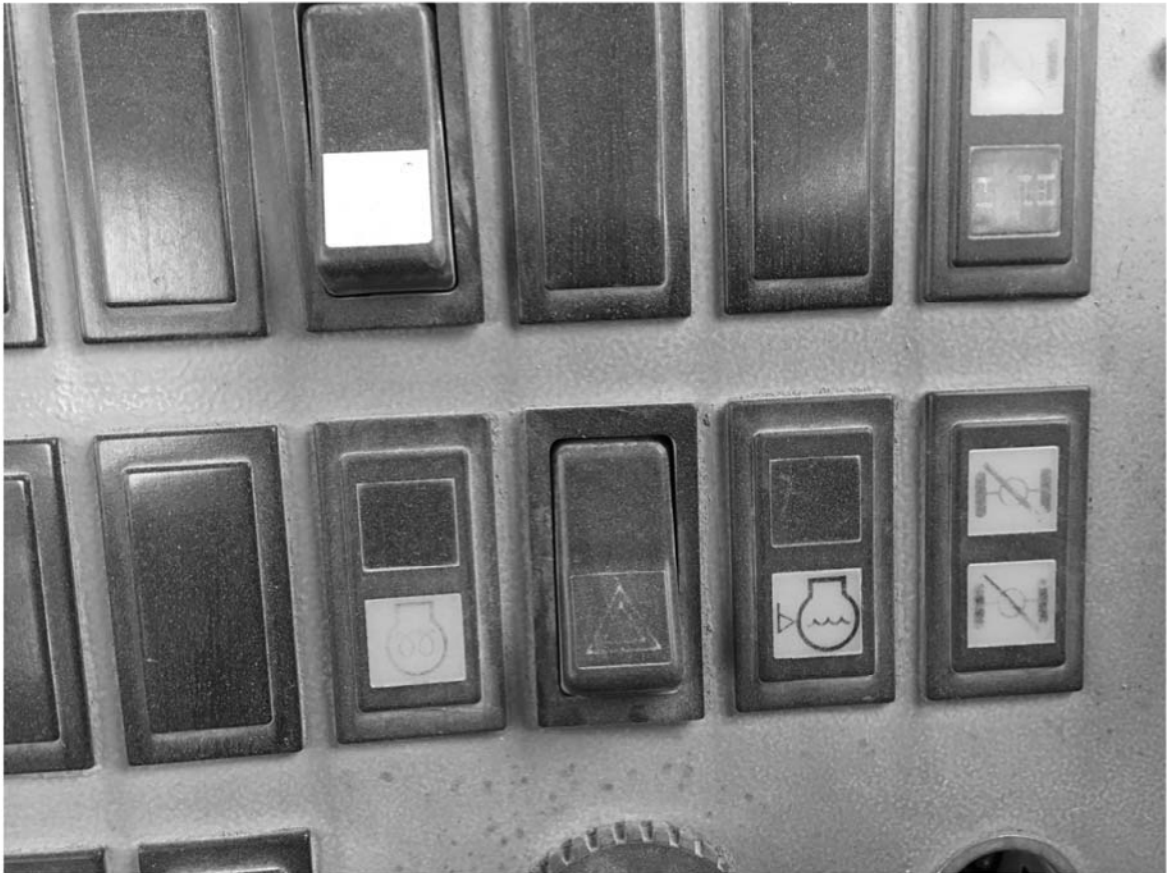
## Heater Seat Switch and Flasher Switch Both OFF

H/switch top

F/Switch bottom

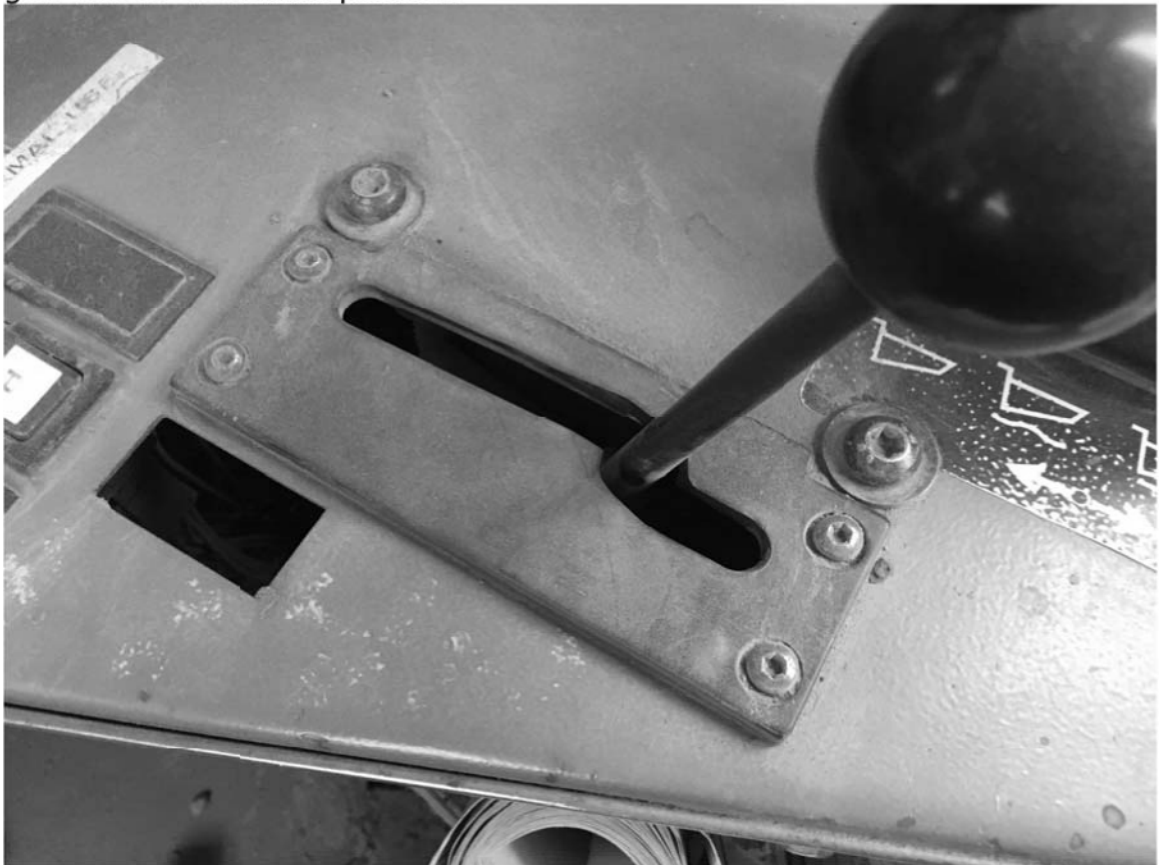
## Transmission Gear

The transmission gear was in the neutral position.

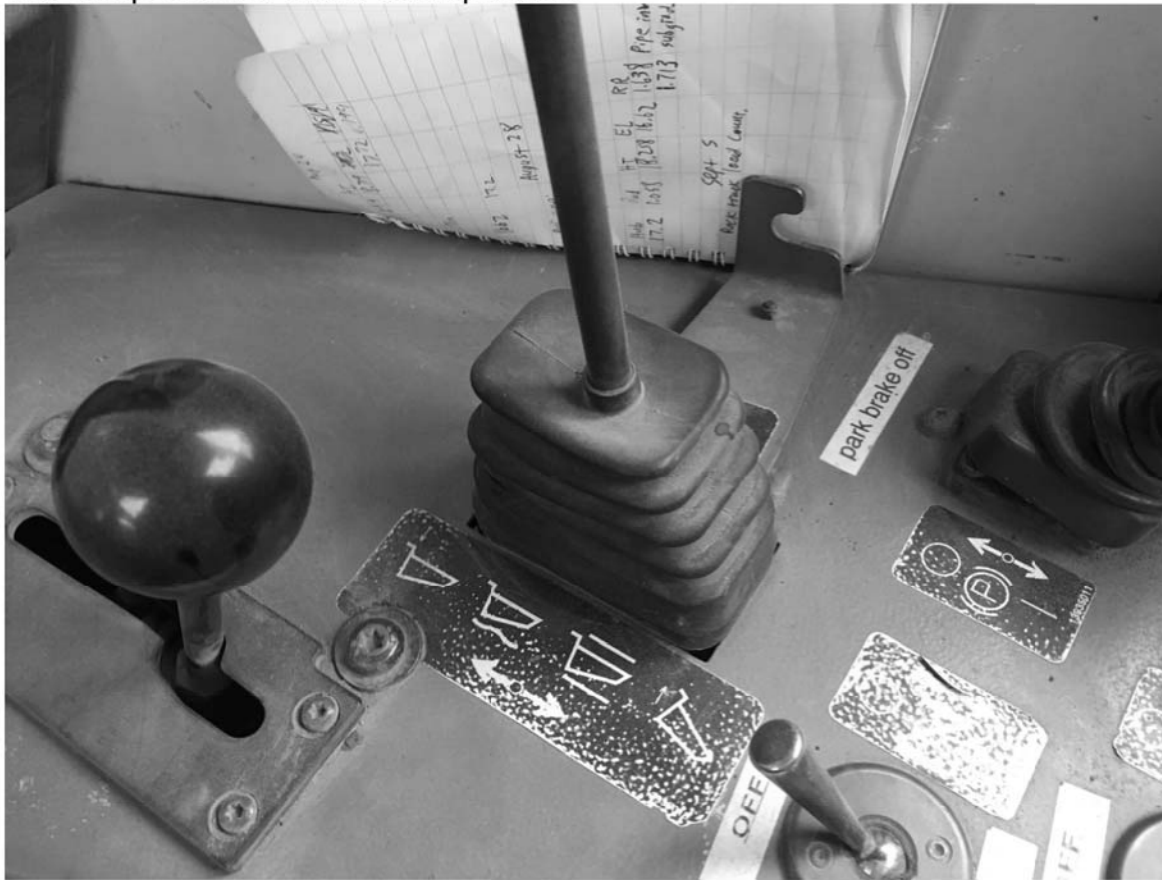
## Box lift lever center position

The dump box was in the down position.

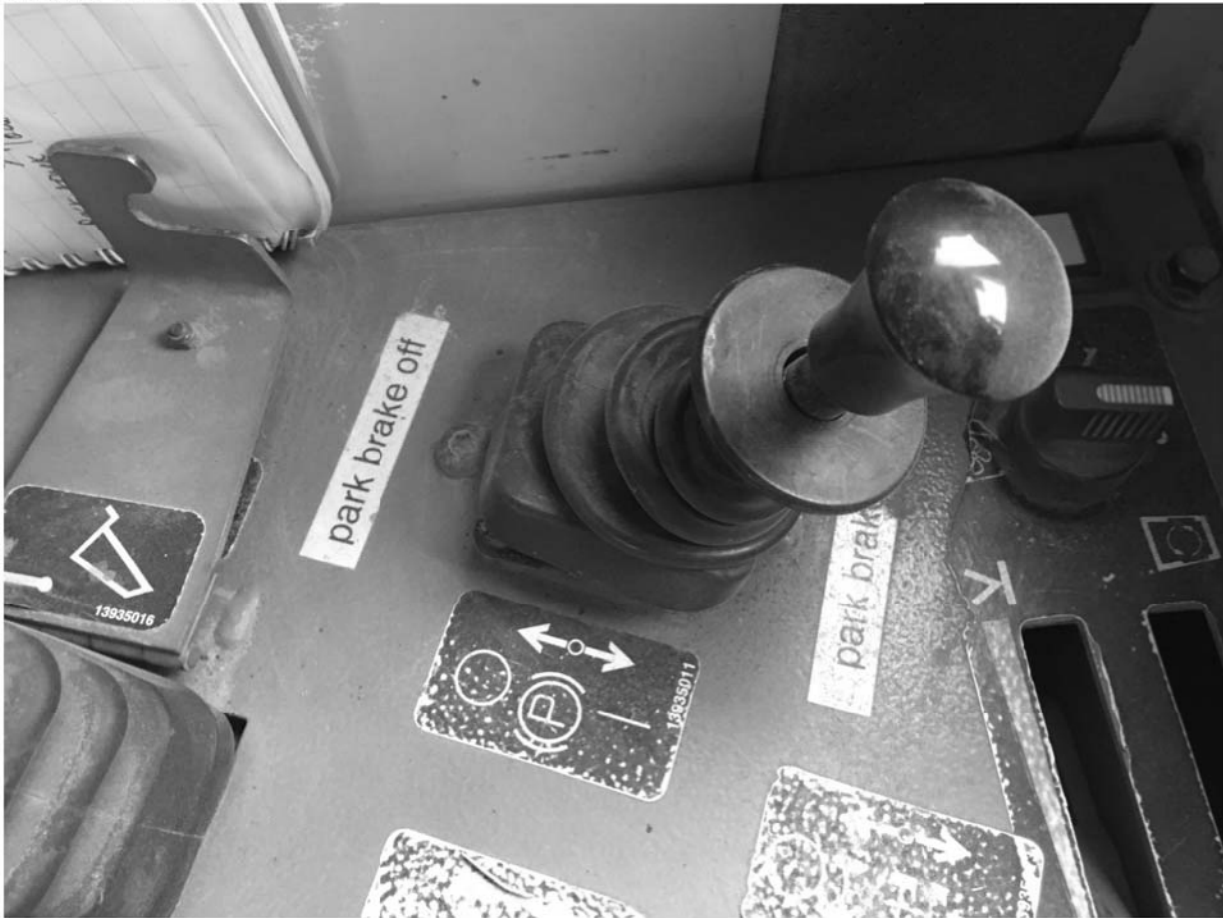
## Park Brake Lever ON

The Park Brake lever was in the on position. This park brake lever has a indent clip that requires the operator to raise it before the park brake lever can be moved to the release park brake position. This indent clip was operating properly when tested. The test was moving the park brake lever from the park brake on position to the Park brake off position. It was noted that if the operator did not fully engage the park brake clip in the on position the lever would spring back to the park brake off position.

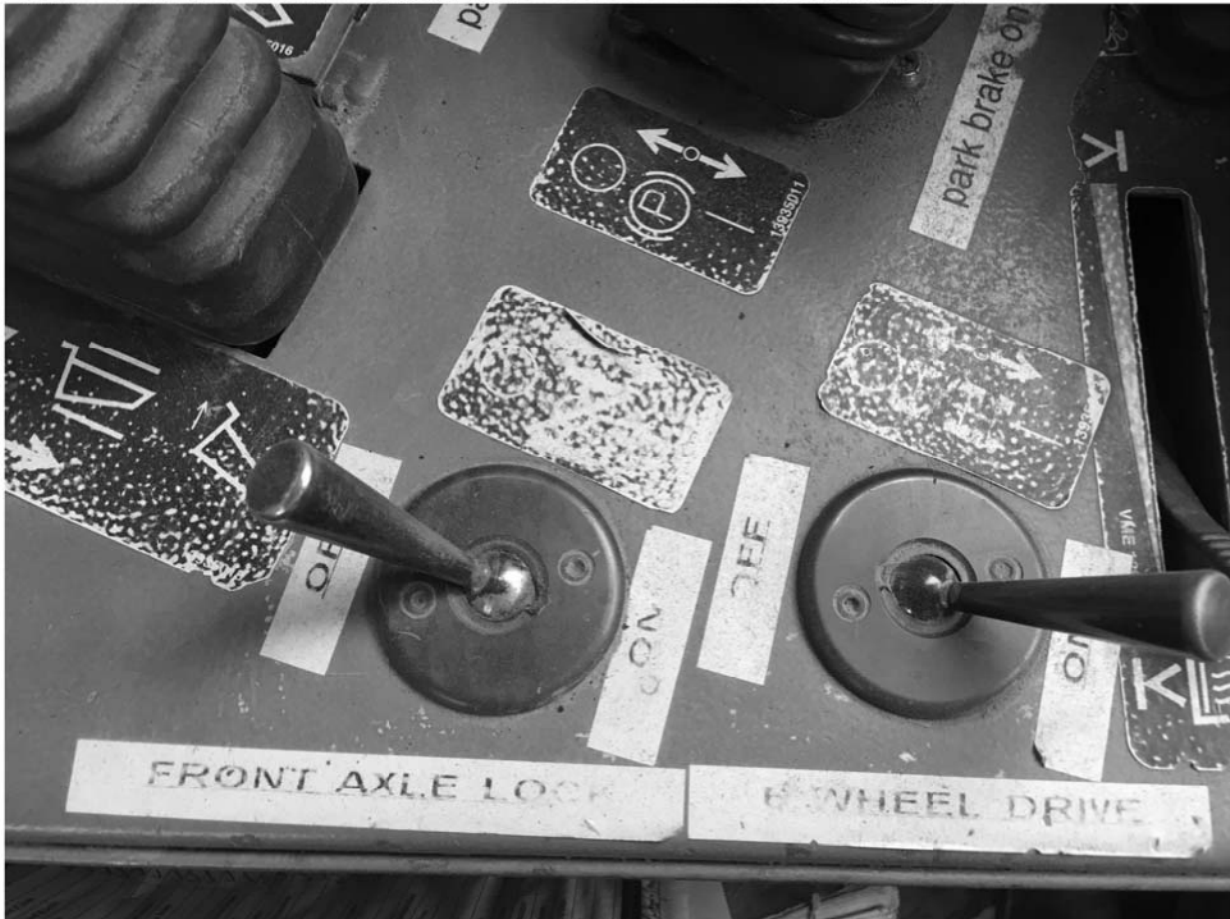
## Front wheel Axle Lock Switch Off. Wheel Drive Switch On

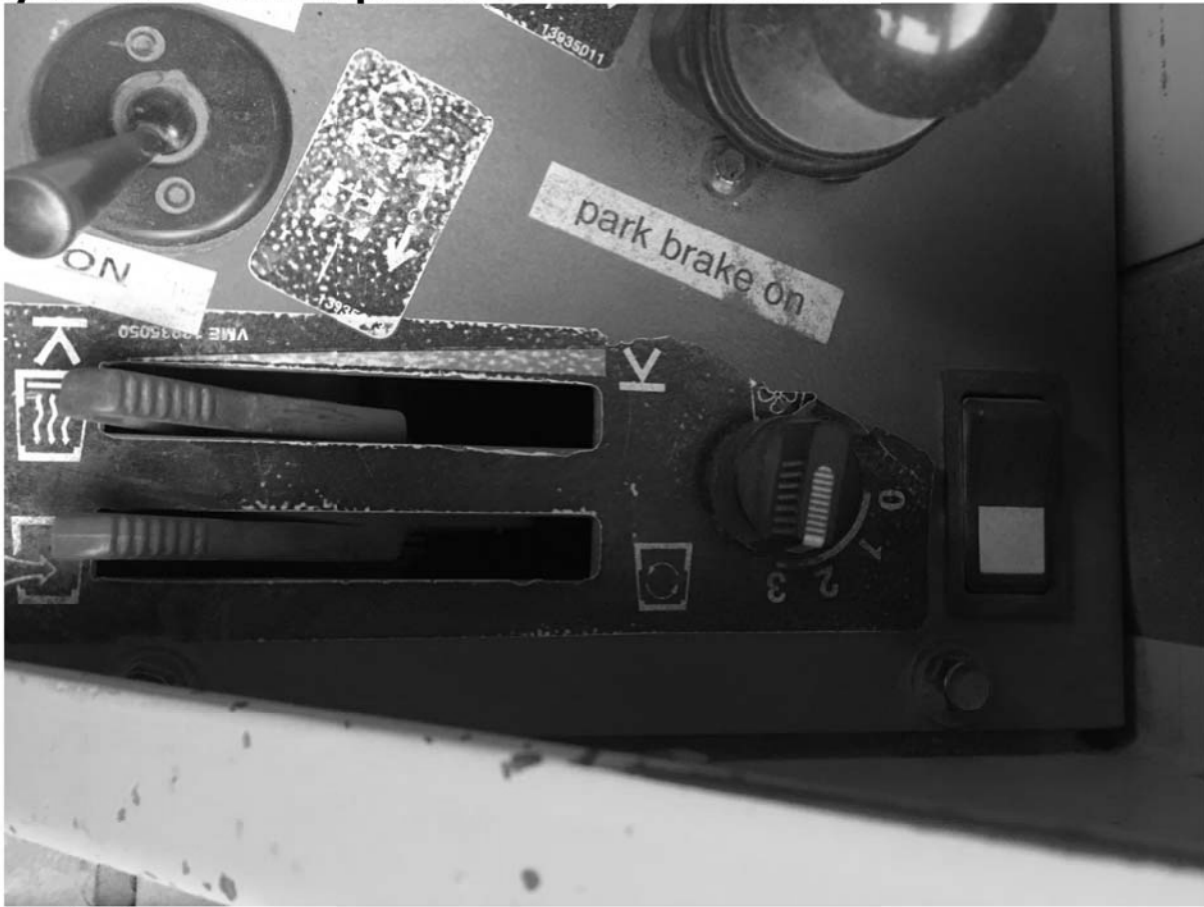
## Heater System Off: Fan on position three: Full Air flow

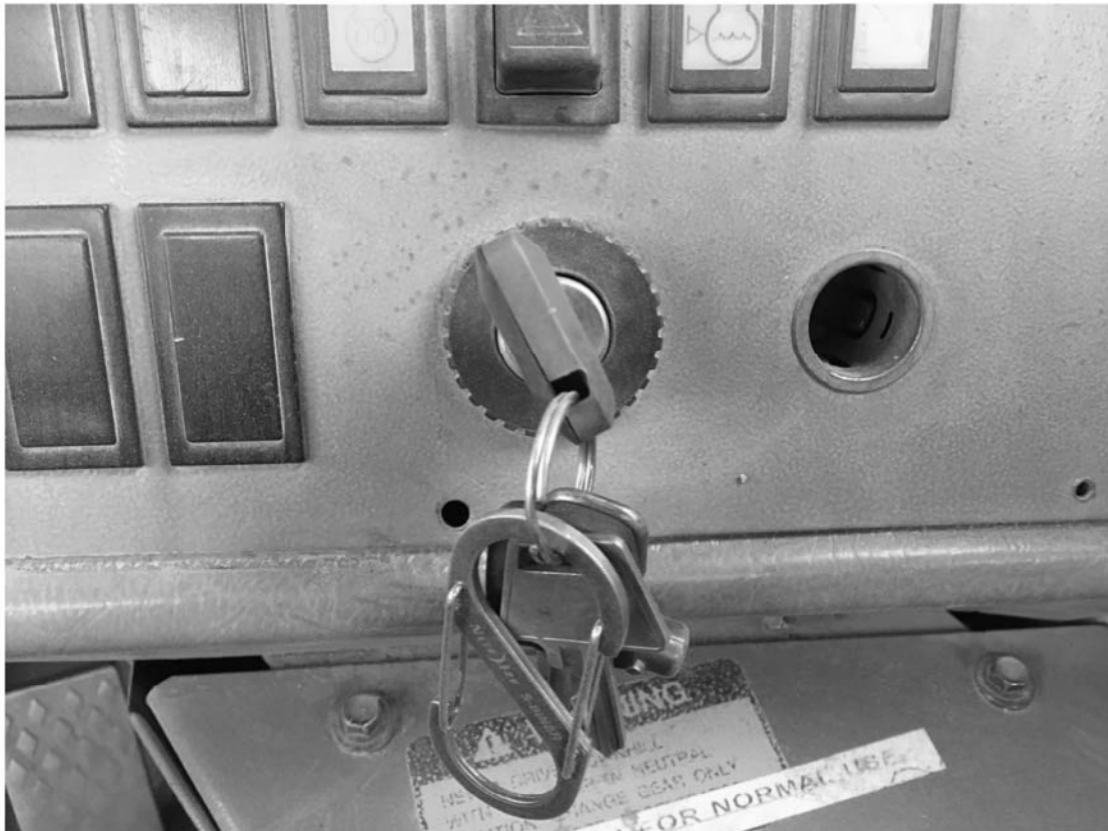
## Ignition Switch OFF

It was noted that the ignition switch was in the off position. In order for that switch to be in that position if the Volvo Truck was running somebody would have had to enter the cab after the collision and turned it off

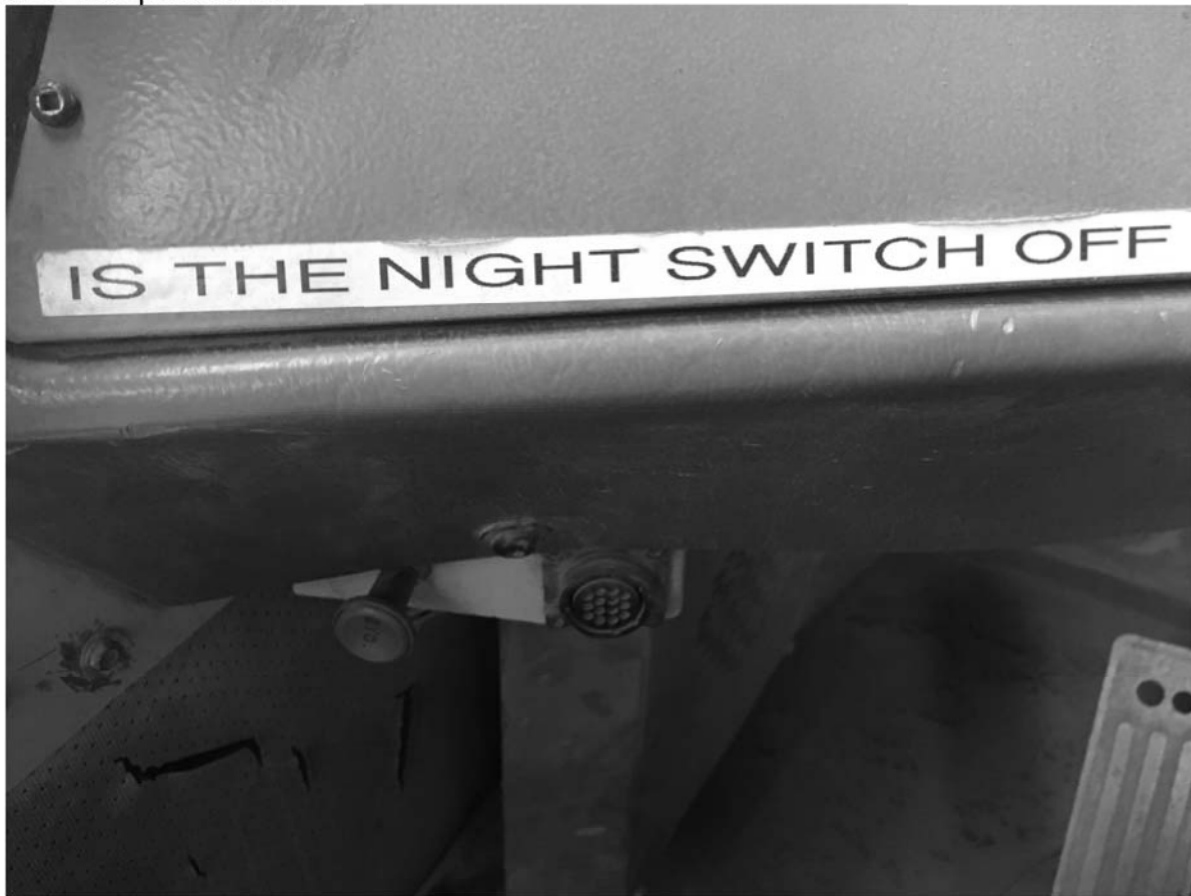
E/Cable

## Engine Shutoff Cable

Shutoff cable was pushed in.

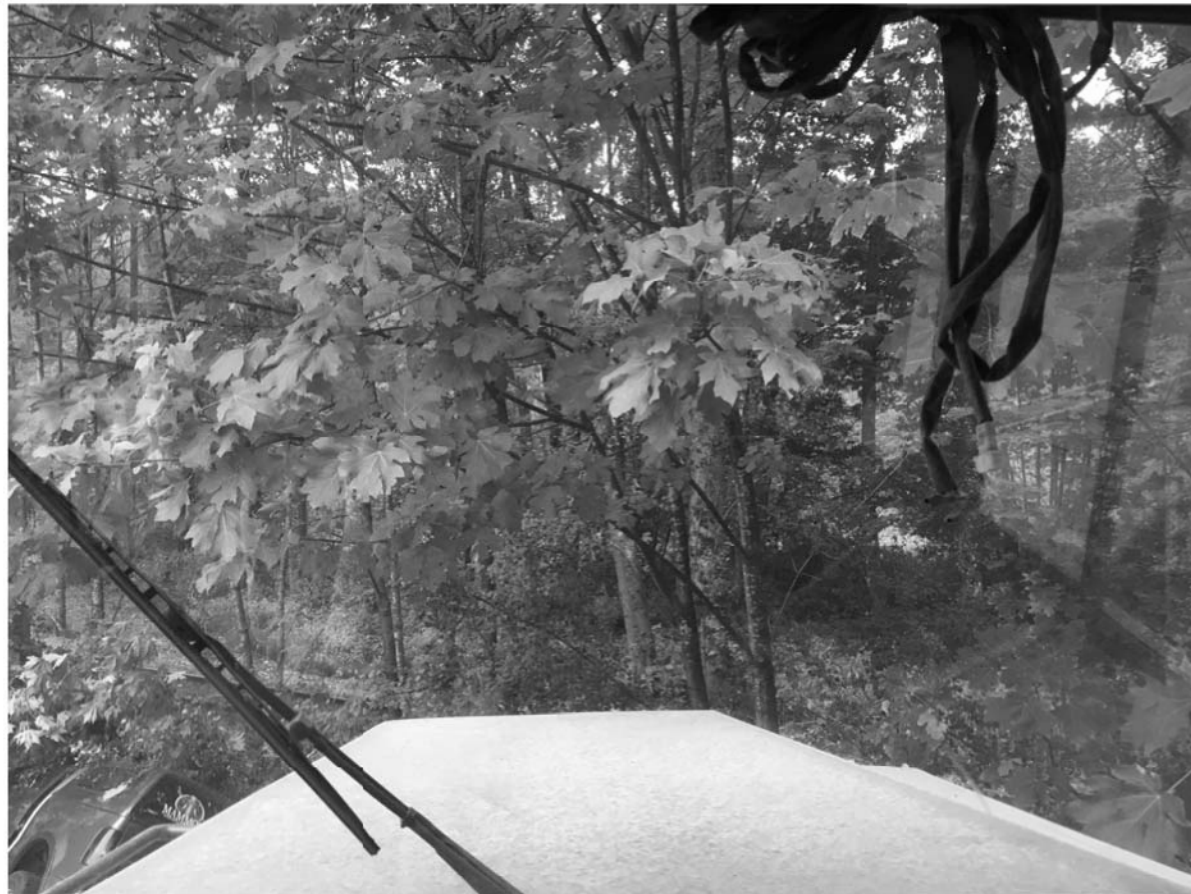
W/glass  
Page 10

## Windshield
