# **MINISTRY OF TRANSPORTATION AND INFRASTRUCTURE**

## **HIGHWAY 97 AND BAILEY ROAD ENGINEERING SAFETY REVIEW**

**SEPTEMBER 1, 2010**

**Prepared By: Nam Nguyen, P. Eng.  
Transportation Engineer  
Ministry of Transportation  
and Infrastructure**

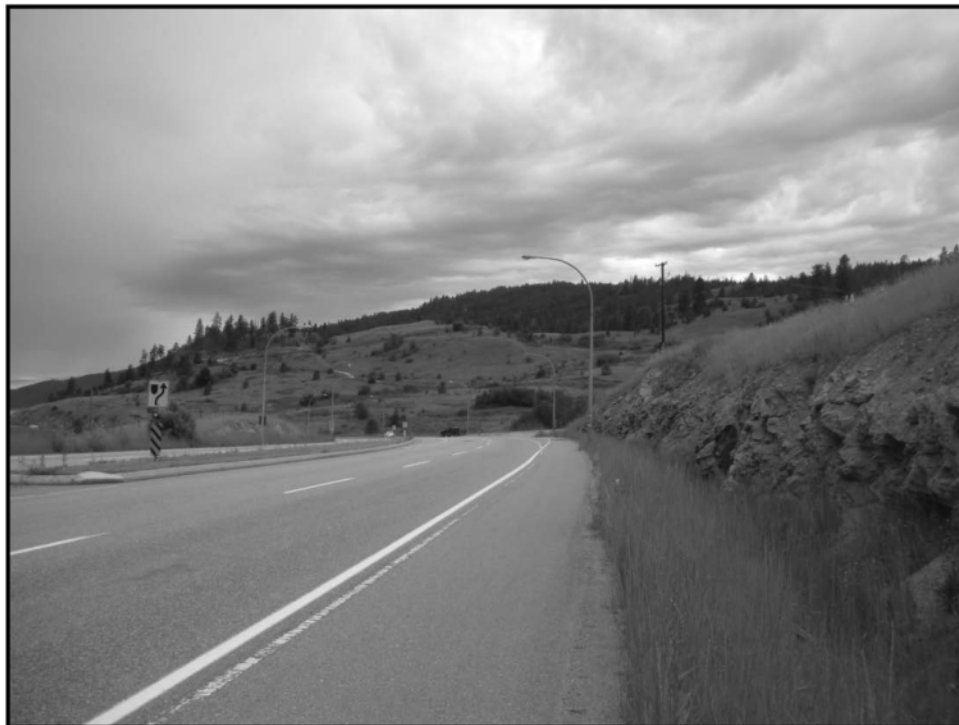
**Figure 3.7: Highway 97 Southbound View Approaching Bailey Road**

The grade southbound on Highway 97 approaching Bailey Road provides 191 m of sight distance. The available sight distance was calculated from the horizontal curve, grade and superelevation of Highway 97 using Ministry engineering software. This meets the 90 km/h Ministry guidelines for stopping sight distance of 190 m.

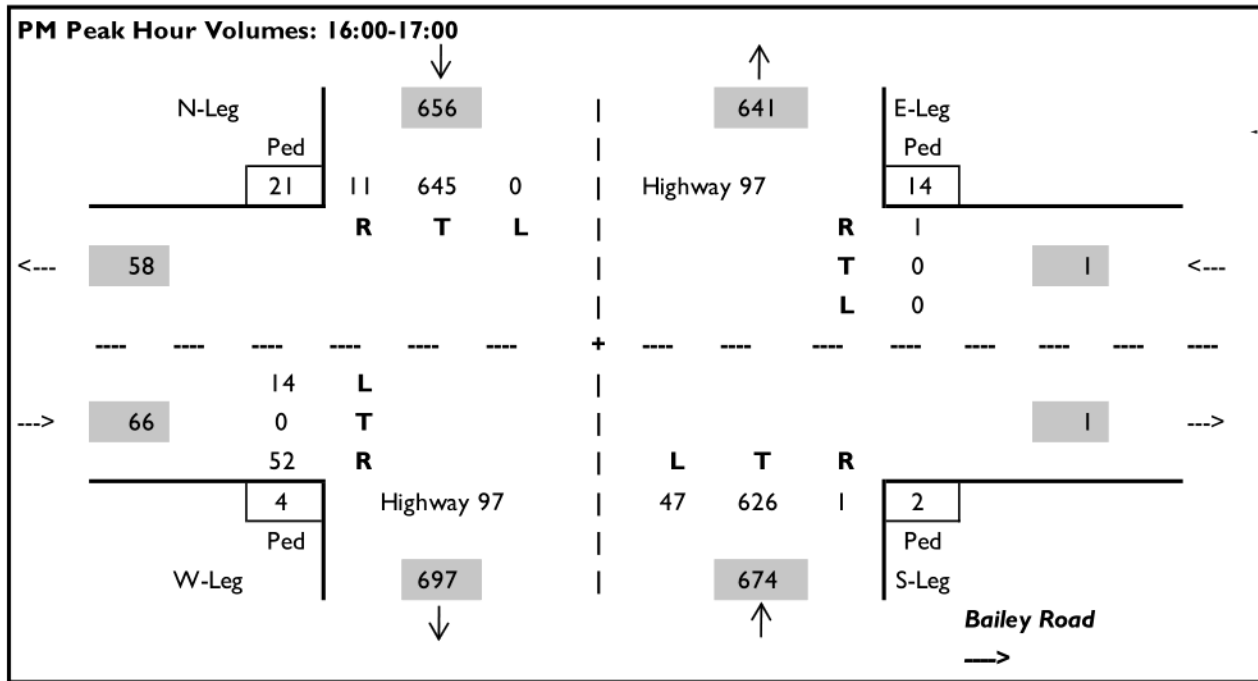
Figure 6.1.1: PM Peak Hour Volumes 16:00-17:00

Peak volumes were observed during the 16:00 hour. Through traffic on Highway 97 is the highest volume movement. Peak hour through volume on Highway 97 was 1271 vehicles.

The left turn movement from Bailey Road onto Highway 97 was recorded at 14 vehicles during the 16:00 peak hour. The right turn movement from Bailey Road heading south towards Lake Country and Kelowna is higher at 52 vehicles during the 16:00 peak hour.

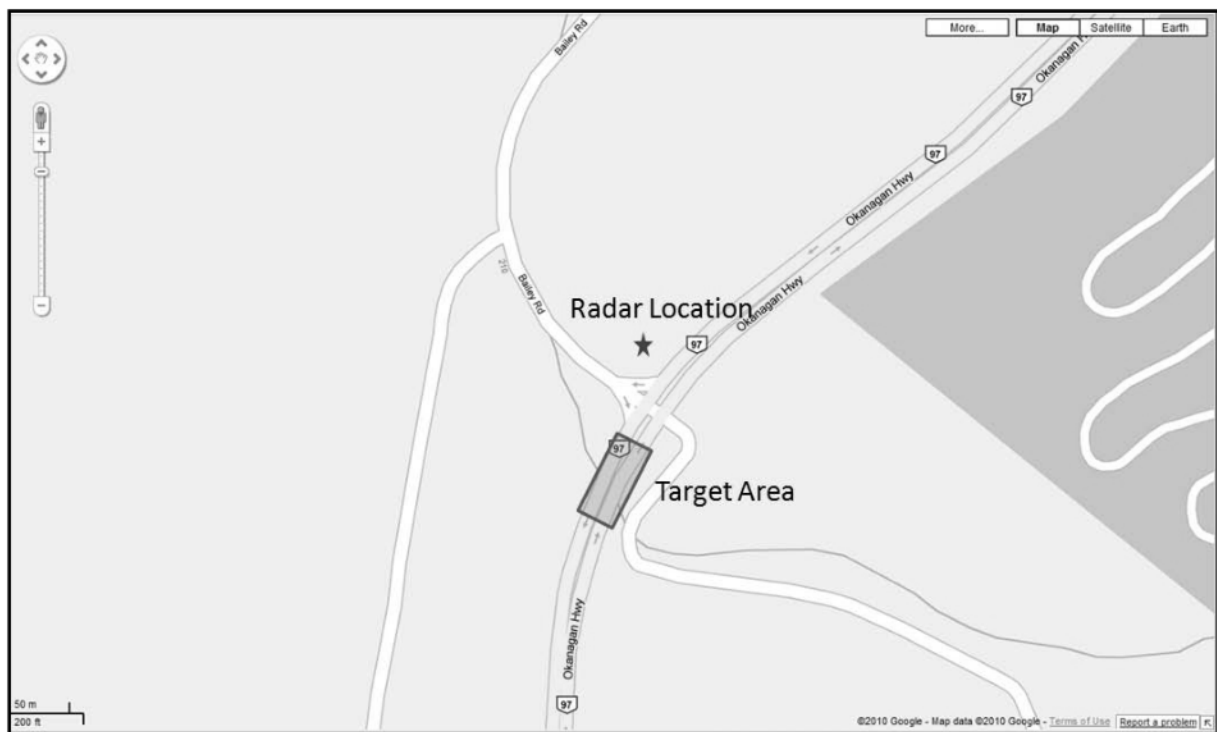
**Figure 8: Speed Survey Target Area**

The 85<sup>th</sup> percentile speed is 108 km/h northbound, 111 km/h southbound and 109 km/h in both directions. The speeds are consistent with other speed surveys conducted in the area surrounding Bailey Road.

Drivers are over-driving on Highway 97 by Bailey Road. The 85<sup>th</sup> percentile operating speeds were 18 km/h to 21 km/h above the 90 km/h posted speed. Less than 15% of drivers in both directions are driving at or below the posted speed limit.

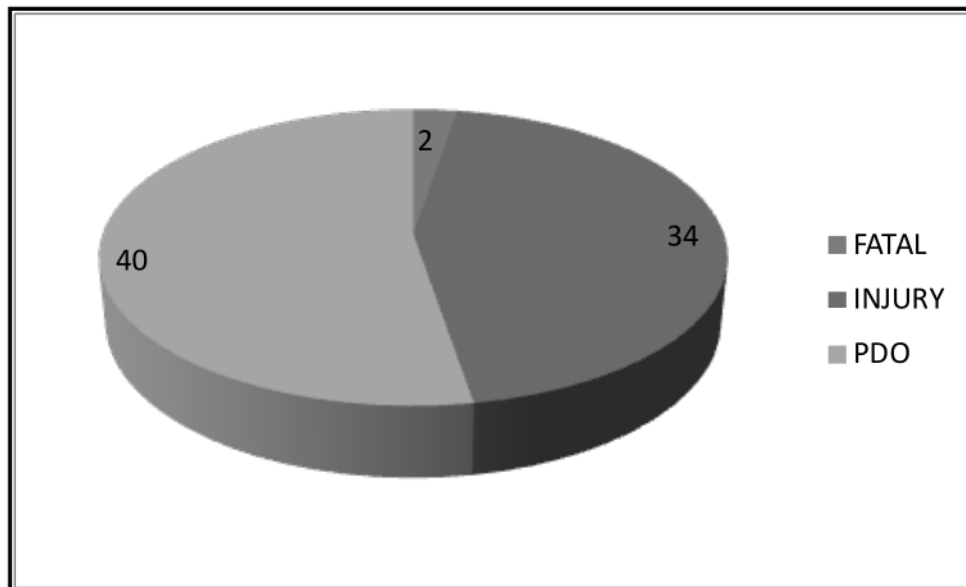
**Figure 9.3.1: Highway 97 and Bailey Road Collision Severity Distribution**

- Fatal: 2 collisions (2.6%)
- Injury: 34 collisions (44.73%)
- Property Damage Only (PDO): 40 collisions (52.6%)

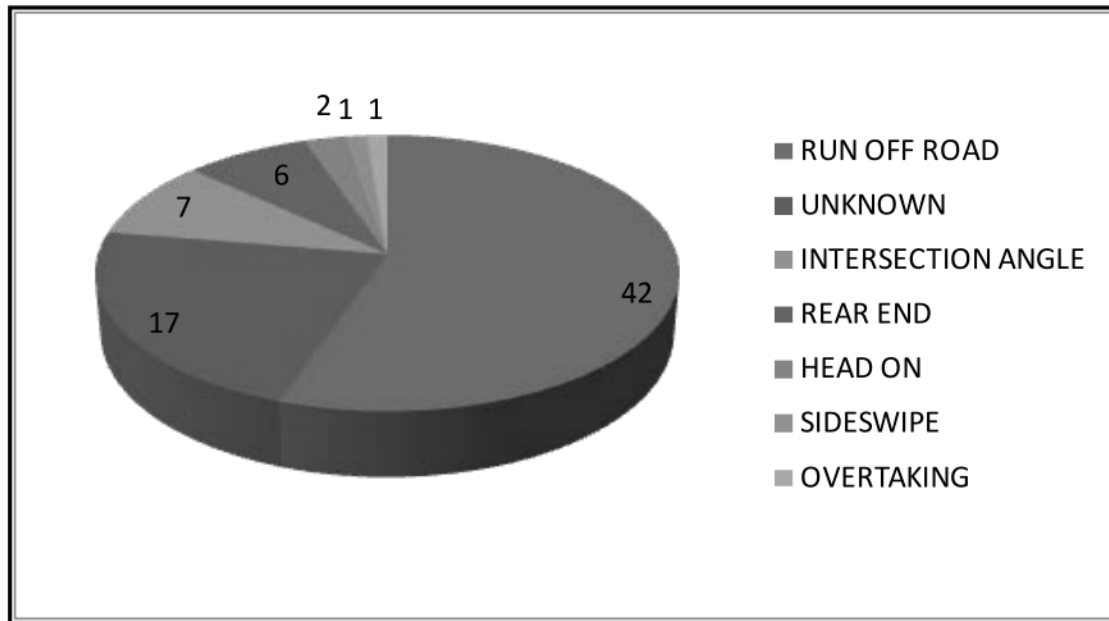
**Figure 9.3.2: Highway 97 and Bailey Road Collision Type Distribution**

Run Off Road is the major collision type. 26 of the Run Off Road collisions have the primary vehicle traveling south, 16 of the Run Off Road collisions have the primary vehicle traveling north. The second most common collision type is of Unknown or uncategorized type.

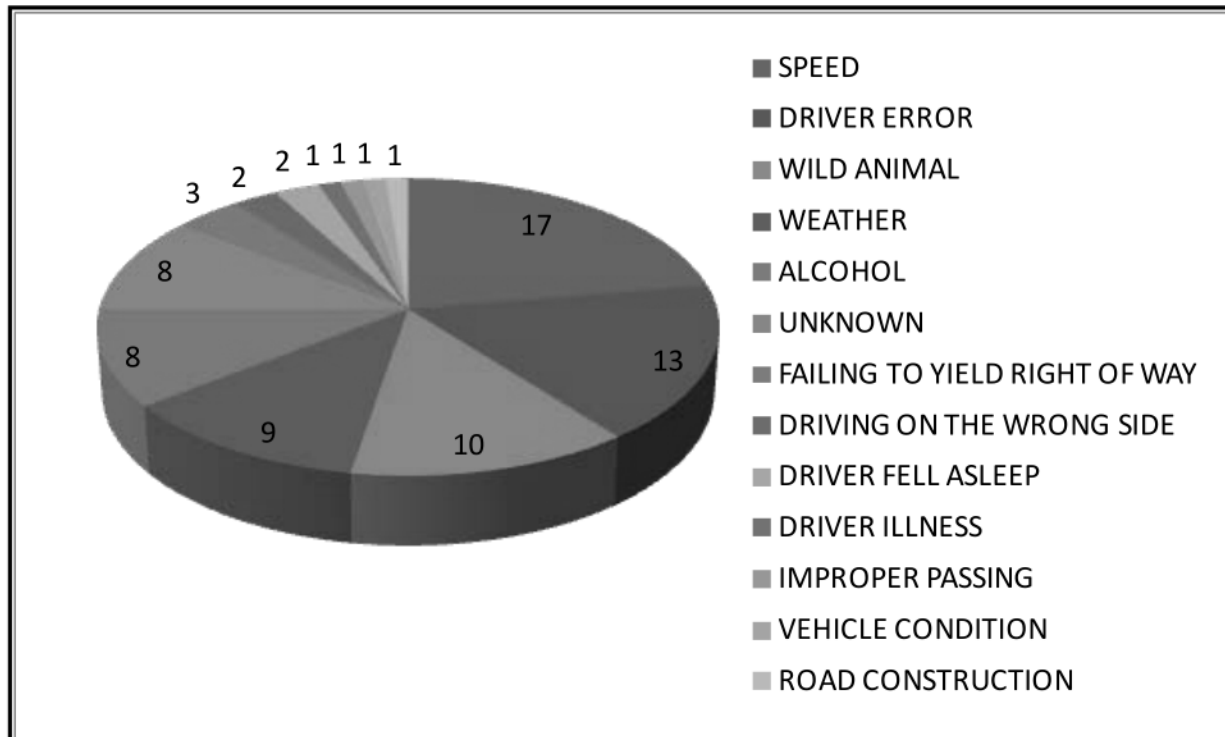
Figure 9.4.1: Primary Collision Contributing Factors

- Speed was the primary contributing factor in 17 (22.4%) collisions
- Driver error was the primary contributing factor in 13 (17.1%) collisions
- Wild animals were the primary contributing factor in 10 (13.2%) collisions
- Weather was the primary contributing factor in 9 (11.8%) collisions
- Alcohol was the primary contributing factor in 8 (10.5%) collisions

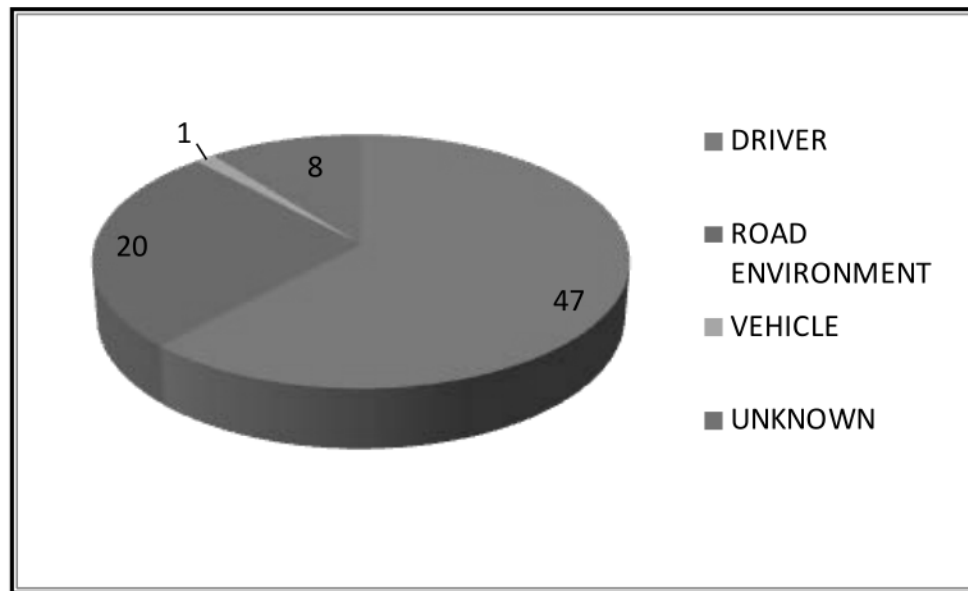
**Figure 9.4.2: Driver, Road Environment and Vehicle Contributing Factors**

- The primary contributing factor was attributed to drivers in 47 (61.8%) collisions
- The primary contributing factor was attributed to road environment in 20 (26.3%) collisions
- The primary contributing factor was attributed to vehicles in 1 (1.3%) collision
- The primary contributing factor was unknown in 8 (10.5%) collisions

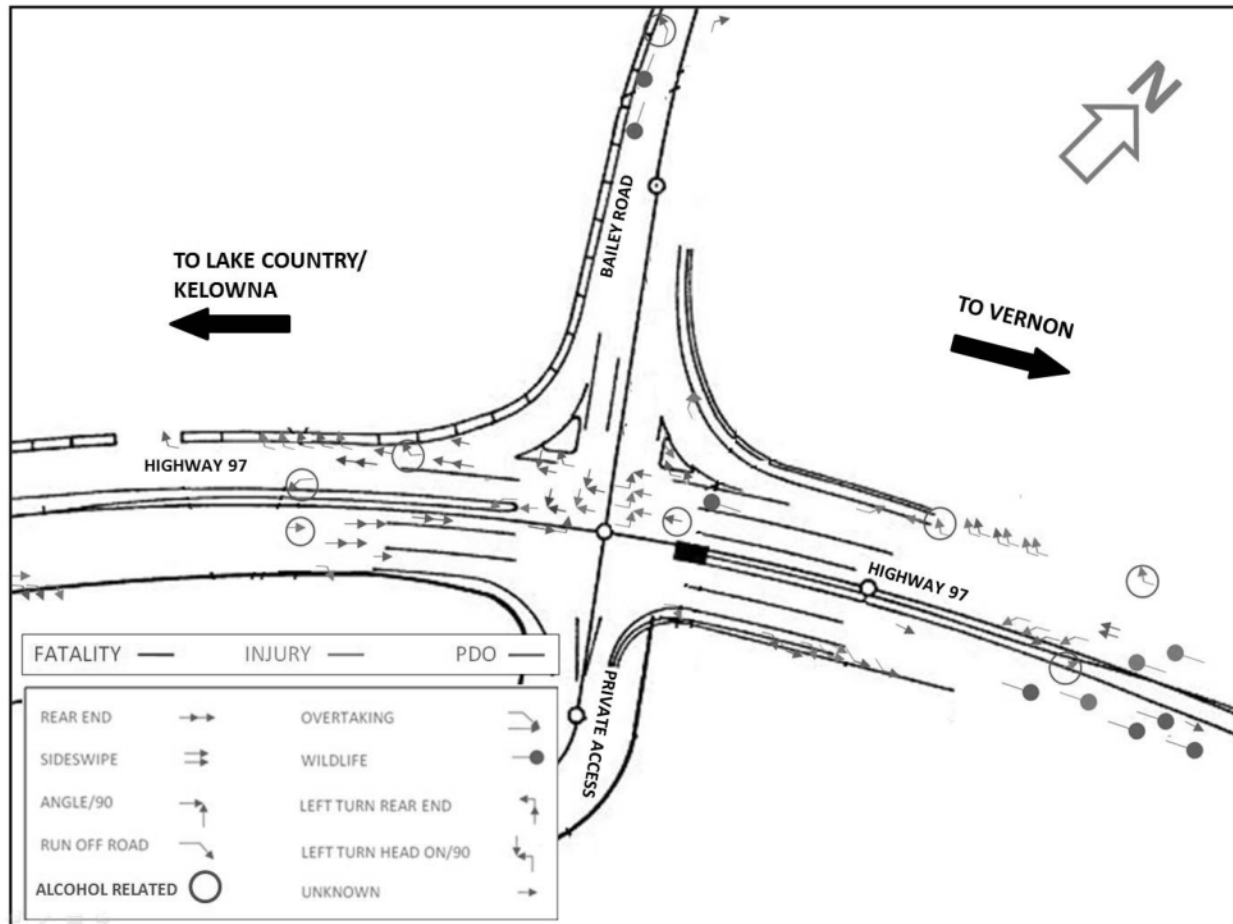
**Figure 9.5: Collision Diagram**

Run Off Road collisions are the major collision type. There is a higher occurrence of Run Off Road collisions than all other collisions combined. The southbound lane has a higher occurrence of Run Off Road collisions than the northbound lane. Run Off roads are occurring by the rock face and guardrail.

It is difficult to say what is causing the Run Off Road collisions. The prevalence of Run Off Road collisions suggest that drivers are performing avoidance maneuvers within the vicinity of the intersection. Lane changes could also be a contributing movement but anecdotally, the lane change movement was not noted to be a common occurrence at Bailey Road. Anecdotally, 3 “close calls” were observed during the Monday, June 28, 2010 traffic counts. These “close calls” involved a vehicle turning right from Bailey Road onto Highway 97 heading towards Lake Country/Kelowna. Southbound vehicles traveling straight through the intersection on Highway 97 were braking or swerving to avoid these vehicles.

It is recommended that speed reader boards be installed in both directions on Highway 97 approaching Bailey Road in an effort to reduce driver speeds. Decreased speeds could lead to a reduction in collision severity and frequency, and provide larger gaps for vehicles turning from Bailey Road.

It is recommended that the conspicuity of the intersection be increased in an effort to target driver error. Intersection conspicuity can be achieved through installation of a flashing beacon, enhancement of the signs at and approaching the Highway 97 intersection, installation of transverse rumble strips and repainting of the pavement markings on Bailey Road.
