BRIDGE MANAGEMENT INFORMATION SYSTEM

Condition Inspection Report

Structure No: 02836E - JULIET EAST

Features Crossed: COQUIHALLA HWY #5 / JULIET CREEK / JULIET CREEK ROAD

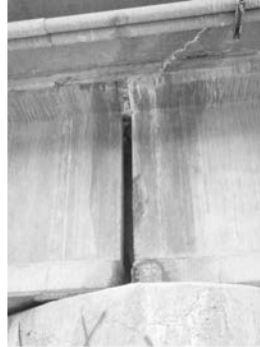
17 Girders

2009 exposed bars at BF in a number of girders particularly at pier 1. Also noted web ends cracked. no exposed strands noted.
2011 no new spalls noted
2012 repaired |

Filename: 2011 at pier #1.JPG

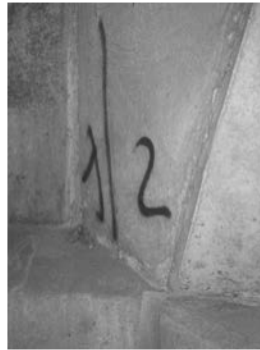
19 Bracing/Diaphragms

| 19 . | Bracing/Diaphragms | 2011 spalls at end diaphragm

Filename: 2011 shows delam.JPG

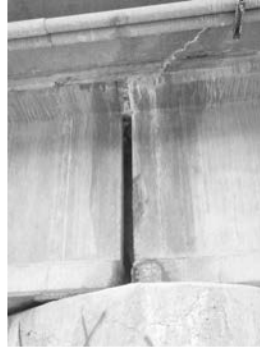
17 Girders

2009 exposed bars at BF in a number of girders particularly at pier 1. Also noted web ends cracked. no exposed strands noted.
2011 no new spalls noted
2012 repaired |

Filename: 2011 at pier #1.JPG

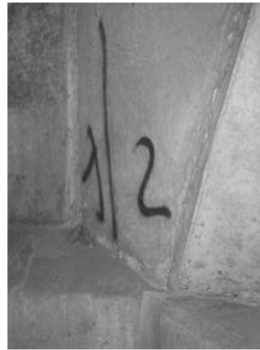
19 Bracing/Diaphragms

| 19 . | Bracing/Diaphragms | 2011 spalls at end diaphragm

Filename: 2011 shows delam.JPG

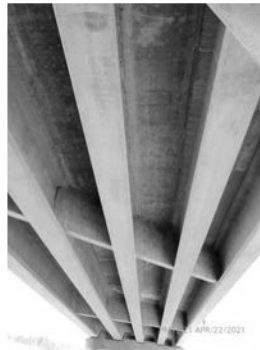
17 Girders

Filename: 036 02836E span 2
subdeck looking north.JPG

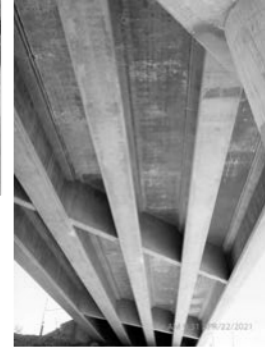
- span 1 extensive map cracking with efflorescence
- span 2 numerous patches ,delaminations ,map cracking and efflorescence
- span 3 areas of heavy efflorescence and map cracking

Filename: 045 02836E span 3 bay 3 efflorescence and delams in the subdeck.JPG

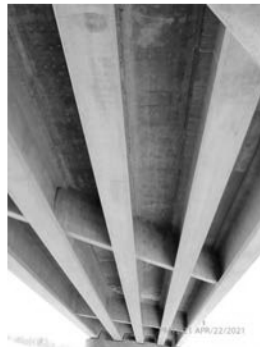
Filename: 044 02836E span 3 looking north eff and cracking in bay 4 at pier 2.JPG

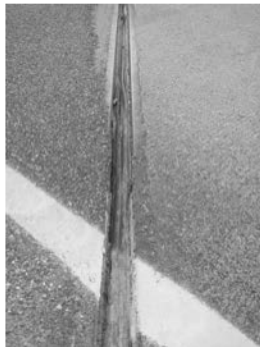
32 Deck Joints

2012 south joint pushed in, leaks
 2013 fast lane south joint squeezed down
 2014 tried to find leak at pier 1 joint area using pails of water. No leak detected
 2016 - water apparent on south abutment seat. this seal is completely pushed through in fast lane
 2017 - above condition worsens

Filename: 2012 joint 1 failure.JPG

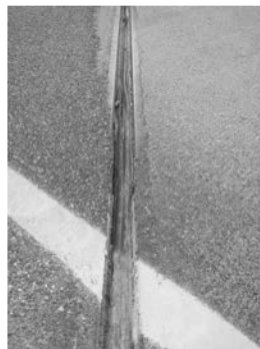
32 Deck Joints

Filename: 2012 joint 1 failure.JPG

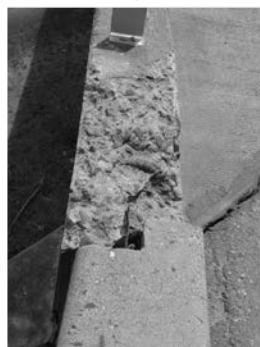
35 Railings/Parapets

Spall on top of parapet at NE corner.
 2009 - one chair loose and one rail bolt missing
 2012 spall noted above has worsened

Filename: 2012 parapet defect.JPG

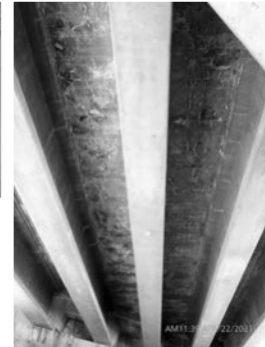
Filename: 043 02836W span 3
girder C eff and fine vertical crack in
the web of the girder.JPG

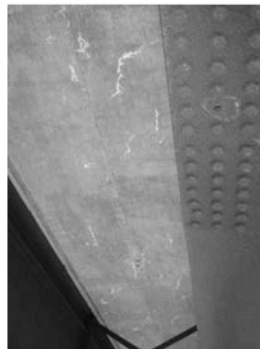
- 26 Pins/Bolts/Rivets

Filename: (02837W)2011
undersized bolt.JPG

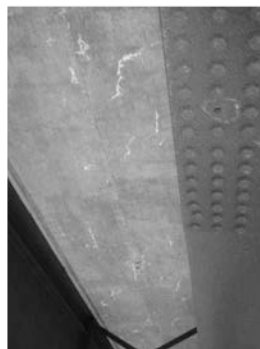
- 26 Pins/Bolts/Rivets

Filename: (02837W)2011
undersized bolt.JPG

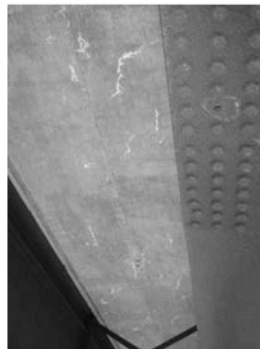
- 26 Pins/Bolts/Rivets

Filename: (02837W)2011
undersized bolt.JPG

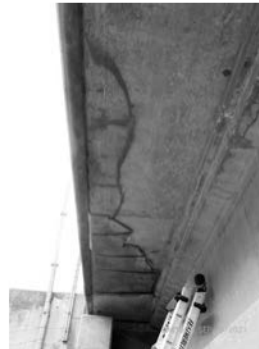
Filename: 053 02840W span 1 west side delams in the soffit.JPG
