**Tree Risk Assessment, &  
Cultural Modified Trees  
Identification, Initial Data  
Collection and Reporting  
Gulf Islands National Park  
Reserve of Canada  
Canal Road  
Pender Island, B.C.**

2022-04-11 | Revision #0

Submitted to: Ministry of Transportation and  
Infrastructure Contract: 851 CS 1013A  
Prepared by: McElhanney

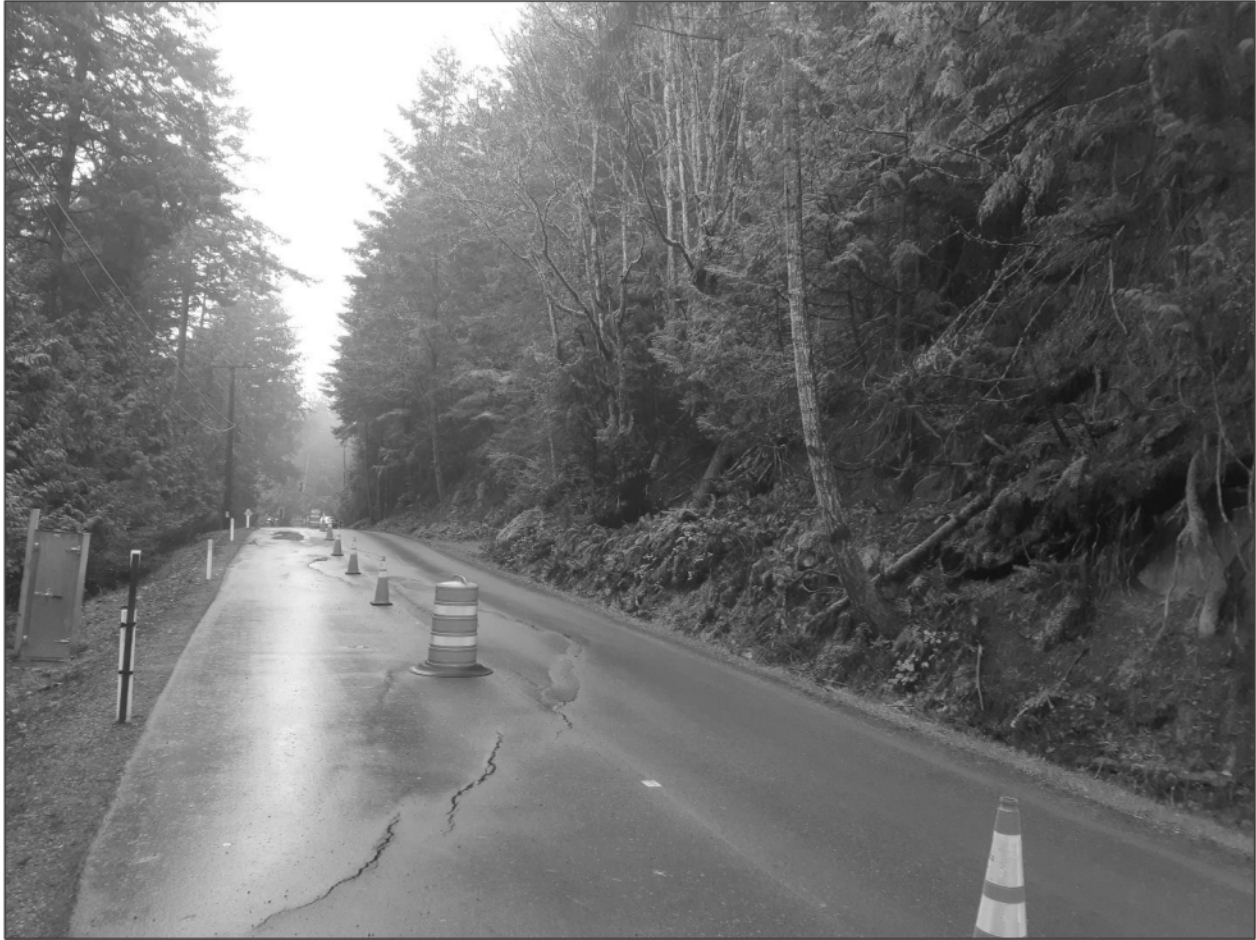
This assignment is designed to support the upslope realignment and emergency recovery of the Canal Road due to a potential landslide. The pavement cracks are benign monitored and the traffic on this section of Canal Road is restricted to one lane alternate, one car only at the time (see Figure 2). This potential landslide and the pavement cracks are located near the Gulf Islands National Park Reserve of Canada boundary (latitude: 48.75938; longitude: -123.22617), but the proposed road realignment location is inside the park boundary and into a private lot to the West.

*Figure 2. Canal Road on South Pender Island, BC - image of the longitudinal pavement crack and steep terrain above the road (view from the West to the East).*

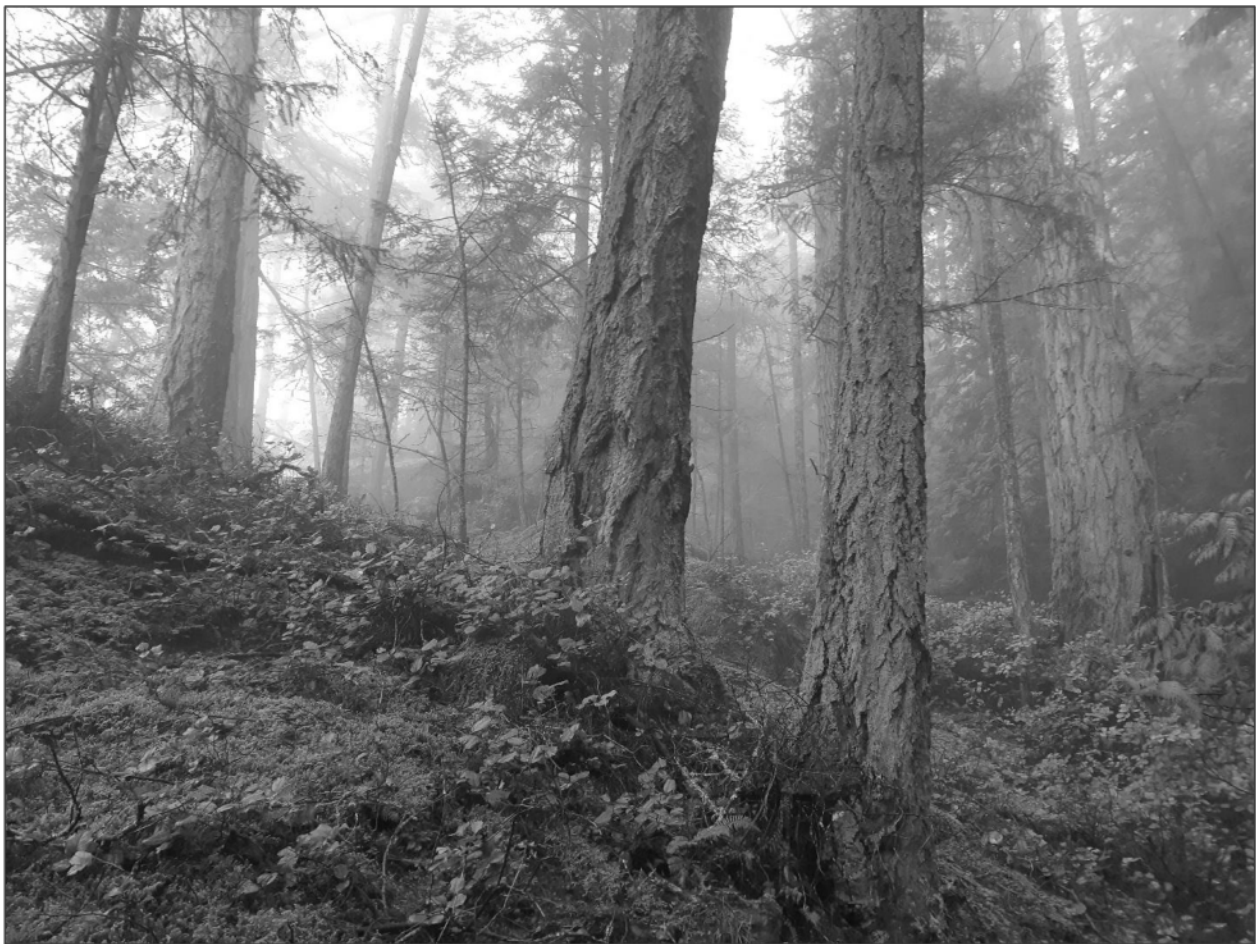
*Figure 3. Spotted areas with old growth characteristics were identified.*

The subject site that is approximately 2.5 hectares in size consists of a second growth natural regenerated forest stand in the Coastal Douglas-fir Biogeoclimatic zone, Moist Maritime (mm) subzone with a combination of 01, 04 and 06 variants (Land Management Handbook 28, 1994). The terrain is variable sloping 10 to 150% North, with some areas appears to be unstable. The soil is in general shallow on the steeper sections and deeper at the base of slope near the road at the eastern half. The multi-layer forest stand is composed of 50% Douglas fir, 40% Western redcedar, 5% red alder and 5% bigleaf maple. The range of heights for the mature trees is 12 to 34 m, the range of tree diameters is 18 to 90 cm. The estimated age of the stand is more than 90 years with some trees acquiring old growth characteristics (see Figure 3). This stand appears to be spot burned more than 90 years ago (estimated).

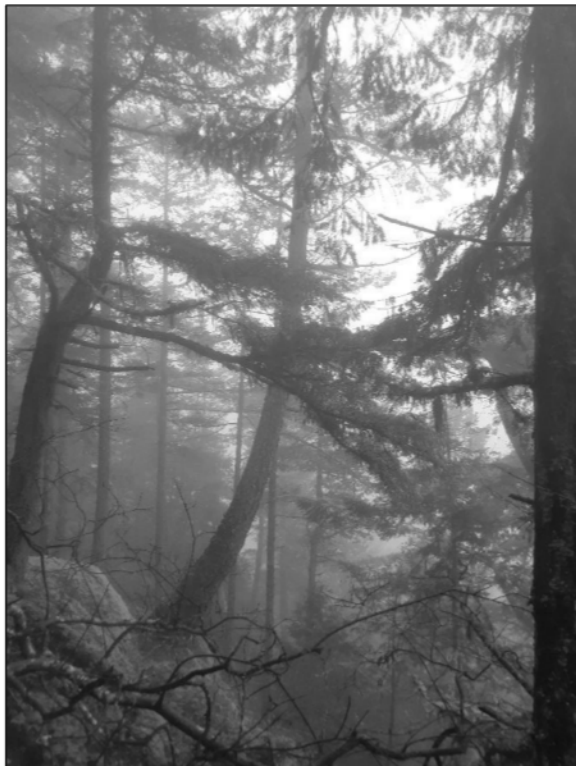
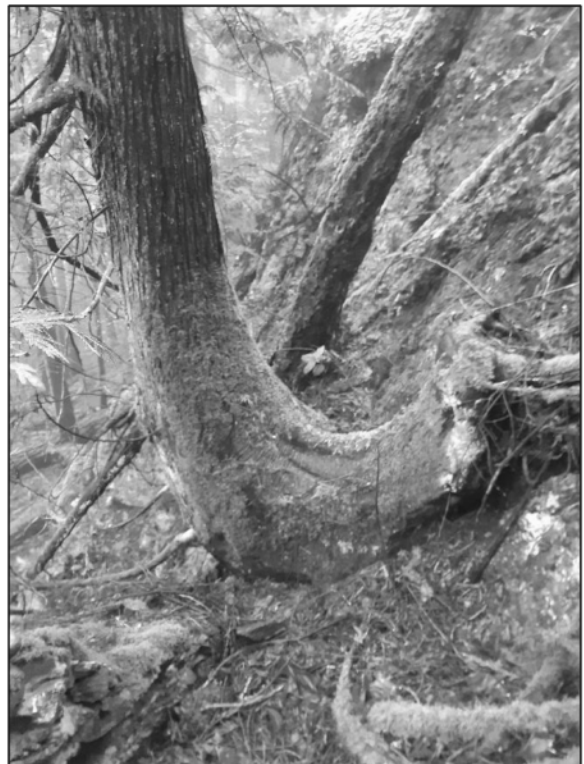
During the site visit I observed signs of unstable terrain like trees with “pistol butts” and large pieces of rock that appear have rolled from above (see figures 4 and 5).

*Figure 4 and 5. Trees with their structure and overall form that has been impacted by unstable terrain.*

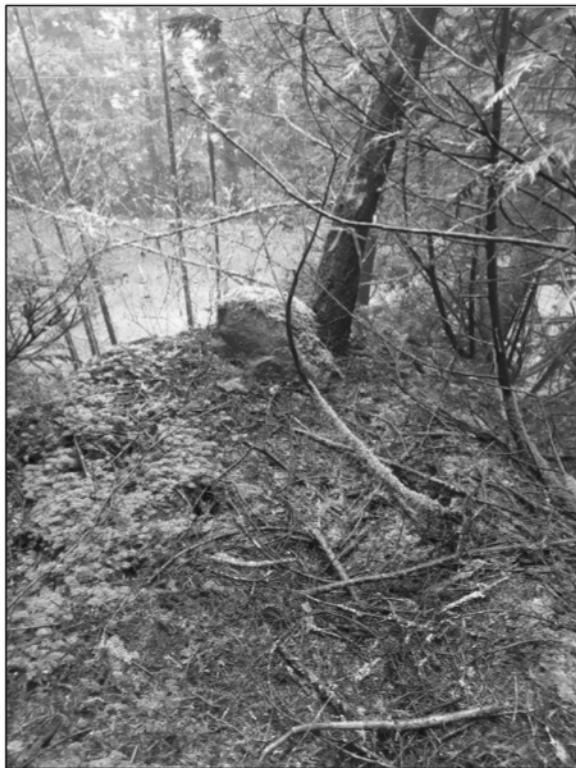
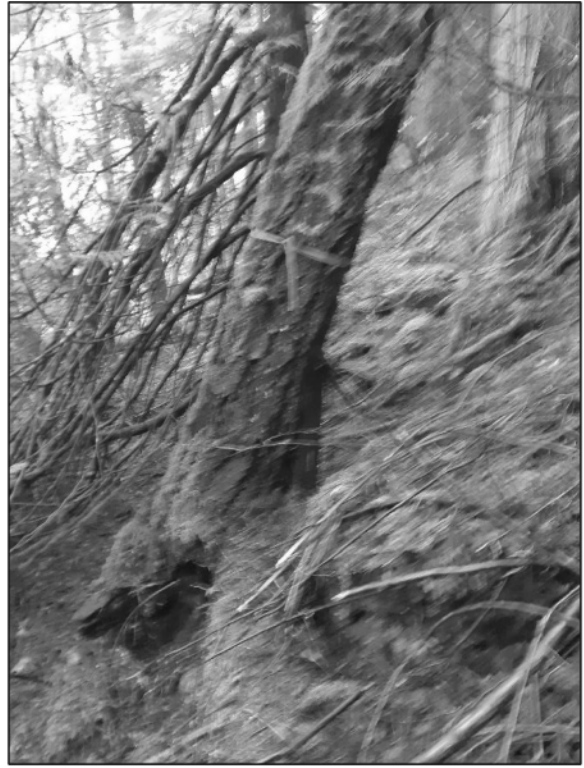
These trees were assessed for risk, on a limited visual assessment basis, and in the context of the current land uses. Two trees were deemed to be danger trees that would require hazard abatement to eliminate present and/or future risks (within a 1-year timeframe of the tree inventory or before any significant storm event) (see Figures 6 & 7).

*Figure 6 and 7. Tree #2 and tree #3 proposed for removal.*

- **Remove tree #2** with a dislocated root plate and leaning over the road.
- **Remove tree #3** with a pronounced lean and decayed roots. This tree is leaning SW on the adjacent tree. Despite the "very low risk" LOD, we recommend removal concurrent with tree #2.

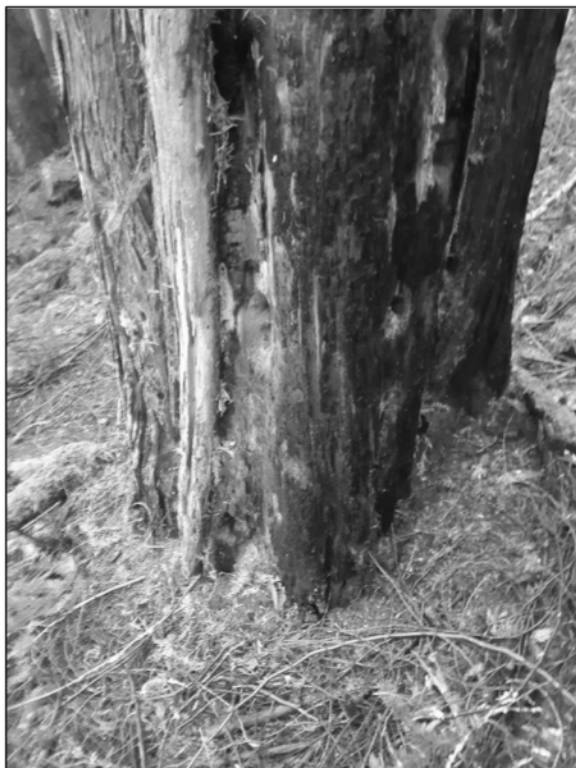
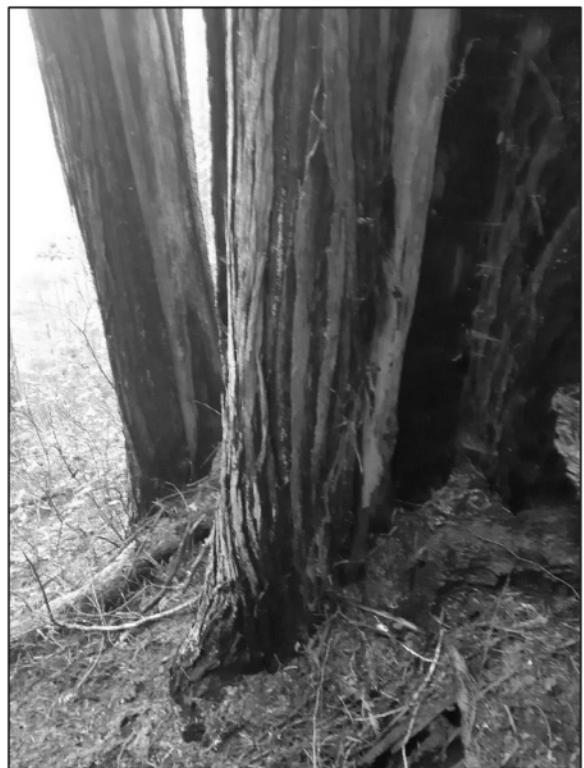
During the site visit, both tree assessment areas "A" and "B" were surveyed for CMTs. The large component of mature Western redcedar and the proximity to the ocean is favorable for creation of CMTs, however I was not able to identify with certainty any trees that qualify under this category. I identified Western redcedar trees with similar scars as CMTs, but in my opinion those scars were produced by partial root rot and surface fires or other mechanical factors like falling trees or rolling rocks. Some trees present scars that were completely closed so, I was not able to identify any marks produced by tools. To document these findings, I attached photographs taken during my site visit (see Figure 8, 9, 10 and 11).

*Figure 8 and 9. Trees with their structure and overall form that has been impacted by responses to historical damage and stress, no conclusive CMT identified.*

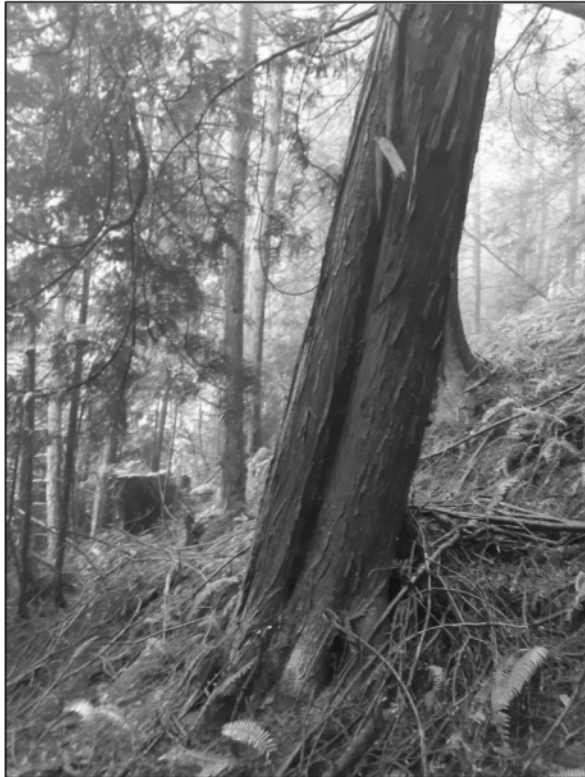
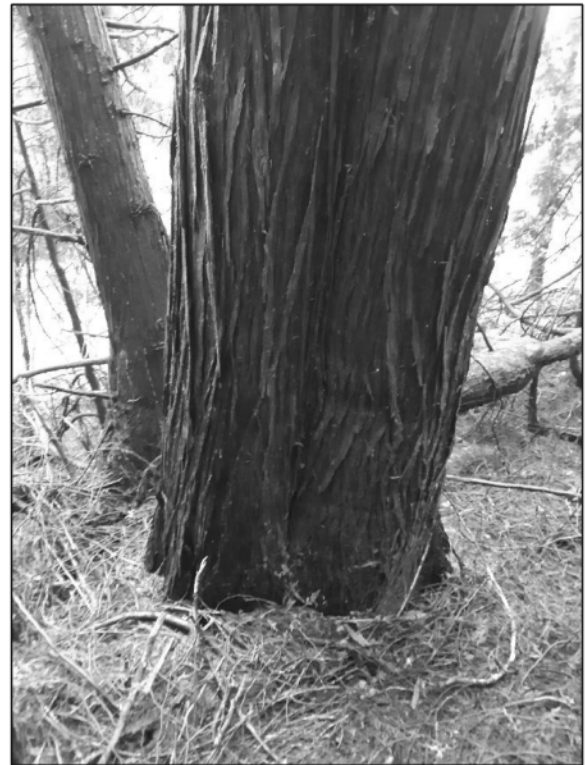
*Figure 10 and 11. Trees with their structure and overall form that has been impacted by responses to historical damage and stress, no conclusive CMT identified.*

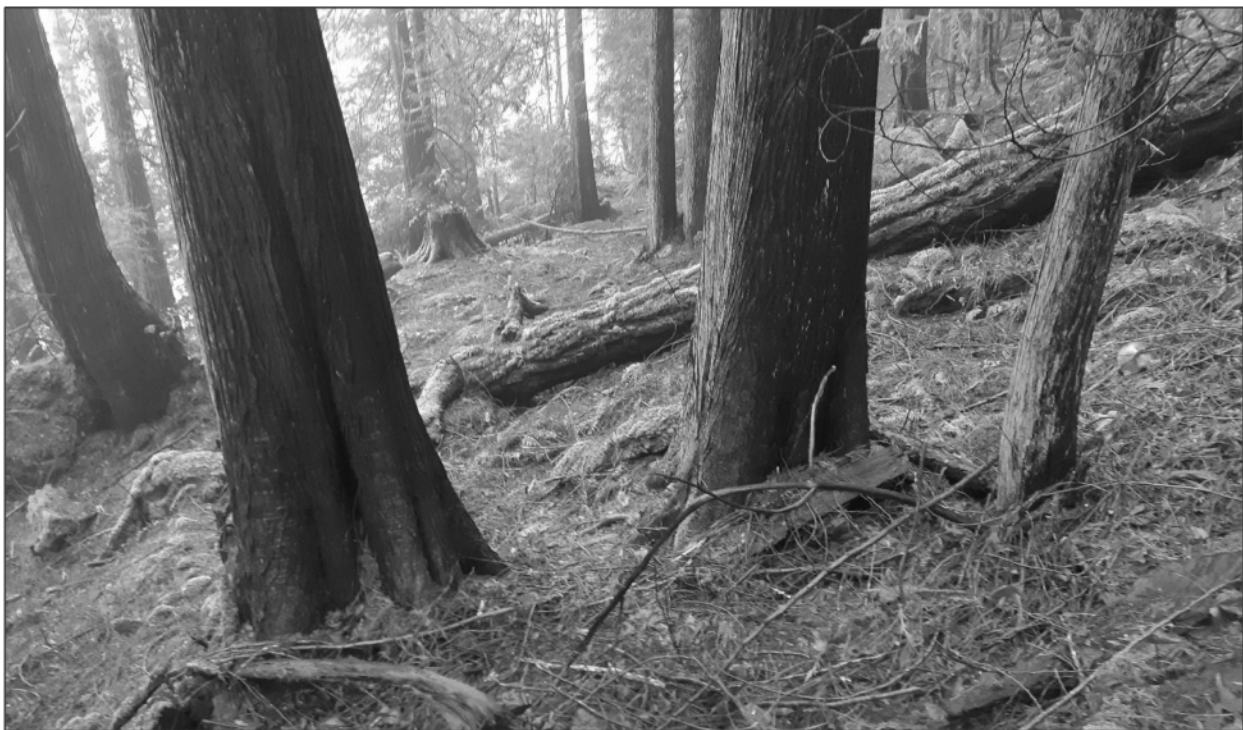
*Figure 12. Image of the interior of the forest stand with a large Western redcedar component.*

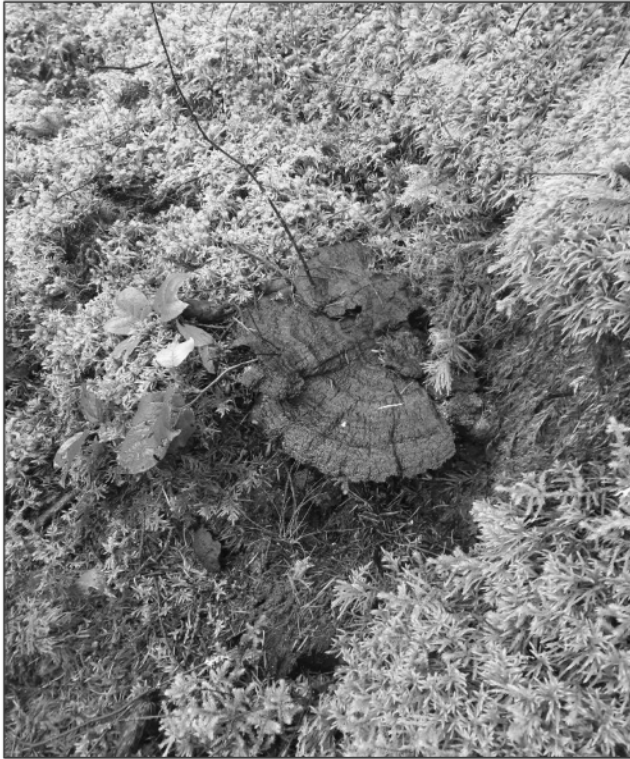
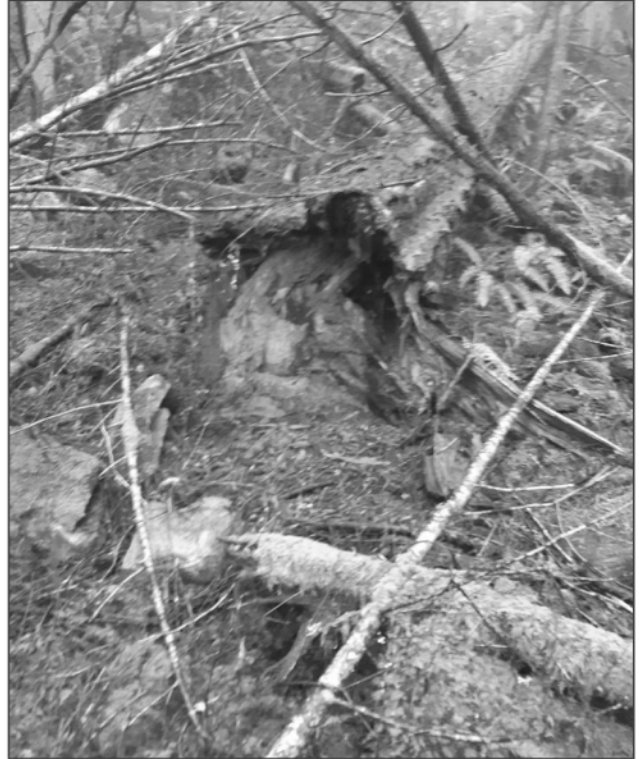
Signs of laminated root rot, Schweinitzii root and butt rot were also identified. This aspect needs to be taken in consideration when selecting trees to be retained along the proposed new forest edge.

*Photo 9 & 10. Signs of Schweinitzii root and butt rot were identified.*

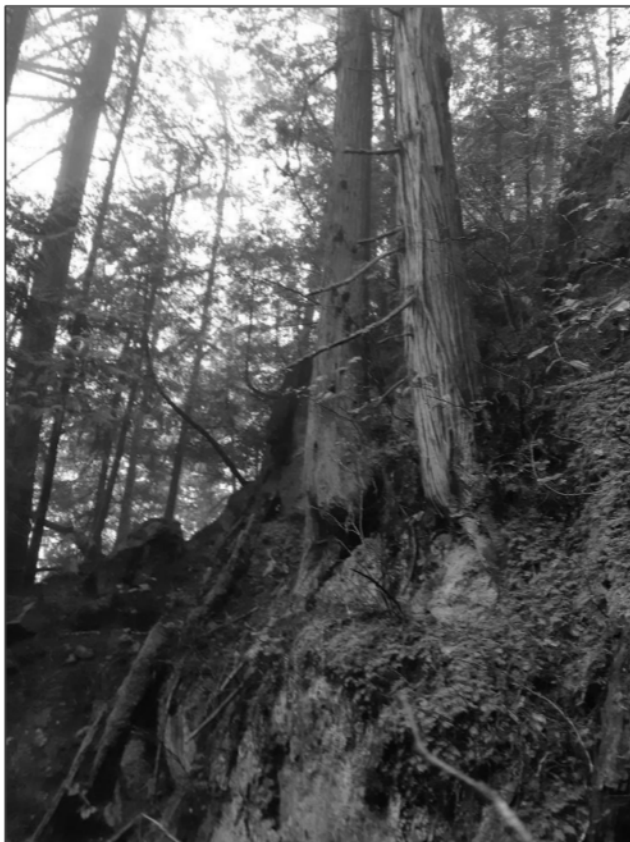
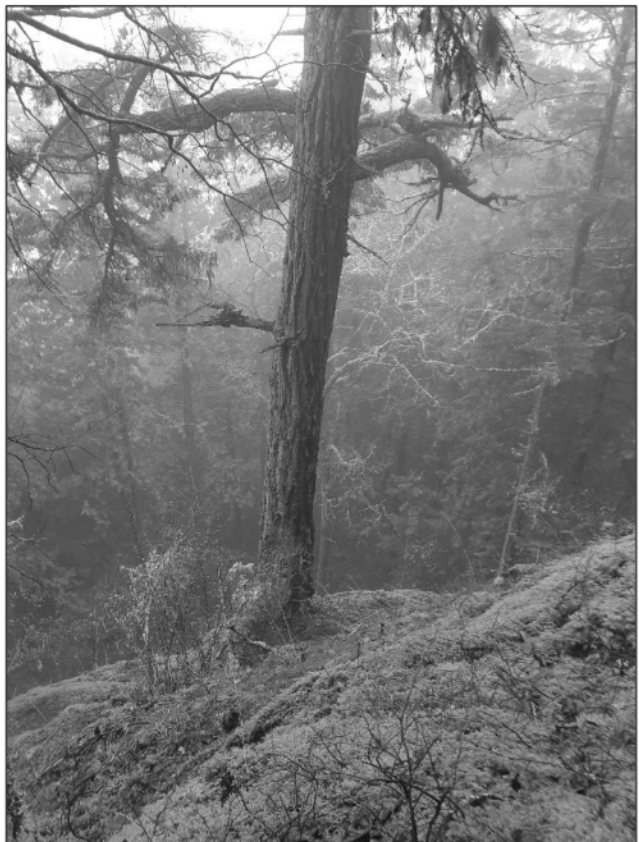
*Photo 11 & 12. Trees growing on superficial soil, overview image.*

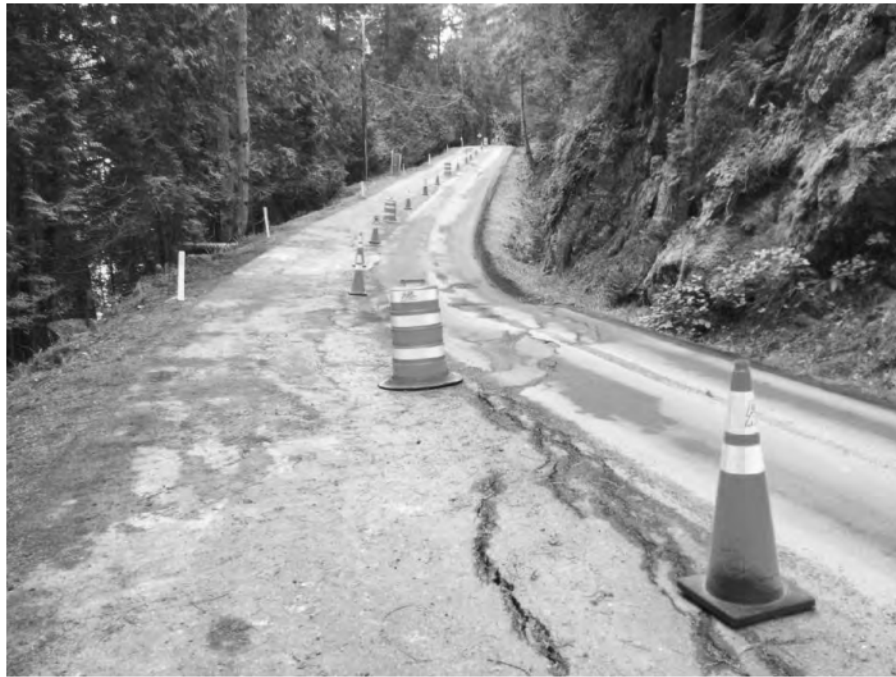
**Photo 1** Canal Road - western limit of site with road failure observed. Photo taken looking east on February 17, 2022.

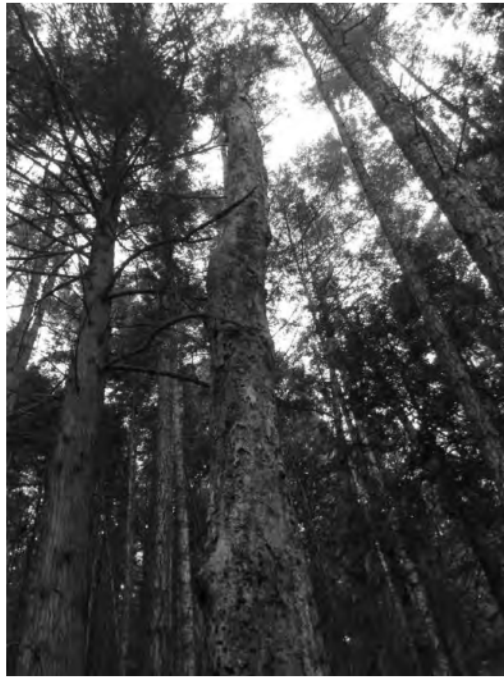
**Photo 11** Wildlife tree (decay class ~7) with visible holes. Photo taken looking south on February 17, 2022.
