To
Alfred Ho, P.Eng., MBA - Asset Management Engineer
**Ministry of Transportation and Infrastructure
(MOTI)**

Re
06880 Canal Road Bridge:
Substructure Renewal Recommendations

Date
November 16, 2020

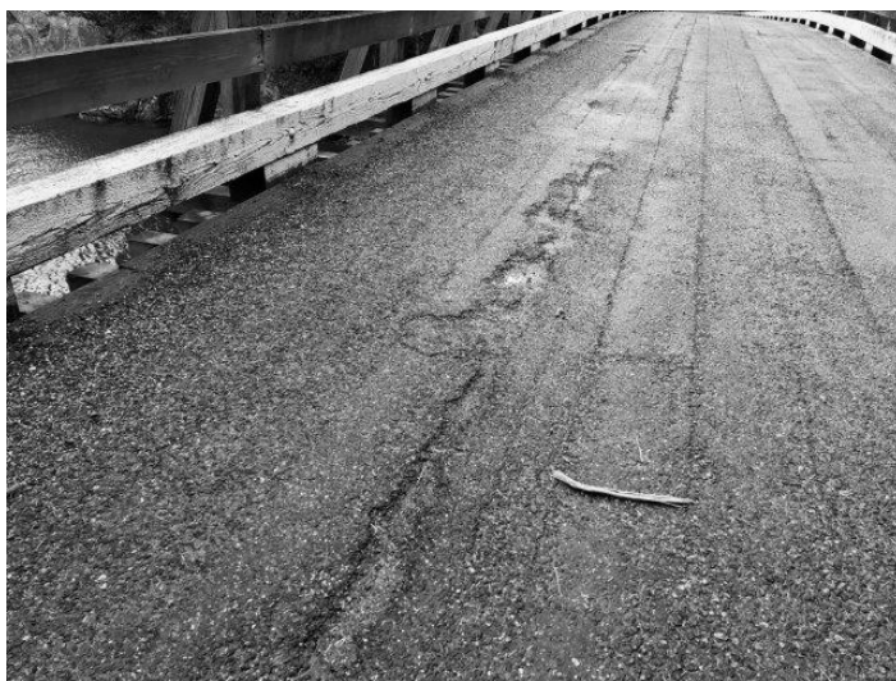
Photo 4 – Deterioration of Asphalt Wearing Surface

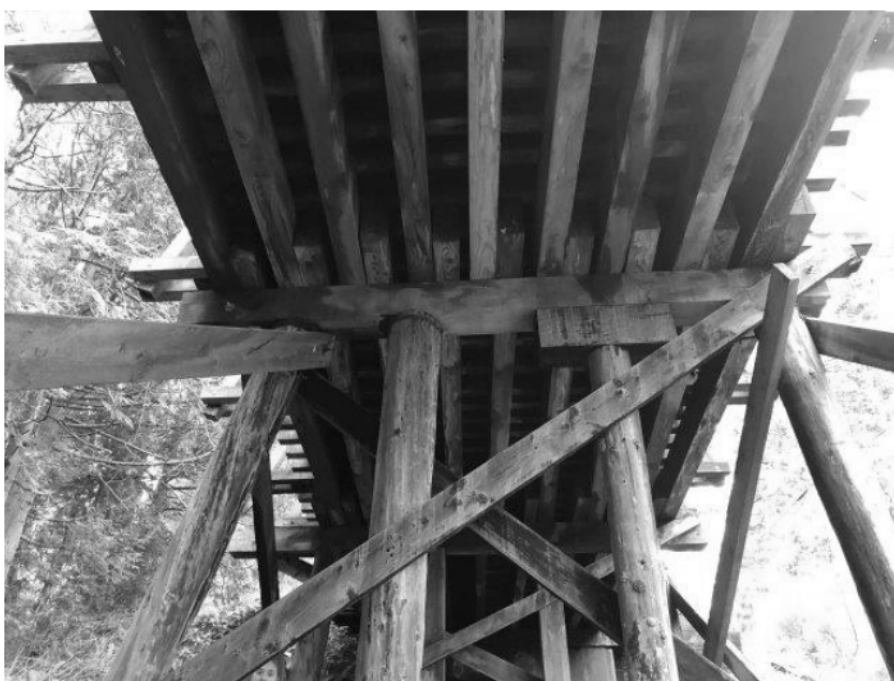
*Photo 8 – Pier 2 Typical View
(sub-cap installed under Pile B, second from east [right] side)*

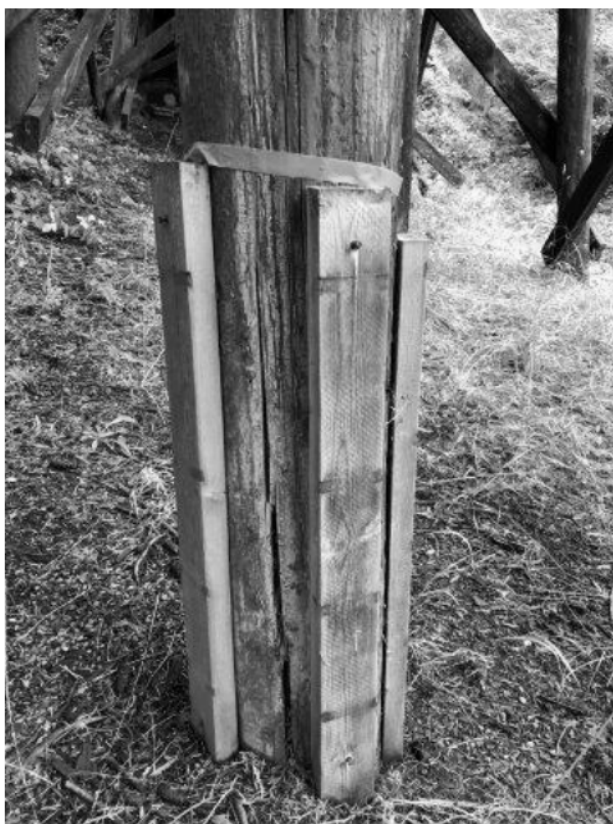
Photo 12 – Pier 4 Failed Pile Clamp Repair

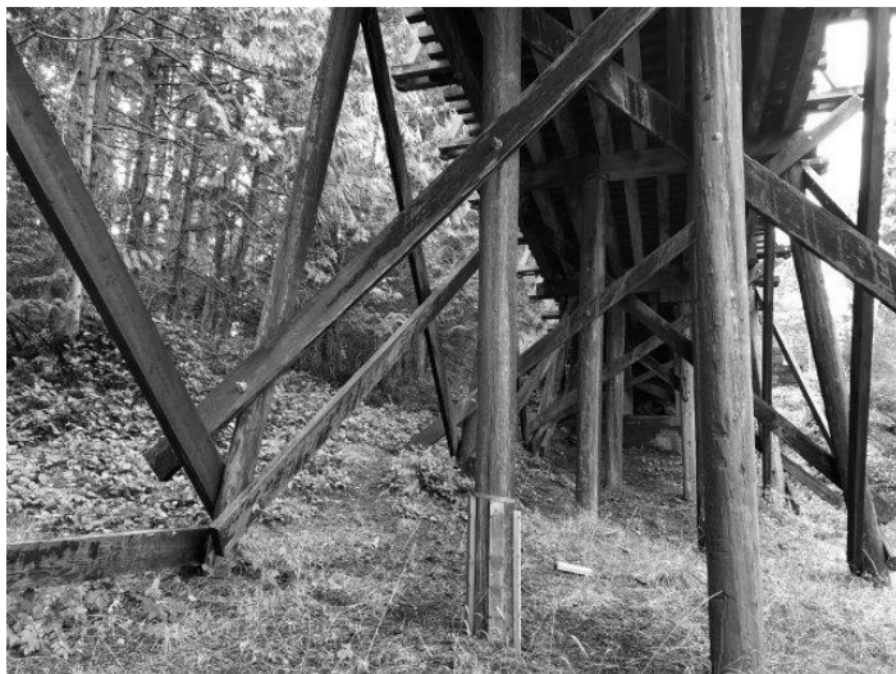
Photo 13 – Pier 4 Substructure Piles at Groundline

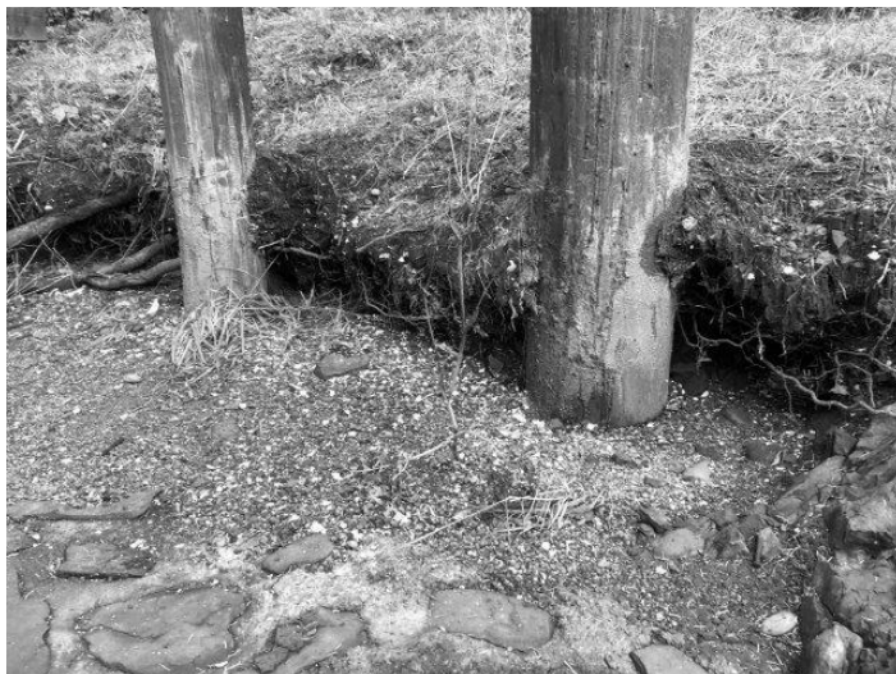
Photo 15 – Pier 5 Erosion at Base of Piles

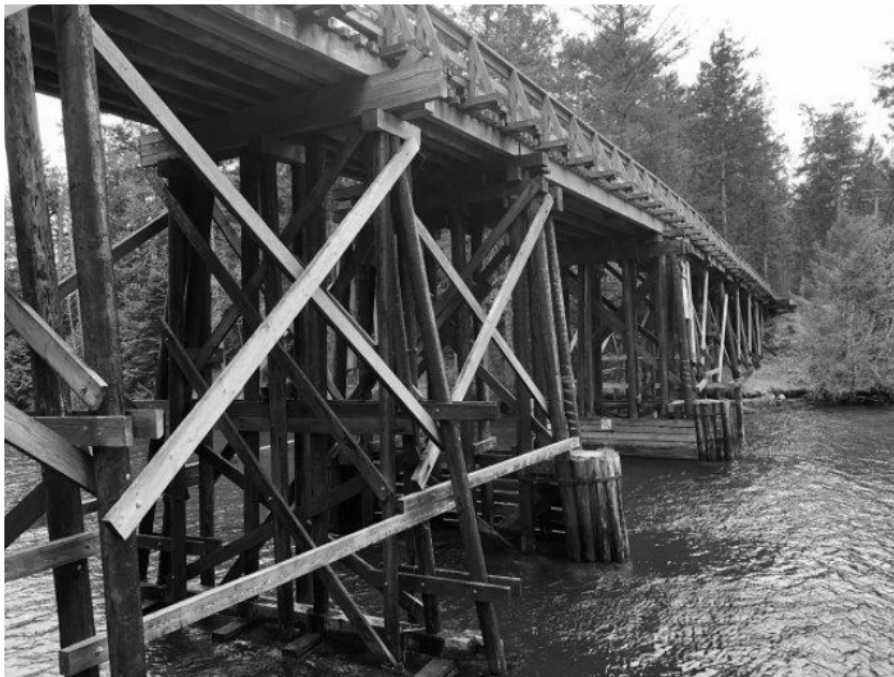
Location	General Description of Condition	Recommended Action Items
Pier 6	<ul style="list-style-type: none"> Typical water ingress and minor localized surface fungal decay of the exposed timber elements (<i>Photos 17 to 18</i>). Previous WorleyParsons report identified significant deterioration of the timber piles in the submerged zone due to marine borer activity. 	Substructure Renewal
Pier 7	<ul style="list-style-type: none"> Typical water ingress and minor localized surface fungal decay of the exposed timber elements. Previous WorleyParsons report identified significant deterioration of the timber piles in the submerged zone due to marine borer activity (<i>Photo 19</i>). 	Substructure Renewal
Pier 8	<ul style="list-style-type: none"> Typical water ingress and minor localized surface fungal decay of the exposed timber elements. Previous WorleyParsons report identified significant deterioration of the timber piles in the submerged zone due to marine borer activity (<i>Photo 20</i>). 	Substructure Renewal

Photo 20 – Piers 8 to 10, North Face, Looking Towards North Abutment

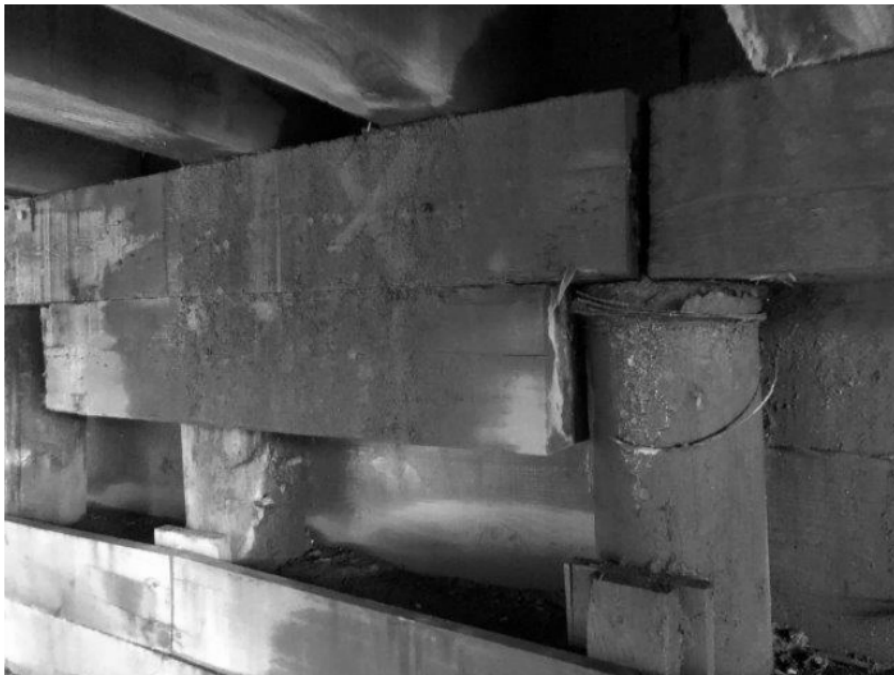
Location	General Description of Condition	Recommended Action Items
South Abutment	<ul style="list-style-type: none"> Minor gaps in timber bulkhead wall with backfill water ingress. Typical water ingress and staining of timber deck and stringers (<i>Photo 27</i>) Minor slope failures of adjacent slope area. Pile cap and corbel block are not adequately secured (<i>Photo 28</i>). 	Install Steel Straps Between Adjacent Pile Cap Sections and Corbel Block.

Photo 28 – Pile Cap and Corbel Block Inadequately Secured

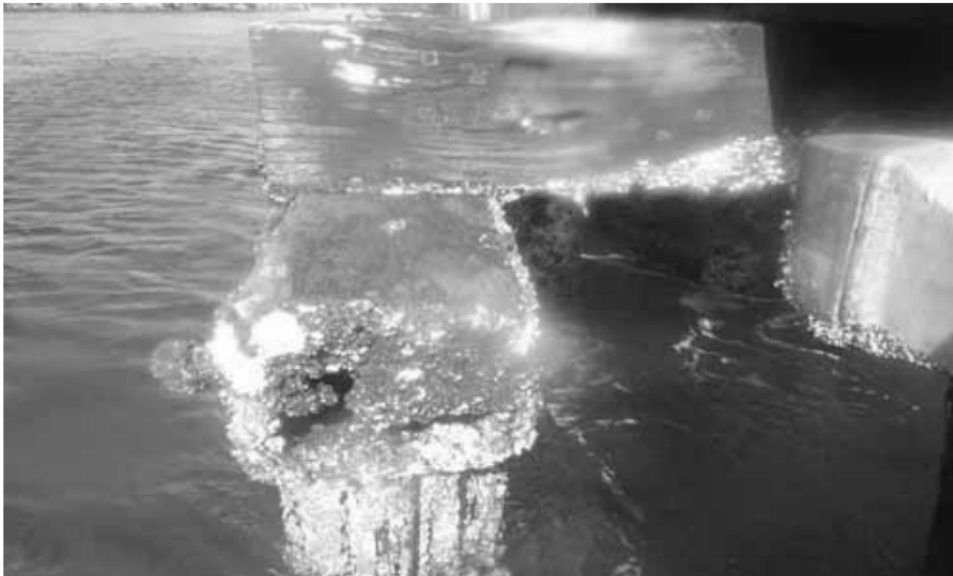
Photo 5: Canal Bridge No. 6880 - severe fungal decay to the southwest sub-cap on Pier No. 6.

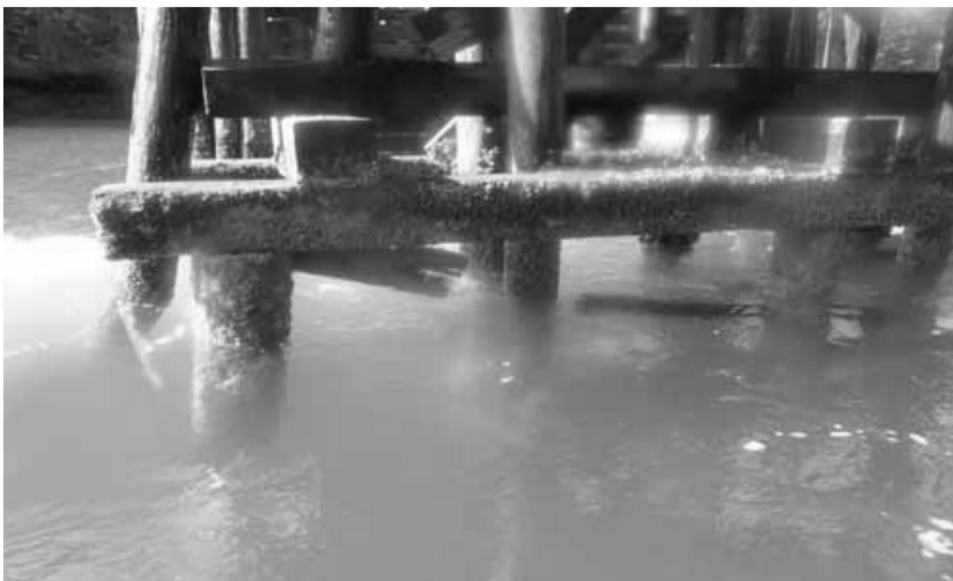
Photo 6: Canal Bridge No. 6880 - typical minor fungal decay to the pile caps on Pier No. 6.

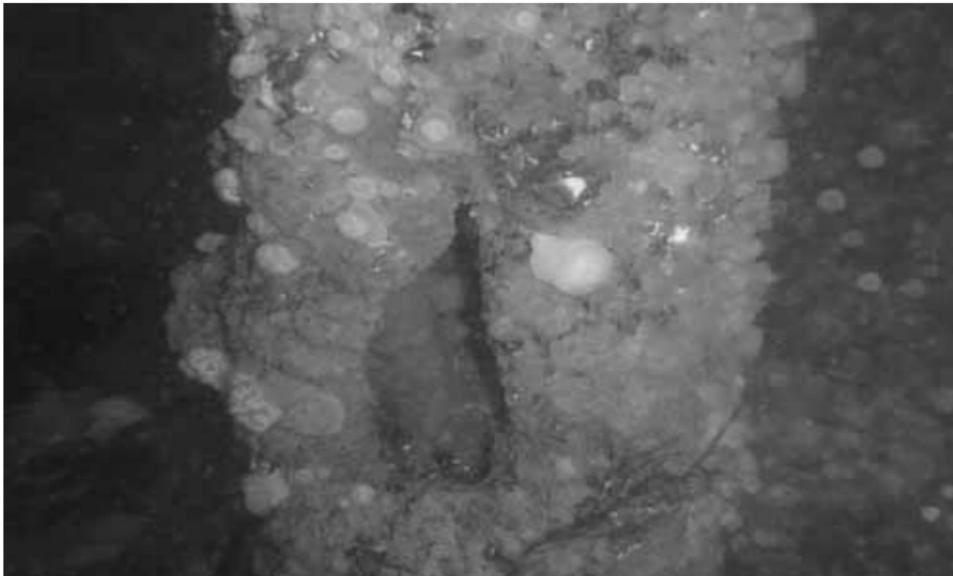
Photo 7: Canal Bridge No. 6880 - marine borer cavity on Pile No. 4 on Pier No. 6.

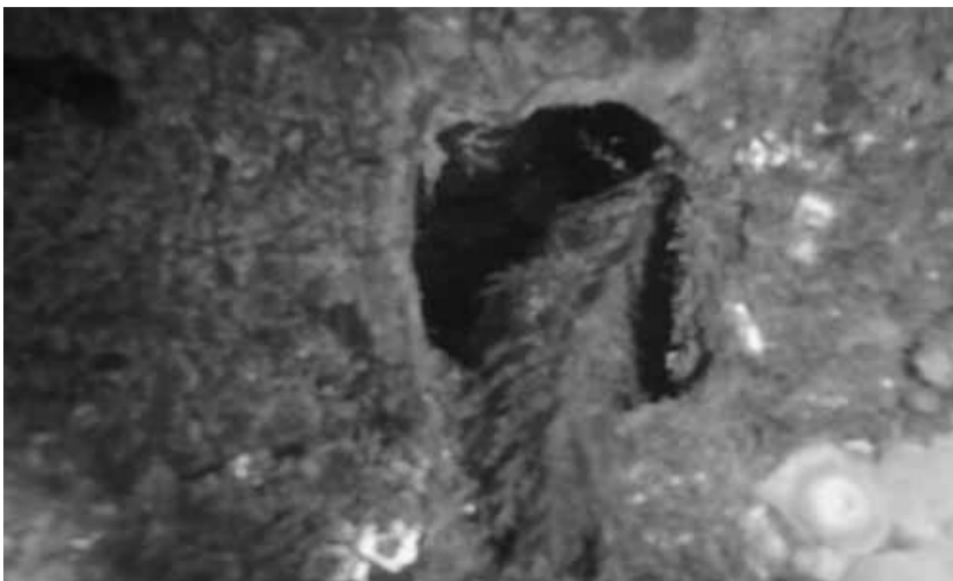
Photo 8: Canal Bridge No. 6880 - severe deterioration due to marine borer attack on Pile No. 9 on Pier No. 6.

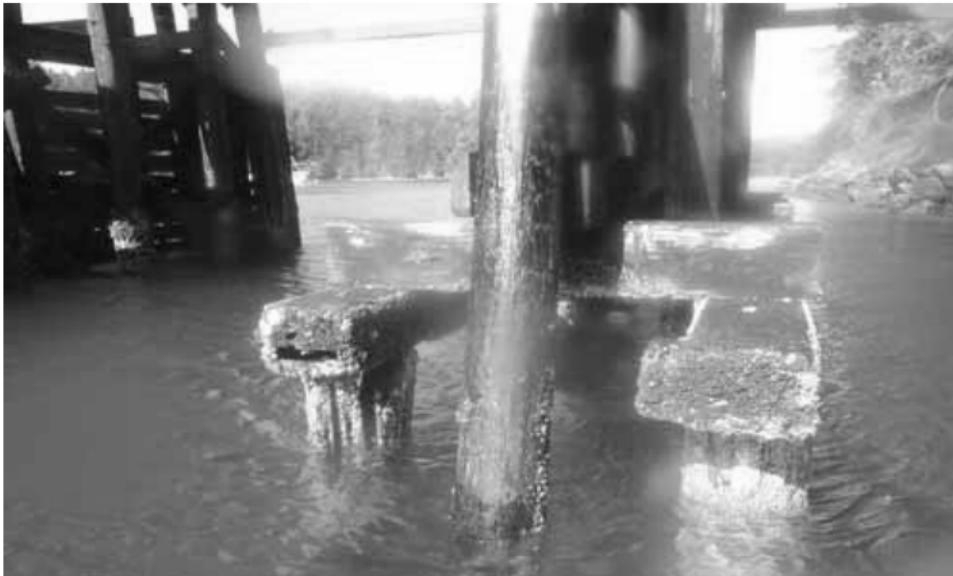
Photo 9: Canal Bridge No. 6880 - severe deterioration due to marine borer attack on Pile No. 13 on Pier No. 6.

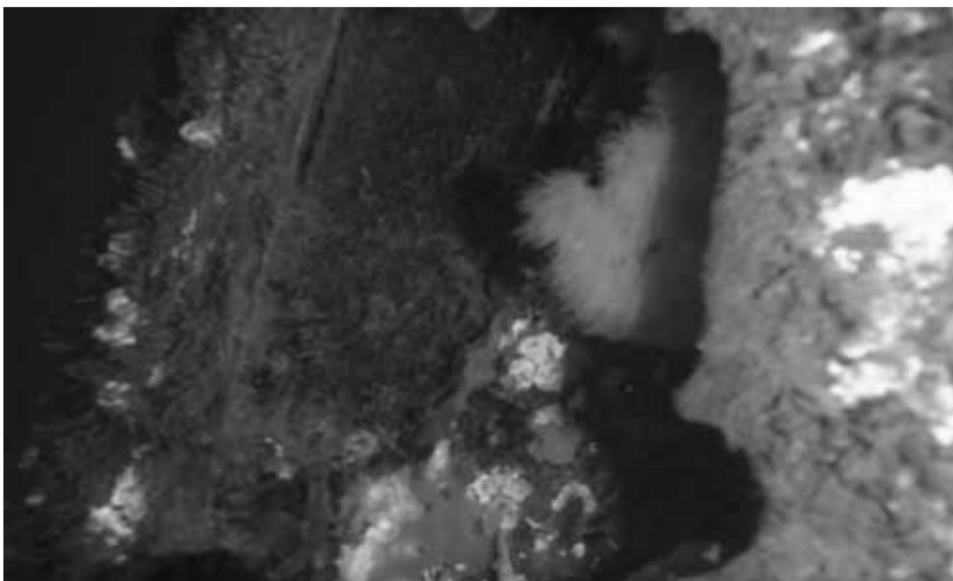
Photo 10: Canal Bridge No. 6880 - severe deterioration due to marine borer attack on Pile No. 4 on Pier No. 8.

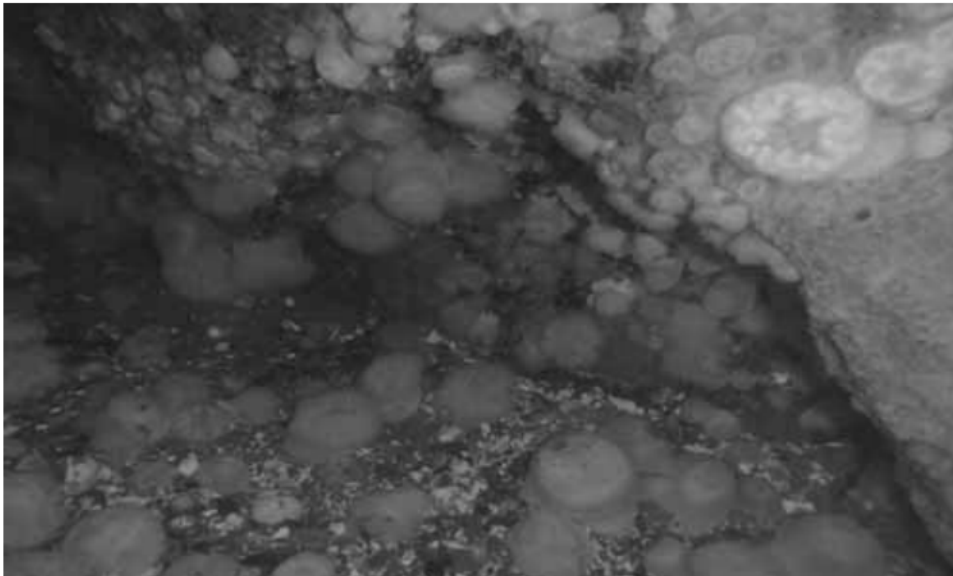
Photo 11: Canal Bridge No. 6880 - spall in the concrete collar on Pile No. 7.1 on Pier No. 8.

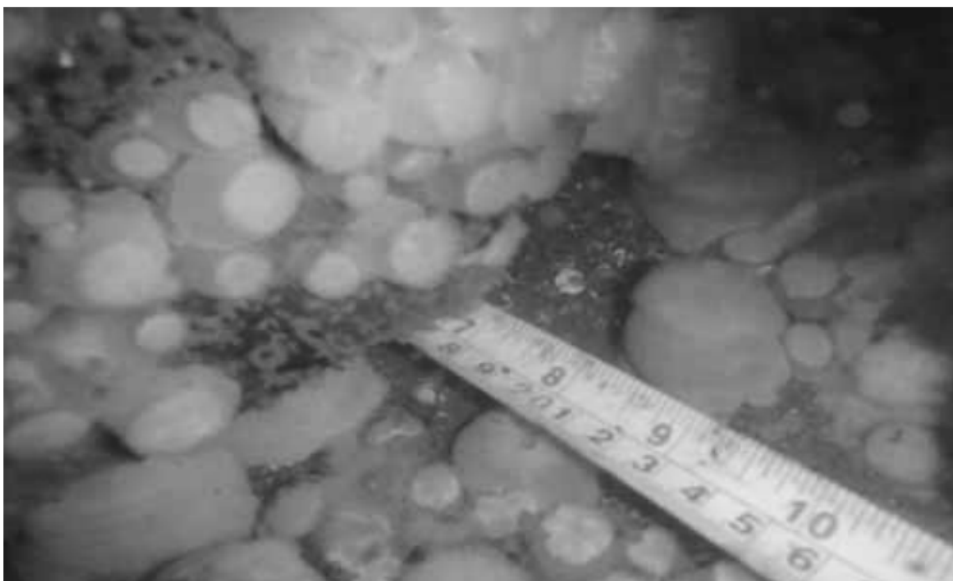
Photo 12: Canal Bridge No. 6880 - Pile No. 7.1 on Pier No. 8 in partial bearing.

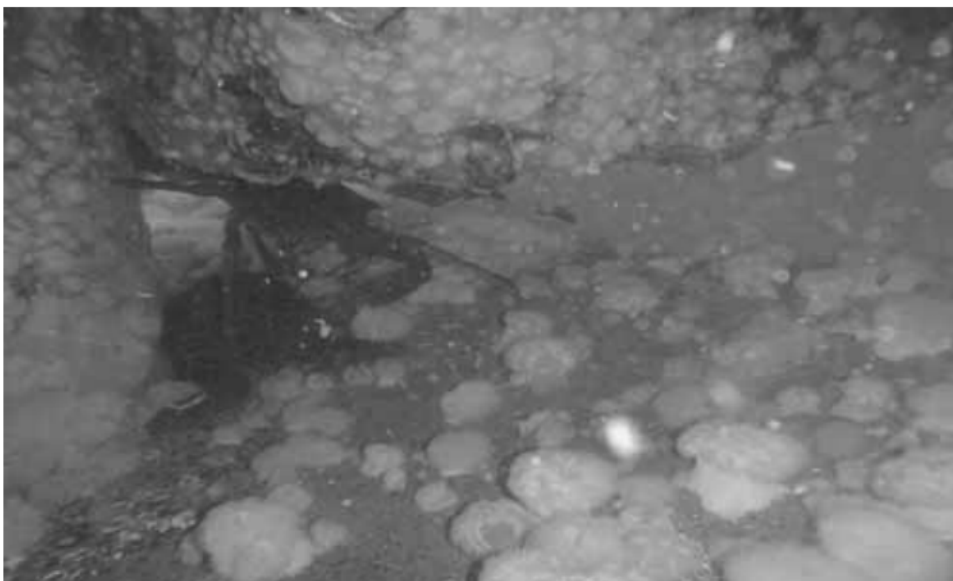
Photo 14: Canal Bridge No. 6880 - Pile No. 8.1 on Pier No. 8 is not in bearing.

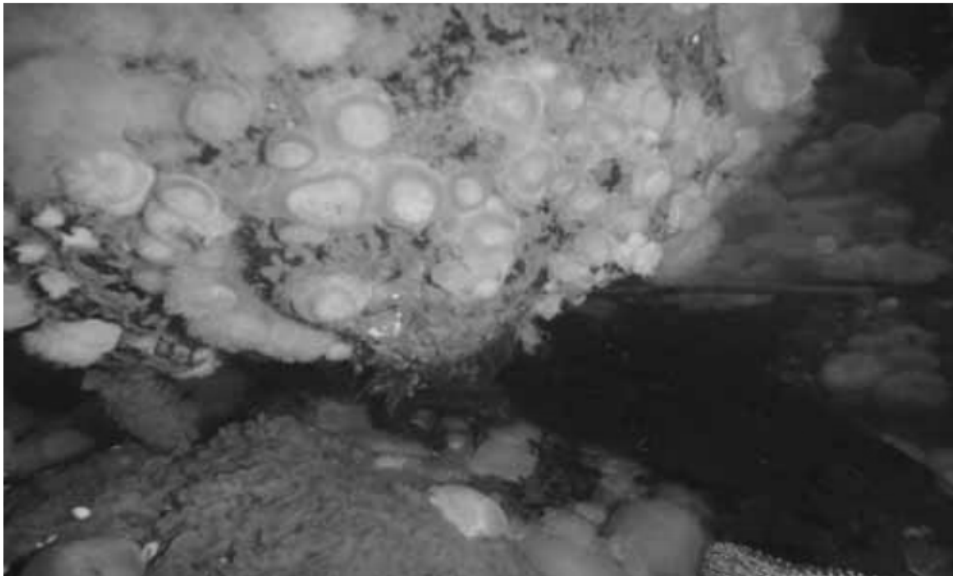
Photo 15: Canal Bridge No. 6880 - Pile No. 10 on Pier No. 8 is not in bearing.

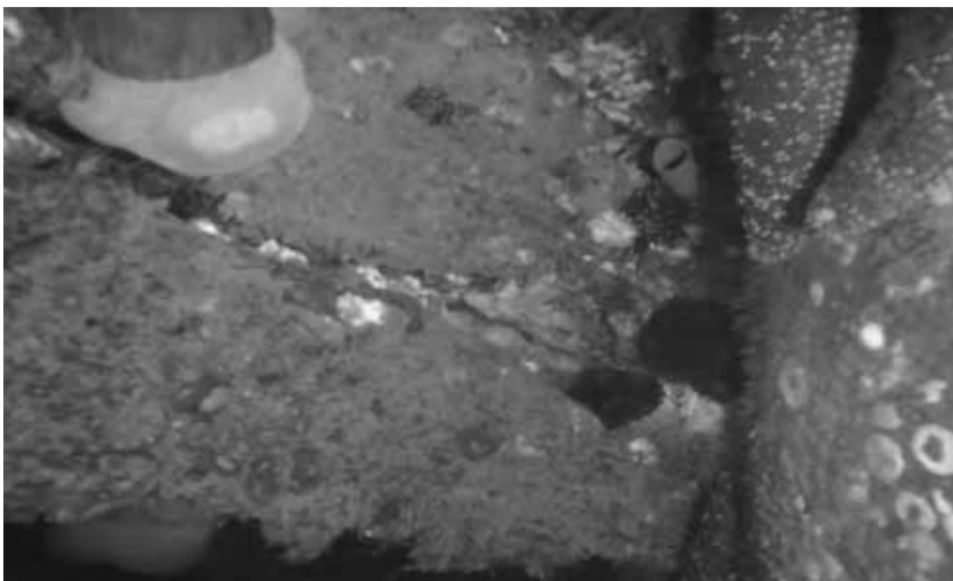
Photo 16: Canal Bridge No. 6880 - severe deterioration due to marine borer attack to a cross-brace on Pier No. 6.

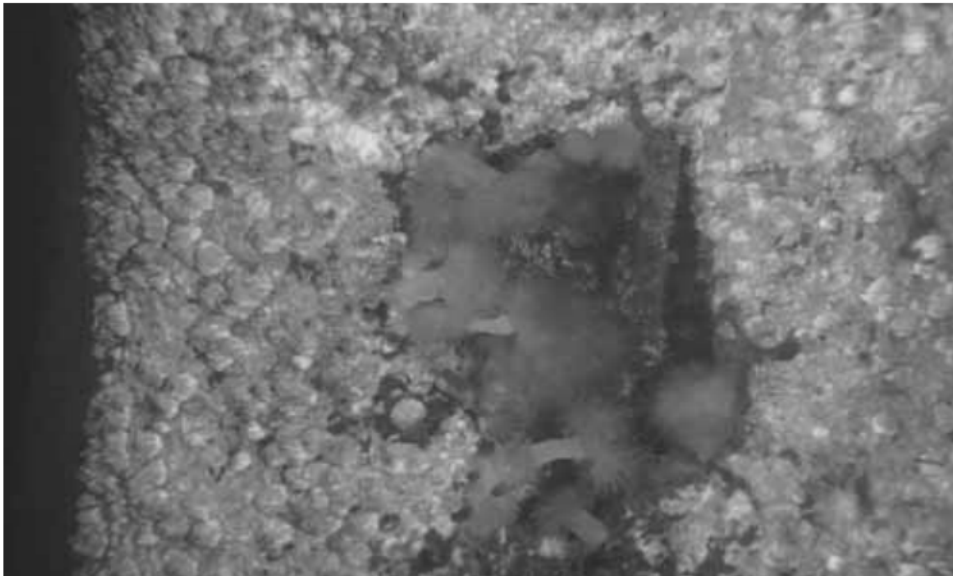
Photo 17: Canal Bridge No. 6880 - severe deterioration due to marine borer attack to a cross-brace on Pier No. 6.

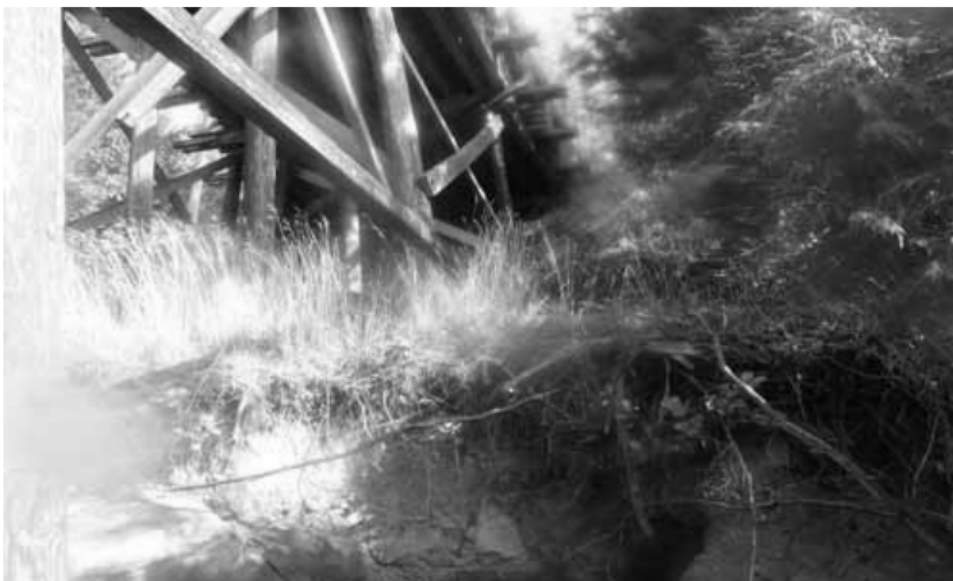
Photo 20: Canal Bridge No. 6880 - erosion of the embankment adjacent to Pier No. 4.

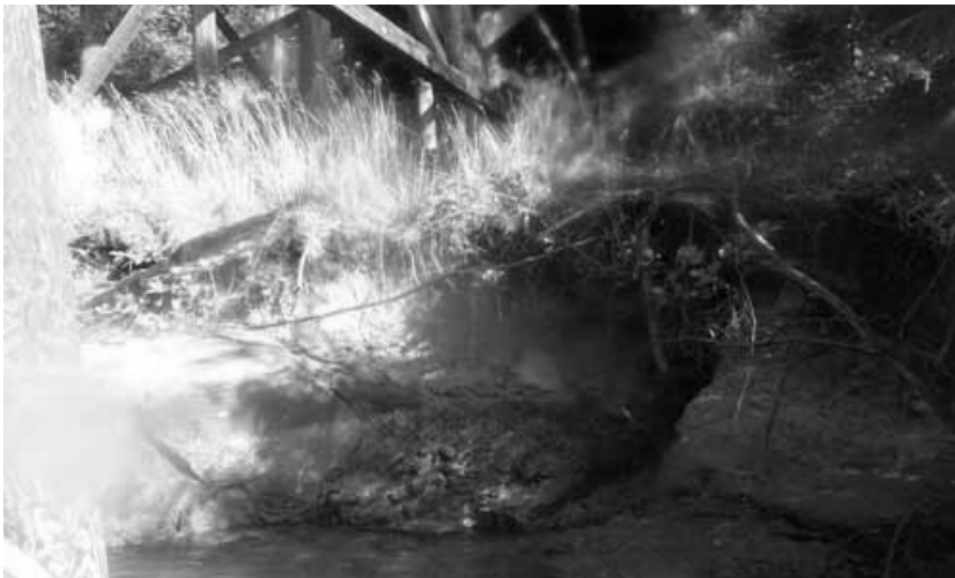
Photo 21: Canal Bridge No. 6880 - erosion of the embankment adjacent to Pier No. 4.
