Post-Crash Vehicle Inspection Report

2022-5742

04-22-12-27-MV435-01

Date: January 13, 2023

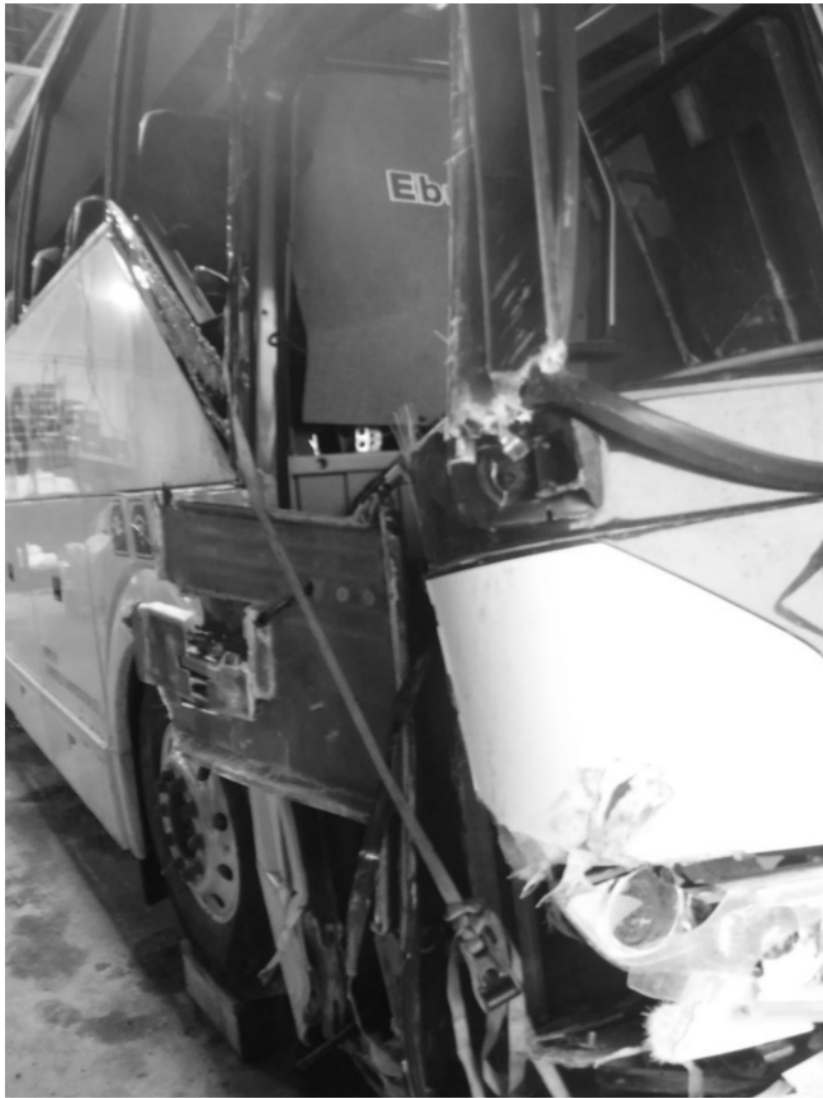
Photo #3 right front view of bus

The Right front head lamp was damaged and left and right rear turn/stop lamp assemblies were displaced (consistent with crash damage)

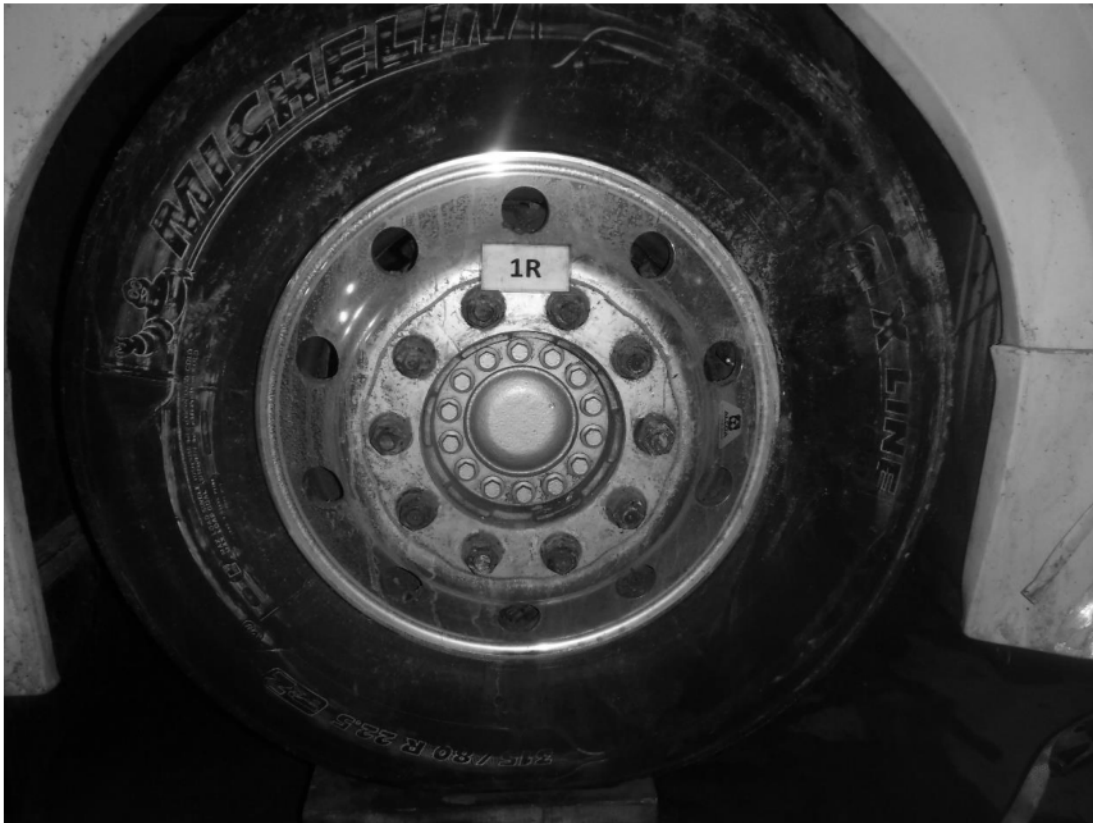
Photo #11 axle 1 right steer tire/wheel

Axle #1 (Steer Axle)	Type	Size	Make	Tread Depth (mm)	Inflation Pressure (PSI)	Maximum Tire Inflation Pressure (PSI)	Load Range	Wheel Rim
Left	Ribbed steering style tread	315/80R22.5	Michelin X-Line	16 mm	90 psi	130 psi	L	Aluminum
Right	Ribbed steering style tread	315/80R22.5	Michelin X-Line	16 mm	115 psi	130 psi	L	Aluminum

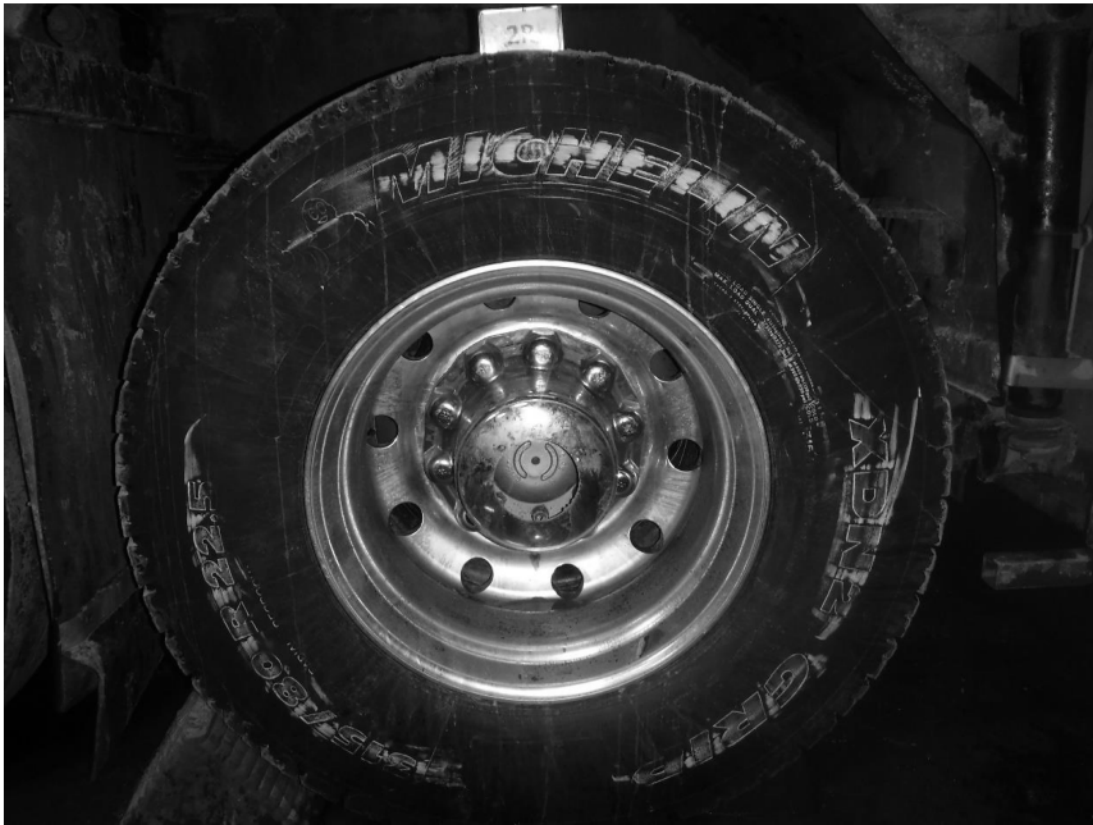
Photo #15 axle 2 right drive tire/wheel

Axle #2	Type	Size	Make	Tread Depth (mm)	Inflation Pressure (PSI)	Maximum Tire Inflation Pressure (PSI)	Load Range	Wheel Rim
Left Outer	Traction/grip Style tread	315/80R22.5	Michelin XDN2 Grip	16 mm	90 psi	130 psi	L	Aluminum
Left Inner	Traction/grip Style tread	315/80R22.5	Michelin XDN2 Grip	16 mm	90 psi	130 psi	L	Aluminum
Right Inner	Traction/grip Style tread	315/80R22.5	Michelin XDN2 Grip	16 mm	90 psi	130 psi	L	Aluminum
Right Outer	Traction/grip Style tread	315/80R22.5	Michelin XDN2 Grip	15 mm	90 psi	130 psi	L	Aluminum

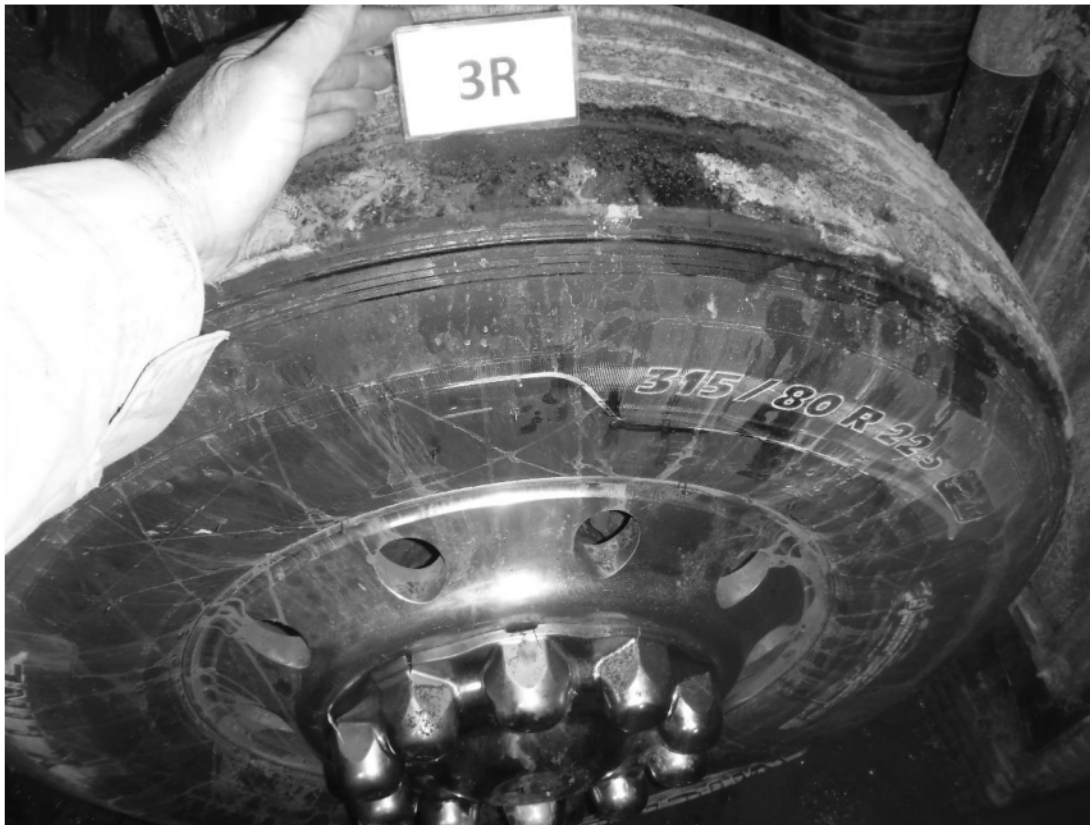
Photo #21 axle 3 right tire/wheel

Axle #3	Type	Size	Make	Tread Depth (mm)	Inflation Pressure (PSI)	Maximum Tire Inflation Pressure (PSI)	Load Range	Wheel Rim
Left	Ribbed steering style tread	315/80R22.5	Michelin X-line	5 mm	95 psi	130 psi	L	Aluminum
Right	Ribbed steering style tread	315/80R22.5	Michelin X-Line	6 mm	95 psi	130 psi	L	Aluminum

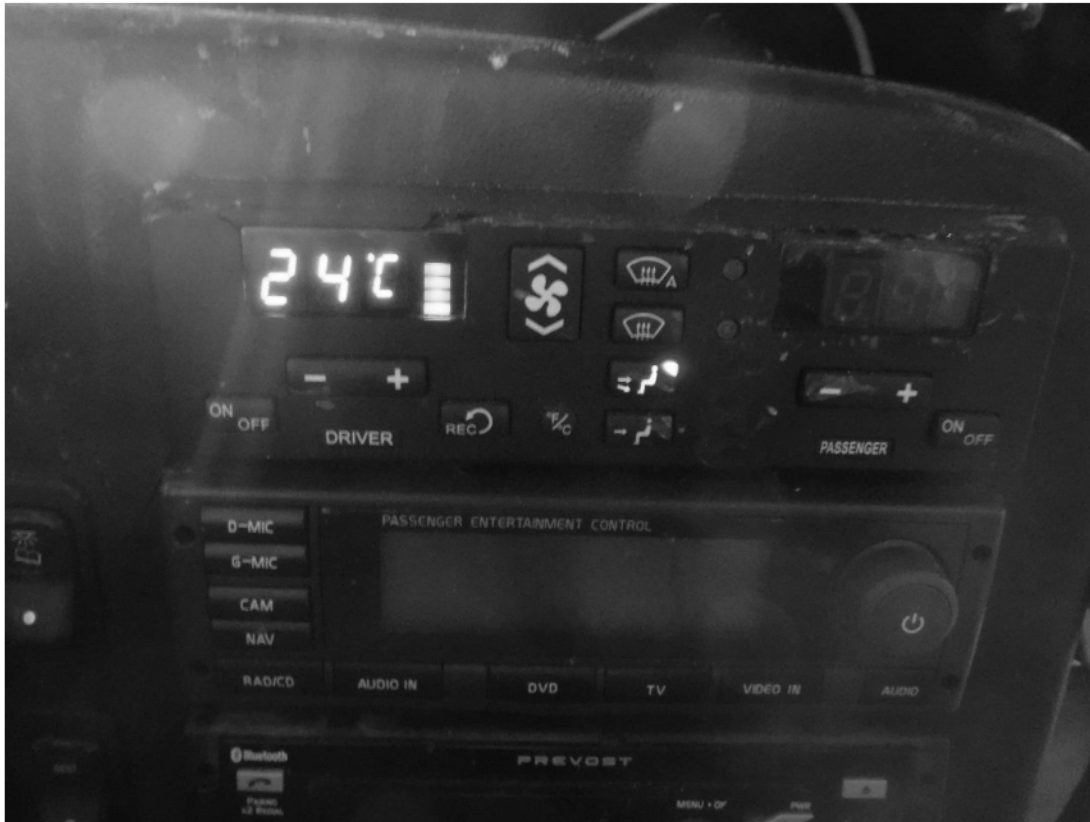
Heater setting at 24c, vent setting feet and legs

Photo #25 driver heat and vent settings

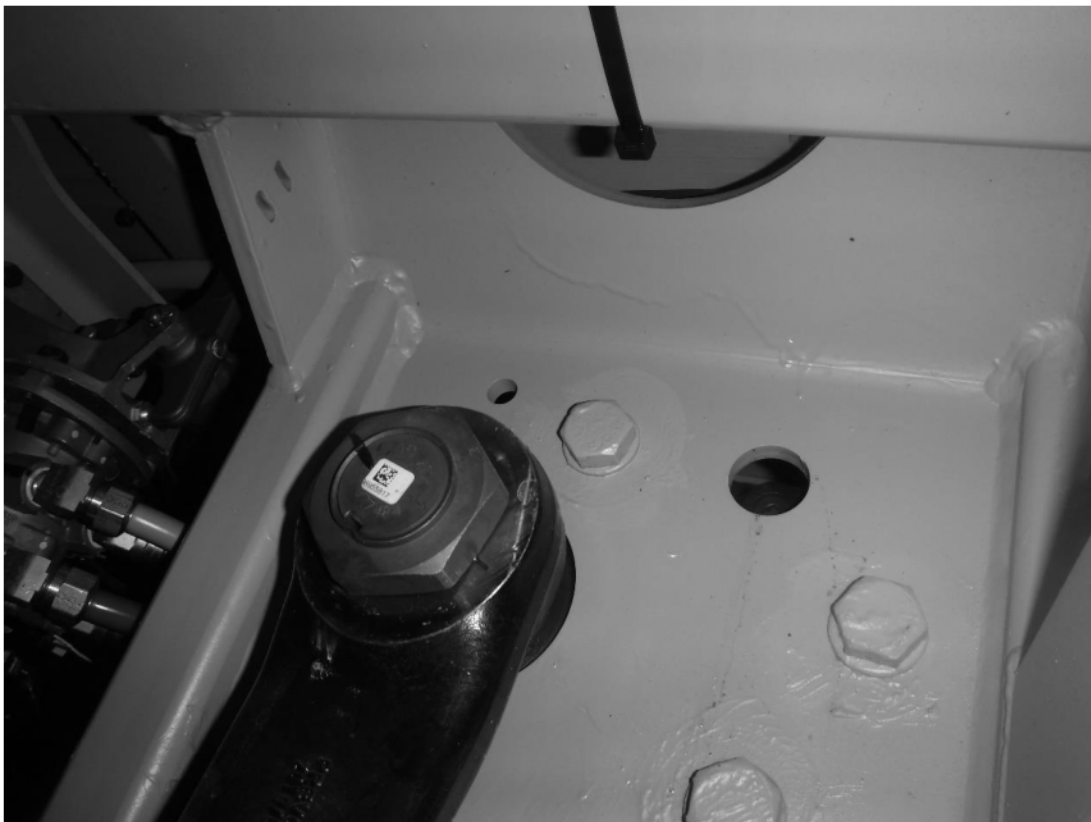
All steering linkage was connected as manufactured.

Photo #26 pitman arm connected to sector shaft

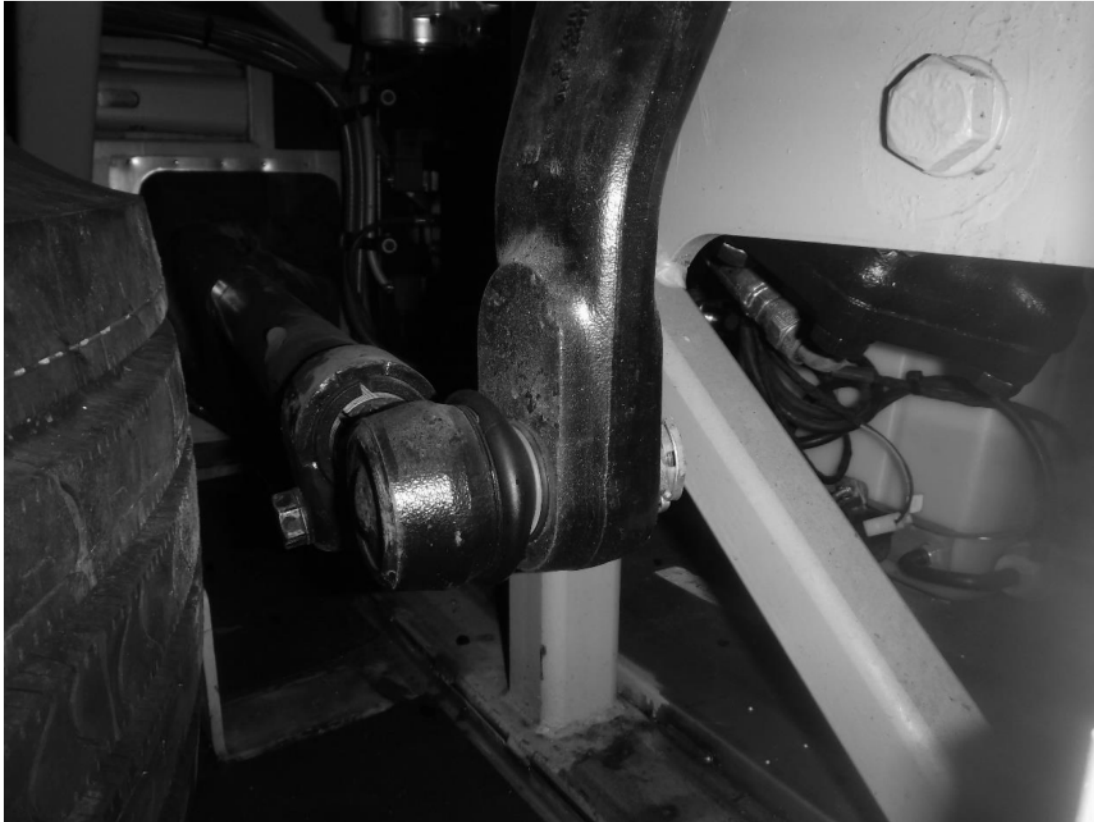
All tie-rod and drag link ends were in good condition.

Photo #27 drag link connected to pitman arm

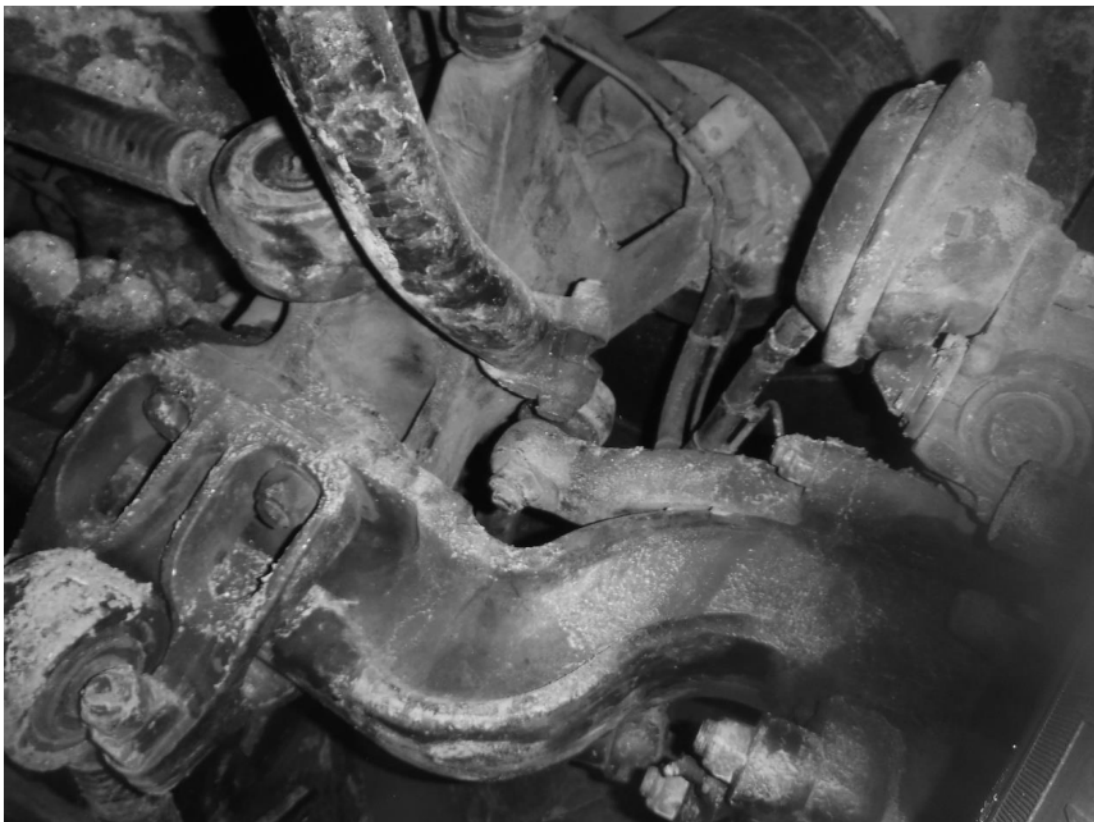
Photo #28 drag link connected to steering arm

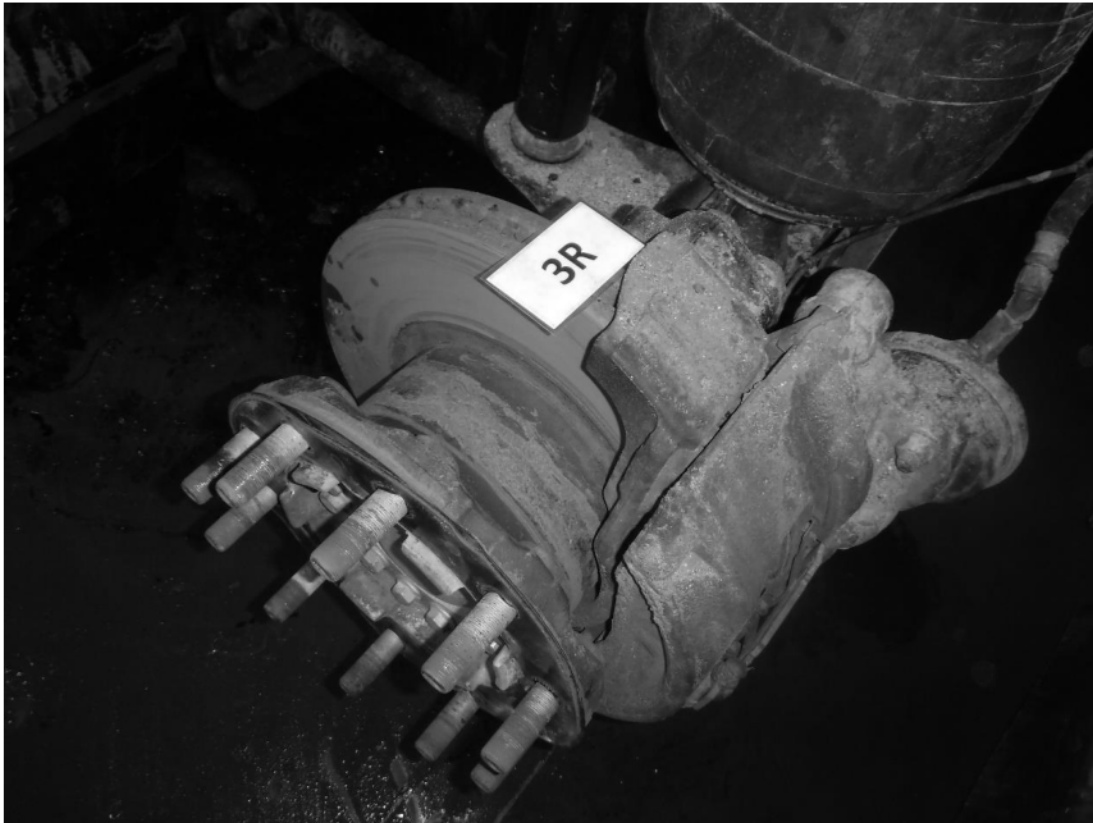
Photo #29 sample of disc brakes

The brake rotors were in serviceable condition.

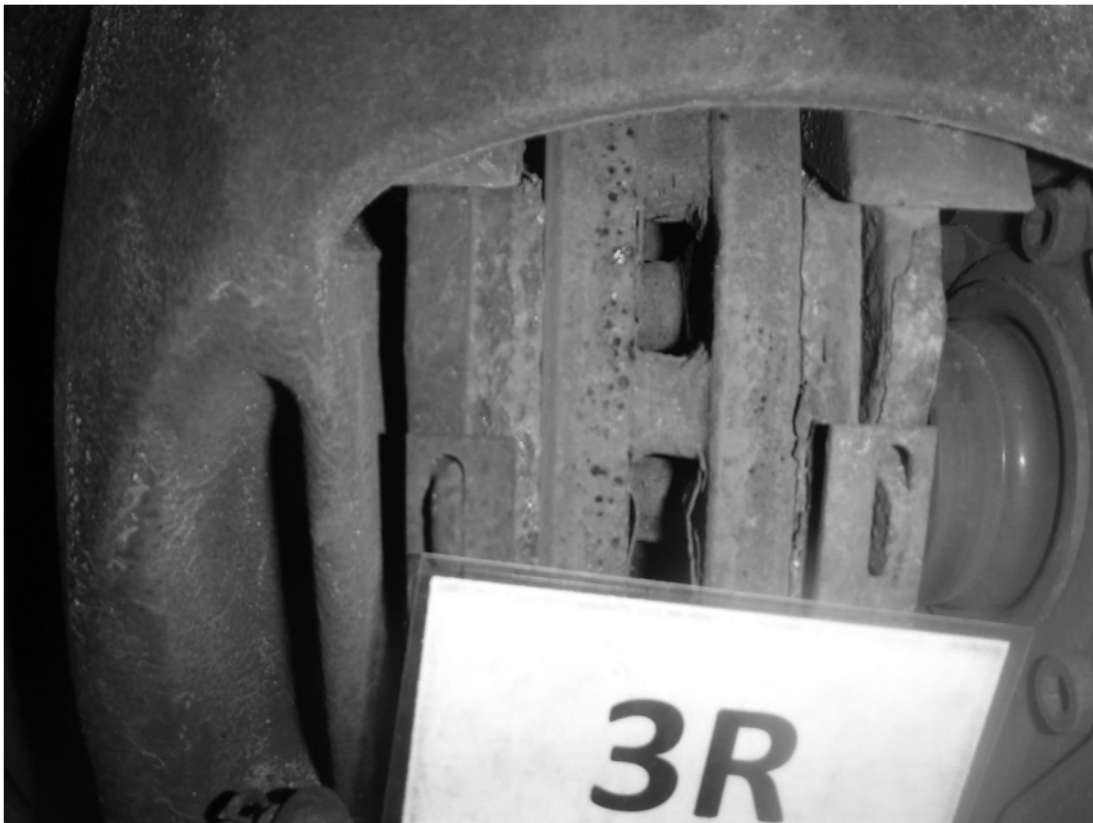
All brake pad thickness was above the manufacturer wear indicators as required by the Province of British Columbia Motor Vehicle Act Regulations Div.7.09 (23). They also exceeded the 2016 Vehicle Inspection Manual Truck, Trailer, and Bus Inspection Manual Sec. 3A (19), which has a minimum requirement of 3.2 mm thickness at the thinnest point.

Photo #30 sample of brake linings 10 mm

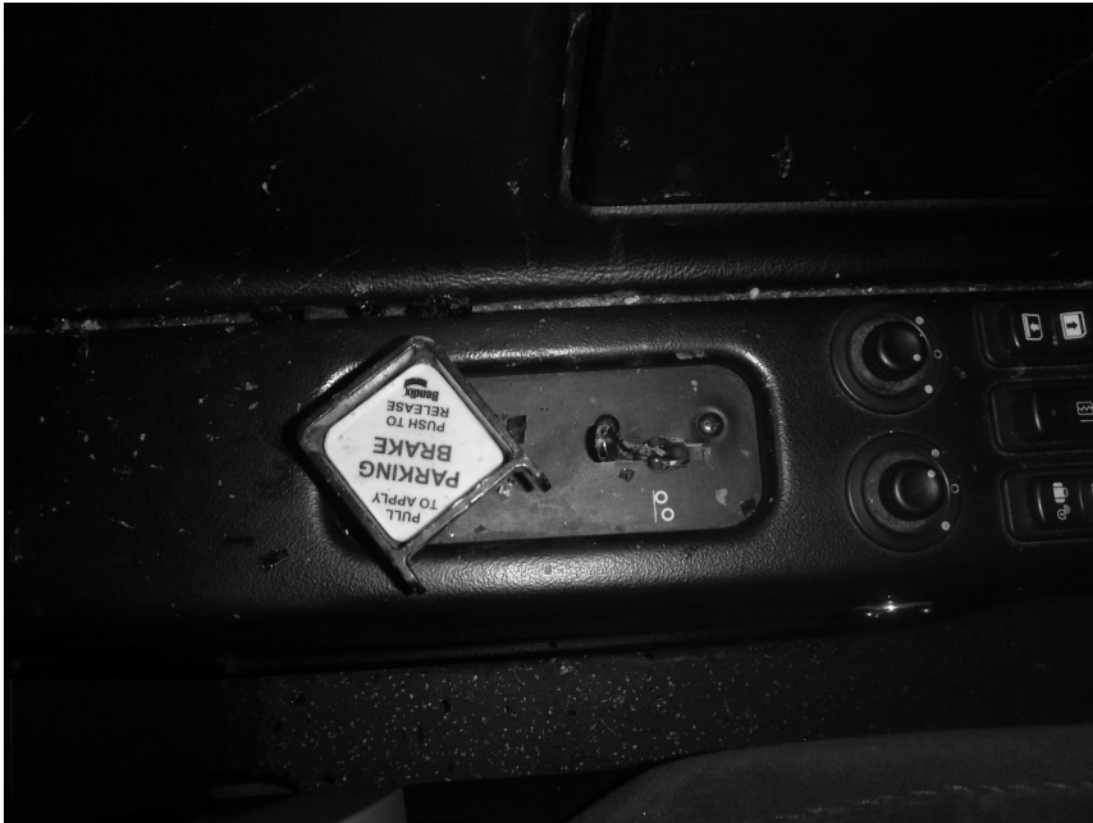
The tag axle (axle 3) control switch was in the down position.

Photo # 31 tag axle switch in down position
