Vista Naramata Subdivision Naramata, BC

Natural Hazards Assessment

June 28, 2021

Report Number: 21.540.25
Distribution: Vista Naramata - 1 copy
SNT Geotechnical Ltd. – 1 copy

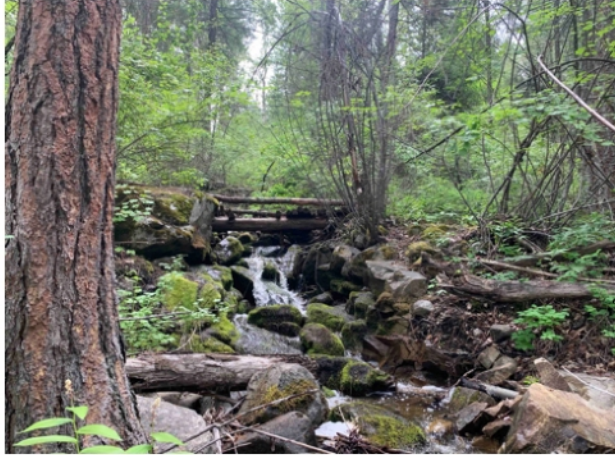
Photo 1: Arawana Creek at 685m elev., 400mm pine tree adjacent to creek with no damage.

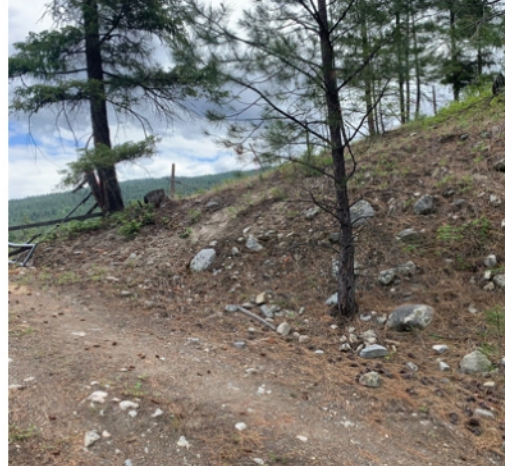
Photo 2: Road cut through creek channel bank showing typical material

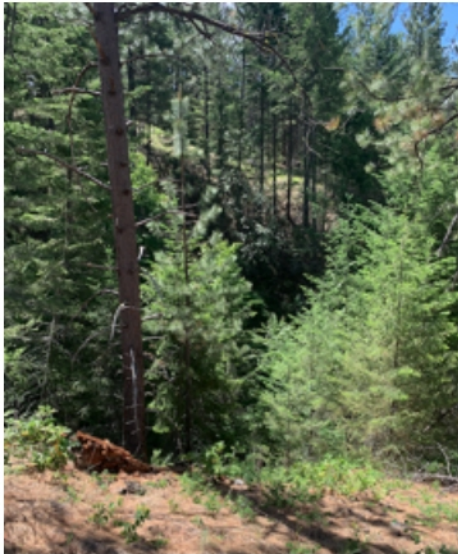
Photo 3: Arawana Creek channel, 50m width at 680m elev, mature forest on slopes

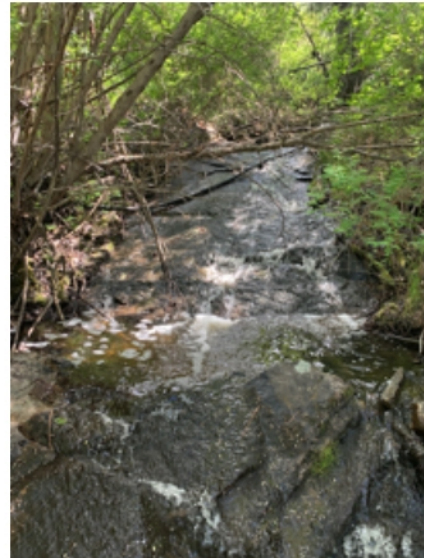
Photo 4: Bedrock controlled channel at 705m elev.

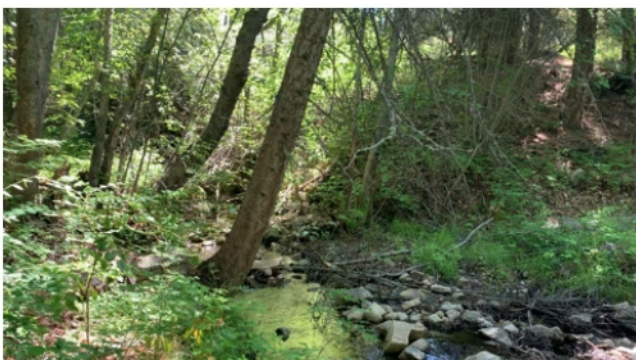
Photo 5: Arawana Creek channel at 730m elev.

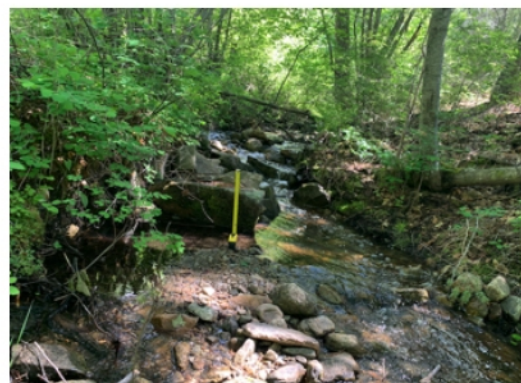
Photo 6: Arawana Creek at 750m elev.

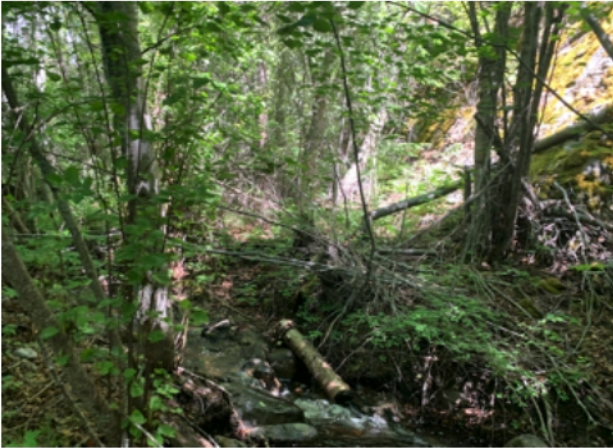
Photo 7: bedrock confined channel, elev 790m

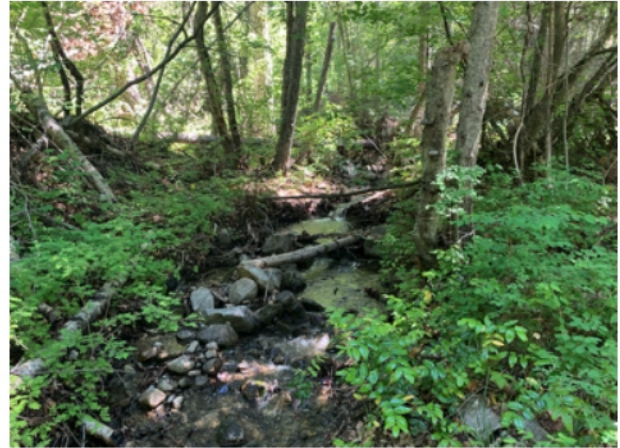
Photo 8: shallow steep pool morphology, elev 820m

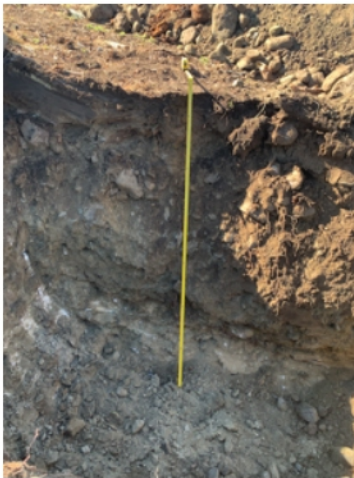
Photo 9: Test pit, typical morainal outwash soil over bedrock at 640m elev, SW corner of property

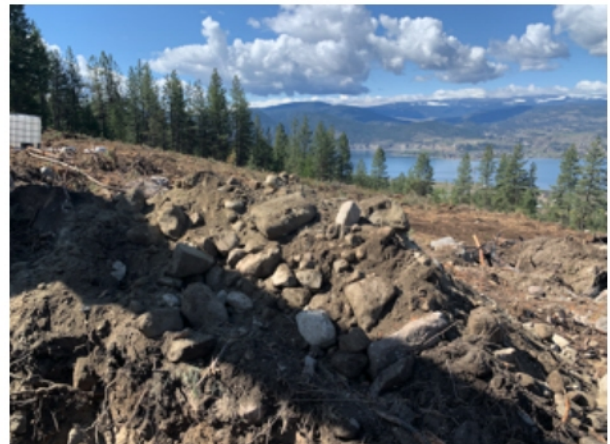
Photo 10: Test pit spoil pile with typical soils, elev 675m

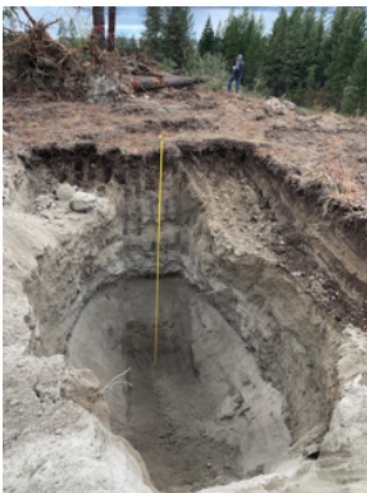
Photo 11: Test pit, silty sands, 710m elev

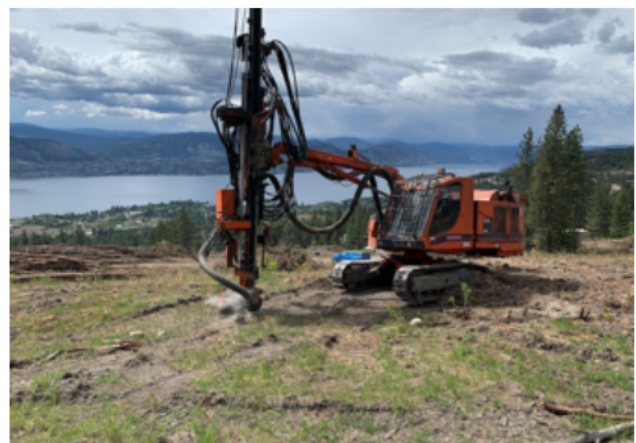
Photo 12: Typical drill probing for bedrock
