July 19, 2012

Project No. 1014940294-001-L-Rev0

**REVISED GEOHAZARD ASSESSMENT PROPOSED SUBDIVISION OF PROPERTY NE1/4 OF
SECTION 27, TP22, RG.17 W6M KDYD PLAN B11979, WESTSYDE ROAD, NORTH OF KAMLOOPS, BC**

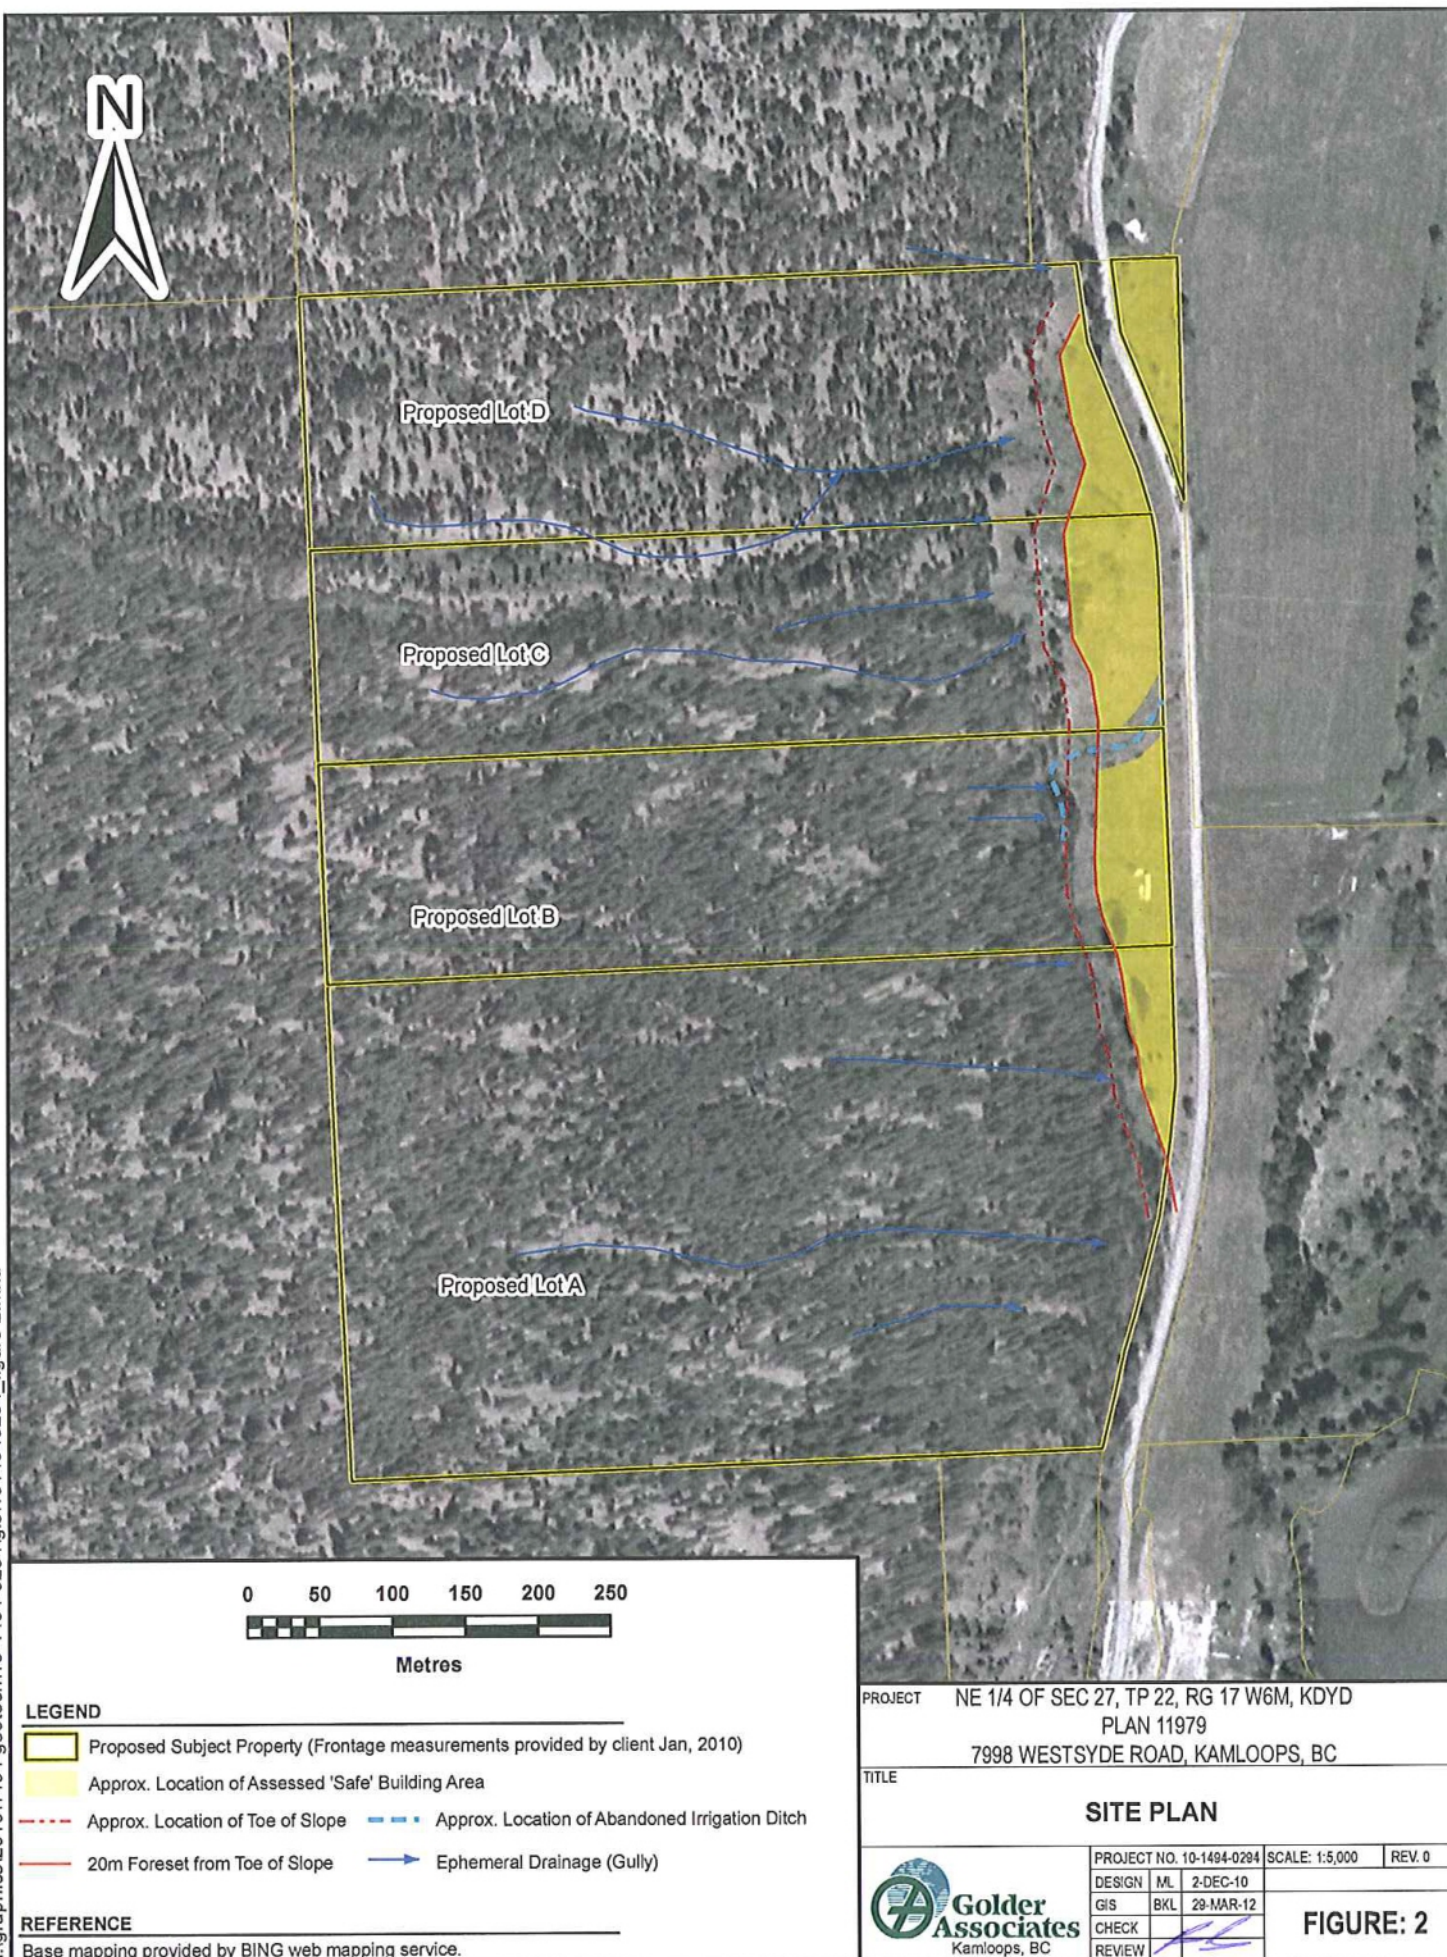
It is understood that the Owner proposes to subdivide the subject property into four lots, Lot A to Lot D, as shown of Figure 2. It is also understood that the proposed building locations for all four proposed lots are on the gently sloping grassland area which is adjacent to Westsyde Road.

The slopes above the proposed development area are incised by a series of well separated minor gullies oriented in the downslope direction. The gullies are assessed to be ephemeral drainage channels that terminate in colluvial fans, commonly coalescing colluvial fans, which comprise the gently sloping terrain on the eastern parts on the proposed lots. However, there were observed to be localized occurrences of steeply sloping fan deposits containing cobbles which have developed at the outlets of some of the minor gullies. At the time of the reconnaissance, the gullies were dry and the gently sloping terrain at the toe of the ridge (beyond any local steeply sloping fan deposits) was covered by grass with no observed signs of recently deposited material. There are reportedly two irrigation ditches on the lower slopes (only the lower ditch was observed in the reconnaissance) both of which were reportedly historically fed by diversion from Jamieson Creek in the early 20th Century. As reported by Mr. Cory, it is understood that the irrigation ditches have been abandoned and non-functional for in excess of 70 years. The lower of the two abandoned irrigation ditches crosses through the south side of Lot C (refer to Figure 2).

Golder has identified and delineated a "safe" building area on the property with respect to rolling rock geohazard which includes land suitable for development of a single family residential house on each lot, as indicated in Figure 2. The lot boundaries and the location of assessed toe of slope as flagged in the field by Golder are shown in Figure 2, and are located as provided to Golder by the client on an unsigned Allnorth Subdivision Plan received by Golder on January 27, 2012. The location of the toe of slope provided in the Allnorth Subdivision Plan also matches our own GPS reference points collected during flagging of the line, providing corroboration that the toe of slope line is accurately located.

The assessed safe building areas (with respect to rolling rock geohazard) for single family house development were determined by adding a 20 m foreset from the surveyed toe of slope line. The assessed building areas are all located on the lower gently sloping and grass covered portion of the lots near Westsyde Road.

To address the potential of rolling rocks reaching building sites, a conservative minimum building foreset of 20 m from the toe of the moderately steep ridge slopes is recommended. As previously noted, the toe of the steep ridge slopes was flagged by Golder, and the flagged line was surveyed by Allnorth Land Surveyors. Residential building sites on the subject site which have a minimum 20 m foreset from the flagged line are considered to be "safe" with respect of geotechnical rolling rock hazard. This foreset is not intended to apply to septic fields and backup fields, yards, gardens, or storage sheds which are considered acceptable uses of the residential building foreset zone.

- 1) houses be located offset at least 30 m from the projected discharge path from outlet of each of the main gullies;
- 2) houses be located outside the area of any local low lying land, ditch or ephemeral drainage channel;

- 3) the perimeter grade surrounding the houses be elevated at least 1 m above any nearby low point or apparent ephemeral drainage channel; and
- 4) the house perimeter grade to be shaped and graded to direct surface runoff away from the building.

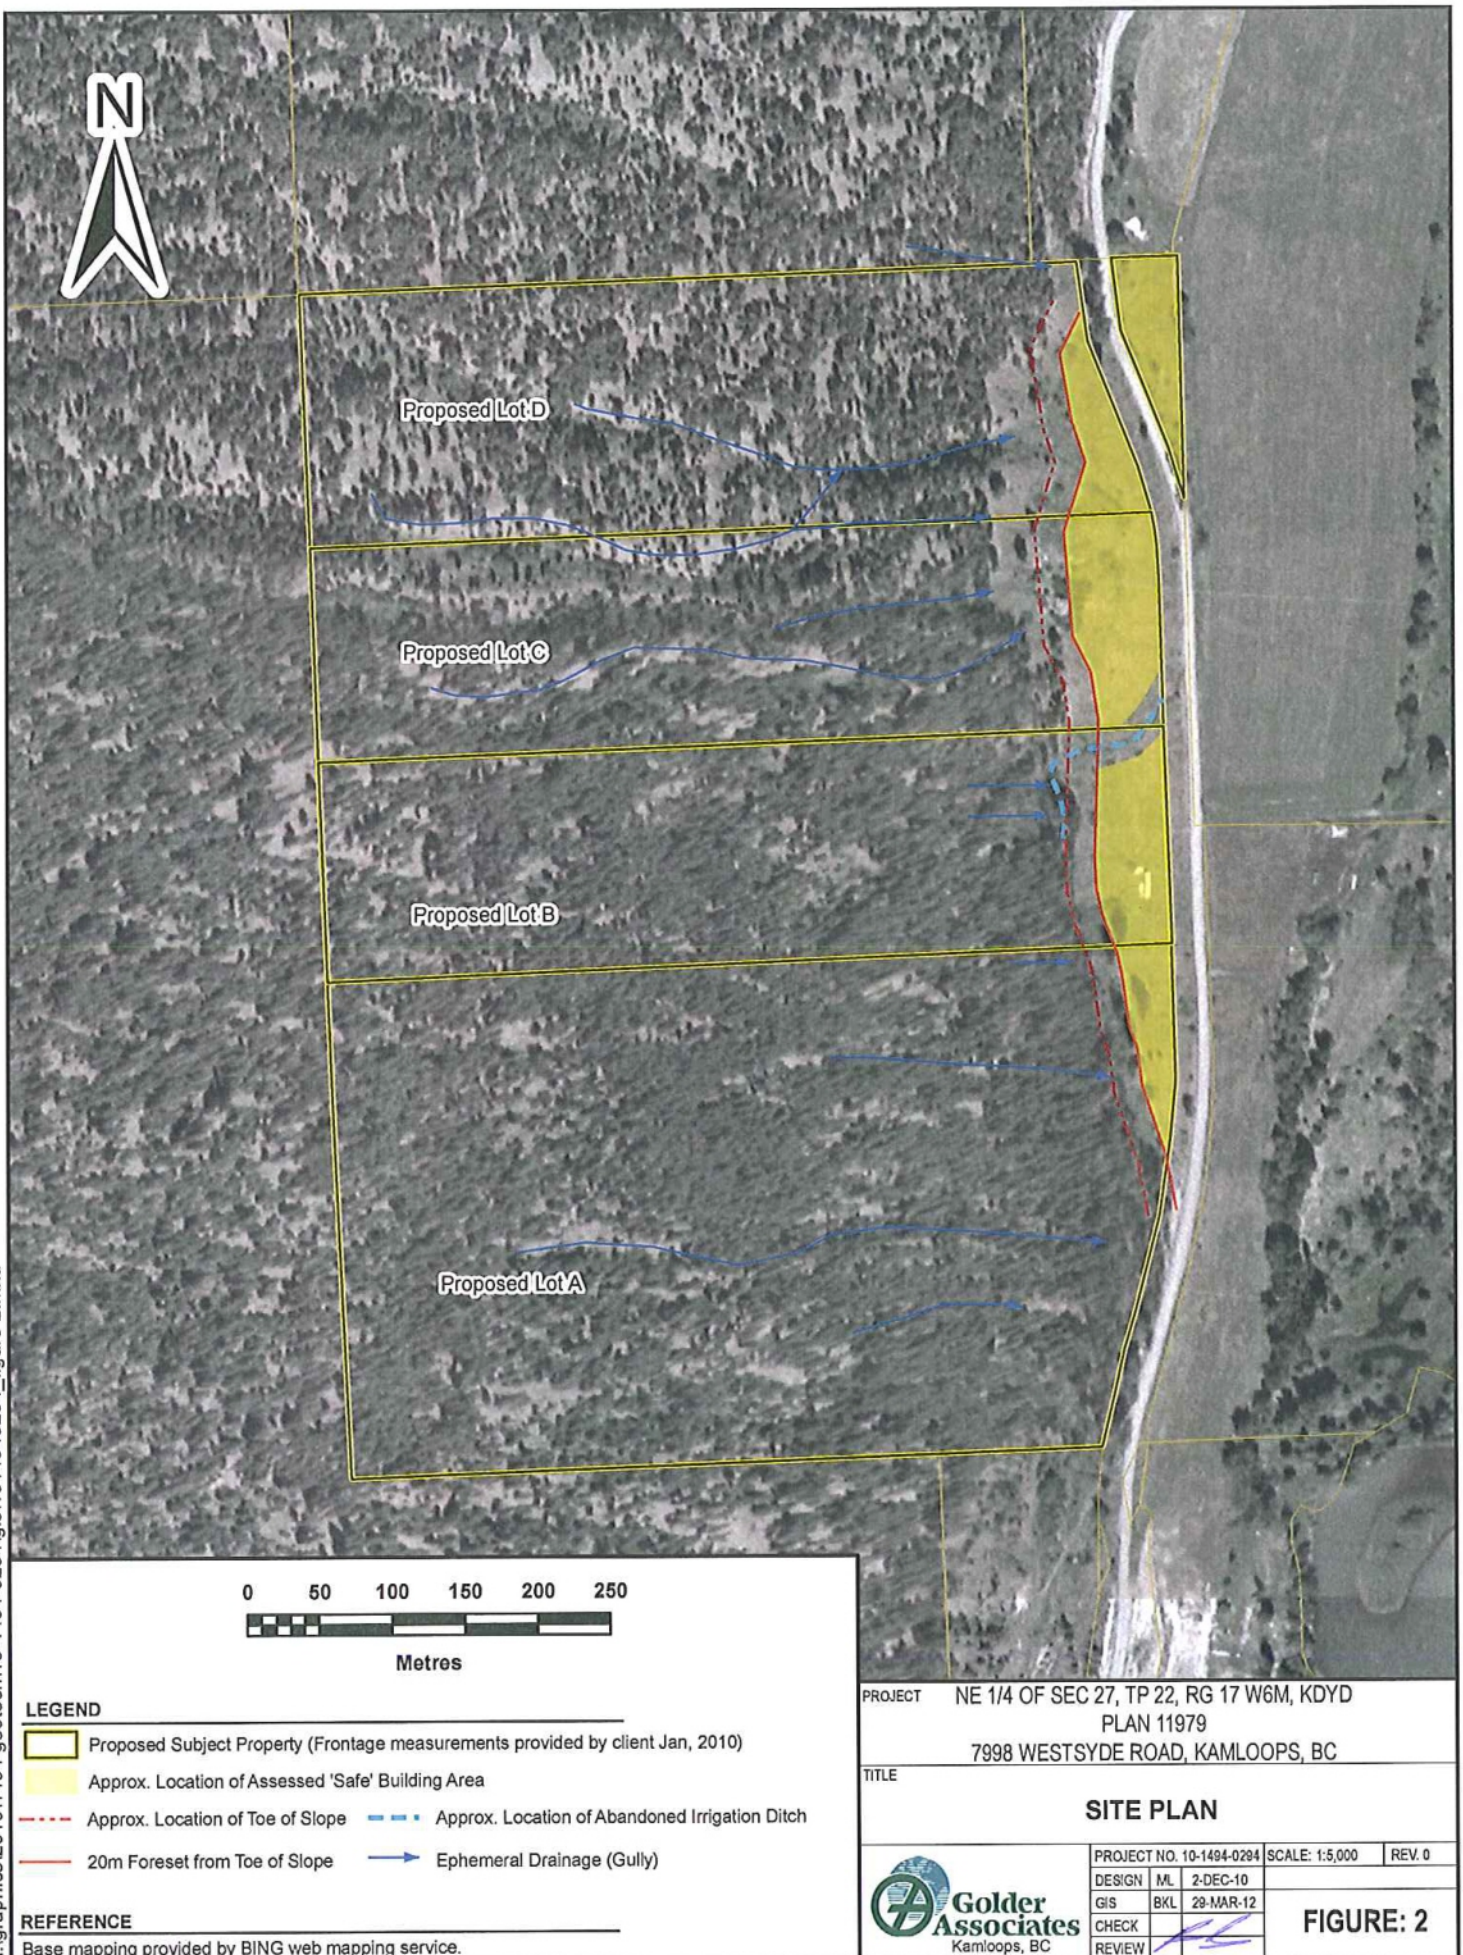
The slopes above the proposed development area are incised by a series of well separated minor gullies oriented in the downslope direction. The gullies are assessed to be ephemeral drainage channels that terminate in colluvial fans, commonly coalescing colluvial fans, which comprise the gently sloping terrain on the eastern parts on the proposed lots. However, there were observed to be localized occurrences of steeply sloping fan deposits containing cobbles which have developed at the outlets of some of the minor gullies. At the time of the reconnaissance, the gullies were dry and the gently sloping terrain at the toe of the ridge (beyond any local steeply sloping fan deposits) was covered by grass with no observed signs of recently deposited material. There are reportedly two irrigation ditches on the lower slopes (only the lower ditch was observed in the reconnaissance) both of which were reportedly historically fed by diversion from Jamieson Creek in the early 20th Century. As reported by Mr. Cory, it is understood that the irrigation ditches have been abandoned and non-functional for in excess of 70 years. The lower of the two abandoned irrigation ditches crosses through the south side of Lot C (refer to Figure 2).

The results of the Geohazard Assessment indicate that each of the proposed subject lots contain "land that may be used safely for the use intended" with respect to rolling rock geotechnical hazard, located as shown on Figure 2, and development on the subject site is considered feasible with respect to the identified geohazards, subject to a 20 m foreset from the assessed "toe of slope" and implementation of the four drainage recommendations provided herein.

To address the potential of rolling rocks reaching building sites, a conservative minimum building foreset of 20 m from the toe of the moderately steep ridge slopes is recommended. As previously noted, the toe of the steep ridge slopes was flagged by Golder, and the flagged line was surveyed by Allnorth Land Surveyors. Residential building sites on the subject site which have a minimum 20 m foreset from the flagged line are considered to be "safe" with respect of geotechnical rolling rock hazard. This foreset is not intended to apply to septic fields and backup fields, yards, gardens, or storage sheds which are considered acceptable uses of the residential building foreset zone.
