GEOTECHNICAL FIELD REVIEW / SITE INSTRUCTION

Project No: 10943-1

Project: Dam Assessment

Project Address: Morningstar Golf Club – Parksville, BC

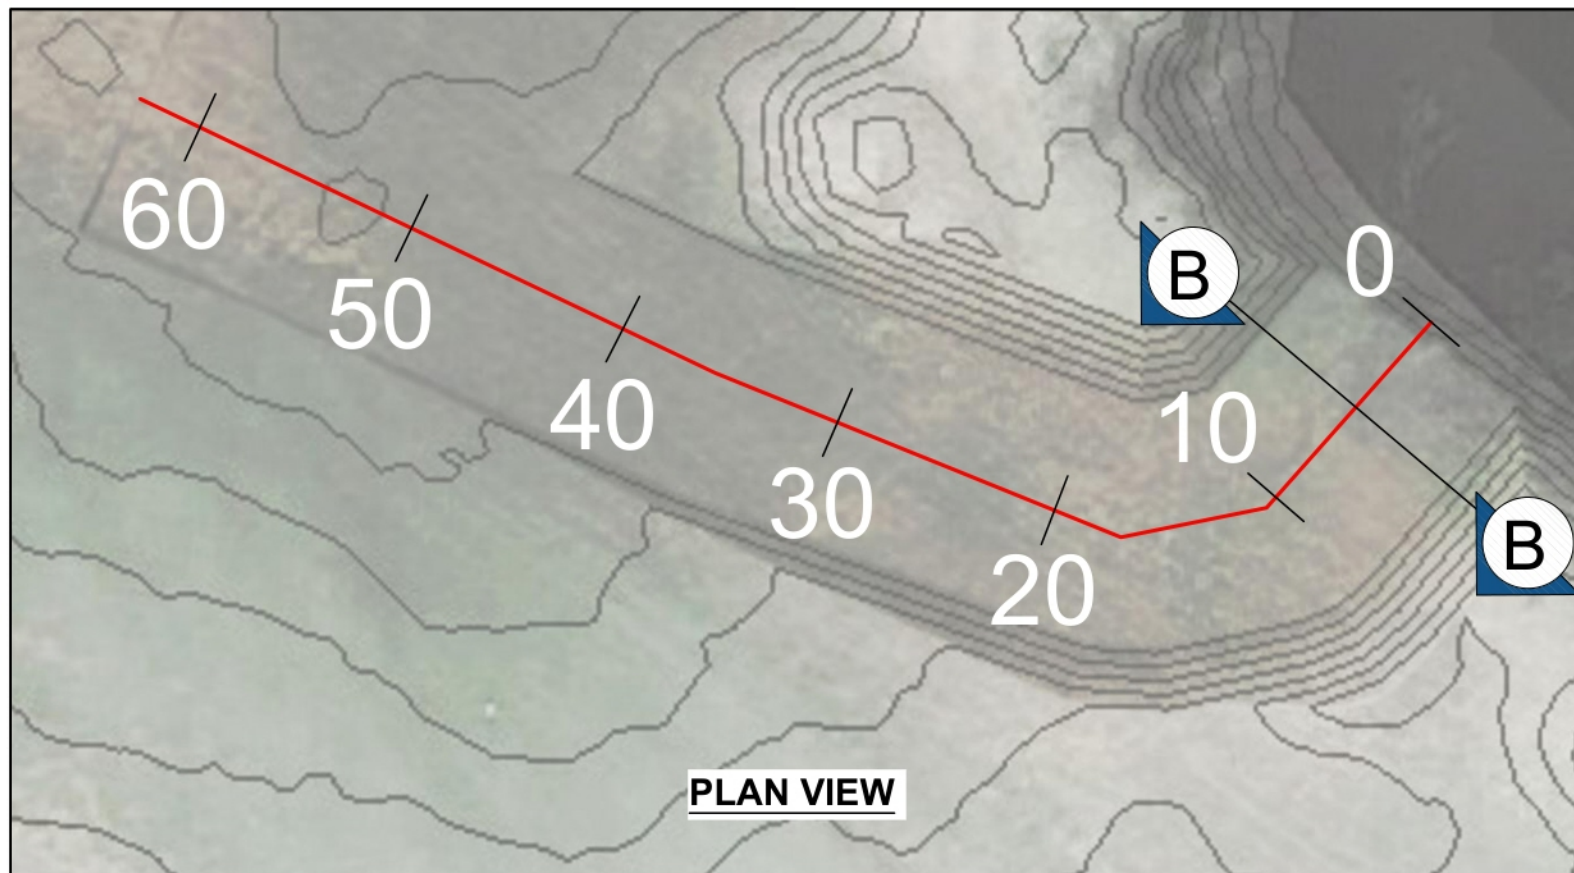
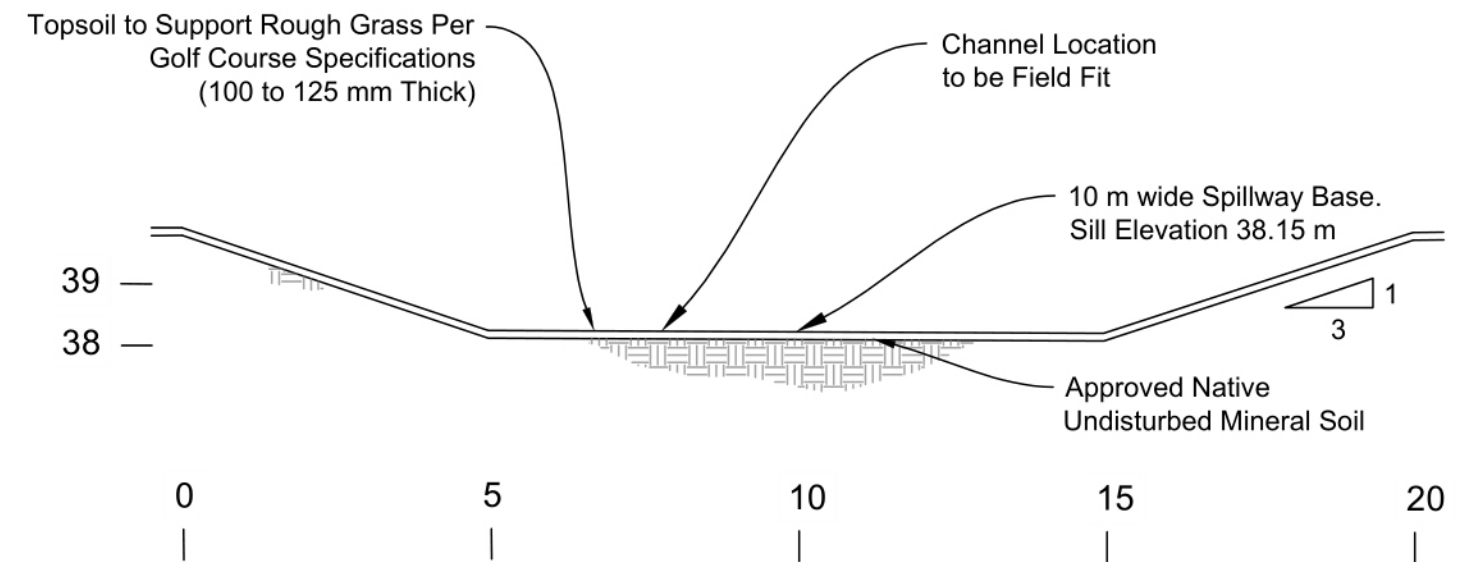
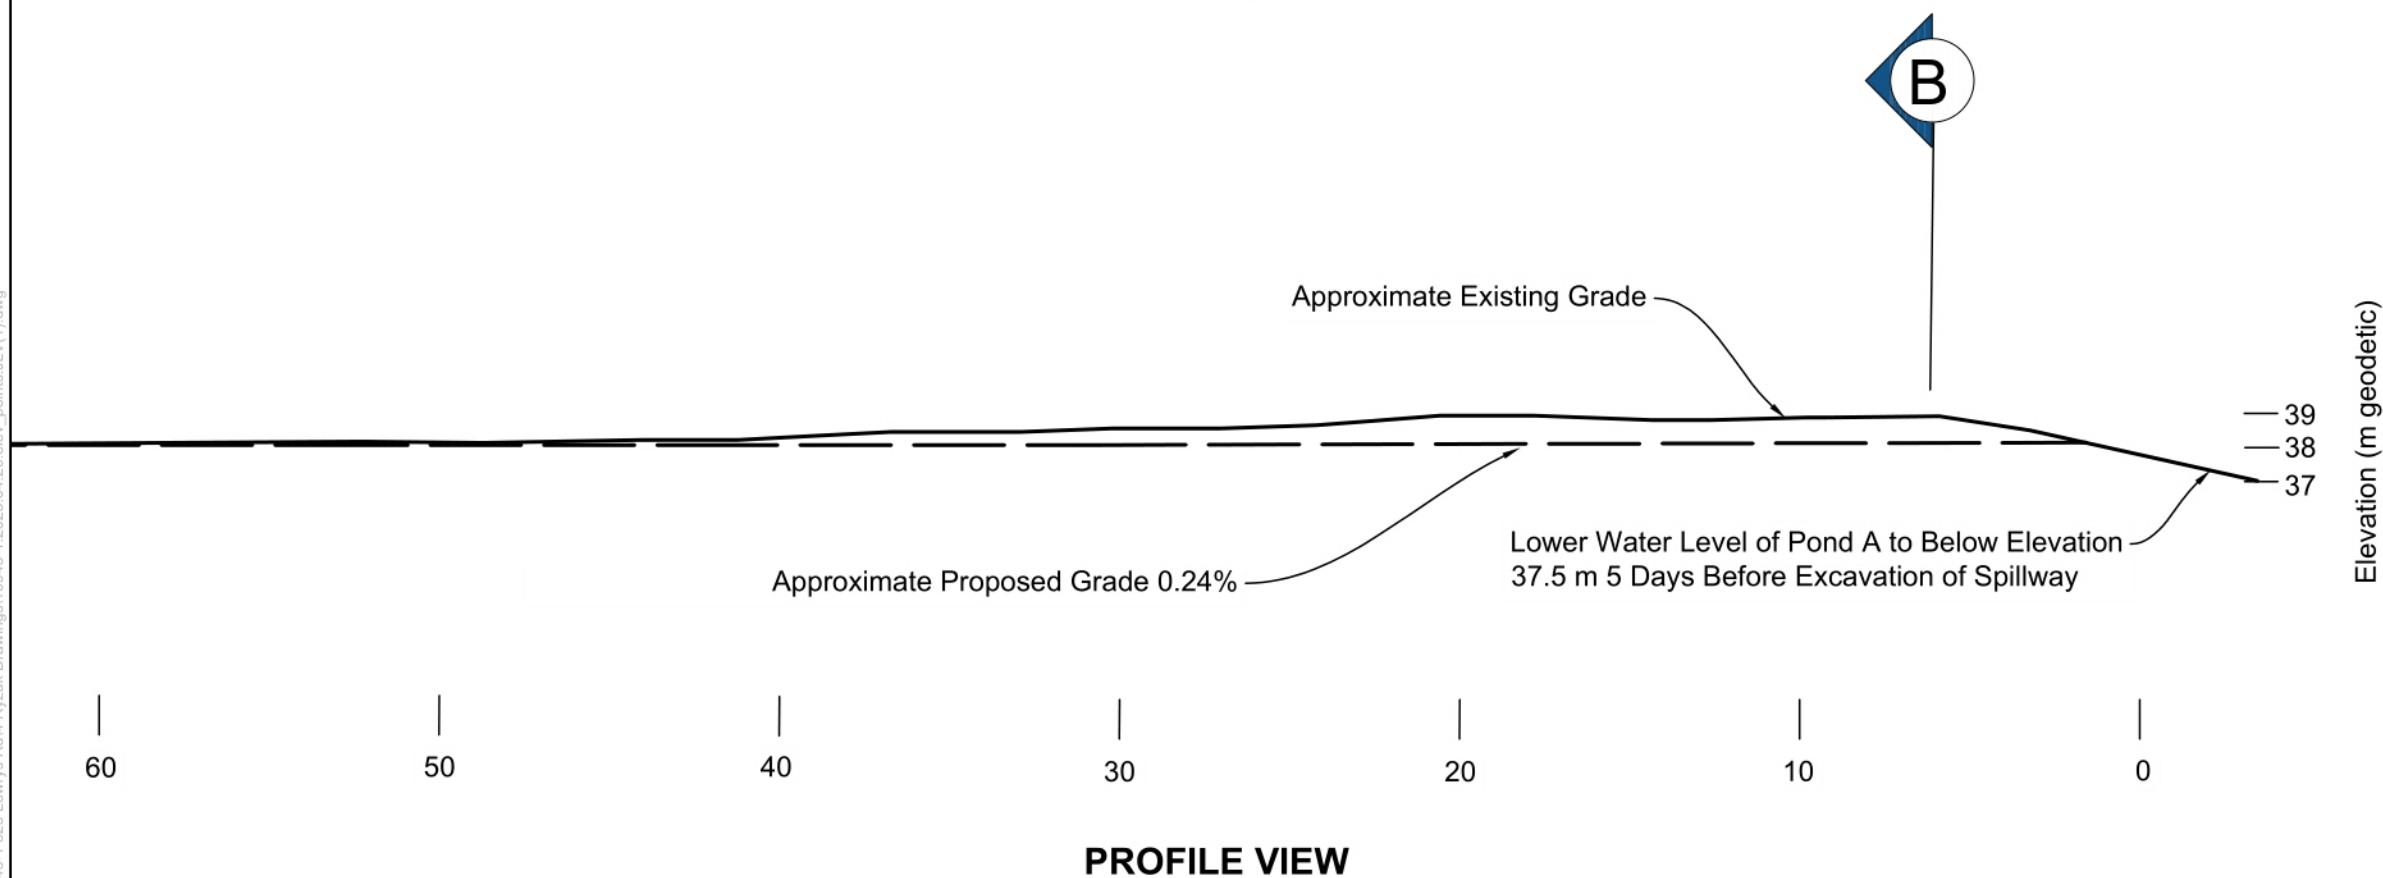
PROJECT No. 10943-1	CLIENT Realcor Golf Ltd.
EOR/LEAD ARJ	PROJECT TITLE Dam Assessment
REVIEW JAR	PROJECT ADDRESS 525 Lowrys Road - Parksville, BC
SCALE NTS	DRAWING PACKAGE Spillway and Berm Design
SHEET No. 03 of 03	SHEET NAME Spillway Design

Based on the analyses, a spillway with a base width of 10 m and 3H:1V side slopes excavated in the natural terrain beyond the left (western) abutment of Dam 2 is proposed. As the spillway would only need to perform for a brief period to act as a dewatering slew in the event of failure, we consider that the design surface could be prepared with the typical rough grass of the golf course bordering the fairway. The flows within the flood model were indicated to be less than approximately 1 m/s for less than a 1hr period and therefore an established gently sloped (0.24%) coarse grass surface over competent mineral soils is expected to perform adequately to resist erosion for the short duration. However, the proposed design sill at 50 mm above the pipe invert may result in the spillway becoming active intermittently during full capacity conditions combined with significant rain fall. Therefore, we consider when the spillway becomes active some light sheet flows could occur in the channel and the area would need to be assessed for performance as part of the periodic maintenance directive. Local filling/fine tuning of the spillway may be anticipated in the long term, along with some periodic soggy grass conditions when active. It may be desirable to

Water levels should be lowered by 500 mm below the design cut for several days prior to final excavation of the spillway. Once surface organics have been removed the mineral soil excavation is to be completed with careful grade control to excavate the design subgrade at 100 to 125 mm below the finished grass surface. The initial exposure will need to be monitored by Ryzuk to review the soil conditions and confirm the cut is completed within the native ground vs through embankment fill soils. Therefore, the alignment shown in the drawings is subject to field conditions and may require adjustment pending review.

1. Refer to Site Plan for the approximate Spillway location.
2. Excavation of the Spillway to be carried out with careful survey control to limit deviation from design surface. Lower water of Pond A below 37.5 m 5 days before excavation.
3. Ryzuk to inspect subgrade of the Spillway area following removal of surficial organics.
4. Organic soils can be set aside for potential reuse as capping soils or for general terrain incorporation pending field review.
5. Topsoil/Sod to be prepared in accordance with Morningstar Golf Course specifications.
6. Ensure no disturbance or sediment ingress over riparian boundary by means of grading, silt abatement measures, etc.

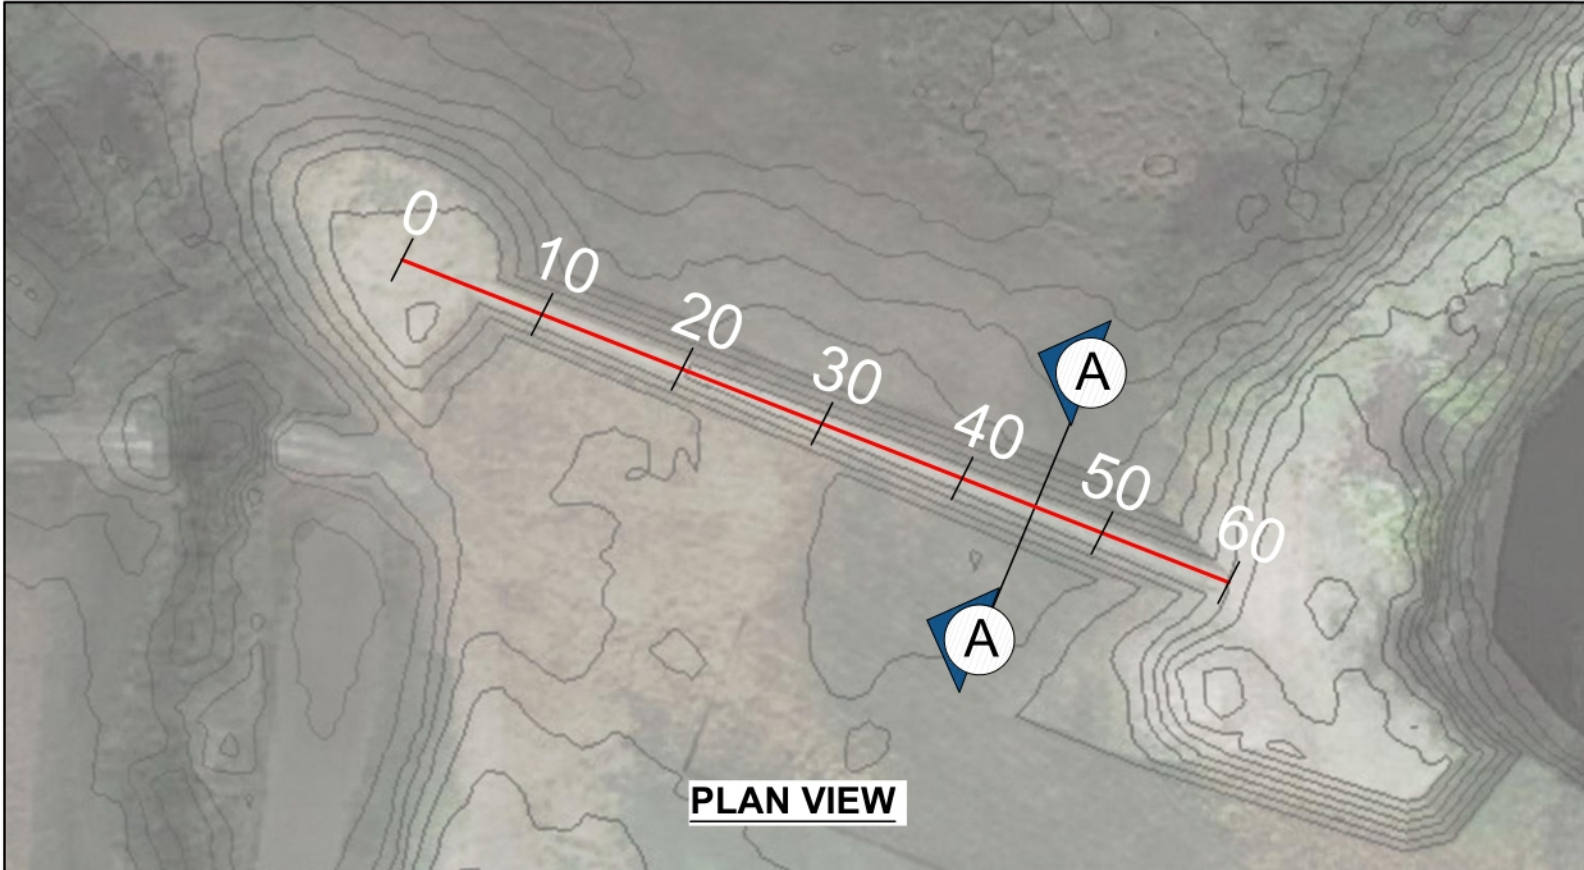
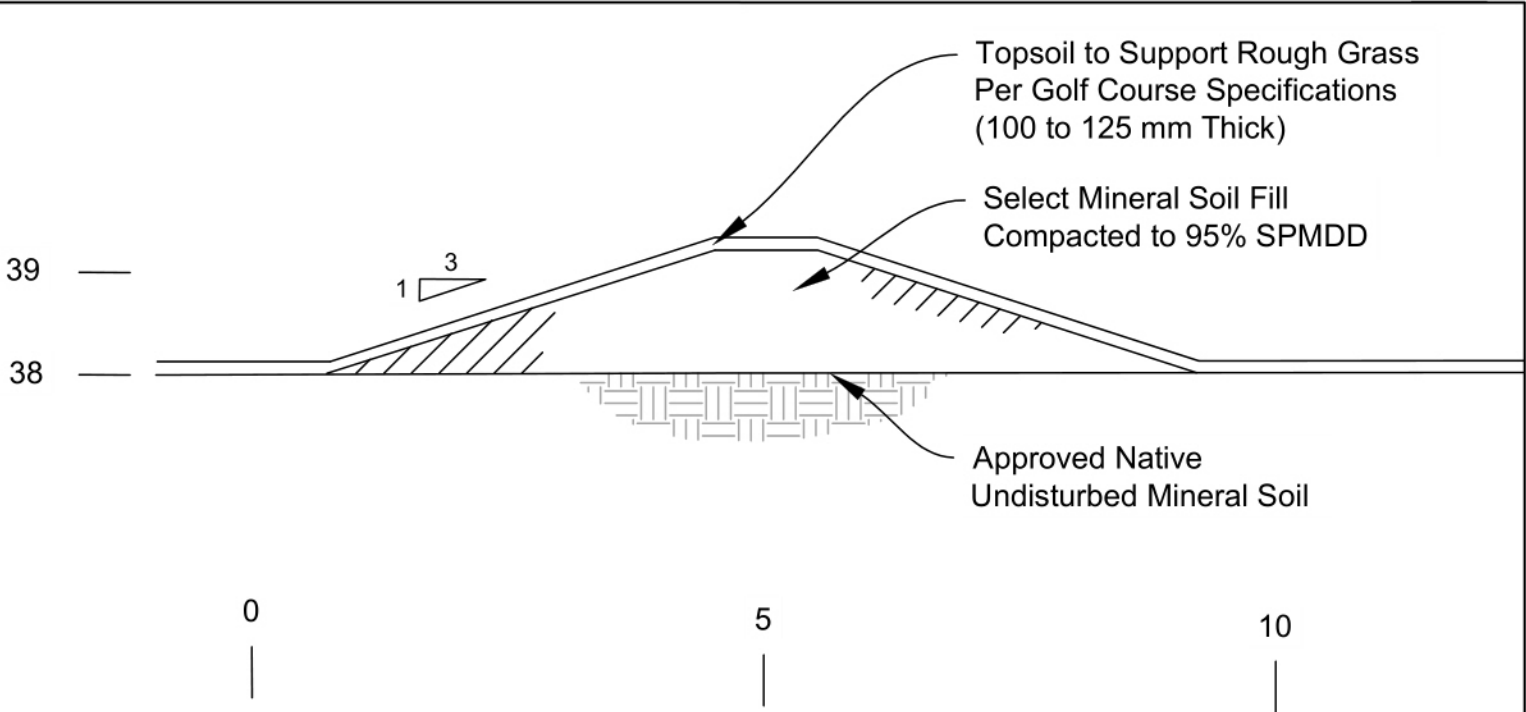
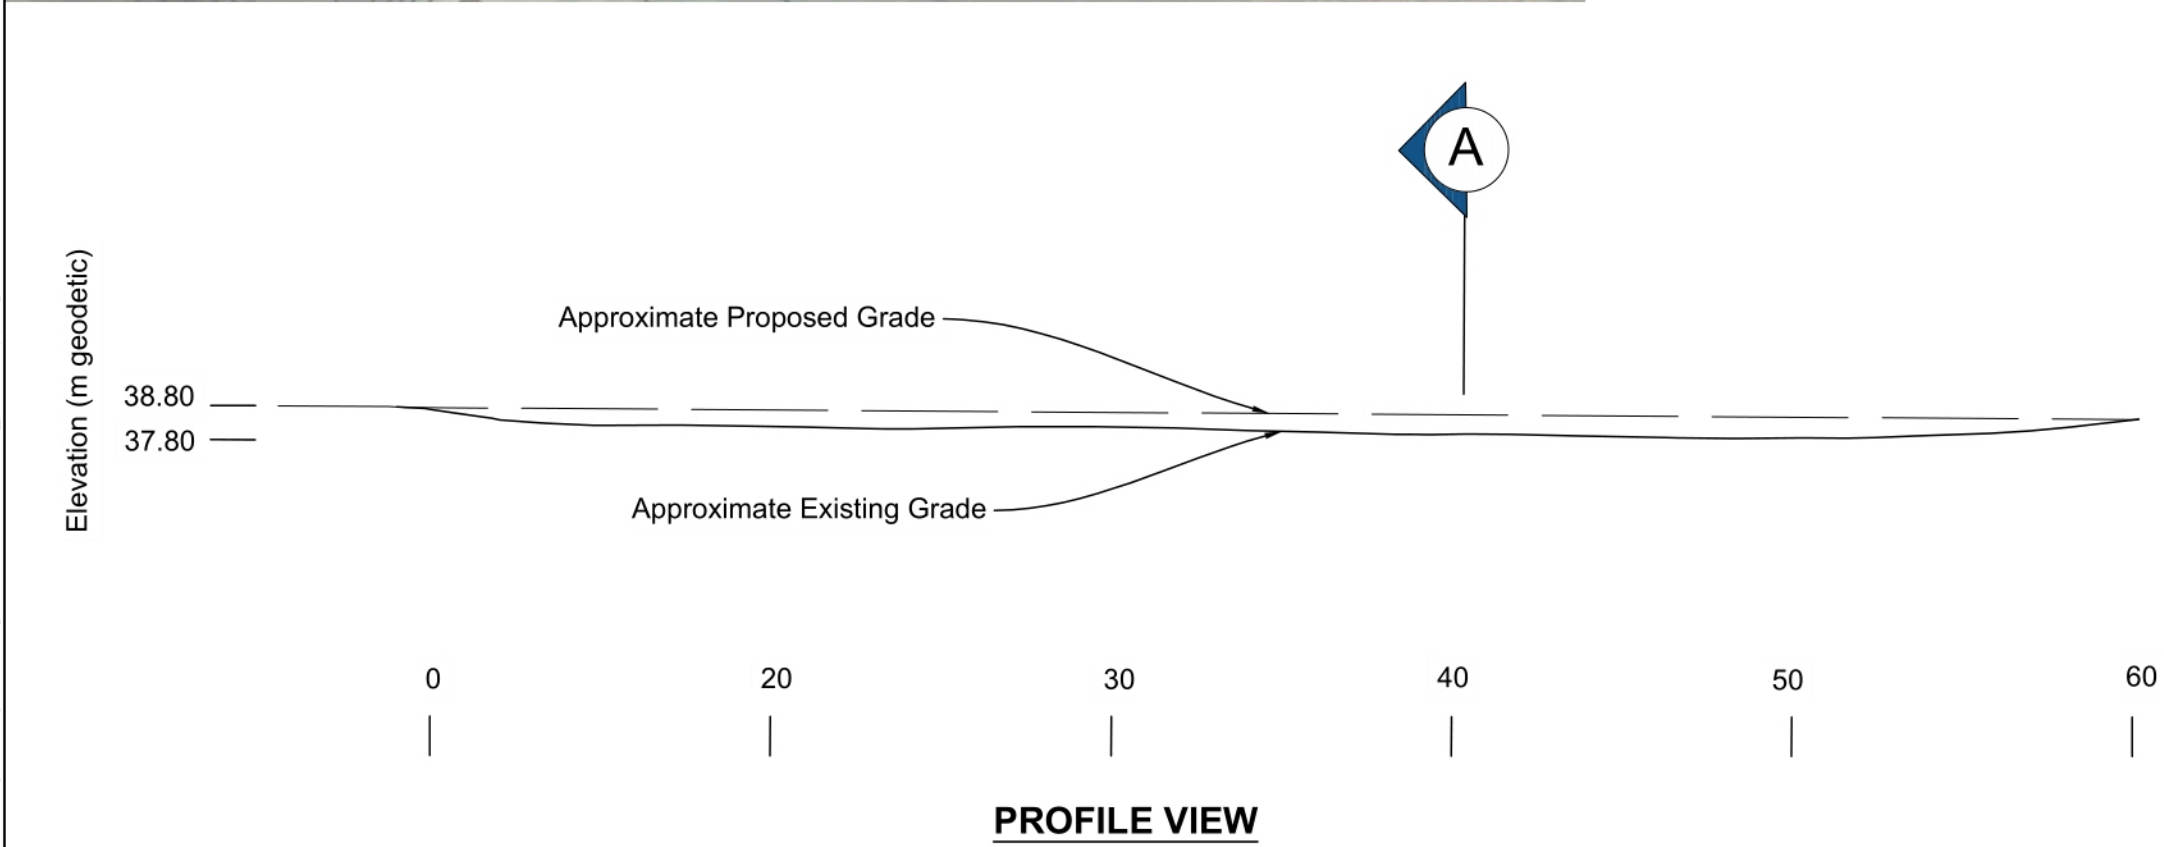
The subgrade preparations for the fill berm would require removal of the surficial organic soils and inspection prior to placement of select mineral soils. Fill soils are to be placed in thin lifts with moisture control and compacted to 95% Standard Proctor Maximum Dry Density (SPMDD). We will need to periodically monitor the material compaction during placement for approval and direct compaction methodology at the time of construction based on soil performance and available equipment. Capping layer of topsoil to be prepared for rough grass surface per Morningstar Golf Club specifications. Surplus fill soils can be placed in surrounding areas to suit terrain adjustments to direct flow to south of adjacent 'Tee Off' area. Silt abatement to be provided on the downstream side of the work areas to ensure no sediment ingress into the riparian area until vegetation have developed to provide surface stability.

1. Refer to Site Plan for the Berm location.
2. Ryzuk to inspect subgrade of the Berm area following removal of surficial organics.
3. Organic soils can be set aside for potential reuse as capping soils or for general terrain incorporation pending field review.
4. Mineral soils to consist of select compactable soils generated from spillway excavation. Soil quality and conditions to be assessed by Ryzuk at initial stages for determination of placement methodology with available equipment.
5. Topsoil/Sod to be prepared in accordance with Morningstar Golf Course specifications.
6. Ensure no disturbance or sediment ingress over riparian boundary by means of grading, silt abatement measures etc.

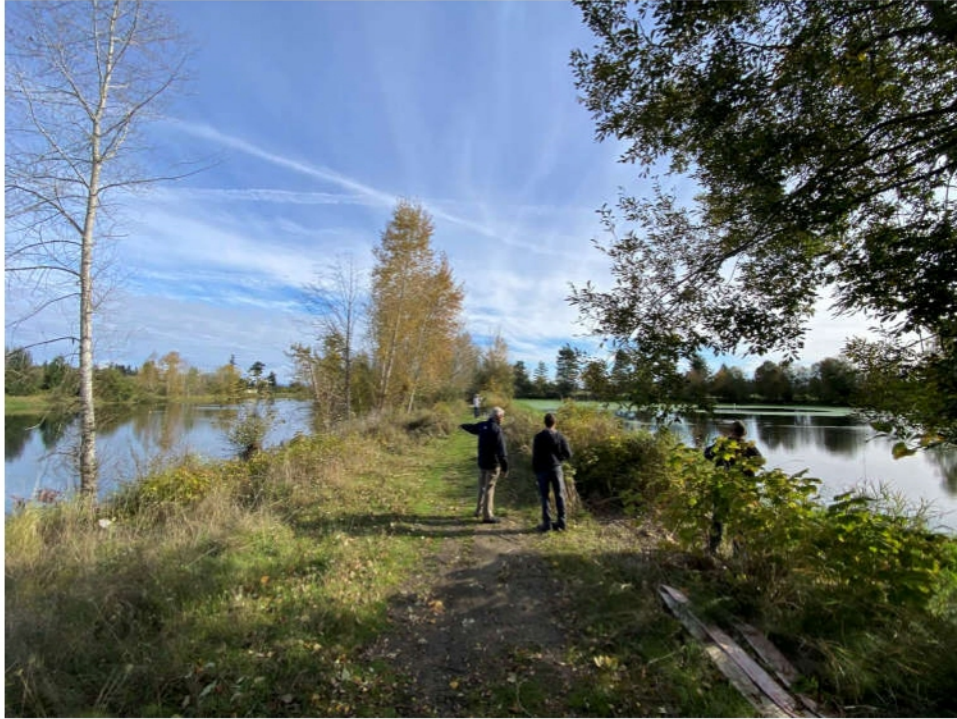
Figure 2. Photo of Dam 1 looking northeast from the left abutment.

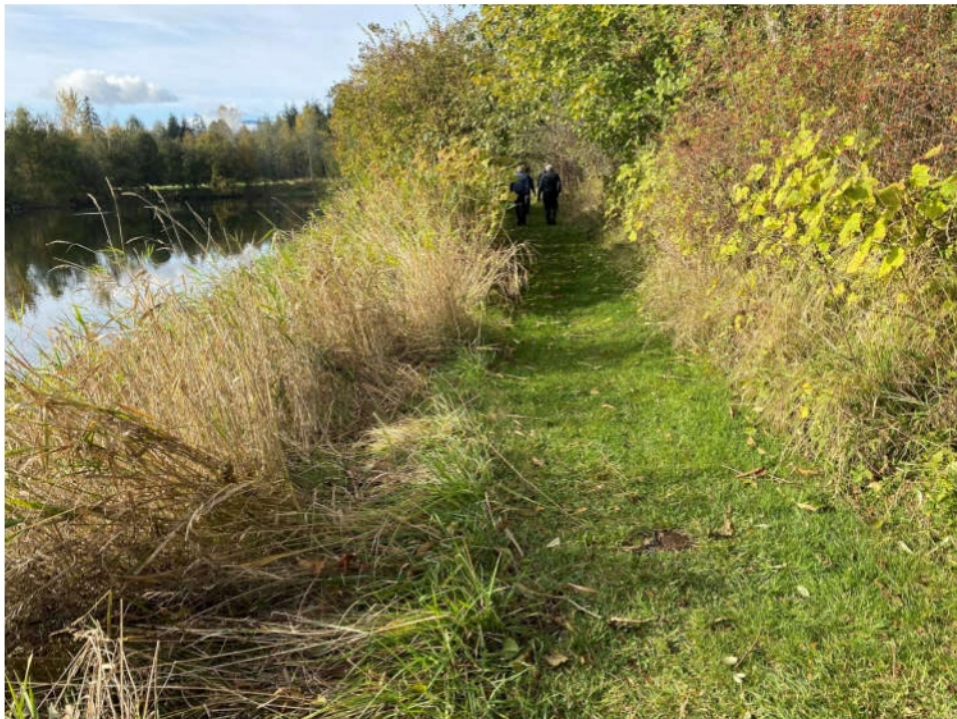
Figure 3. Photo of Dam 2 looking southwest from the right abutment.

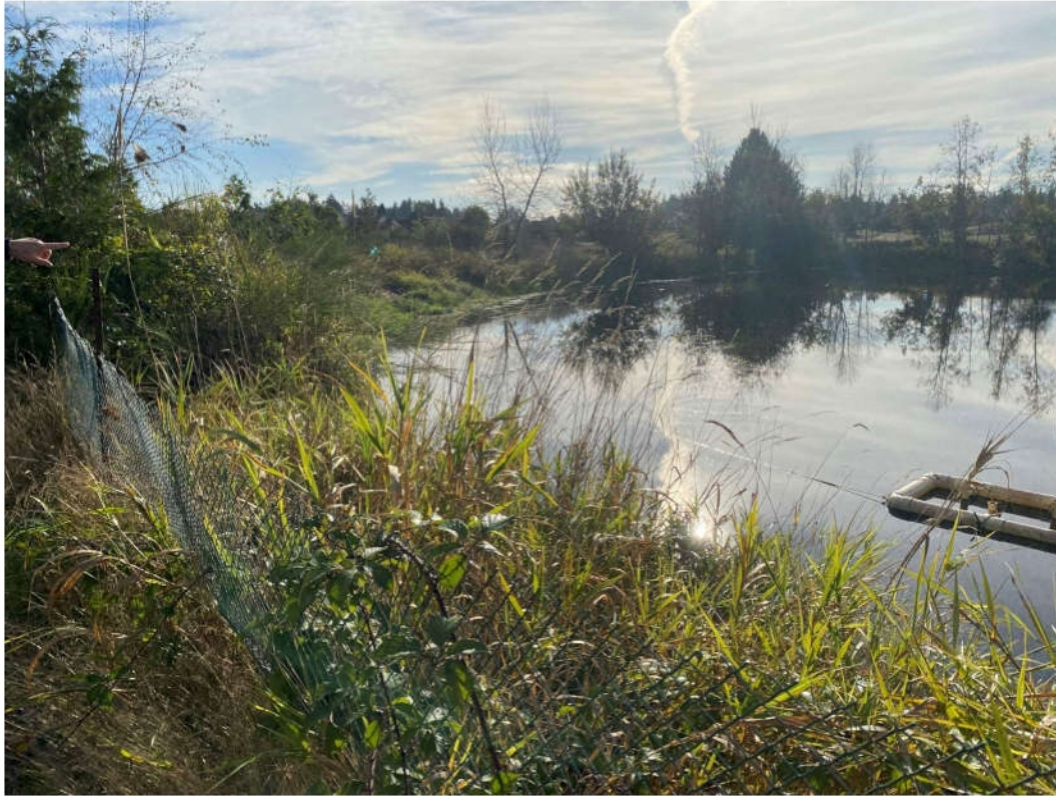
Figure 4. Photo of Dam 3 looking southeast from the left abutment.

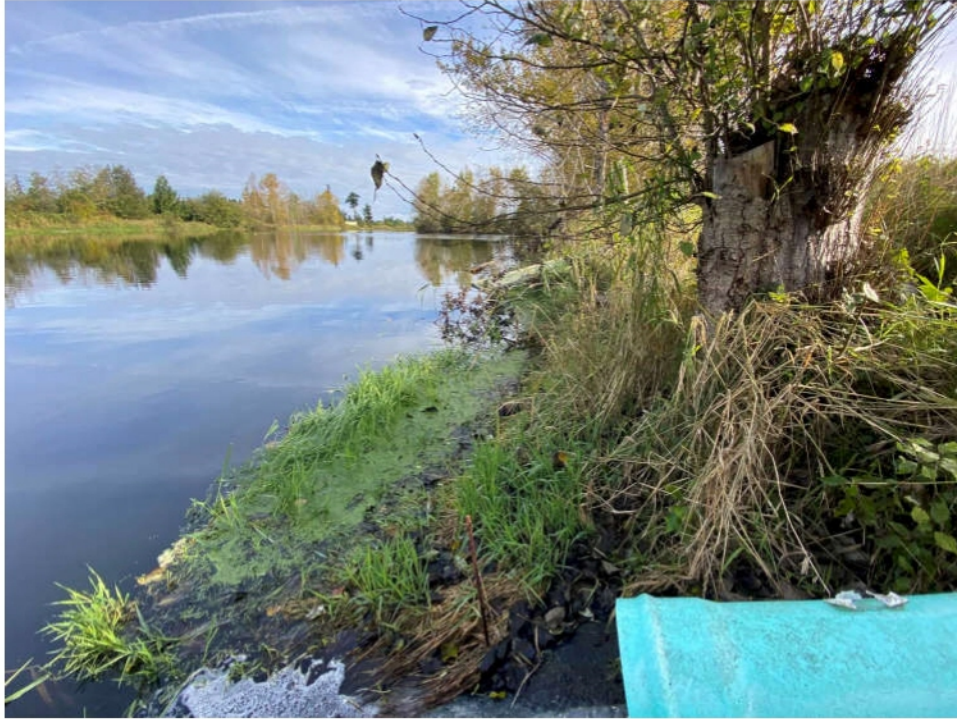
The two PVC culverts located in the saddle dam between Pond A and Pond B are approximately 0.34 m diameter and include a concrete segment headwall at the inlet. The headwall appears to have been subject to some differential settlement as the sections were noted to be leaning towards Pond A locally. The pipes have an overall length of approximately 20 m, generally following the geometry of the embankment surface, with the outfall discharging atop a wooden board armored surface close to the winter static levels of Pond A. The areas directly surrounding these culverts are lightly vegetated and the portions of the pipes on the downstream side are not buried. The photographs in Figures 5 and Figure 6 below show the PVC pipes. We note that PVC may be sensitive to ultra-violet light and such may deteriorate more quickly due to sun light exposure. No spillway exists for Pond A other than the two overflow pipes with sandbag headwalls which are denoted on the design drawing as a 150 mm and 200 mm diameter PVC. These pipes outfall to a 1.2 m diameter concrete barrel collector sump which in turn discharges to a 200 mm diameter leader extending close to Morningstar Creek within the golf course 18th hole fairway.

Figure 5. Photo view of culvert outlet at Pond A looking northeast.

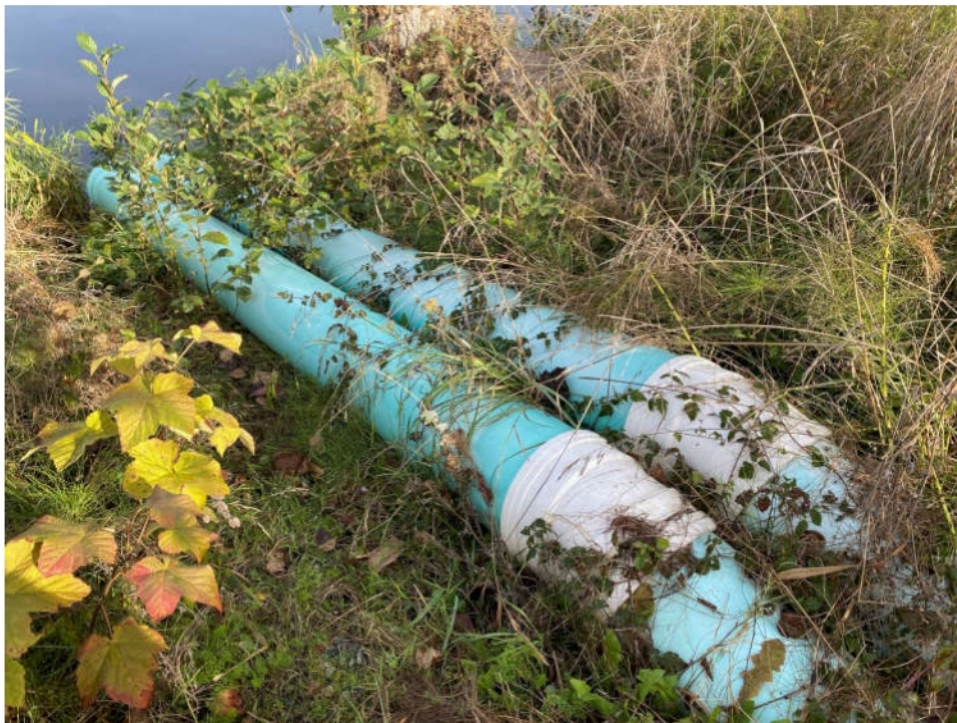
Figure 6. Photo view of culverts exposed along the west side of Dam 1 looking northwest.

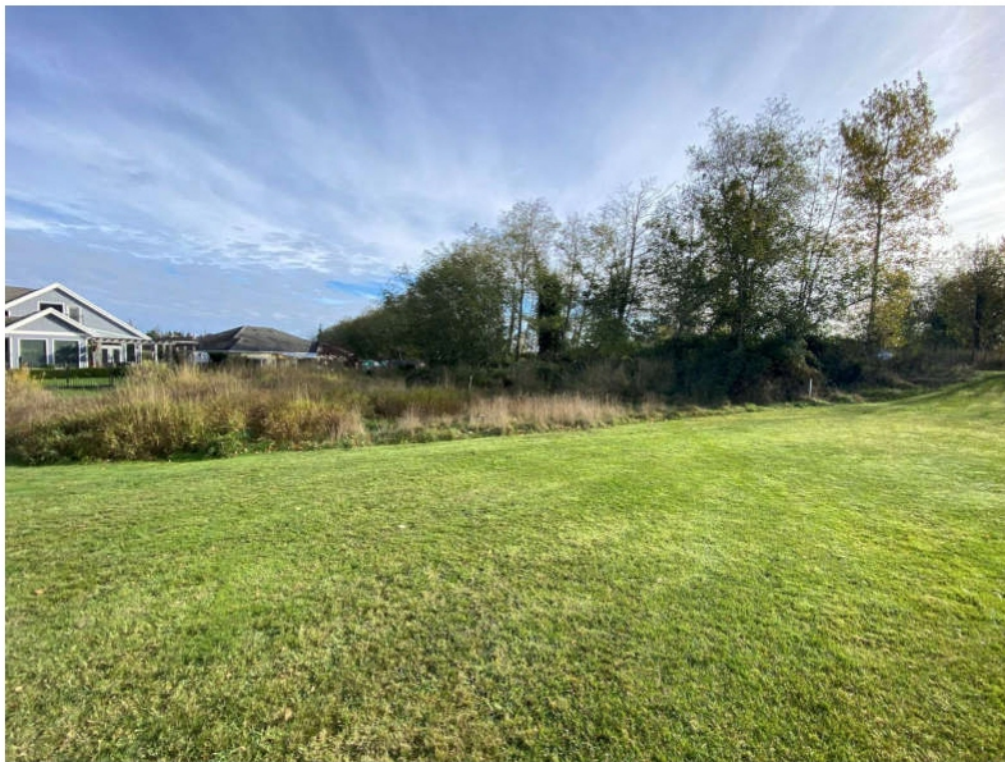
Figure 7. Photo of western inundation area looking northeast toward wooded border along Dam 2

Breach of Dam 2 would be limited to a height of approximately 1.6 m based on the dam section. This occurrence would result in inundation flow impacting the treed boulevard area and adjacent roadway, the residential lots along the southern side of Morningstar Drive, as well as the golf course rough/fairway to the west of the ponds. The modeling suggests that Q_p would be approximately $11.5 \text{ m}^3/\text{s}$ at the breach, but as the terrain is gentle and vegetated the flow would spread out radially from the hydraulic step and attenuate rapidly. In the case that the flow broke through the sparse woodland band within the central-eastern portions and spread onto the 10 m wide roadway bound by curbs and gently upsloped front lawns/driveways, the average depth (d_{avg})
