2012 INSPECTION COMPLIANCE FORM FOR OWNERS OF HIGH, VERY HIGH & EXTREME CONSEQUENCE DAMS

By Fax at: By email at:	250-952-6792 dam.safety@gov.bc.ca)52-6792 safety@gov.bc.ca		N, NL, WL, PG
MCCUDDY CREE	KRESERVOIR #2 SADDLE DAM	Is Contact N	ame and Address corr	ect?
KEVIN TULAK MCKINNEY RD W	ATER USERS COMMUNITY	YESNO_	Piease correct belo	w:
s.22		· .

Small earthfill saddle dam at north end of reservoir.

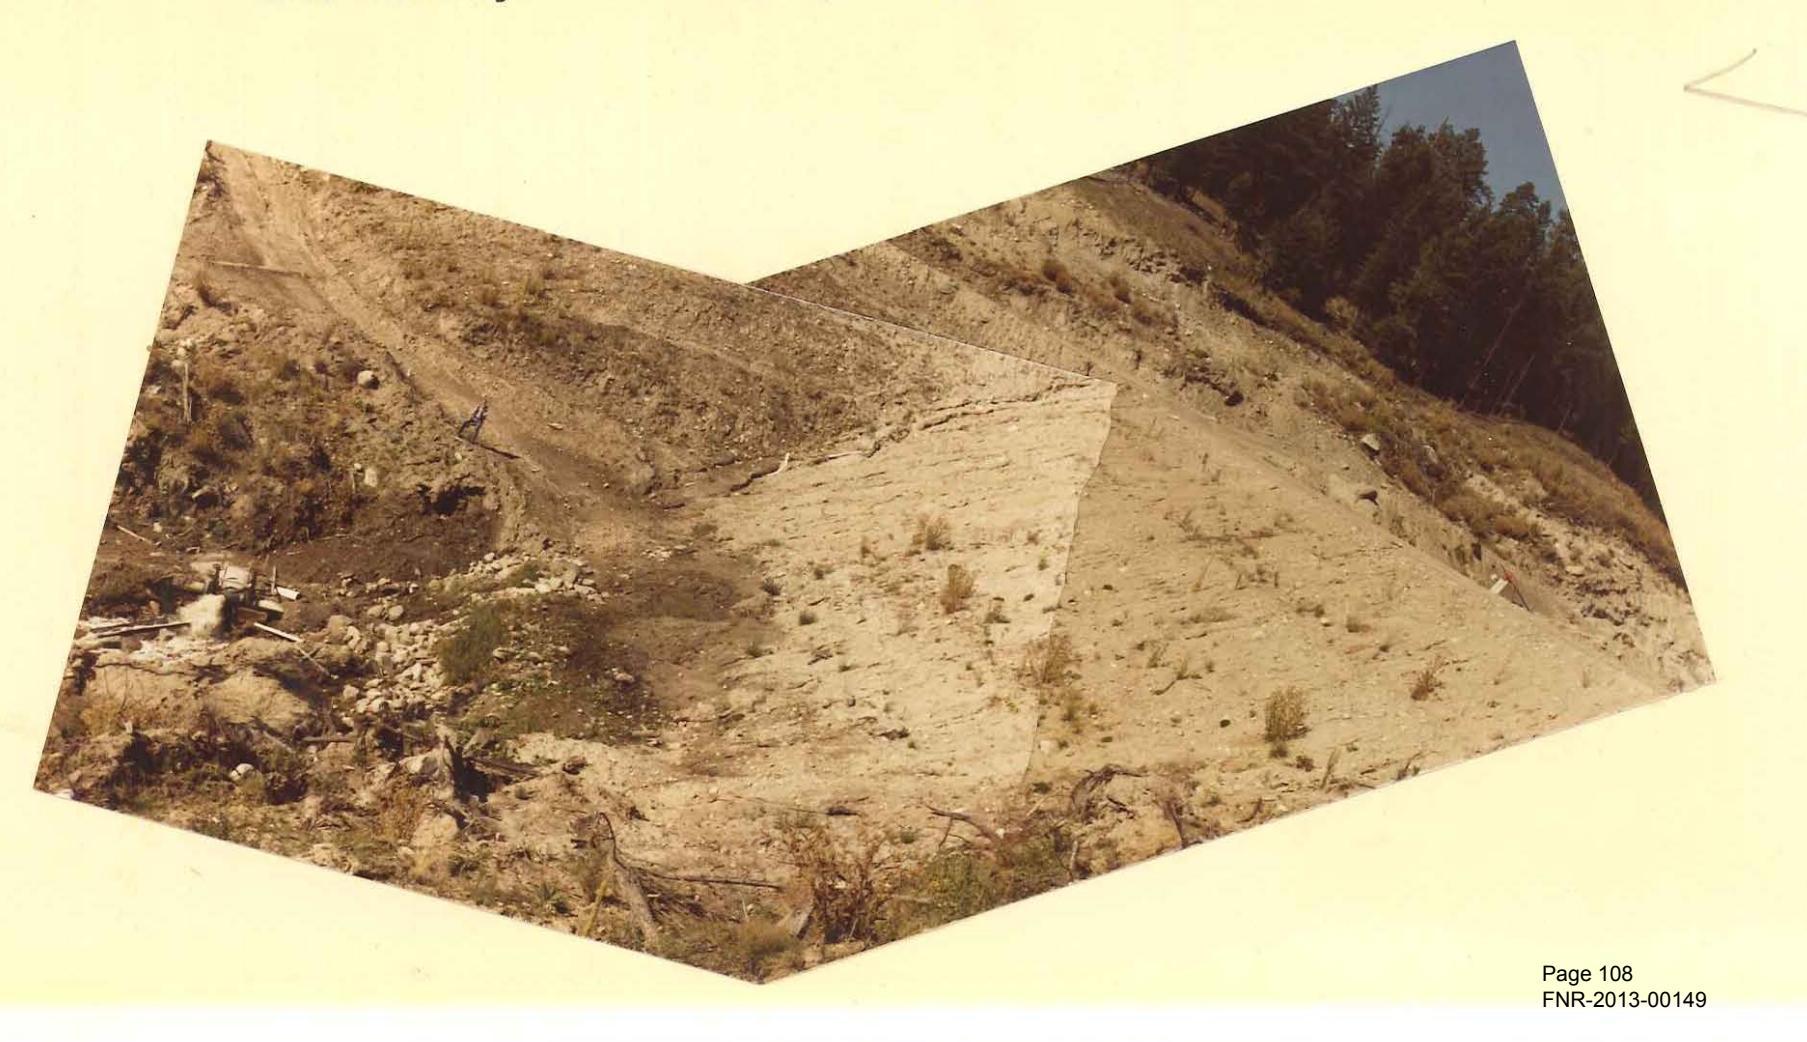
MCCUDDY CREEK #2

View of downstream face of dam showing saturated toe and berm. Note sluffing in lower right groin area.

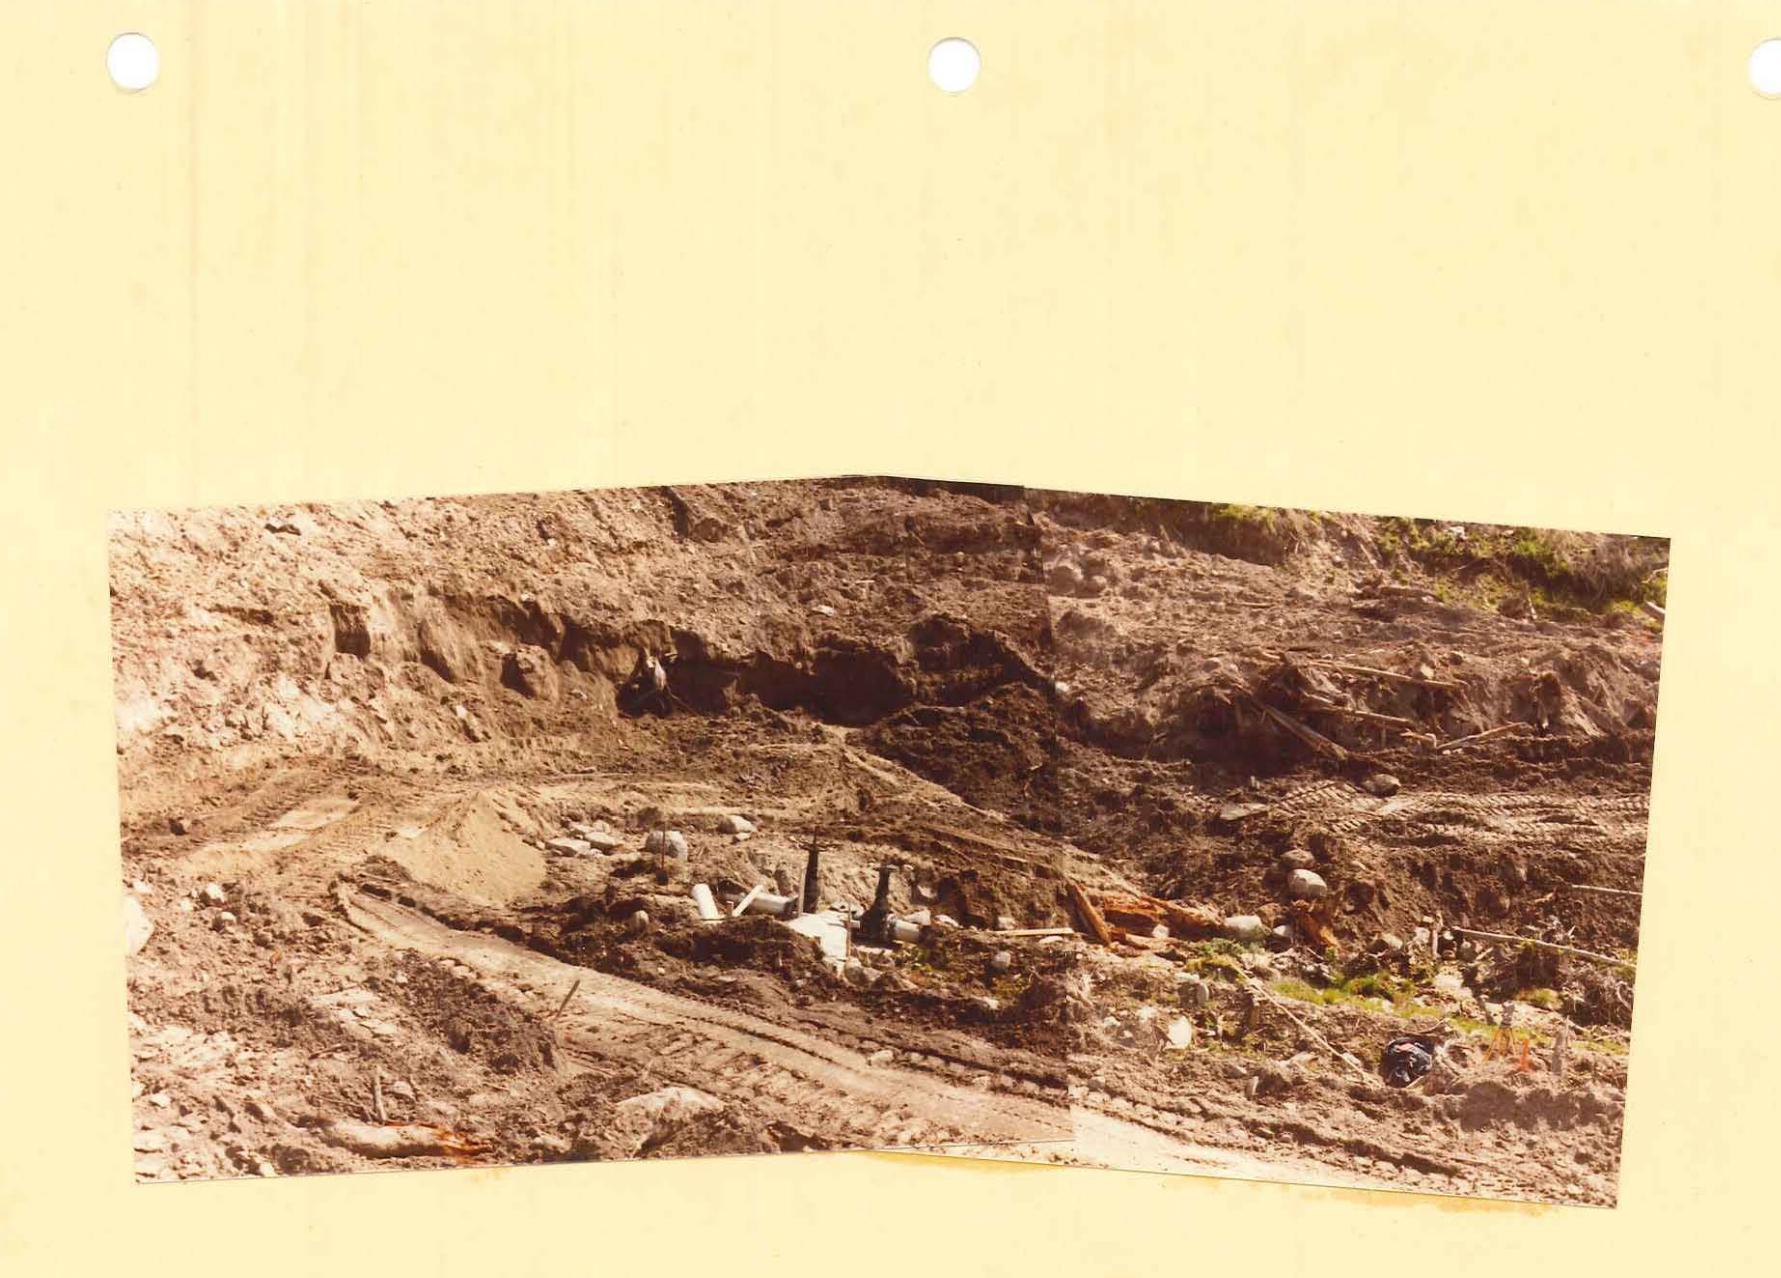
McCUDDIE CREEK #2

More deleterious materials exposed while stripping downstream toe area.

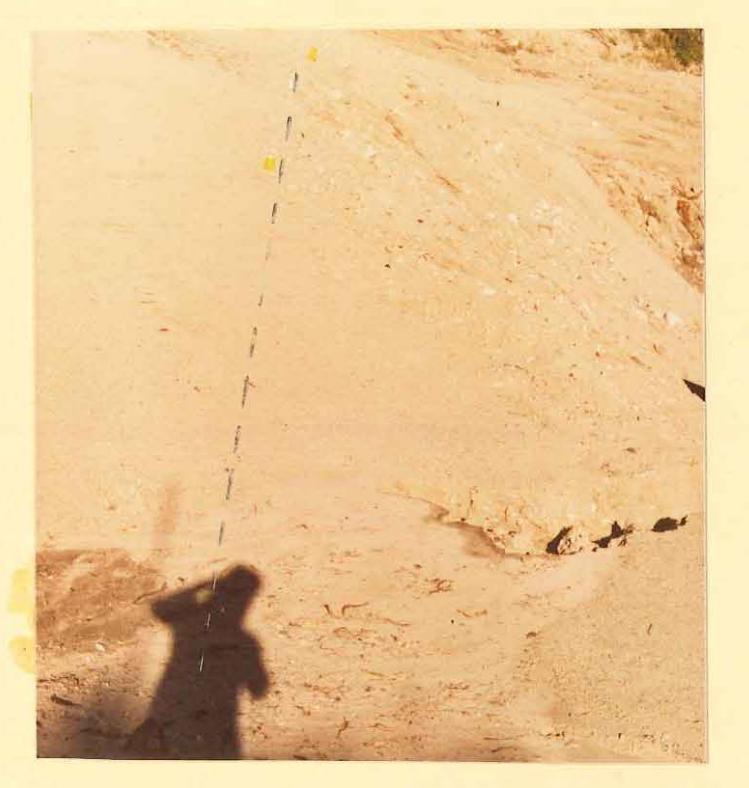
Minor erosion in filter berm. (Broken line indicates berm shoulder).

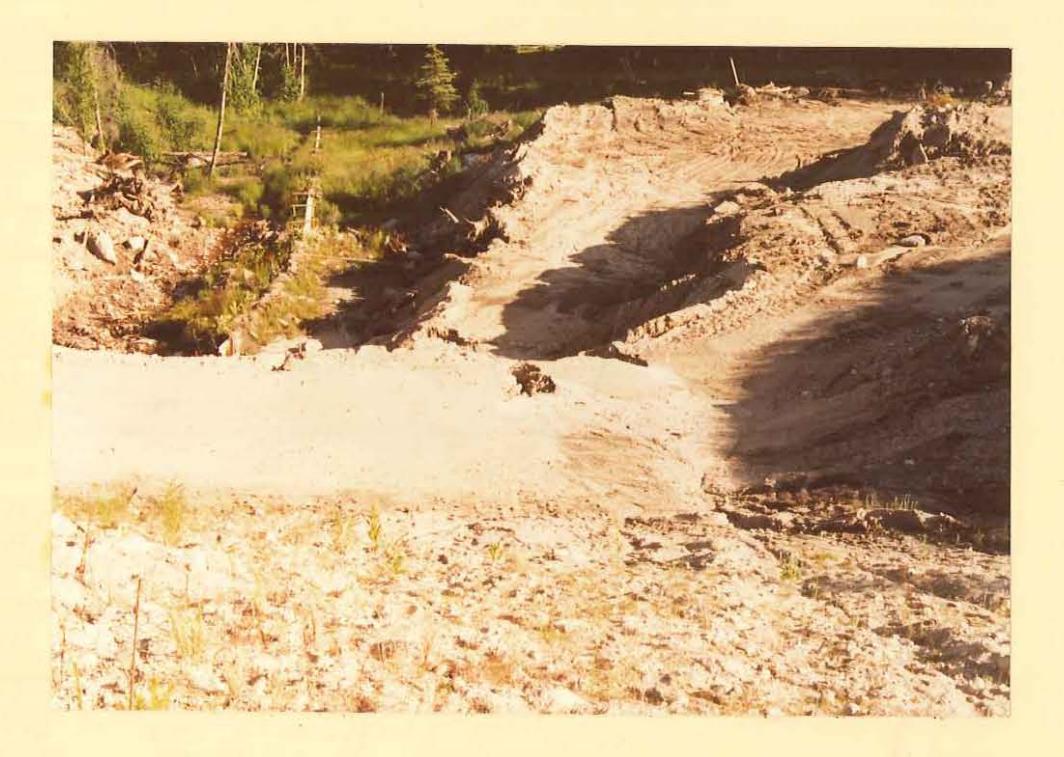
View of erosion on shoulder of recently placed filter berm.

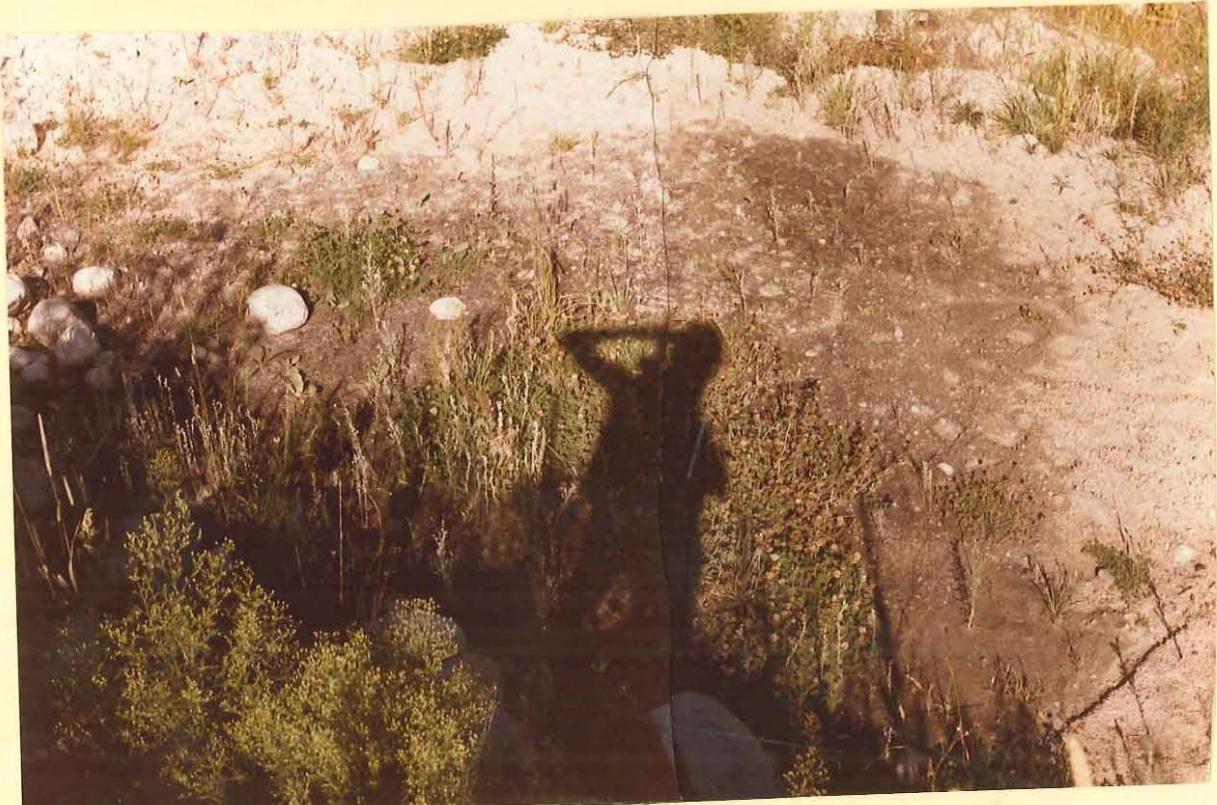
Damp area noted in original ground downstream of dam in left embankment.

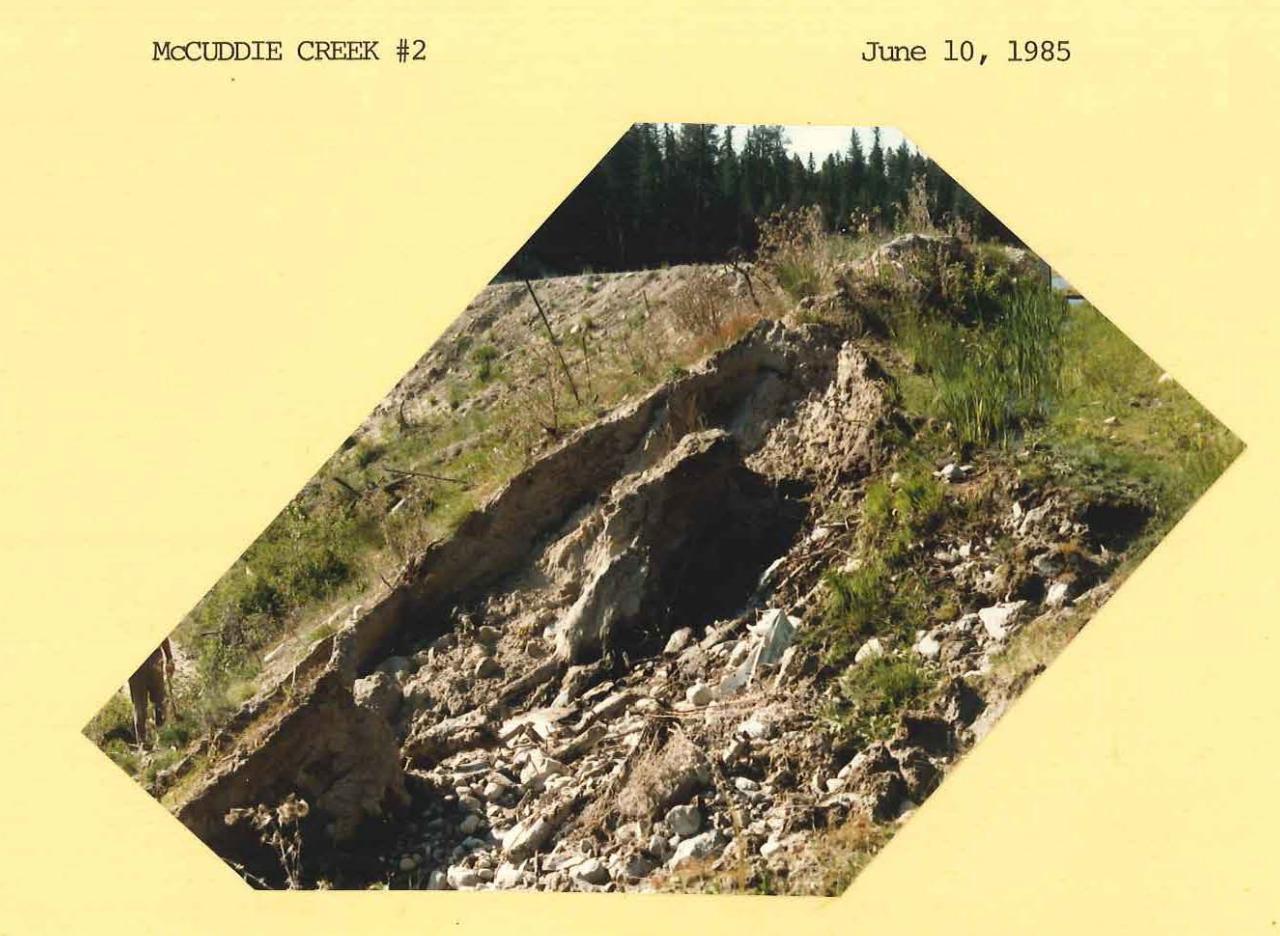
Spillway exit heavily eroded downstream of box culvert.

Circle indicates eroded area.

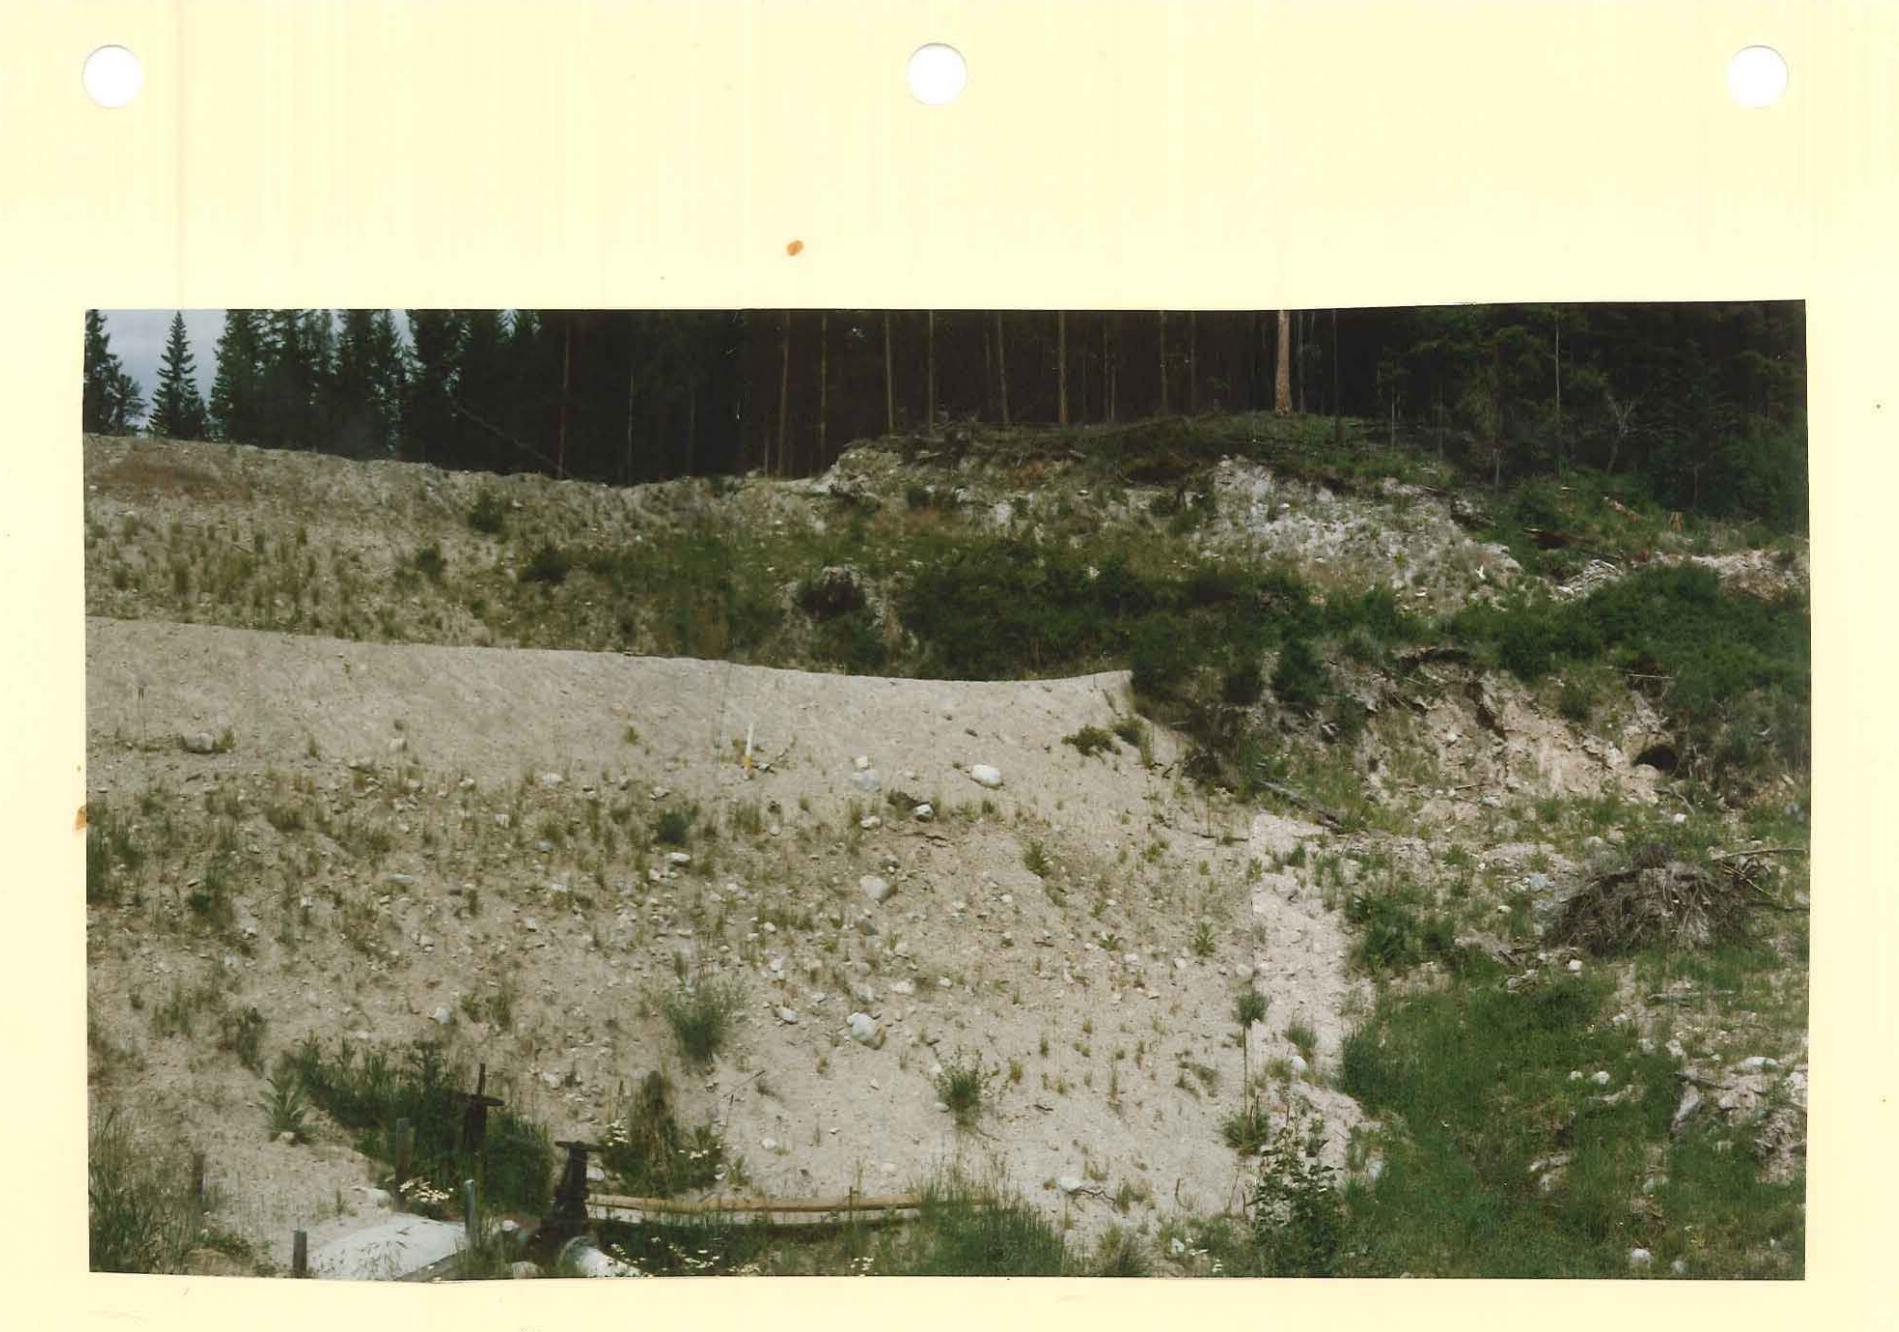
MCCUDDY CREEK #2

Spillway erosion shown in relation to stabilization berm.

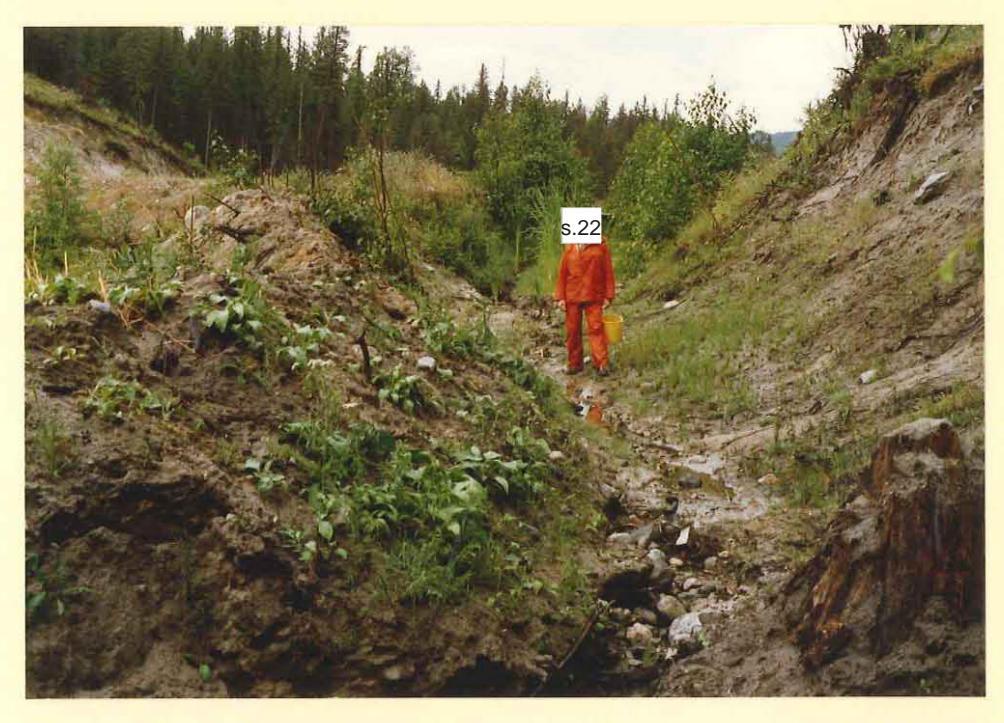
Material replaced in spillway embankment at outlet. Initial erosion beginning at spillway exit.

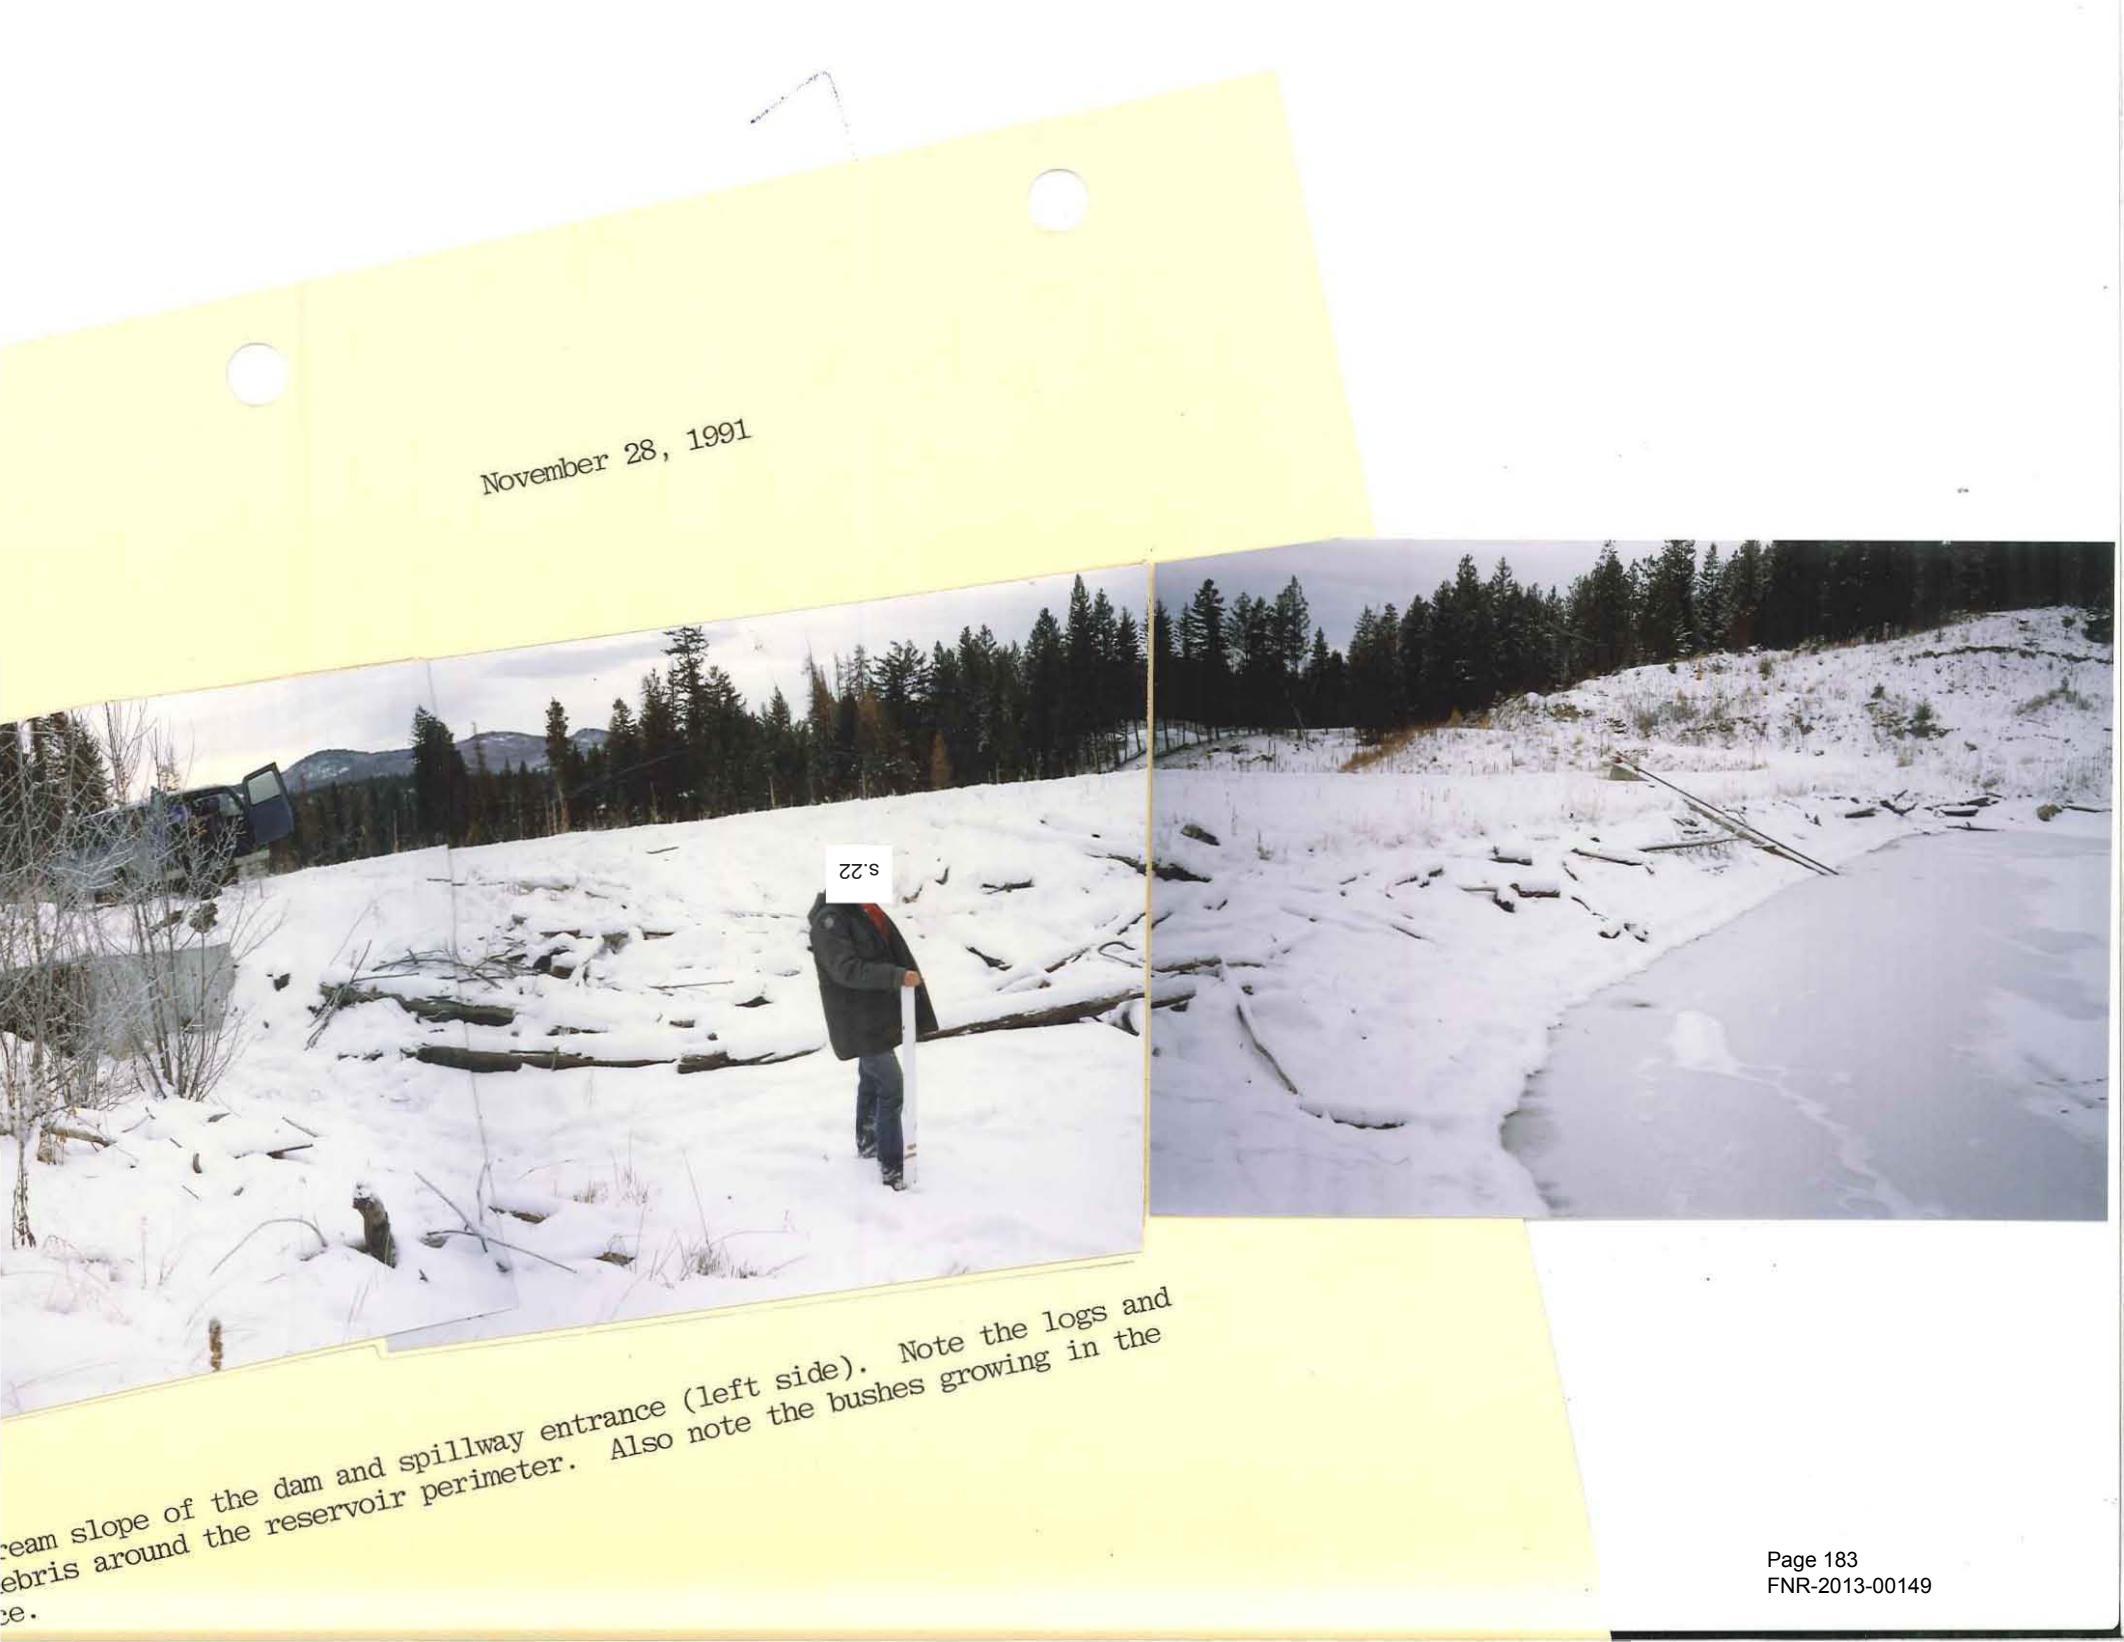
View of the upstream slope of the dam and spillway entrance (left side). Note the logs and other floating debris around the reservoir perimeter. Also note the bushes growing in the spillway entrance.

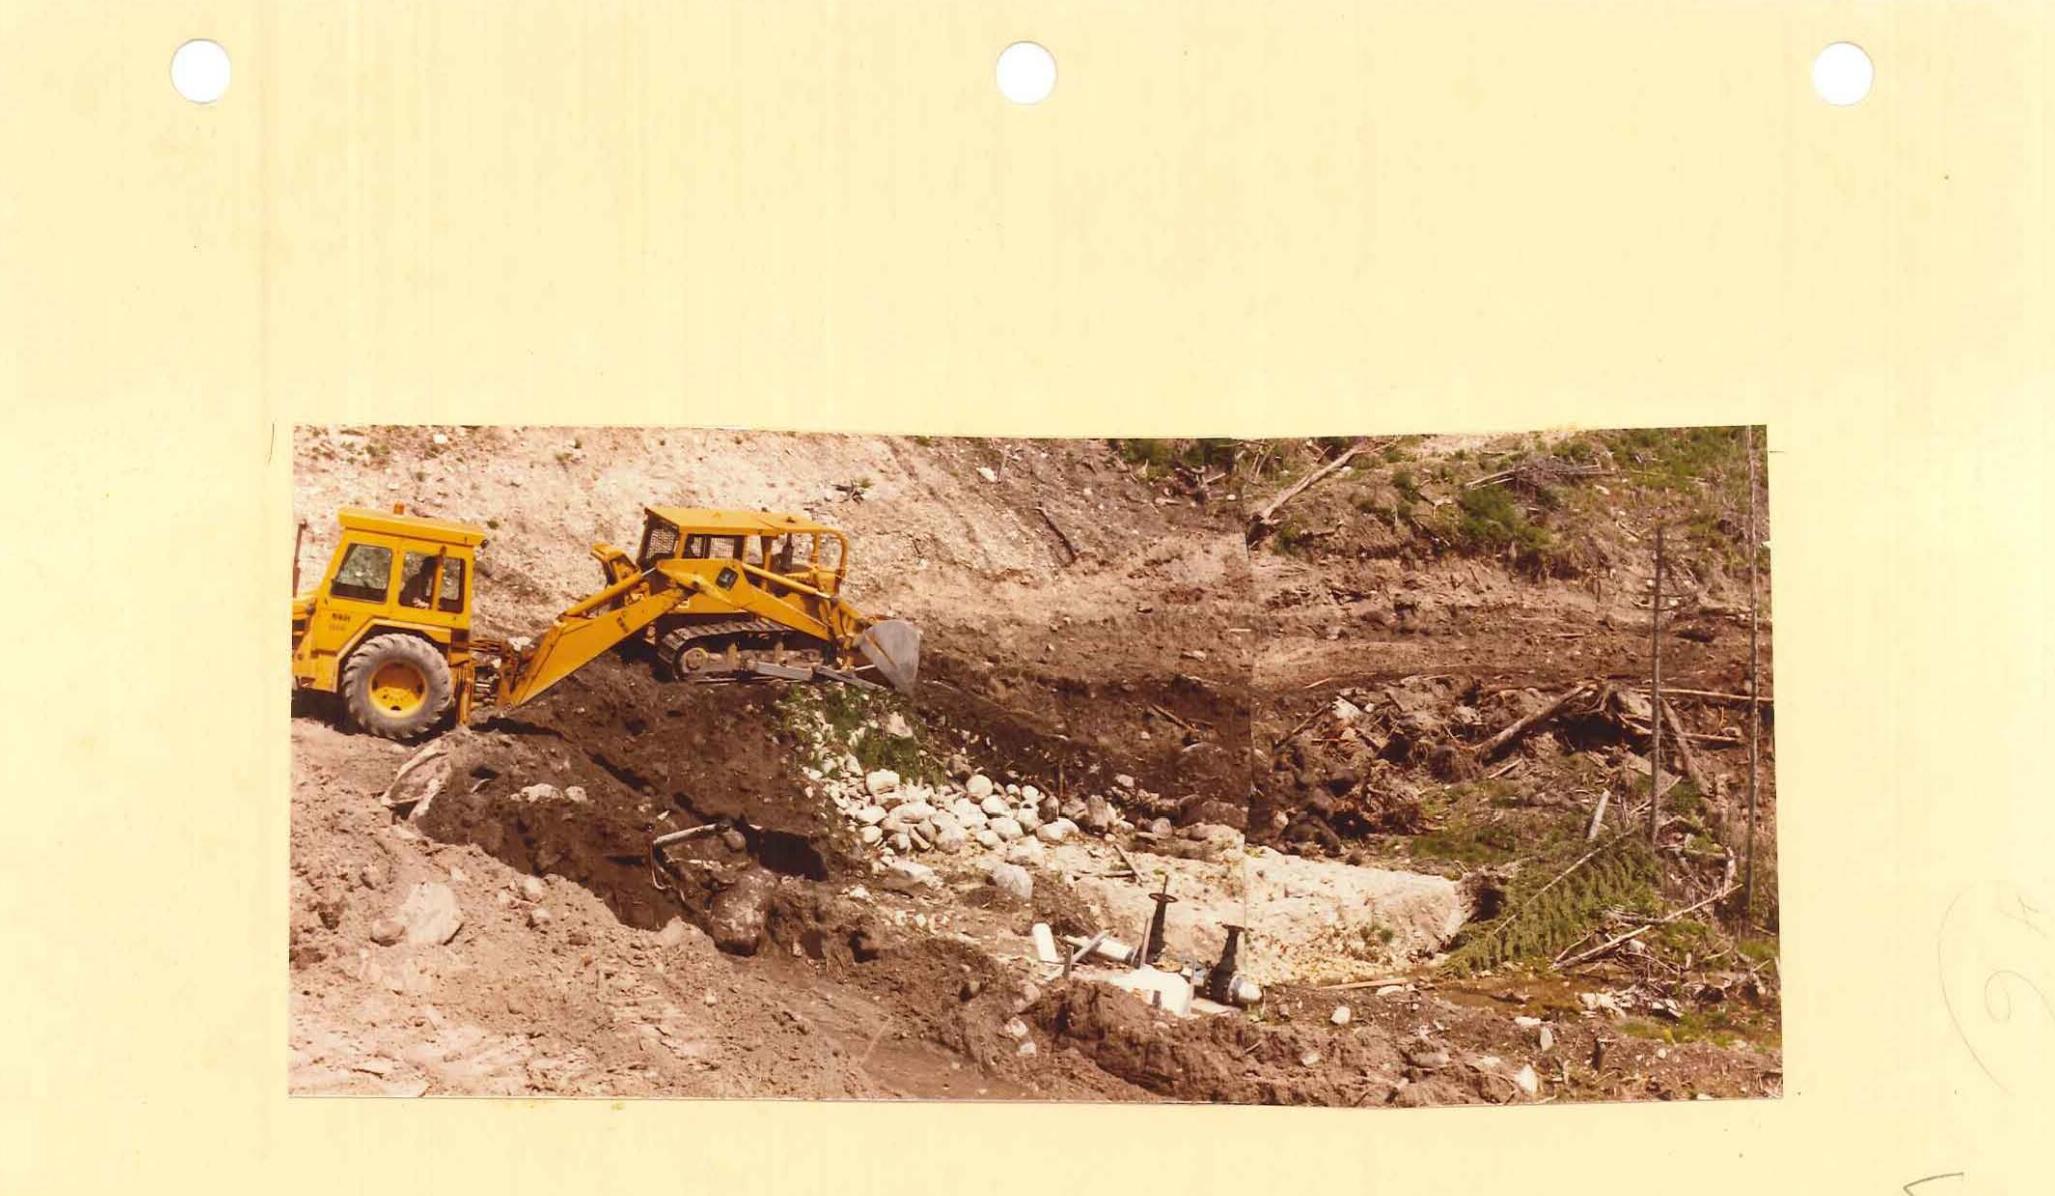
May 18, 1983

Large quantity of debris appearing in downstream toe area. This material is unsuitable and must be removed prior to placement of berm material.

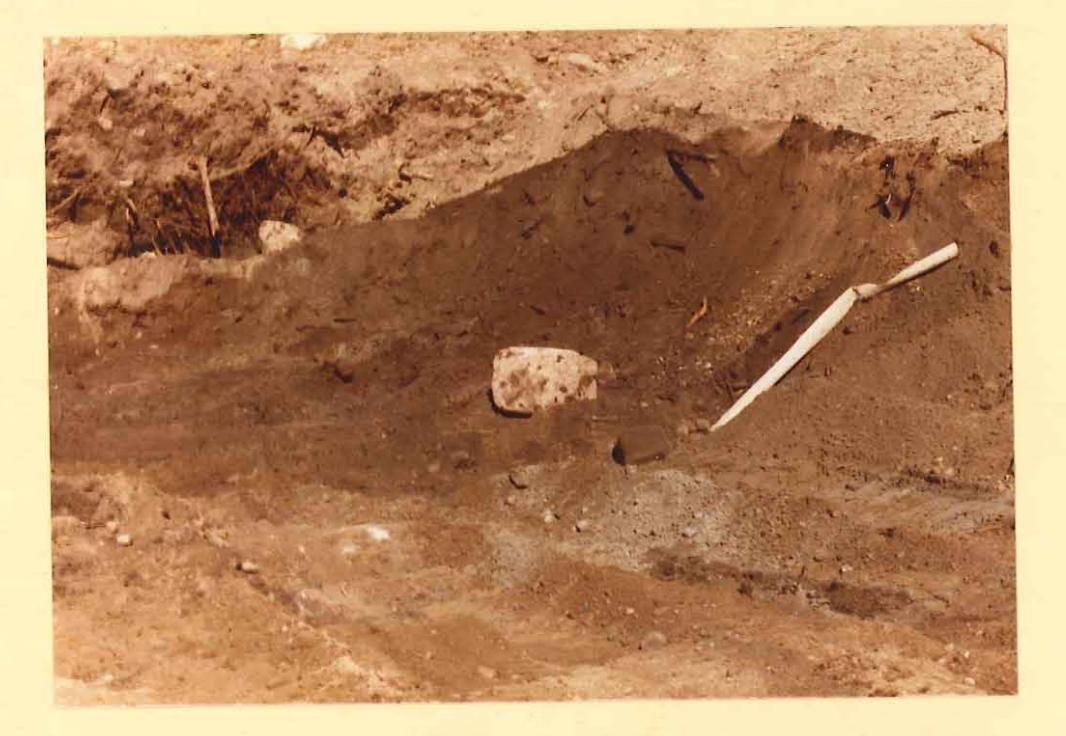
Damaged perforated pipe exposed and replaced.

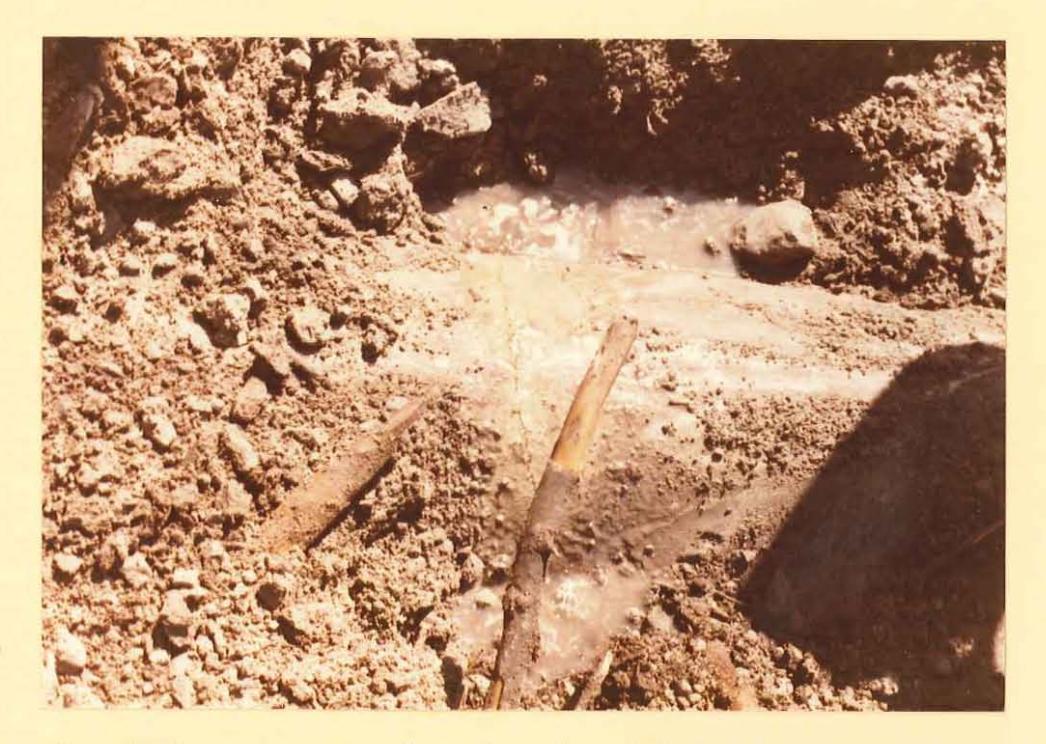
Crack in concrete low level outlet pipe.

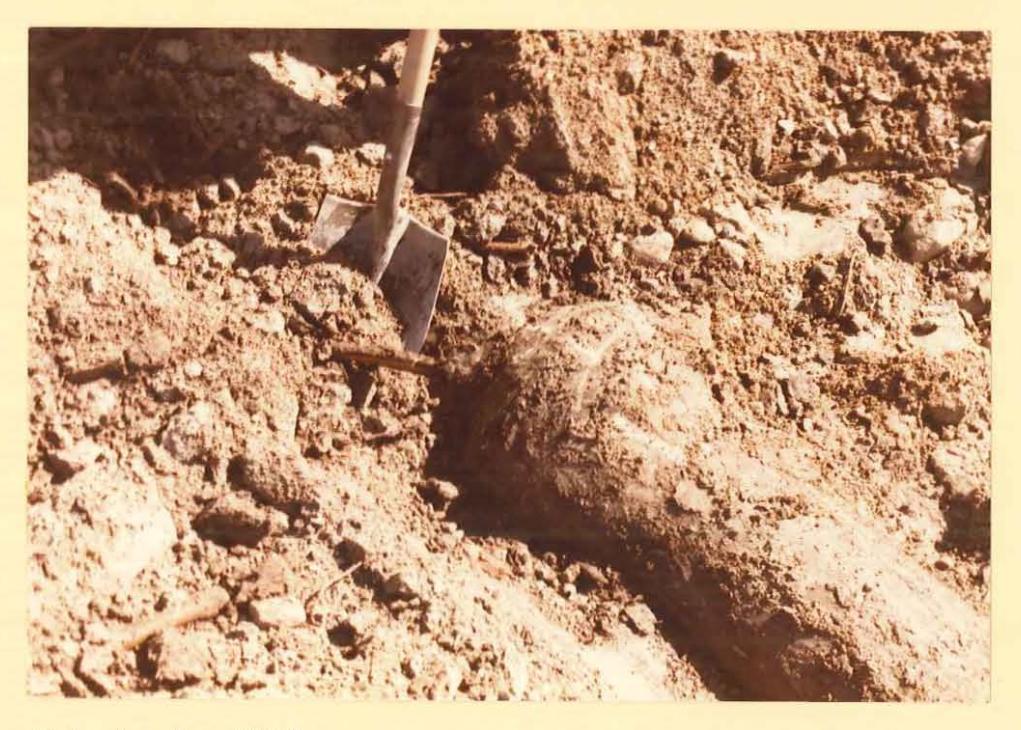
Debris in fill.

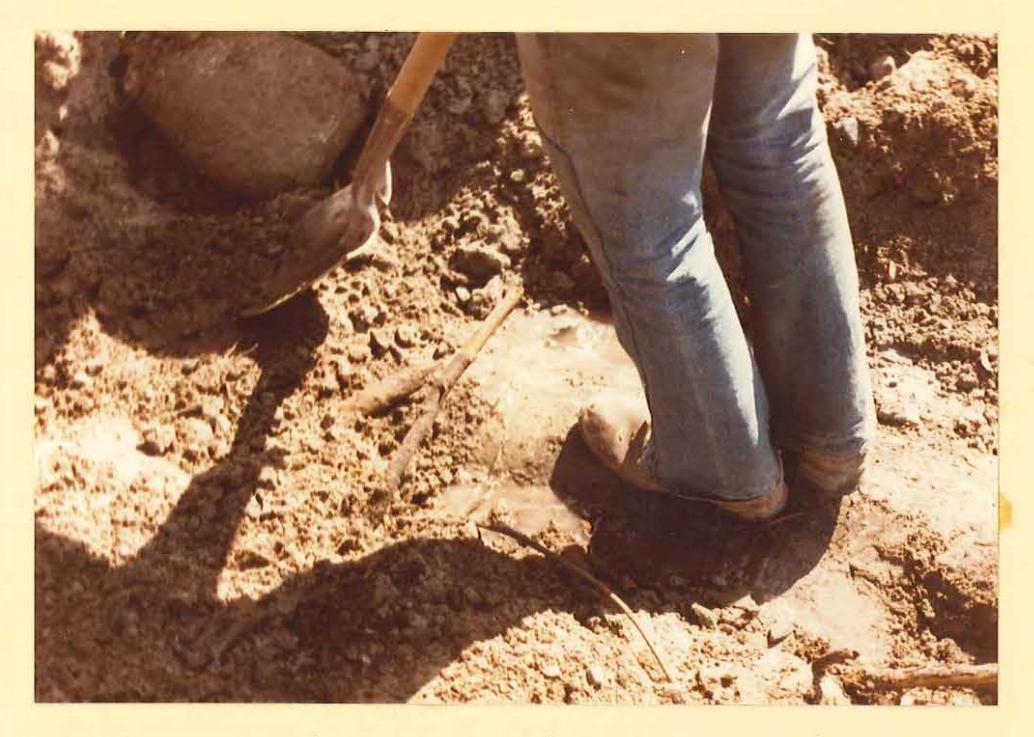
Boulder and sticks on leaking concrete pipe.

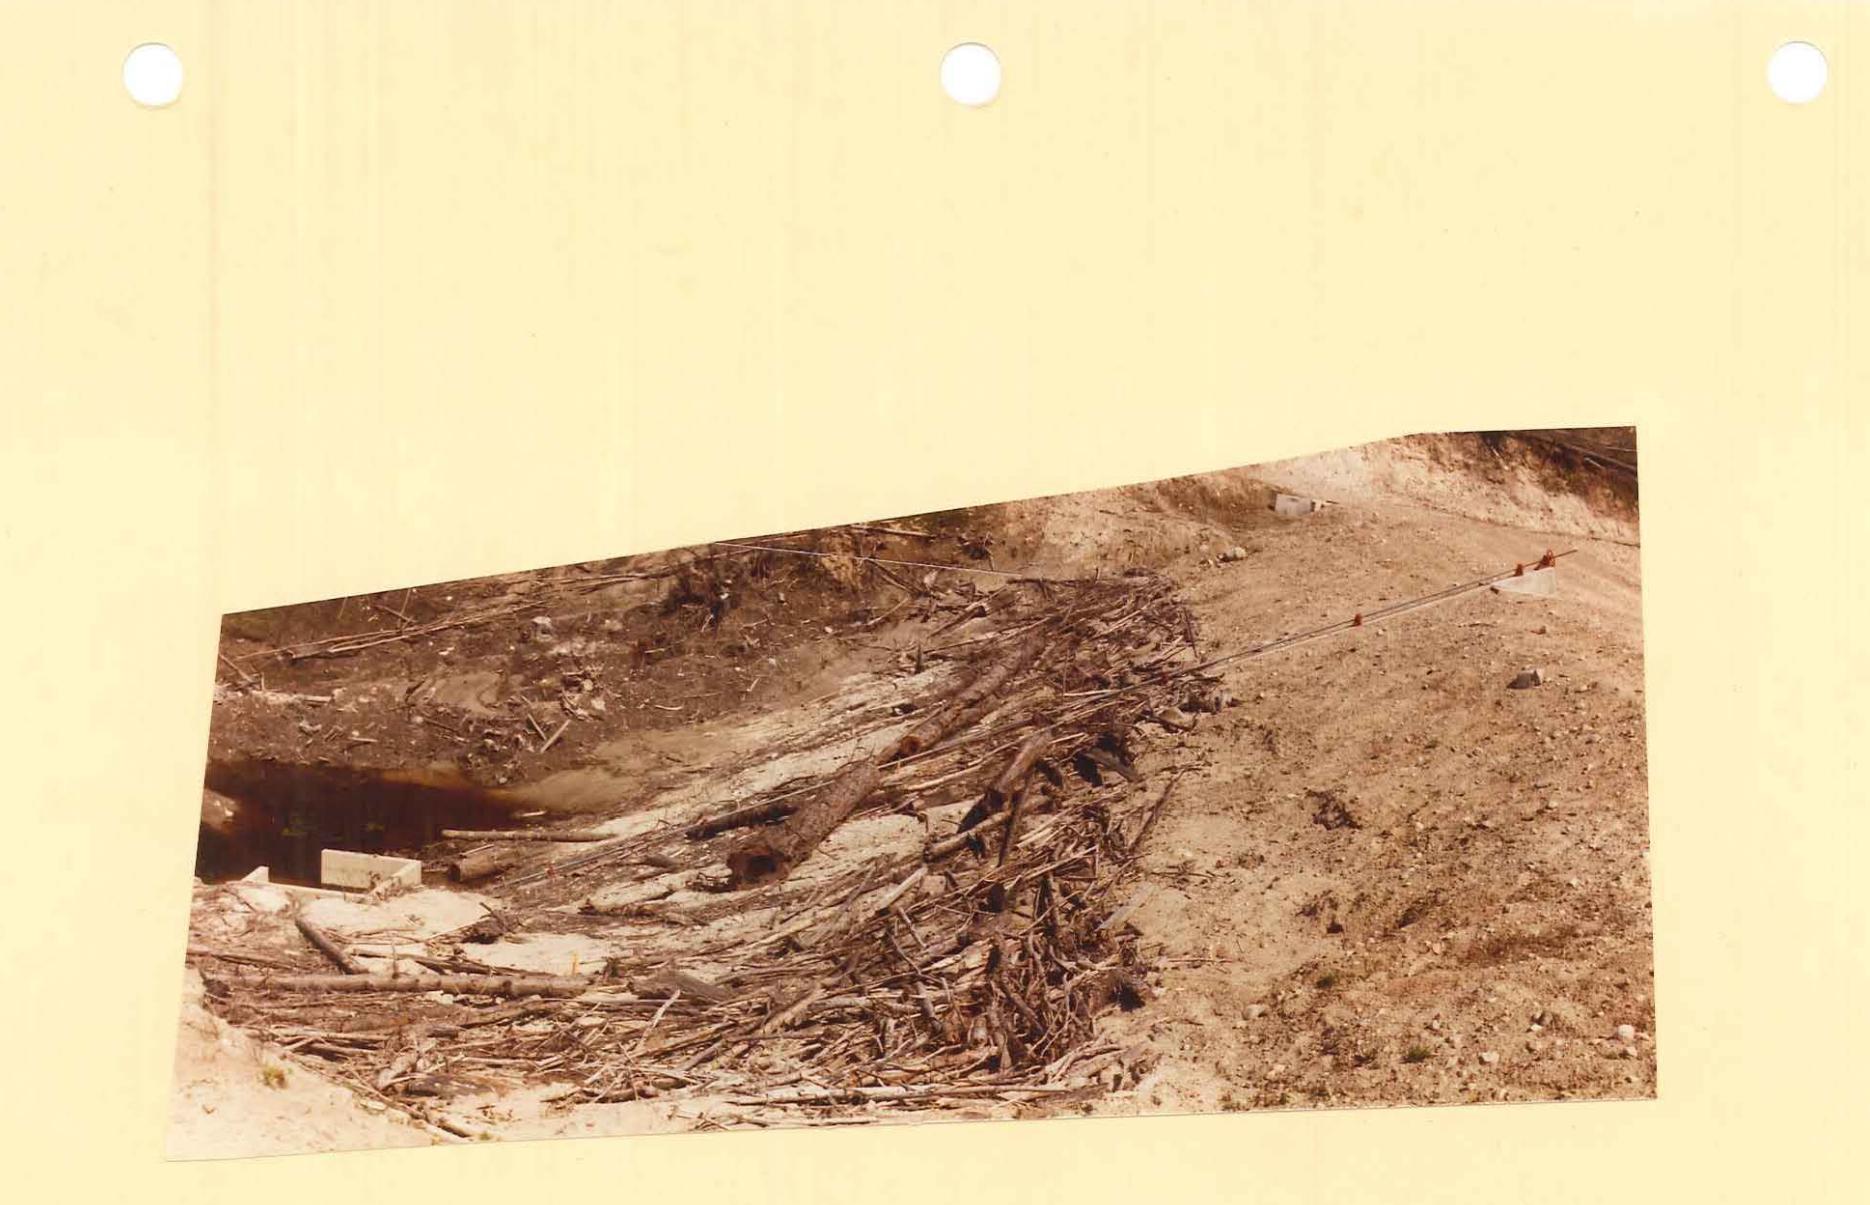
Sloping gate stem and considerable debris on upstream face.
