NOTICE OF EMERGENCY WORKS | SLOPE FAILURE AT MANTLE CREEK | LAFARGE COQUITLAM SAND AND GRAVEL, COQUITLAM, BC

SUPPLEMENTARY EMERGENCY WORKS, SLOPE FAILURE AT MANTLE CREEK LAFARGE COQUITLAM SAND AND GRAVEL, COQUITLAM, BC

COQUITLAM SAND AND GRAVEL PROGRESSIVE RECLAMATION 2013 REVIEW

COQUITLAM SAND & GRAVEL DAM INVENTORY

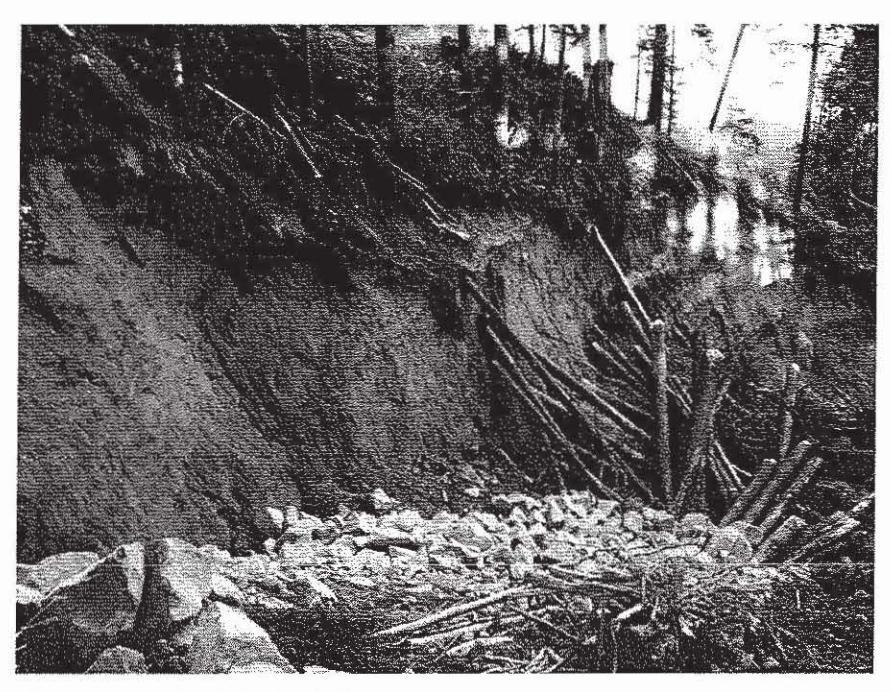
Photograph 1: March 28, 2013. Partial view of Mantle Creek failure zone and riprap placement.

On Monday March 25, 2013 Lafarge began placing approximately 500 tonnes of nominal 12" x 24" riprap. All rock was placed using an excavator with the help of a spotter to guide and direct the placement of the boulders. The riprap was placed to eliminate the plunging water from entering the failure zone and causing further bank erosion and instability. Lafarge is continuing to monitor the area for potential settlement and bank erosion, and will add more riprap if necessary, to minimize potential for plunging water from entering the erosion zone (Refer to Photographs 1 and 2).

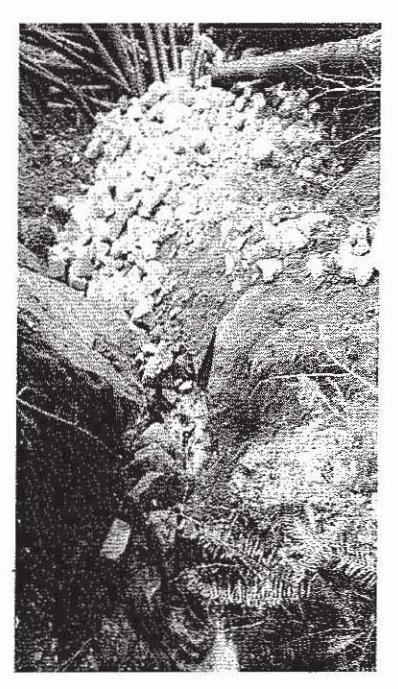
Photograph 2: March 28, 2013. Partial view of Mantle Creek failure zone and riprap placement.

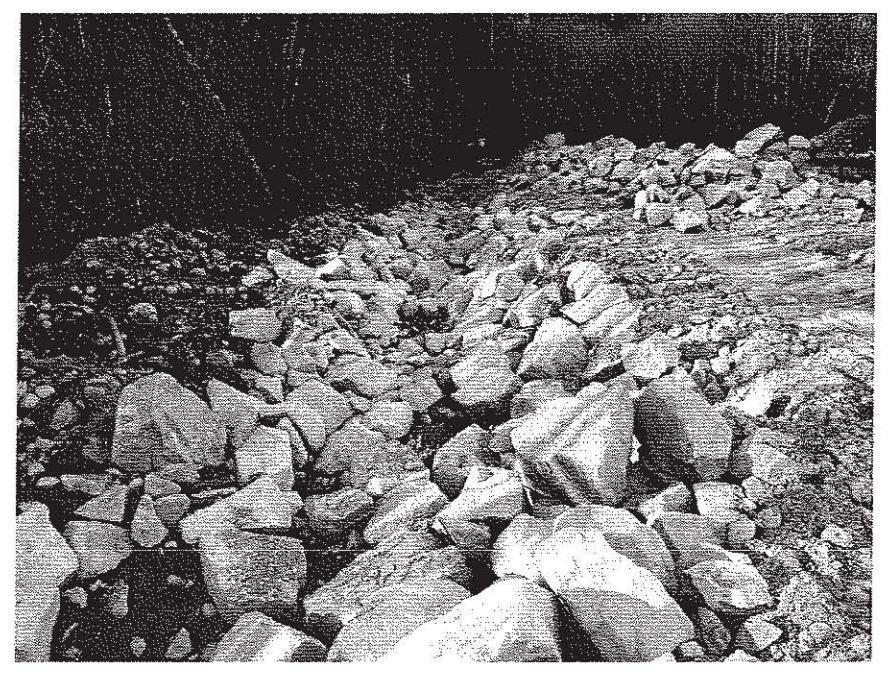
Photograph 3: March 28, 2013. View of ditch excavation, filter cloth (Geotextile) lined and riprap placement.

Lafarge constructed a riprap and filter fabric lined diversion ditch to convey flows through culverts that pass under Pipeline Road. Beginning on March 23, 2013, Lafarge removed debris from the lower portion of the slope failure zone, and excavated the new ditch to convey Mantle Creek flows to the culverts under Pipeline Road. The ditch was lined with filter cloth and filled in with 12" x 24" riprap. The ditch will need to be completed once a new manhole and sump are constructed to replace a blocked culvert that could not be cleared. The fabric cloth was laid out by hand and then the riprap was placed using an excavator. Once water flows are directed through the ditch, additional riprap may be required to direct flows in the correct channel and to control velocities (Refer to Photograph 3).

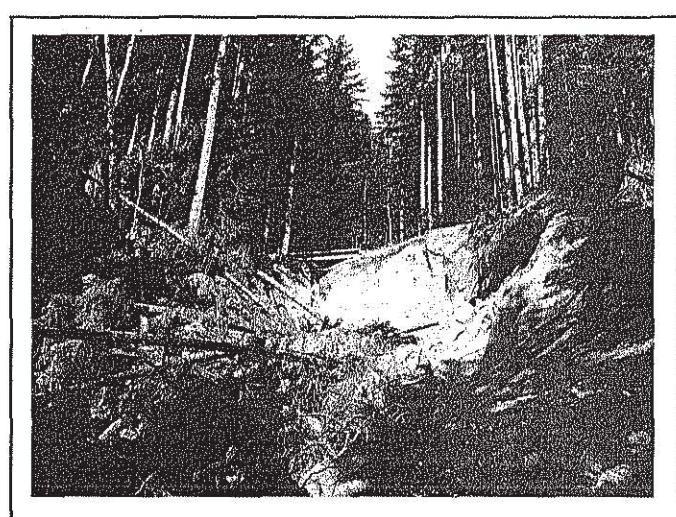
Looking upstream at Mantle Creek failure area from confluence of Mantle Creek/Fulton Creek. Note exposed soils on right, fallen trees on left and temporary bridge deck at upper center.

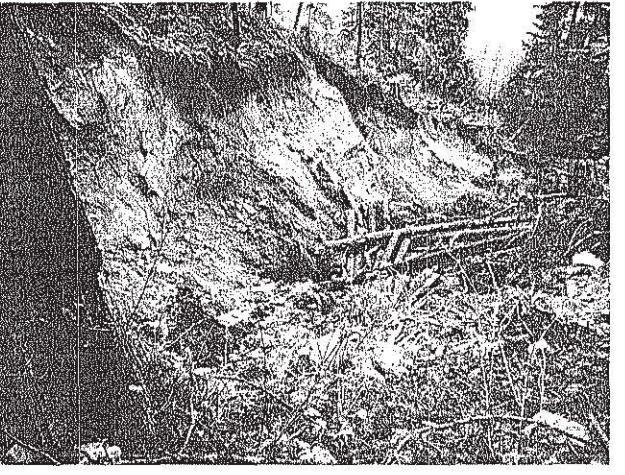
Looking downstream at Mantle Creek failure area from access road and temporary bridge deck.

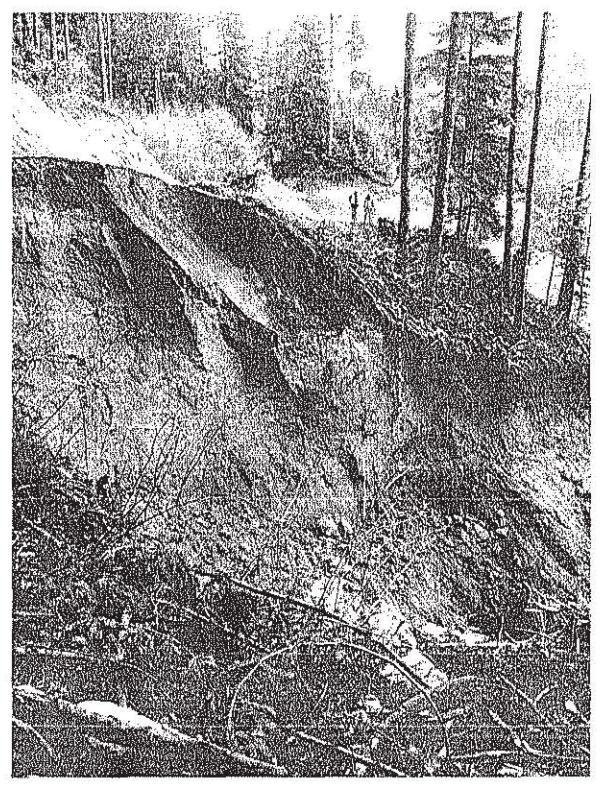
Looking downstream at Mantle Creek failure zone. Note personnel standing on access road near crest of previous Fulton Creek restoration works (constructed in 2011).

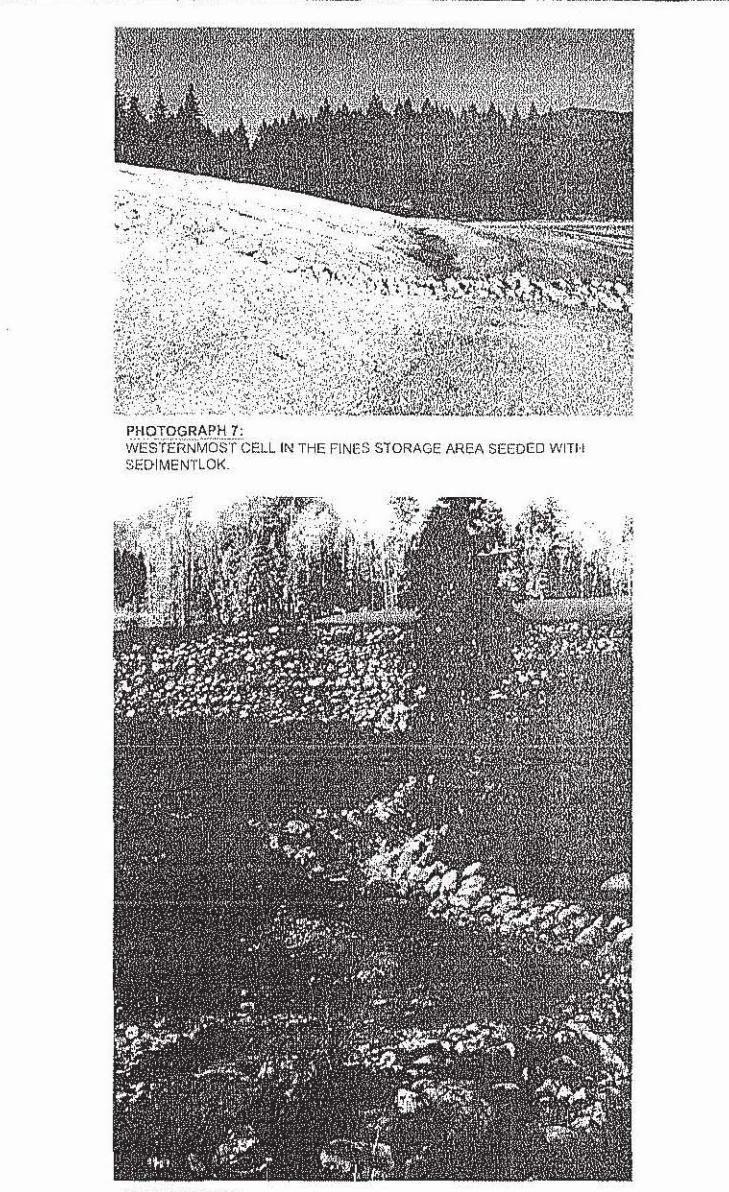
PHOTOGRAPH 8: HYDRO-SEEDING ON THE DISTURBED AREA WITHIN THE EASTERN HALF OF THE FINES STORAGE AREA.

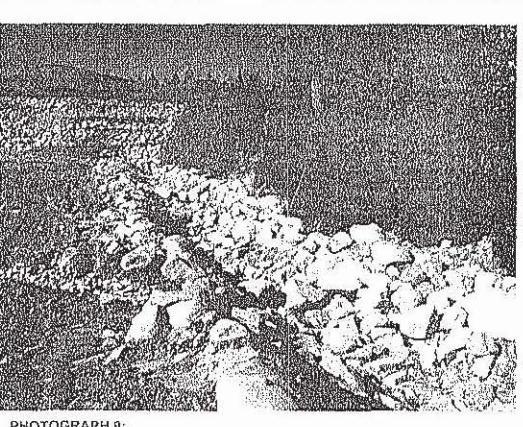
PHOTOGRAPH 9: RE-ESTABLISHED AND ARMORED DRAINAGE DITCH WITH CHECK DAMS ALONG THE NORTH EDGE OF THE FINES STORAGE AREA.

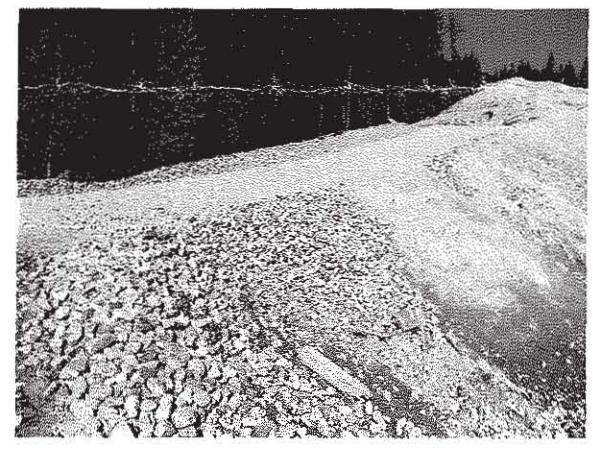
It was noticed that the main ramp towards the upper pit digging area has a drop off of more than 3 meters on both sides, did not have adequate shoulder barrier. This section of the haul road shall not be used until it is provided with adequate shoulder berms on both sides having a height of at least ³/₄ the height of the largest tire on any vehicle used on this road. The manager is reminded that the berms shall be maintained while this section of the road is used as a haul road.

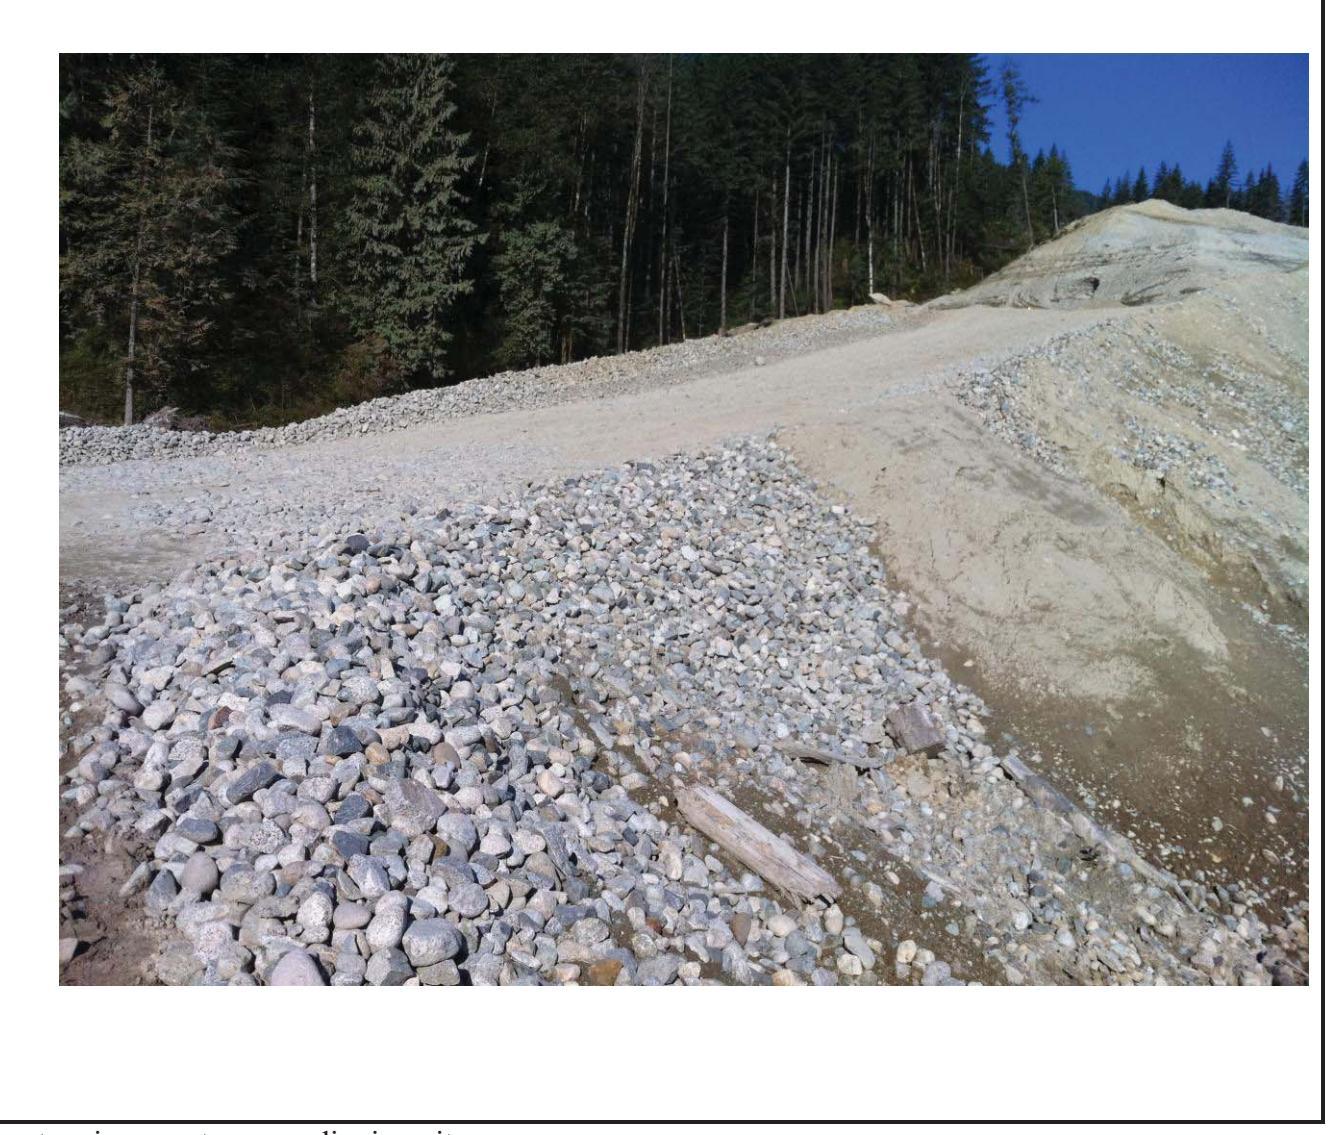
Low berm at main ramp to upper digging pit.

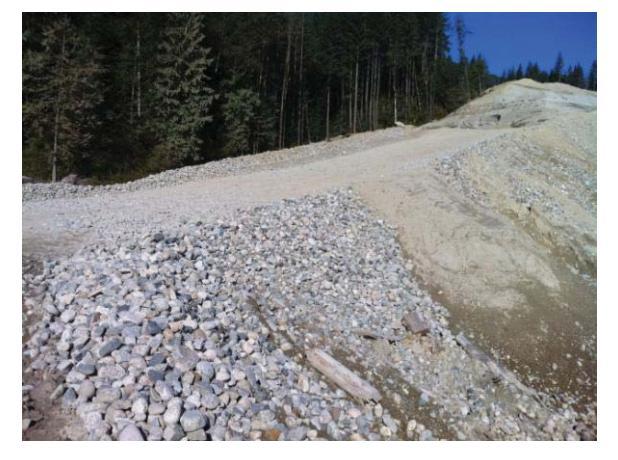
It was noticed that the main ramp towards the upper pit digging area has a drop off of more than 3 meters on both sides, did not have adequate shoulder barrier. This section of the haul road shall not be used until it is provided with adequate shoulder berms on both sides having a height of at least ³/₄ the height of the largest tire on any vehicle used on this road. The manager is reminded that the berms shall be maintained while this section of the road is used as a haul road.
