Further to our telephone conversation regarding the Young Building at the Lansdowné Campus of Camosun College, attached is the report prepared by Ken Johnson regarding the cast stone on the building.

Re: Cast Stone - Young Building

As per our proposal of April 18, 2007, we enclose below our final report regarding the cast stone on the Young Building, Lansdowne Campus, Camosun College.

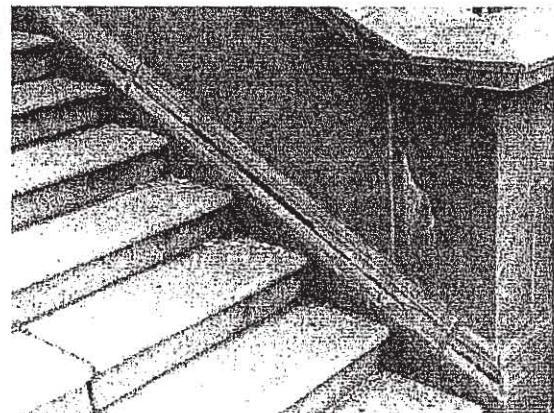
A significant number of cast stone units have failed due to corrosion of the reinforcing steels. Many additional units are in the process of failure as evidenced by the number of cracks in those areas where reinforcing steel was detected, notably the window sills along the lower floor levels where longitudinal cracks exist. One or two of these sills have failed and others could be expected to fail within the next one or two years.

South Facade - Photo S53 - Corrosion of reinforcing steel at Main Entrance.

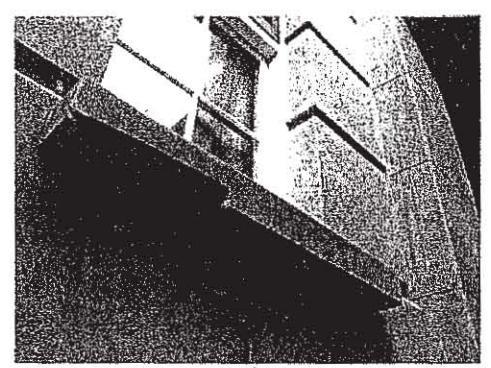
The investigation of the building carried out in early August reveals many other areas of corroding reinforcing where the ends of reinforcing bars are exposed. Some of these would appear to be due to poor fastening of the reinforcing prior to casting allowing the ends of the steel to contact the outer edge of the form. It would appear that these were covered with the thin coating of parging but now, after weathering, they are starting to be exposed to the weather and are now corroding. In a number of other instances, notably on the water table mouldings, where the piece of cast stone was required to be mitred to facilitate a return around a corner, the cast stone units were

saw cut to form the angle, sawing through the reinforcing steel as well Photo E26 - Steel corrosion under window as the concrete, and the exposed ends of the reinforcing steel were not <sup>sill</sup>, East Facade. cut back as recommended.

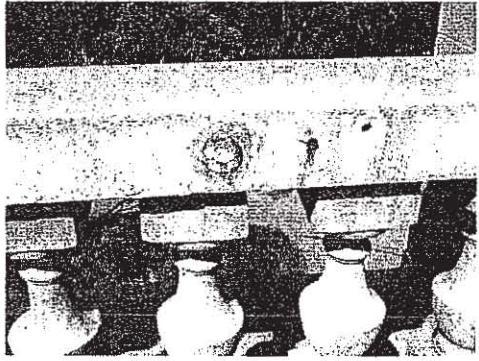
A similar problem of corrosion is seen with the lifting anchors used to facilitate handling and placing the cast stone units. These are fabricated of a mild steel which are currently corroding. These are exposed to the weather on headers and, in most cases, on the coping on the balustrades. In some instances, radial cracking is occurring indicating that either the concrete was of low strength when the units were handled or that the products of corrosion are expanding, causing the concrete to crack. These lifting devices should have been fabricated of stainless steel or have been recessed 40 mm within the cast stone unit and properly patched subsequent to installation.

Photo N8 - Corroding lifting inserts and ends of reinforcing steel on coping.

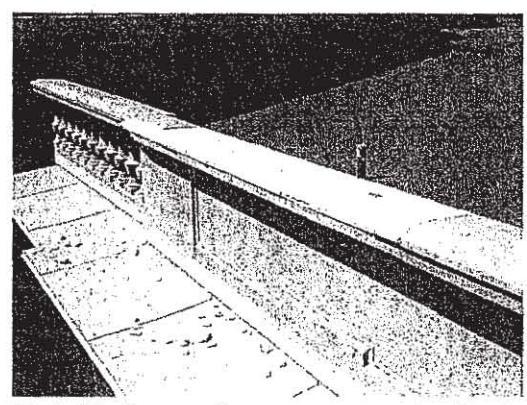
In a number of locations the quality of the concrete was found to be so poor the surface could be scribed to a depth of 1/8" with a pen knife. The cast stone elements were literally 'blowing apart' when exposed to the elements, apparently after the surface parging has delaminated and ceased to provide an element of protection. The cause of the weak concrete is unknown and could only be determined through laboratory testing. The concrete mixture used in the fabrication of the cast stone contained a Type K cement, within the Rapid Set Non Shrink Grout. This cement is dependent upon the reaction between calcium sulfates and calcium aluminates within the cement to produce ettringite which expands and counteracts the shrinkage inherent in most concrete mixtures. If the concrete is cured at temperatures at or over about 70° C, this ettringite

Photo S9 - Poor quality concrete on coping. South facade above East Entrance.

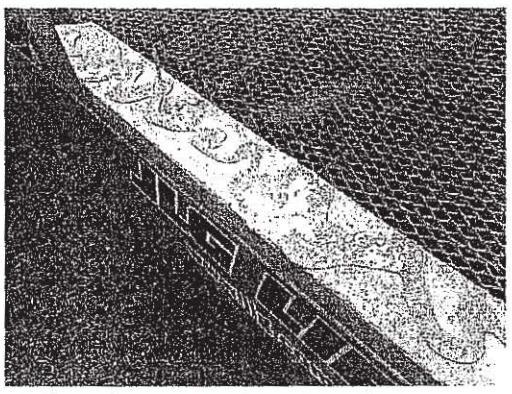
Scaling - Photo 30 - Failure of bond between acrylic resin and substrate. Note SS pin with no anchor resin.

(1) The resin had failed at one of the surfaces, having bonded well to a weak, friable surface that had not been fully prepared. In correspondence with Hilti Canada, we are advised that Hilti has no design data for the product when used in this manner. As far as Hilti is concerned, the HY150 product in not designed to be used as an adhesive between two pieces of concrete. A product designed as an adhesive between two pieces of hardened concrete, such as Sikadur 31 Hi Mod Gel, should have been used.

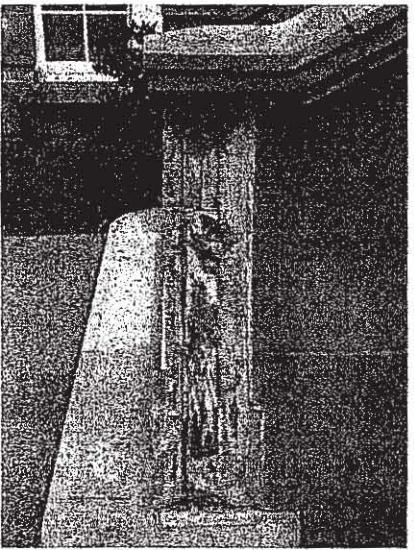
During the scaling process of September 15, 2007, in the process of removing loose pieces which were considered at risk of falling, it was noted that a number of smaller pieces were fastened with a combination of an acrylic resin similar to Hilti HY150 (a methacrylate resin) in combination with stainless steel pins approximately 3/8" in diameter. In spite of these methods of fastening, the pieces were loose and warranted removal. In other instances, as illustrated by the units forming the stair posts, only the acrylic resin was used for fastening and this has failed.

South Facade - Photo 19 - Failure of acrylic resin used to fasten cast stone to stair.

All units currently fastened with the acrylic resin should be removed and replaced with new cast stone units as their performance in a seismic event is, subject to verification by a structural engineer, suspect. There are many of these comparatively small details around the building and unless they can be certified as being safe, a budget of \$250,000 must be set for removal and replacement.

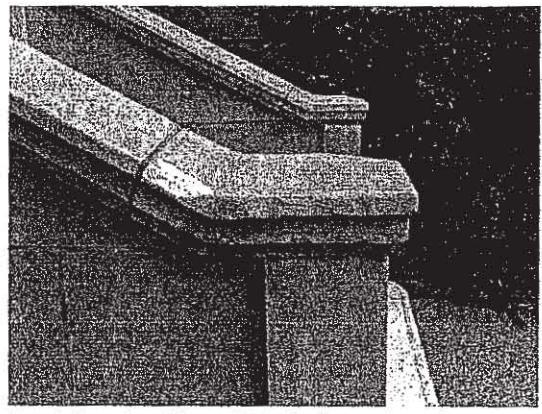
South Facade - Photo S74 - Failure of parging.

Most of the parging has performed well. Where it was applied over a surface that had been previously acid etched or power washed and cleaned, the bond seems good. Where it was applied over cast-in-place concrete or onto surfaces that had not been previously etched or prepared properly, we see bonding failures. Those areas which had previously failed and were subsequently repaired performed well as the tradesmen took some care to prepare the surfaces.

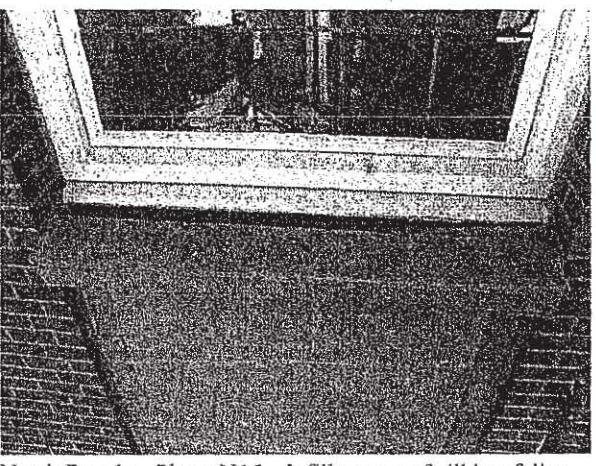
North Facade - Photo N15 - Infill at rear of sill has fallen into cavity leaving a gap about 1-1/2" for width of sill.

infill piece was used to make up a lack depth of a window sill. On one window, as illustrated, the infill piece has fallen away leaving an open gap across the length of the sill; on other windows, the infill is evidenced as a crack across the rear of the sill. Other window sills along the upper floors of this facade have the same infill detail and, as cracks occur, future problems must be expected.

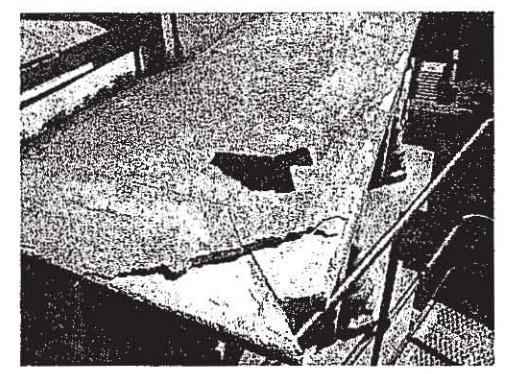
Some window sills were installed with little or no outwards slope. In order to correct this, a thicker coat of parging, sloping outwards, was applied to the sills. In many cases the bond between the substrate and the parging has failed, allowing water to penetrate and lie below on the original sill. In addition, on most pediments, a mortar topping was applied to provide enough slope to shed water. Failure has occurred in these as well. Failure of these toppings can be attributed poor preparation and application procedures. We would suggest that, in the case of the pediment tops, a method of incorporating a membrane system into a visually acceptable surface finish be developed and applied.

South Facade - Photo S47 - Failure of topping on pediment at Main Entrance
