From:	Luke Moger
To:	<u>Jim Kuipers (jkuipers@kuipersassoc.com);</u> "Chris Carr" s.22
Cc:	Demchuk, Tania MEM:EX; Adams, Rick MEM:EX; Don Parsons
Subject:	KCB Laboratory Reports
Date:	Wednesday, January 7, 2015 12:41:54 PM
Attachments:	image001.png 150105-RH14-10 SS01 33" 400 kPa - Static Simple Shear.pdf 150105-RH14-10 SS01 33" 800 kPa - Static Simple Shear.pdf 150105-RH14-22 SS02 30.5" 400 kPa - Static Simple Shear.pdf 150105-SH14-10A 06 400 kPa - Static Simple Shear.pdf 150105-UGLU Block Sample 400 kPa - Static Simple Shear.pdf 150105-UGLU Block Sample 800 kPa - Static Simple Shear.pdf 150105-RH14-03A SS03 400 kPa - Static Simple Shear.pdf

Breach Repair and Perimeter Embankment Buttress Design for 2015 Embankment]

Chris Carr, P. Eng. Geotechnical Mines Inspector On behalf of Ministry of Energy and Mines

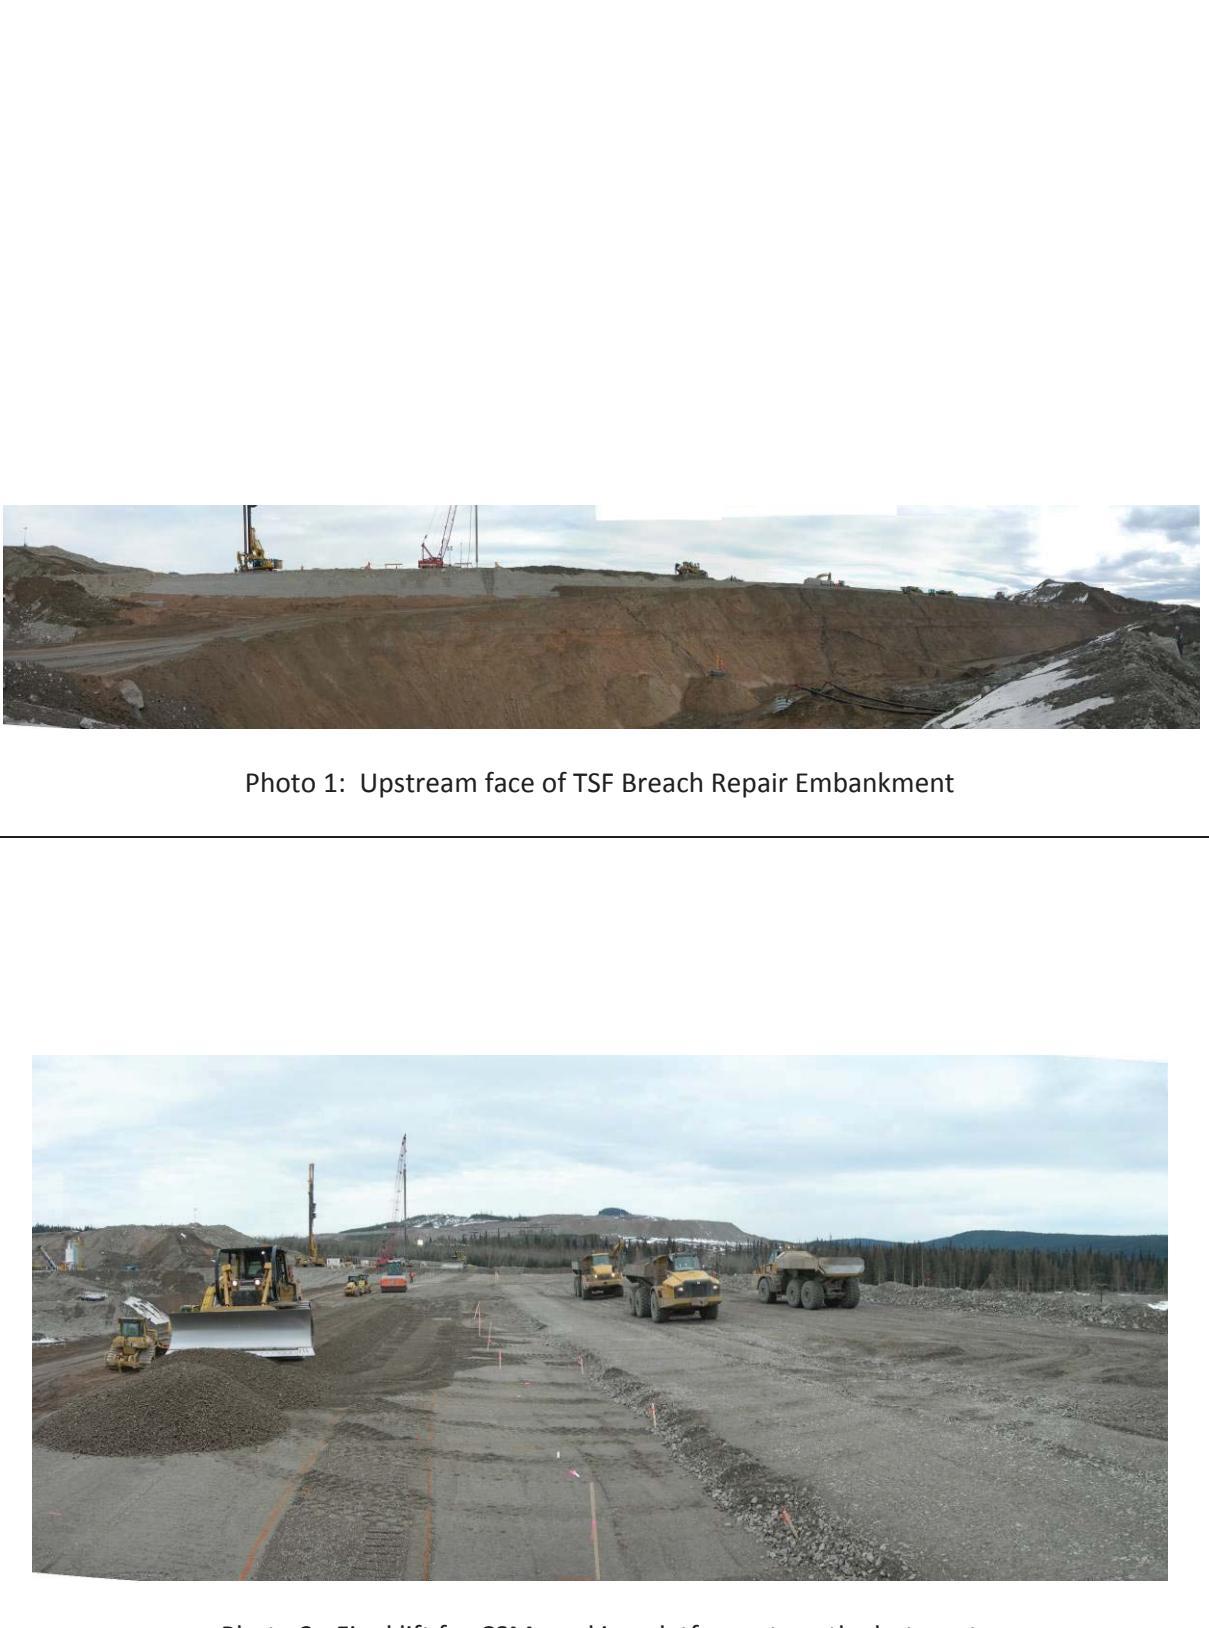
Photo 2: Final lift for CSM working platform at south abutment

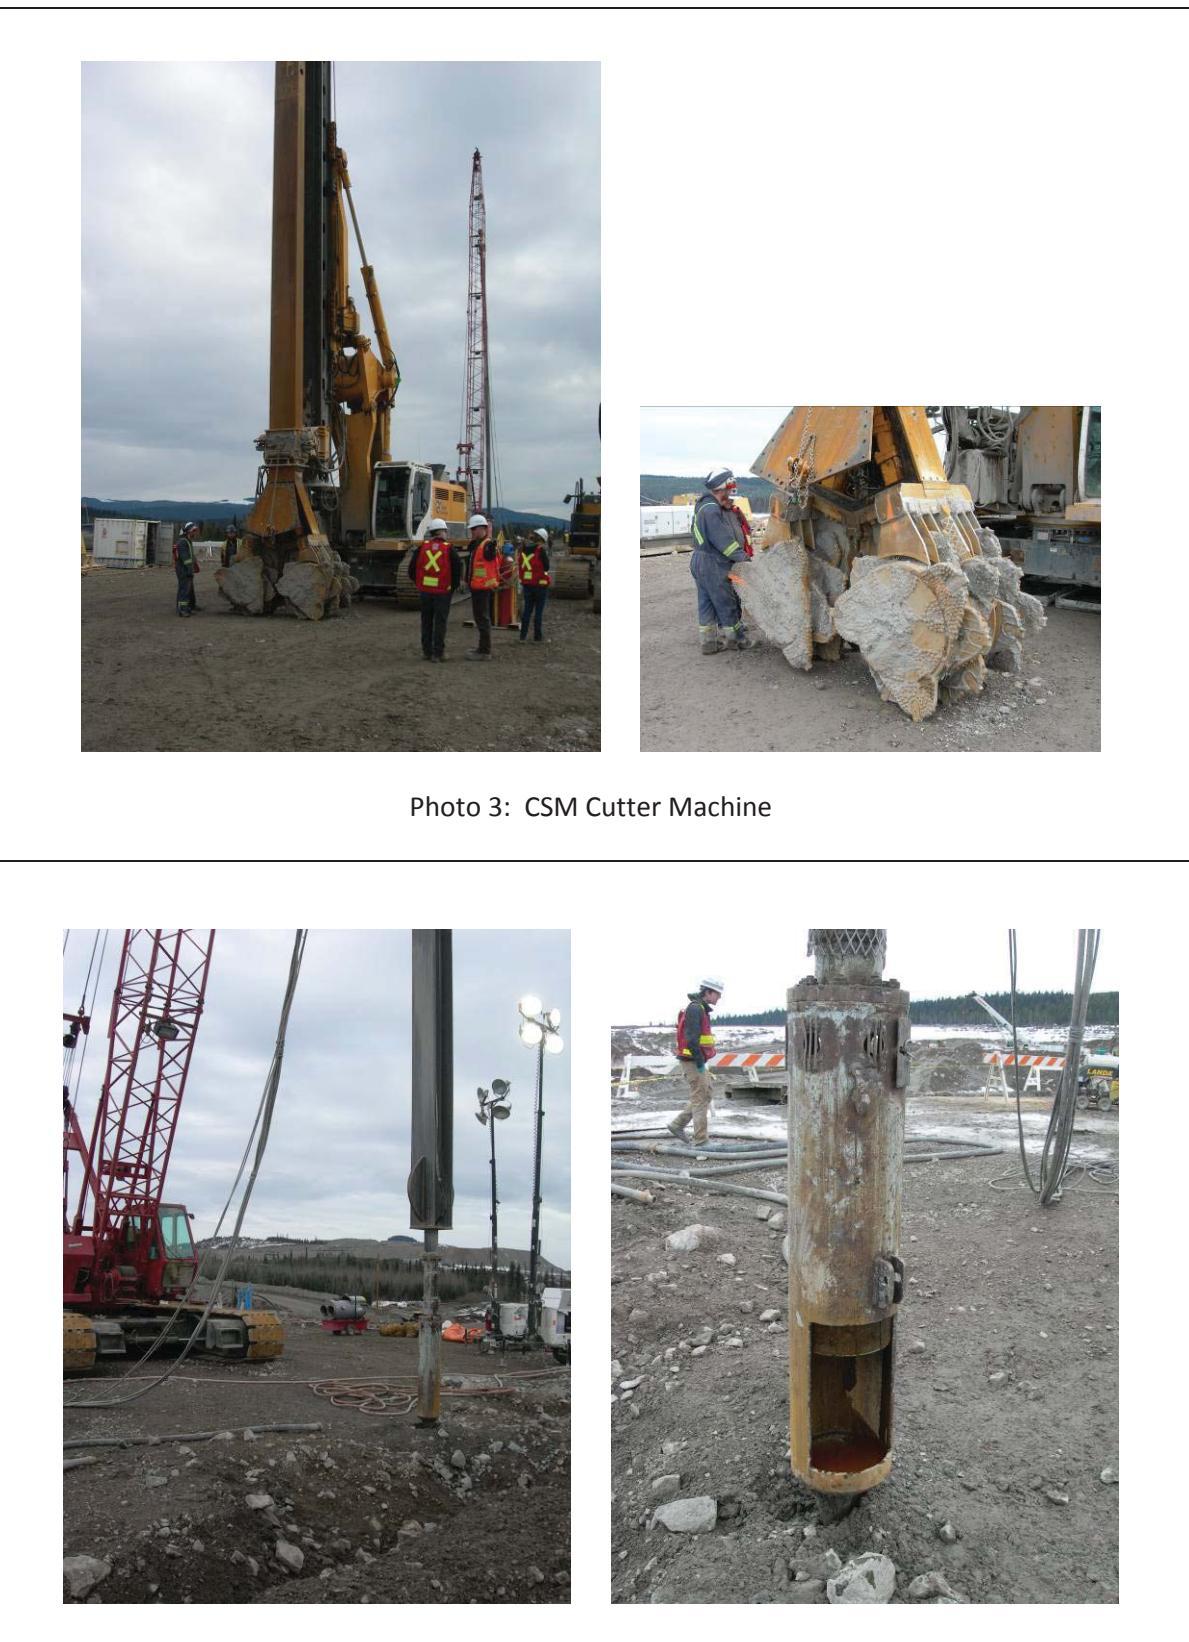
Photo 4: Cut-off Wall CSM Panel Sampling Rig
