693 STEBBINGS ROAD

JUNE 25, 2015

Active Earth Engineering Ltd			
CLIENT NAME: SOUTH ISLAND RESOURCE MANAGEMENT		PROJECT LOCATION: SHAWNIGAN LAKE, BC	
TITLE: AS-BUILT OF PERMANENT ENCAPSULATION CELL 1 CROSS SECTION A-A'			
DWN BY: GM	DWG NAME: X SEC	DATE: 2015-07-30	FIGURE 2
CHK'D: MP	PLOT:	CADFILE: C1ABJUL15

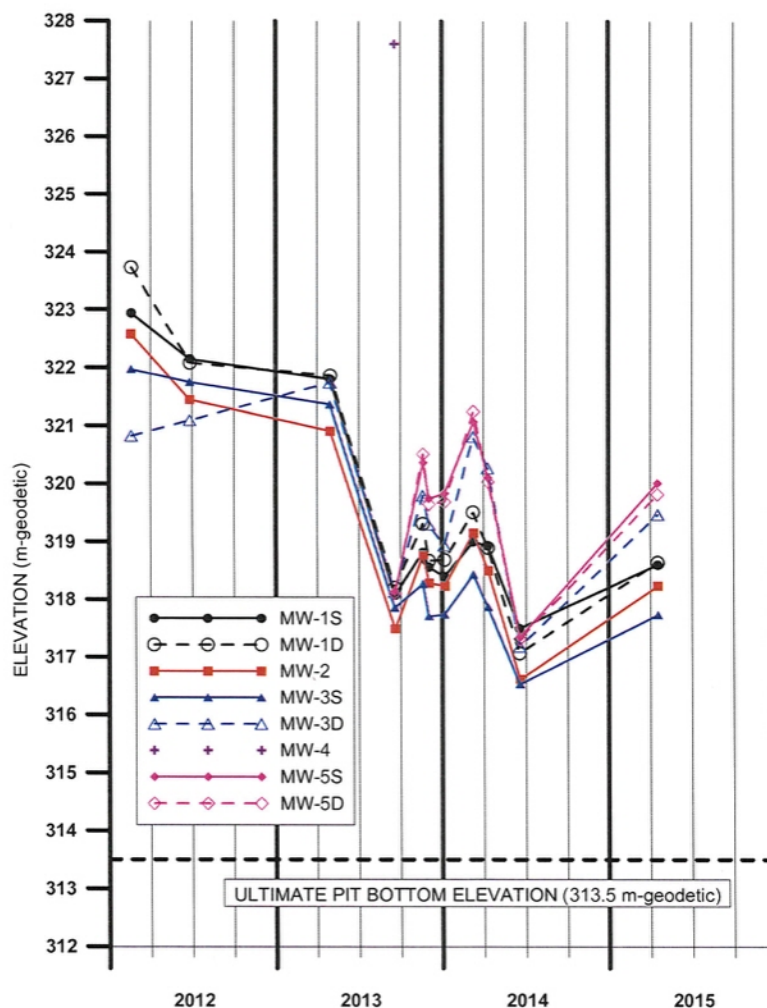
- There is still groundwater present in the limited fractures within the bedrock, and the water pressure in these fractures has been measured. This is the "piezometric pressure" in the rock and it has been monitored at the Site since early 2012. The plot below presents the piezometric monitoring results.

- As shown in the plot, the piezometric pressure is above the pit bottom elevation at all monitoring locations on the Site. The ponded water currently in the base of the pit is very close in elevation to the ultimate pit bottom.

- If there were groundwater flow within fractures in the rock it would be evident as seepage into the pit, however, we do not observe any seepage into the pit below the piezometric elevations. This is because the rock is an aquitard and does not convey significant groundwater flow.

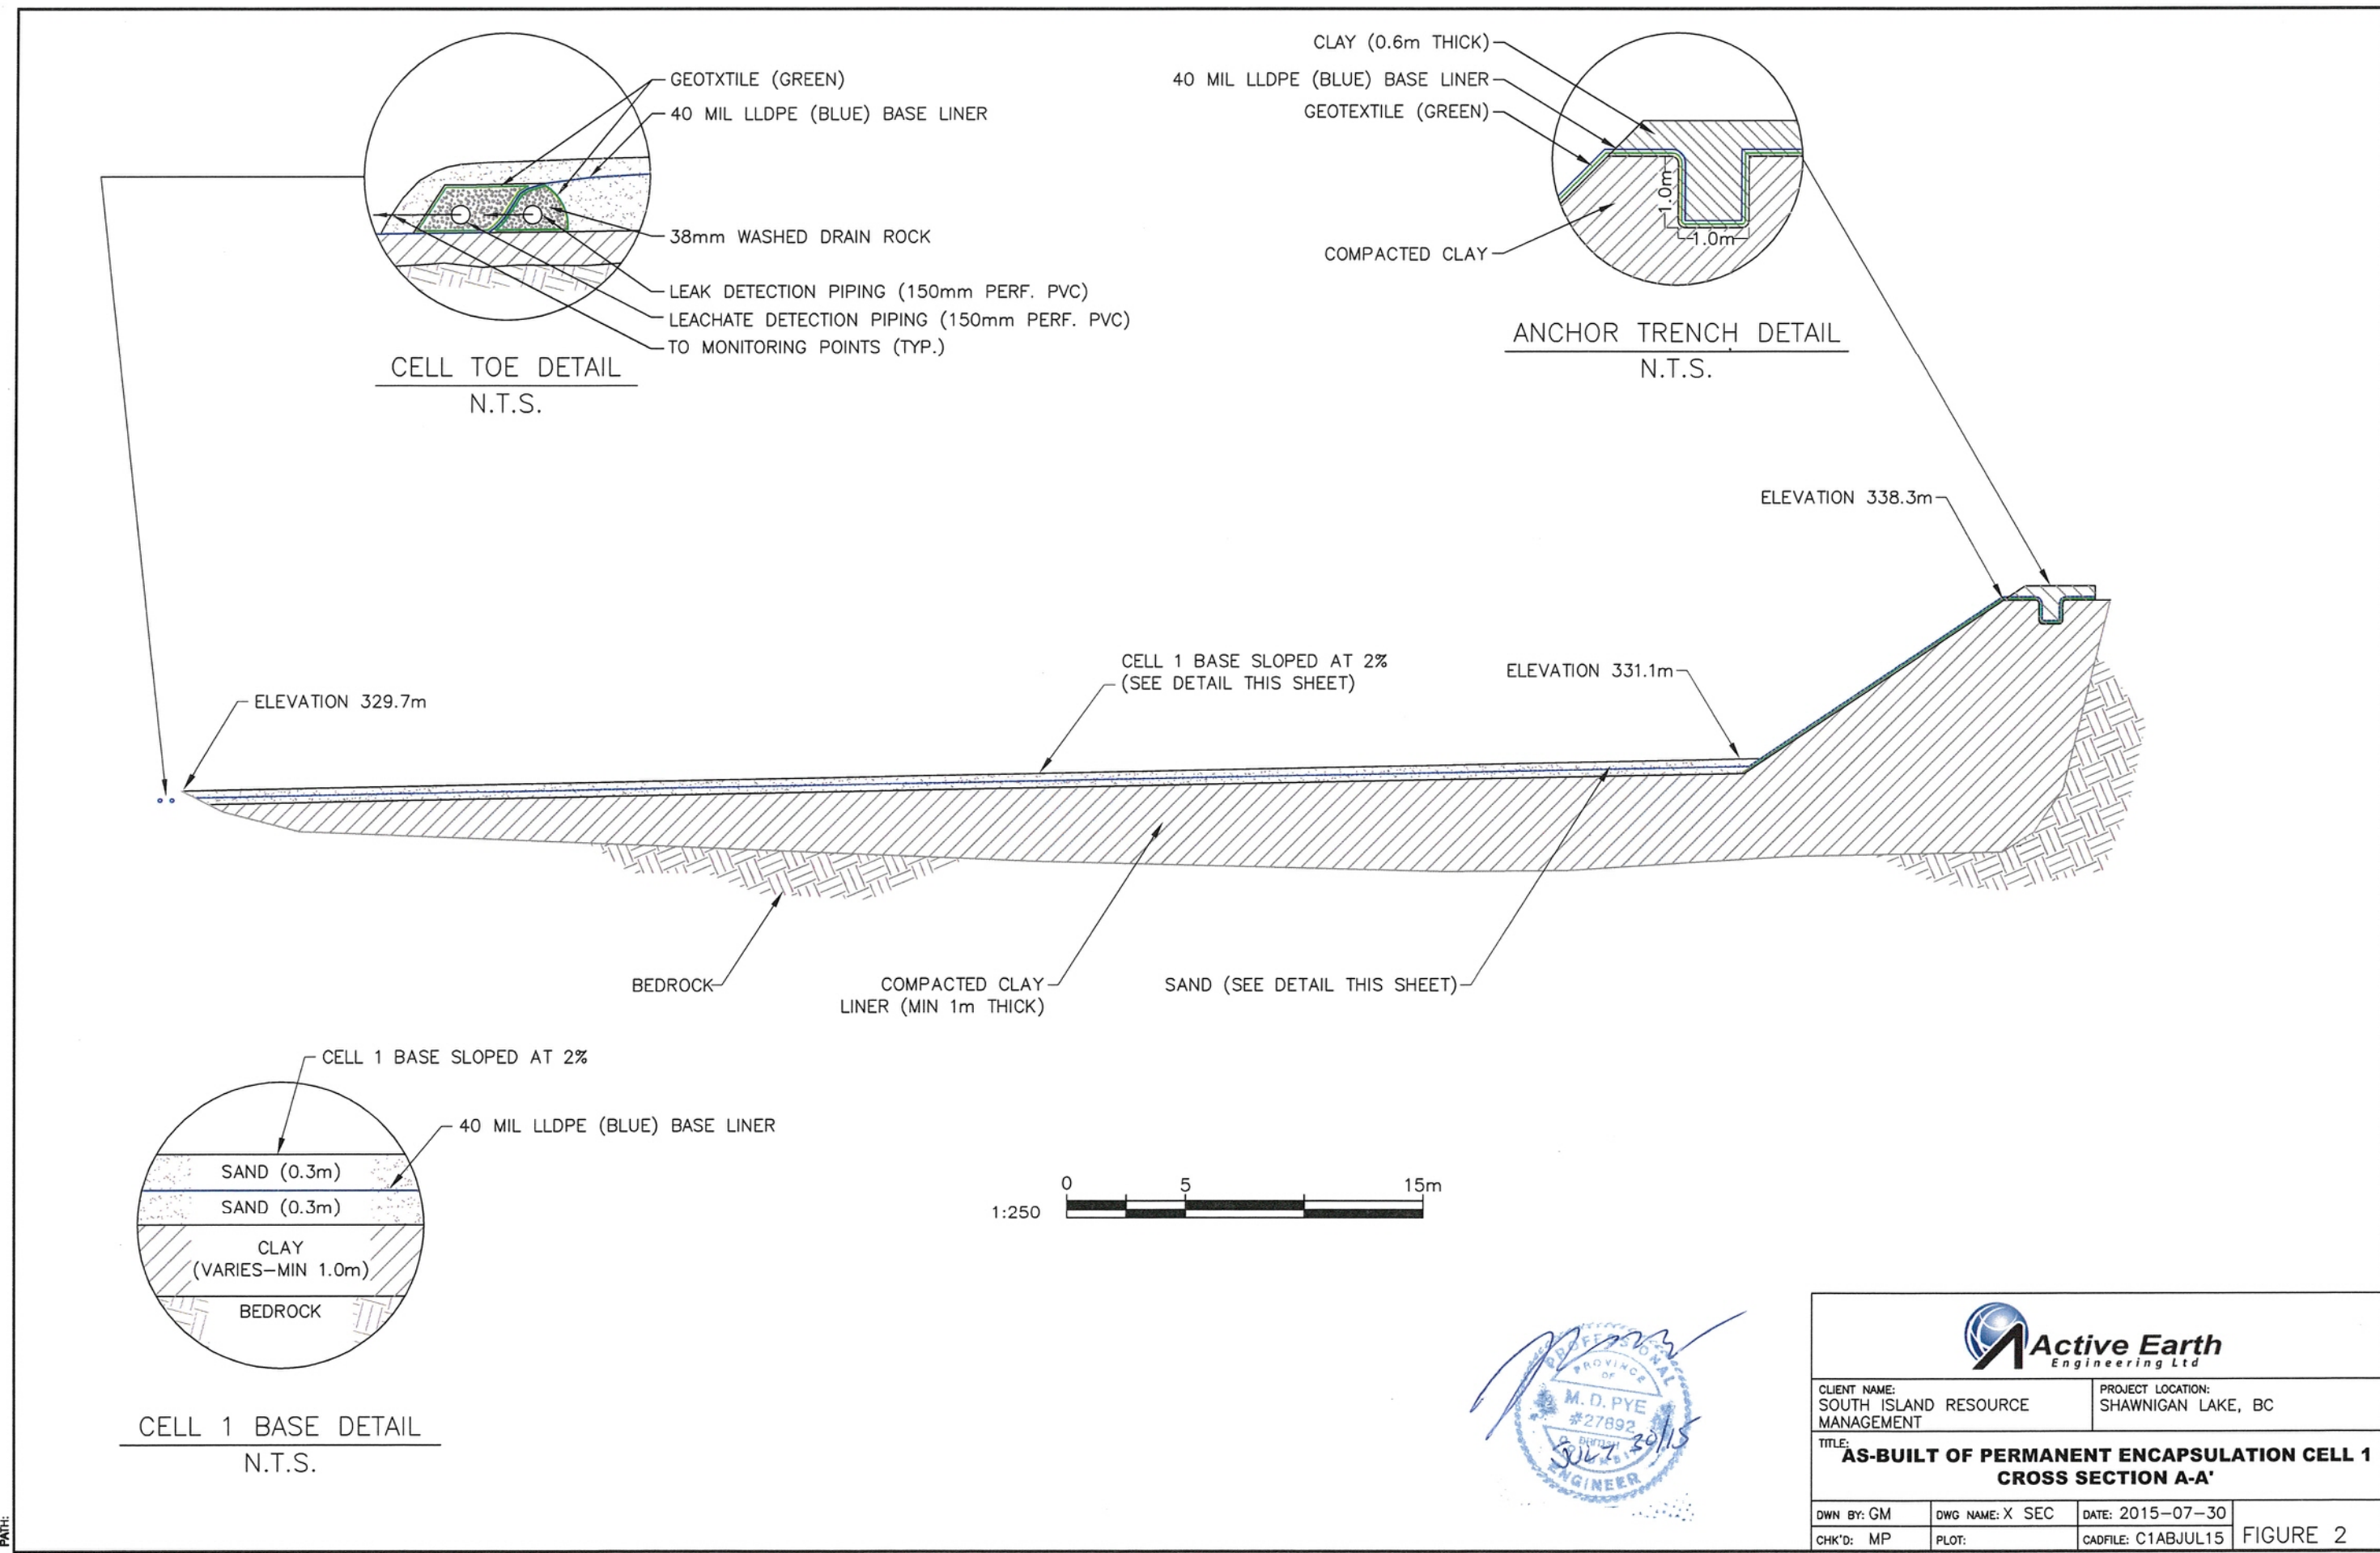
- A single panel (no field welds) of 40 mil LLDPE synthetic liner was placed over the sand layer. The liner dimensions are 35.5m x 85m. The liner was placed up the berms on the south and east sides of Cell 1. The liner was underlain by a geotextile on the berm slopes to provide protection. The required protection on the base is provided by the underlying sand leak detection blanket. The liner is sloped downward to the north at approximately 2%, towards the toe of the cell. Liner specs and manufacturer QA/QC details are attached.

- A second free-draining sand layer was placed at a minimum of 0.3m thickness overlying the synthetic base liner. This sand layer acts as a leachate collection layer and protects the liner from potential puncture/damage. The sand layer is hydraulically connected to a second perforated piping collection system at the north side of the cell. The leachate collection piping conveys any water to a second 2500 gallon holding tank at the northwest corner of the cell.

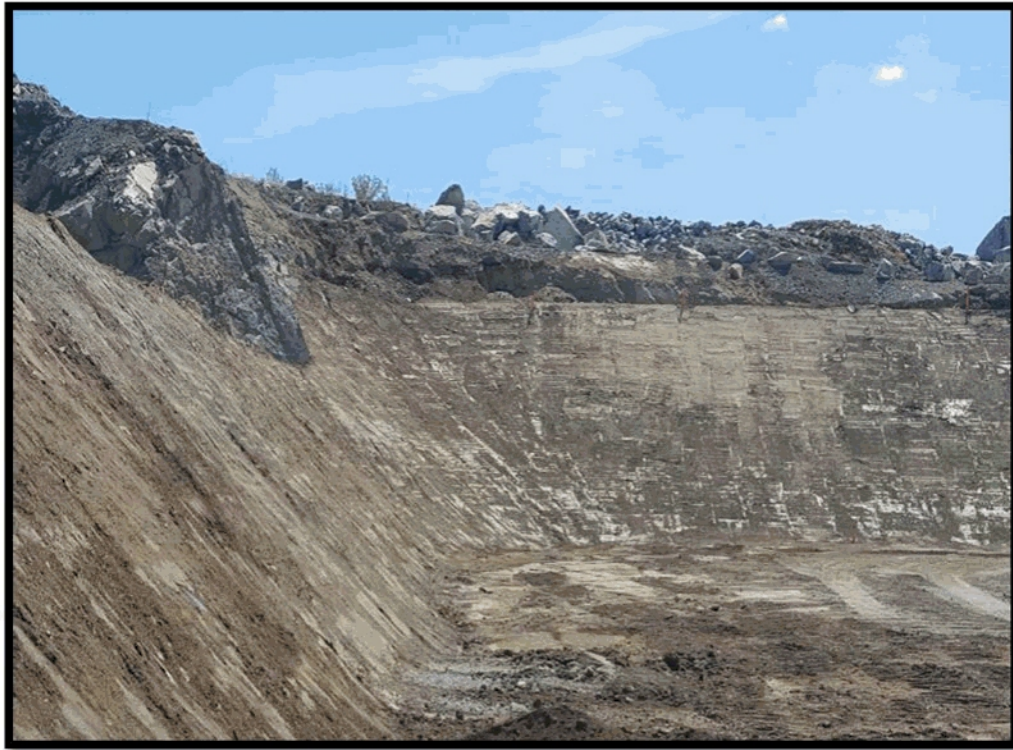
Photo 1 – Looking south at clay berms

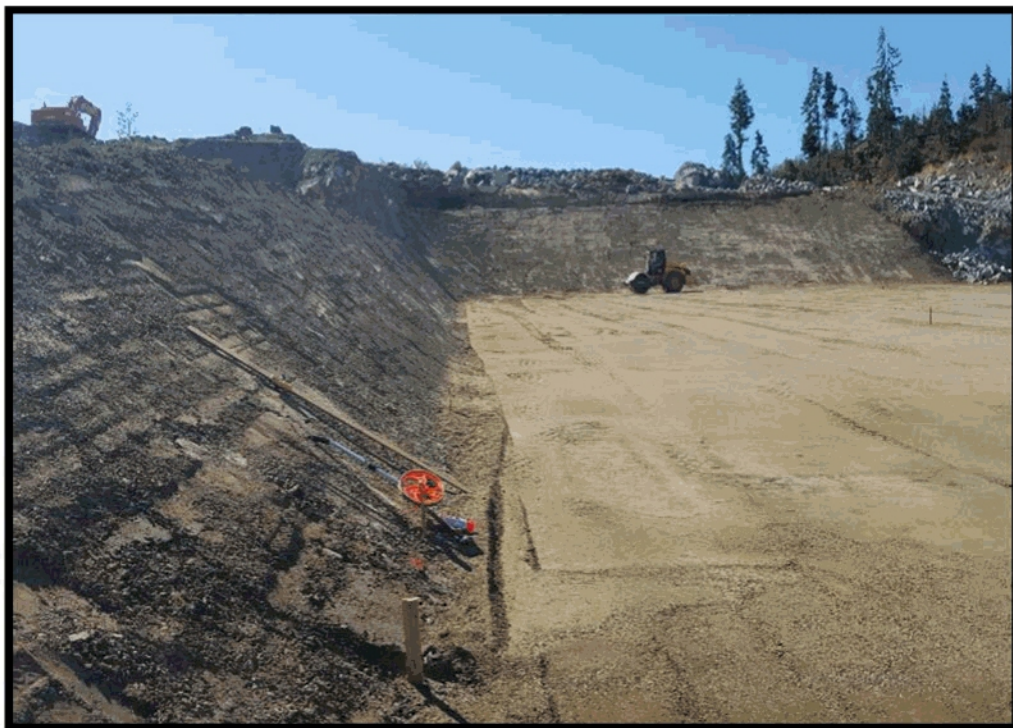
Photo 2 – Base sand surface being prepared for liner deployment

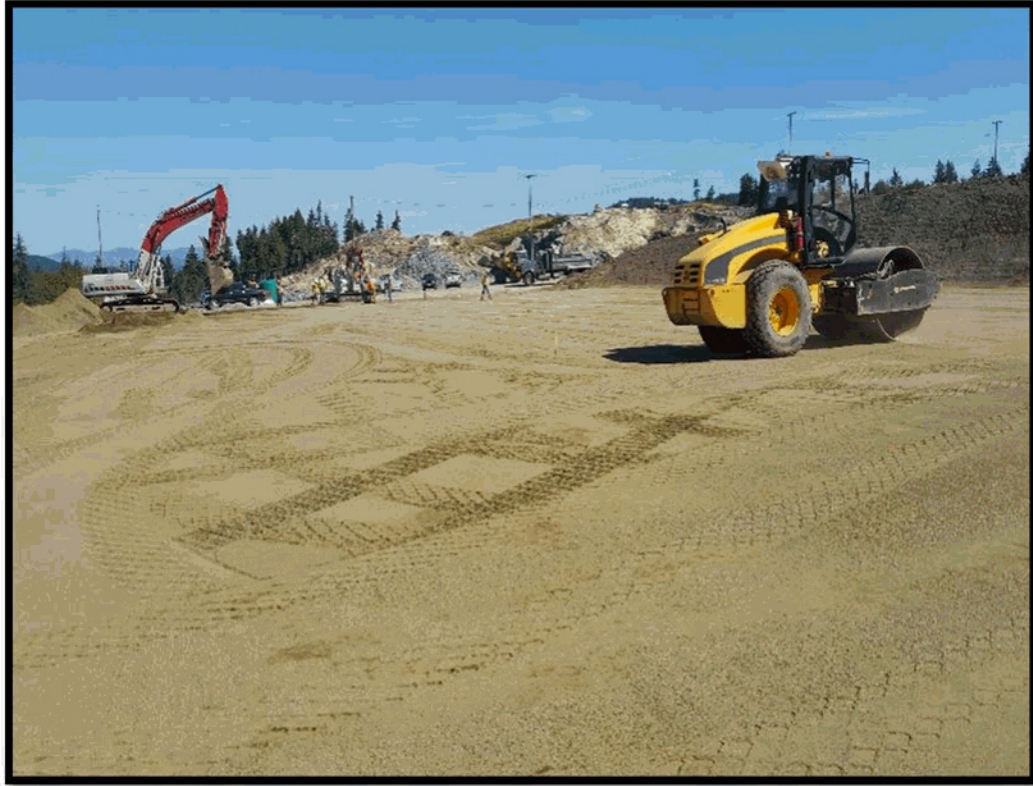
Photo 3 – Base sand surface being prepared for liner deployment

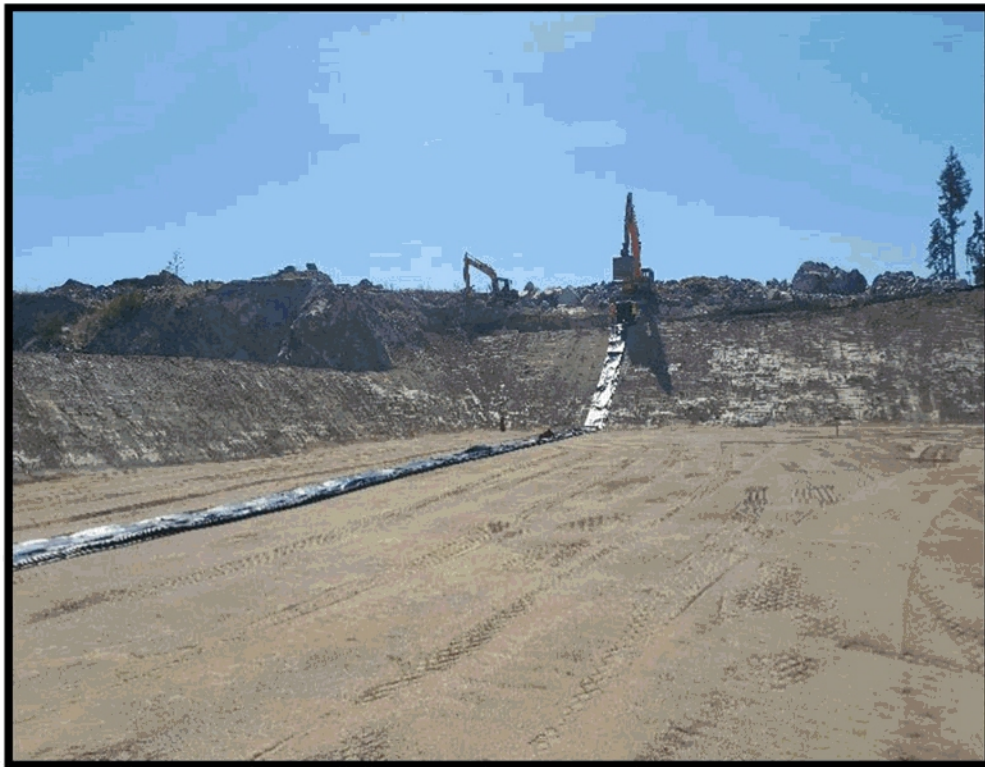
Photo 4 – Liner deployment

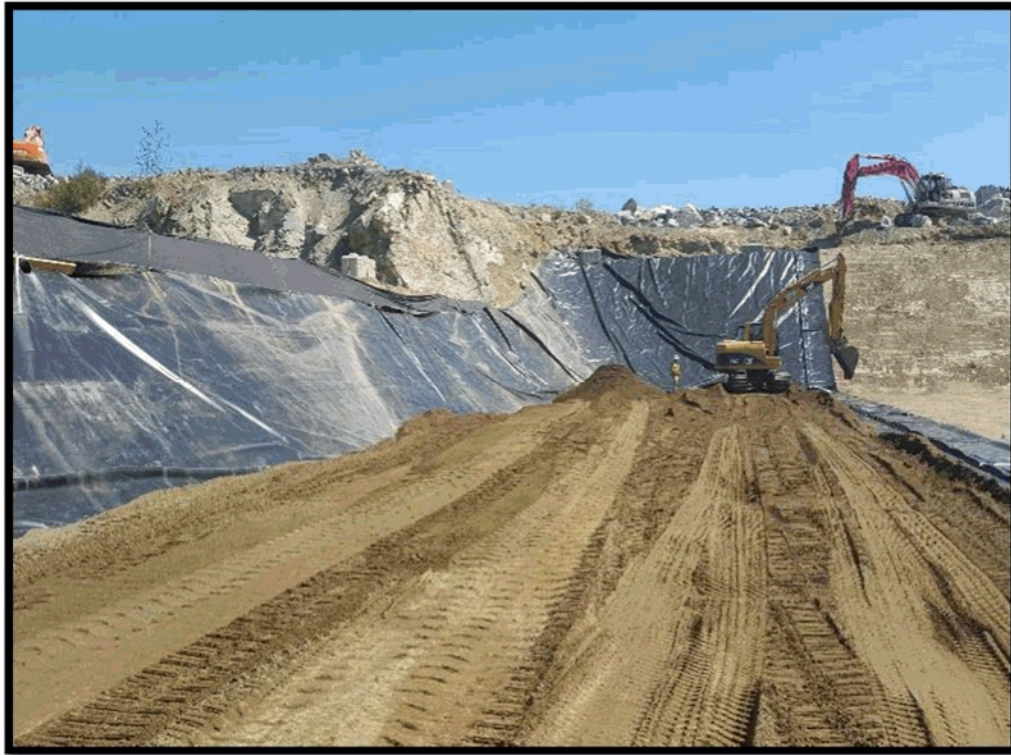
Photo 5 – Placement of Leachate Collection Sand Drainage Blanket

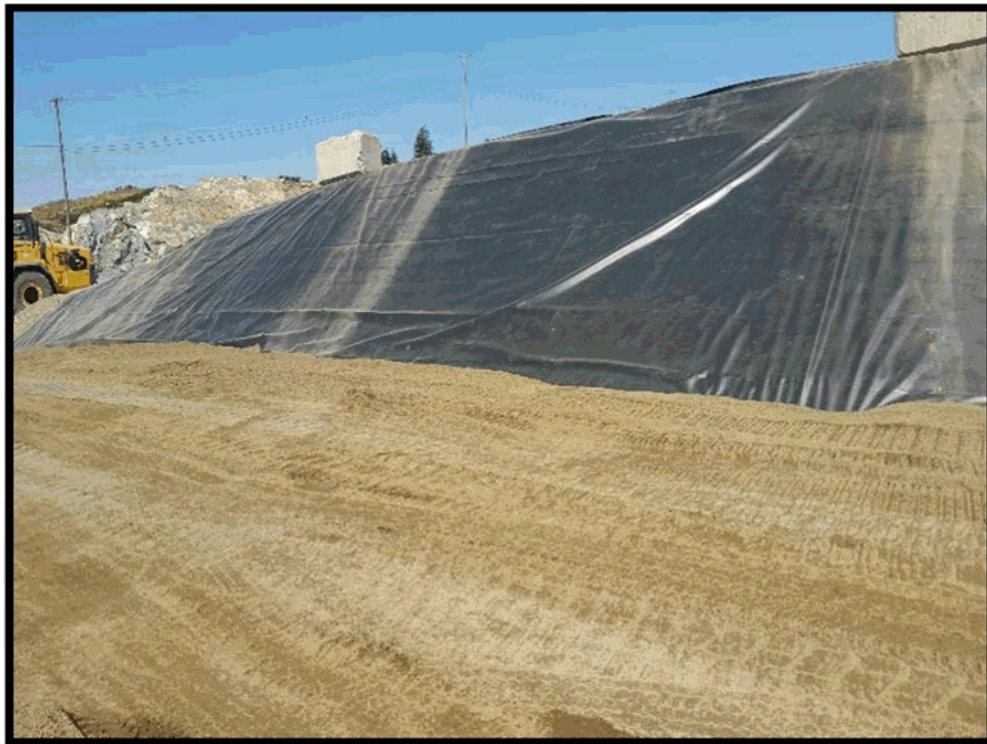
Photo 6 – Looking East at completed Cell 1 berm

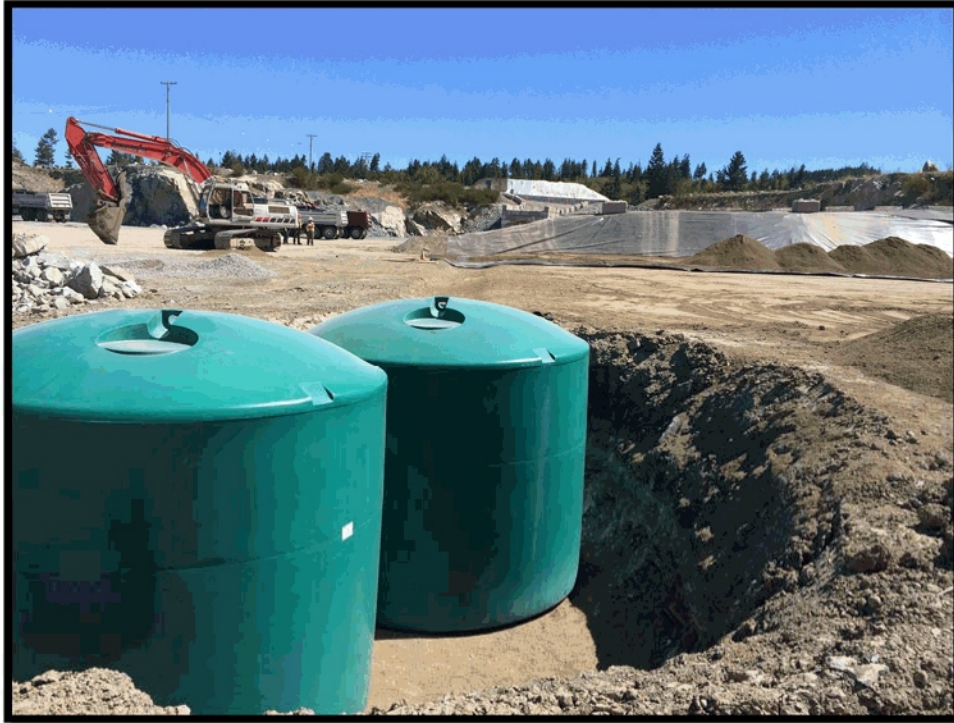
Photo 7 – Leak Detection and Leachate Collection Tanks

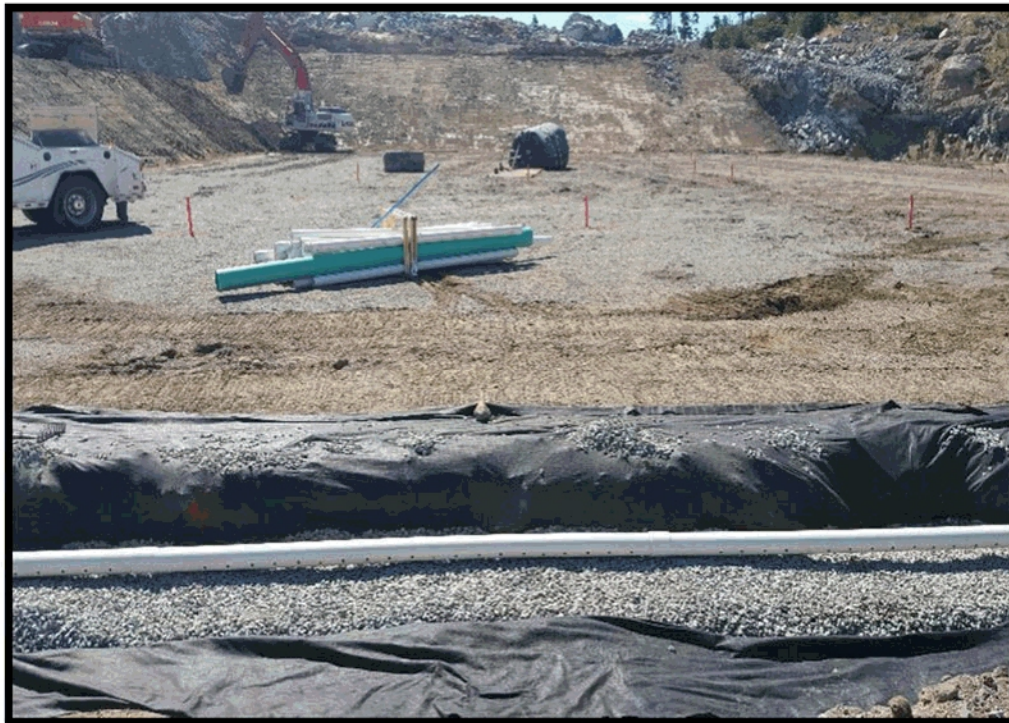
Photo 8 – Leak Detection and Leachate Collection Piping Systems
