HYDROGEOLOGICAL STUDY

Proposed Quarry off of Ward Road
Sumas Mountain, BC

January 19, 1995
File: 894-324

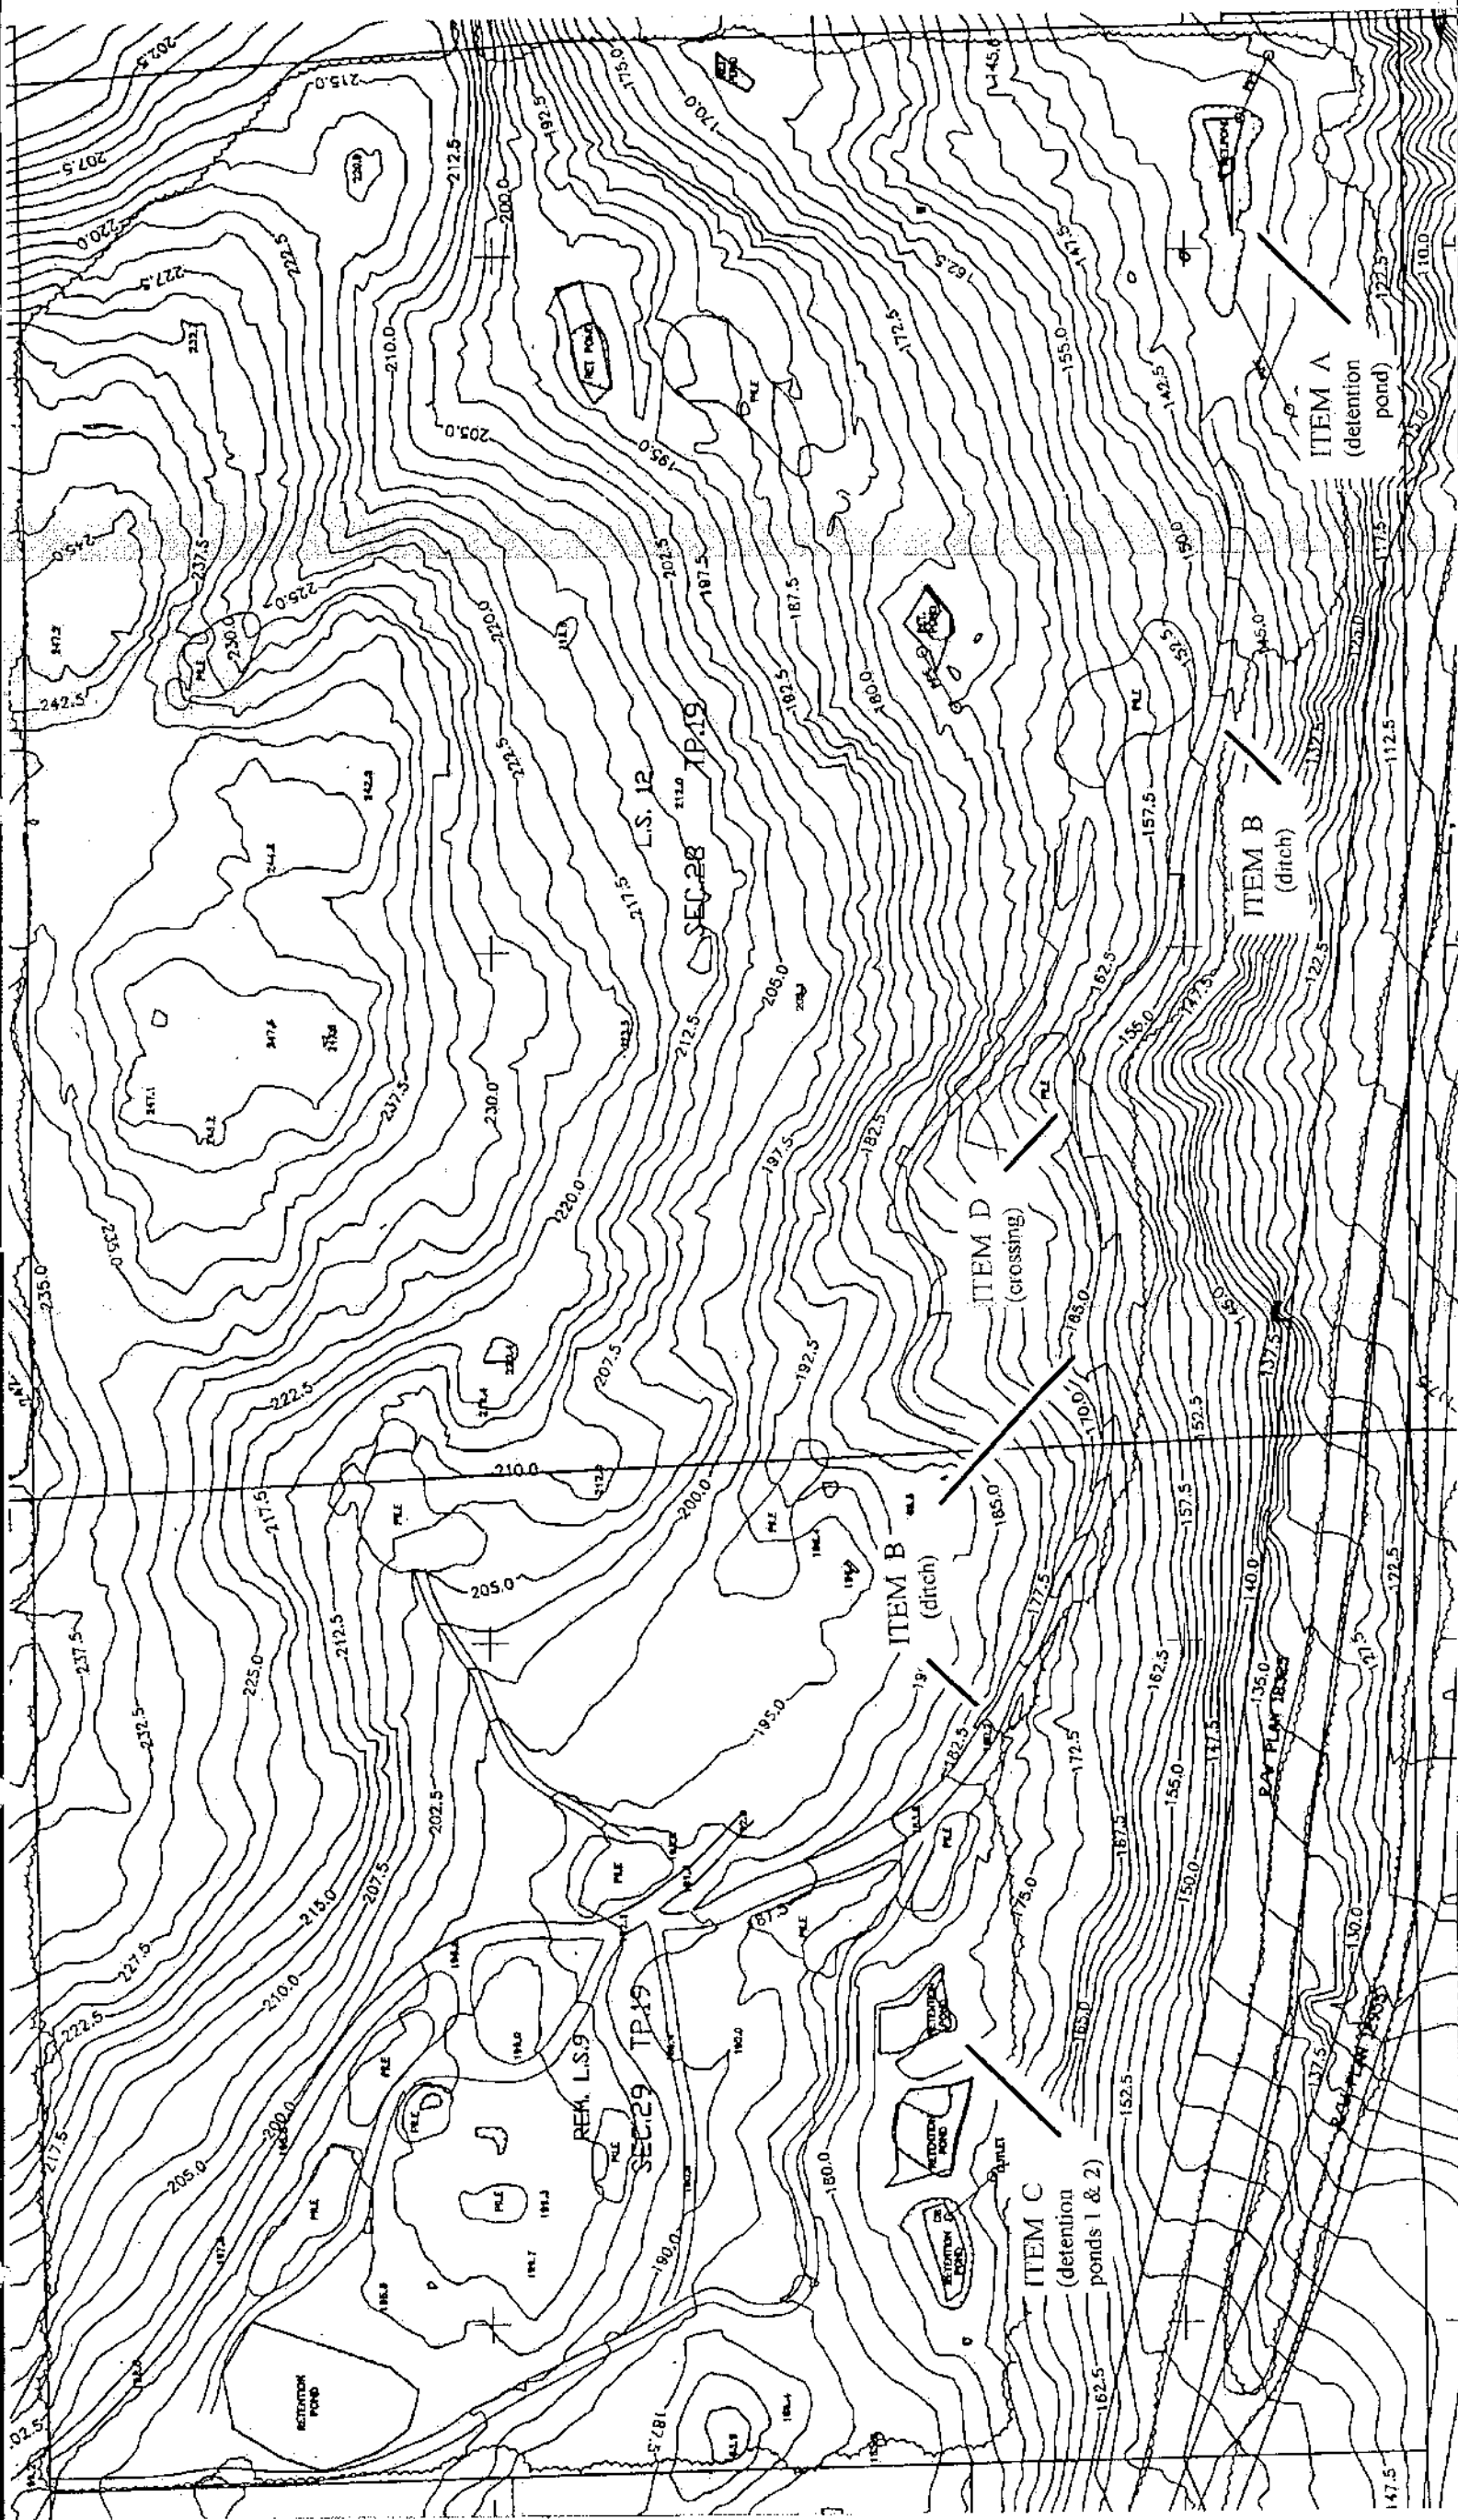
<p>FILE No. 9715</p> <p>DATE: NOVEMBER 1998</p>	<p>DRAINAGE ENHANCEMENT TOEWS BROS. BULLDOZING LTD.</p>	<p>AQUATERRA CONSULTANTS LTD</p>
<p>FIGURE 1</p>	<p>CLIENT:</p> <p>PROJECT: PROPOSED WHISPERING PINES QUARRY</p>	<p>3297 ABBOTSFORD, B.C. V2T 5G6 PHONE (604) 850-3521 FAX (604) 850-3542</p>

The detention pond in the southeast corner of the property will require cleaning out of the silt material that has accumulated on the base. This should be done as soon as possible, before the pond begins to accumulate water and should be performed on an annual basis. The southeast outlet valve should remain closed unless emergency conditions exist and the pond requires maintenance.

A portion of the south access road crosses a narrow ravine area. Above this area is a large brush pile from earlier clearing activities. Presently this pile acts to block the ravine above the road. When this pile is burned or removed, it will again allow water to flow unrestricted down the ravine. Upon removal of the pile, that area should be excavated to create a small 6m X 6m X 1m pond to act as retention. The pond should exit into the ditch north of the road. It is also advisable to consider at that time, to upgrade the section of road by adding two - 100mm diameter culverts (spaced 2 metres apart horizontally) under the road crossing to allow for unimpeded water passage and to decrease the chance of washout.

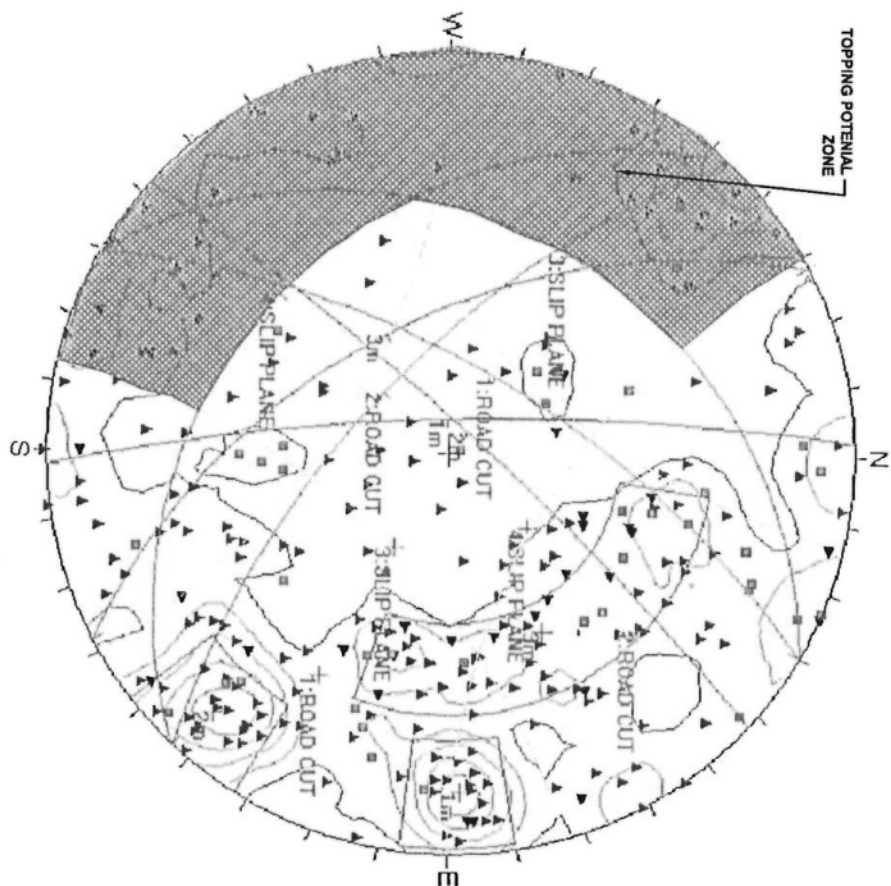
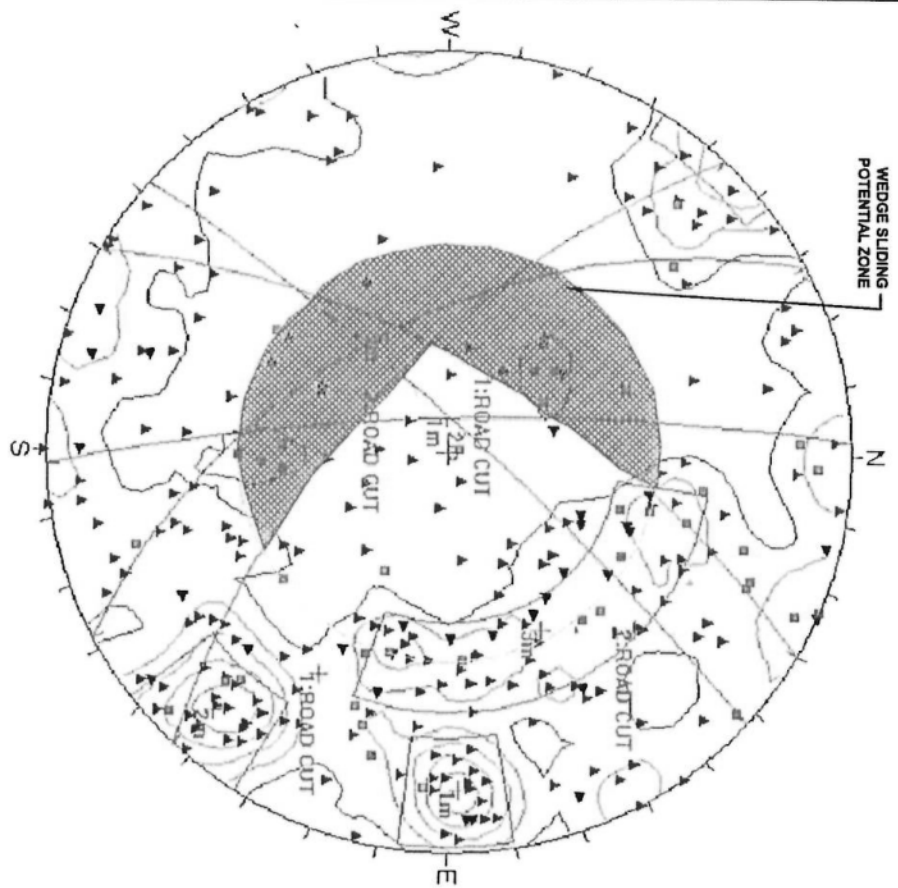
A stereonet analysis of potential failure modes (toppling, wedge sliding and planar sliding) was conducted. As the bedrock in this area is considered to have medium to strong rock strength erosion is not considered to be an important mechanism for slope regression. A brief discussion of each potential failure mode is presented below. Three discontinuity orientations have been identified as being statistically significant. J1 has an orientation of 80/268 (dip/dip direction), J2 has an orientation of 82/311 and J3 has a general orientation of 53/242; however J3 appears to have highly variable orientation with respect to dip direction.

Wedge Sliding – The potential for a wedge failure exists with the intersection of J1 and J3. Due to the highly variable nature of the dip direction of J3 the intersection of these joint sets is also expected to vary significantly. Due to the limited persistence and variable nature of J3 we are of the opinion that a large volume wedge failure is unlikely. As such, a wedge mode failure event with sufficient material loss to extend beyond the property boundary is considered unlikely.

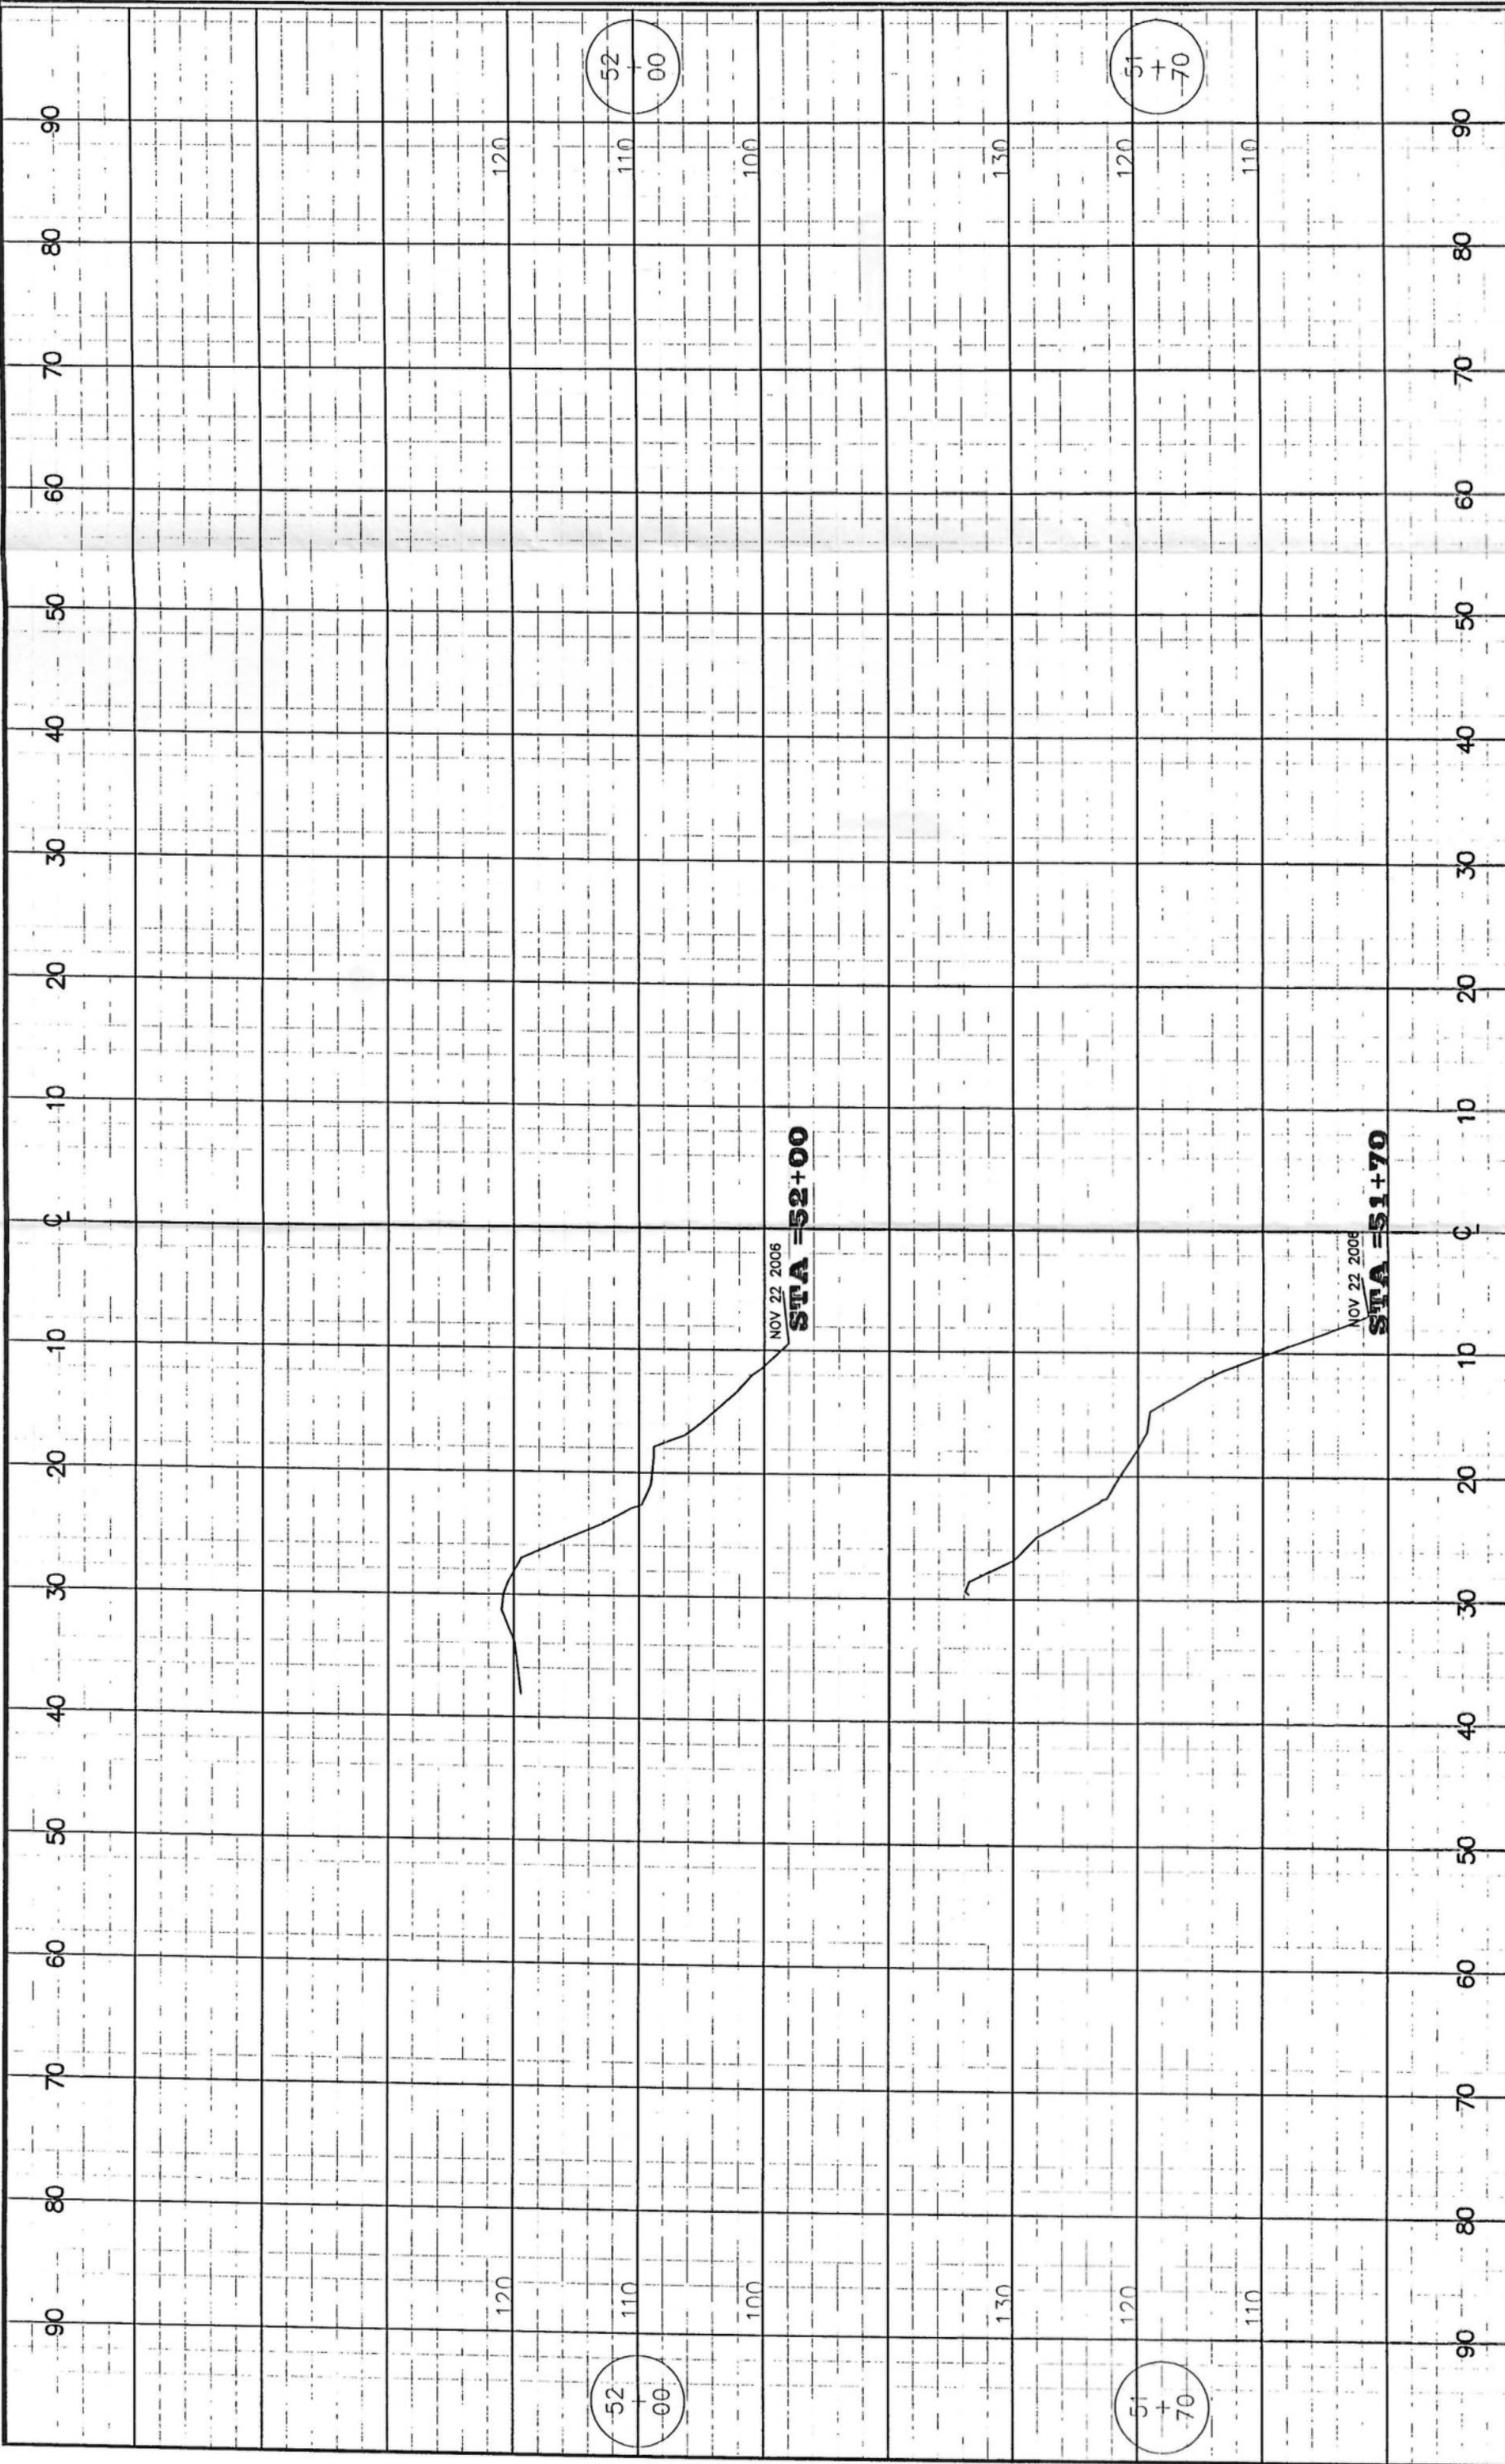
The subject rock cut varies in height from about 20 metres to 65 metres with the maximum height located near the northeast corner of the haul road excavation where the roadway alignment turns to the west and away from the property boundary (see Drawing 051-01695-02). The bedrock in the subject area generally consists of an altered volcanic breccia with occasional mafic dykes and ranged in rock strength from medium to strong. Some metasediments were noted in the northern portion of the subject area. Numerous shear zones were noted throughout the bedrock with widths ranging from a few centimeters up to 0.5 metres with high persistence. Jointing within the bedrock was generally closely spaced with low to moderate persistence. Due to the method of blasting (production), blast damage of excavated rock cut faces was prevalent and consisted of blast-induced opening of tight joints and fractures and loosened rock fragments. Maintenance of the rock cut slopes will require regular review and cleanout of the catchment ditches and benches over the life of the haul road.

It is our opinion that failures within the exposed bedrock cut will mainly consist of raveling irregular blocks up to medium in size that were loosened during production blasting and excavation. Individual failure events of the required scale to encroach onto the adjacent property are considered unlikely. As part of the maintenance plan for the road, regular inspections of the rock face and the crest of cut slope should be undertaken to review rate and extent of slope crest retrogression that may occur as the rock cut slope weathers over time.
