ENVIRONMENTAL SAFETY PROGRAM SPILL REPORT

SKEENA REGION

ENFORCEMENT ROUTING SHEET

SUBJECT NAME: Park Avenue Corner Store
LOCATION: 1665 Park Avenue, Prince Rupert
SPILL # 151/95 OFFENCE DATE : Dec 1-6, 1995

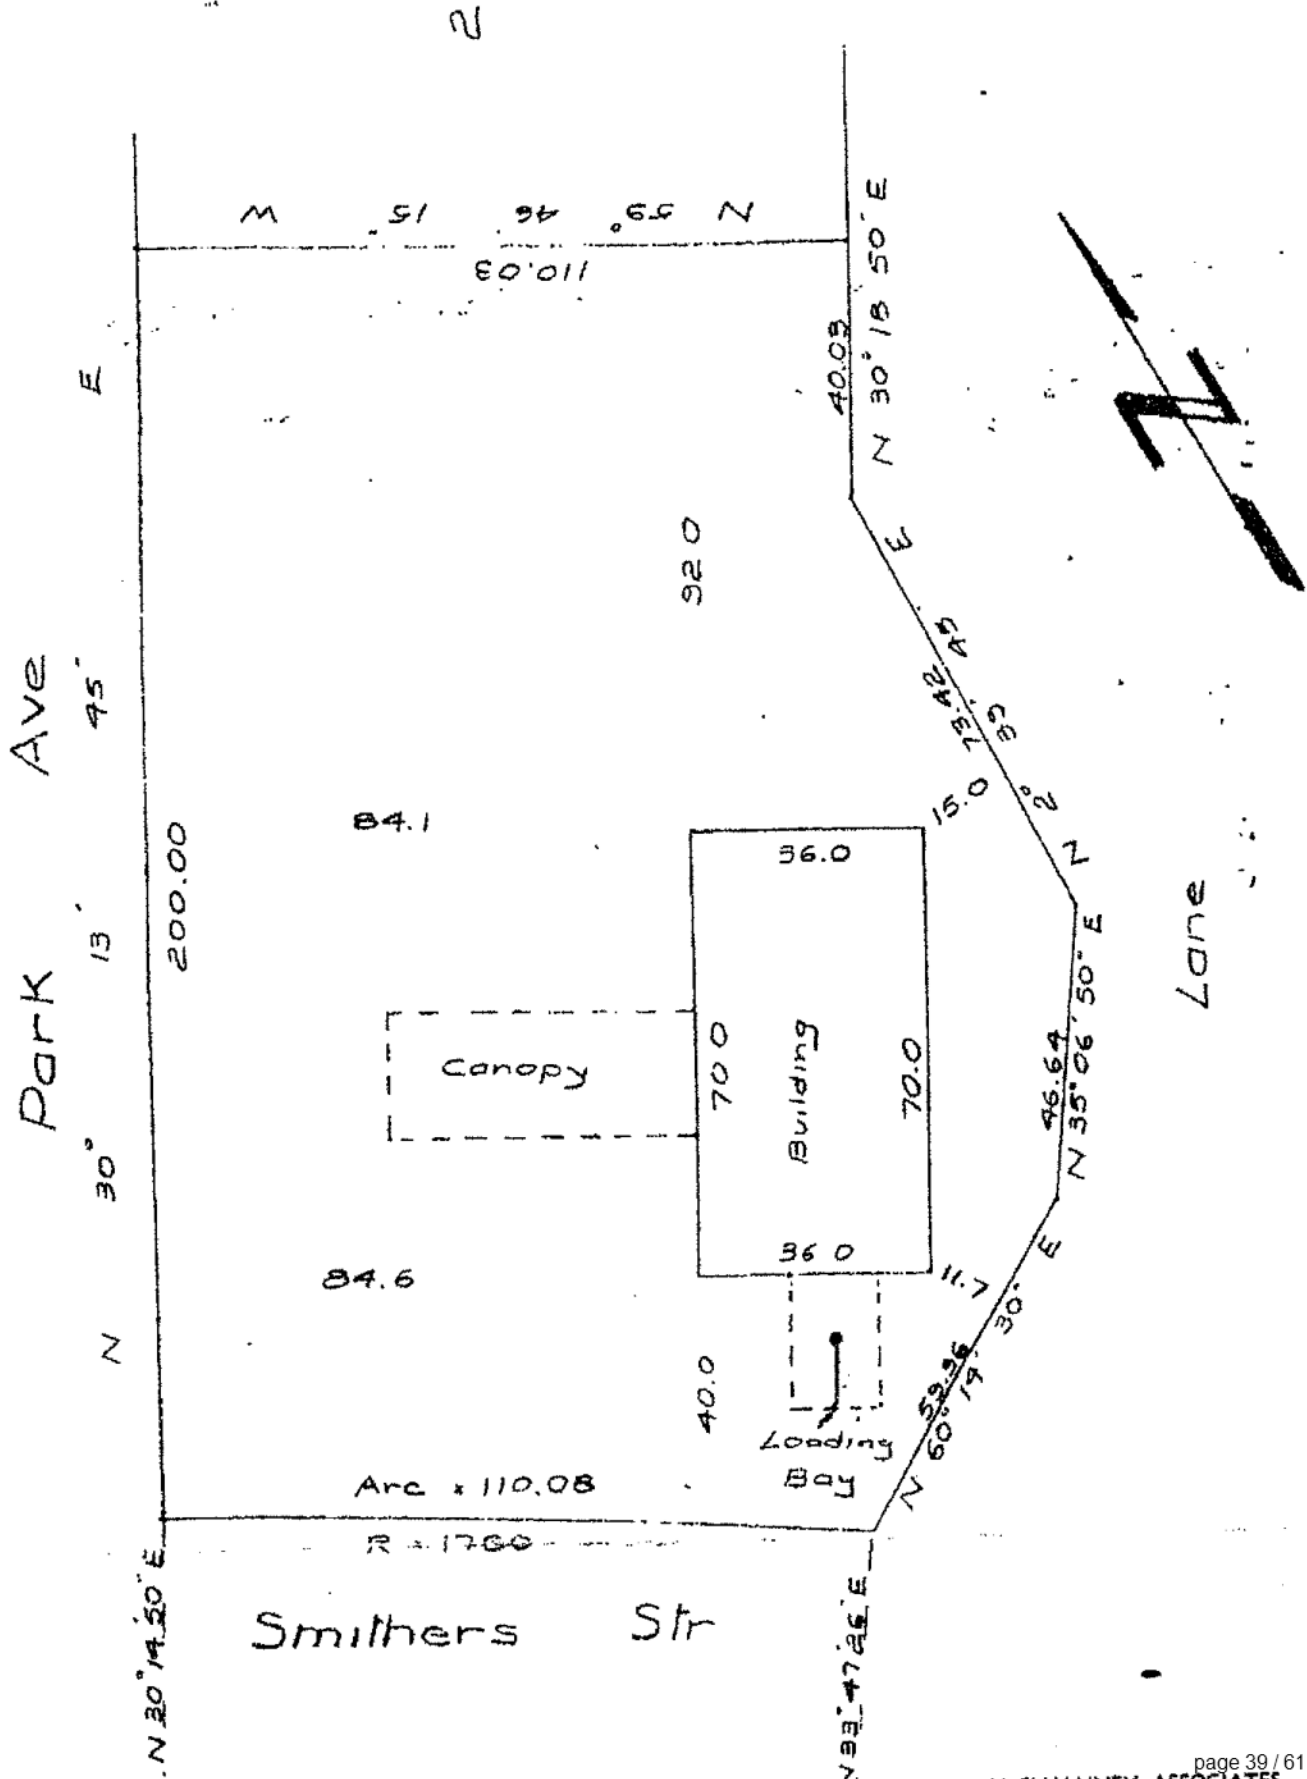
Scale: 1 inch = 30 feet

- Leaking underground "Bronze" gasoline tank distribution line caused a spill of approximately 10,000 litres of gas to the ground over 6 days.
- Impact- Dec. 6th- Flammable vapours identified by the Fire Department in 4 neighbouring residences. Liquid gas observed at discharge from storm sewer in Moresby pond in Moresby Park. Dec. 11th- One dead cutthroat trout (length 10 cm.) observed by AGrant 3 metres upstream of the entrance of storm water discharge into Moresby pond. (Fish given to DFO, Uriah Orre on Dec. 11th). (See attached spill report #151/95)

- Response- Spiller responded on Dec. 6th under direction of AGrant by hiring a consultant to dig 5 gas recovery wells, pressure test the lines, clean up soil contamination, place sorbents in sewer and creek. Prince Rupert and Fire Dept staff assisted. 25% of the liquid product was recovered by 11 Dec. '95.
