Jumbo Glacier Resort Project

- On March 21, 2015, EAO received GRLs "Snow Avalanche Risk Zoning for a Day Lodge and Service Building" report, composed by Alan Jones, P.Eng.
- On April 24, 2015, EAO C&E concluded the investigation and determined that the project is out of compliance with condition 36. The Alan Jones Report states that:

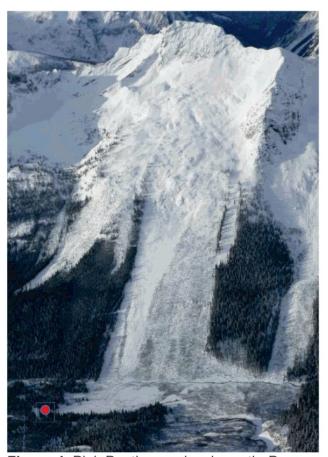
Figure 4. Pink Panther avalanche path. Day Lodge and Service Buildings are located in lower left of photo. Red dot shows the approximate location of the Day Lodge.

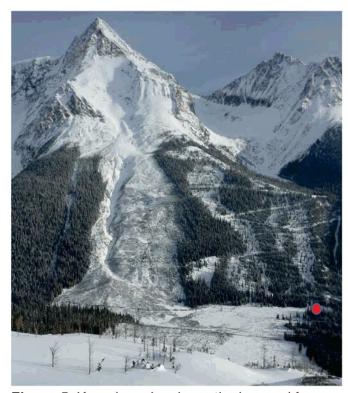
Figure 5. Karnak avalanche path observed from Pink Panther path. Red dot shows the approximate location of the Day Lodge.

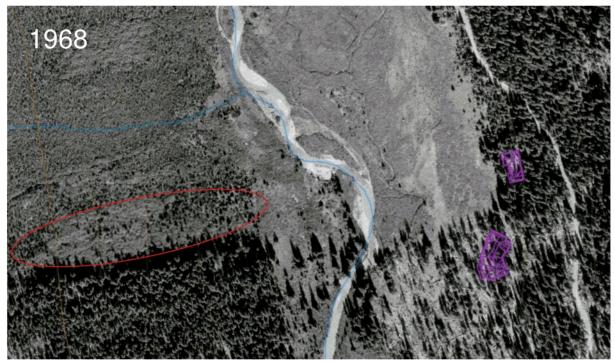
- A large swath of forest along the southern (bottom on photo) trimline of the 1968 photo
 was removed by an avalanche prior to 1968. Given that the vegetation had already
 partly re-vegetated in 1968, it is interpreted that this event may have occurred during the
 1950's. In 2005, this vegetation had grown in significantly, but the pre-1968 trimline can
 still be clearly observed and remains a potential avalanche area.

- Fallen logs near the Day Lodge can be observed on the 1968 photo, and are distributed
 in a random manner. If a large, destructive dense or powder avalanche had flowed
 through this area and knocked over trees, there would be evidence of fallen logs lying
 parallel to the avalanche flow (i.e. west to east). This implies that no major (i.e.
 destructive) avalanches had reached the Day Lodge site for a number of years prior to
 1968, nor have any reached this location up to 2014 (verified by field observations).
- The area east of the resource road was harvested sometime between 1968 and 1981.
 This may have removed some long-term evidence of powder avalanches in this area.

Figure 6a. Day Lodge and Service building overlain on the 1968 air photo. Red oval shows area where an avalanche removed forest cover, estimated to have occurred during the 1950's. Note selective logging and random orientation of deadfall in the vicinity of the Day Lodge.

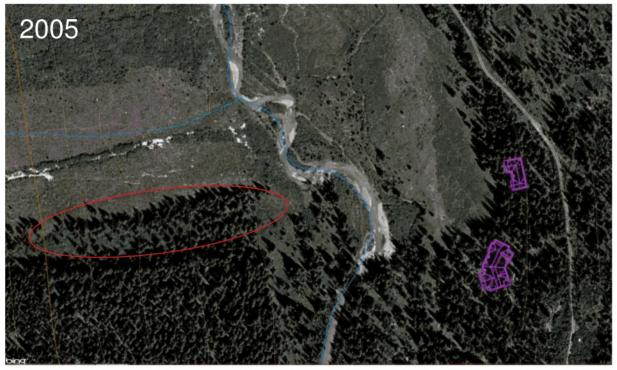
- The forest surrounding the Day Lodge regenerated significantly during 1968-2005.
 Evidence of large, logged stumps were observed in this area, showing that it had been selectively harvested prior to 1968. The distinct line of mature trees immediately north of the Day Lodge has not been significantly modified by avalanches in the 46 year period since 1968.

Figure 6b. Day Lodge and Service Building location overlain on the 2005 imagery. Red oval shows regenerated forest (trimline) from pre-1968 (estimated 1950's) avalanche event.

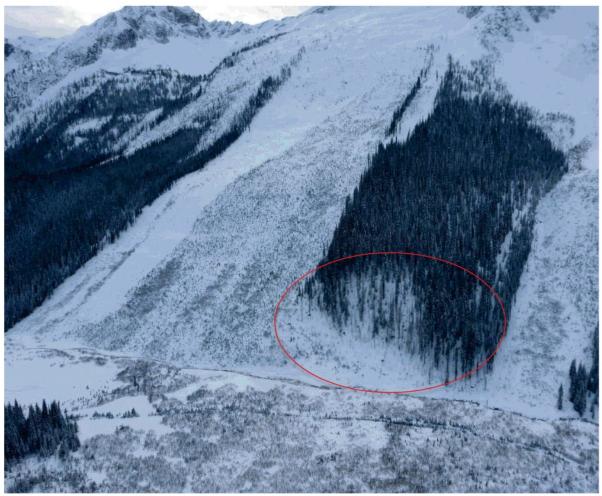
avalanche in the Karnak path that crossed the valley and impacted forest in the Pink Panther path. Although this event caused significant damage to the forest, there is no evidence in this video, field evidence, air photos or terrain analysis to suggest this avalanche path can turn southwards and flow a significant distance down valley and affect the Day Lodge.

Figure 7. Destructive impacts to forest cover adjacent to the Pink Panther path caused by the cross-valley Size 4 explosive-triggered powder avalanche from the Karnak path in February 2013. Pink Panther path is located to the south (left) of red oval.

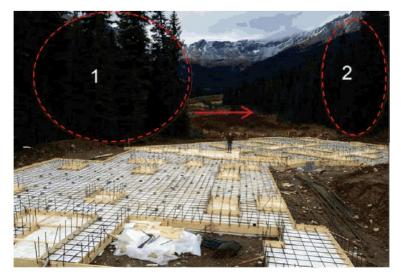
Figure 9. Day Lodge construction site. Area 1 indicates a mature forest immediately northwest of the site with no evidence of avalanche impacts. Area 2 indicates area with some powder avalanche impacts (see Figure 8). Red line shows main avalanche flow direction north of Day Lodge.

There was no evidence of dense flow or powder impacts noted at the Day Lodge site during the field investigation, on aerial photographs, or on photos of the site prior to construction. The only evidence of a powder avalanche reaching the Day Lodge was provided by RK Heli (2009) which shows a light powder flow travelling towards and possibly reaching the Day Lodge (Figure 10). Observation of vegetation at the site indicates that the 2009 event did not produce destructive powder effects to the Day Lodge site.

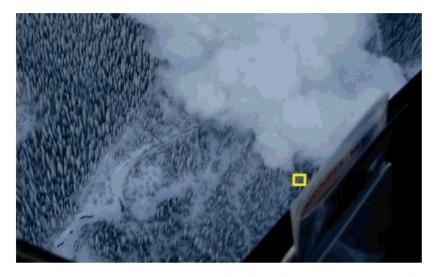
Figure 10. Powder flow during January 2009 explosive triggered avalanche in Pink Panther path. Day Lodge foundation location, as constructed in 2014 approximately indicated by yellow square. (Modified from RK Heli photo).
