DGIR 214026 Fire Duncan

Email from North Cowichan re DGIR 214026 Fire at OK Tire in North Cowichan

Re: *SURFACE WATER INSPECTION LETTER* – 6482 Norcross Road, Duncan, BC

Site Photographs – January 24, 2022

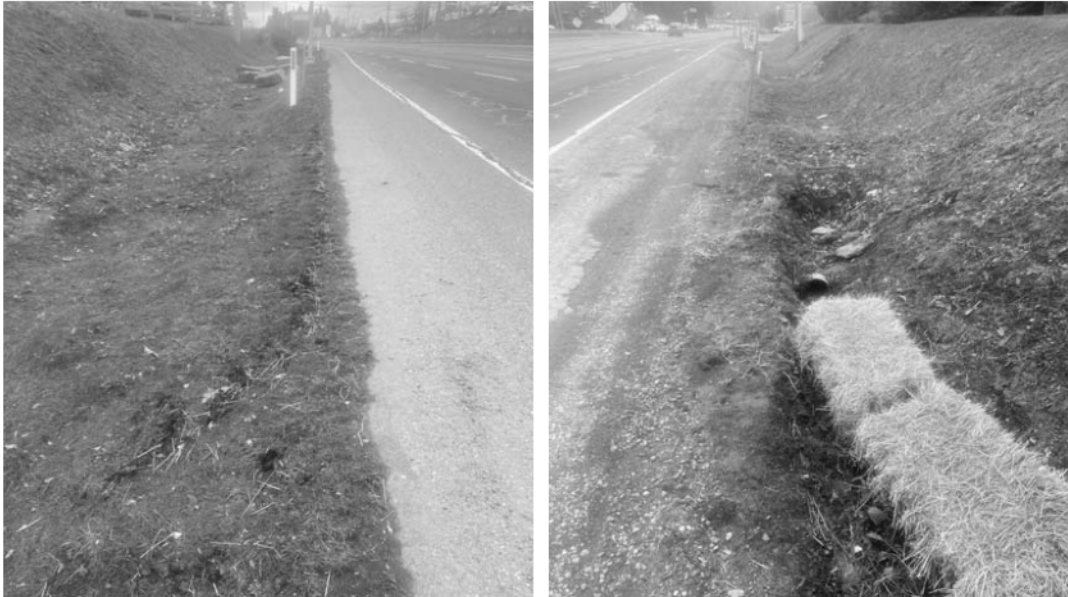
Photo 1 (left): View looking north, standing on west side of Highway, OK Tire in far background. Observable charcoal and fire debris along edge of asphalt.

Photo 2 (right): View looking south, standing on west side of Highway, OK Tire to photographers back. Hay bales placed by North Cowichan staff, drainage water enters underground culvert system.

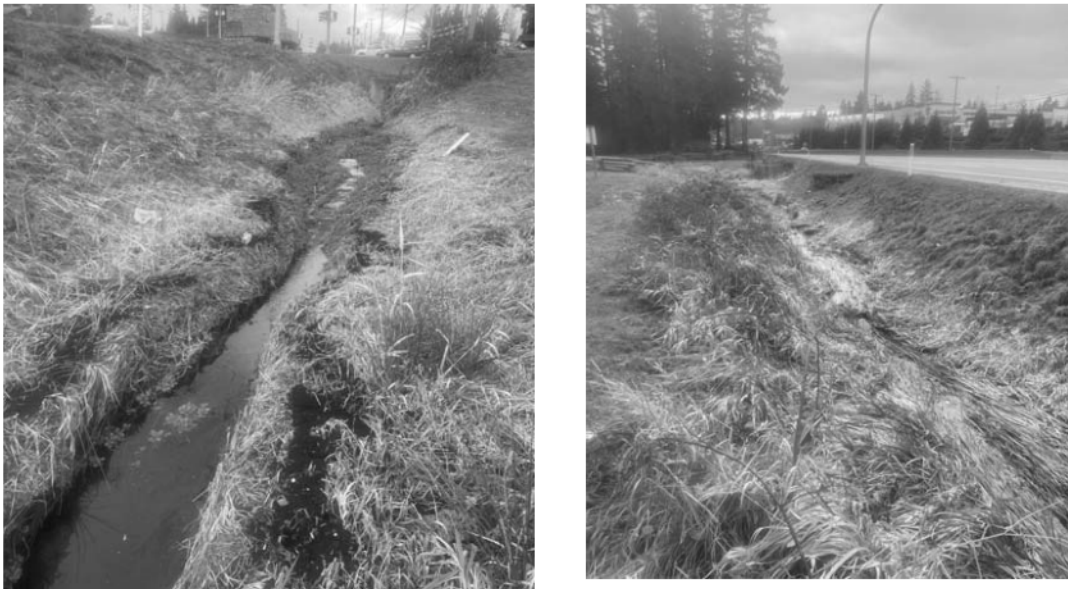
Photo 3 (left): View looking north, standing at Forest Discovery Center on east side of highway. Observable charcoal and fire debris at high water mark in drainage ditch.

Photo 4 (right): View looking south of ditch drainage. Note tall grass and reeds.

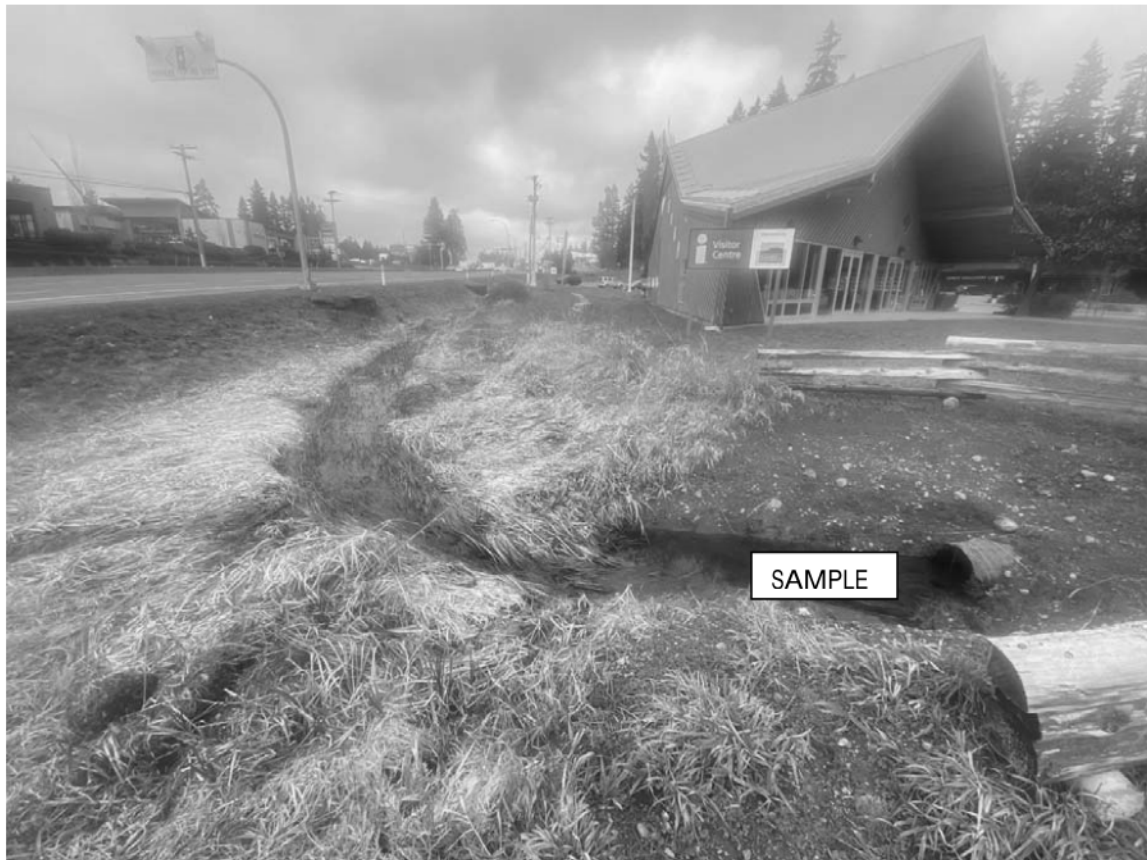
Photo 5 (above): View looking north of entire drainage ditch next to Forest Discovery Center, and where water enters the greater drainage system via underground culvert. Sample location at the culvert, annotated in photo.
