AQUATIC EFFECTS ASSESSMENT

Sweltzer River Bridge Rehabilitation

Report Number: 1114220030-002-R-Rev1-1100

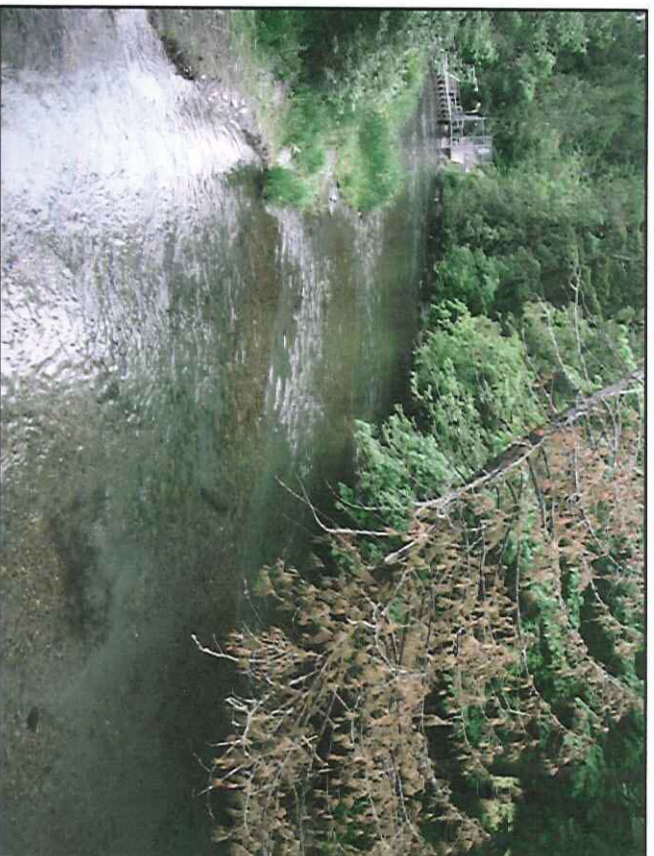
Photograph 1: View of the downstream portion of the Project area showing riparian conditions. DFO counting fence is visible in the background.

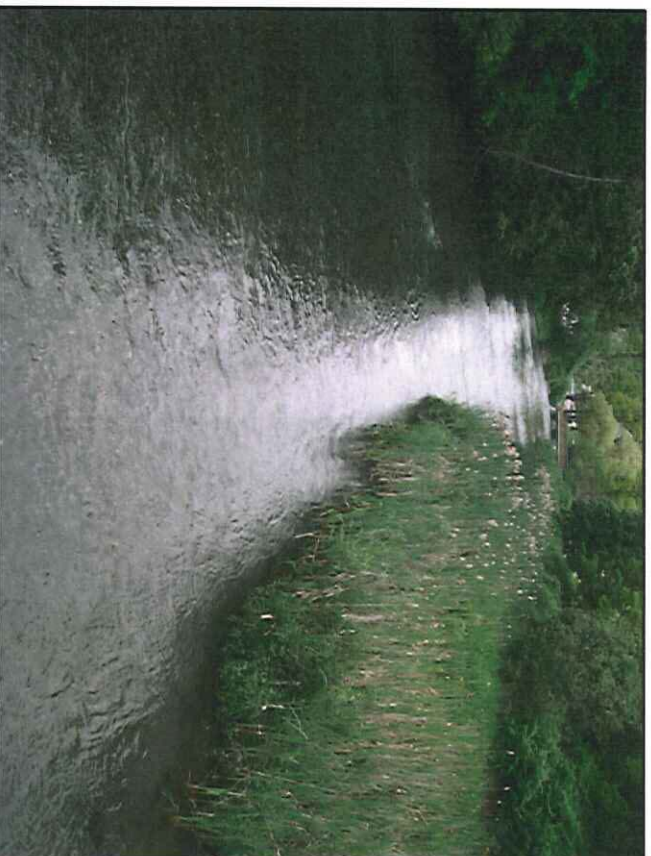
Photograph 2: View of upstream portion of the Project area showing riparian and instream vegetation conditions. The cattail/bulrush area is the largest section of instream vegetation.

Instream vegetation within the assessment area is limited primarily to a large area of bulrush (*Schoenoplectus* spp.) and cattails (*Typhus latifolia*) located west (upstream) of the bridge site as indicated on Figure 2. Within the remainder of the channel, instream vegetation is very sparse and limited to the channel margins. The invasive Yellow-Flag Iris (*Iris pseudacorus*) was also observed in the Project area. At the bridge, no instream vegetation was observed.

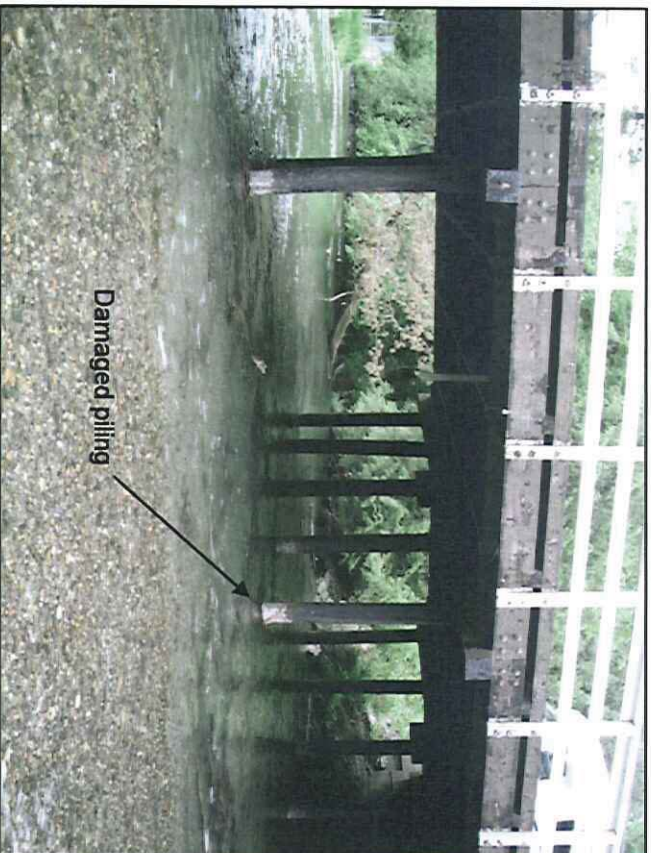
Photograph 3: View of piling repair location looking downstream. Recommended instream access would be from the right hand (southern) side of the photograph.

- Depending on the work method used to repair the piling, install a temporary instream structure (sandbag coffer dam or similar) to facilitate full isolation and dewatering of the channel area around the piling;

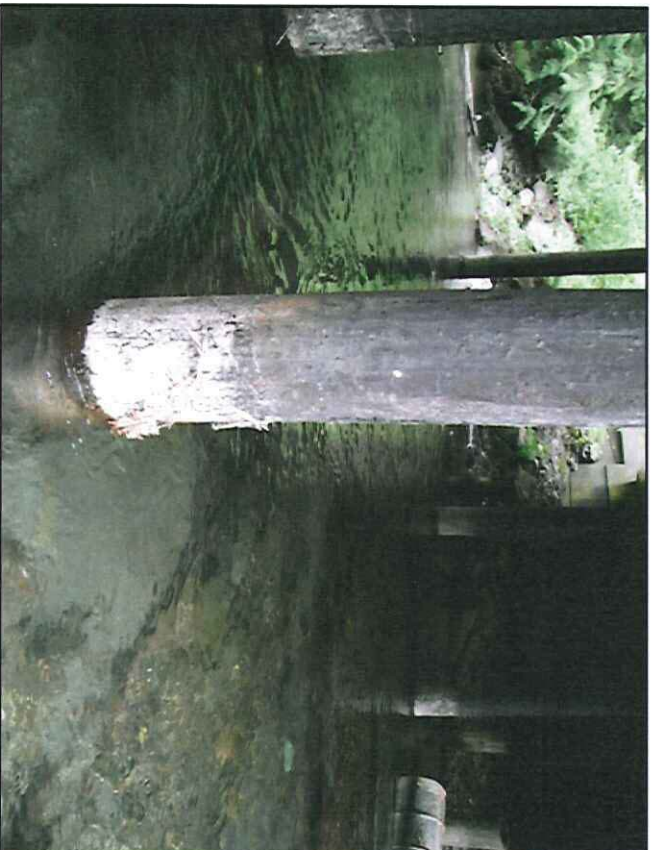
Photograph 4: View of piling repair location. Substrate at this location is predominantly sand; water depth was 0.6m.

Overall fish habitat quality within the general Project area and specifically at the bridge location was assessed as moderate to good, but in general lacks more complex habitat features and instream cover. Rearing and overwintering habitat potential was assessed as good, based on the presence of perennial flows, sufficient water depth, and proximity to accessible riverine habitat downstream and lacustrine habitat (Cultus Lake) upstream. Migration habitat potential was assessed as good to excellent based on the observed water depth, perennial flow, shallow gradient and unobstructed passage to and from Cultus Lake. The Sweltzer River is considered a critical migration corridor for the Cultus Lake sockeye salmon (Stone & Stone 2006). Spawning habitat potential was assessed as moderate to good, based on observed water depth, flow, gradient, and the presence of suitably sized gravels. Spawning areas have been identified upstream of the Project site at the outlet of Cultus Lake (Stone & Stone 2006). However, observations made during the field reconnaissance indicate that spawning habitat within the Project area is best downstream of the bridge, and that spawning habitat potential is low to moderate directly beneath the bridge as the substrate is mainly sand.

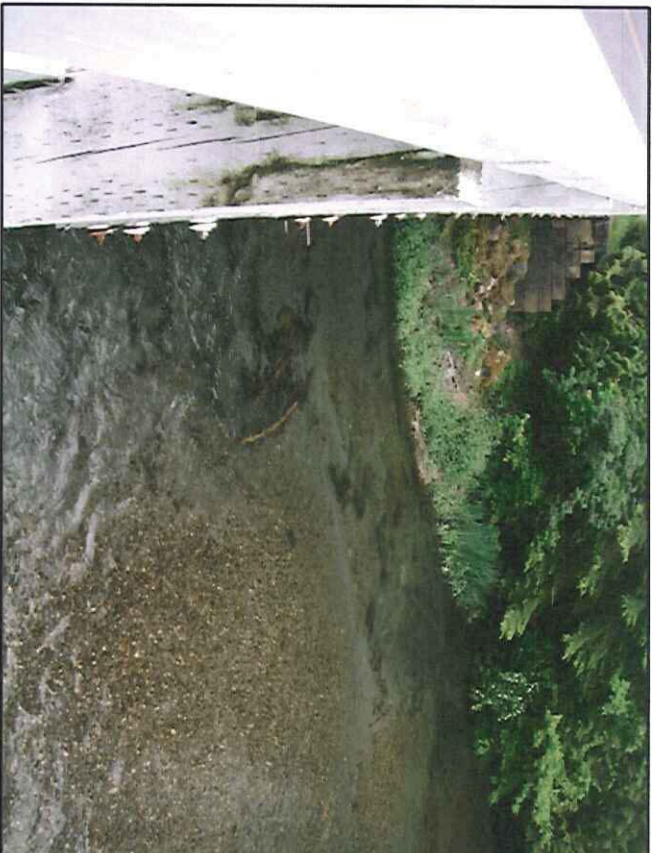
Photograph 5: View of channel and riparian conditions at the southwest corner of the bridge. This area is the recommended instream access point.

unidentified horticultural varieties. The understorey consists primarily of Salmonberry (*Rubus spectabilis*), Thimbleberry (*Rubus parviflorus*) and invasive Himalayan Blackberry (*Rubus discolor*). Riparian groundcover was predominantly unidentified grasses and forbs. At the bridge crossing, the riparian areas of least sensitivity (predominantly introduced grasses and forbs) were directly adjacent to the bridge approaches, including the southwest corner of the bridge nearest to the location of the damaged piling.

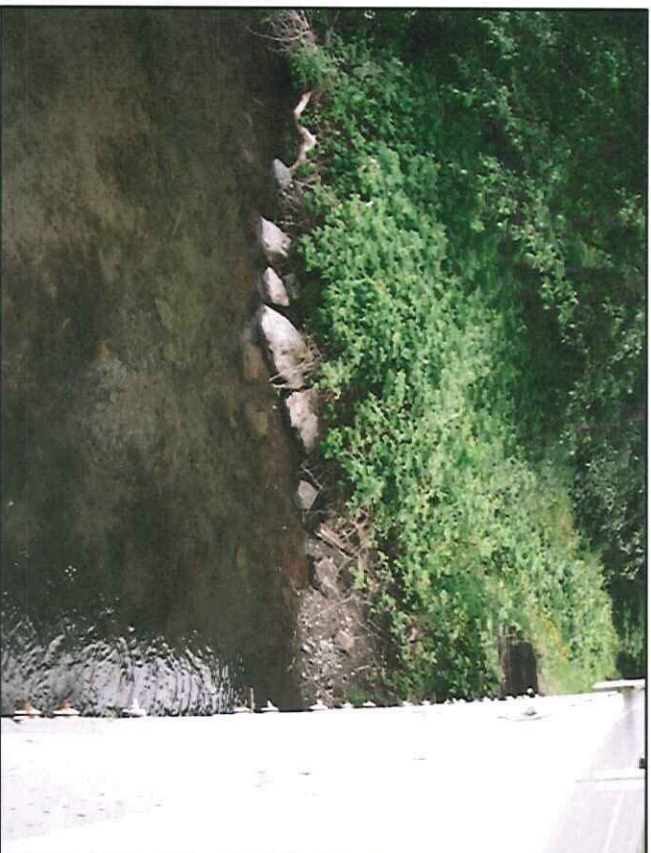
Photograph 6: View of channel and riparian conditions at the southeast corner of the bridge.
