Stage 1 Preliminary Site Investigation
508 Clarke Road
Coquitlam, BC

Project Number: 328P
June 2011

EXECUTIVE SUMMARY

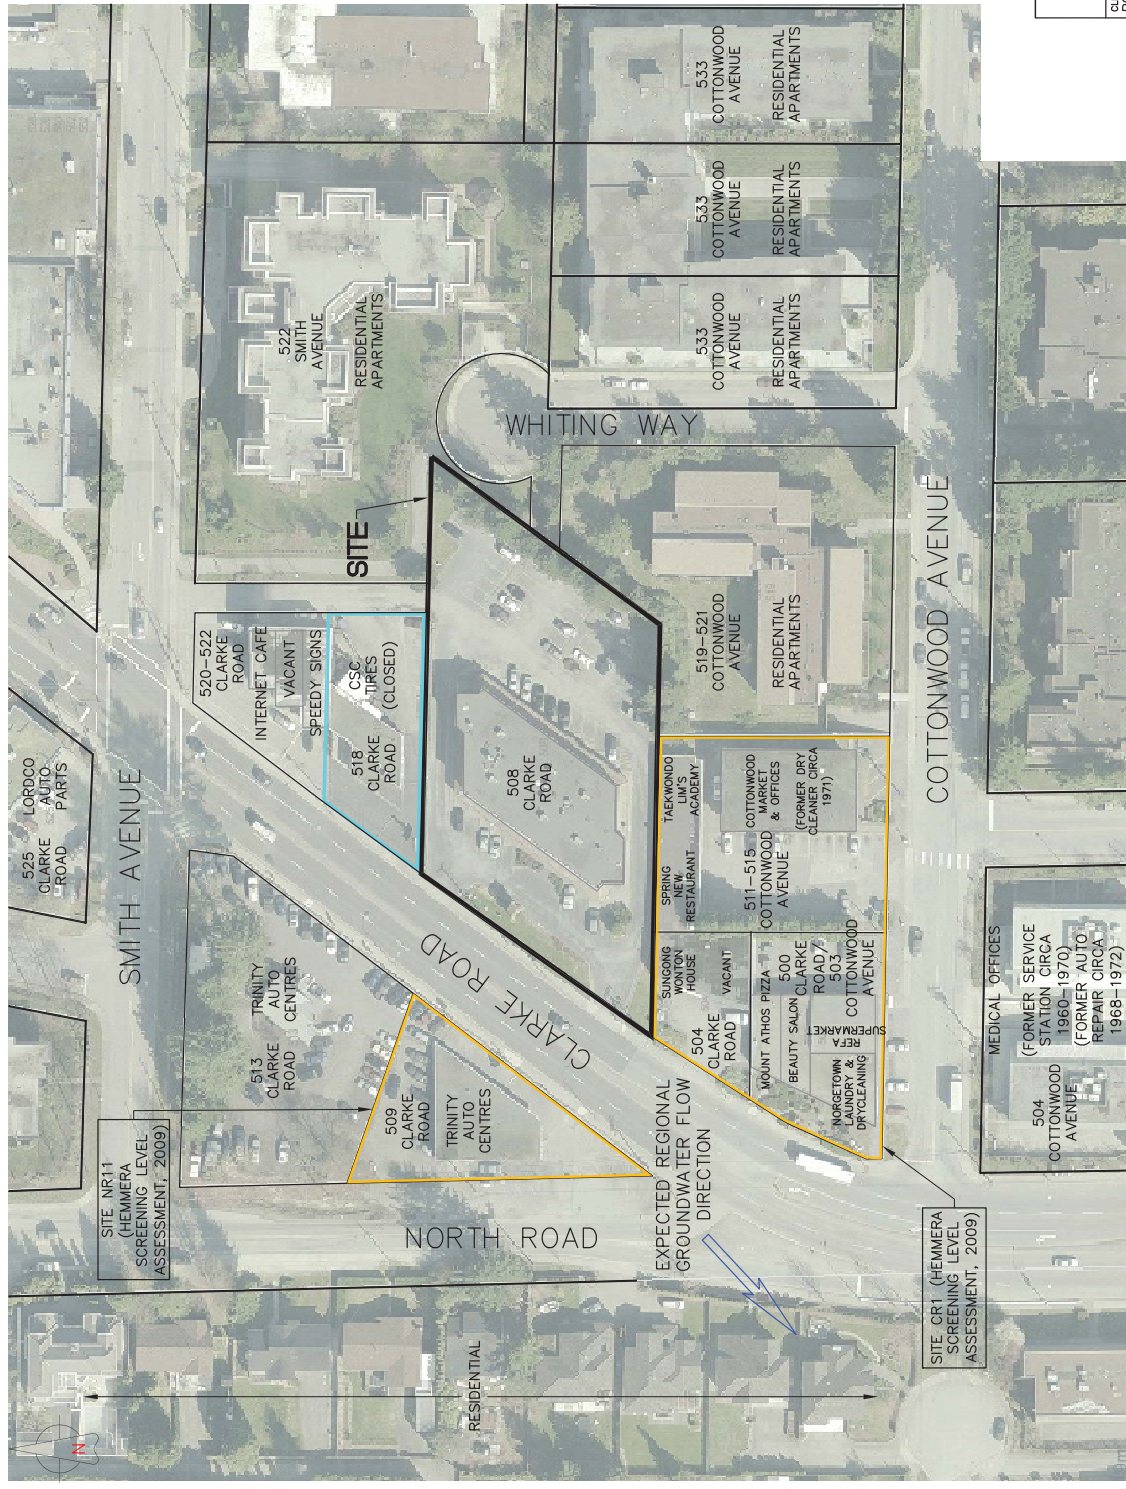
APEC	POC
APEC 1 - Historic and Current Automotive Repair to the north (Up-Gradient) at 518 Clarke Road.	POC 1 - Soil: LEPA, HEPH, PAH, VOC, VPH, Glycols, Metals Groundwater: LEPA, PAH, VOC, VPH, Glycols, Metals Soil Vapor: Napthalene, VOC

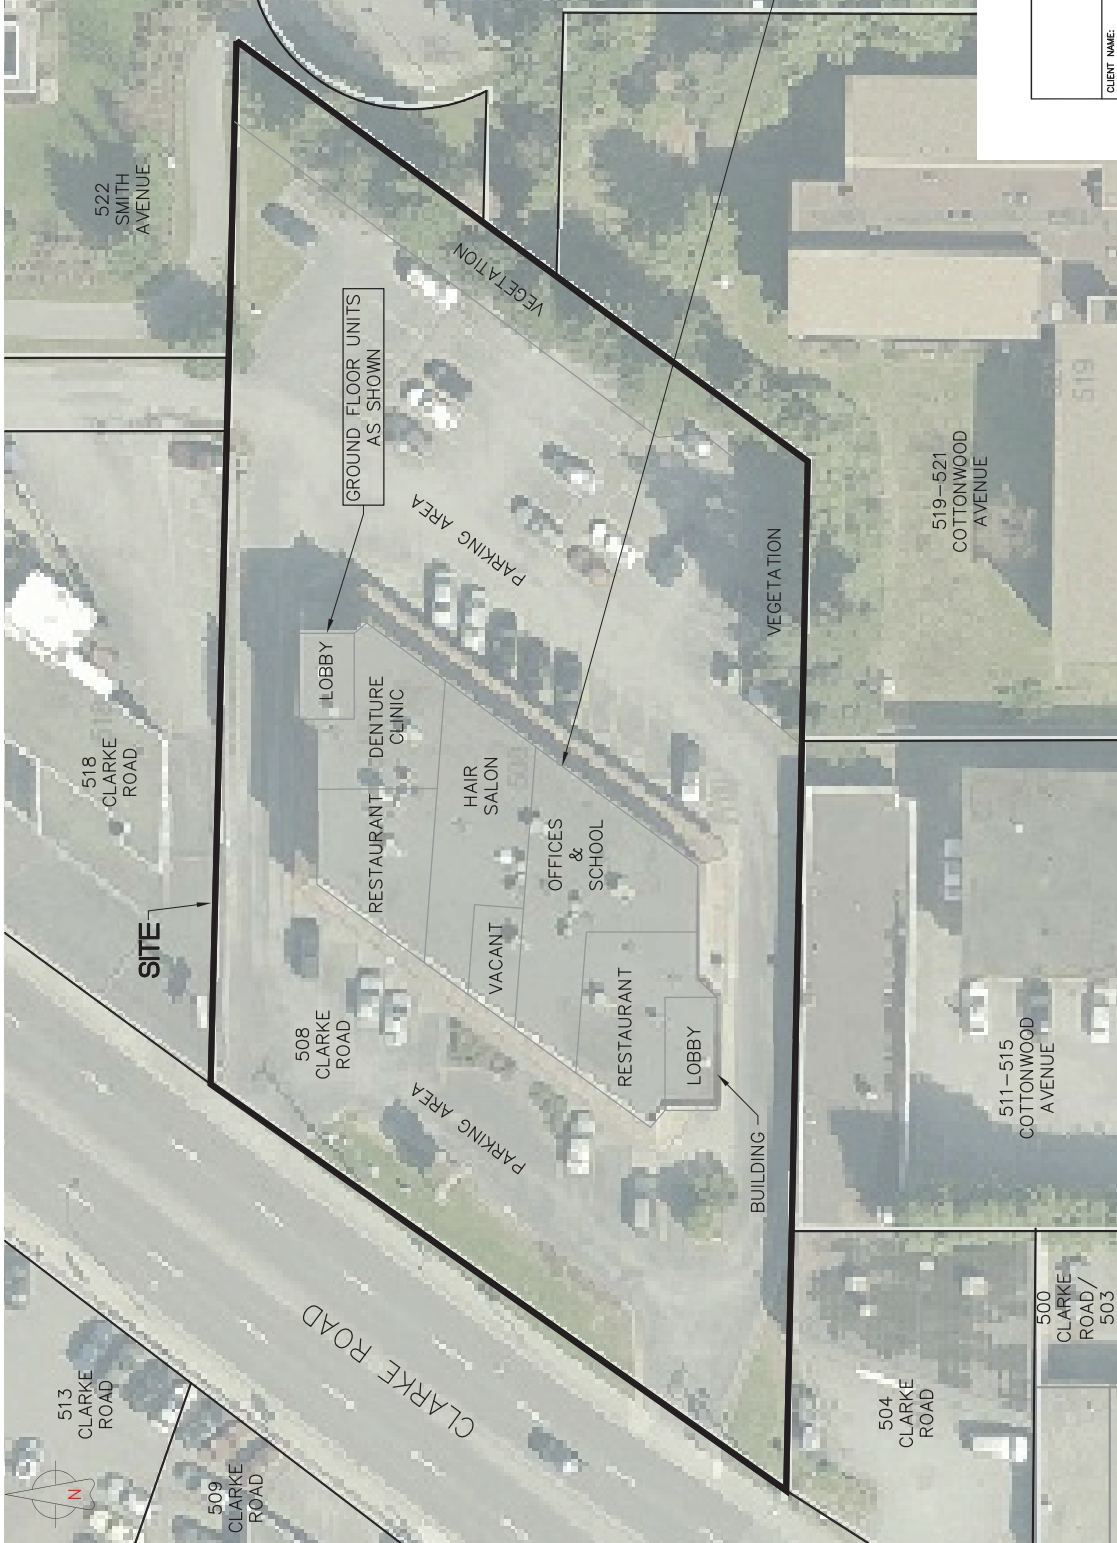
PAGE 3
FIGURE 3

The Site was occupied by a two-story brick building with a concrete slab-on-grade, which covers approximately 30% of the Site, as shown on Figure 3. The upper exterior story is finished with wood shingle siding. Two gas meters were observed along the southern exterior wall; natural gas is inferred to be used for restaurant operations and heating throughout the building. Electric baseboard heaters were also observed within several building units.

The remainder of the Site was occupied by asphalt entrance and parking areas (approximately 50% of the Site), and vegetated landscaped areas (approximately 20%). Dumpsters and a cooking-oil disposal tank were observed on a concrete pad in the south-east corner of the lot; the soil in the vicinity of the cooking oil tank appeared slightly stained. No evidence of Above-ground Storage Tanks (ASTs), Underground Storage Tanks (USTs), or oil-water separators was observed on-Site. No evidence of previous intrusive environmental investigations (i.e. boreholes or groundwater monitoring wells) was observed. No significant staining was observed on the asphalt surfaces.

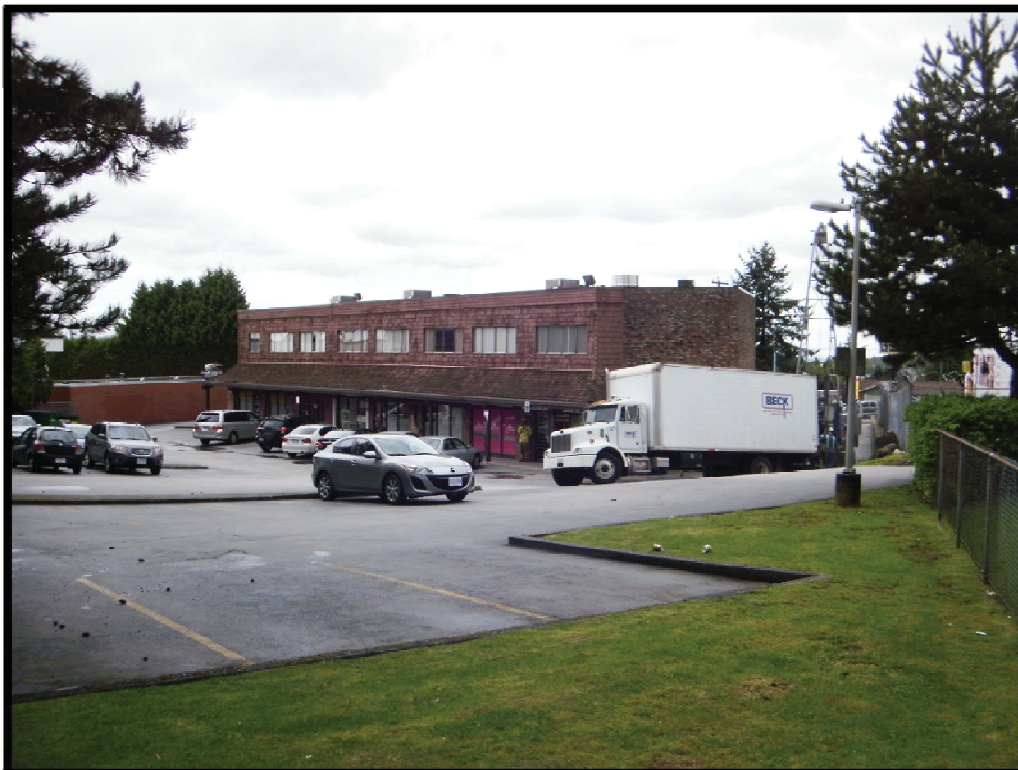
Photo 2 –

A representative of Keystone Environmental was on-site during the Site visit, conducting what appeared to be a Phase 2 investigation involving the advancement of three boreholes and installation of groundwater monitoring wells. An auger drill rig, operated by Beck Drilling and Environmental Services Ltd. was observed on-Site. It is understood that this Phase 2 investigation was being completed on behalf of the current property owner.

On-Site building, landscaped areas and asphalt parking. Crew from Beck Drilling and Environmental Services and Keystone Environmental conducting Stage 2 investigation work. Looking southwest from northeast corner of Site.

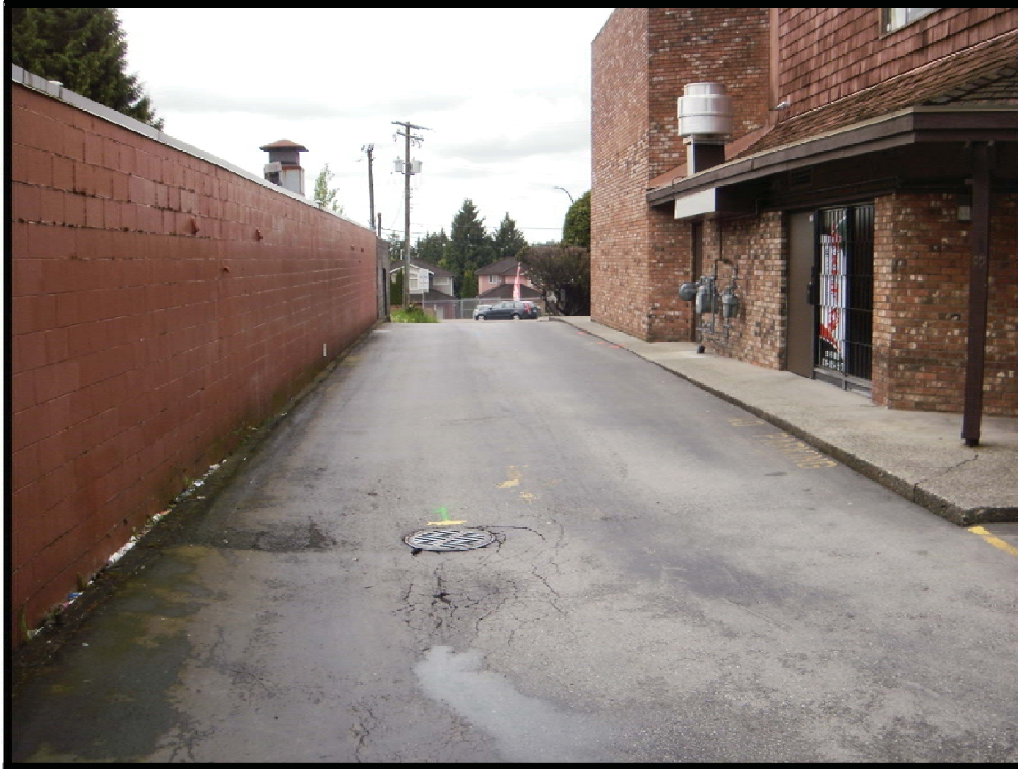
Photo 3 –

Asphalt driveway showing storm drain catch-basin and gas meters along southern wall of on-Site building. Wall of neighbouring property to the south (504 Clarke Road) is shown on the left. Looking west from Site, toward Clarke Road.

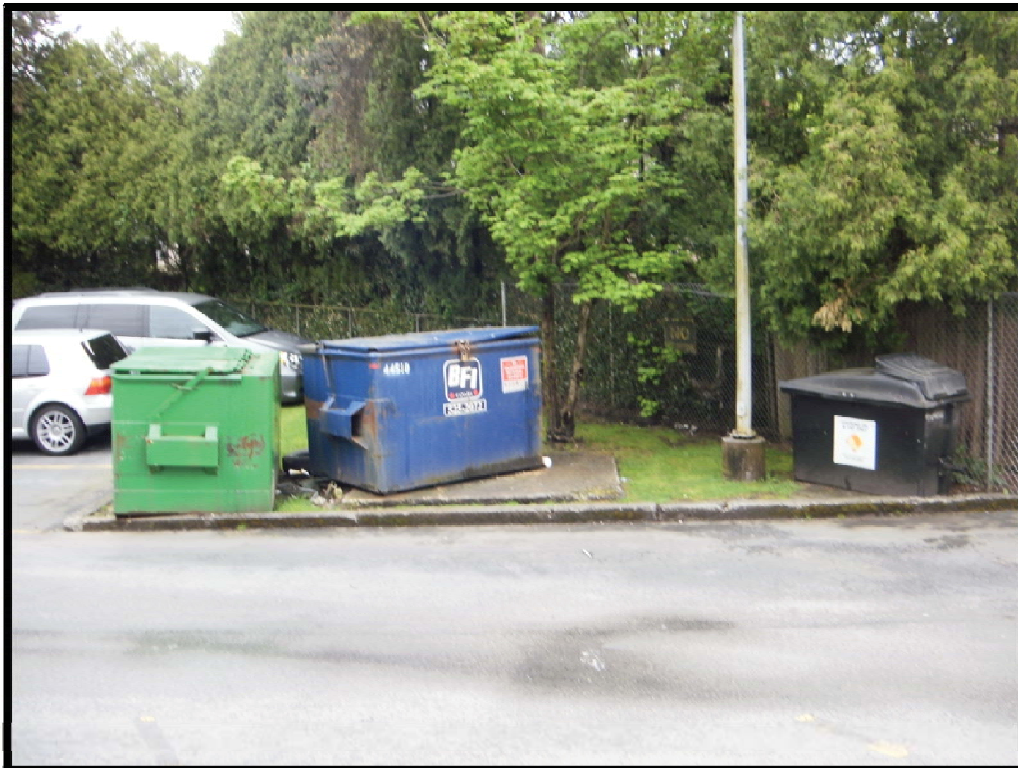
Photo 4 –

Garbage dumpsters and waste cooking oil bin, located in southeast corner of Site. Looking east.

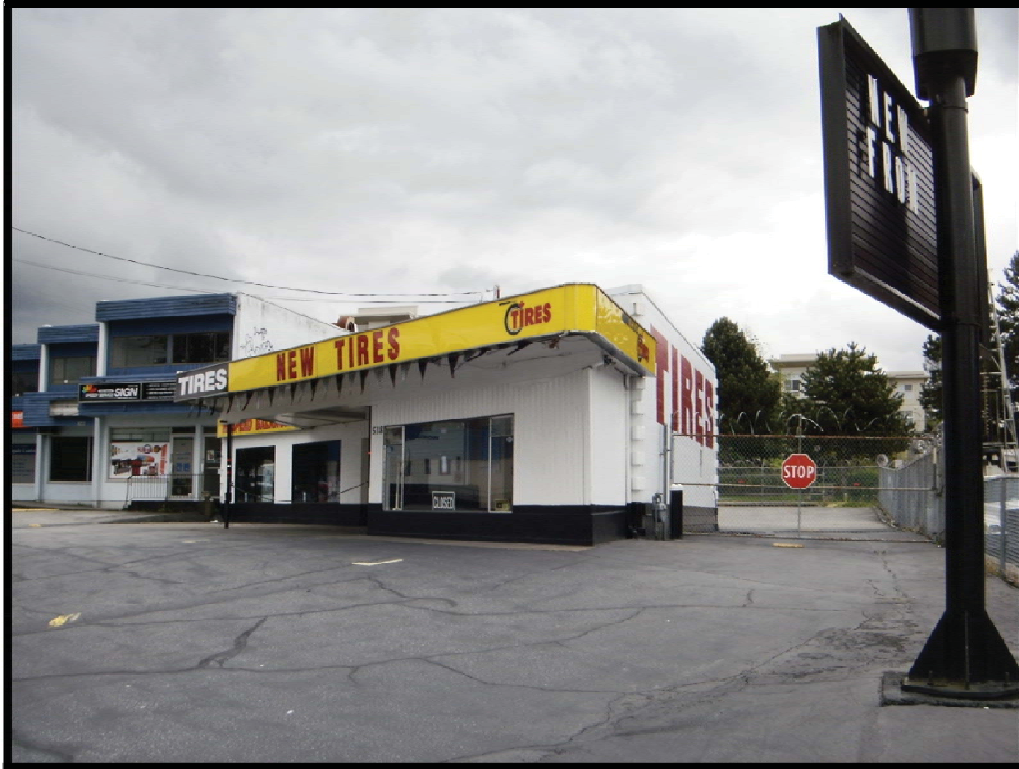
Photo 5 –

Off-Site APEC 1 is located to the north (up-gradient) of the Site. A single-bay automotive repair garage was observed within the building. The operation was closed and repair equipment appeared to have been removed. The garage was not inspected, although the floor was observed to be concrete and indications of a former above-ground hoist were observed. A concrete patch was observed, which may be indicative of a former below ground hydraulic hoist. No ASTs or USTs were observed on the property. Given the history, proximity, and up-gradient orientation relative to the Site, this APEC presents a moderate risk of contamination to the Site, and specifically to the SRW.

Off-Site property to the North at 518 Clarke Road (APEC 1). Looking northeast from Clarke Road.

Further investigation in the form of a Stage 2 is recommended. This Stage 2 may be limited to a single borehole/monitoring-well located within the northwest extent of the SRW.

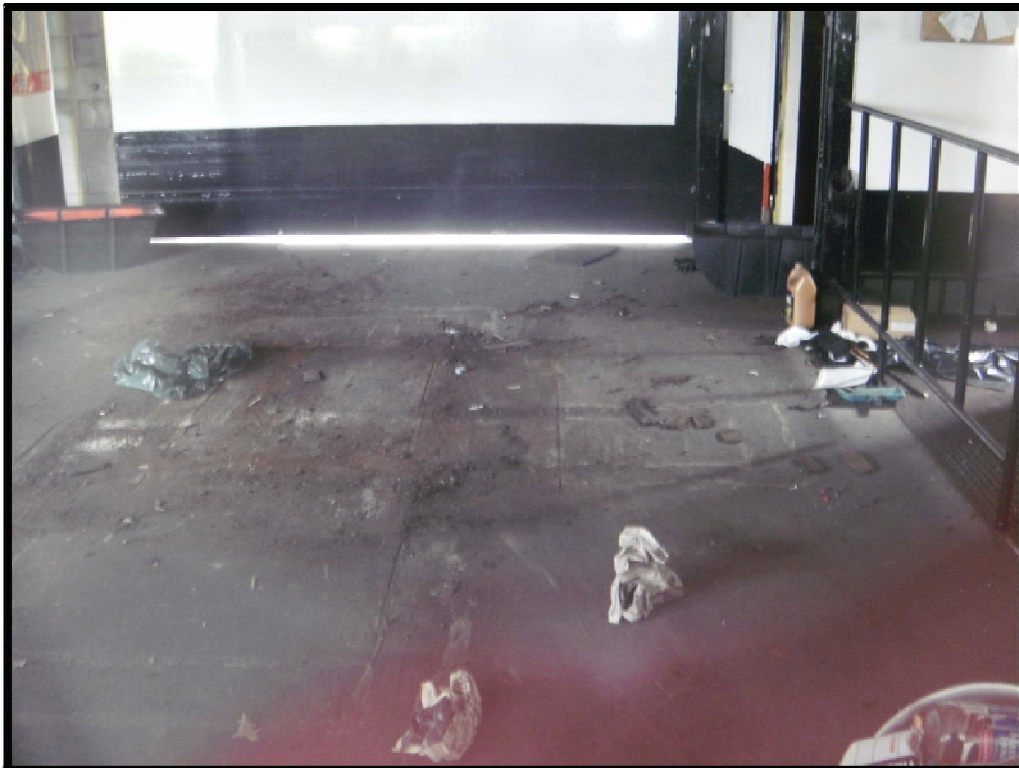
Photo 6 –

According to historic directories, the operations at 518 Clarke Road (APEC 1) have consisted of tire sales. However, during the Site visit, a small (1 bay) automotive repair garage was observed within the building. The operation was closed and repair equipment appeared to be no longer present. The garage was not inspected, although the floor was observed to be concrete and indications of a former above-ground hoist were observed. A concrete patch was observed, which may be indicative of a former below ground hydraulic hoist. No ASTs or USTs were observed on the property. However, given the extensive history of automotive operations, this property is considered and APEC.

Auto repair area at 518 Clarke Road, showing likely former above-ground hoist location.

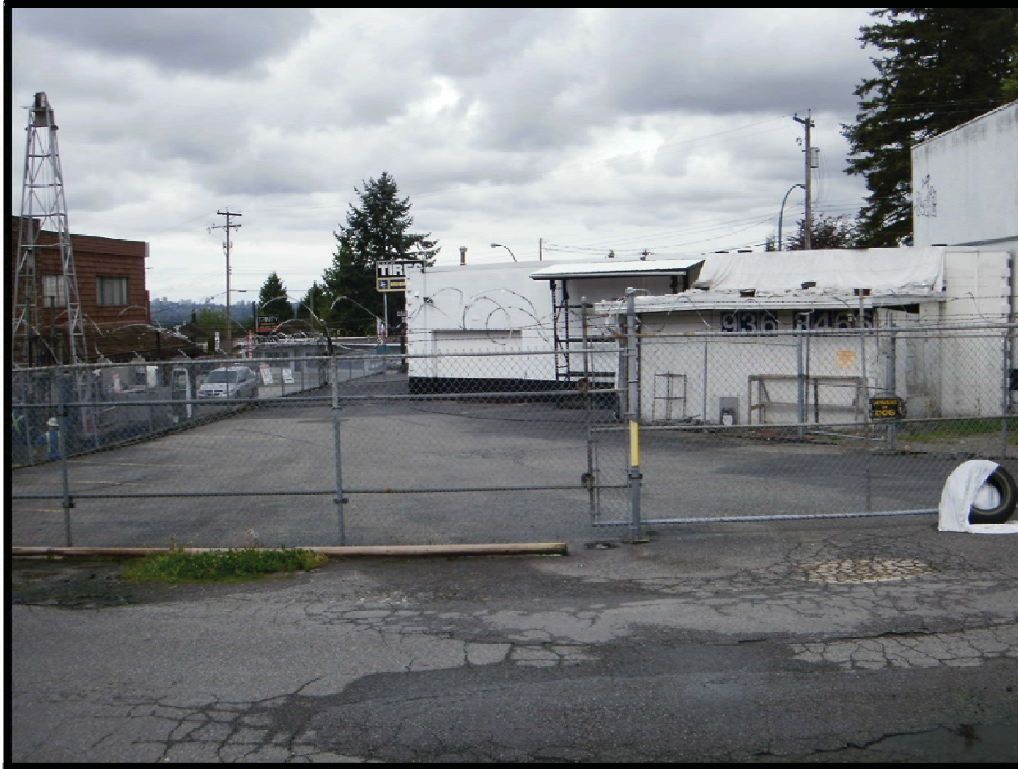
Photo 7 –

Rear yard to
518 Clarke
Road. Looking
east from
Lane.

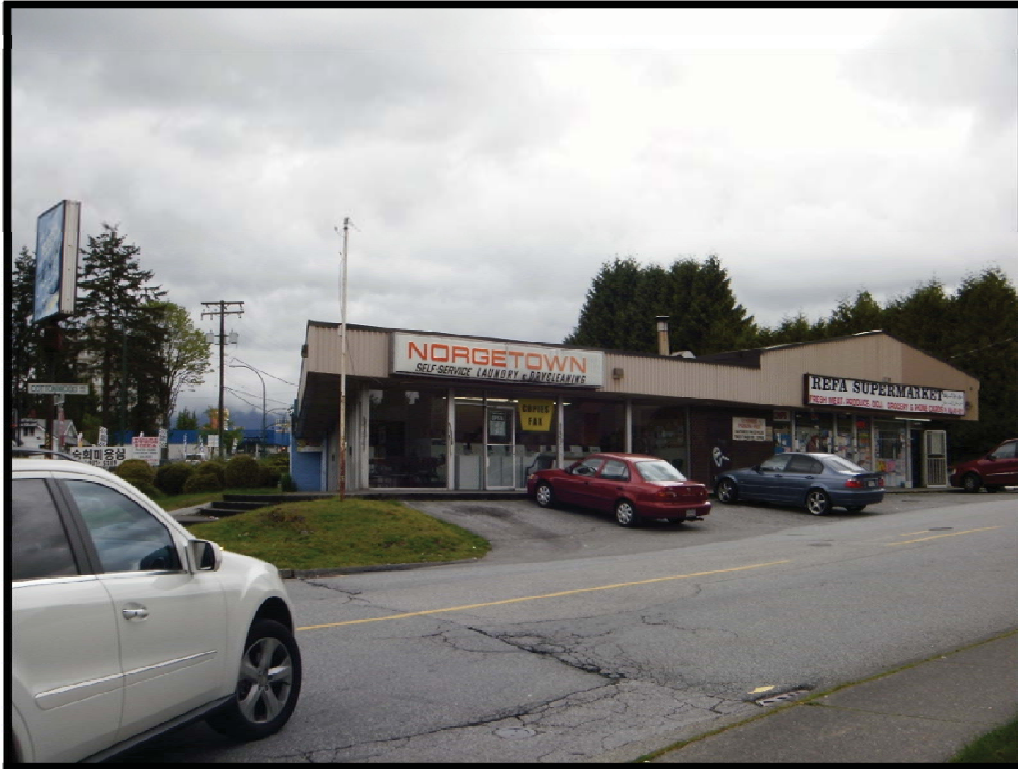
Photo 13 –

Issue	Distance / (Orientation)	Low Risk Rationale
Historic and Current Dry-Cleaning to the South (Down-Gradient) at 500 Clarke Road.	40m South/Southwest	Dry-cleaning operations were observed to occur in the southwest corner of the property, furthest from the Site. The property at 504 Clarke is located between the dry-cleaner and the Site. Based on local topography, groundwater is inferred to flow south/south-west, away from the Site. This facility is considered to present a minimal risk of contamination to the Site.

Off-Site building to the south, including Dry-Cleaners (500 Clarke Road) and Refa Supermarket (503 Cottonwood Ave). Looking north from Cottonwood Ave / Clarke Road intersection.
