## Environmental Assessment Document Cambie Creek Bridges Replacement Project Final

MMM Group Vancouver, British Columbia

# ENVIRONMENTAL ASSESSMENT DOCUMENT CAMBIE CREEK BRIDGES REPLACEMENT PROJECT

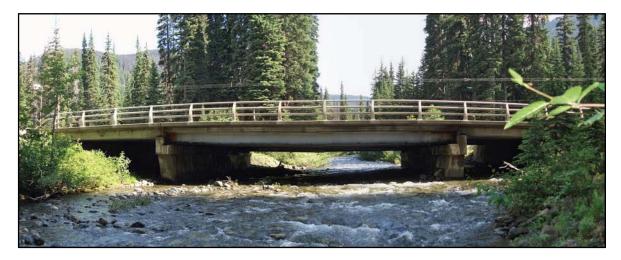
Figure 3 Existing Upper Cambie Creek Bridge structure panorama.

The existing bridge abutments span 30 m and abutments are currently located in the channel (Figure 3). The western pier is situated below the high water mark but is dry most of the year, while the eastern pier is situated within the wetted area of the stream year-round. The channel under the existing bridge was widened artificially during the installation of the existing bridge in the 1940s and does not reflect the upstream and downstream channel conditions. The hydrotechnical assessment that was conducted by MoTI surveyed the channel 500 m upstream and downstream of the bridge and measured an average width of 15 to 16 m. During the original bridge construction the channel width at the bridge was artificially widened to >19 m. In order to naturalize the channel in this reach of the creek the replacement bridge will reduce the channel width to 16.3 m. The instream piers will be removed and will not be replaced. The bank will be reinforced with rip rap and the rip rap toe will be embedded under natural channel substrate (see Figure 6 and Figure 7).

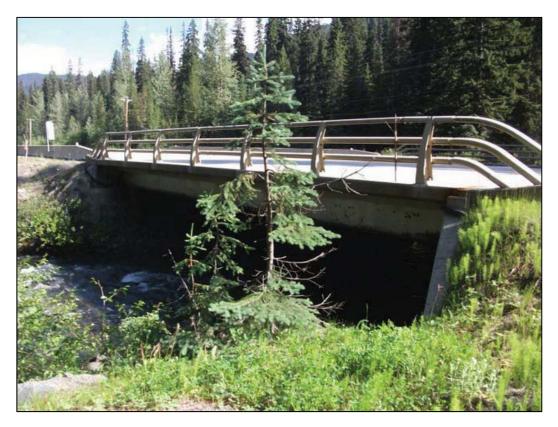
#### Figure 4 Existing Middle Cambie Creek Bridge.

The existing bridge abutments span just over 15 m (Figure 4) and the western abutment is within the wetted area of the stream year-round. The eastern abutment is only seasonally wetted. The new bridge will be 28 m long between abutments and the existing abutments will be cut 100 mm above the existing footings and will not be replaced. The new abutments will be reinforced with rip rap. The rip rap toe will be embedded and any rip rap with potential for submersion will be covered with the native substrate (Figure 8).

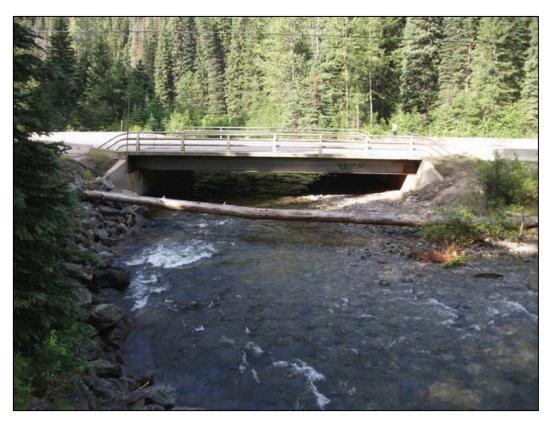
#### Figure 5 Existing Lower Cambie Creek Bridge.

The existing bridge abutments span just over 15 m (Figure 5) and the eastern abutment is within the wetted area of the stream year-round. The western abutment is only seasonally wetted. The new bridge will span 28.5 m between abutments. The existing abutments will be cut to 100 mm above the existing footings and will not be replaced. The remaining portion of the existing abutments will be used to support the toe of rip rap revetment around the new abutments (Figure 9).

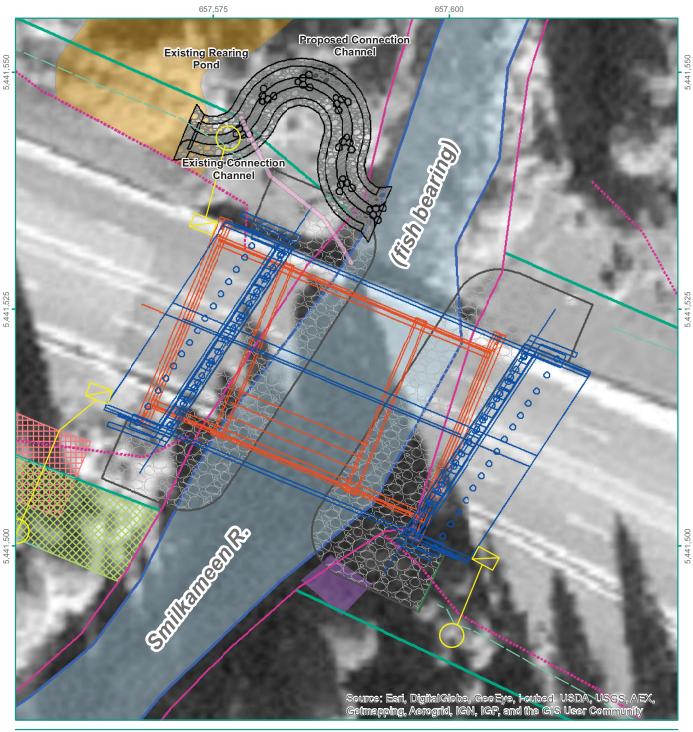
#### Figure 7 Proposed vs existing Upper Cambie Creek Bridge design.

The proposed replacement bridges will span 28 m (Upper and Middle) and 28.5 m (Lower), measured along the control line between abutments. In all three cases the existing abutments will be demolished and rip rap will be used to reinforce the banks under the new bridges. Rip rap will extend from the edge of the new bridge abutments and descend into the channel at a slope of 2H:1V. Rip rap that will be submersed in the stream channel will be covered with the native substrate (Upper Cambie Bridge only).

- During the original bridge construction the channel width at the bridge was artificially widened to >19 m. In order to naturalize the channel and improve fish passage through the definition of a thalweg at low flow the replacement bridge will reduce the channel width to 16.3 m complete with scour protection along the banks (i.e., rip rap revetment).

- The instream abutments will be removed and will not be replaced. The bank will be reinforced with rip rap and partially embedded under natural channel substrate (embedded rip rap considered a temporary/construction impact and not calculated as a permanent impact).

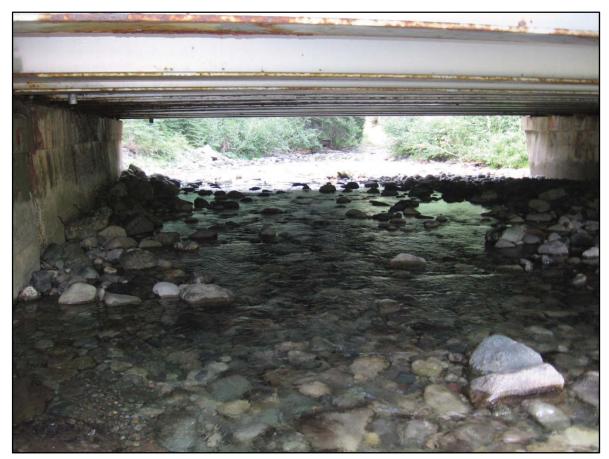
Figure 10 Upper Cambie Creek Bridge crossing location photos (Sept. 5, 2012).

At the time of the site assessment water levels were low (0.10 m to 0.25 m). The wetted width upstream and downstream of the bridge averaged 9.0 m and the channel width upstream and downstream of the bridge averaged 16.0 m. The channel width at the bridge crossing site was measured at >19.0 m and was found to be artificially widened during the installation of the original bridge. Channel bank slopes were typically shallow on one side of the channel and steep on the other side, alternating sides depending on the direction of meander and extent of the thalweg. Velocity averaged 0.4 m/s.

Upper Cambie Creek bridge looking upstream at the bridge.

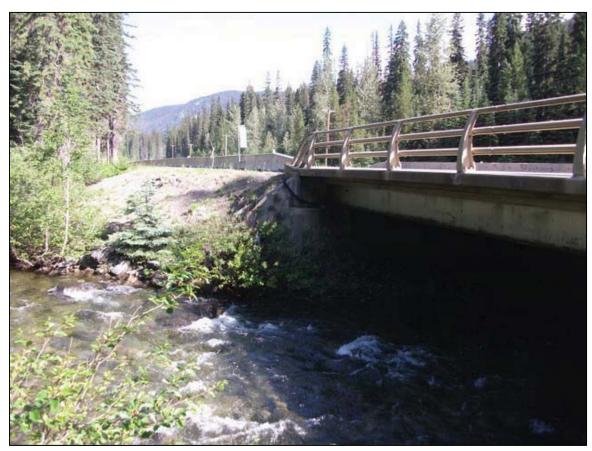
Figure 12 Middle Cambie Creek Bridge crossing location photos (Sept. 5, 2012).

Middle Cambie Creek Bridge looking at the left bank.

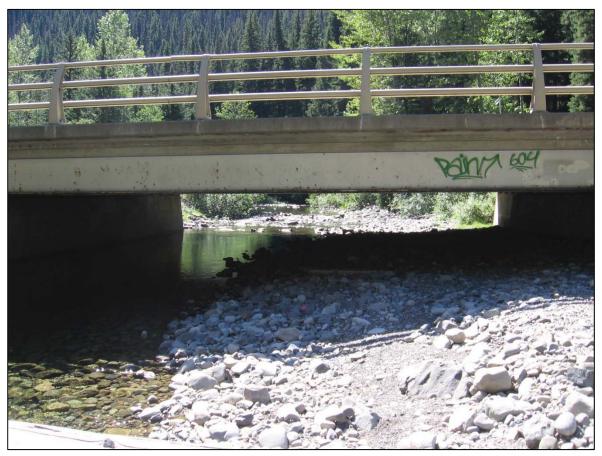
Figure 14 Lower Cambie Creek Bridge crossing location photos (Sept. 5, 2012).

Lower Cambie Creek Bridge looking upstream at the bridge.
