Swift Current CK. Bridge
M46-18-14

Foundation conditions at Swift Current
Creek Bridge - Yellowhead Highway

FOUNDATION INVESTIGATION - SWIFT CURRENT CREEK BRIDGE

**HAZARD ASSESSMENT
HIGHWAY 16 - SPITTAL AND LEONA CREEKS
ROBSON DISTRICT**

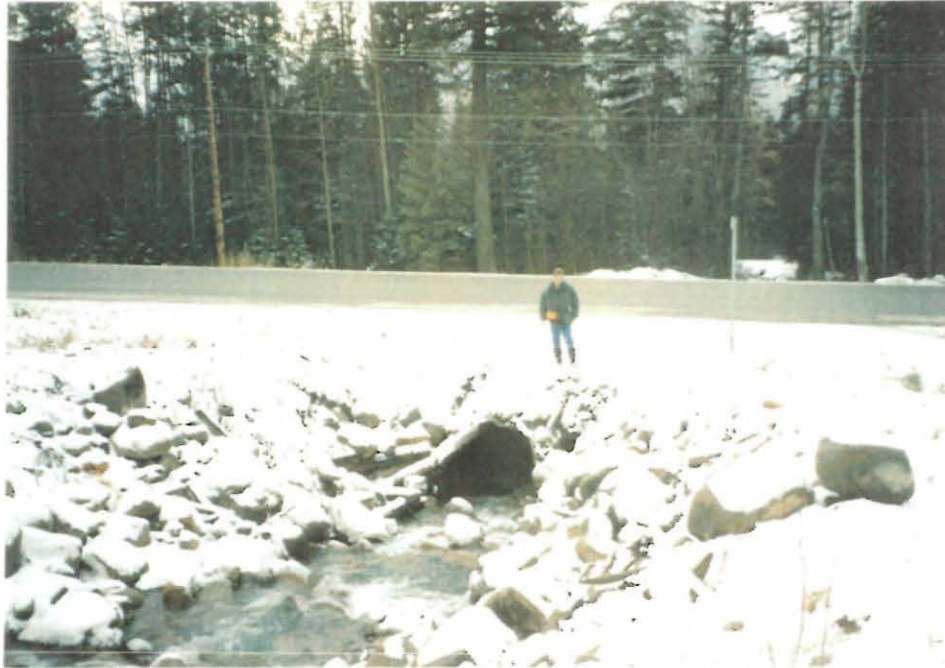
PHOTOGRAPH 1: (Spittal Creek, Nov. 17, 1998): Metal Culvert (1500 mm diam.) at Highway 16.

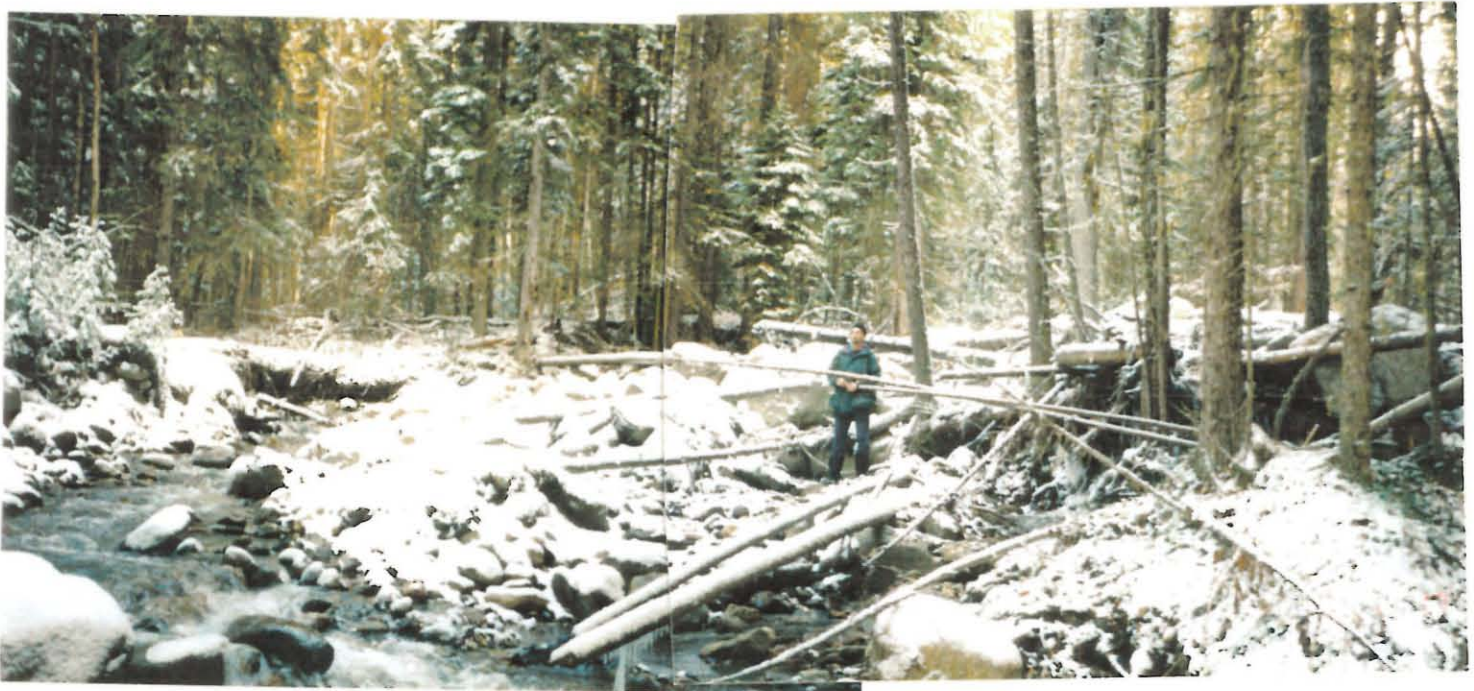
PHOTOGRAPH 3: (Spittal Creek, Nov.17, 1998): Stream Section 2 deposition area located at approximately 560m upstream from Hwy. 16. Transported boulders to 2m diameter.

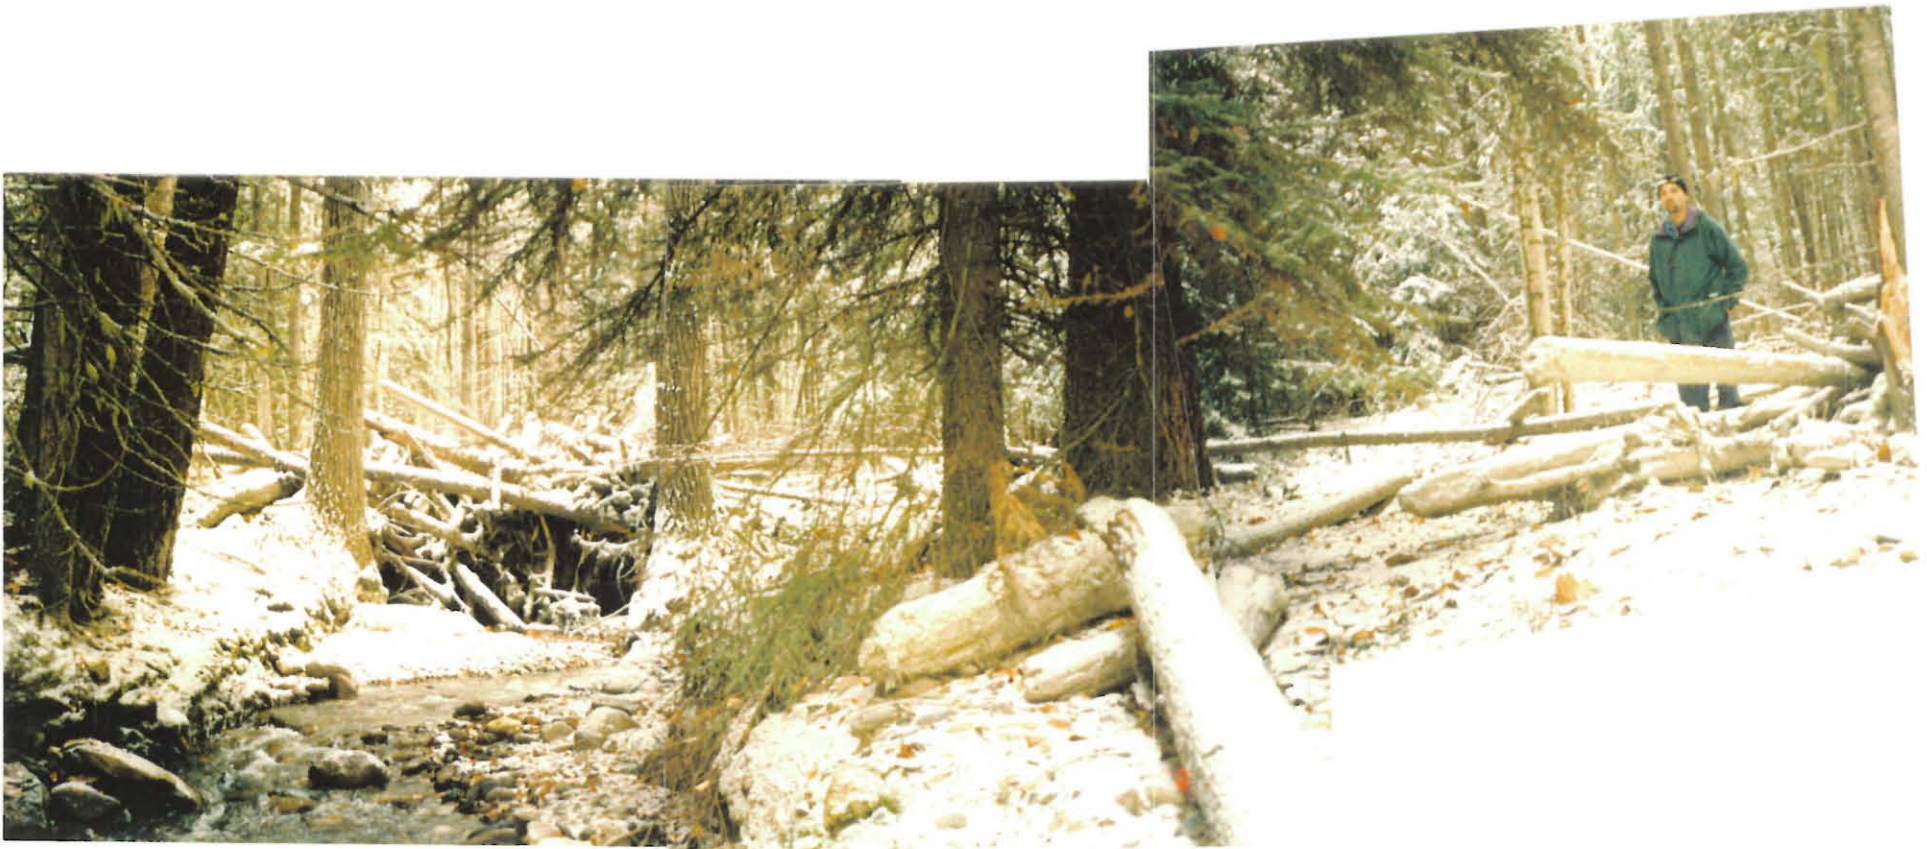
PHOTOGRAPH 2: (Spittal Creek, Nov. 17, 1998): Upstream view of stream Section 1 debris jam and overbank deposits located about 160m upstream of the Hwy. 16 culvert.

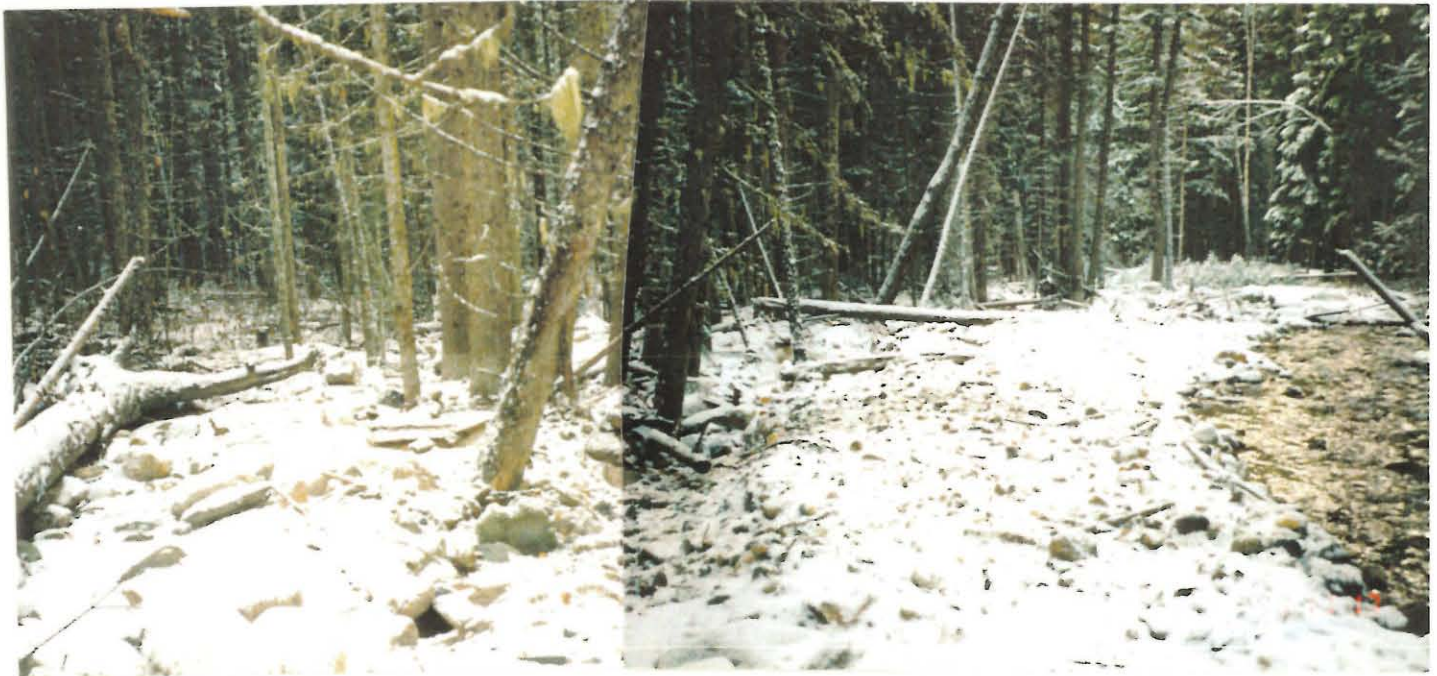
PHOTOGRAPH 4: (Spittal Creek, Nov.17,1998): Downstream view of stream Section 2 deposition area. The photo was taken from the second timber bridge located at 590m upstream of Hwy.16.

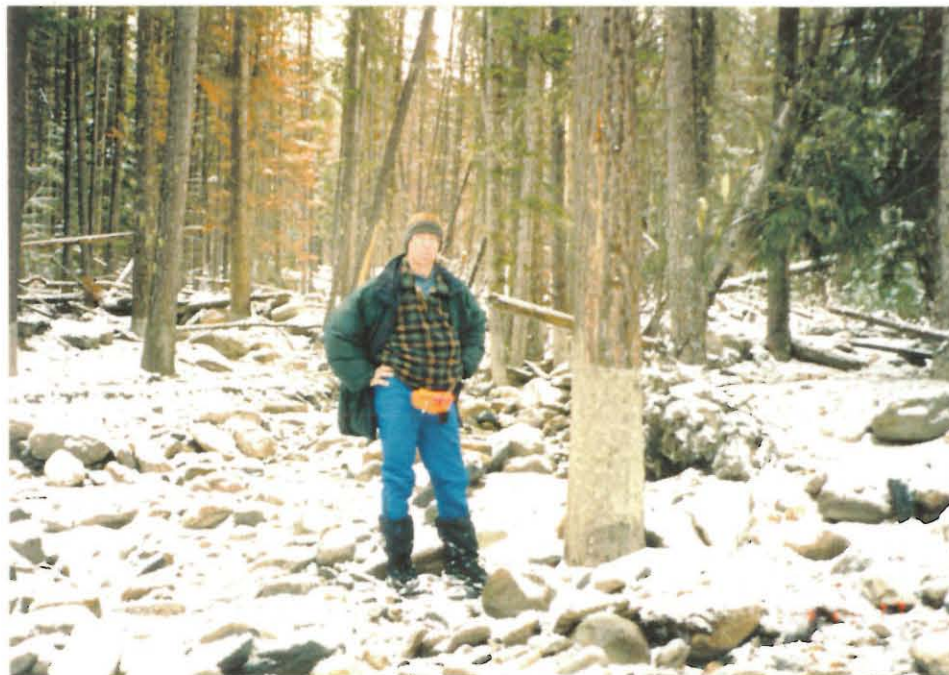
PHOTOGRAPH 5: (Spittal Creek, Nov. 17, 1998): Debris flow wash within 120m wide deposition area of stream Section 3.

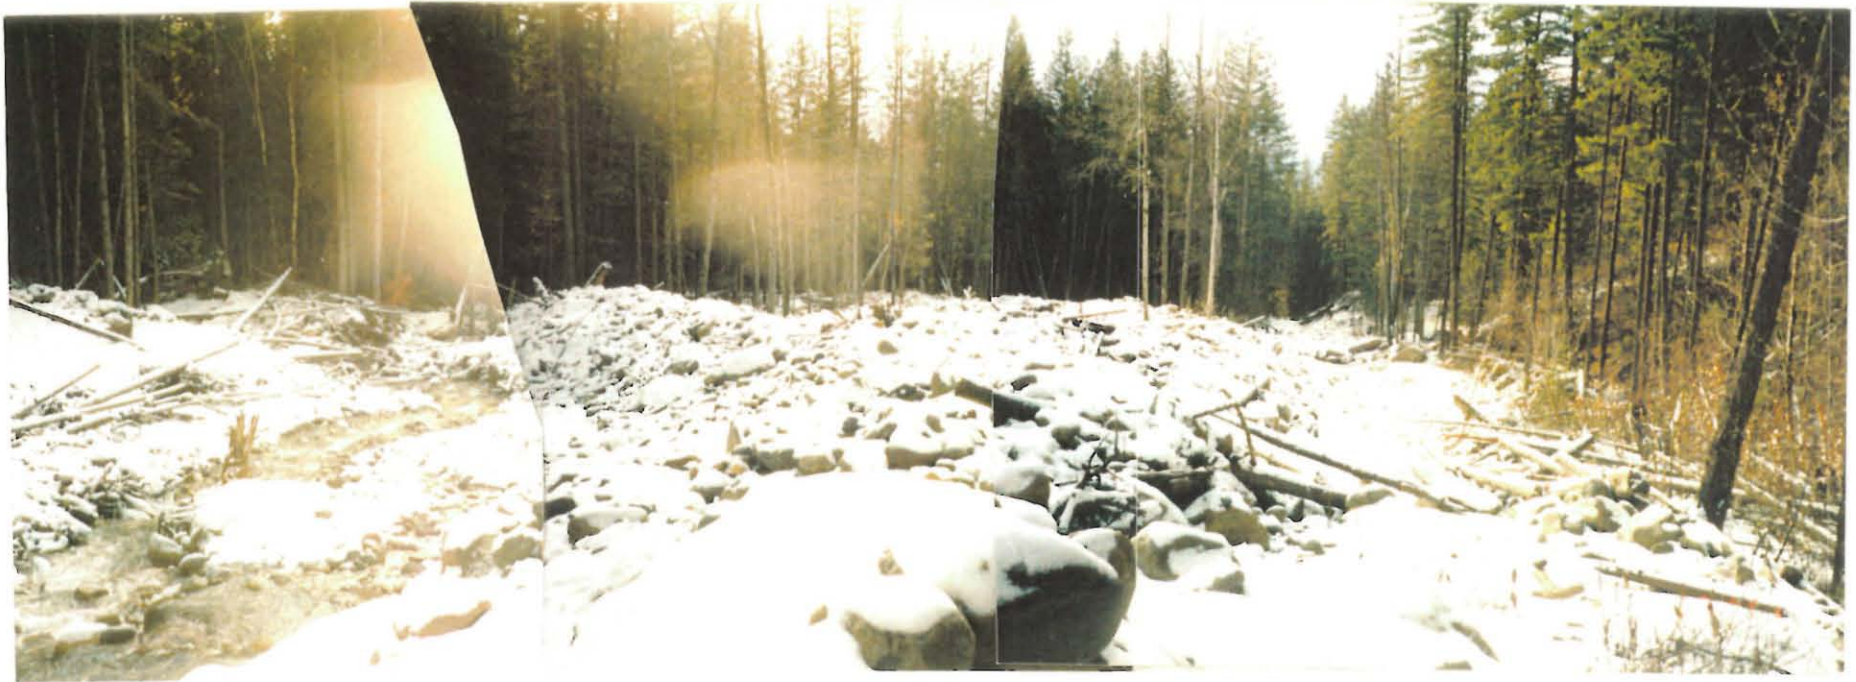
PHOTOGRAPH 6: (Spittal Creek, Nov. 17, 1998): Stream Section 4 deposition area located at approximately 1550m upstream from Highway 16. Existing access road is located along the right side of the photo. Photo is taken looking downstream.

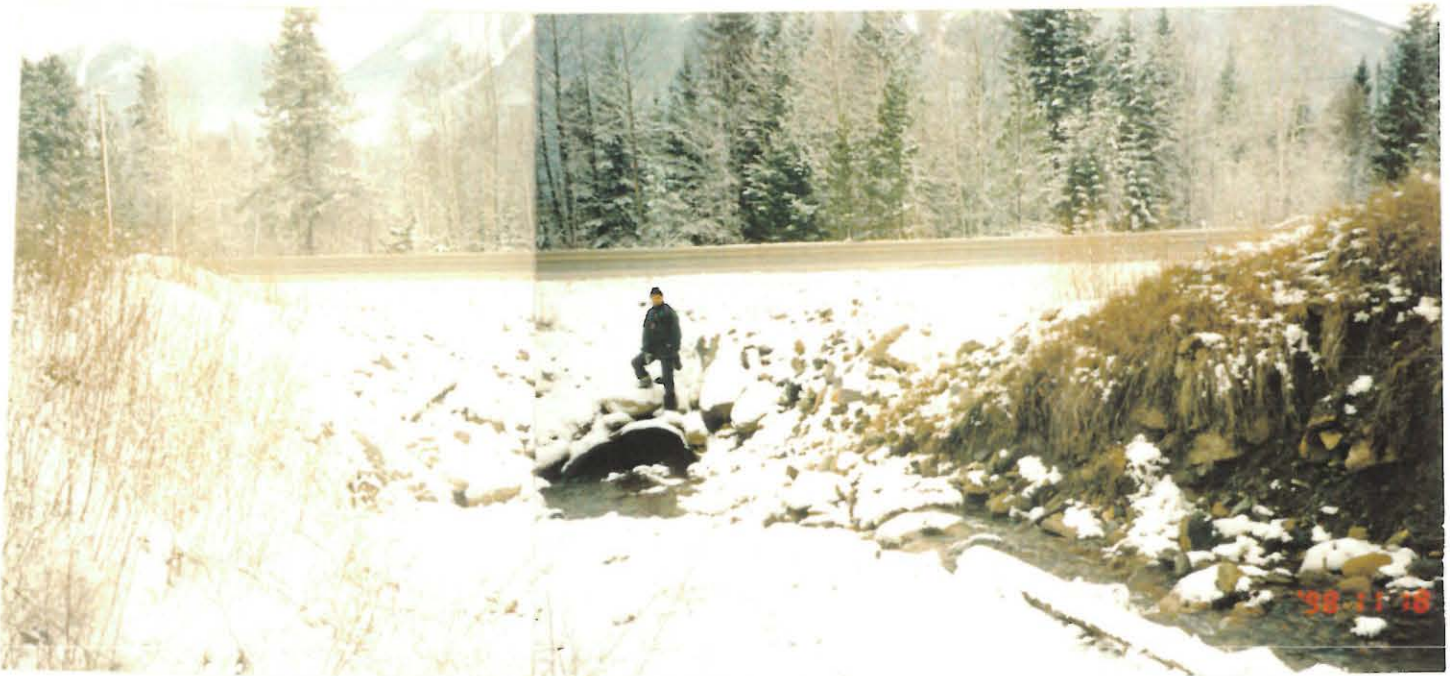
The first stream section (Section 1) initiates at the Hwy. 16 culvert (Photograph 7) and continues upstream for approximately 400 m. Observed channel gradients through this section typically range between 7 and 9 percent and the entrenchment is 1.5 to 3 m. As shown in Photograph 8, a residential structure is located approximately 20 m east of the existing stream channel at an upstream distance of about 200 m from Hwy. 16. Depositional material associated with the 1993 and 1997 debris flow events has flowed around the foundation areas of the structure and through the grassed yard area.

PHOTOGRAPH 7: (Leona Creek, Nov. 18, 1998): Deformed metal culvert (1500mm diameter) at Highway 16.

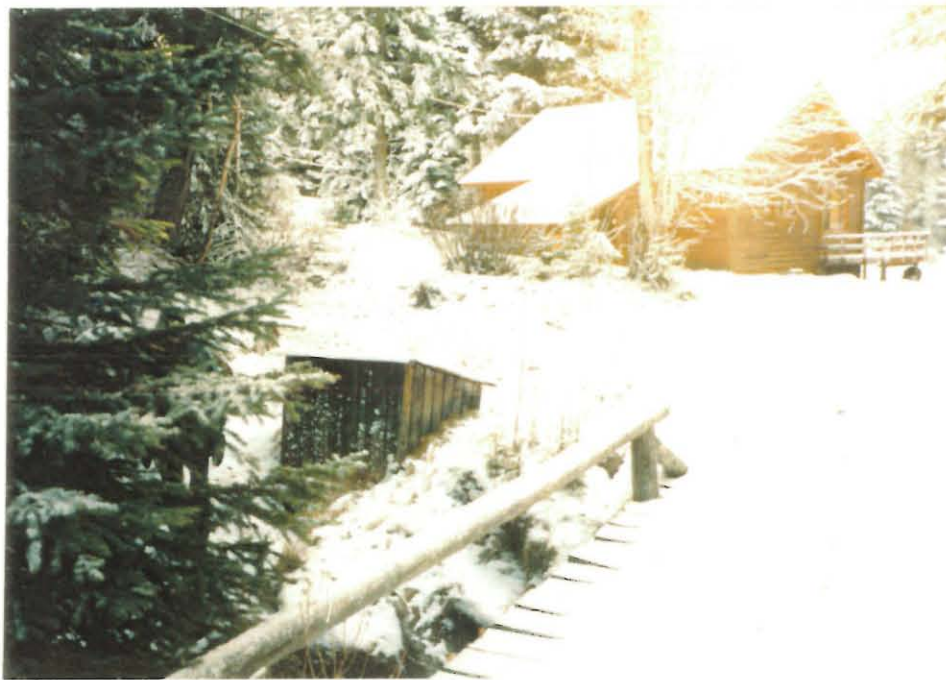
PHOTOGRAPH 8: (Leona Creek, Nov. 18, 1998): Residence located at approximately 200m upstream of Highway 16 and offset 20m east from stream.

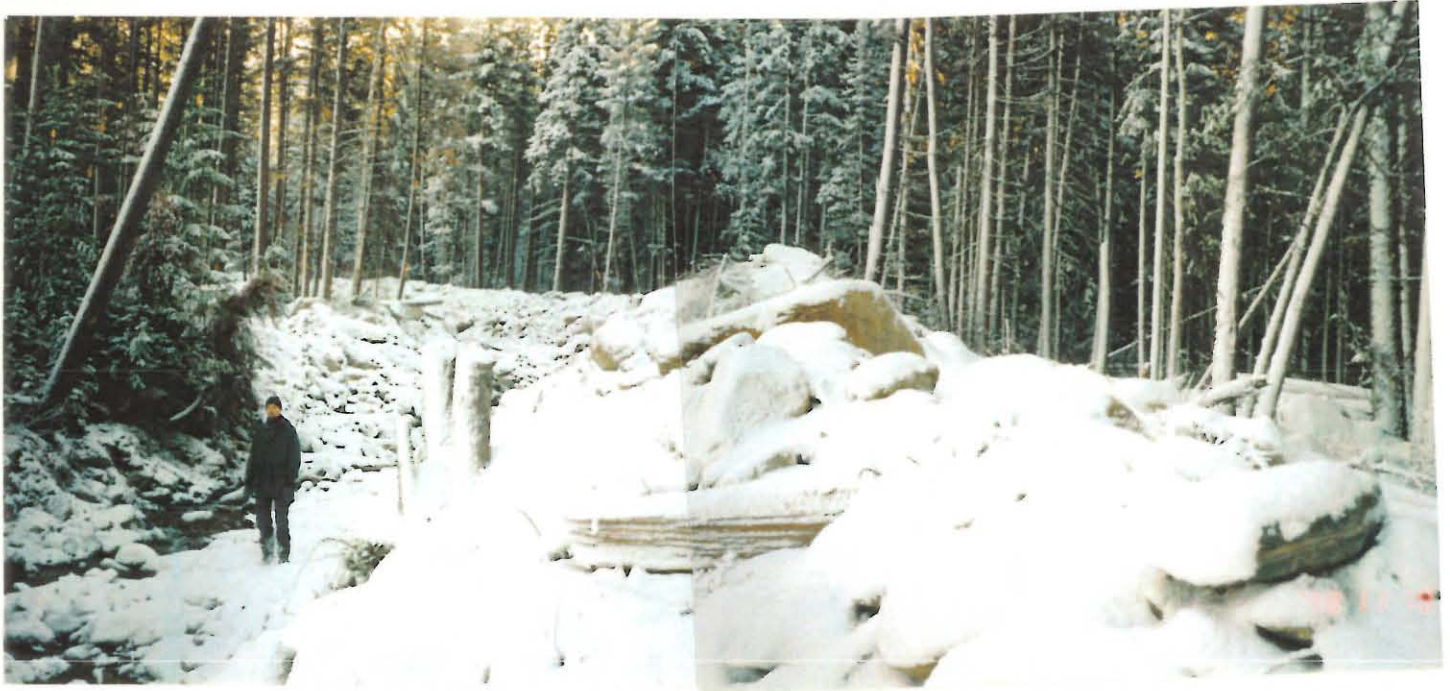
PHOTOGRAPH 9: (Leona Creek, Nov. 18, 1998): Rechannelized (July 1997) stream section within “S-Turn” area at 450-550m upstream of the Highway 16 culvert.

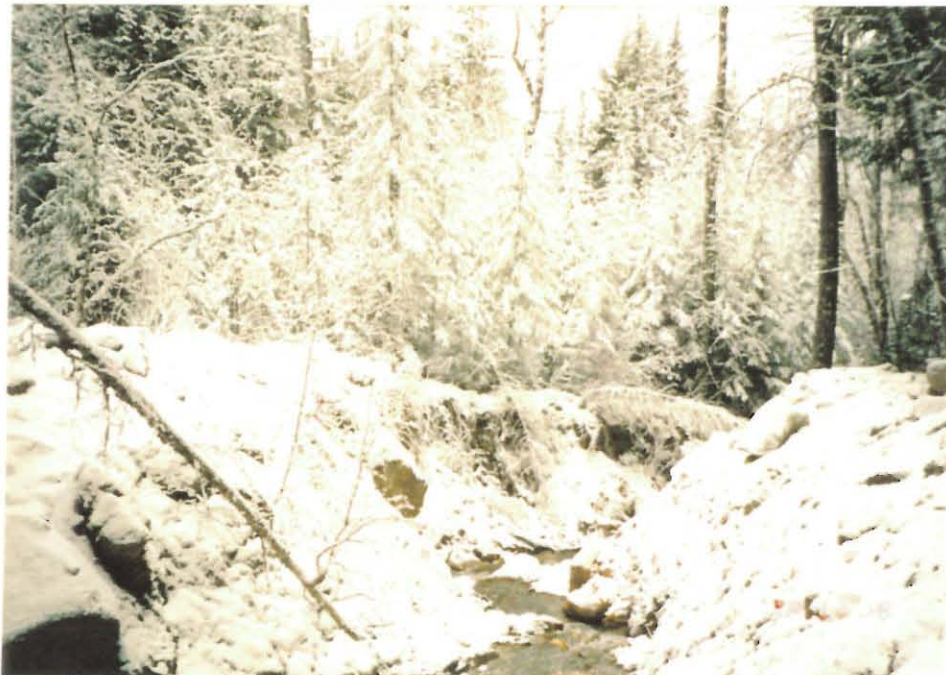
PHOTOGRAPH 10: (Leona Creek, Nov 18, 1998): Sharp channel turn at approximately 1150m upstream of Highway 16. Note overbank timber destruction from previous debris flow event.

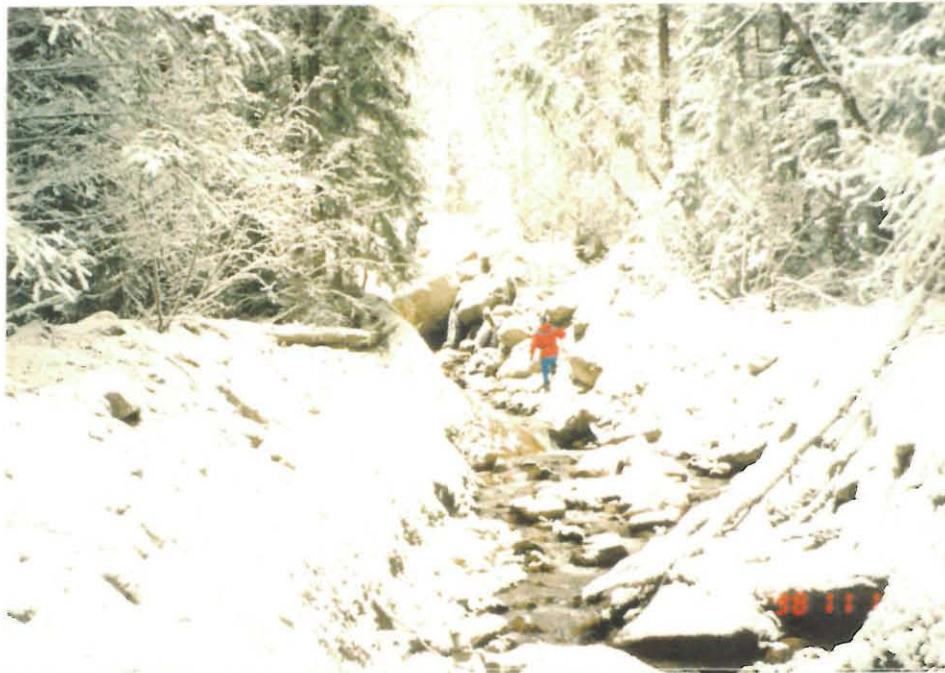
As shown in Photograph 11, boulders with maximum dimension of approximately 4 m were observed in a rock jam located at 1215 m upstream of the highway. Previous berming works through Section 3 were carried out at the breach areas located at distances 750 to 800 m and 1260 to 1360 m from the highway. The berming works carried out in these areas has created access roads immediately adjacent to the stream channel.

PHOTOGRAPH 11: (Leona Creek, Nov. 18, 1998): 3m high rock dam comprising boulders to 4m diameter at 1215m upstream of Highway 16.

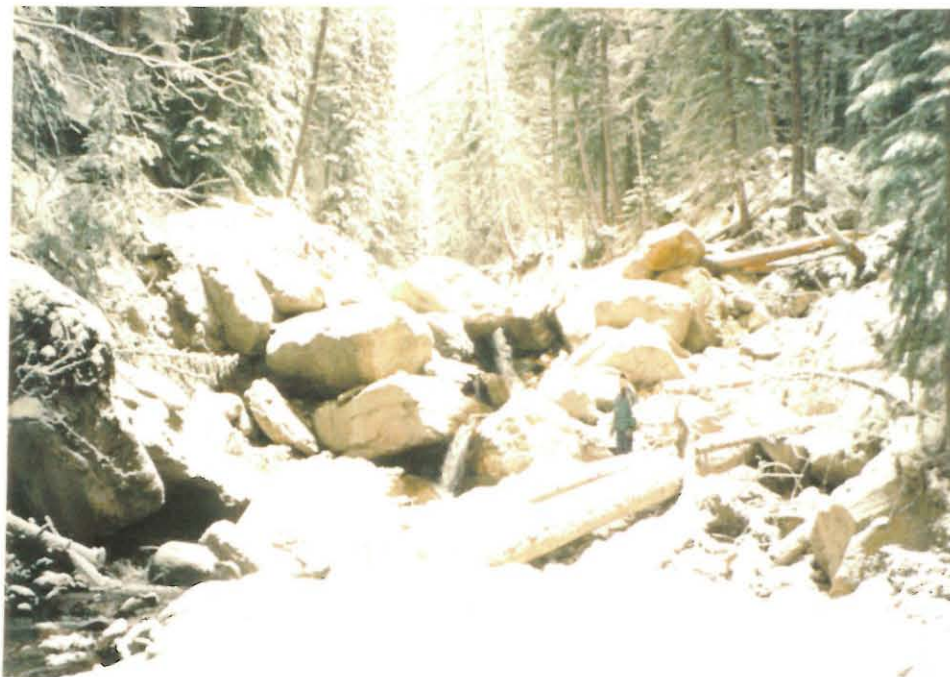
PHOTOGRAPH 12: (Leona Creek, Nov. 18, 1998): 5m high rock dam located at 1465m upstream of Highway 16.

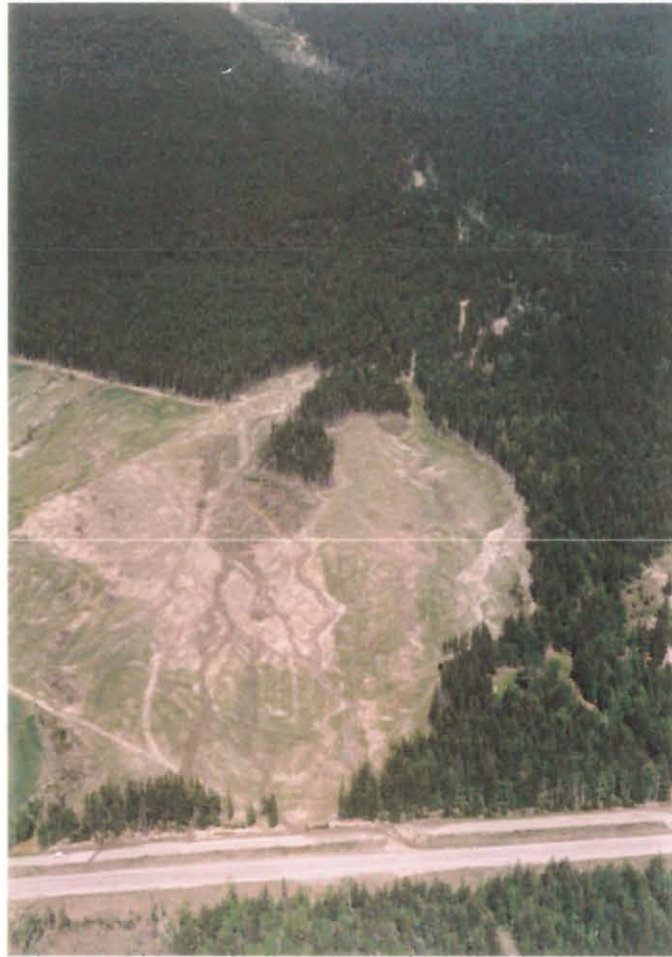
PHOTOGRAPH 13: (Leona Creek, May 1993): Dispersement of flows across agricultural land immediately west of Leona Creek during the May 1993 debris flow event.
