Re: **Fatal Accident – Seabridge Gold Inc. – KSM Project -**

# Report of a Fatality

KSM Project

Seabridge Gold Inc

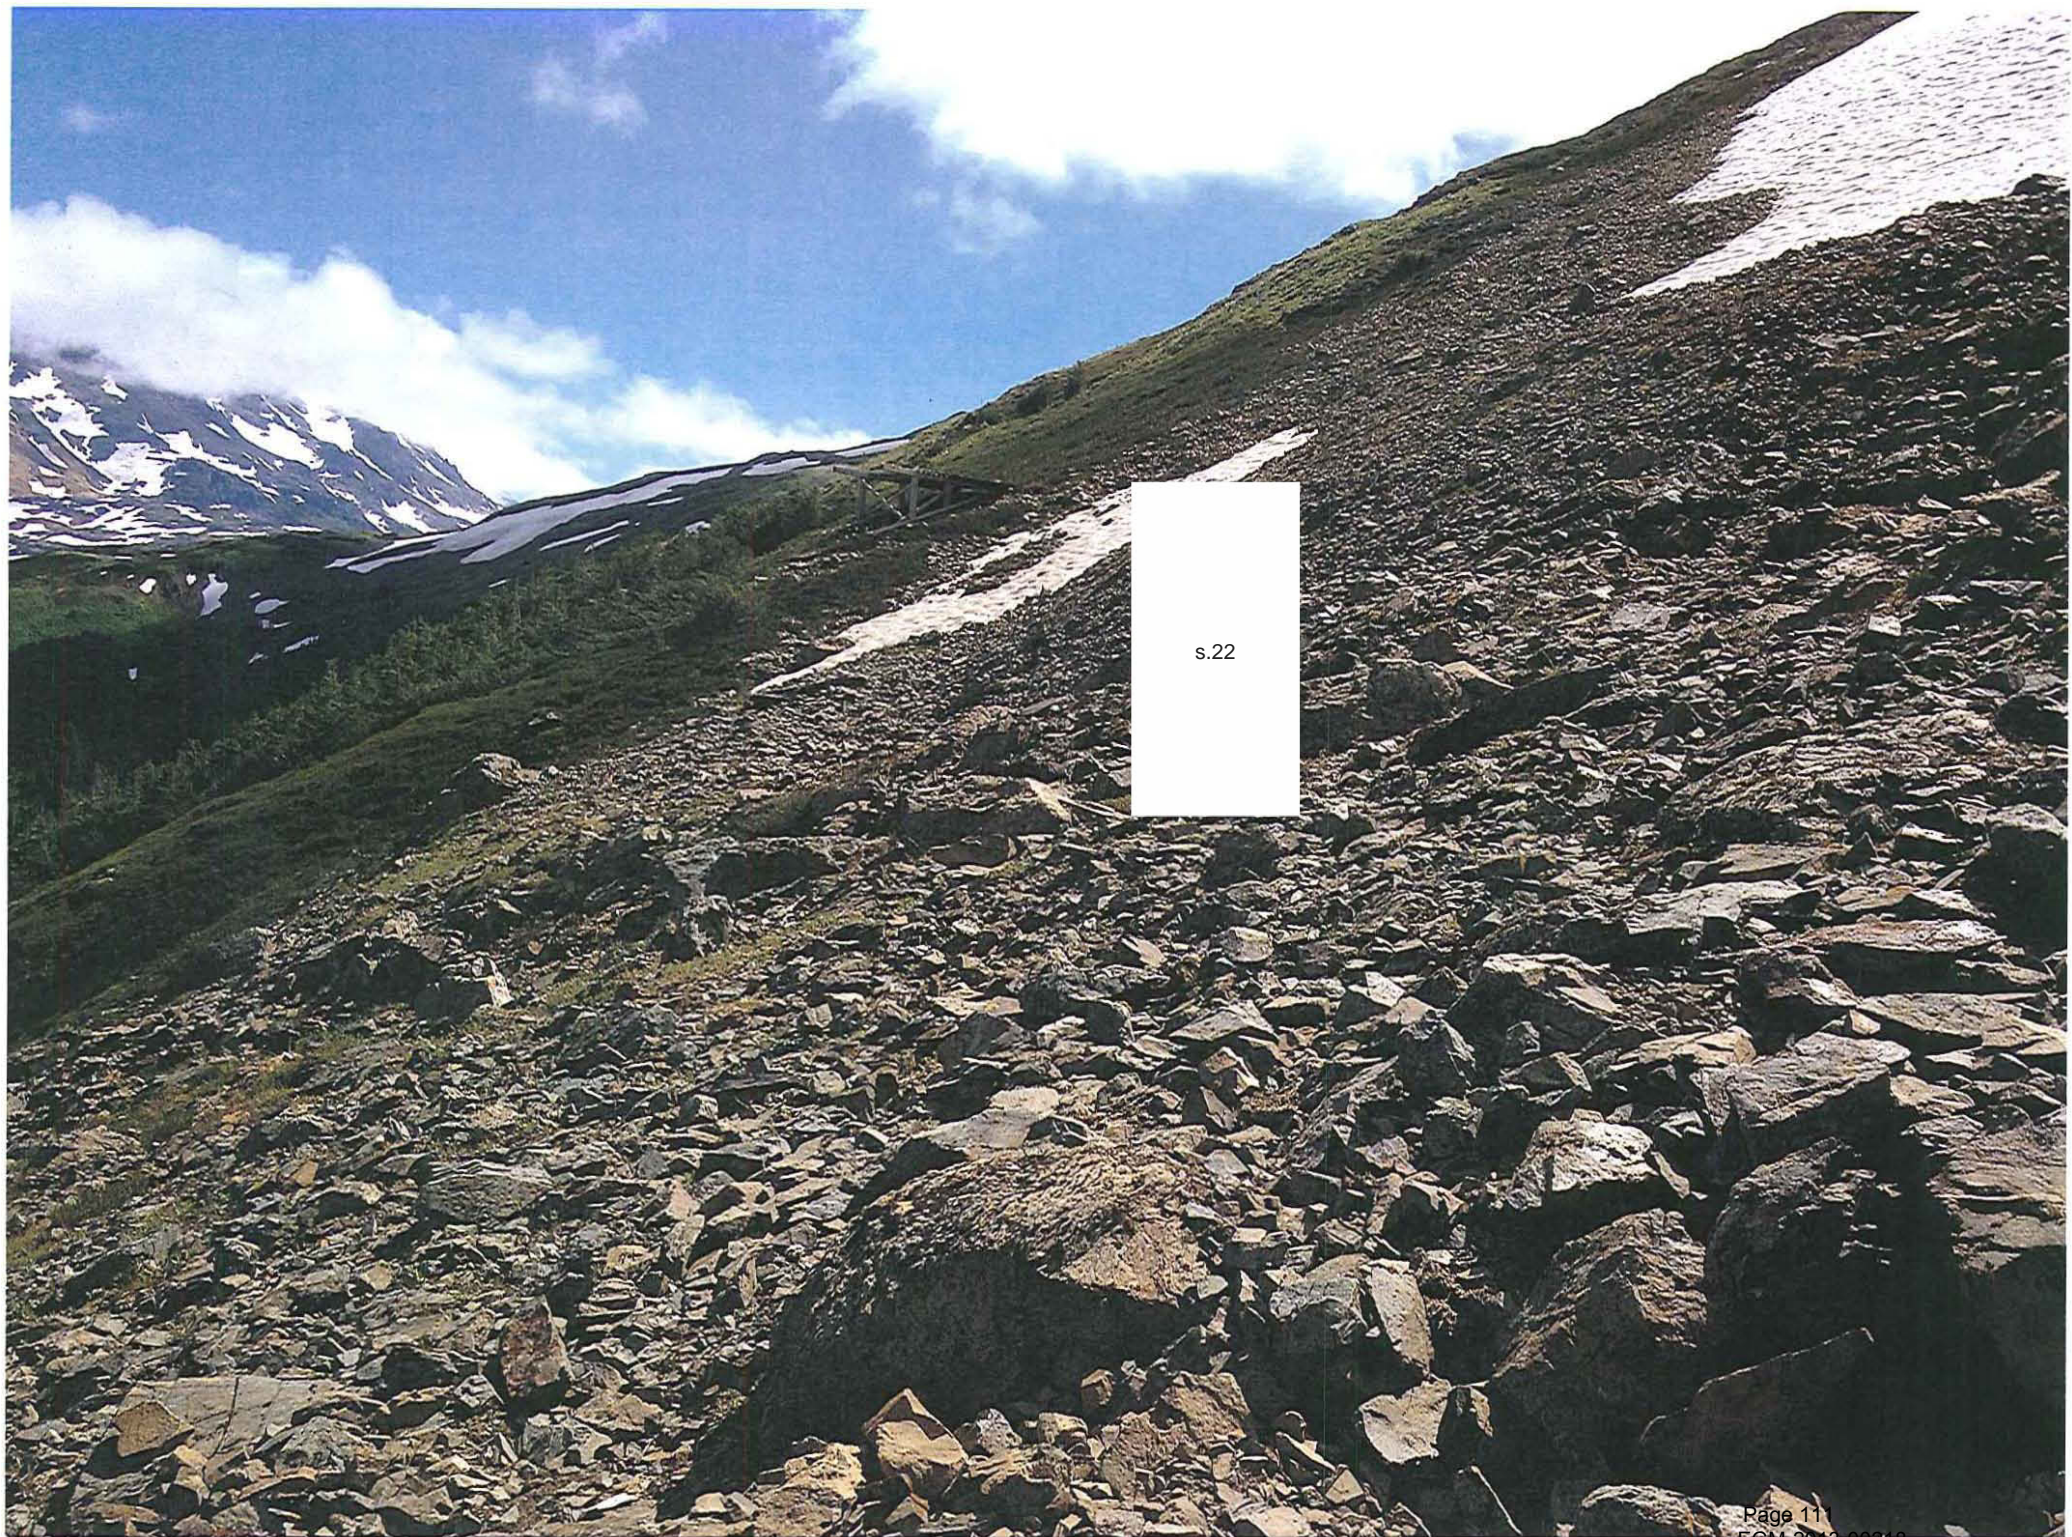
KSM Assessment June 25/2013	Description		
Site ID # Co-ordinates	KSM_ KERR K-13-B 6259900      420900	Geographic	Above Sulpherettes lake below Lower Kerr drill site. N aspect, Elevation 1260m
Hazard (Y)	<ul style="list-style-type: none"> <li>• This site is good to use now but with accumulations of snow would need reassessment.</li> <li>• Expect snow above site to melt in coming weeks leaving good sz talus requiring over 25cm of new snow to reach threshold.</li> </ul>		
Hazard Code	Green	Yellow	Red
Photo #1	<p>Specific close up of work area, landing zone, and terrain affecting site.</p>
