**From:** [Cousins, Autumn EAO:EX](#)  
**To:** [Milne, Andrew EAO:EX](#); [Parks, Chris EAO:EX](#)  
**Subject:** FW: Avalanche Risk Zoning Report  
**Date:** Saturday, April 18, 2015 12:28:34 AM

This work was completed by Dynamic Avalanche Consulting Ltd. (DAC) on behalf of Pheidias Project Management Corp. (Pheidias), who is providing resort development services to Glacier Resorts Ltd. The work presented in this report is intended for the exclusive use of Pheidias and Glacier Resorts Ltd. (GRL).

**Jumbo Glacier Resort**  
**Day Lodge and Service Building**  
**Overview Map**

**Jumbo Glacier Resort**  
**Day Lodge and Service Building**  
**Snow Avalanche Risk Zoning Map**

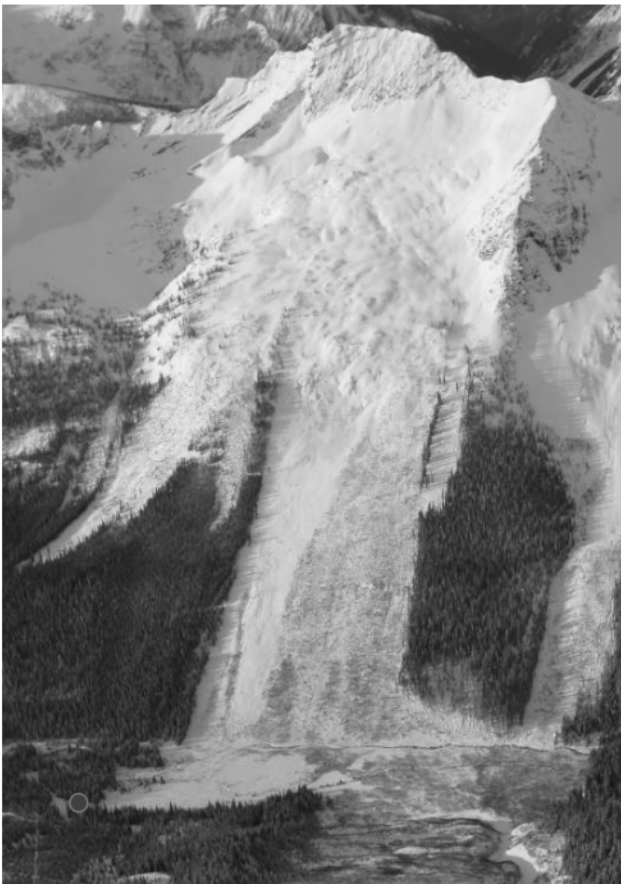
**Figure 4.** Pink Panther avalanche path. Day Lodge and Service Buildings are located in lower left of photo. Red dot shows the approximate location of the Day Lodge.

The Pink Panther path starts immediately below a narrow ridge, with a starting zone between approximately 2400 m and 2700 m elevation. The starting zone consists of a large, east facing bowl, with a primary starting zone in the northern part of this bowl (upper right of Figure 4). This bowl is wind-loaded with snow due to its orientation to predominantly southwest winds. Slope inclines in the starting zone average 30-40°, with a steeper, rocky headwall in the southern part of the starting zone.

The track consists of unconfined terrain with an average incline of 25°. There are several distinct benches located in the track that serve to slow down avalanches, including a 350 m length of 16-21° terrain. The track includes two small, poorly defined streams, but neither are confined features and do not channelize avalanche flow.

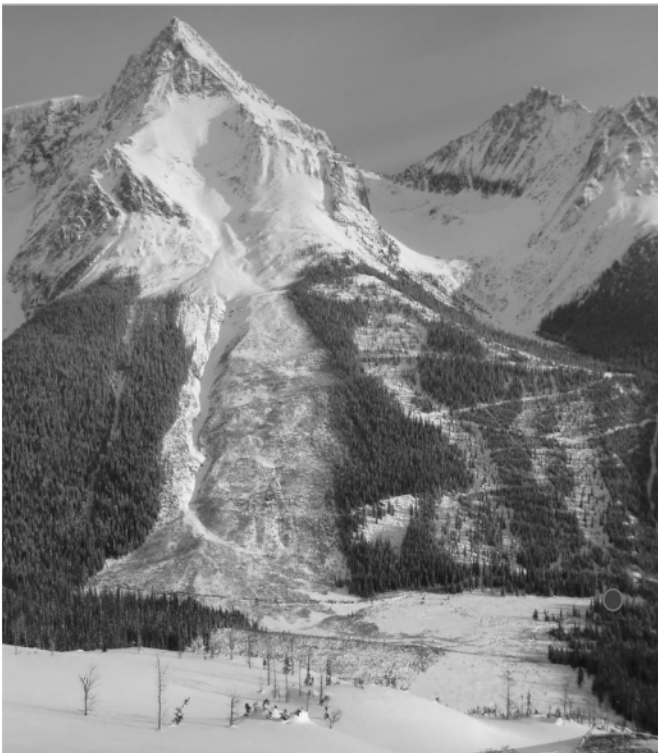
**Figure 5.** Karnak avalanche path observed from Pink Panther path. Red dot shows the approximate location of the Day Lodge.

The Karnak avalanche path is located on the east side of the valley, immediately north of the Pink Panther path. The two paths share overlapping runout zones in the valley bottom. The southern edge (trimline) of the Karnak path is located approximately 350 m north of the Day Lodge. The starting zone for this path is at approximately 2960 m in a well-confined alpine bowl below a steep rocky headwall.

The Karnak path becomes very well confined in a gully that disperses onto a colluvial fan near 2240 m elevation. Below this elevation, part of the path is confined in a gully while the rest is on an open slope approximately 300-350 m wide. The lower track near 1760 m can turn toward the south on a natural deflection berm, while larger dense and powder flows will travel straight and across the valley.

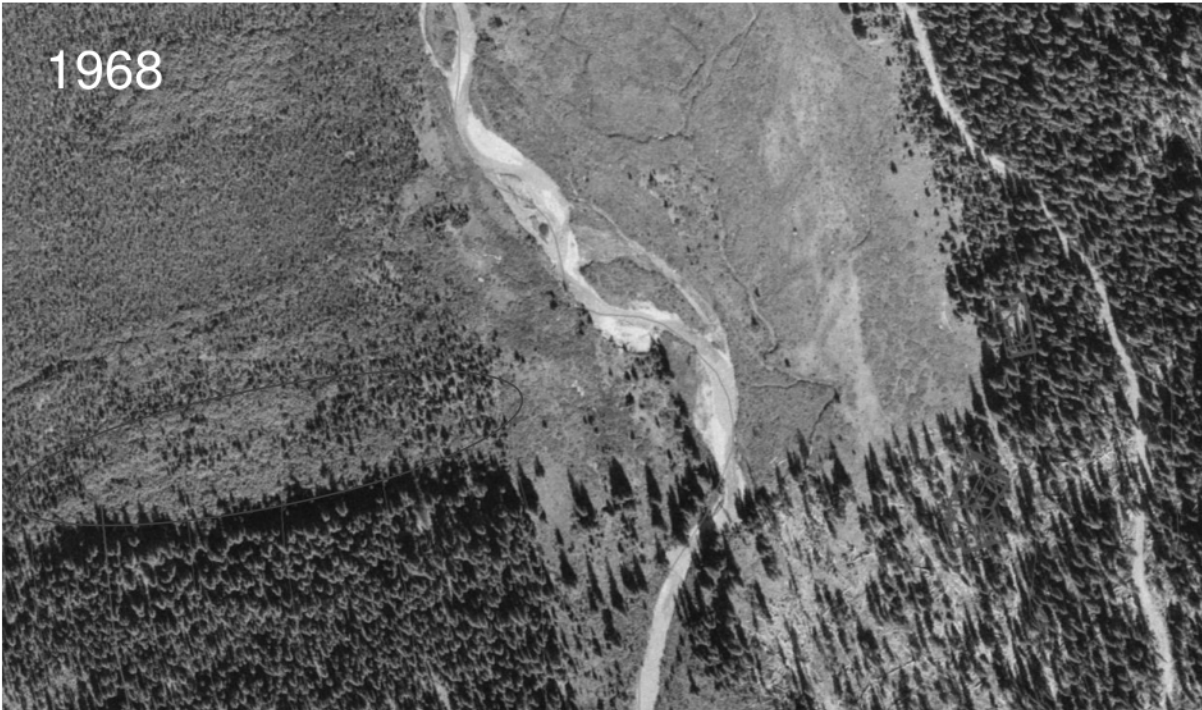
**Figure 6a.** Day Lodge and Service building overlain on the 1968 air photo. Red oval shows area where an avalanche removed forest cover, estimated to have occurred during the 1950's. Note selective logging and random orientation of deadfall in the vicinity of the Day Lodge.

- A large swath of forest along the southern (bottom on photo) trimline of the 1968 photo was removed by an avalanche prior to 1968. Given that the vegetation had already partly re-vegetated in 1968, it is interpreted that this event may have occurred during the 1950's. In 2005, this vegetation had grown in significantly, but the pre-1968 trimline can still be clearly observed and remains a potential avalanche area.

- The forest surrounding the Day Lodge regenerated significantly during 1968-2005. Evidence of large, logged stumps were observed in this area, showing that it had been selectively harvested prior to 1968. The distinct line of mature trees immediately north of the Day Lodge has not been significantly modified by avalanches in the 46 year period since 1968.

- Fallen logs near the Day Lodge can be observed on the 1968 photo, and are distributed in a random manner. If a large, destructive dense or powder avalanche had flowed through this area and knocked over trees, there would be evidence of fallen logs lying parallel to the avalanche flow (i.e. west to east). This implies that no major (i.e. destructive) avalanches had reached the Day Lodge site for a number of years prior to 1968, nor have any reached this location up to 2014 (verified by field observations).

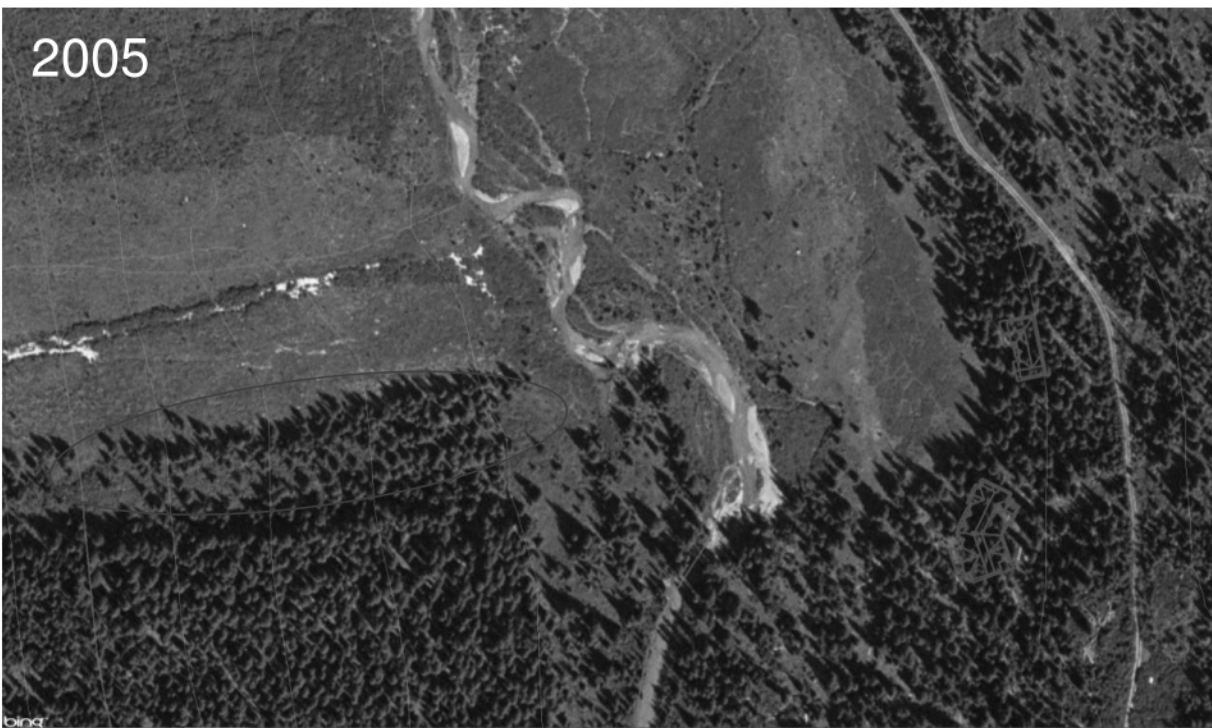
**Figure 6b.** Day Lodge and Service Building location overlain on the 2005 imagery. Red oval shows regenerated forest (trimline) from pre-1968 (estimated 1950's) avalanche event.

- A brown-toned swath of vegetation can be observed in the lower track in the 2005 image. This swath was produced by glading activity to improve the Pink Panther ski run (pers. comm., Andrew Nelson, RK Heliski), not by avalanches or terrain instability.

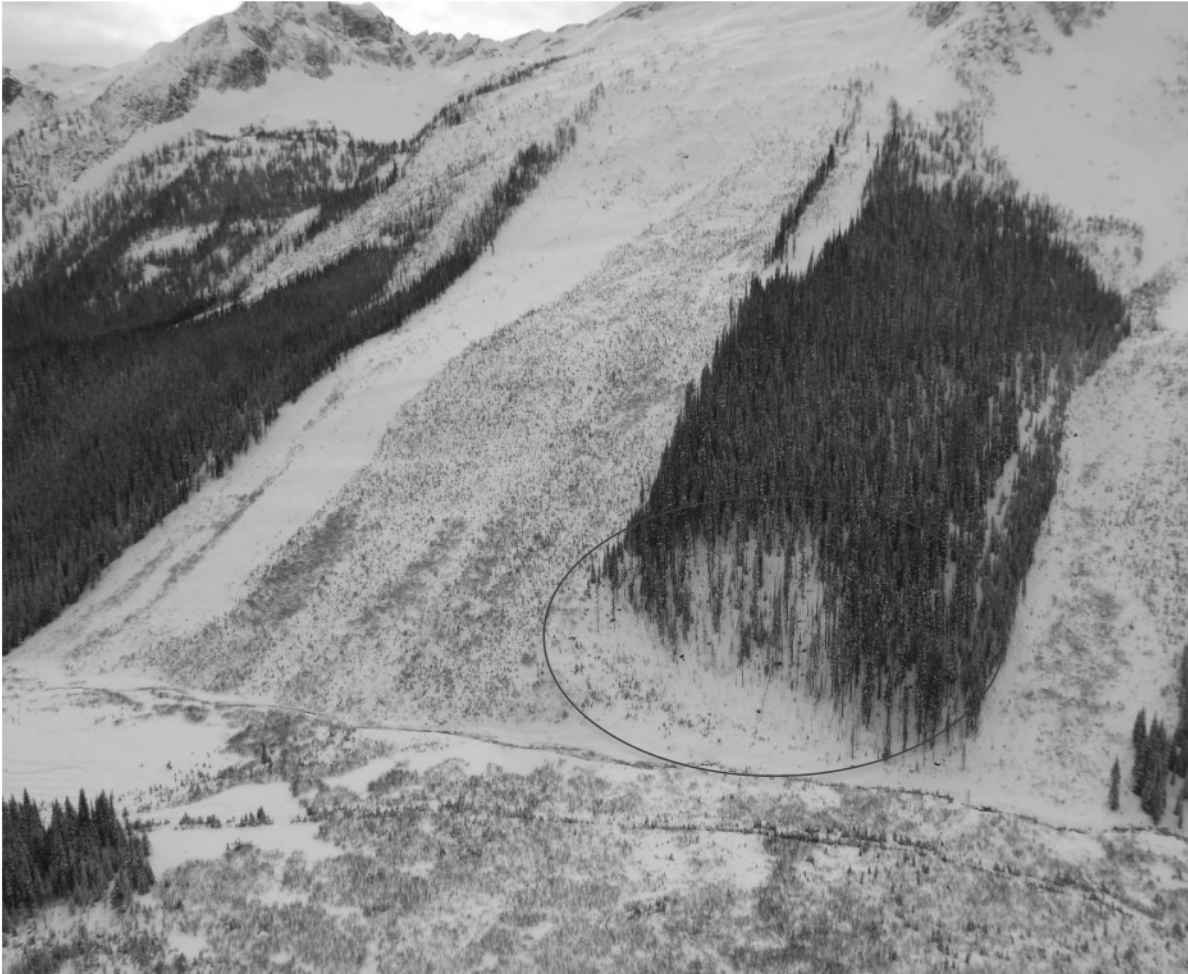
**Figure 7.** Destructive impacts to forest cover adjacent to the Pink Panther path caused by the cross-valley Size 4 explosive-triggered powder avalanche from the Karnak path in February 2013. Pink Panther path is located to the south (left) of red oval.

avalanche in the Karnak path that crossed the valley and impacted forest in the Pink Panther path. Although this event caused significant damage to the forest, there is no evidence in this video, field evidence, air photos or terrain analysis to suggest this avalanche path can turn southwards and flow a significant distance down valley and affect the Day Lodge.

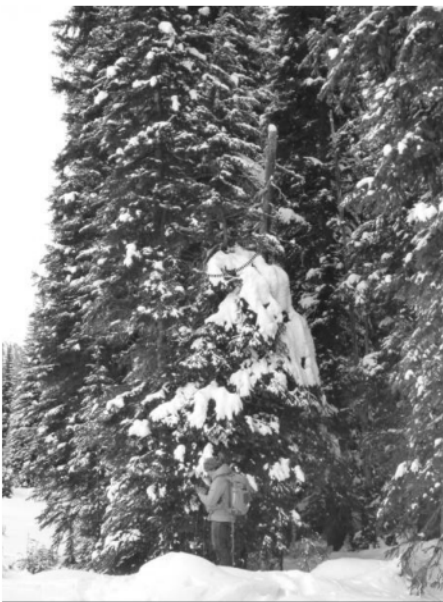
**Figure 8.** Power avalanche impact to a tree located 15 m north of the Day Lodge.

Powder avalanche impacts to vegetation were observed approximately 15 m north of the Day Lodge foundation in the form of a small, snapped tree stem, likely from the 1996 avalanche event (Figure 8). The force from this event was limited, indicating a relatively low impact pressure. However, mature (>100 years) forest the same distance away (Figure 9) to the northwest showed no evidence of avalanche impacts, indicating that the powder flow was light, laterally dispersed flow, and likely not a flow directed at the Day Lodge.

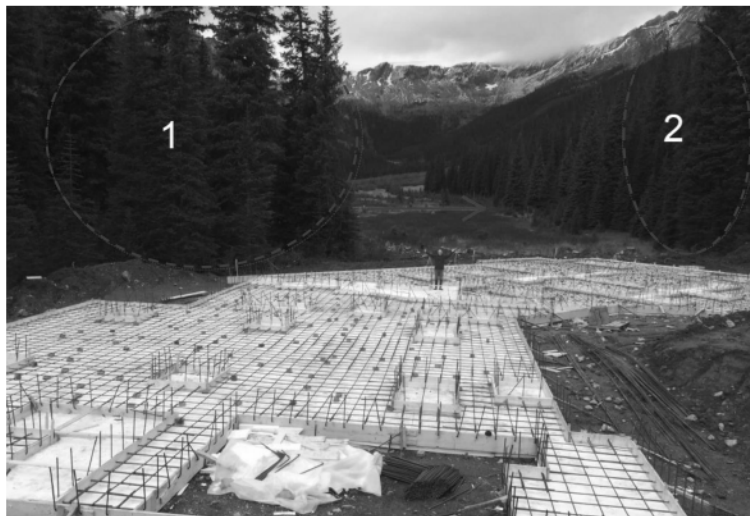
**Figure 9.** Day Lodge construction site. Area 1 indicates a mature forest immediately northwest of the site with no evidence of avalanche impacts. Area 2 indicates area with some powder avalanche impacts (see Figure 8). Red line shows main avalanche flow direction north of Day Lodge.

There was no evidence of dense flow or powder impacts noted at the Day Lodge site during the field investigation, on aerial photographs, or on photos of the site prior to construction. The only evidence of a powder avalanche reaching the Day Lodge was provided by RK Heli (2009) which shows a light powder flow travelling towards and possibly reaching the Day Lodge (Figure 10). Observation of vegetation at the site indicates that the 2009 event did not produce destructive powder effects to the Day Lodge site.
