Seismic Project Identification Report

REPORT NO. SPIR- 39-033

BLOCK #47-1 (1910/12 Classrooms)

Lord Tennyson Elementary School

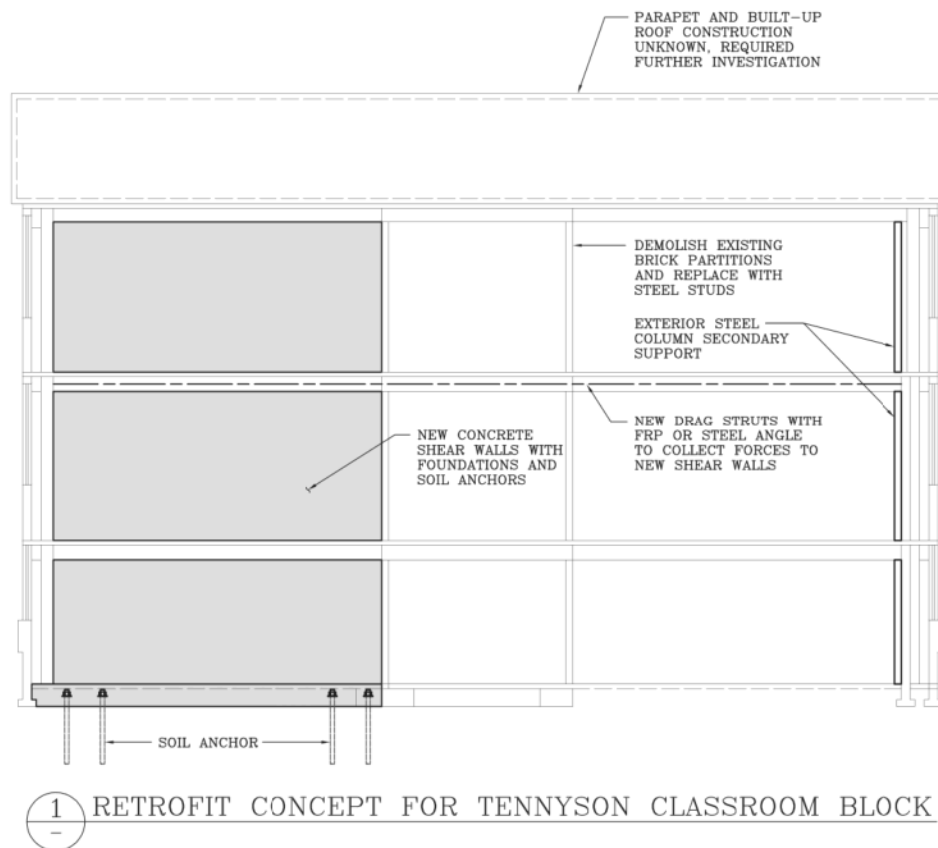
Figure 7.1: Typical Section –

- New concrete shear walls with foundations and soil anchors
- New drag struts to collect diaphragm forces to the new walls and improve on load paths
- Around the perimeter, new steel columns to provide secondary supports in the event of excessive damage of the short columns (because of constraints from basement walls).
- Strong back exterior walls
- New steel stud partitions to replace existing brick partitions where possible, otherwise strong back existing brick partitions.
- New plywood to overlay play area cover and provide connections back to walls in Classroom Block.
- Infill portions of the existing long shaft openings to improve on diaphragm connection.

Comments on Figure 7.1 and Figure 7.2 (Box #7-1)

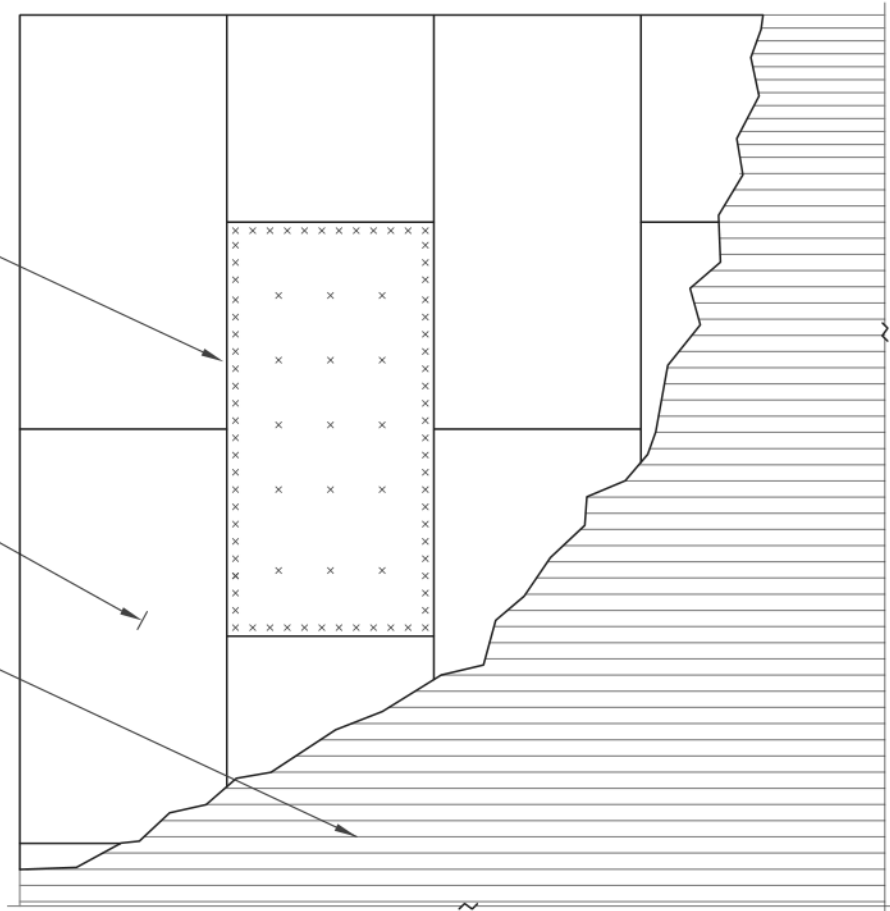
1. ROOF SHEATHING TO BE NAILED WITH 64 NAILS (3.3mm \emptyset). DO NOT USE THIN GAUGE GUN NAILING STAPLES OR NAILS. NOTCHED HEAD NAILS ARE NOT ACCEPTABLE.
2. DO NOT NAIL THROUGH EXISTING JOINTS IN TONGUE AND GROOVE DECKING.
3. STAGGER JOINTS AND ORIENT PLYWOOD PANELS PERPENDICULAR TO DIRECTION OF TONGUE AND GROOVE DECKING.
4. NAIL TO CHORDS, DRAG STRUTS AND SHEAR WALLS

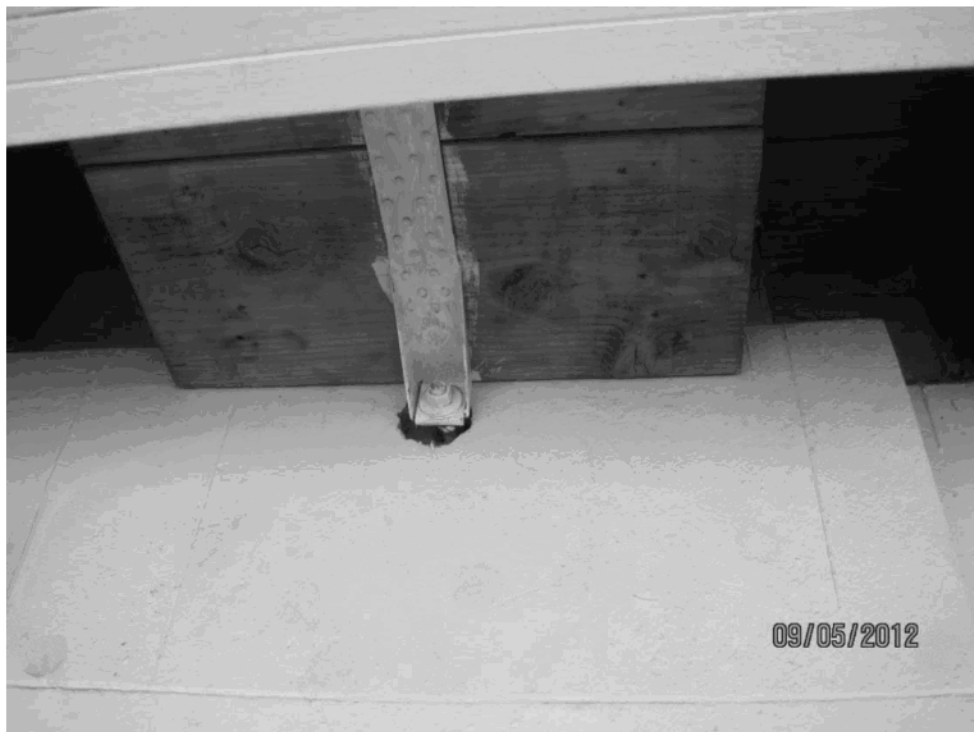
Figure 8: Play Area Cover Attachment to Classroom Wall

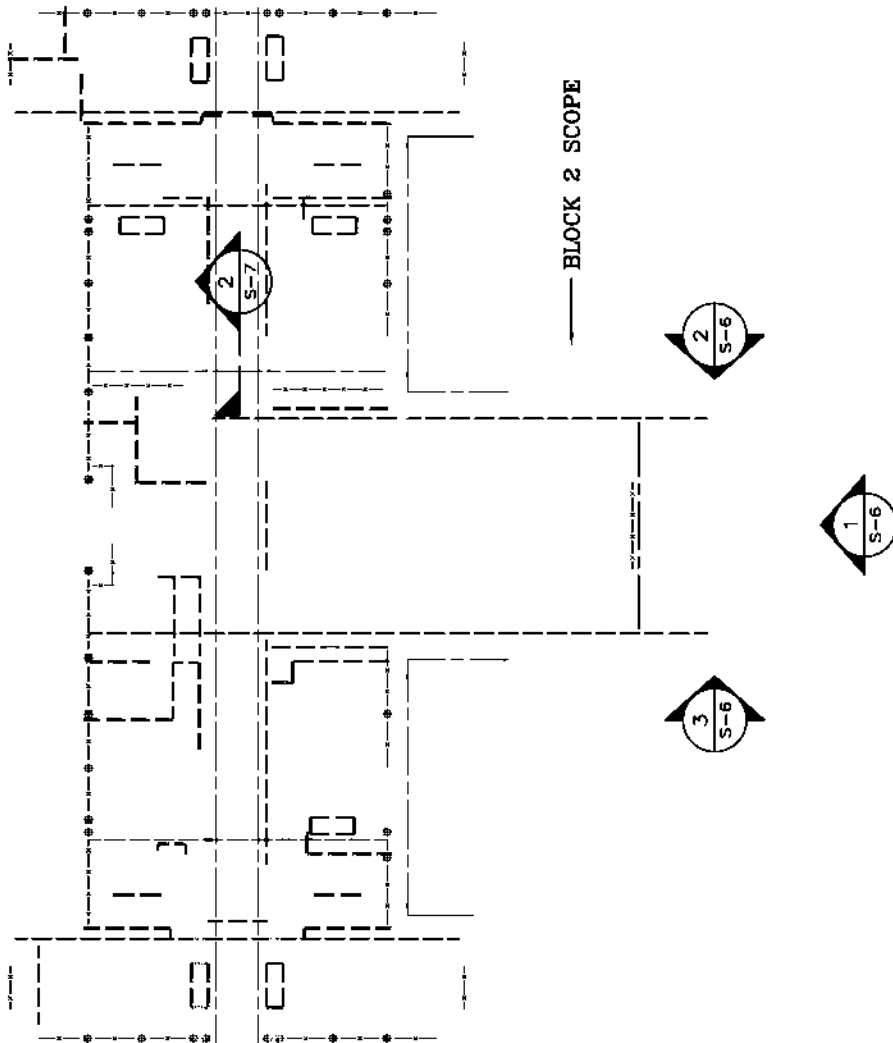
PROPOSED SEISMIC RETROFIT
 CONCEPT FOR MAIN FLOOR PLAN
 SCALE: 1:300

- DENOTES REMOVE EXISTING BRICK SHAFT WALLS AND INFILL SHAFT OPENINGS WITH NEW CONCRETE SLAB (SEE DETAIL 4/S-7)
- DENOTES NEW 300 THICK CONCRETE SHEARWALLS ON EXISTING BRICK/CLAYTILE WALLS
- DENOTES NEW 400 THICK CONCRETE SHEARWALLS ON EXISTING BRICK/CLAYTILE WALLS
- DENOTES NEW 450 THICK CONCRETE SHEARWALLS ON EXISTING BRICK/CLAYTILE WALLS
- DENOTES NEW FRP DRAG STRIP U/S OF CONCRETE SLAB. USE COMPOSITE ANCHORS TO PASS THROUGH EXISTING INTERSECTING BEAMS
- DENOTES NEW L152x152x9.5 STEEL DRAG STRUT U/S OF CONCRETE SLAB
- ⊕ DENOTES NEW STEEL COLUMN (SEE DETAIL 3/S-7)
- x--- DENOTES NEW STEEL STRONGBACK SYSTEM (SEE DETAIL 1/S 7)
- DENOTES EXISTING HOLLOW CONCRETE BLOCK/BRICK/CLAYTILE TO BE REMOVED AND REPLACED BY METAL STUD AND DRYWALL
- DENOTES NEW PLYWOOD OVERLAY TO EXISTING ROOF FRAMING

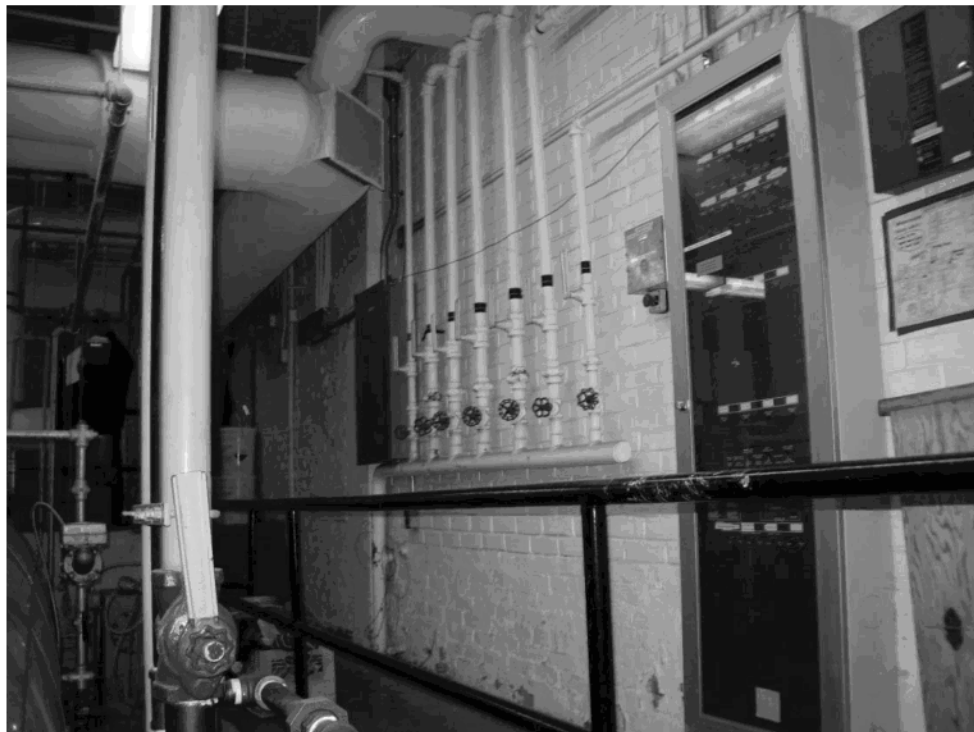
Figure 8: North Wall of Boiler Room

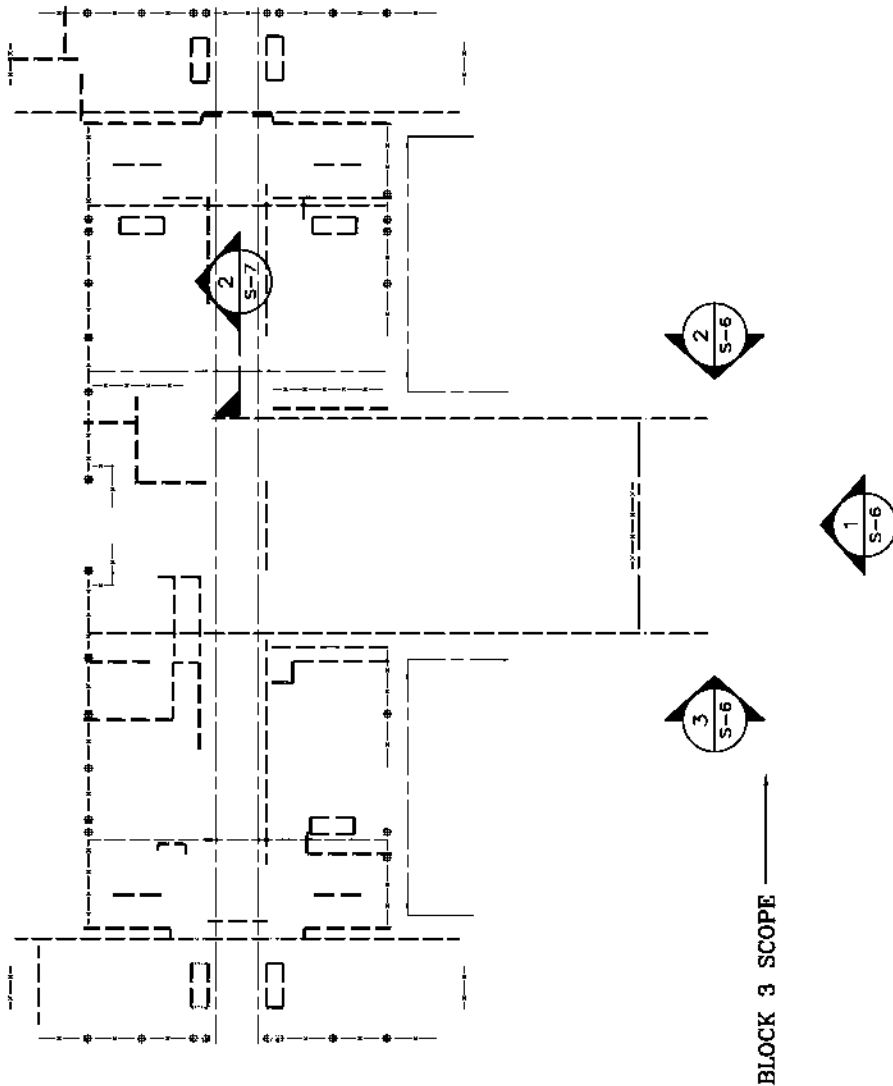
PROPOSED SEISMIC RETROFIT
 CONCEPT FOR MAIN FLOOR PLAN
 SCALE: 1:300

- DENOTES REMOVE EXISTING BRICK SHAFT WALLS AND INFILL SHAFT OPENINGS WITH NEW CONCRETE SLAB (SEE DETAIL 4/S-7)
- DENOTES NEW 300 THICK CONCRETE SHEARWALLS ON EXISTING BRICK/CLAYTILE WALLS
- DENOTES NEW 400 THICK CONCRETE SHEARWALLS ON EXISTING BRICK/CLAYTILE WALLS
- DENOTES NEW 450 THICK CONCRETE SHEARWALLS ON EXISTING BRICK/CLAYTILE WALLS
- DENOTES NEW FRP DRAG STRIP U/S OF CONCRETE SLAB. USE COMPOSITE ANCHORS TO PASS THROUGH EXISTING INTERSECTING BEAMS
- DENOTES NEW L152x152x9.5 STEEL DRAG STRUT U/S OF CONCRETE SLAB
- ⊕ DENOTES NEW STEEL COLUMN (SEE DETAIL 3/S-7)
- x— DENOTES NEW STEEL STRONGBACK SYSTEM (SEE DETAIL 1/S 7)
- DENOTES EXISTING HOLLOW CONCRETE BLOCK/BRICK/CLAYTILE TO BE REMOVED AND REPLACED BY METAL STUD AND DRYWALL
- DENOTES NEW PLYWOOD OVERLAY TO EXISTING ROOF FRAMING

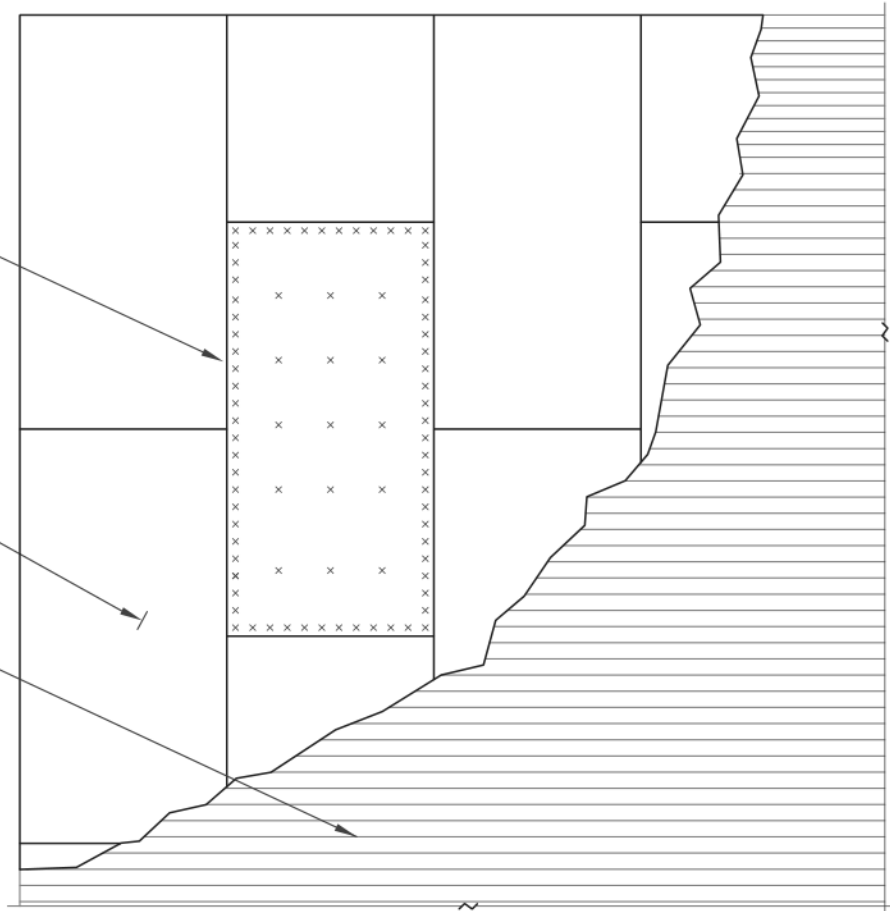
1. ROOF SHEATHING TO BE NAILED WITH 64 NAILS (3.3mm \emptyset). DO NOT USE THIN GAUGE GUN NAILING STAPLES OR NAILS. NOTCHED HEAD NAILS ARE NOT ACCEPTABLE.
2. DO NOT NAIL THROUGH EXISTING JOINTS IN TONGUE AND GROOVE DECKING.
3. STAGGER JOINTS AND ORIENT PLYWOOD PANELS PERPENDICULAR TO DIRECTION OF TONGUE AND GROOVE DECKING.
4. NAIL TO CHORDS, DRAG STRUTS AND SHEAR WALLS
