AGGREGATE EXTRACTION PLAN

Lot 1, Section 16, Range 4, Shawnigan District, Plan 28682

Prepared for: Gordon and Barbara Truswell

Prepared by: Brian M. French, P. Ag.

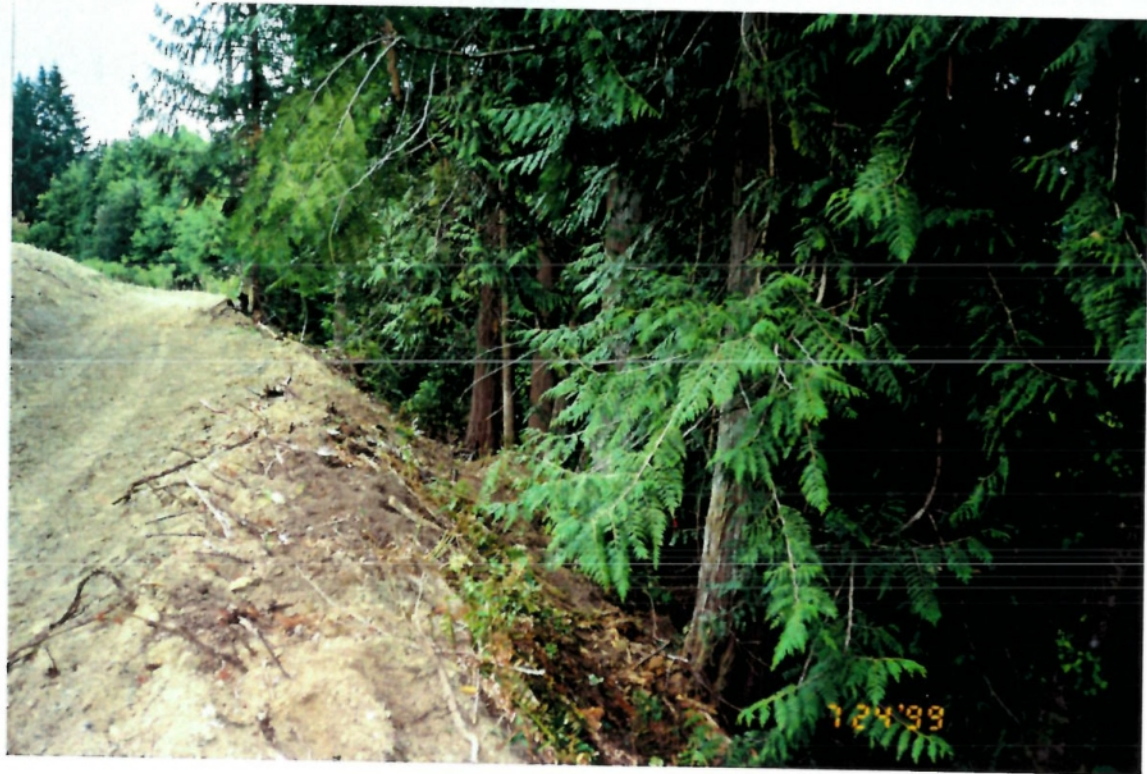
4(b): Access road along east boundary looking north from point within ALR portion

The internal movement of material will be by truck and loader through a service road along the east property line and thence west across the existing pit property and exiting onto Leaside Road. A E&N Railway crossing has been installed at the east end of the access road to allow access to the small landlocked parcel to the east of the tracks. Eventually, the plan is to construct a road around the cultivated area as shown on the drawing.

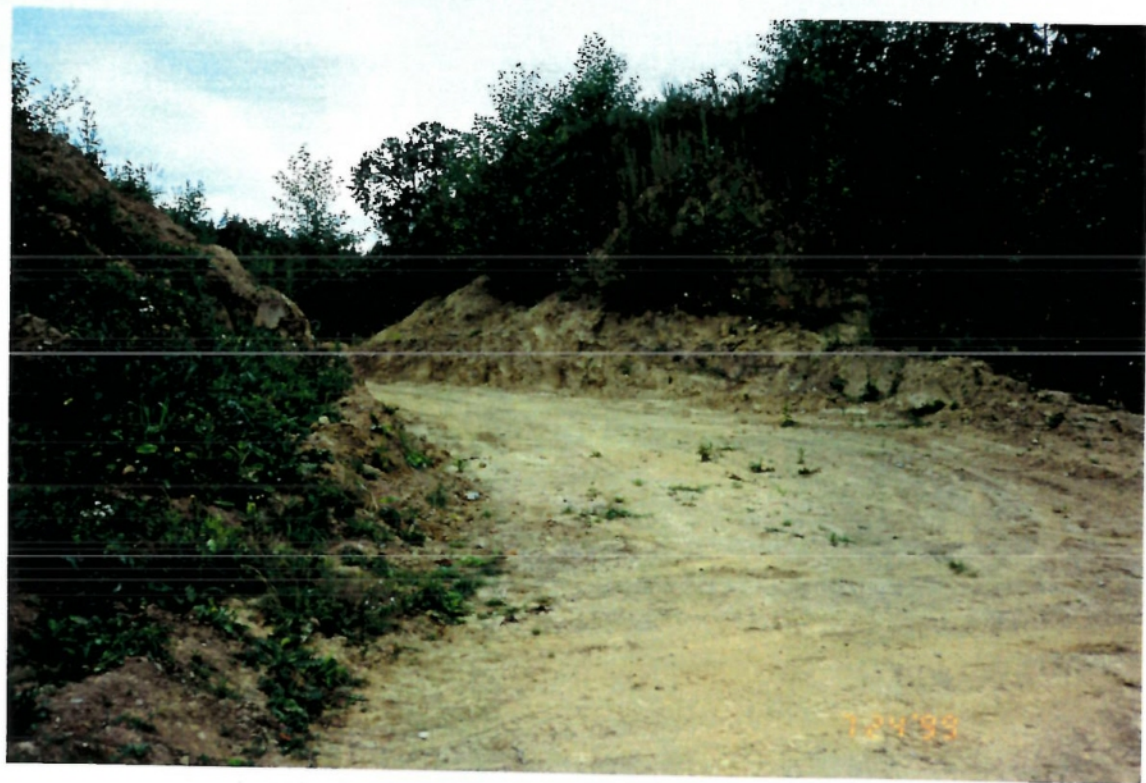
4(c): Access road along east boundary looking north from point near ALR boundary

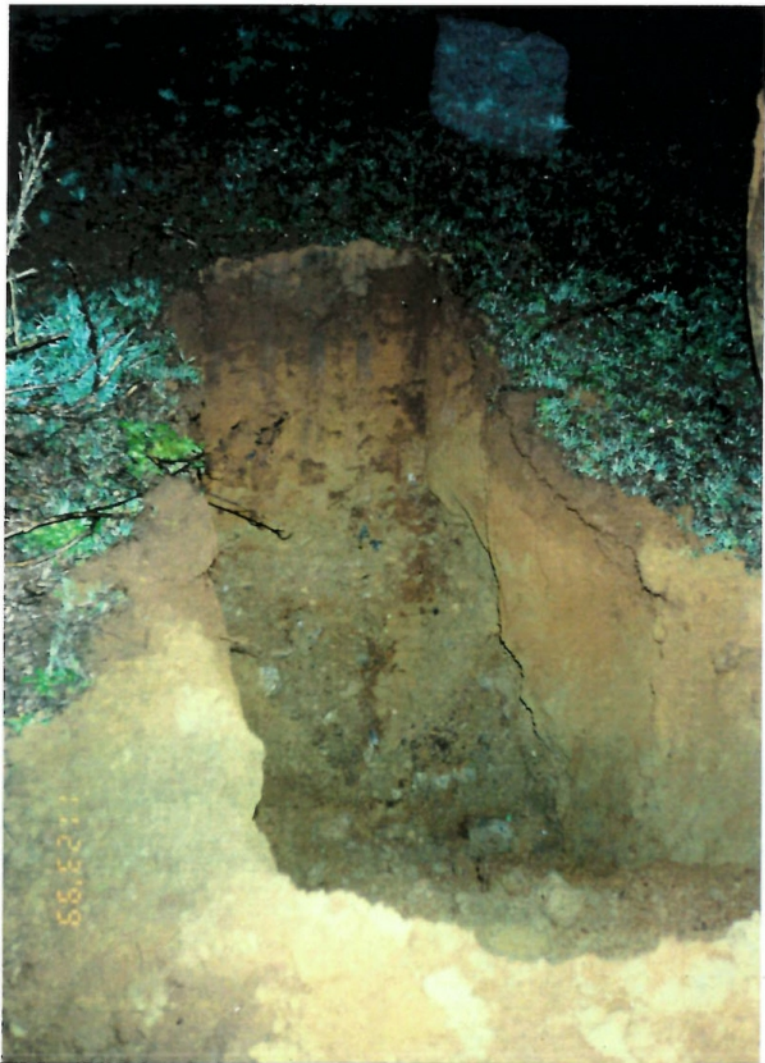
5(a): Soil Pit #1 located within area mapped as Fairbridge series on MOE mapping
Profile is typical of Qualicum series

Two soil types were identified on the property. The dominant soil type was the Qualicum series which occupied the higher landscape locations, mainly in the north, east and west. This soil was characterized by a shallow veneer, 10 to 20cm thick, of aeolian material mixed with the underlying coarse gravels resulting in a surface texture of coarse, very gravelly loamy sand. The soil profile was very gravelly and stony throughout. The soil was rapidly drained with very low water holding capacity. The topography was highly variable and ranged from gently sloping to steeply sloping with slopes 5 to 30%. Vegetation

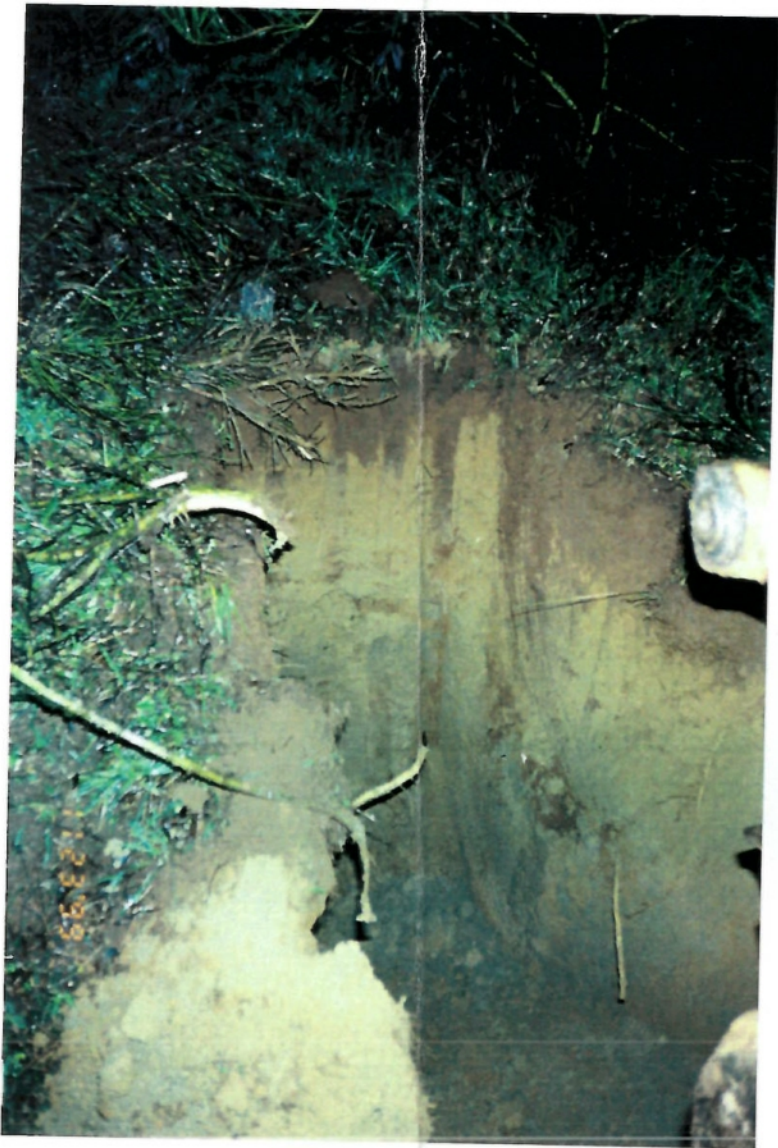
5(b): Soil Pit #2 located within area mapped as Fairbridge series on MOE mapping
Profile is typical of Flewett Series with deep aeolian and slopewash fine sandy loam over gravel

The subordinate soil type was the Flewett series which generally occupied the lower landscape positions. This property is within a transitional landform and the expression of these series is complex at the interface. The surface texture was generally fine sandy loam to a depth between 30 and 90cm. The surface layer ranged from stone free to slightly stony with total coarse fragment content less than 10%. The soil was well drained with small pockets imperfectly drained in locally depressional areas where finer textured materials has accumulated during deposition. The topography was generally more subdued on this unit with slopes 5 to 15%. The vegetation consisted of broom on abandoned cleared areas and mixed Douglas Fir and Alder on the remainder.

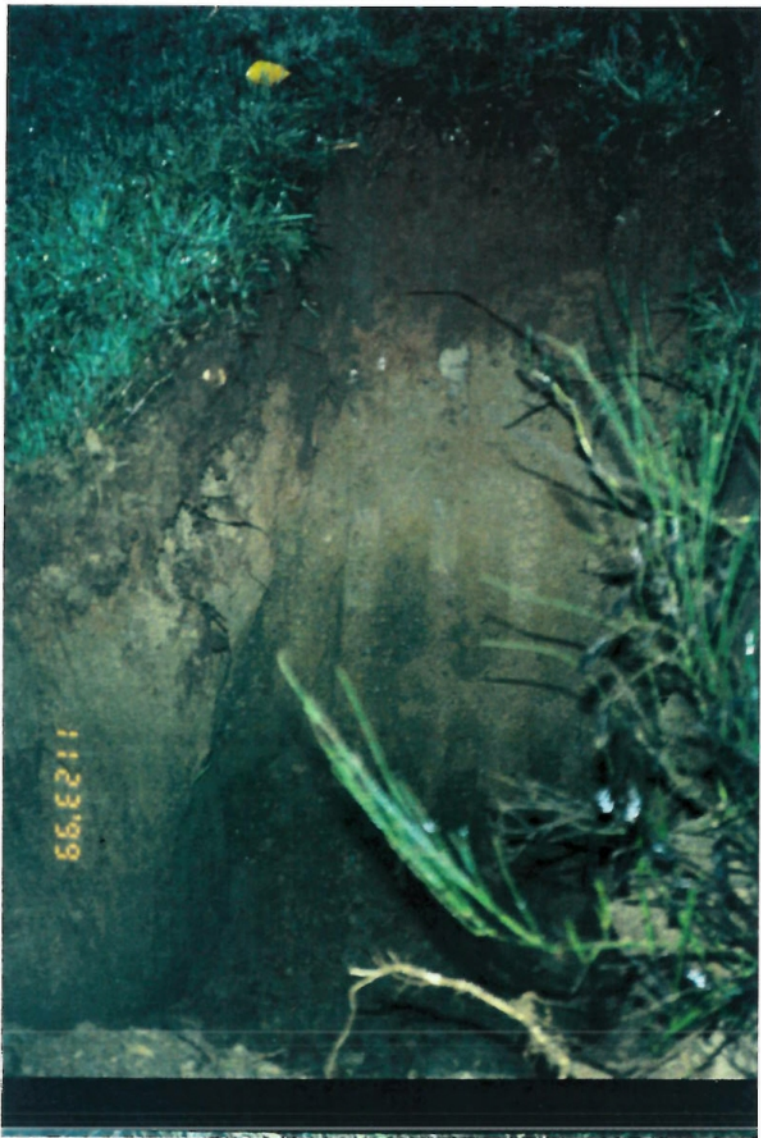
5(c): Soil Pit #3 located and identified as in 5(b) above.
