**KARST FIELD ASSESSMENT
Block SL1 – Skull Lake Area**

CUTTING PERMIT APPLICATION MAP TSL 50650, C.P.F. BLOCK SL1

ROAD RECONSTRUCTION MAP (Map 1 of 2) TSL A50650 BLOCK SL1 & SL1A

**TERRAIN STABILITY HAZARD ASSESSMENT
TSL A50650 – Block SL1
Skull Lake Area**

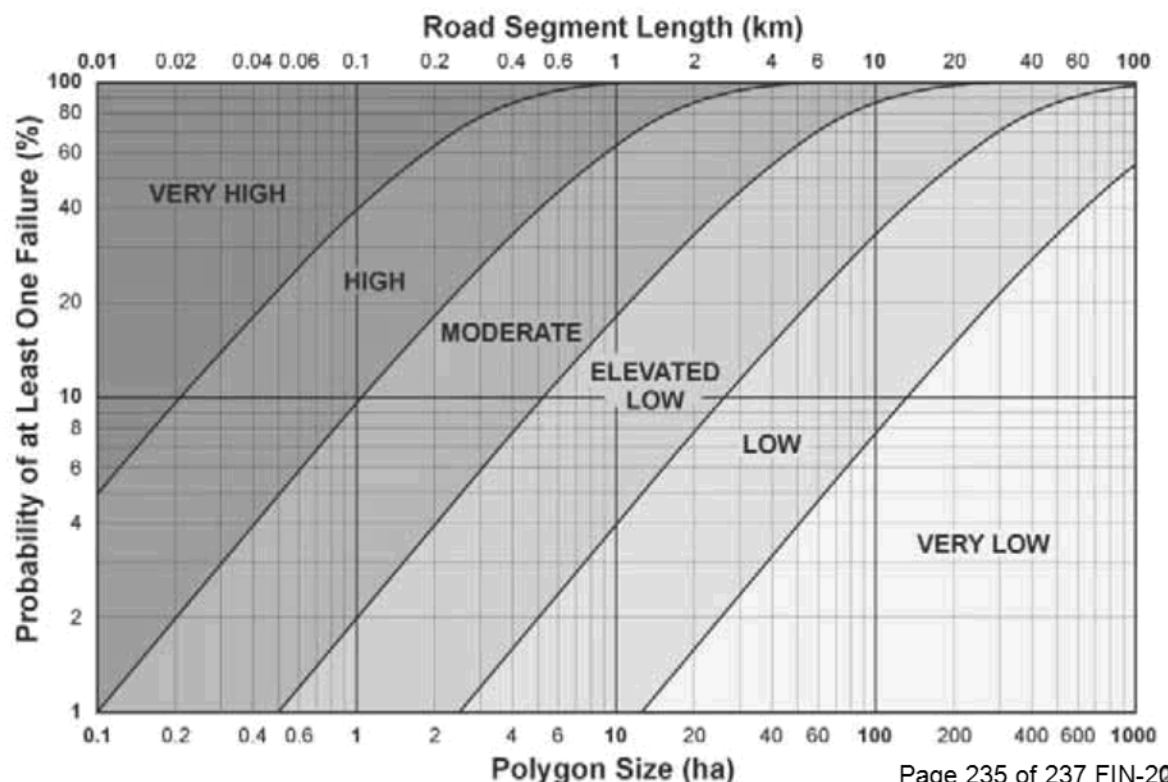
Probability of at Least One Failure

Assuming that the size of the failure initiation surfaces is small in relation to the polygon size, the probability of a specified number of failures occurring within a polygon is related to the size of the polygon by the Poisson distribution. The probability of at least one failure occurring in a polygon is plotted below against polygon size.
