Subject: Text info from SF

RE: Surface Stormwater Quality at Cobble Hill Holdings November 14, 2015; Metals, TSS and Turbidity

Runoff was observed leaving the west boundary of Cobble Hill Holdings quarry site (PR-105809) following a heavy rainfall event November 12 & 13, 2015. Ministry staff were on site to sample and observe conditions on November 14, 2015. At that time, a very low volume trickle was observed leaving the site though it was evident that higher flow was present prior to constructed channeling. The purpose of sampling was to determine whether the subsequent runoff had contacted landfilled material and whether it meets ambient water quality guidelines.

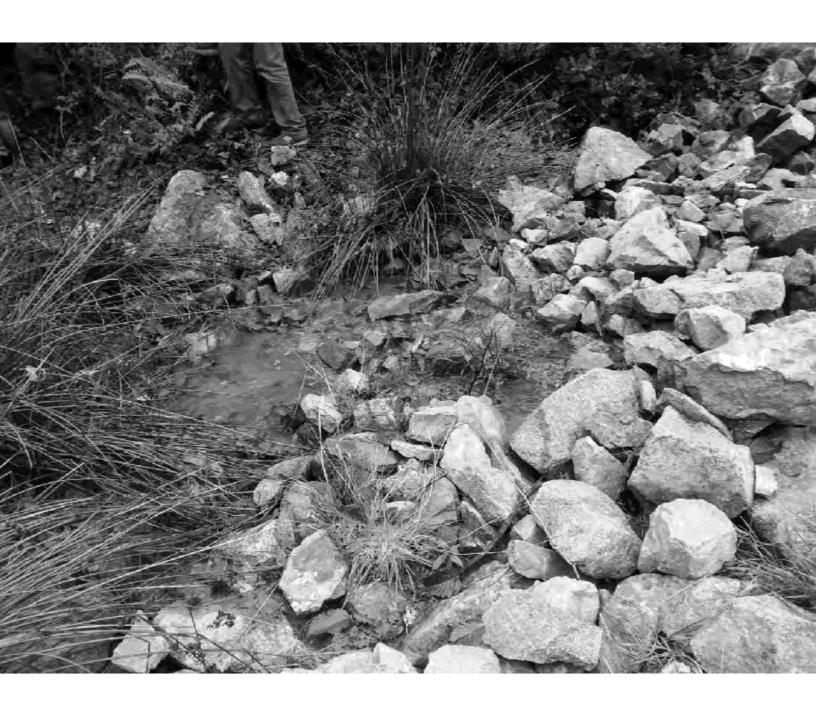
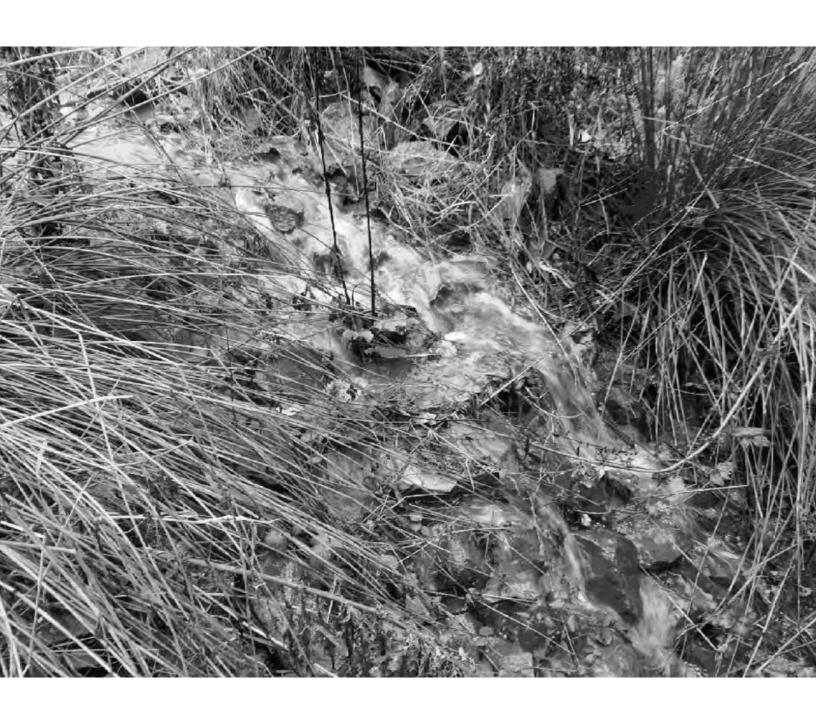
textplain_2
While the MoE staff are up there can they go to the bottom of Lot 21 and collect samples from the red water oozing out. Strong septic/sulphur smell down there yesterday.

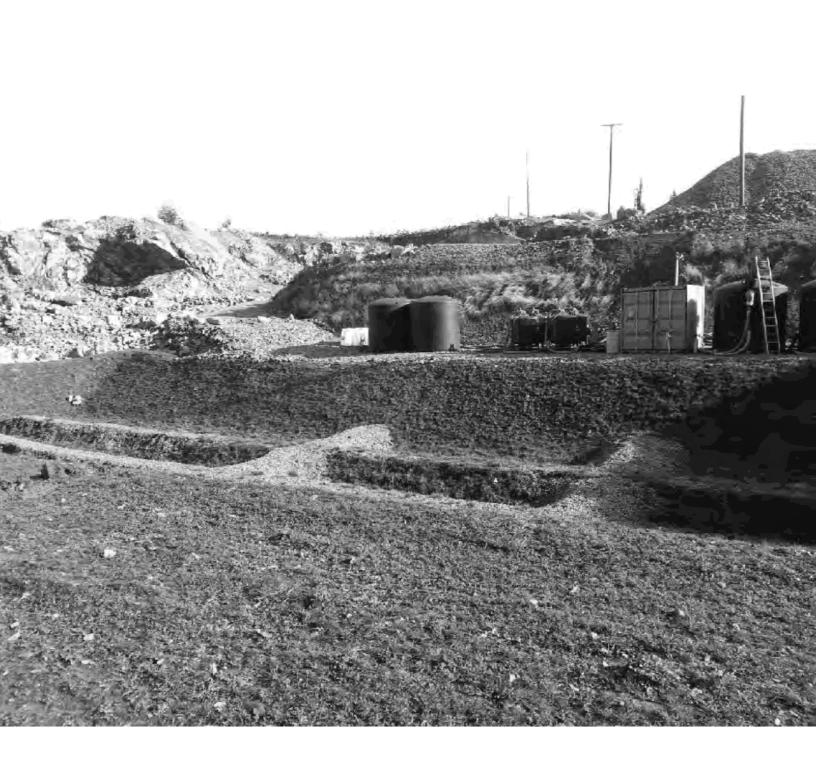
The settling pond does not hold water. Where is the water going, Jennifer? There is no liner, just gravel. Water is pouring out from underground into the stream.

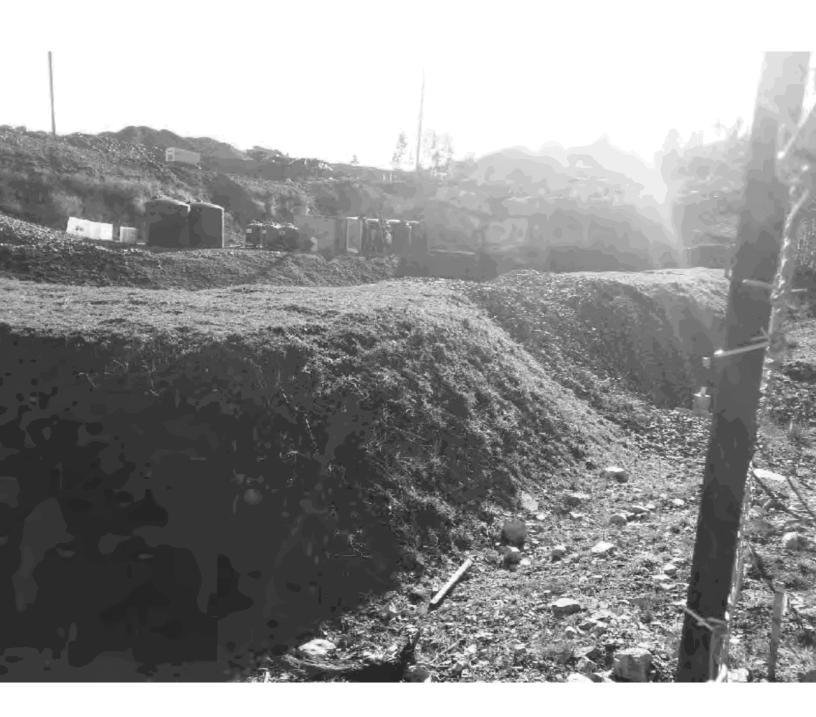
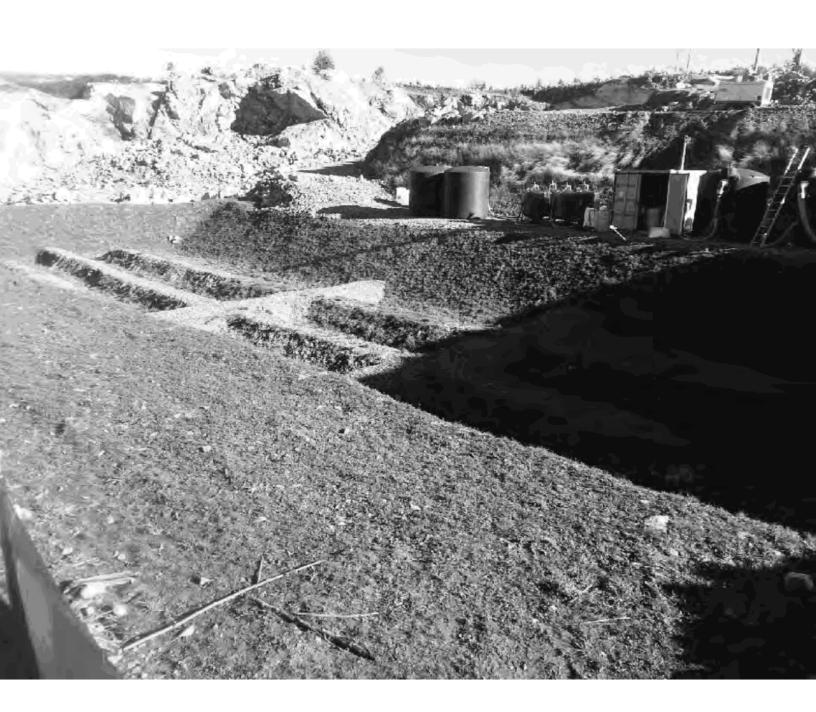
textplain_2
New berm has been built within five metre buffer zone of cvrd property. Was Mines contacted? CVRD was not contacted.

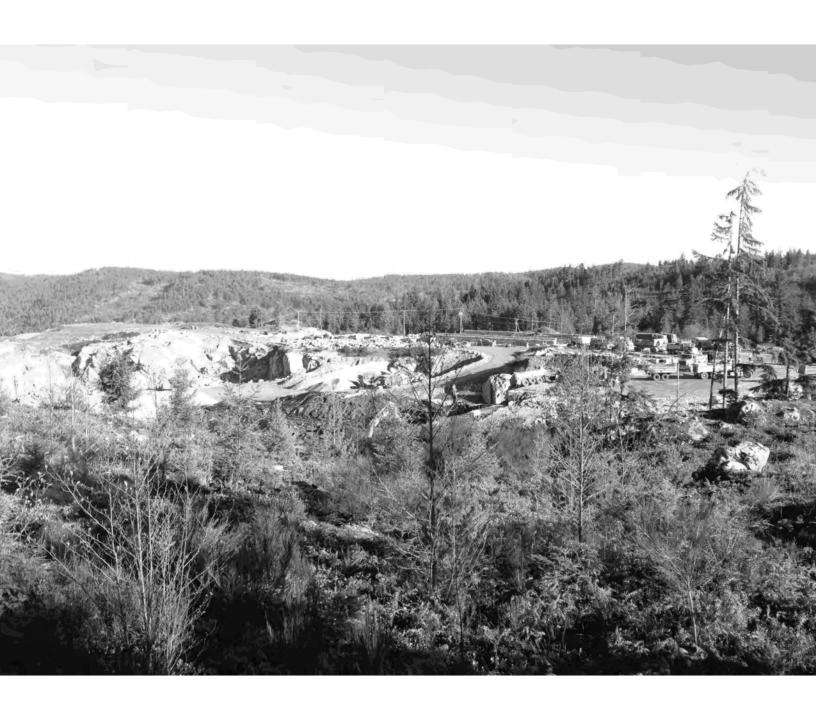
Truck pup falling off edge of cell just now. Machine pushed it back up. More pictures to come.

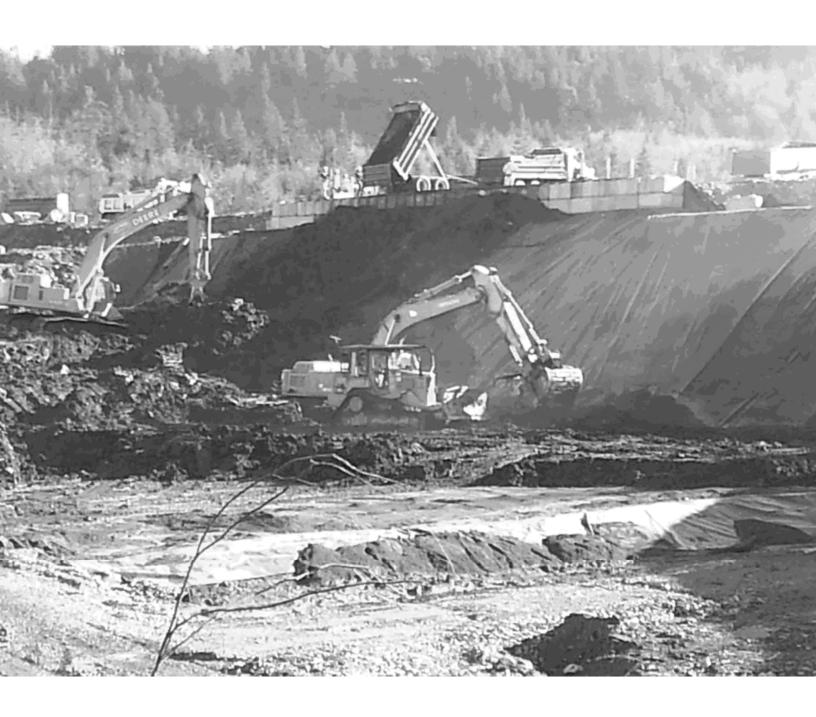
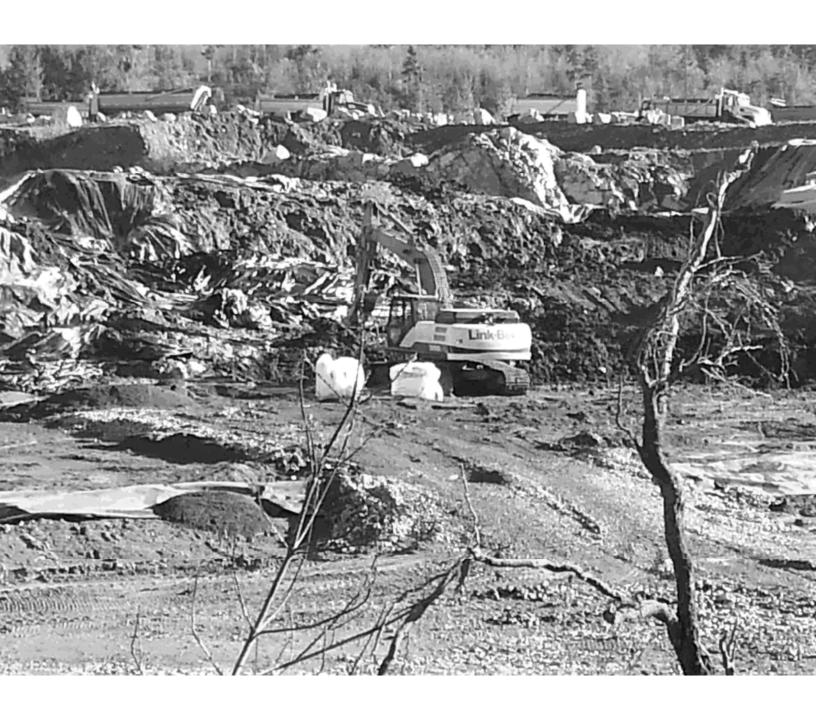
f) During construction, appropriate Quality Assurance/Quality Control (QAQC) shall be carried out. Within 30 days of completing construction, a construction QAQC report shall be submitted to the Inspector. This report shall include a summary of the liner installation, materials testing and compaction information and the QAQC measures employed during construction.

Has this cell been inspected? Is the cell construction complete?

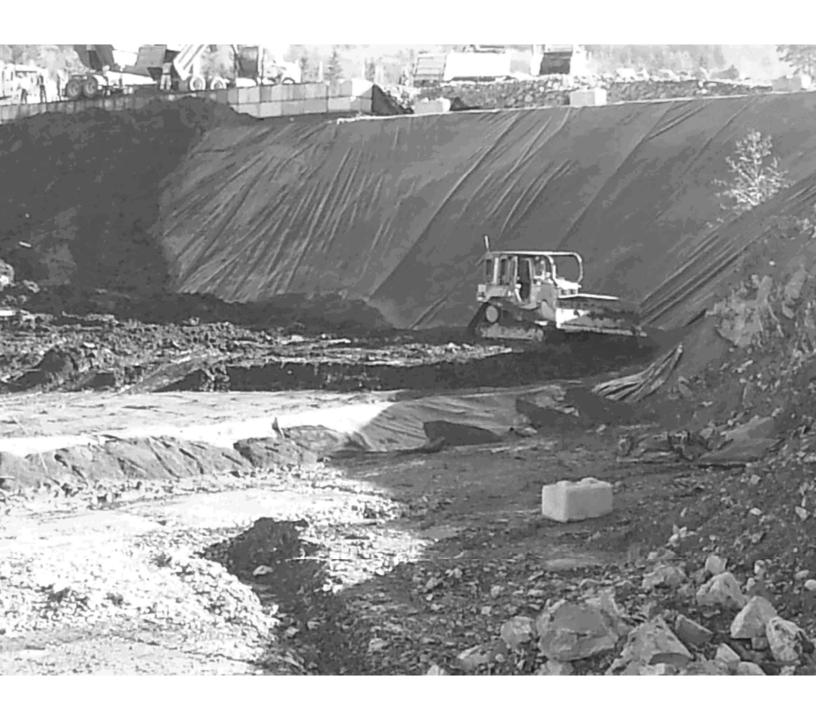
If it were raining right now, do tou thi k this would prevent contact water from leaving the cell?

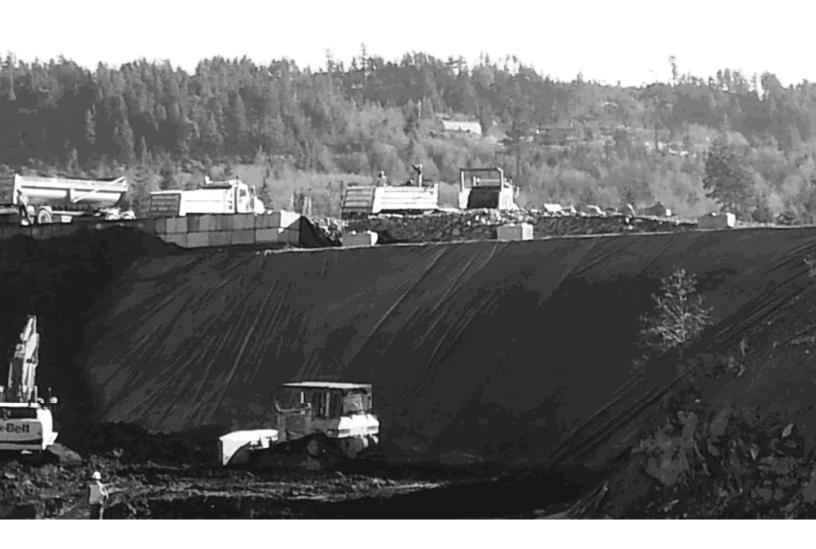
Men are atanding in the pup of thw dump truck working in contaminated soil without safety gear.

2. The incoming soil is very wet – during transportation last week in heavy rain, water and sludge was dripping out of the backs of trucks. One truckload appeared to be too heavy to dump, and three staff members were standing in the back of a dump truck appearing to be loosening the soil with shovels.

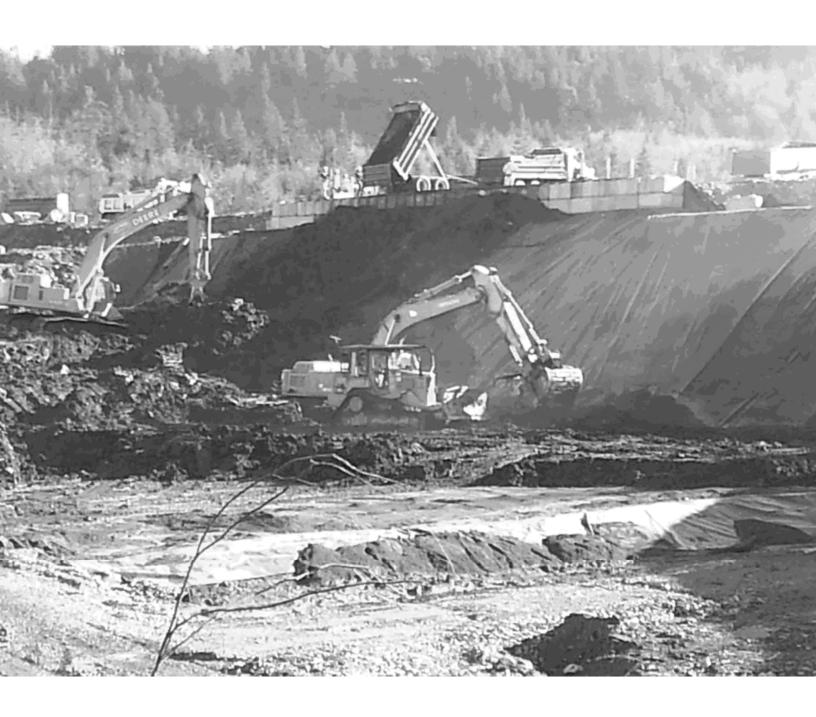
f) During construction, appropriate Quality Assurance/Quality Control (QAQC) shall be carried out. Within 30 days of completing construction, a construction QAQC report shall be submitted to the Inspector. This report shall include a summary of the liner installation, materials testing and compaction information and the QAQC measures employed during construction.

Has this cell been inspected? Is the cell construction complete?

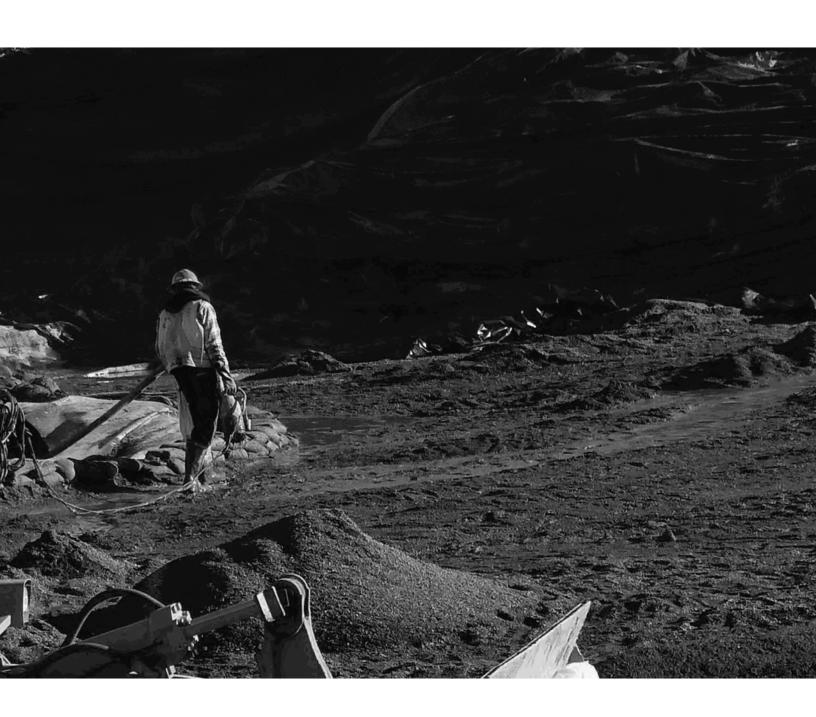
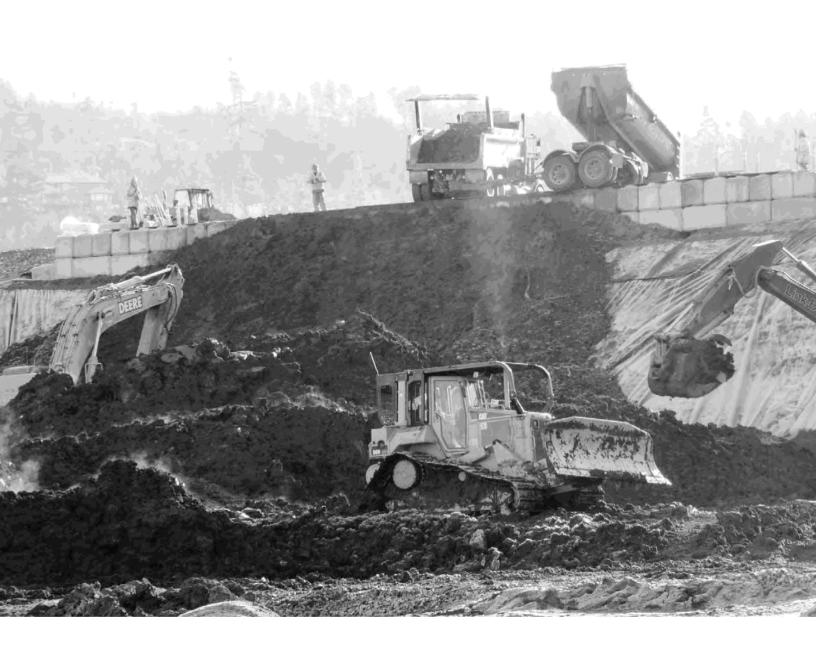
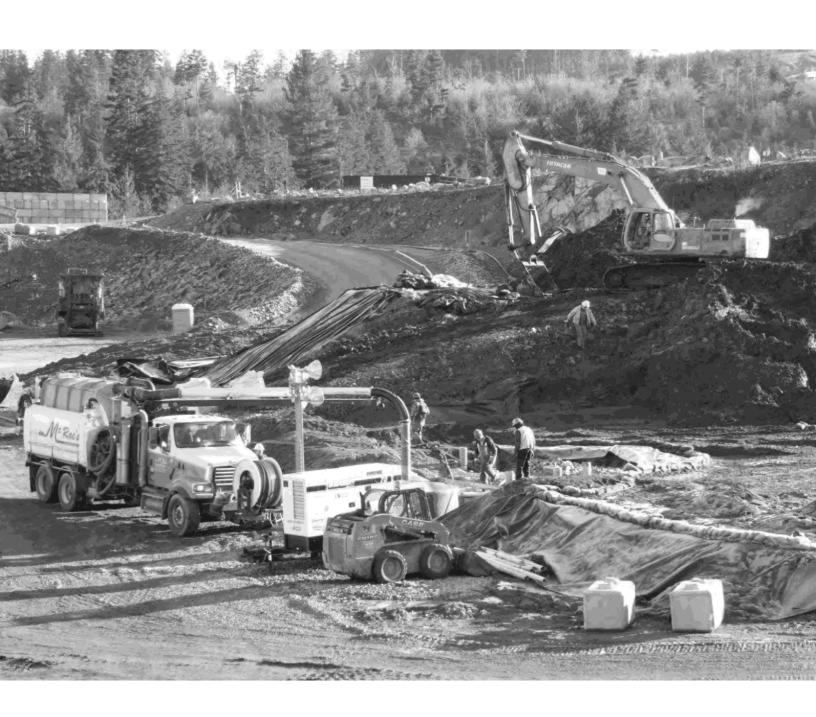
We were up there also about 10am and saw that also, along with all the other activity. Saw a tank truck pumping out the green contact water tanks – guess the system isn't working properly on its own – see attached. It boggles me how the machines are working the material on top of the liner like that – I don't see how it can escape damage. Couple of photos attached.

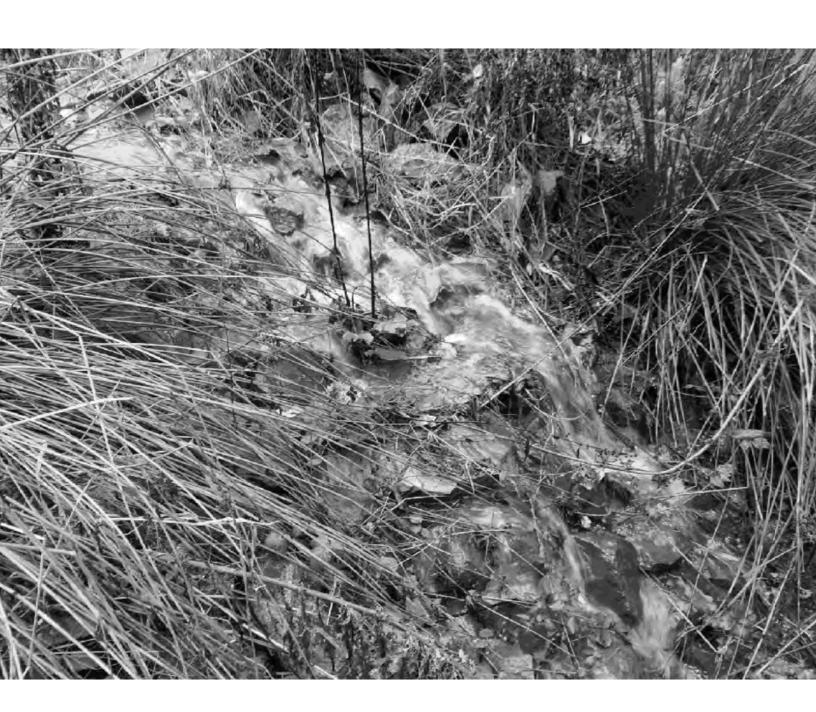
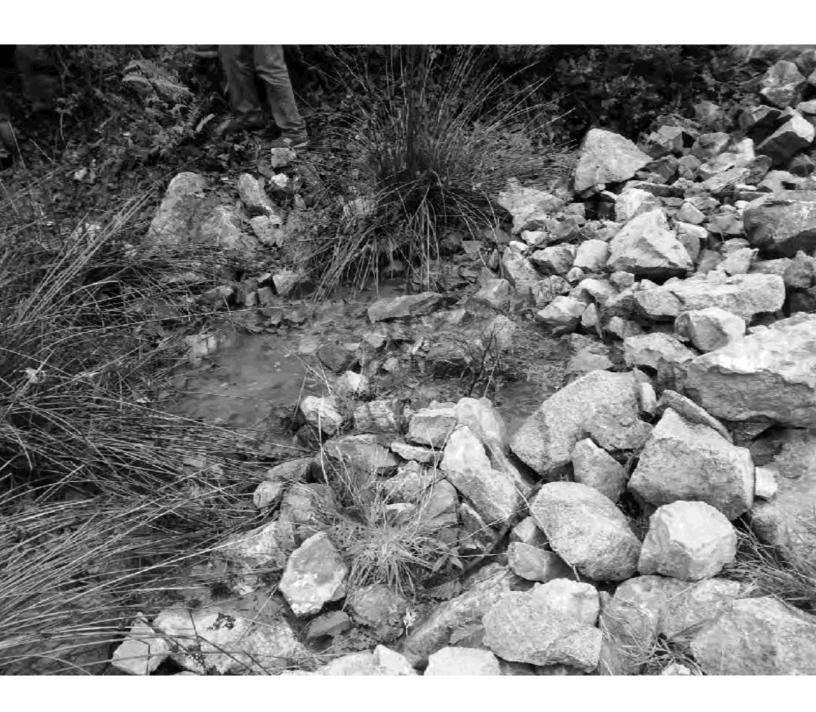
textplain_2
While the MoE staff are up there can they go to the bottom of Lot 21 and collect samples from the red water oozing out. Strong septic/sulphur smell down there yesterday.
