TMX - Anchor Loop Pipeline Project

Reinforced Silt Fence

COMPENSATION EFFECTIVENESS MONITORING: 2011
For the TMX – Anchor Loop Project:
Mount Robson Provincial Park and British Columbia

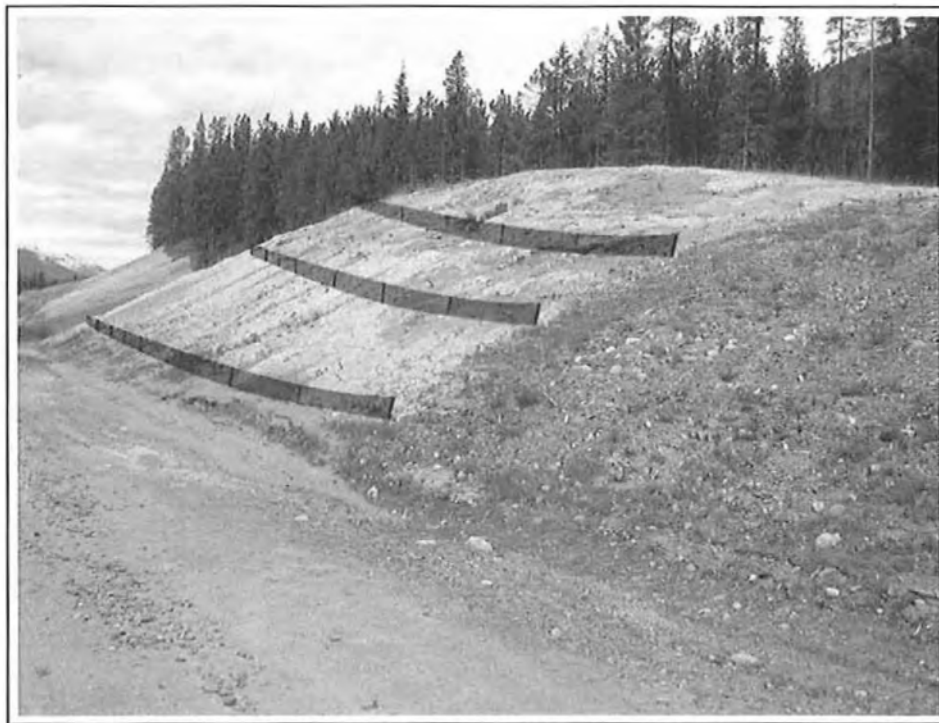
Plate 1 View northwest of the approximately 25 m wide by 15 m long disturbance located at KL 419.5 (May 24, 2011).

Industry best management practices information was used to determine the appropriate spacing requirements for the RSF measure on the seven disturbances (see Plates 1 to 7). Due to the steep slope gradient and long slope length (increasing the potential for the production of sediment) observed at the disturbance located at KL 424.95, the Revised Universal Soil Loss Equation (RUSLE) was used to estimate the expected yearly loss of soil from the disturbed slope before and after measure installation. Using slope data collected at the KL 424.95 site in May 2011, the RUSLE equation estimates an 85% reduction of soil loss from the slope following the installation of the RSF measure at the prescribed slope spacing.

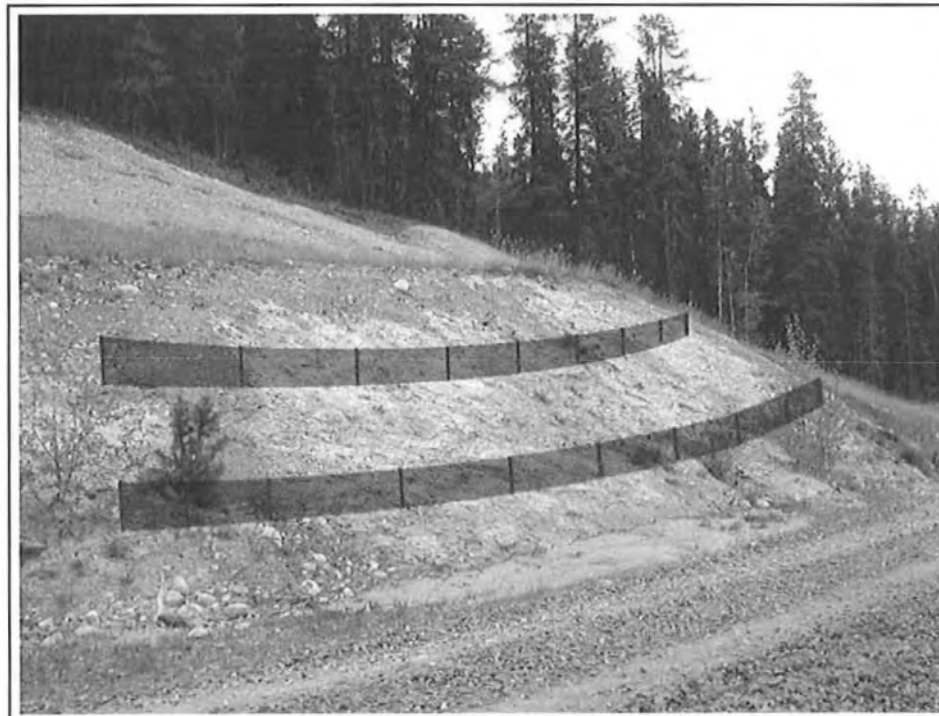
Plate 2 View east of the approximately 20 m wide by 7 m long disturbance located at KL 419.7 (May 24, 2011).

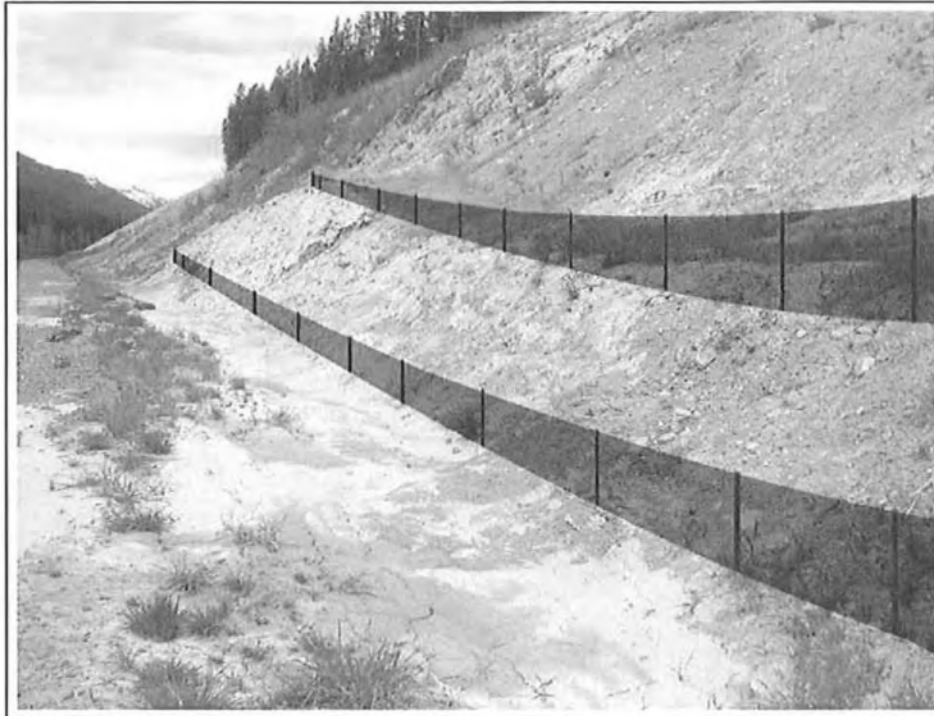
Plate 3

View west of the approximately 50 m wide by 6 m long disturbance at the toe of the slope located at KL 424.65 (May 24, 2011).

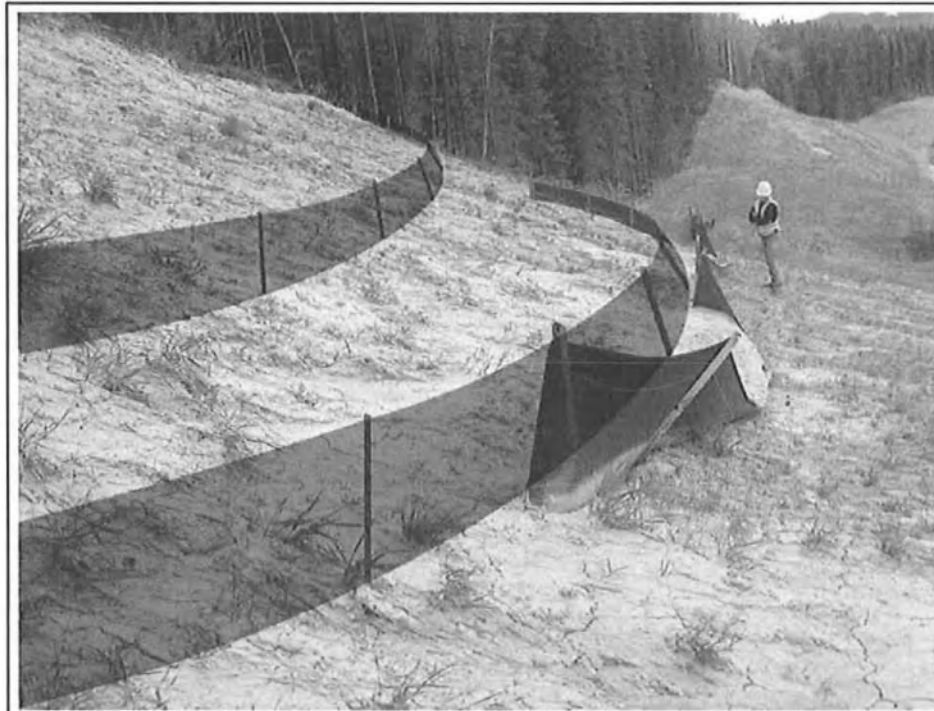
Plate 4

View east of the approximately 40 m wide by 20 m long disturbance at the top of the slope located at KL 424.65 (May 24, 2011).

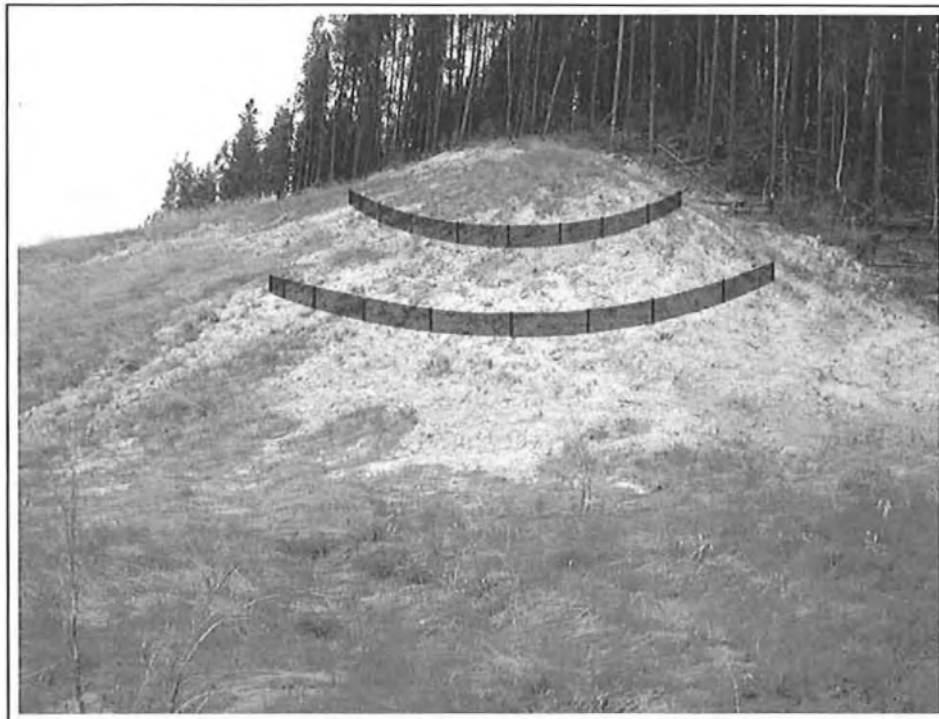
Plate 5 View north of the approximately 25 m wide by 20 m long disturbance at the east side of the slope located at KL 424.65 (May 24, 2011).

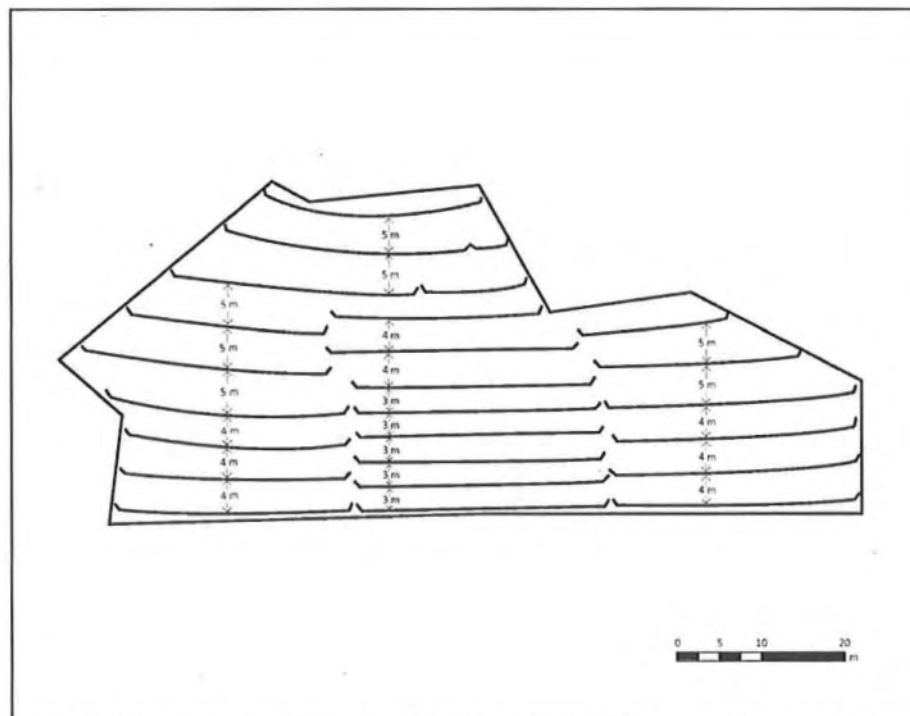
Plate 6 Illustration of the approximately 80 m wide by 45 m long disturbance polygon and proposed RSF spacing at the slope located at KL 424.95.

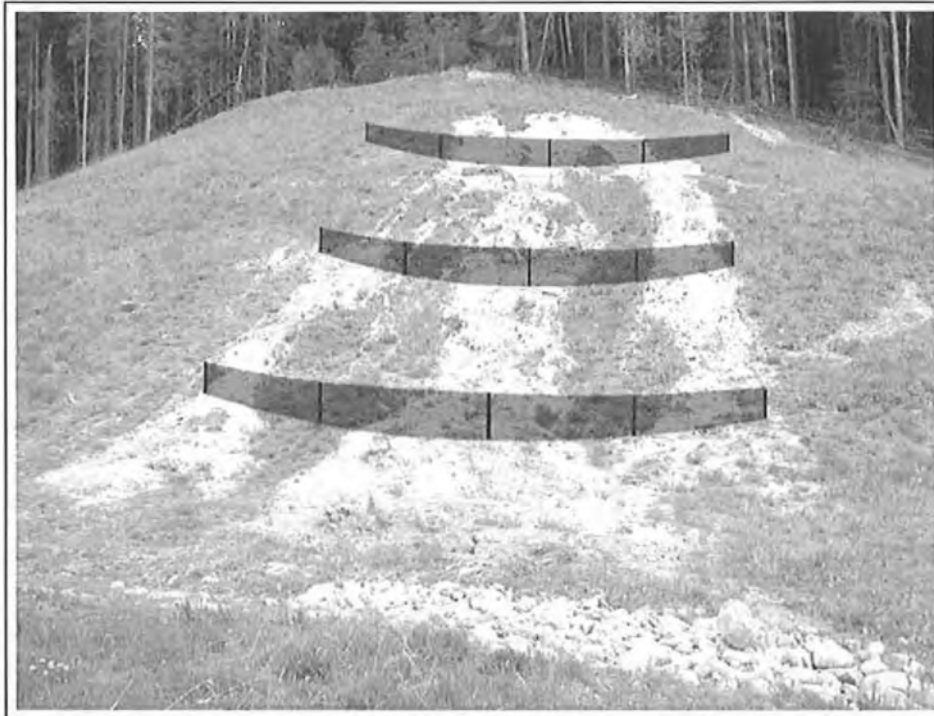
Plate 7 View northeast of the approximately 15 m wide by 25 m long disturbance at the slope located at KL 425.95 (May 24, 2011).

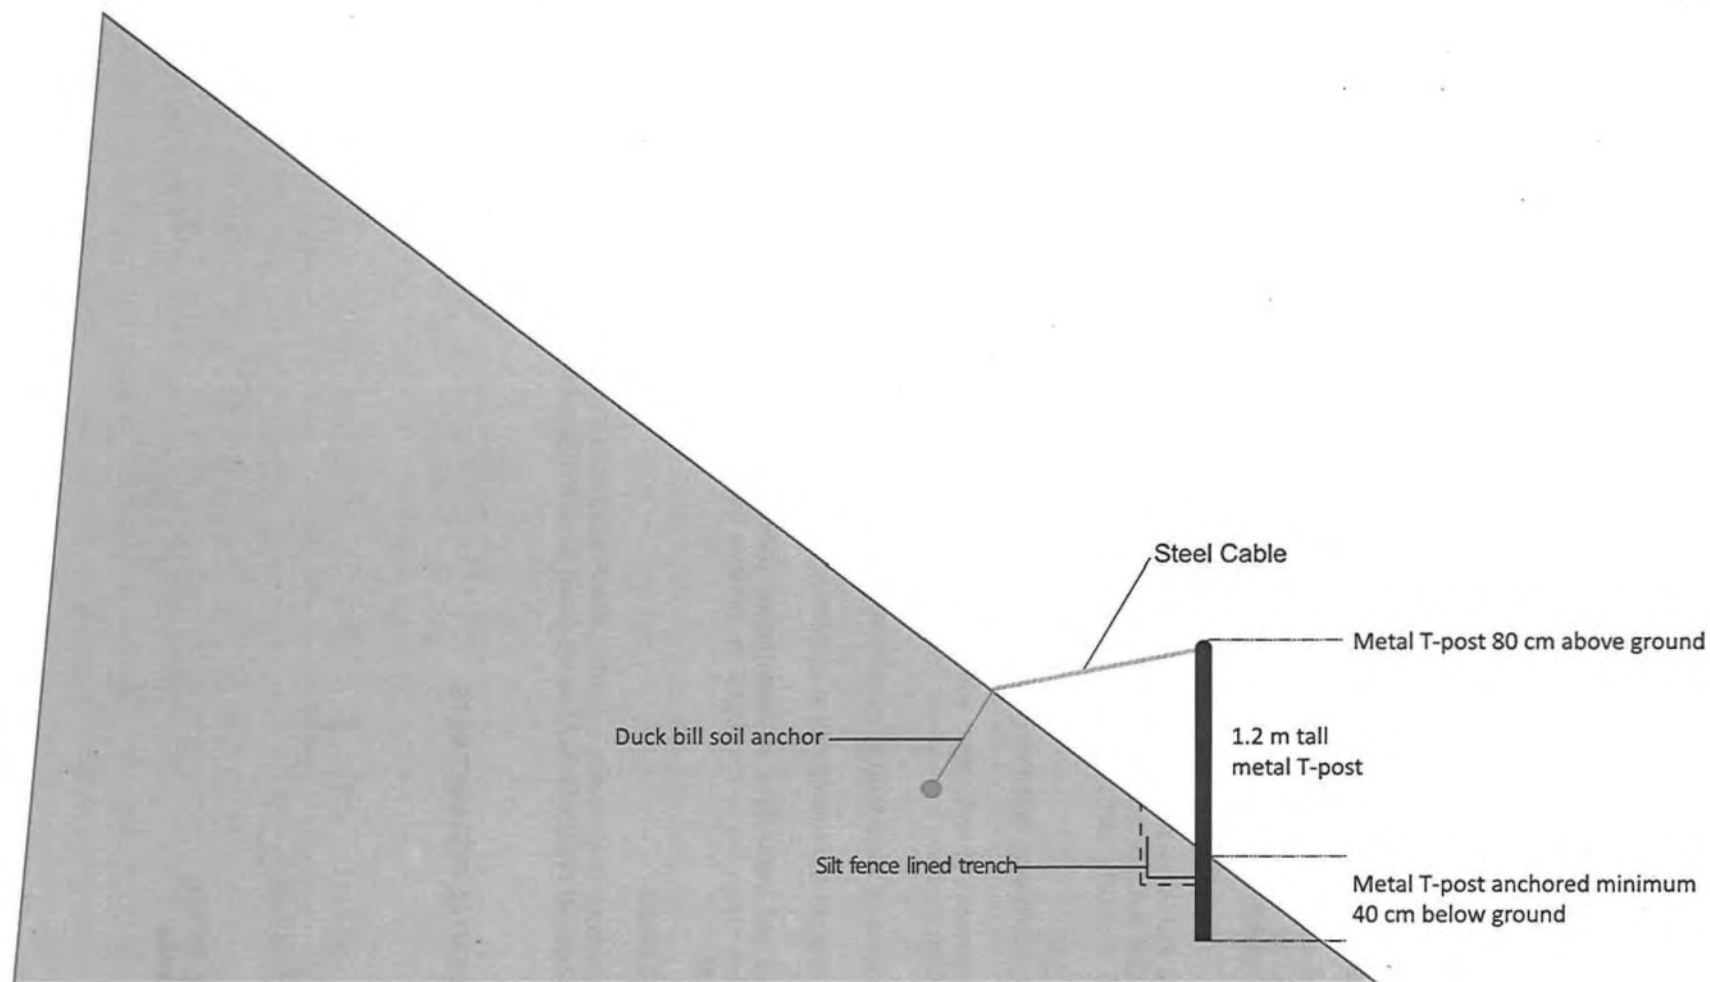
- at a location directly upslope and at approximately the same horizontal height as the top of the t-post, secure the duckbill soil anchor (probe and cable) to the installation rod and then drive the probe (with cable attached)/rod combination into the soil to a depth of 60-75 cm using a sledgehammer or Hilti-hammer at an angle that is approximately perpendicular to the slope, unscrew the rod from the anchor probe and remove the rod from the soil – leaving the probe in the soil and the anchor cable exposed; and

- secure the anchor cable to the top of the t-post (add another length of cable if the anchor cable does not reach to the top of the t-post) and tighten.

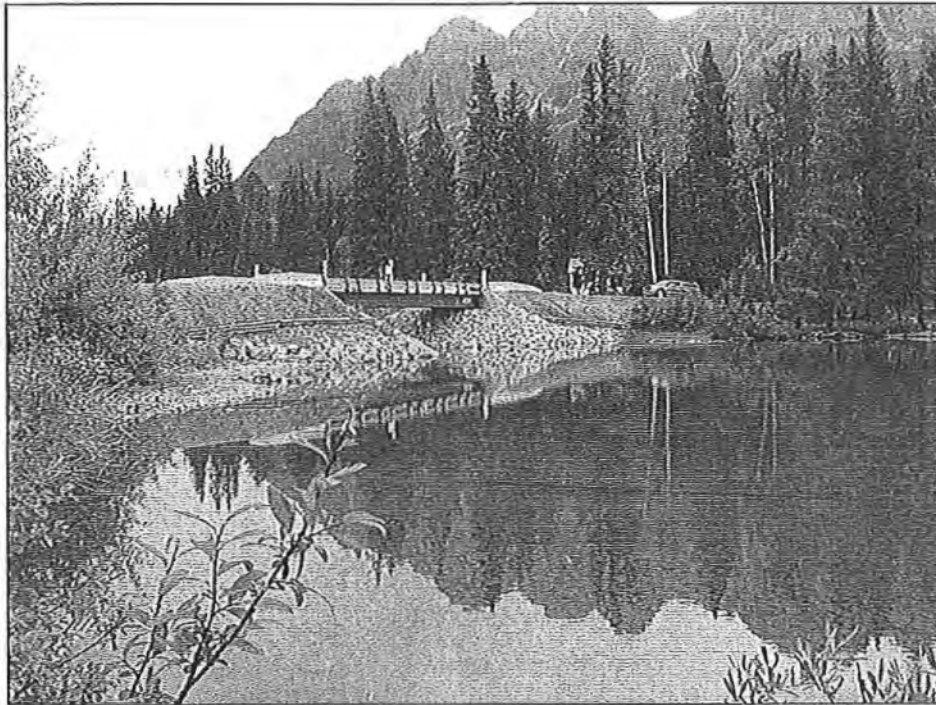
The seven culverts have been successfully replaced with a single-span bridge. Aquatic connectivity between the sub-basins of Yellowhead Lake has been restored, as is evident by the fishes and various aquatic birds that have been seen using the new habitat. Fishes were again observed swimming both upstream and downstream through the restored channel, and holding behind boulders placed within the new channel. Riparian vegetation is slowly becoming established.

Plate 1 Yellowhead Lake: View northwest (downstream) towards new bridge (August 7, 2011).

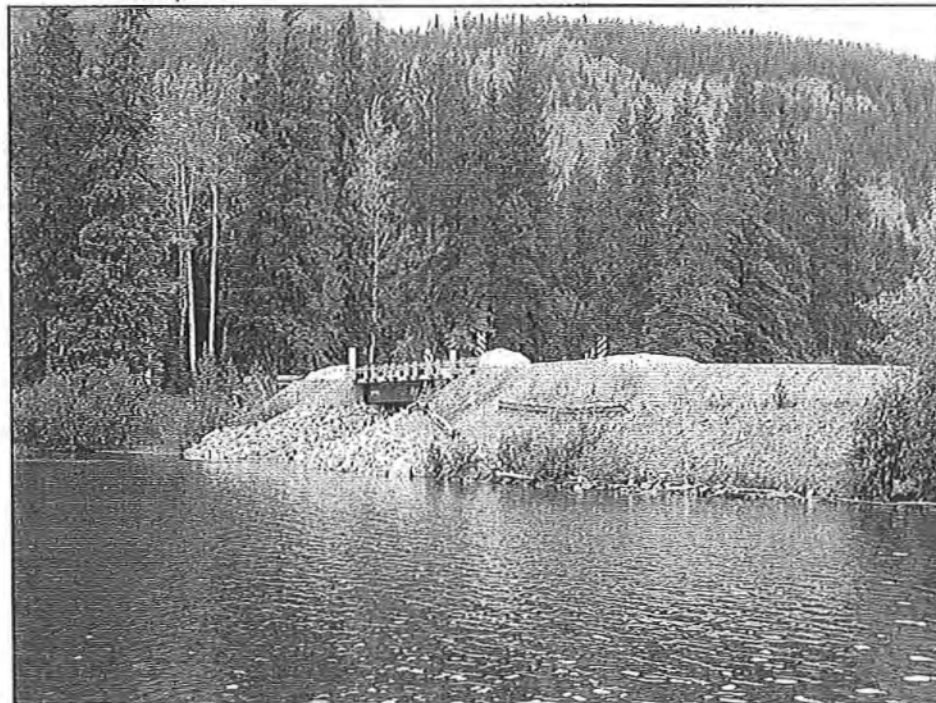
Plate 2 Yellowhead Lake: View northeast across downstream face of new bridge (August 7, 2011).

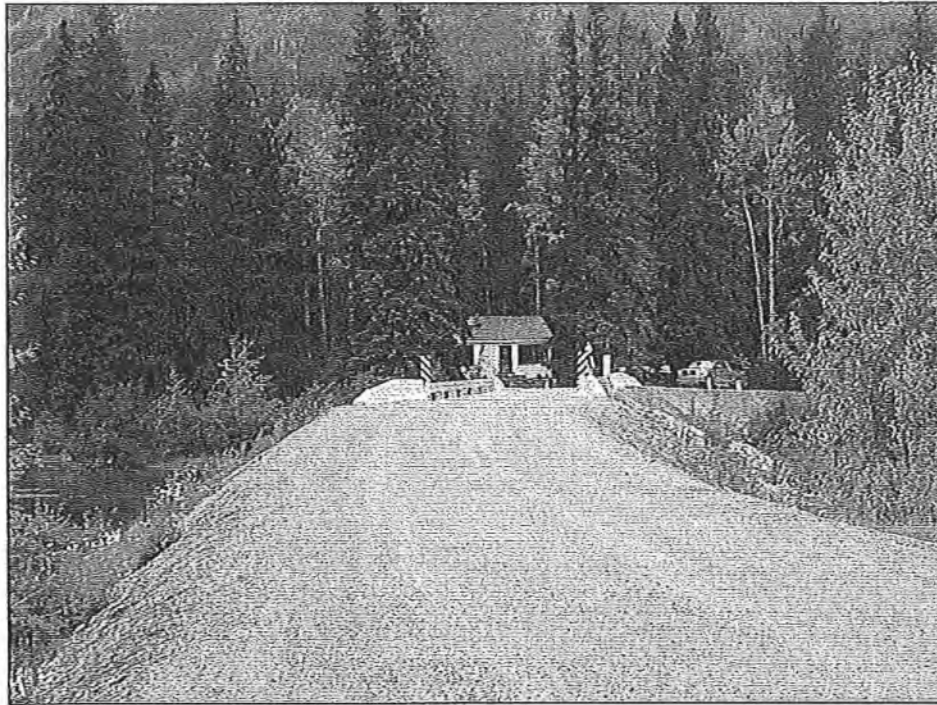
Plate 3 Yellowhead Lake: View north along bridge approach ramp (August 7, 2011).

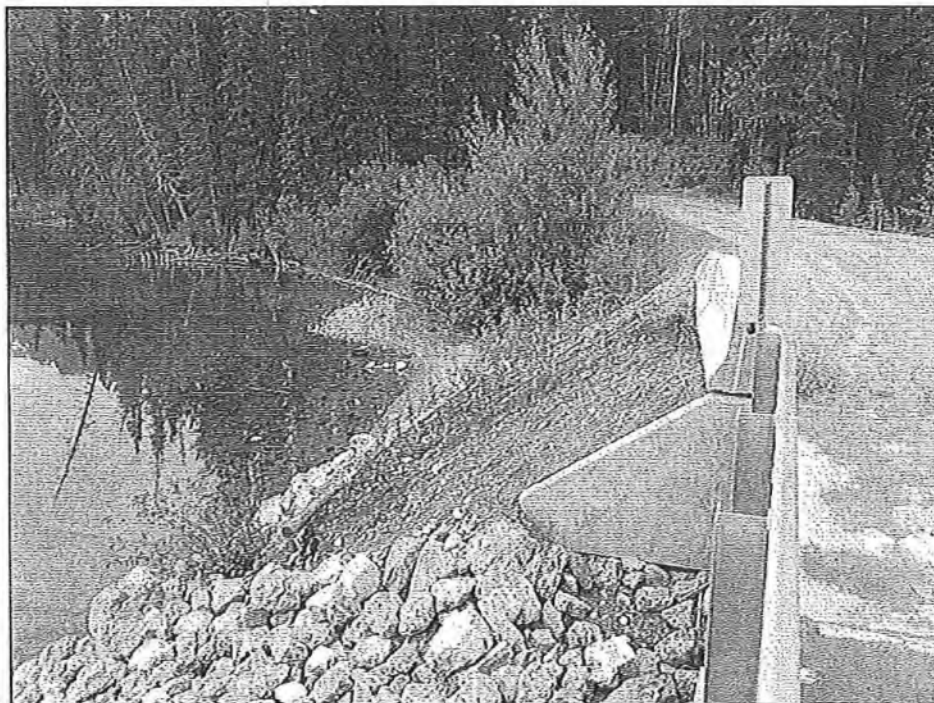
Plate 4 Yellowhead Lake: View south along upstream corner of left bank, showing establishing riparian planting (August 7, 2011).

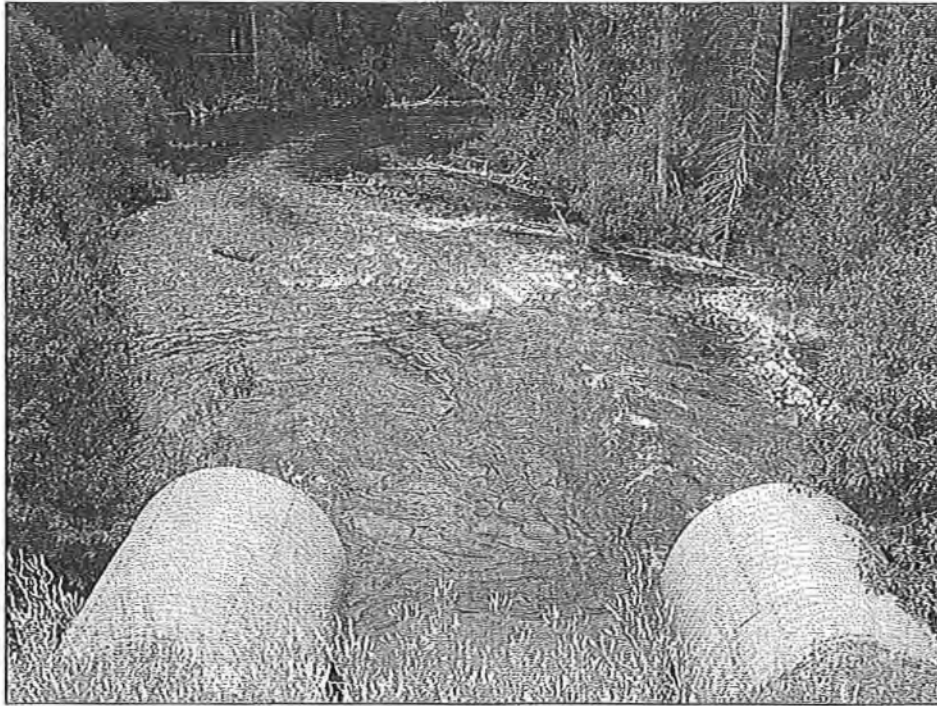
Young-of-the-year rainbow trout were observed rearing within the shallow pools along the margins of habitat made available by the control weir installed at the pool immediately downstream from the culvert outlets (Appendix A: Plate 5 and 8). Mature rainbow trout were observed within the outlet pool and enhanced riffle (Appendix A: Plate 9). Fish passage has been improved and all restored fish habitat is considered functional.

Plate 5 Yellowhead Creek: View downstream from Highway 16 showing outlet pool depth under moderate flow (August 7, 2011).

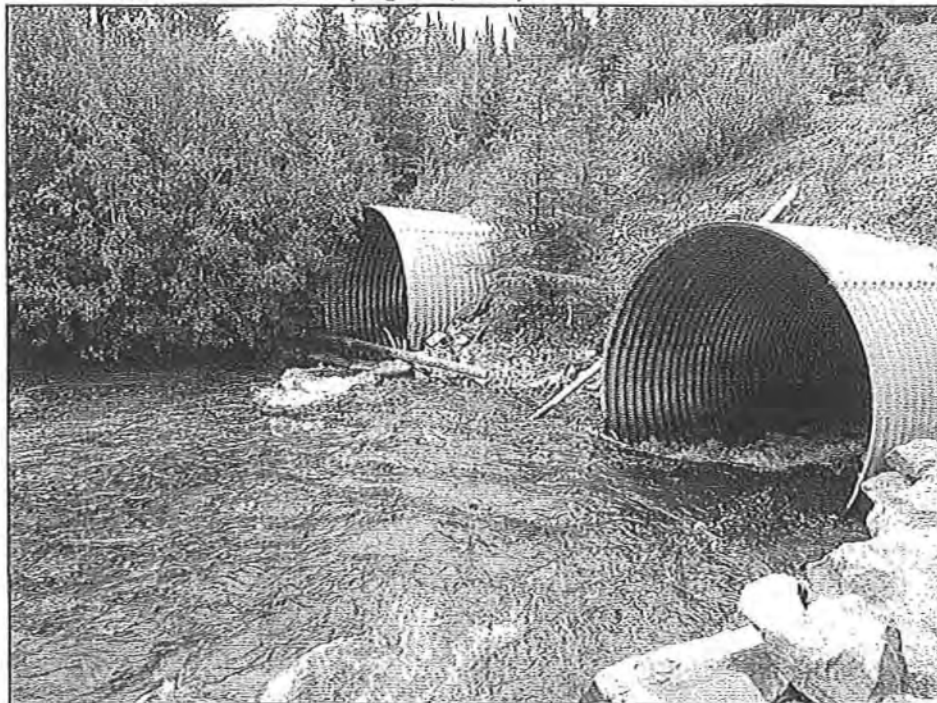
Plate 6 Yellowhead Creek: View downstream towards culvert inlets under Highway 16 (August 7, 2011).

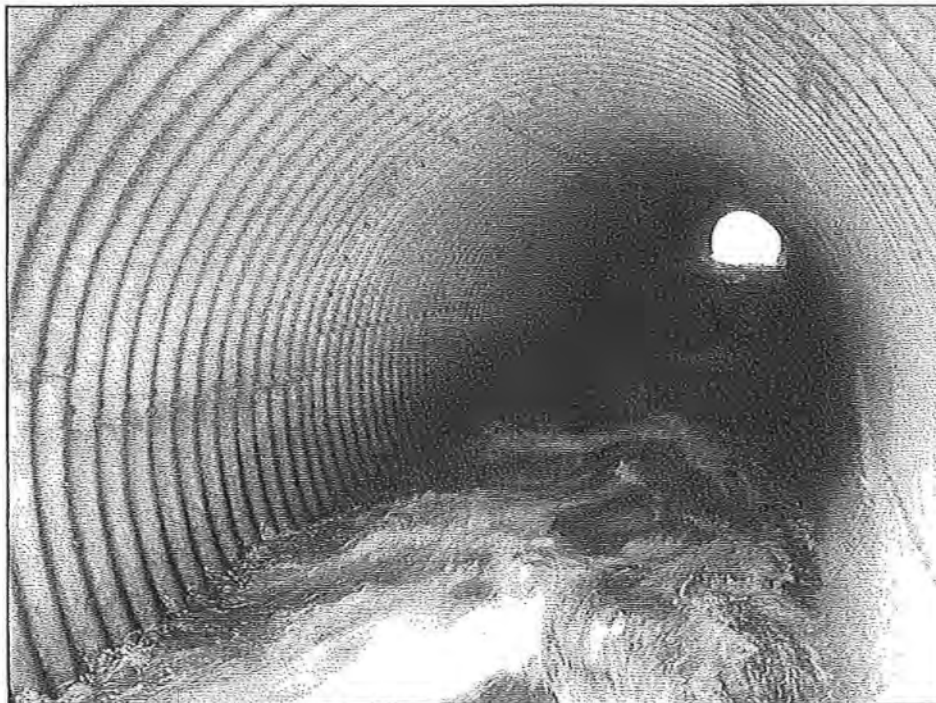
Movement through the Yellowhead Creek culverts under Highway 16 has been greatly improved through the installation of baffles and raising the outlet pool depth with the use of a control weir. While velocity during high flow is likely still a barrier to juveniles, the movement of adult rainbow during these high spring flows has been greatly improved. Fish passage during low flow conditions is now possible for all fishes as a result of the culvert outlets being inundated at all times, and lower velocities recorded in the eastern culvert. Increased water level resulting from the control weir immediately downstream from the culvert outlet has flooded the large cobble/gravel bar against the left bank, and provided functional instream habitat along both margins; as shown by young-of-the-year salmonids observed within these shallow fringe pools. Riparian vegetation has established well where planted on the downstream right banks. No debris jams was observed within either culvert.

Plate 7 Yellowhead Creek: View downstream through west culvert under moderate flow conditions showing turbulence created by baffles (August 7, 2011).

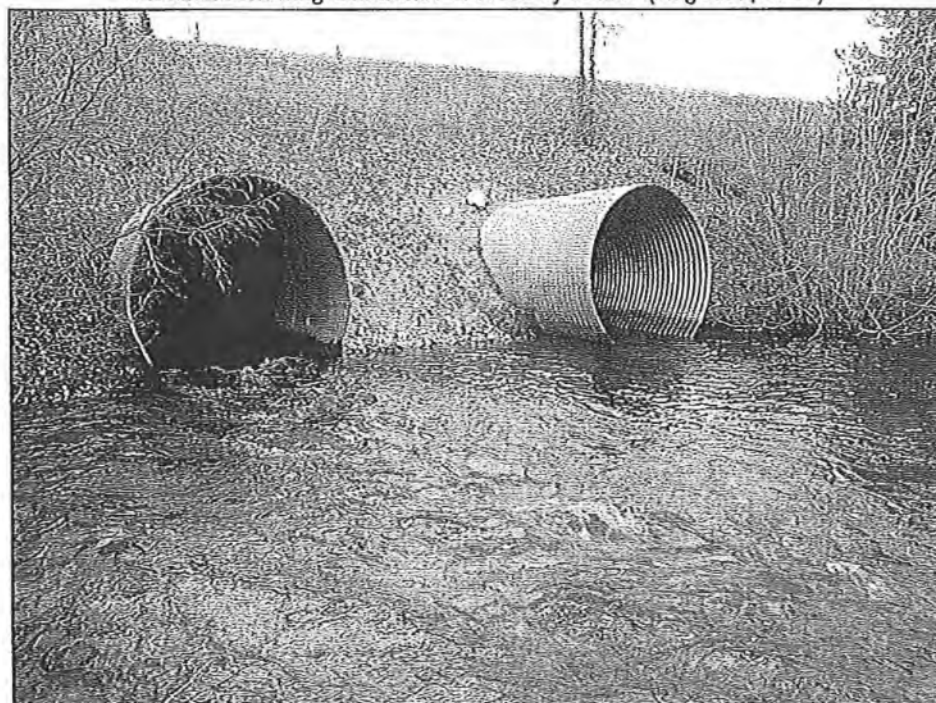
Plate 8 Yellowhead Creek: View upstream towards culvert outlets showing inundation of both culvert outlets under fall low-flow conditions (October 17, 2011).

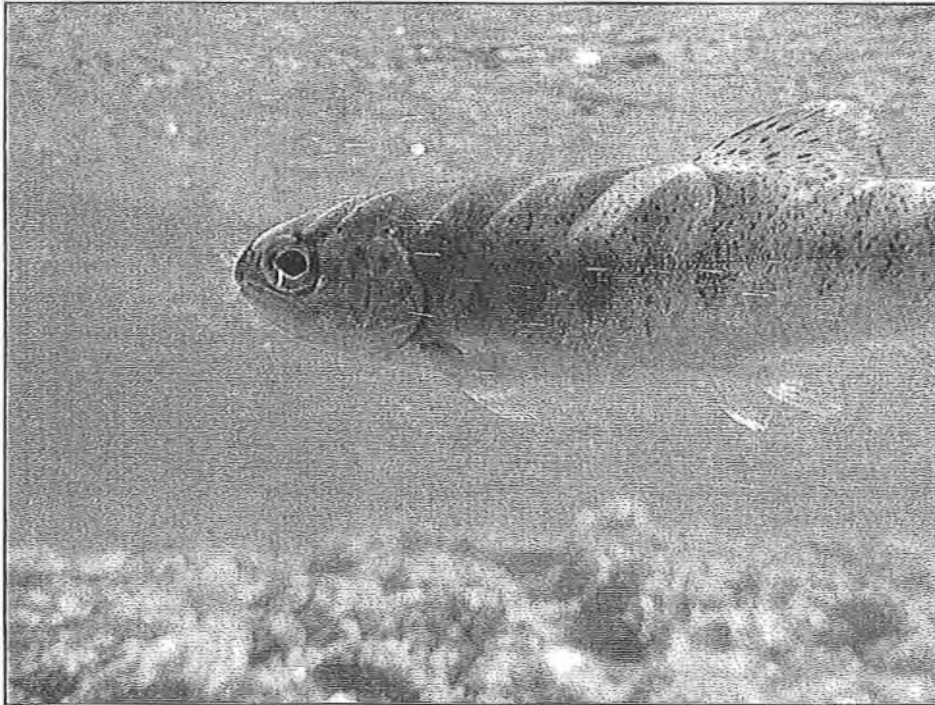
Plate 9 Yellowhead Creek: Mature rainbow trout rearing in culvert outlet pool (August 7, 2011)

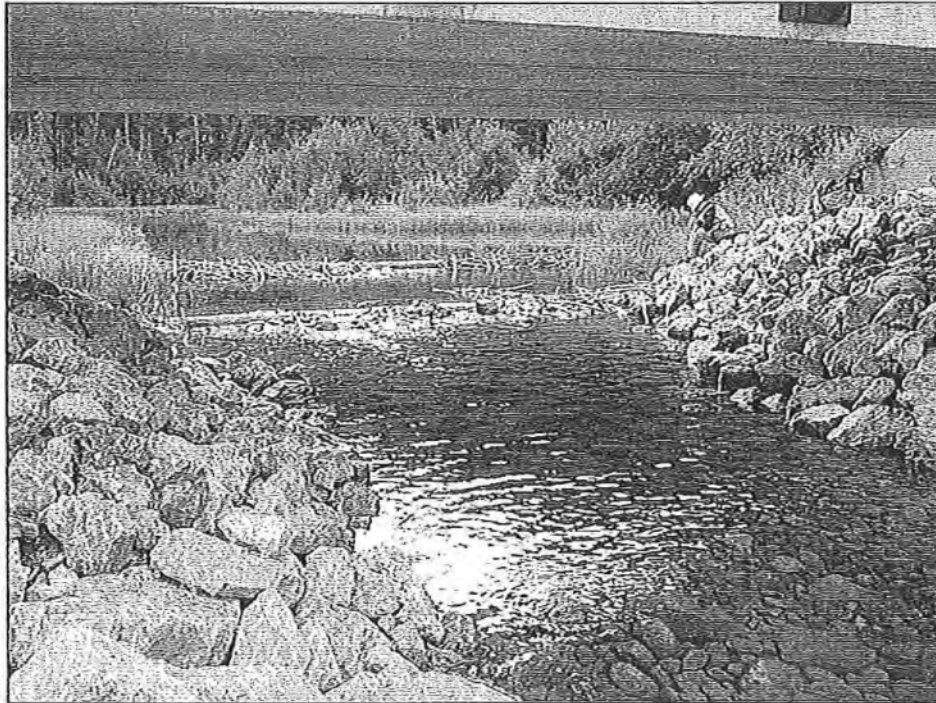
In addition to opening up a section of Fraser River back channel, the compensation project also created new fish habitat previously occupied by the causeway and standpipe. The channel bed between the downstream log weir and the Fraser River was replaced with usable cobble and boulder substrate (Appendix A: Plate 10 and 17).

Plate 10 Fraser Back Channel: View upstream through new channel showing the two log weirs and cobble lined pool created under bridge deck (August 7, 2011).

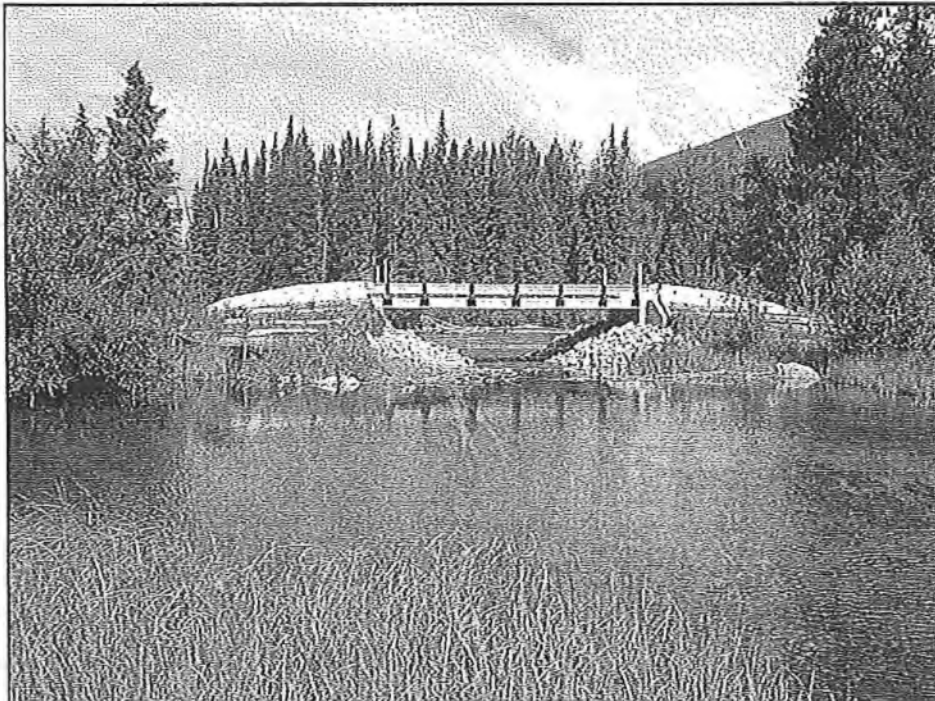
Plate 11 Fraser Back Channel: View downstream from east edge of back channel (August 7, 2011).

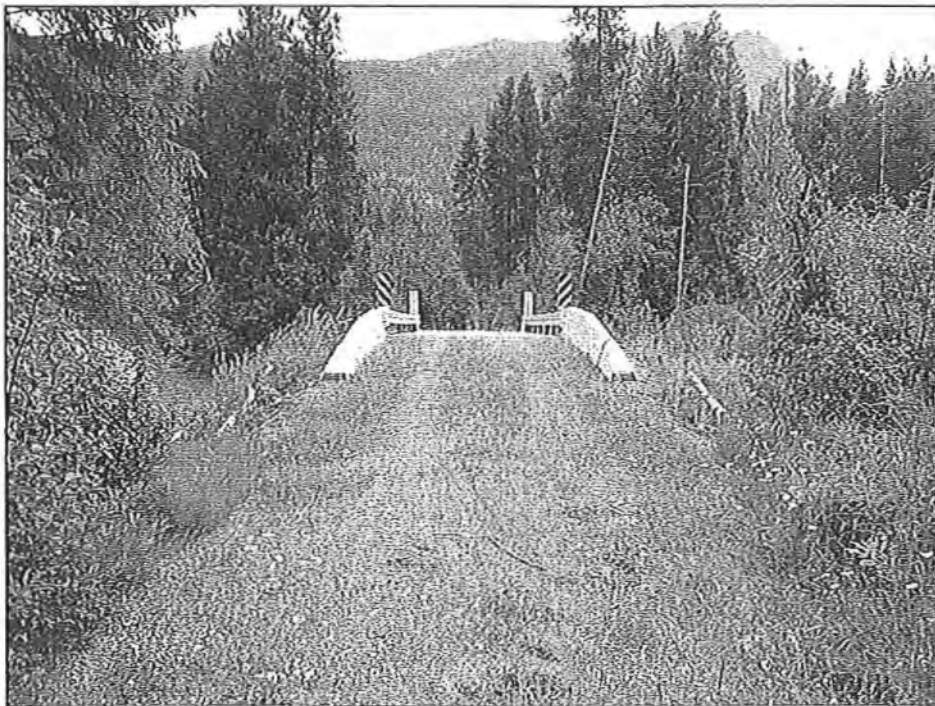
Plate 12 Fraser Back Channel: View north along left bank approach ramp showing regenerating vegetation on ramp shoulders (August 7, 2011).

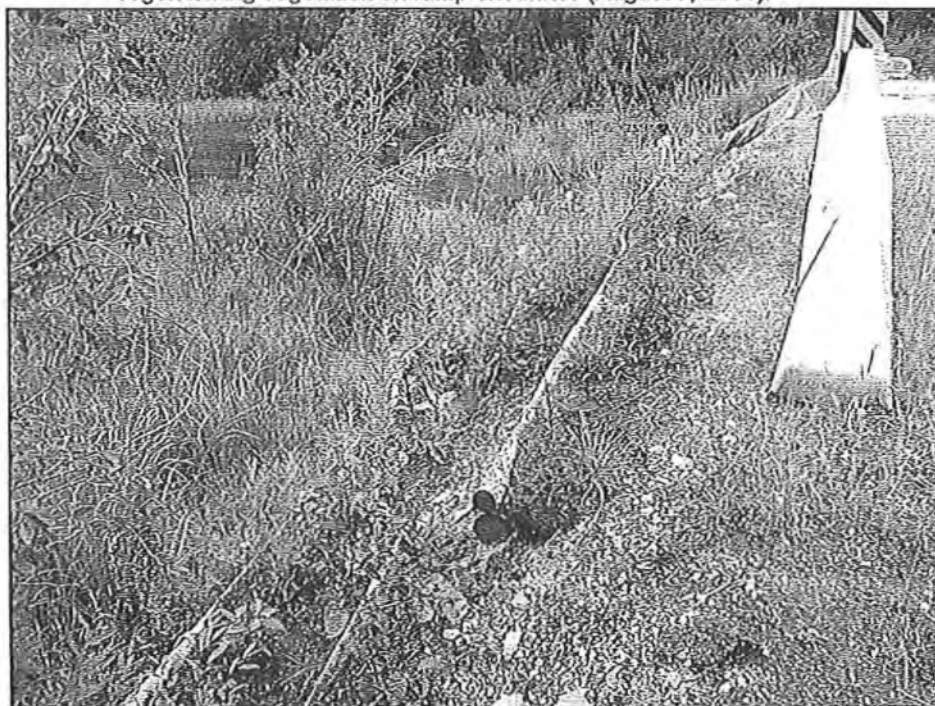
Plate 13 Fraser Back Channel: View along inside edge of right bank bridge approach showing established riparian planting (August 7, 2011).

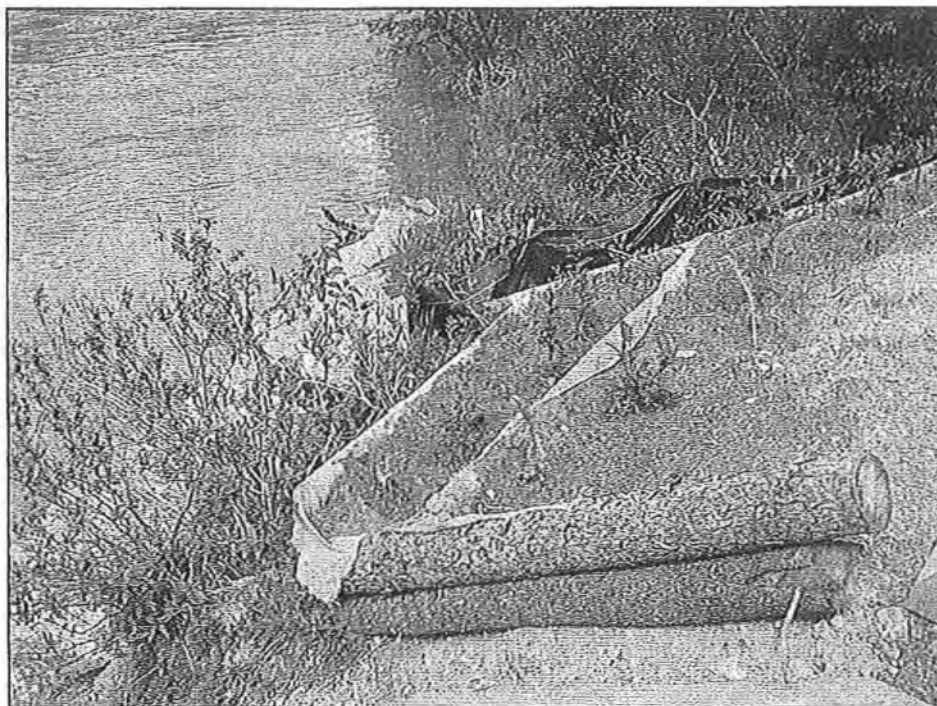
Plate 14 Fraser Back Channel: View upstream along left bank of Fraser River showing salvaged and planted riparian vegetation (August 2, 2010).

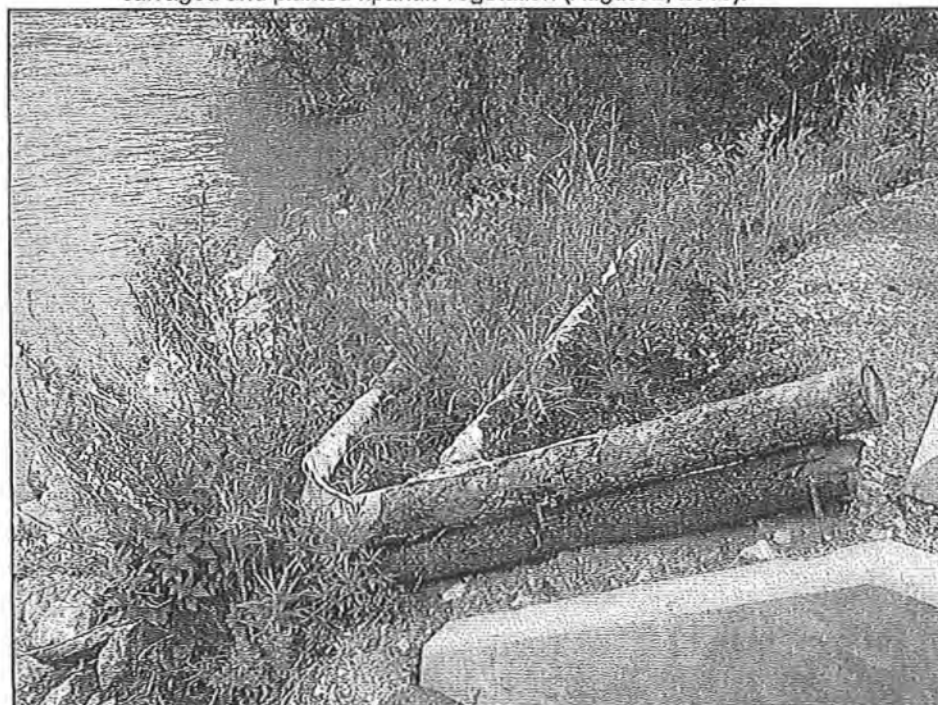
Plate 15 Fraser Back Channel: As for Plate 14, showing salvaged and planted riparian vegetation growth from previous year (August 7, 2011).

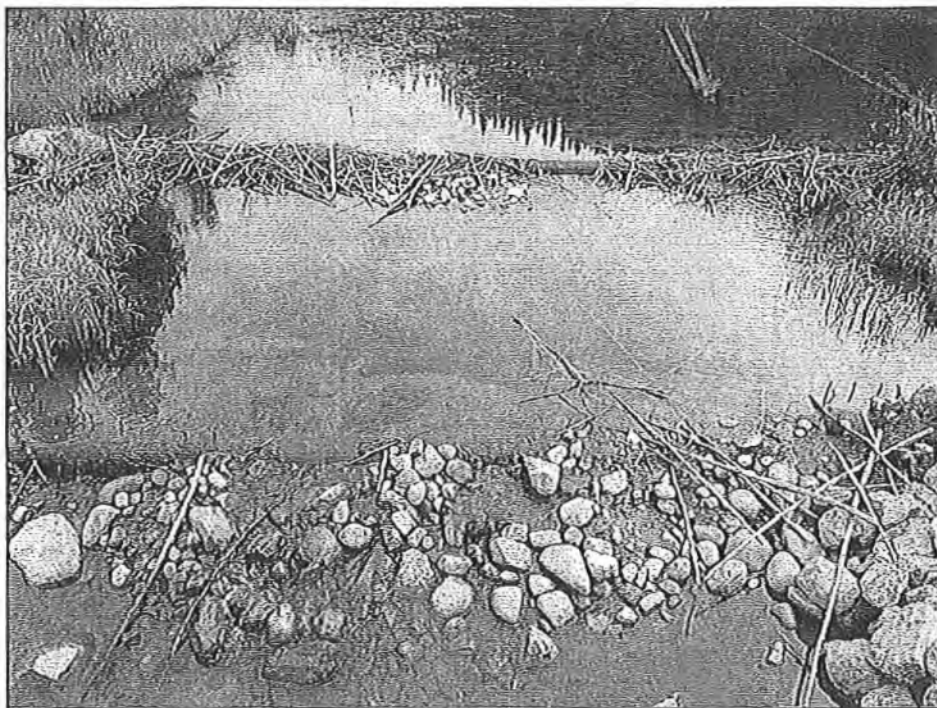
Unidentified young-of-the-year were previously observed rearing within the sedges along the margins within the back channel (AAR 2010). Amphibians and wading birds (dippers) were observed feeding within the back channel marsh habitat. These observations, coupled with the adult mountain whitefish recorded accessing the back channel during implementation of the compensation works (AAR 2009), demonstrates that connectivity and restored aquatic habitat is functional for a range of aquatic species. During the fall low-flow visit, no barriers (velocity or height) were observed at any of the weirs or within the section of new channel (Appendix A: Plate 16 and 17).

Plate 16 Fraser Back Channel: View into back channel from bridge showing partial beaver dam augmentation of weirs and cobble/boulder riffle (October 17, 2011).

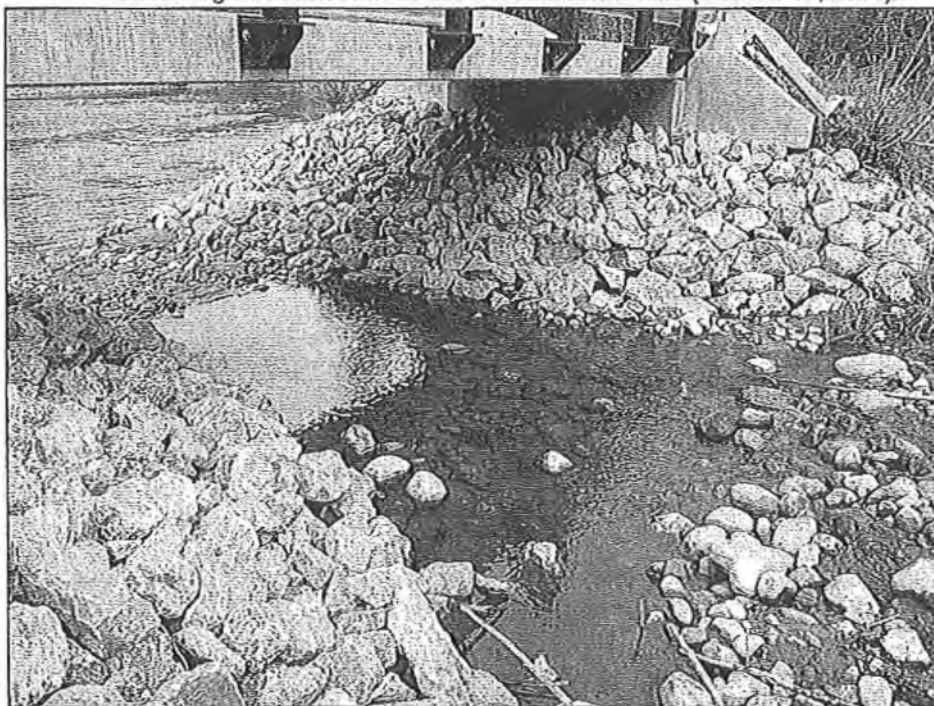
Plate 17 Fraser Back Channel: View downstream across channel outlet showing access into back channel from Fraser River under typical fall low flows (October 17, 2011).

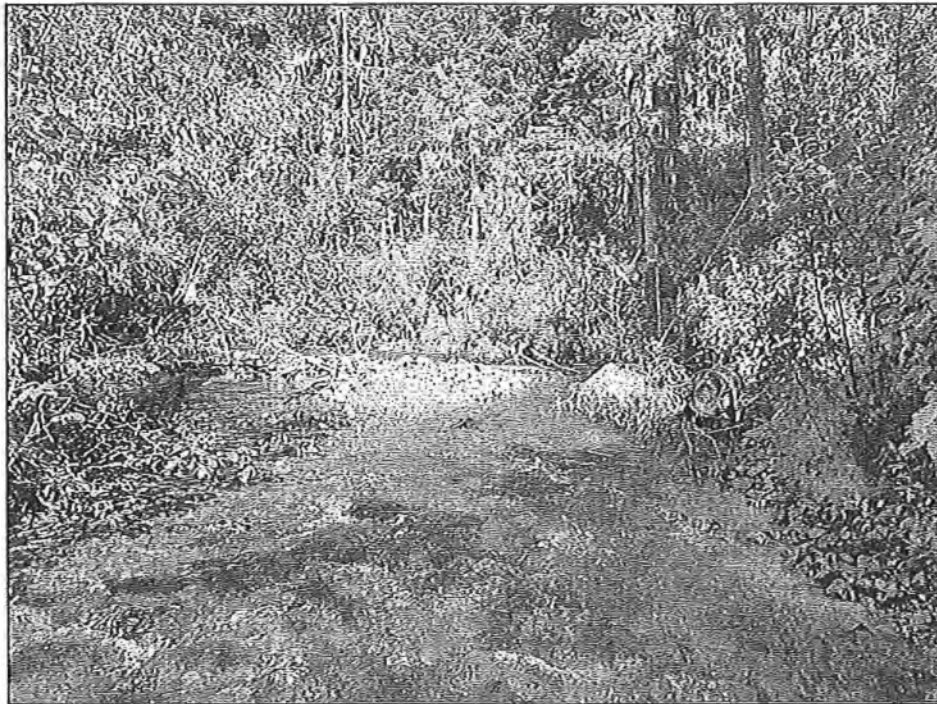
Plate 18 Fraser Tributary: View upstream through restored channel showing end of logs placed along the toe of the left bank scour (August 10, 2011).

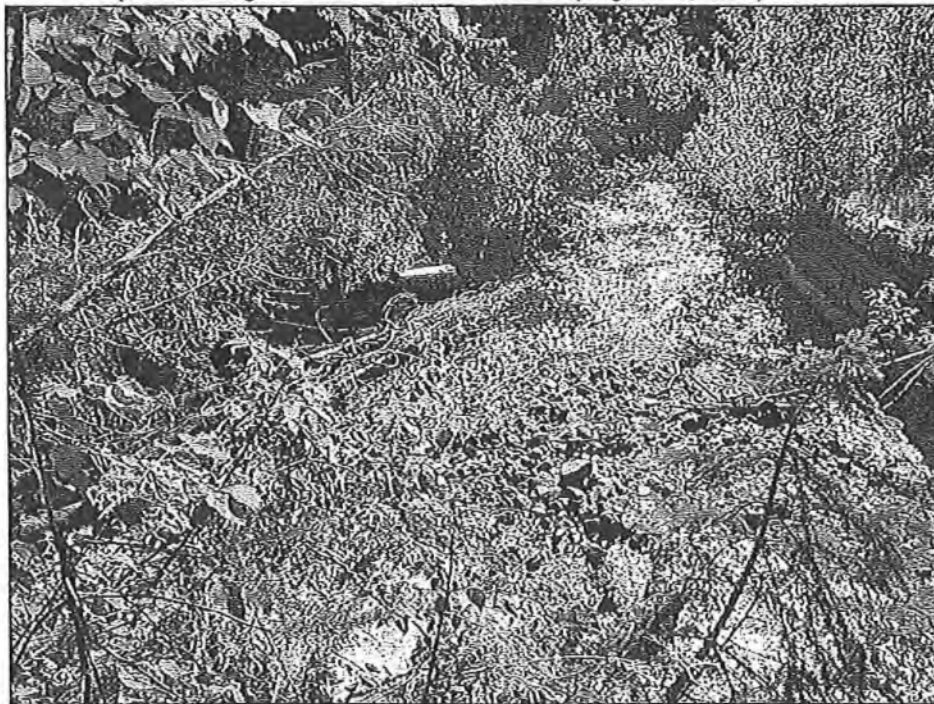
Plate 19 Fraser Tributary: View downstream through restored channel from corner of left bank (August 10, 2011).

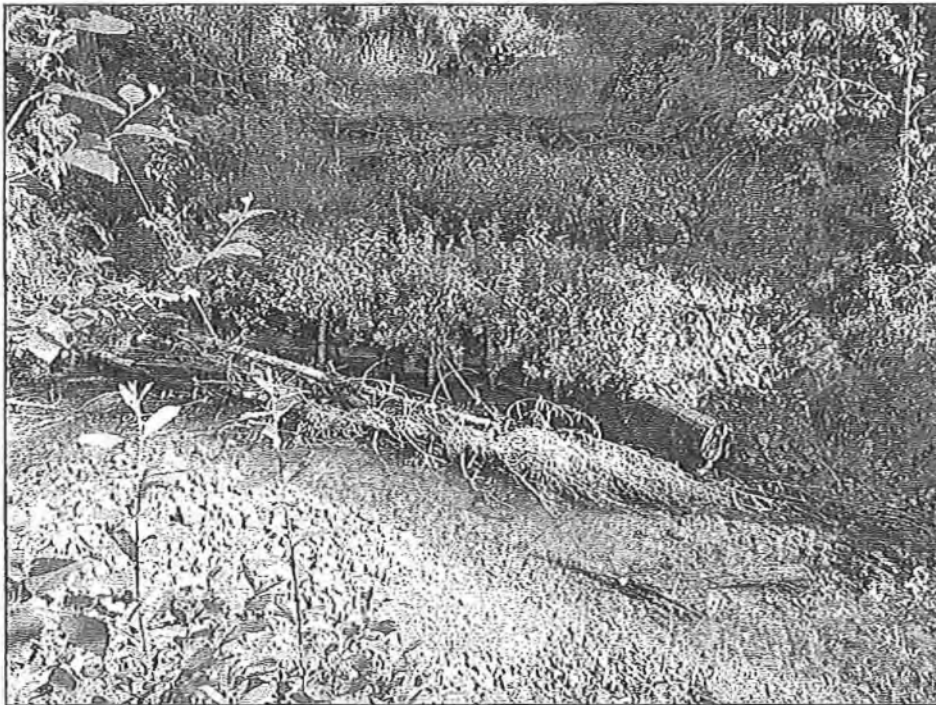
Plate 20 Fraser Tributary: View towards left bank and restoration works from right bank (August 10, 2011).

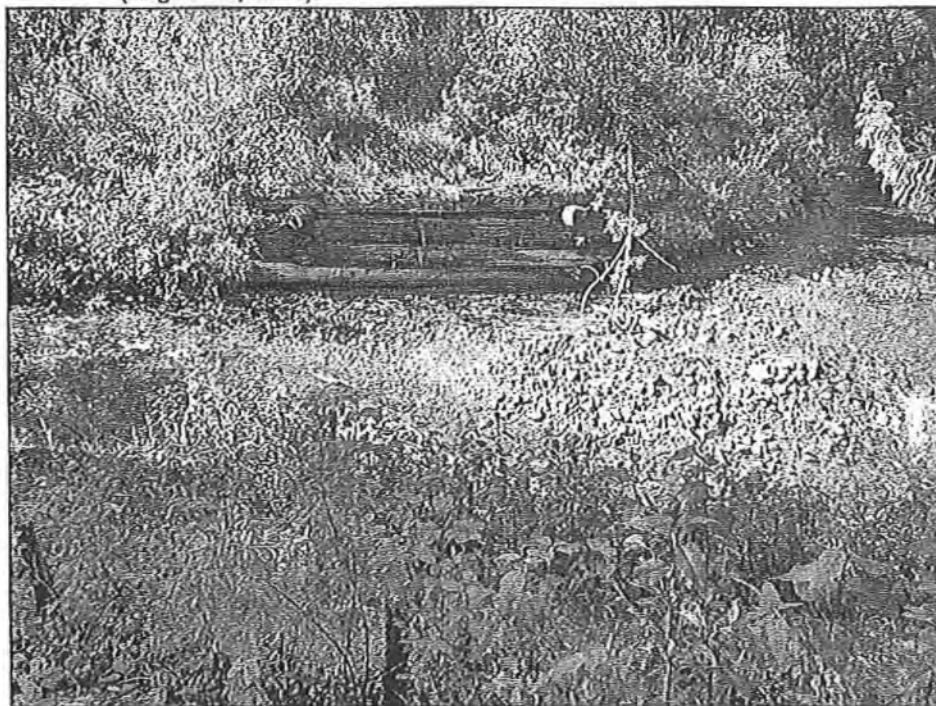
Plate 21 Fraser Tributary: View towards right bank from top of left bank showing growth of poplar stakes in photo foreground (August 10, 2011).

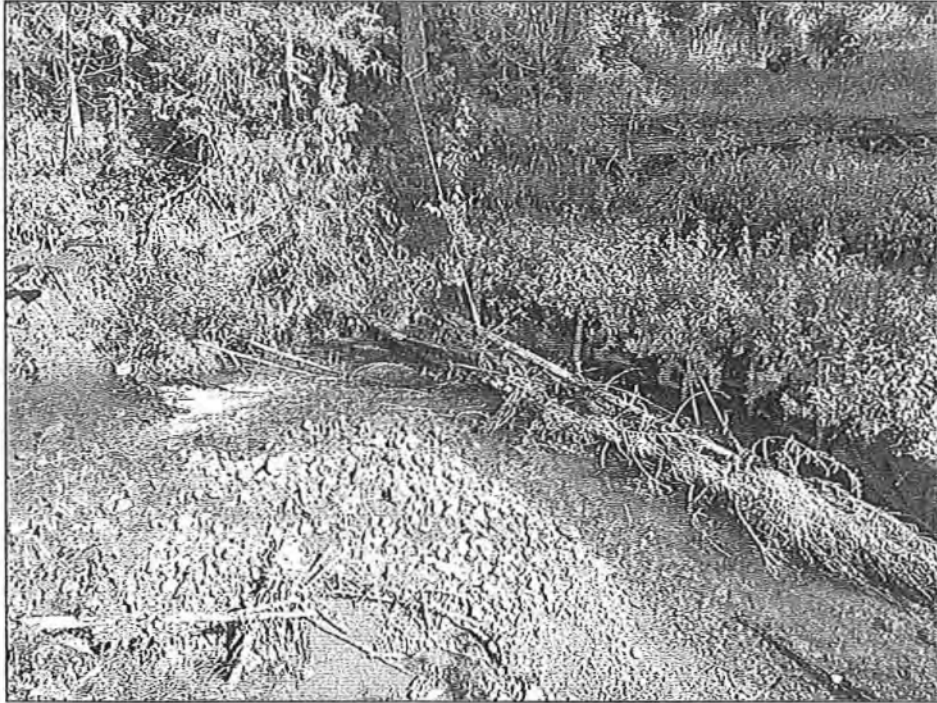
Plate 22 Fraser Tributary: View towards upstream end of left bank showing pool and depth through outside of meander bend (August 10, 2011).
