TMX - Anchor Loop Pipeline Project

Reinforced Silt Fence

COMPENSATION EFFECTIVENESS MONITORING: 2011
For the TMX – Anchor Loop Project:
Mount Robson Provincial Park and British Columbia

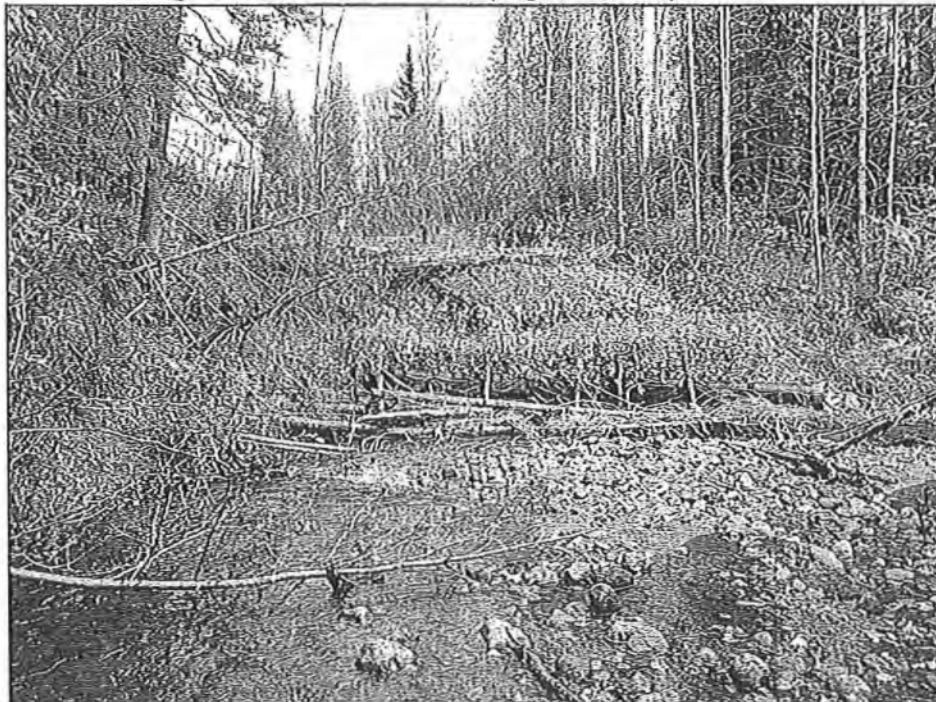
Plate 23 Fraser Tributary: View downstream towards restored bank showing cobble/gravel bar at upstream edge of restored channel right-of-way (October 17, 2011).

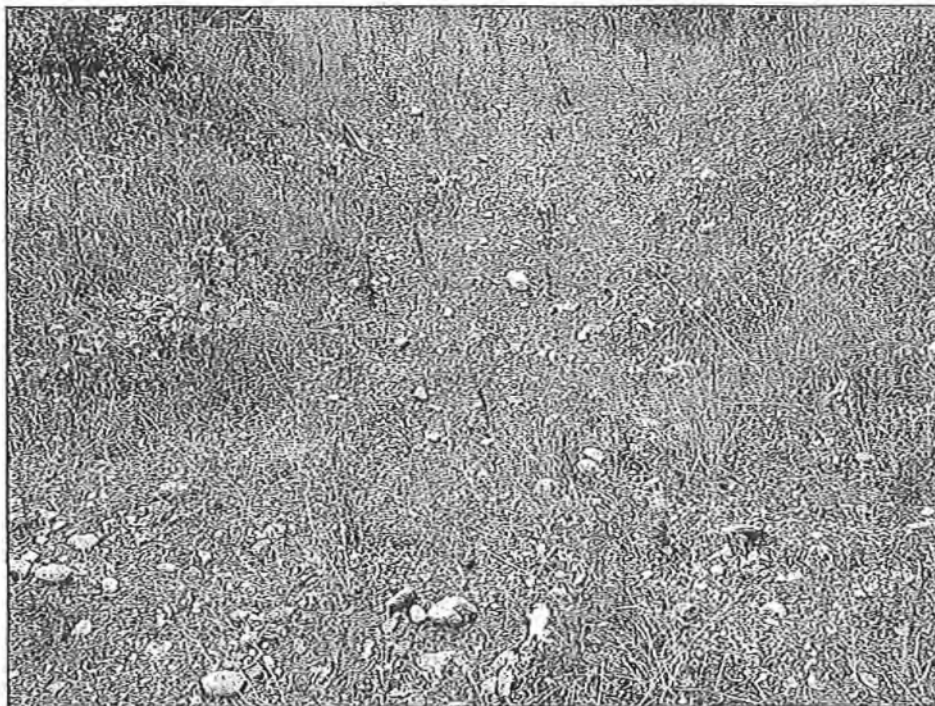
Plate 24 Fraser Tributary: View of left bank approach showing establishing cedar added to riparian area in 2011 (October 17, 2011).
