LAKE LOUETTE FLOODING

T. H. Oxland,
Hydraulic Engineer.

SYNOPSIS

ALOUETTE LAKE FLOODING

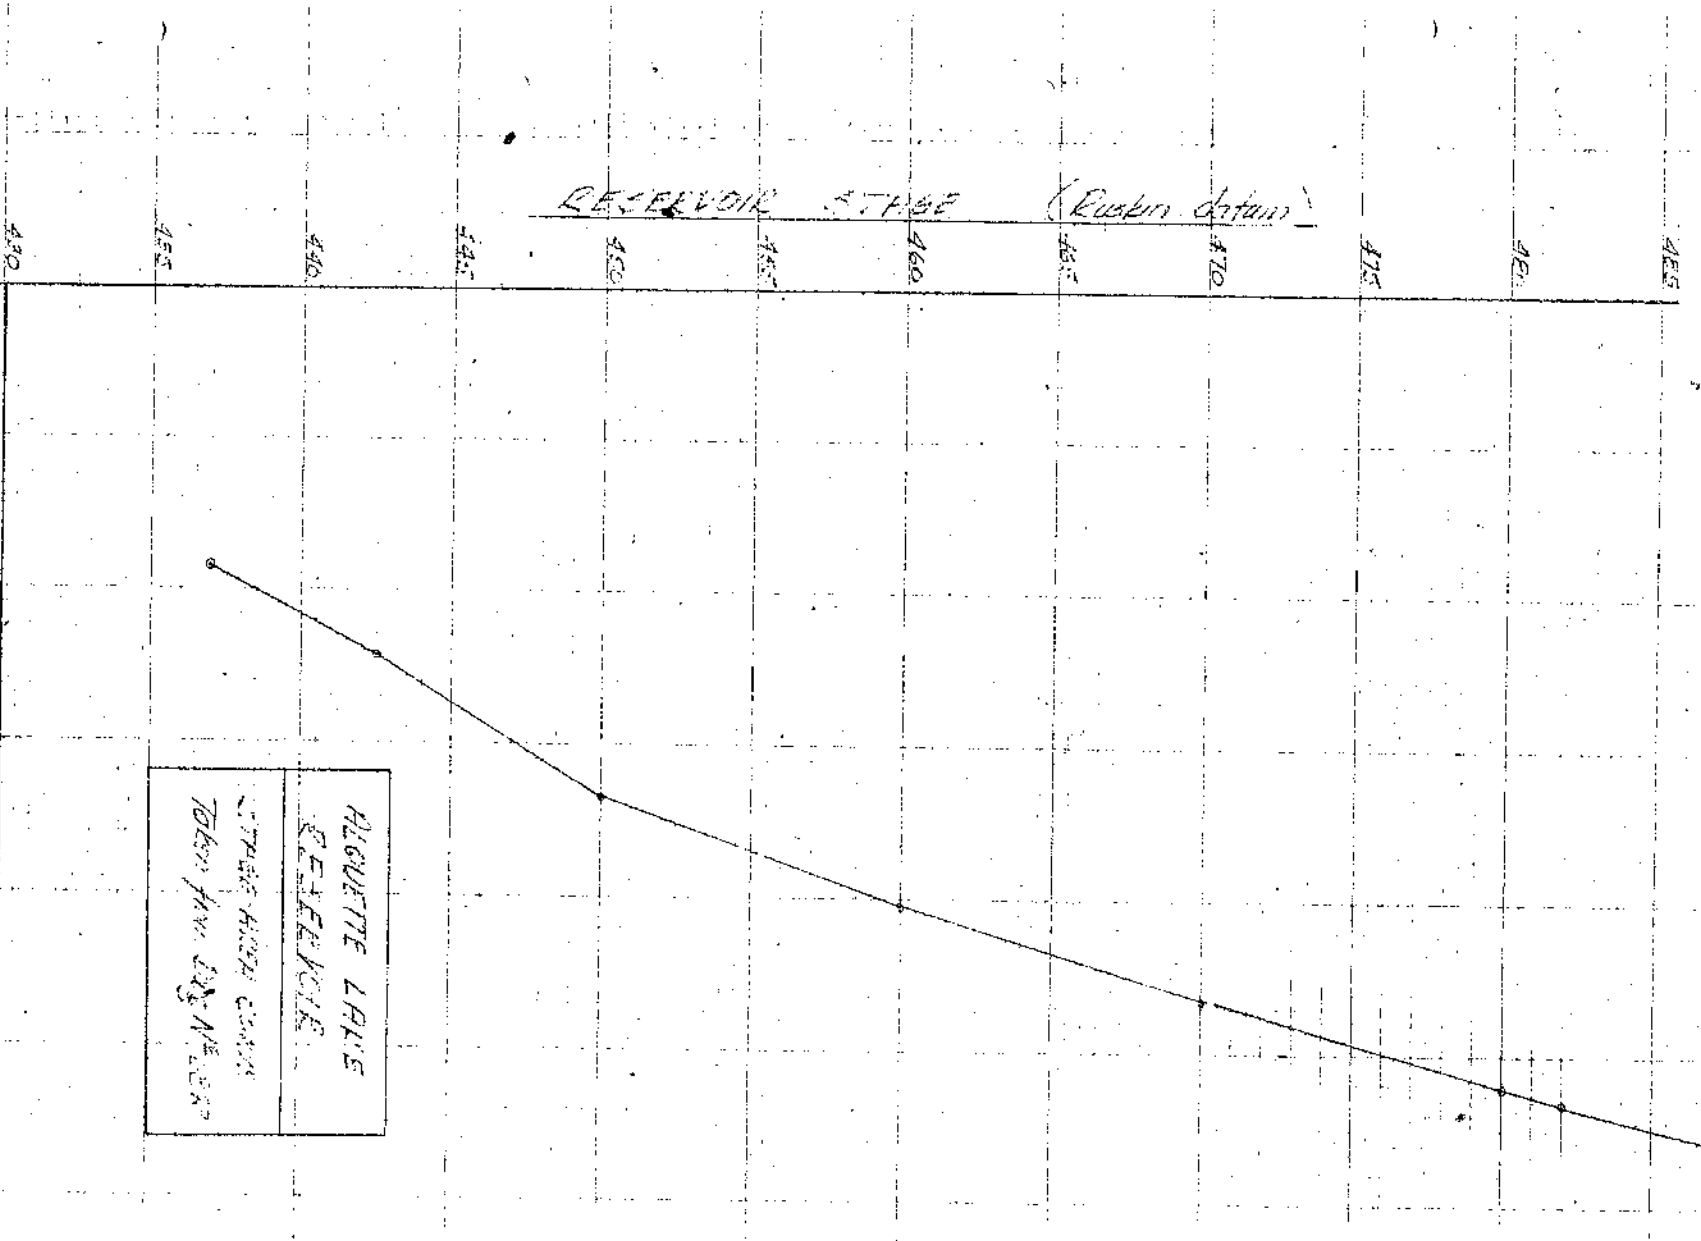
PLATE II

ALCUTTE LAKE
RESERVOIR
STAGE HIGH CORN
TAKEN FROM LOG NEAR

The stage capacity relationship for the present reservoir is tabulated on one of the construction drawings No. 5843 (see Plate II). The elevation for zero storage is shown at elevation 437 (Ruskin datum). This elevation cannot represent the level of zero natural storage in the light of arguments presented under the first assumption. From the information and drawings available the elevation 437 is the level of control of flow from Upper to Lower Lake under natural conditions and also approximates the minimum operating head on the intake for the tunnel to Stave Lake.

The stage-area curve for the reservoir used in the inflow calculations is shown on Plate II.

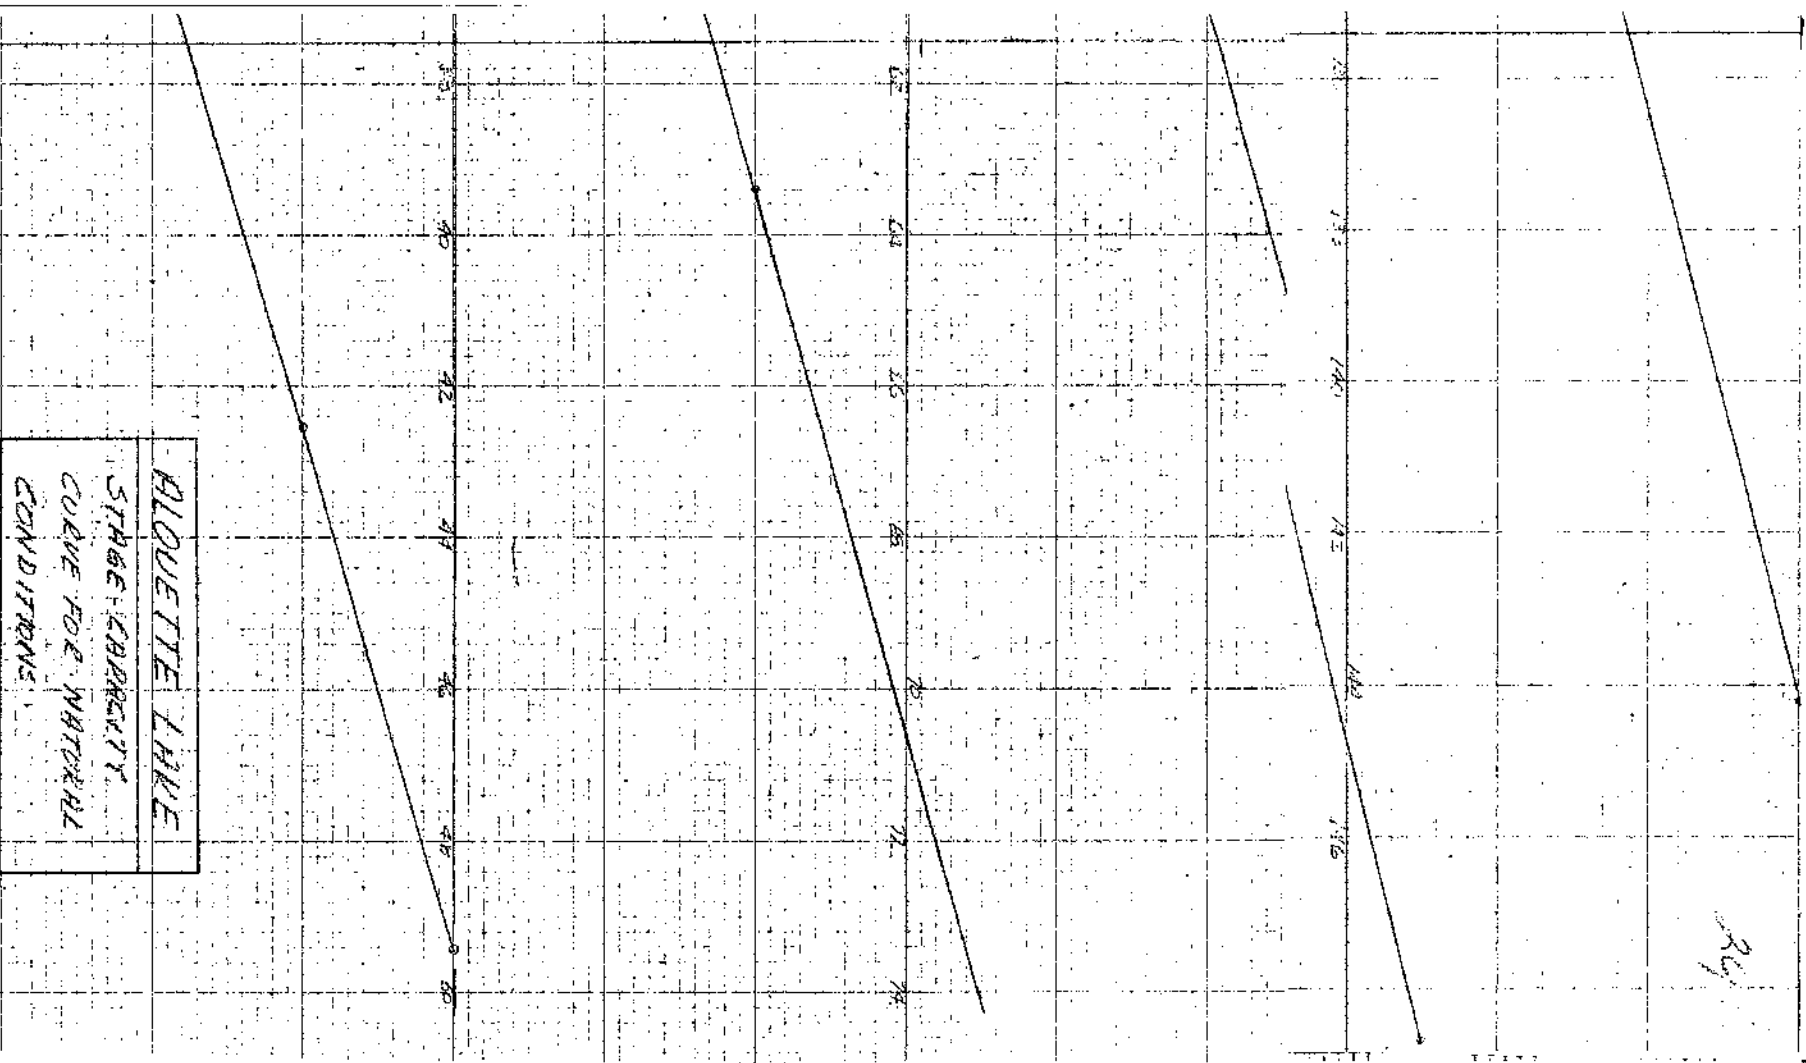
PLATE IV

ALOUETTE LAKE
STAGE CAPACITY
CULVE FOR NATURAL
CONDITIONS

A stage-capacity curve can now be drawn for the lakes under natural conditions:-

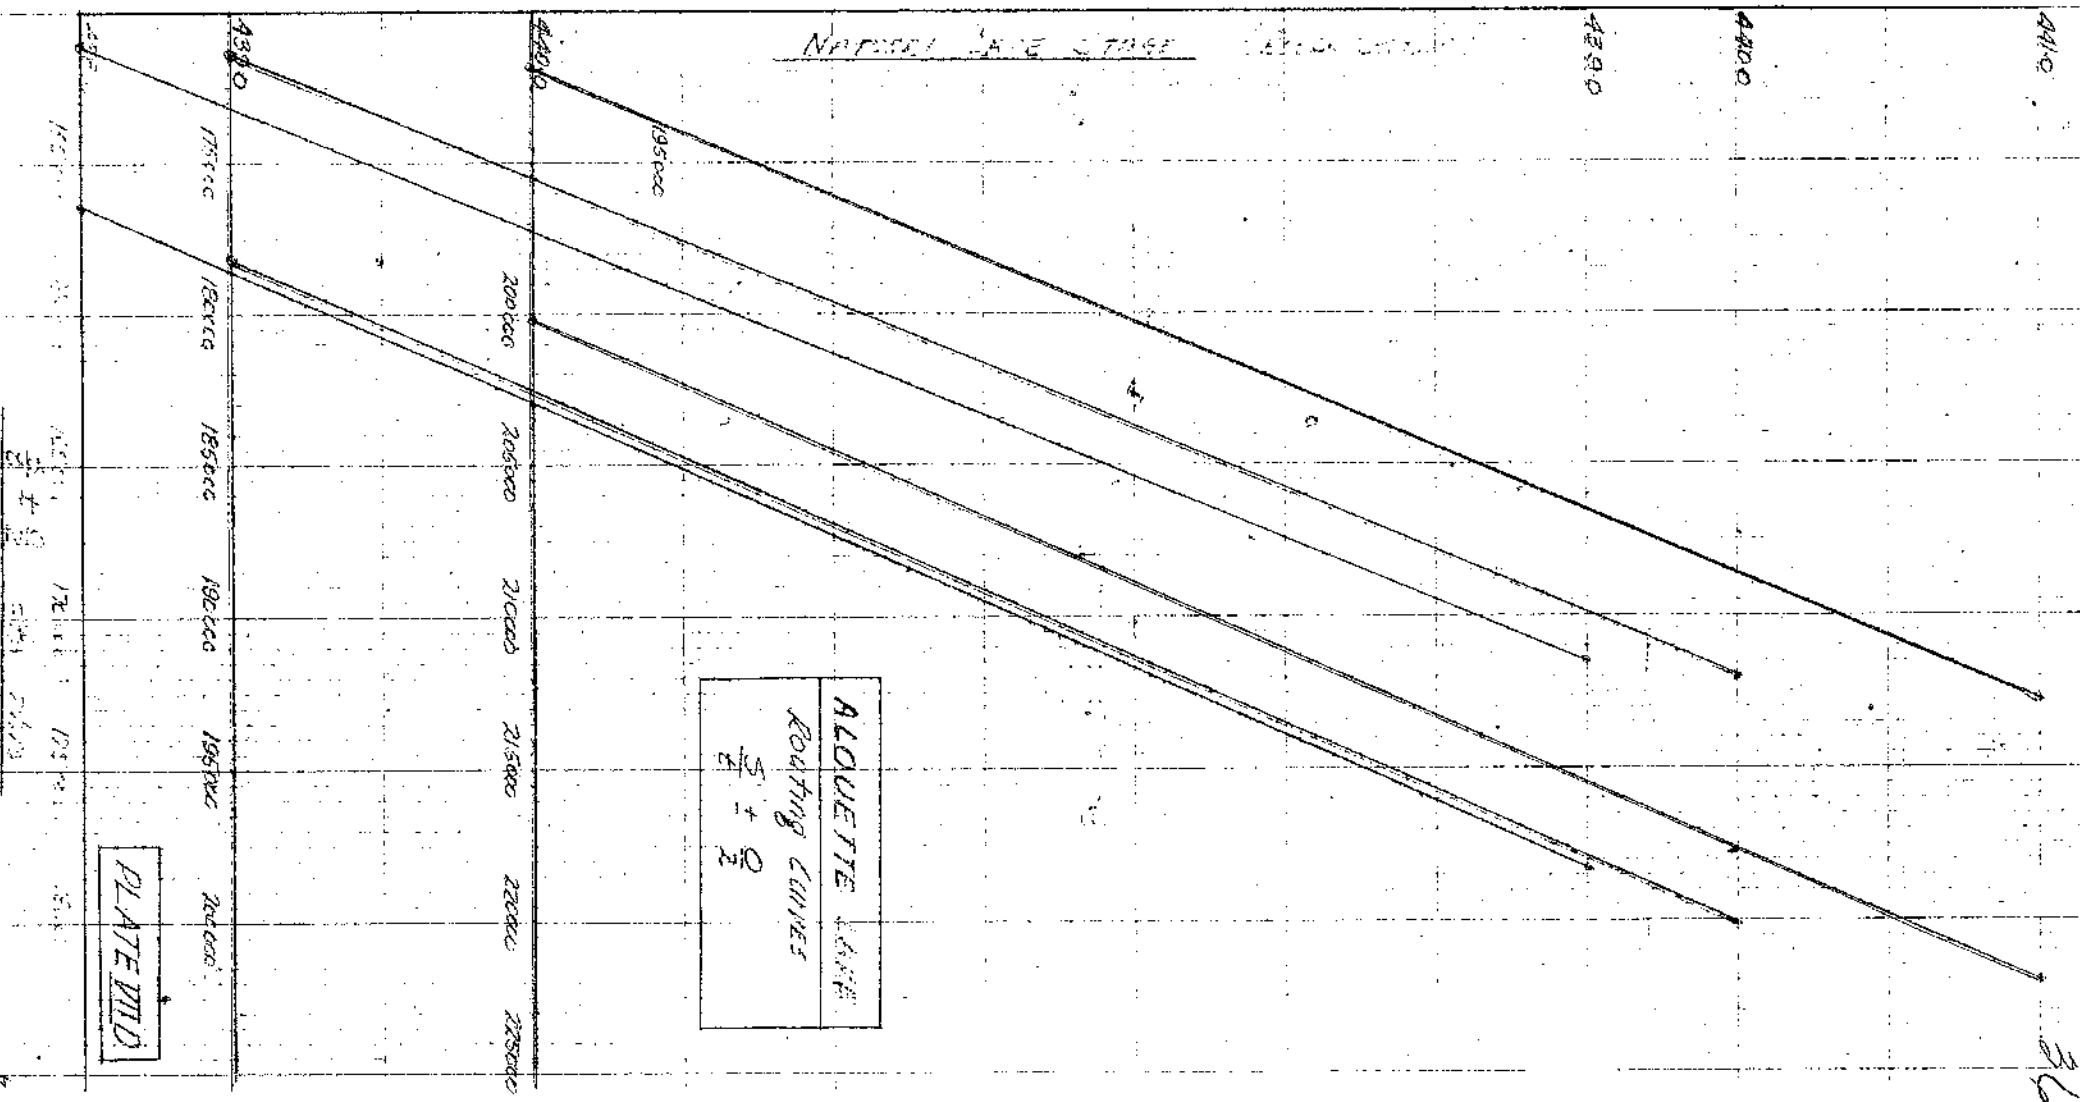
PLATE III

ALOQUETTE LAKE
Routing Curves
$\frac{5}{2} \cdot \frac{1}{4} \cdot \frac{0}{2}$

See Plate VI and VII (A to E) for plotted routing curves.

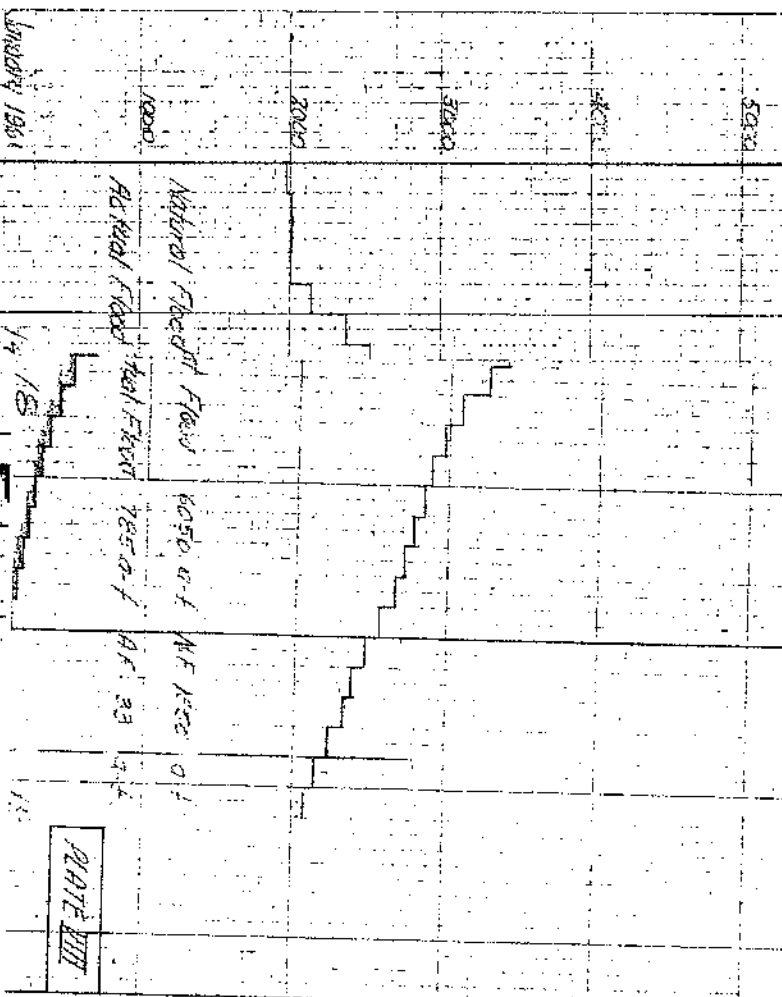
PLATE VIII

ALOUETTE LAKE
Comparison of 2 hr
flow over dam spillway
to calculated natural
outflow from 1952

The actual conditions upstream at the Alouette dam (reference plate VIII) show that the discharge occurring between 2 PM and 8 PM exceeded computed natural outflow conditions by between 500 and 1000 c.f.s. This amounts to between 4% and 8% of the outflow which is probably within the limits of the computing error. It would appear that allowing for a time lag in the 10 miles of intervening river that at least a portion of the upstream peak did coincide with maximum high water conditions to the south.

The maximum 24-hour discharge through the spillway and over the gates started one-half a day later when an average of 10,948 cfs were released between 0600 hrs on January 15 and 16, 1961 (Reference Plate VIII).

The outflow under natural conditions is now calculated using the routing curves developed. The results of the daily and 2-hourly routings are shown on Table X and XI. These results are also shown graphically on Plate VIII and IX.

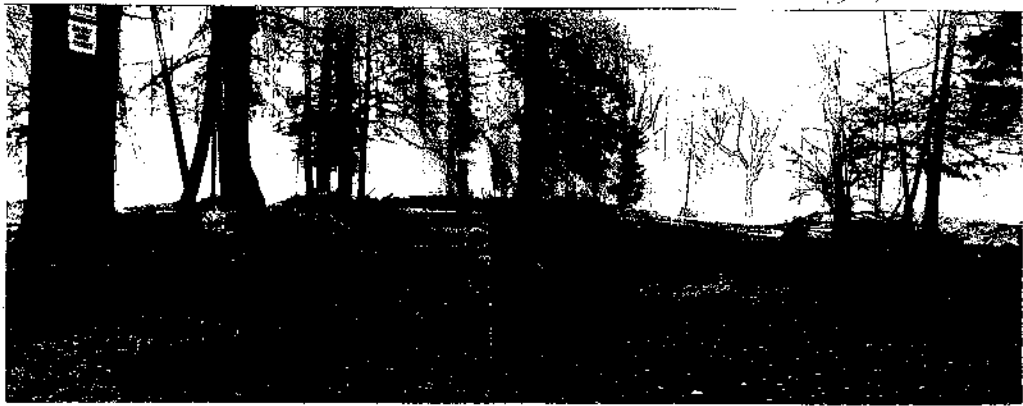
MAPLE RIDGE PARK FINIC SITE. IN THE RIGHT BACKGROUND THE BRIDGE
ON 14th AVE. OVER THE SOUTH ALLEGHENIE RIVER. PICTURE TAKEN FACING SOUTH.

Damage to property in this vicinity was centered on the Maple Ridge Park site. See photographs in Appendix . The private house and barn, although at one time partially surrounded by water, was not damaged.

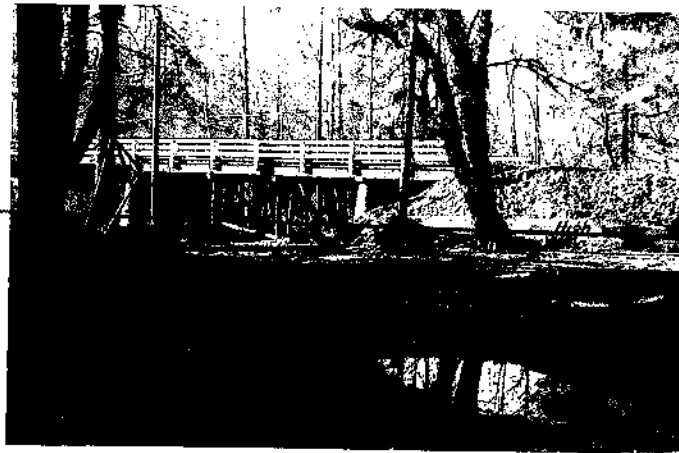
MAPLE RIDGE PARK. THE BRIDGE OVER THE SOUTH ALLEGHENIE RIVER. PICTURE
TAKEN FROM THE DOWNSTREAM SIDE OF THE NORTHERN APPROACH.

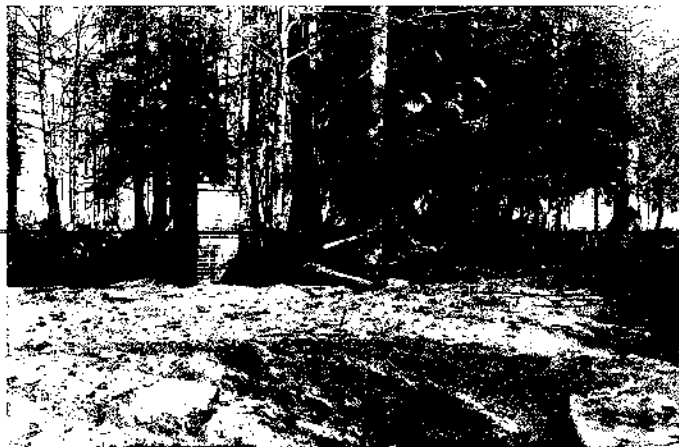
Approx. HWM

MAPLE RIDGE PARK ENTRANCE FROM 14th AVE. PICTURE TAKEN FROM 14th
AVE. FACING S. STREAM, (EAST).

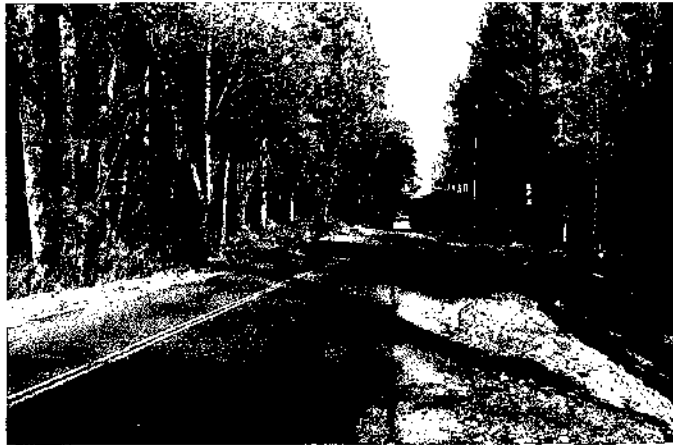
HAILE RIDGE PARK. VIEW FACING NORTH ALONG 14th AVE TOWARDS THE BRIDGE
OVER THE NORTH ALOUETTE RIVER. NOTE THE WINDROW OF SAND ON EITHER SIDE
OF THE ROADWAY OPPOSITE THE VEHICLES.

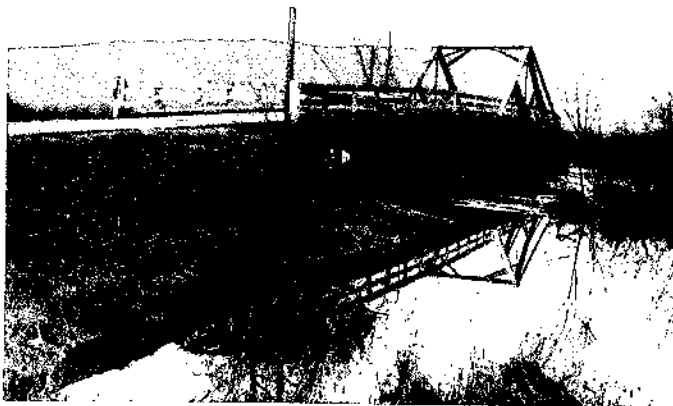
BRIDGE OVER THE SOUTH ALOUETTE RIVER ON NEAVES ROAD. PHOTOED TAKEN FROM
THE SOUTH UPSTREAM BANK. H.W.M. 13.06 G.S.C.

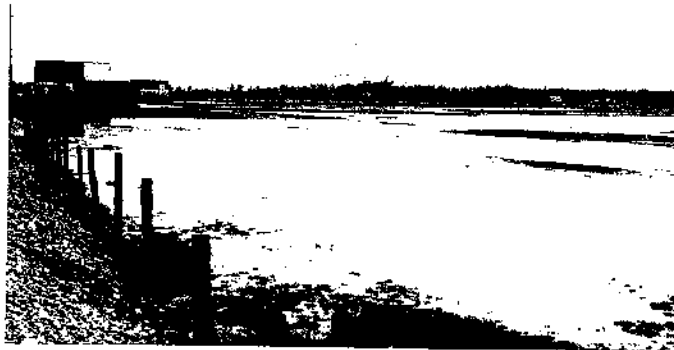
CASLE RIDGE DISTRICT. VIEW LOOKING SOUTH FROM THE DEWDNEY TRUNK ROAD
JUST EAST OF THE INTERSECTION OF THE DEWDNEY TRUNK ROAD AND MCKENSHINE ROAD.
WATER LEVEL IN FIELD IN FOREGROUND 4.29 G.S.C.

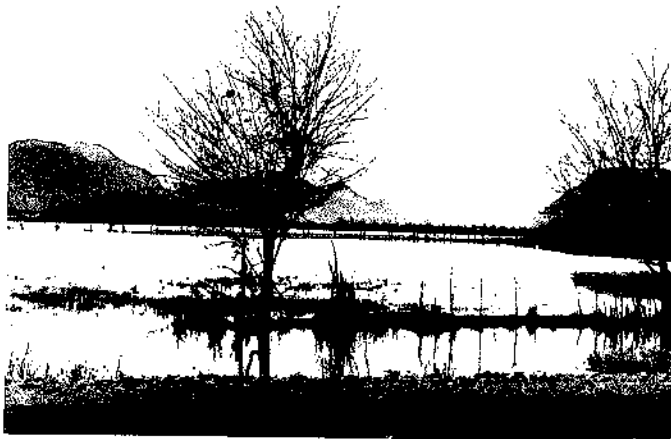
CASLE RIDGE DISTRICT. VIEW LOOKING NORTH FROM DEWDNEY TRUNK ROAD FROM
SAME POSITION AS IN PICTURE ABOVE. PITT FOLDER IN THE BACKGROUND.
