SITUATION REPORT #2

Event: Flooding and Landslides

From: Edward Witwicki
Sent: February 17, 2016 3:45 PM
To: Ryan Wainwright <RWainwright@slrd.bc.ca>
Subject: Birken Landslide

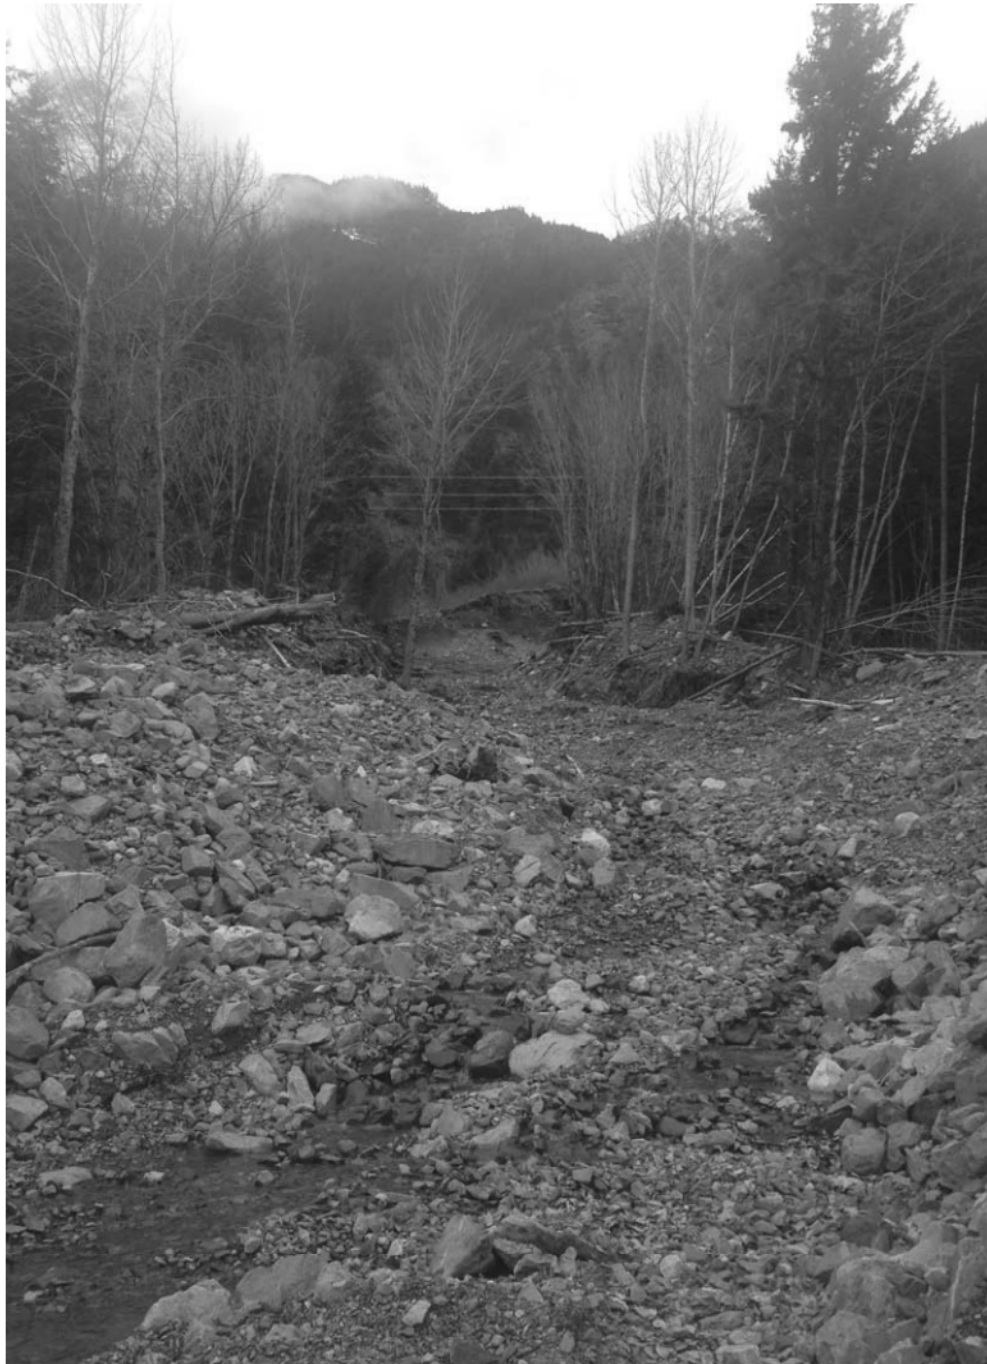
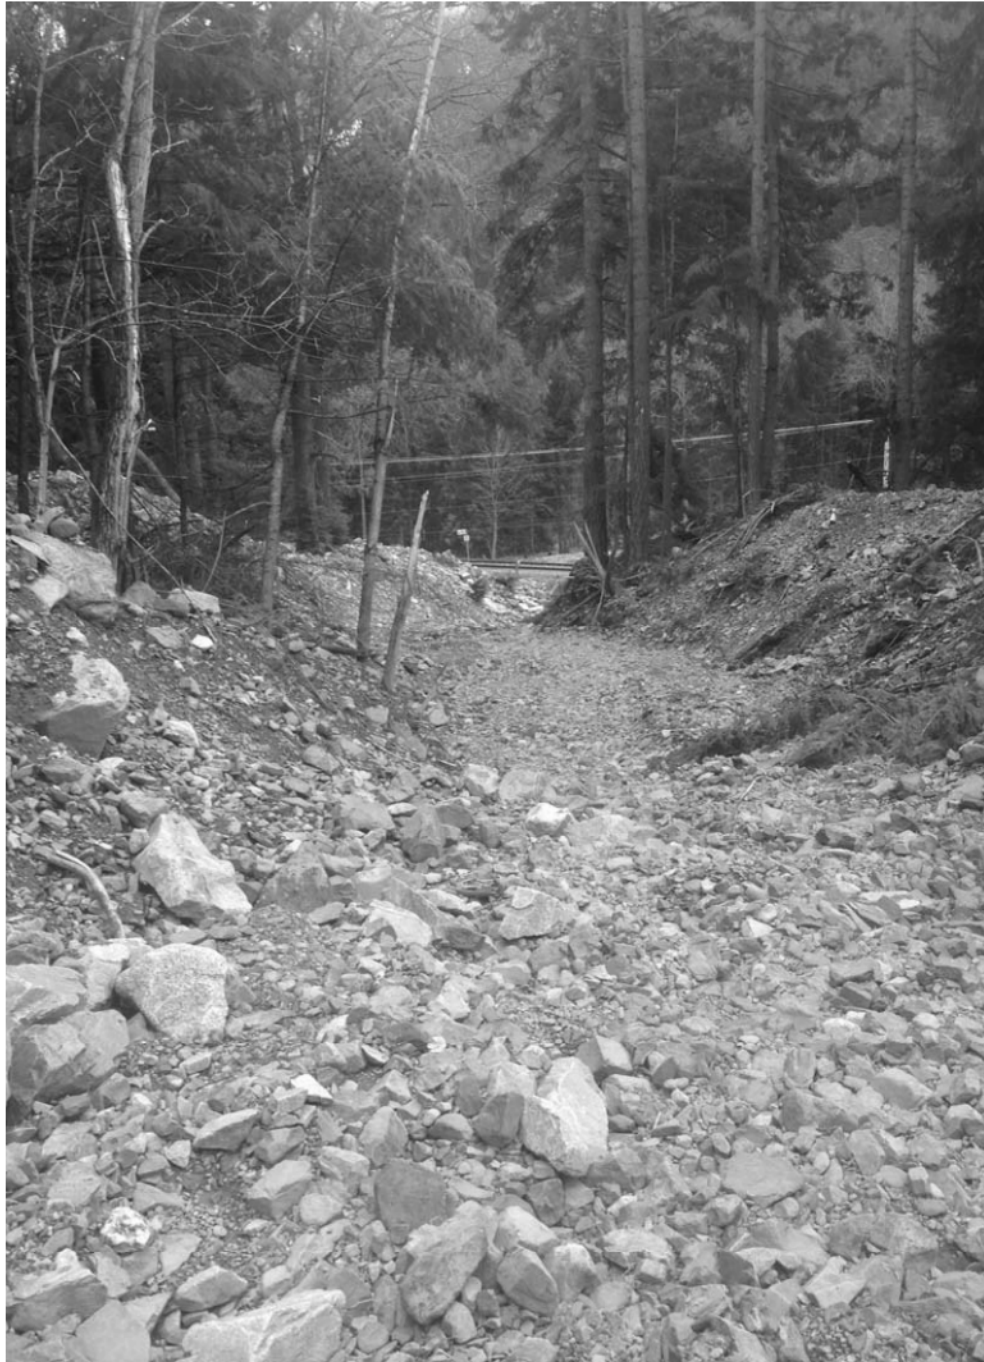
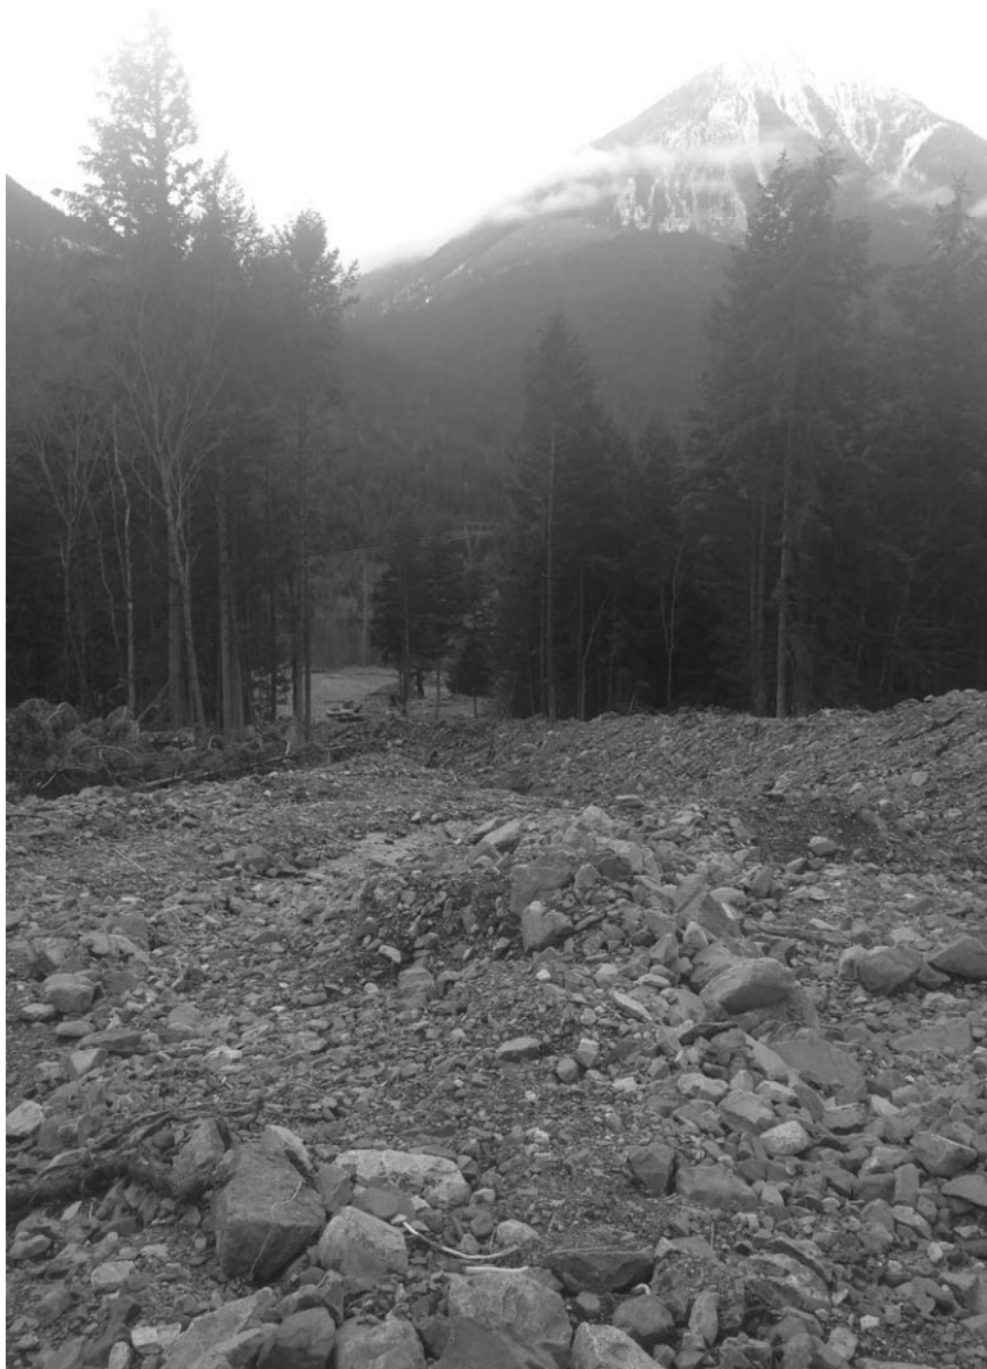
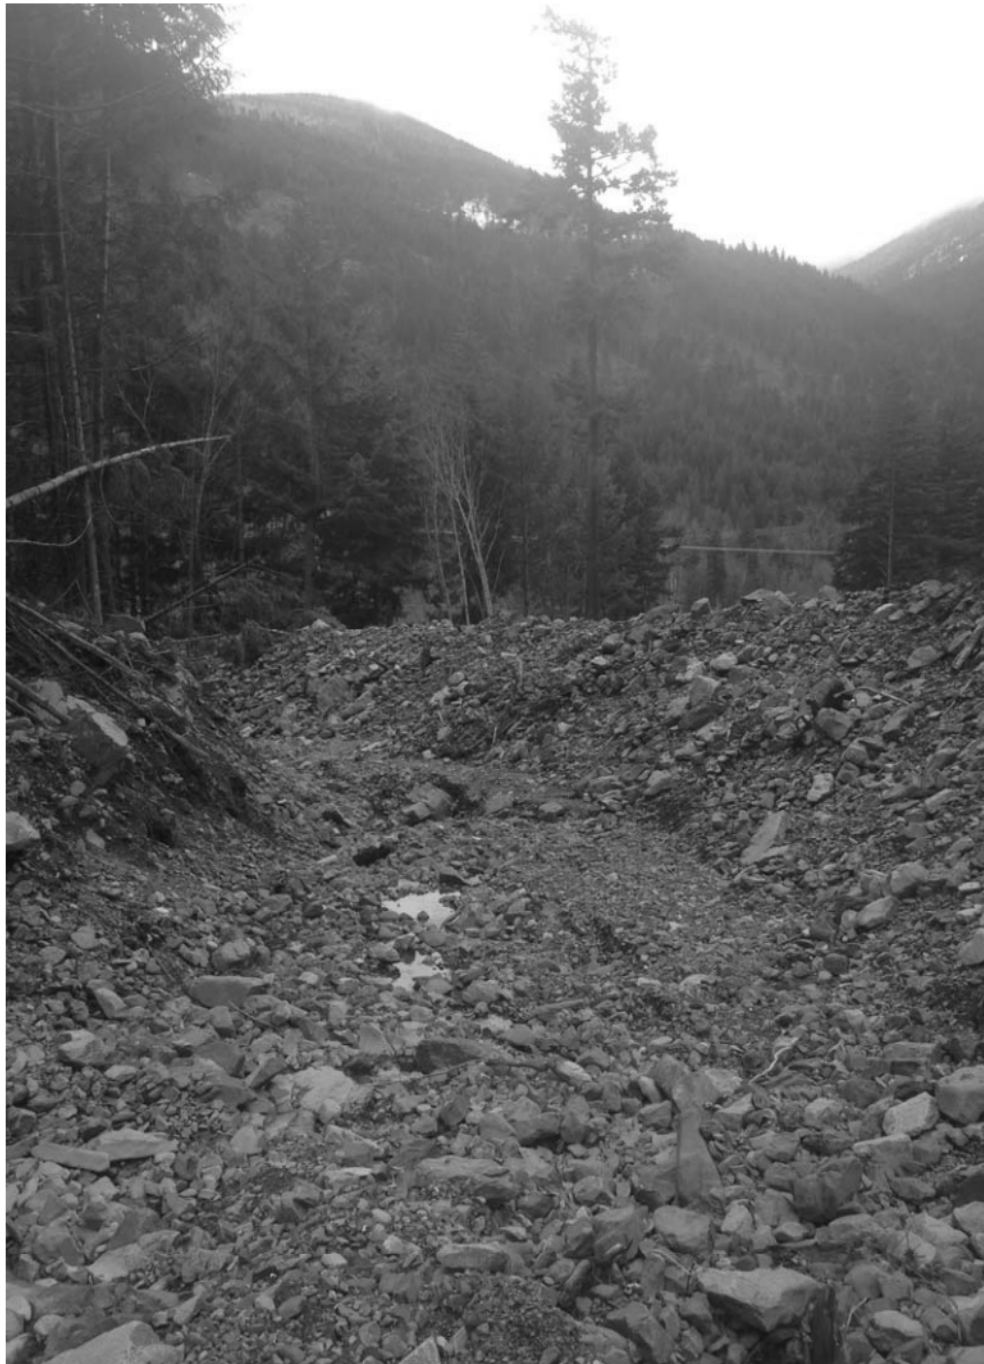
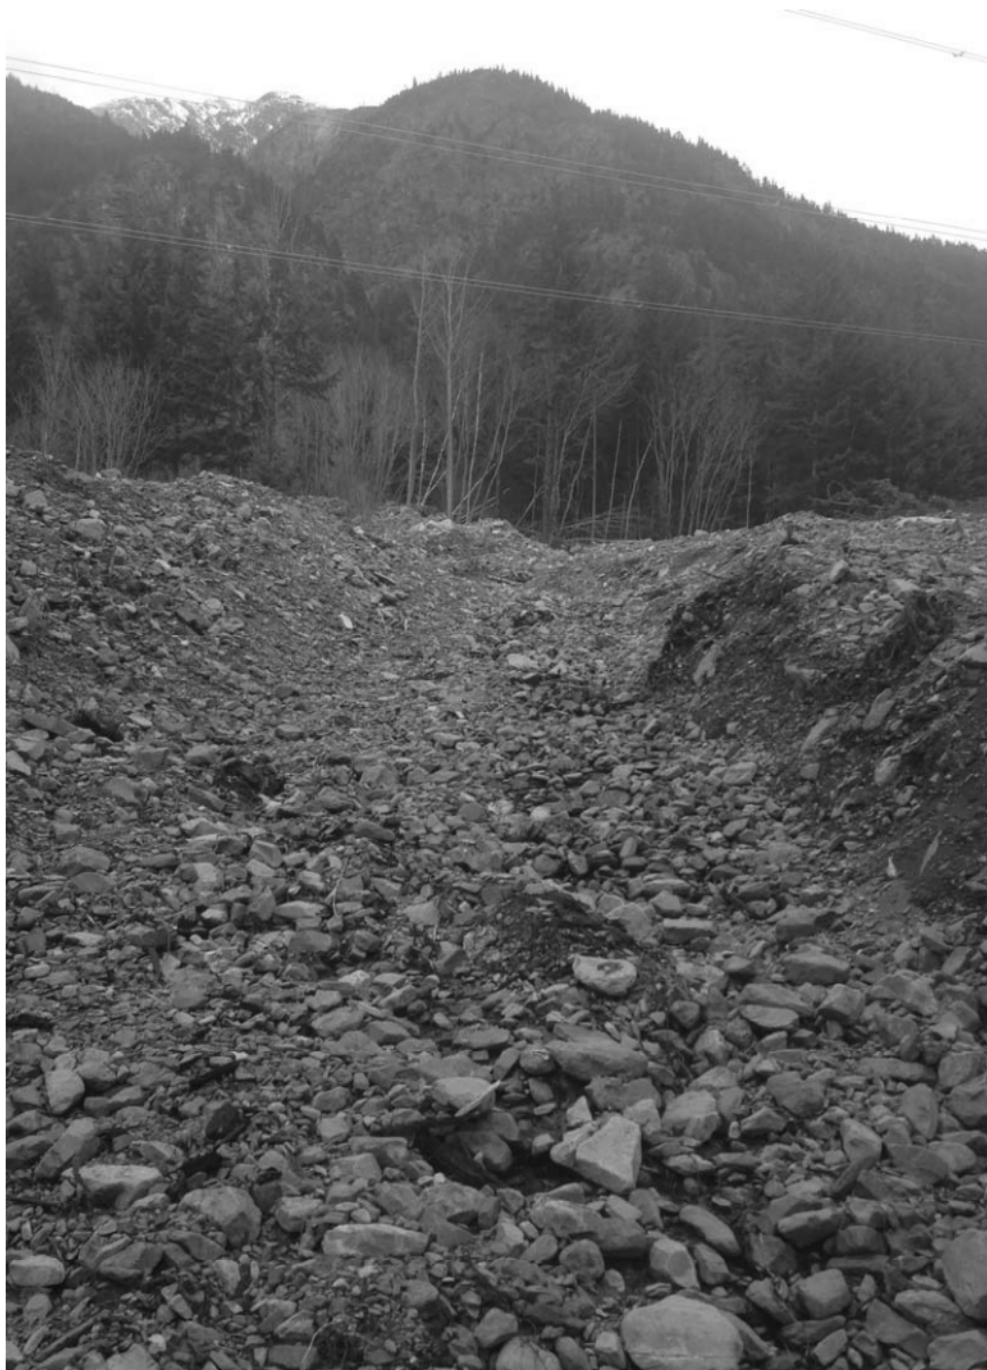
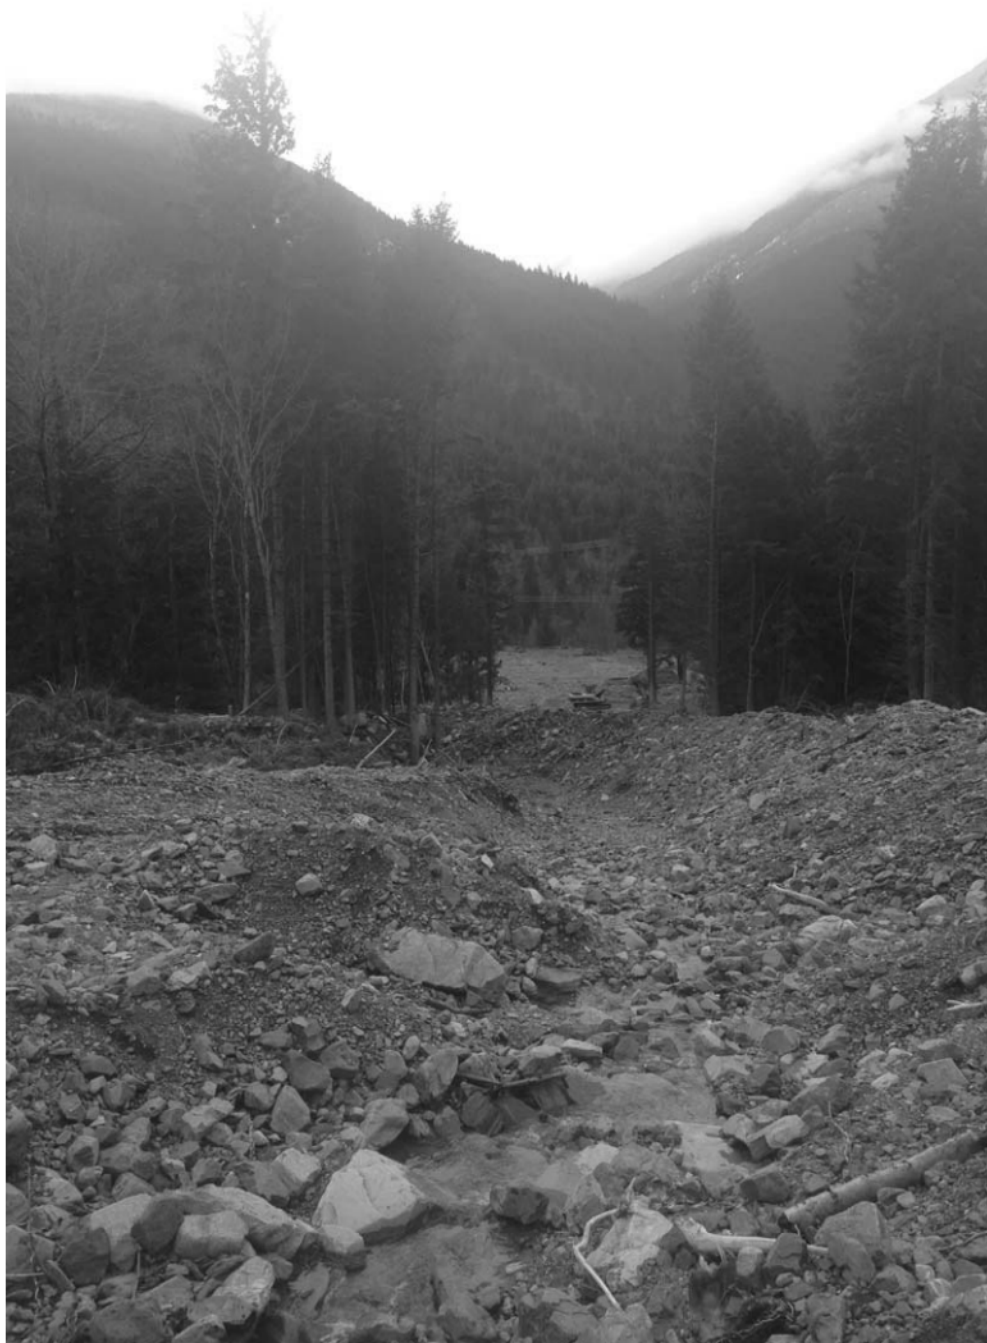
I walked up the creek channel up stream approximatley 200m from the highway . It looks like CN has done some work in the channel up to and under the hydro lines and then had stopped there. There is water running down the creek channel it disperses into the ground upstream from highway approximately 100m. Not water is reaching the the CN bridge. The creek channel alignment seems to be following the path that the slide followed.
